ASBESTOS SURVEY REPORT FOR MONKTON JUNIOR SCHOOL, DAME FLORA ROBSN AVENUE, SOUTH SHIELDS, TYNE AND WEAR, NE34 9RB.

Asbestos Register for Monkton Junior School, South Shields

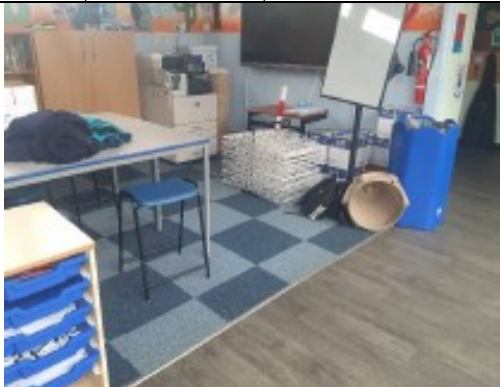
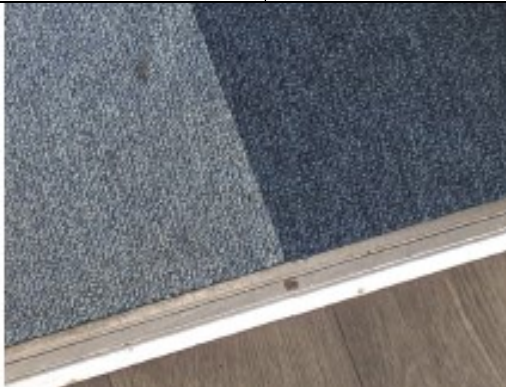
19	As EV007270	Bitumen floor	Work Area G/027	Low Risk – 6 monthly

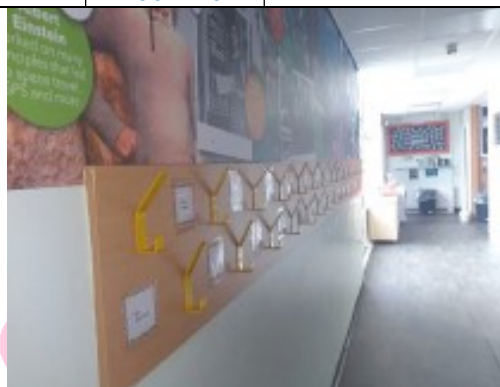
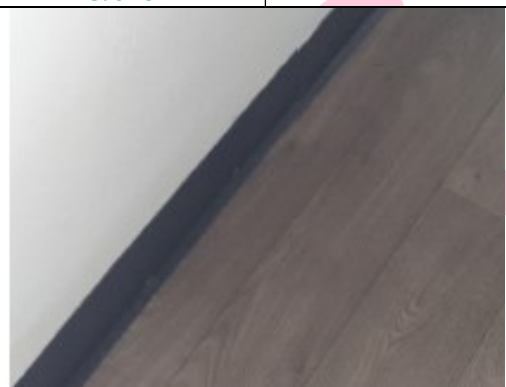
20	As EV007270	Bitumen floor	Circulation/upper corridor G/028	Low Risk – 6 monthly

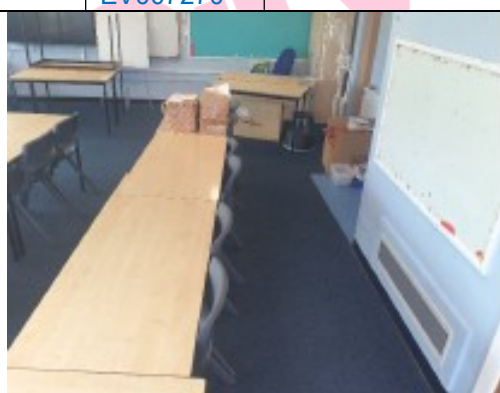
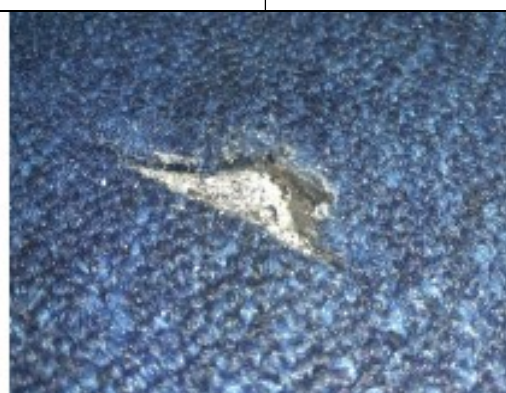
21	As EV007270	Bitumen floor	Classroom 6A G/029	Low Risk – 6 monthly

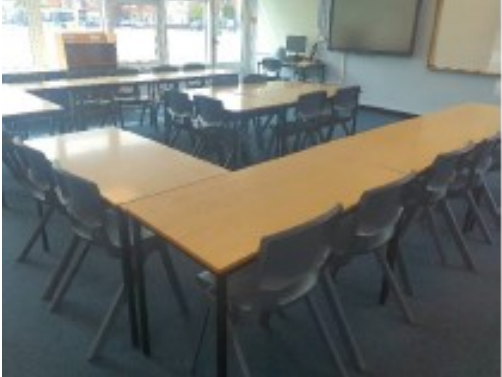
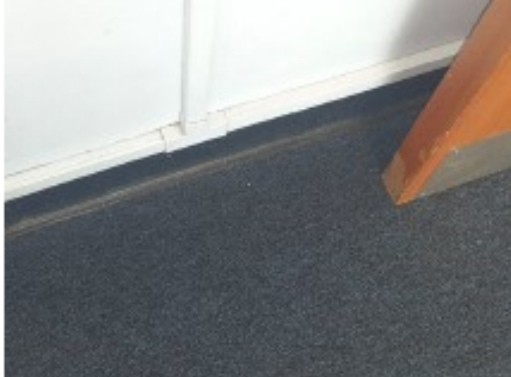
22	As EV007270	Bitumen floor	Classroom 6B G/032	Low Risk – 6 monthly

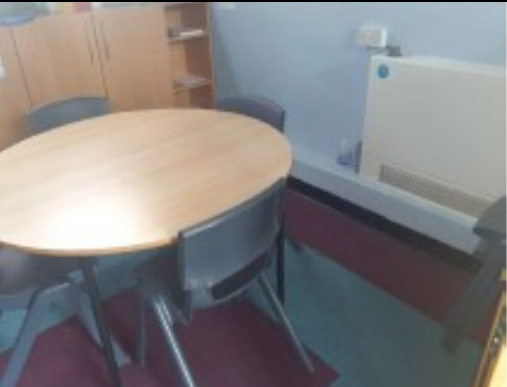
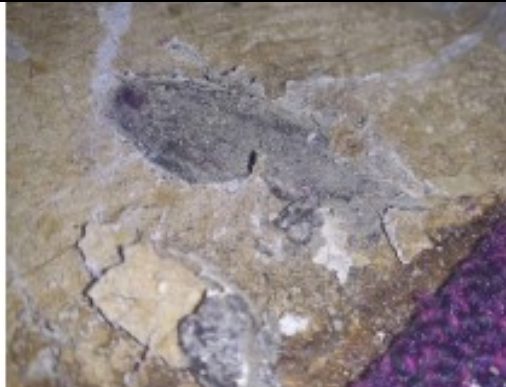
23	As EV007270	Bitumen floor	Classroom/Work Area G/033	Low Risk – 6 monthly

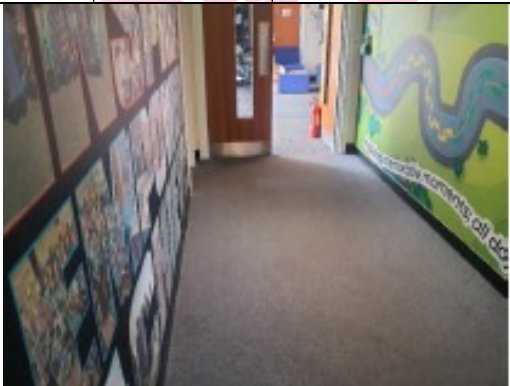
24	EV007278	Vinyl tiles and bitumen floor	Staff Area corridor G/039	Low Risk – 6 monthly

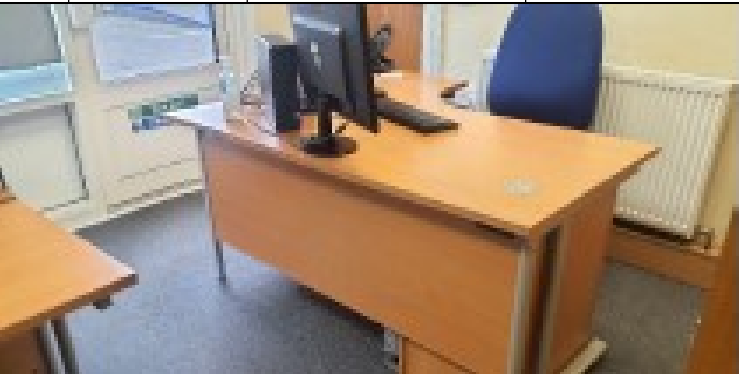
25	As EV007278	Vinyl tiles and bitumen floor	Office G/040	Low Risk – 6 monthly

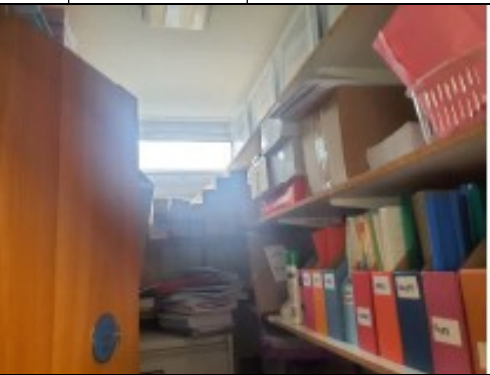
26	EV002729	Vinyl tiles and bitumen floor	Store G/041	Low Risk – 6 monthly
