ASBESTOS SURVEY REPORT FOR MONKTON JUNIOR SCHOOL, DAME FLORA ROBSON AVENUE, SOUTH SHIELDS, TYNE AND WEAR, NE34 9RB.

Asbestos Register for Monkton Junior School, South Shields

Date: 18 August 2025

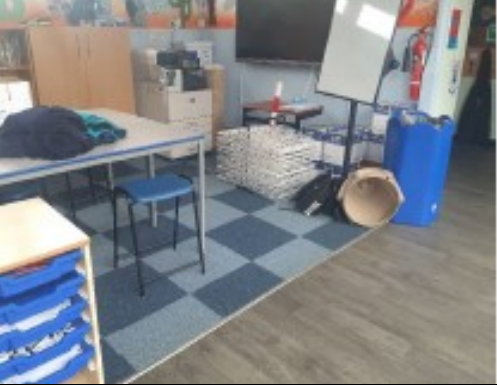
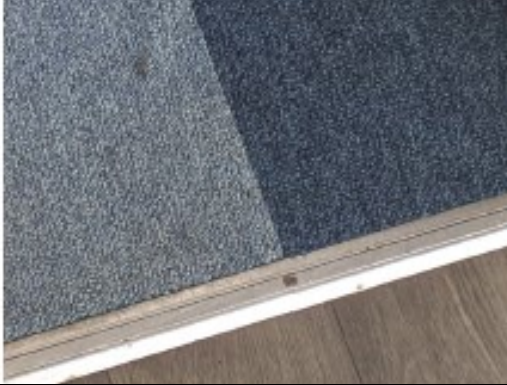
19	As EV007270	Bitumen floor	Work Area G/027	Low Risk – 6 monthly

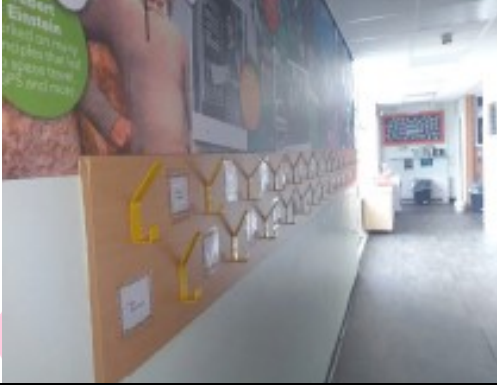
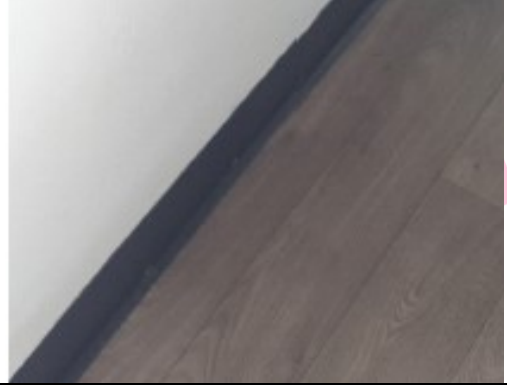
20	As EV007270	Bitumen floor	Circulation/upper corridor G/028	Low Risk – 6 monthly

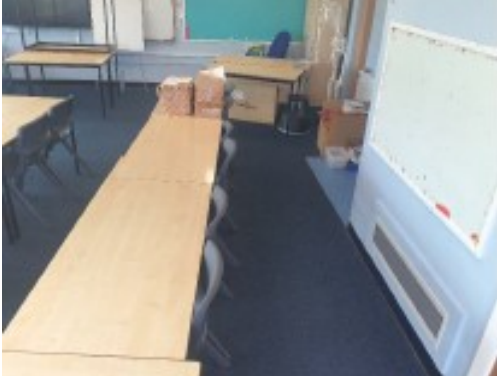
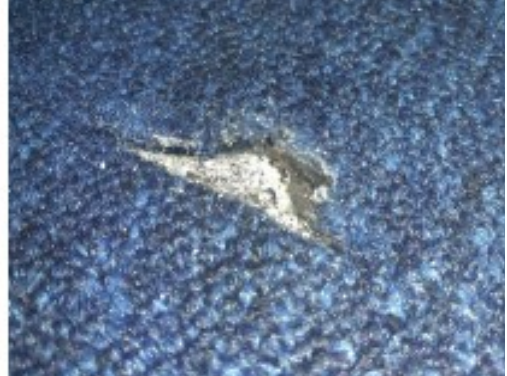
21	As EV007270	Bitumen floor	Classroom 6A G/029	Low Risk – 6 monthly

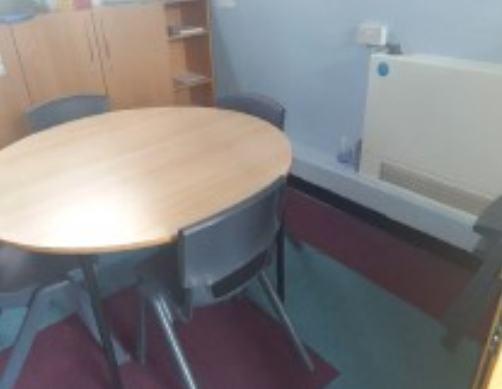
23	As EV007270	Bitumen floor	Classroom/Work Area G/033	Low Risk – 6 monthly
