ASBESTOS SURVEY REPORT FOR RIVERSIDE PRIMARY SCHOOL,
COLLIERY ROAD, GATESHEAD, NE11 9DX

Asbestos Register for Riverside Primary School

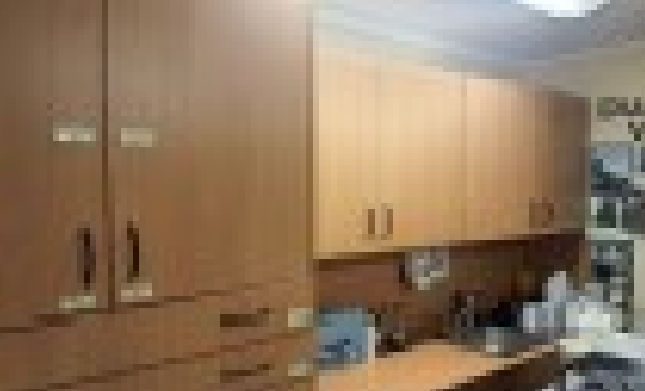
8	EV007302	Textured coating ceiling	Communal area G/025	Low Risk

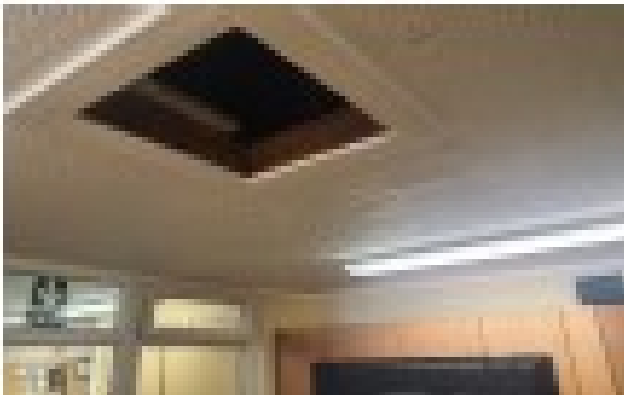
9	EV007303	Insulating board hatch	Communal area G/025	No Risk

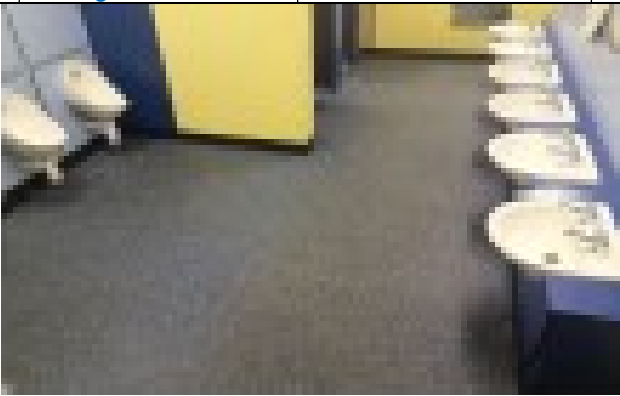
13	As EV007304	Textured coating ceiling	WC G/028	Low Risk

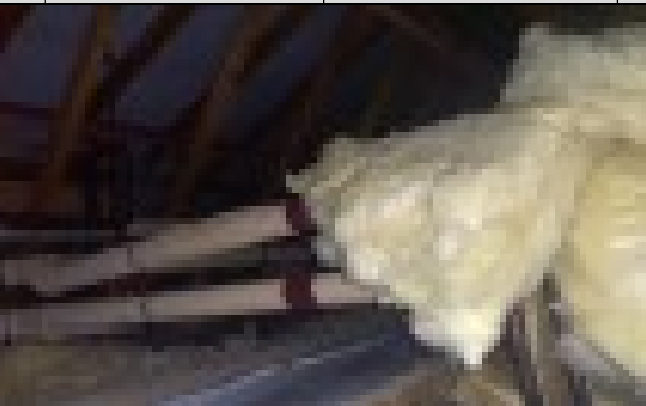
14	As EV007303	Insulating board hatch	WC G/028	No Risk

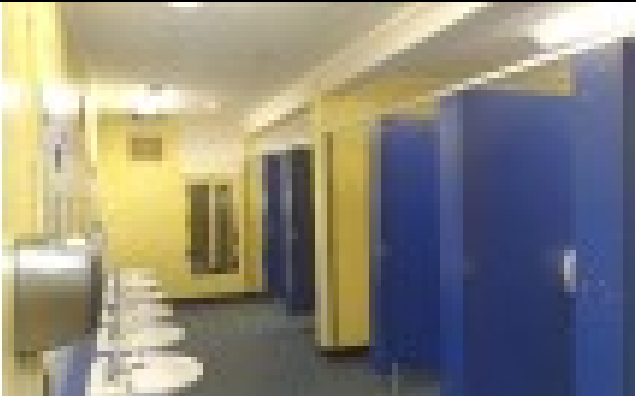
15	EV007305	Textured coating ceiling	WC G/029	Low Risk

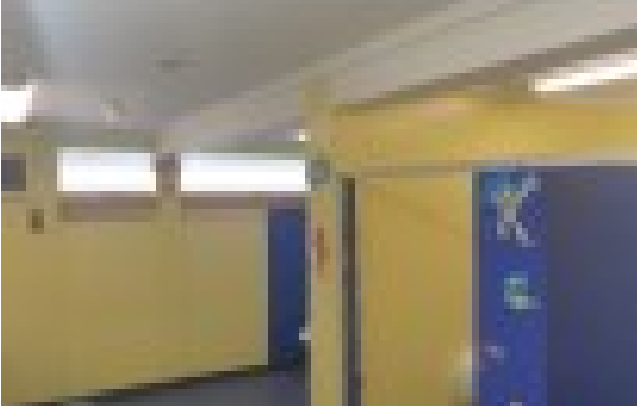
34	As EV007316	Textured coating ceiling	WC G/049	Low Risk

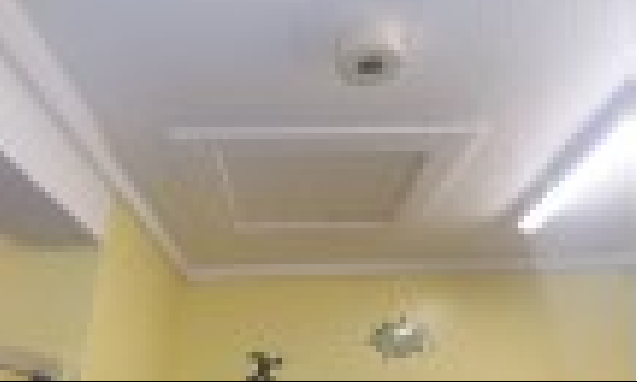
35	As EV007313	Insulating board hatch	WC G/049	No Risk

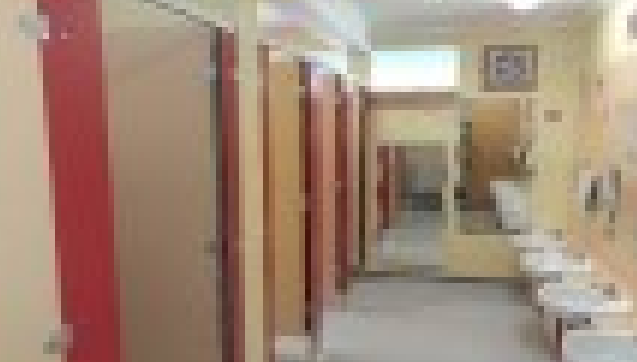
36	As EV007316	Textured coating ceiling	WC G/050	Low Risk

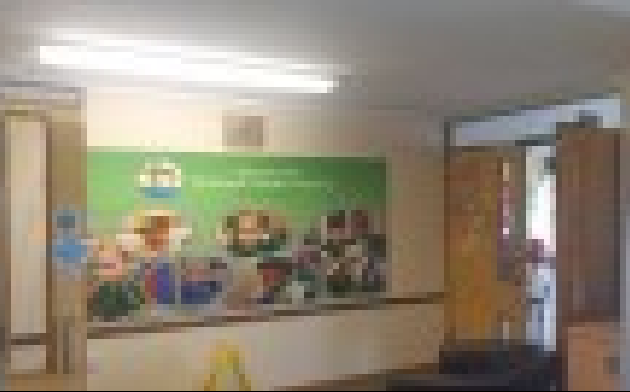
52	EV007325	Textured coating ceiling	Entrance lobby G/065	Low Risk

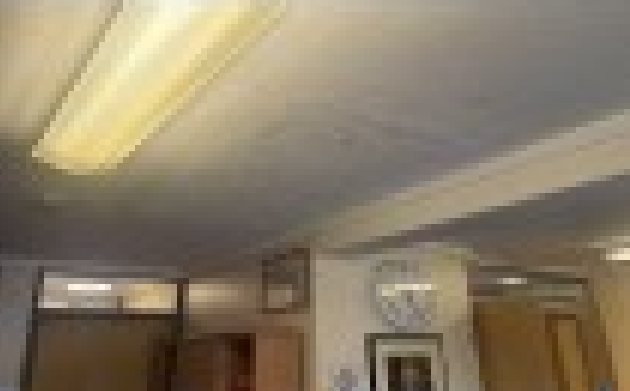
53	EV007326	Textured coating ceiling	Entrance lobby G/065	No Risk

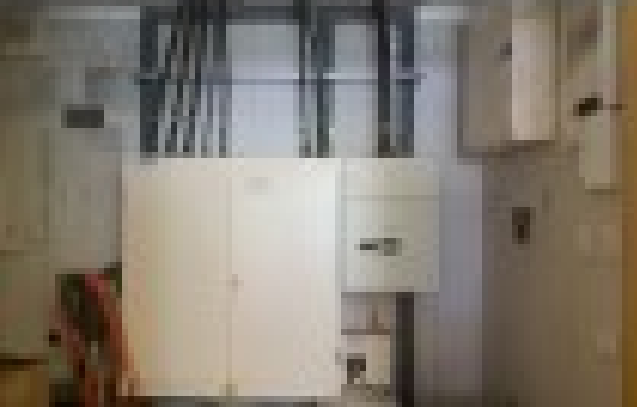
55	EV007327	Textured coating ceiling	Electric cupboard G/067	Low Risk

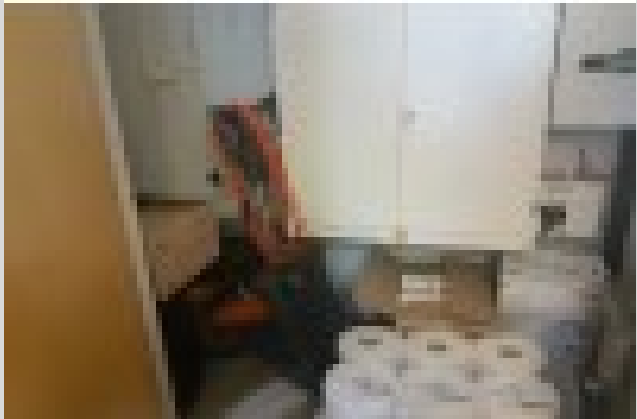
56	EV007328	Vinyl tiles and adhesive floor	Electric cupboard G/067	No Risk

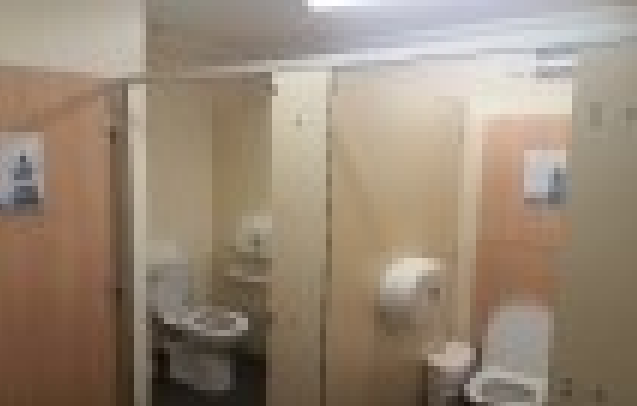
57	As EV007327	Textured coating ceiling	WC G/069	Low Risk

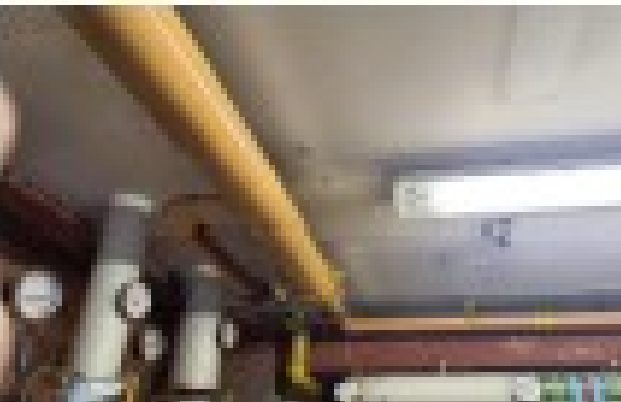
66	EV007336	Insulating board ceiling	Boiler Room G/079	No Risk
