ASBESTOS SURVEY REPORT FOR ST HELEN'S PRIMARY SCHOOL,  
DURHAM ST, HARTLEPOOL, TS24 0HR

**St Helen's Primary School, Durham St,  
Hartlepool, TS24 0HR**

**UPRN: - J149186**

**Date: 18 June 2026**

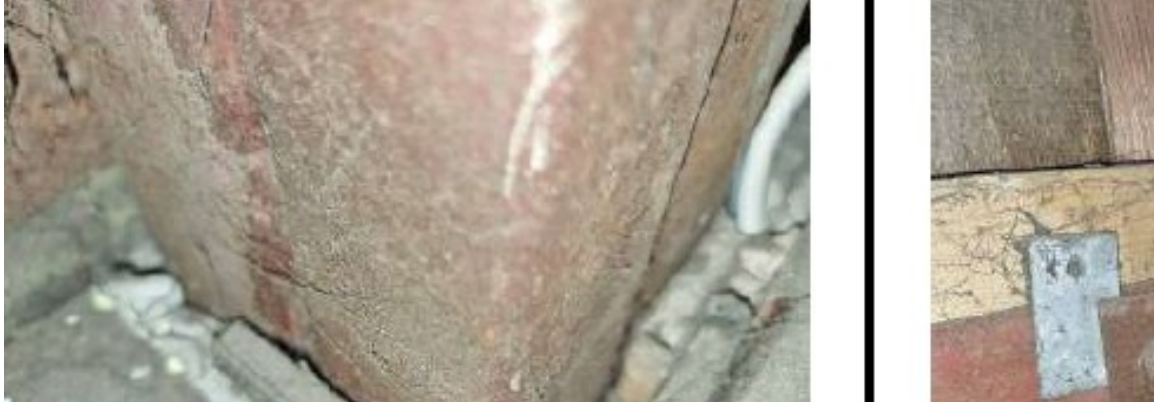
4	As RT000603	Insulating board - to column – 5 column visible to area, presumed to be to all columns	KS2 Building - 2, 001 Head Teacher, G/02	Low Risk – To be checked on a 6 monthly basis

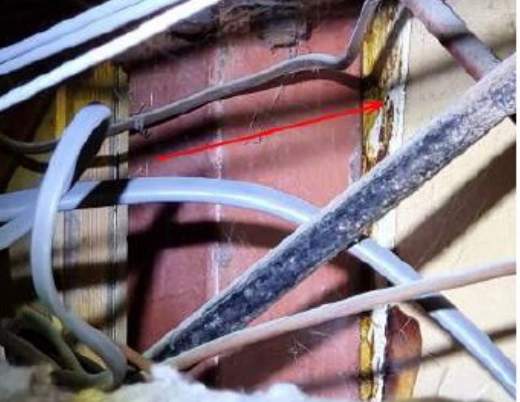
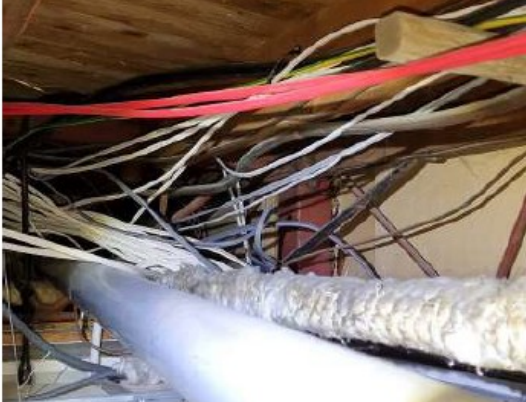
13	As RT000605	Insulating board - to column – 1 column visible	KS2 Building - 8, 022 Thrive Room, G/08	Medium Risk – To be checked on a 3 monthly basis

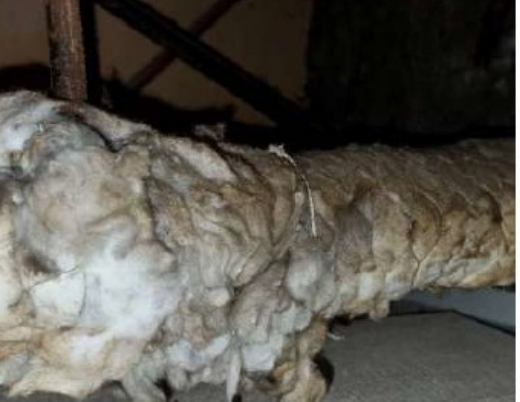
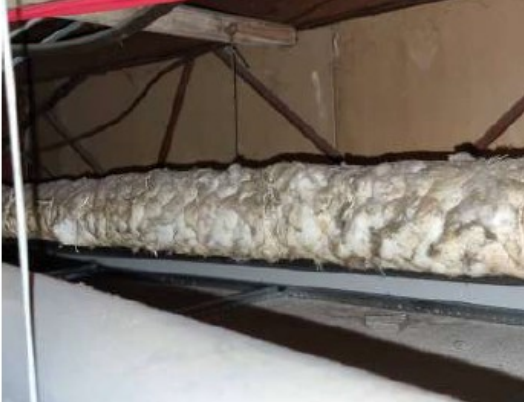
14	As RT000602	String - to pipework - Within ceiling void	KS2 Building - 8, 022 Thrive Room, G/08	Low Risk – To be checked on a 6 monthly basis

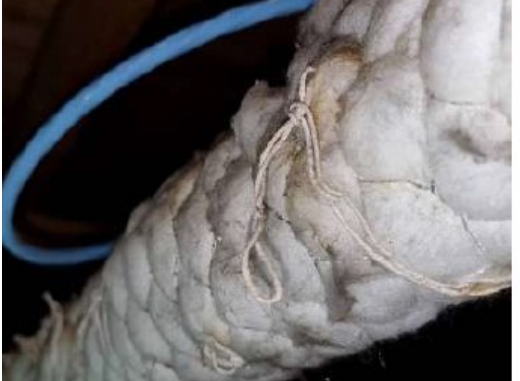
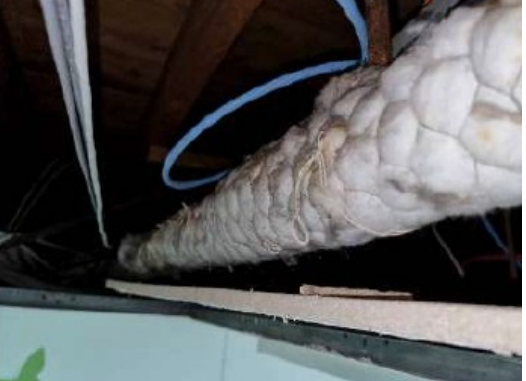
15	RT000607	String - to pipework - Within ceiling void	KS2 Building - 9, 005b Office, G/09	Low Risk – To be checked on a 6 monthly basis

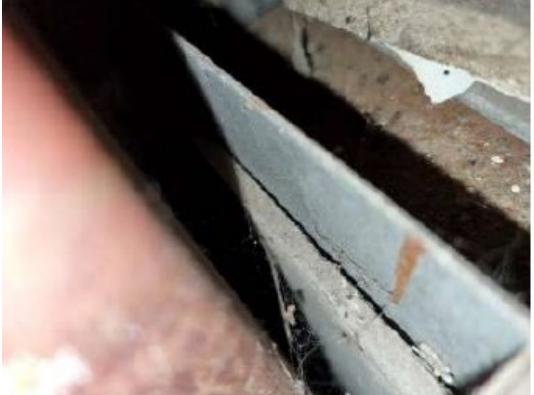
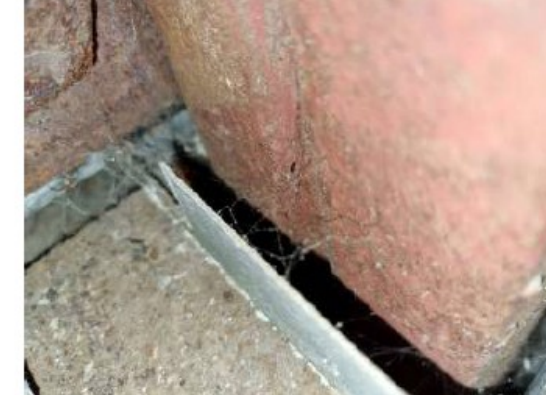
31	As RT000610	Insulating board - to columns and wall end caps	KS2 Building - 16, 009 Teaching Space, G/16	Low Risk – To be checked on a 6 monthly basis

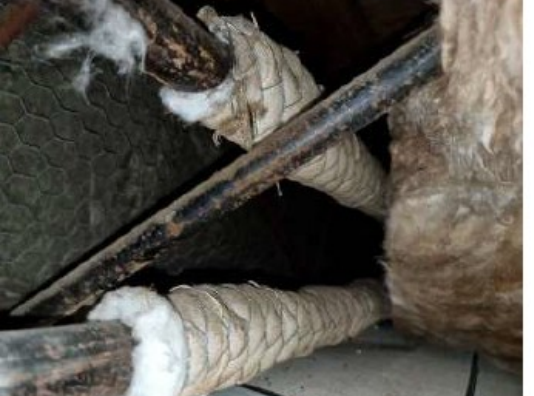
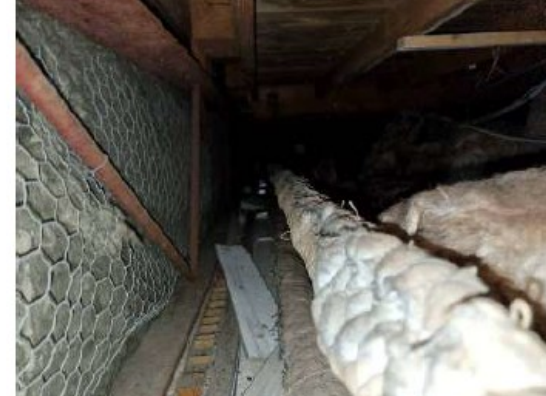
32	As RT000611	String - to pipework - Within ceiling void	KS2 Building - 16, 009 Teaching Space, G/16	Medium Risk – To be checked on a 3 monthly basis

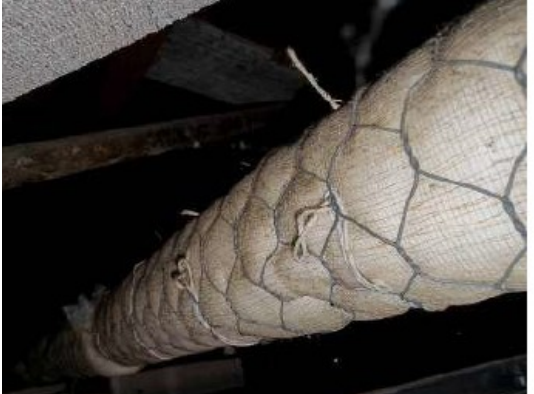
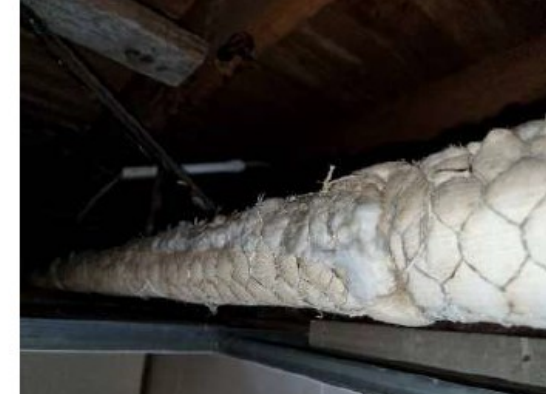
33	As RT000607	String - to pipework - Within ceiling void	KS2 Building - 17, 010 Store, G/17	Low Risk – To be checked on a 6 monthly basis

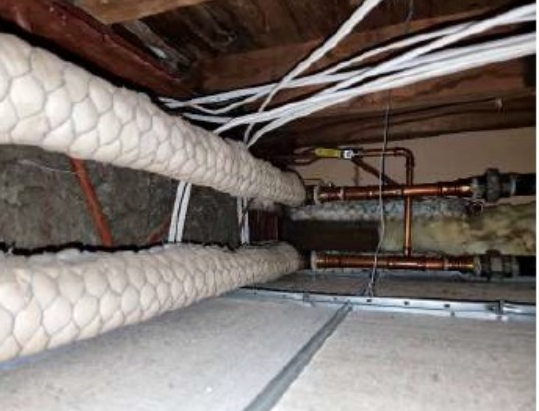
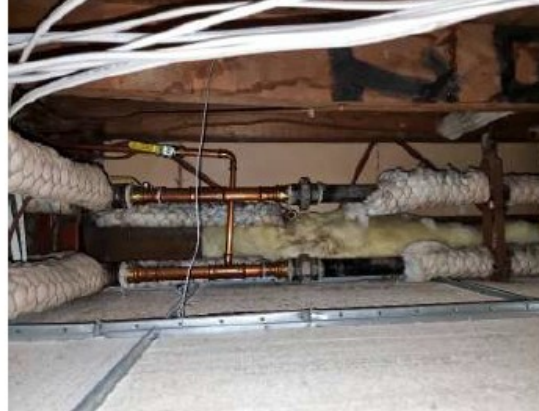
40	As RT000611	String - to pipework - Within ceiling void	KS2 Building - 20, 019 Circulation, G/20	Low Risk – To be checked on a 6 monthly basis

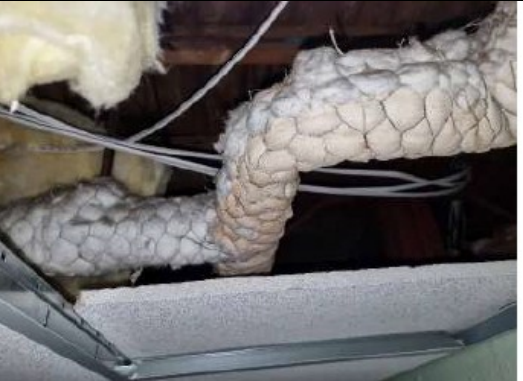
41	As RT000611	String - to pipework - Within ceiling void	KS2 Building - 21, 018 Print Room, G/21	Low Risk – To be checked on a 6 monthly basis

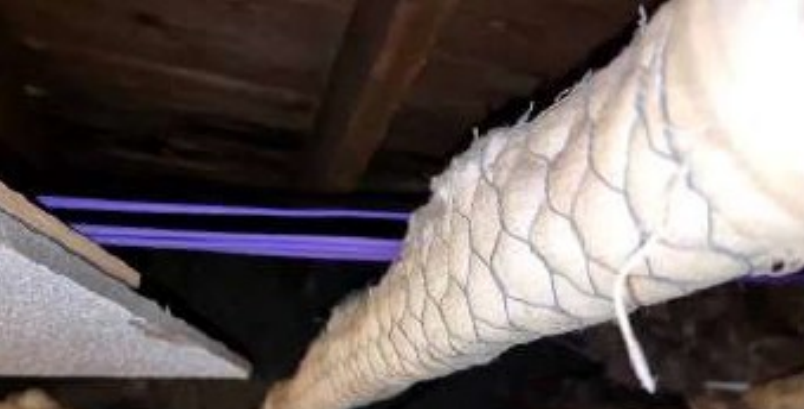
42	As RT000607	String - to pipework - Within ceiling void	KS2 Building - 22, 013 Store, G/22	Low Risk – To be checked on a 6 monthly basis

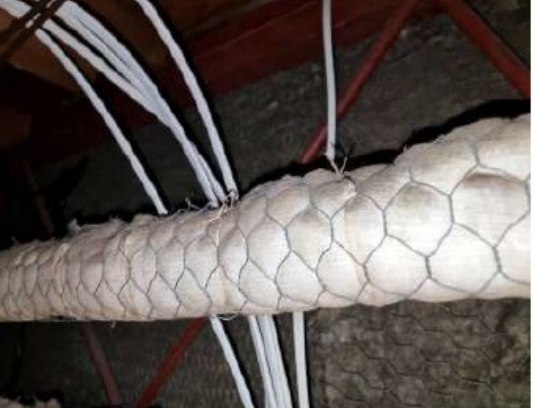
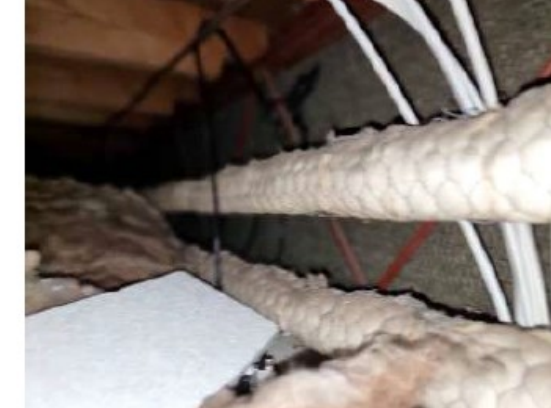
46	As RT000611	String - to pipework - Within ceiling void	KS2 Building - 23, 014 Teaching Space, G/23	Medium Risk – To be checked on a 3 monthly basis

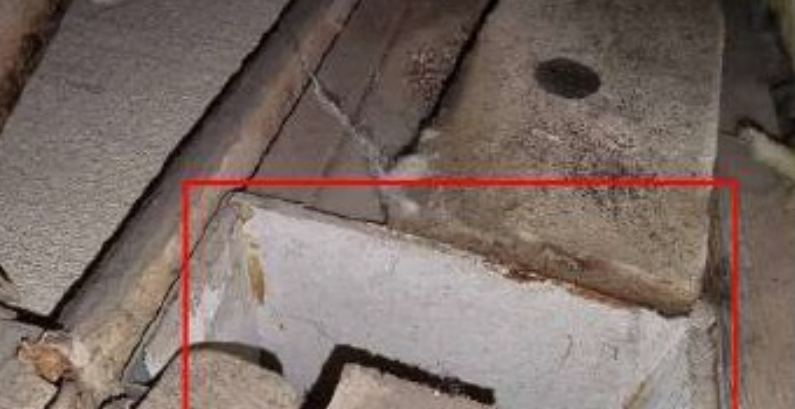
47	As RT000610	Insulating board - to columns and wall end caps	KS2 Building - 24, 015 Teaching Space, G/24	Low Risk – To be checked on a 6 monthly basis

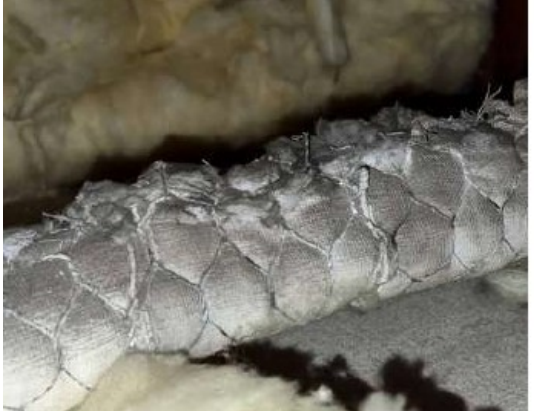
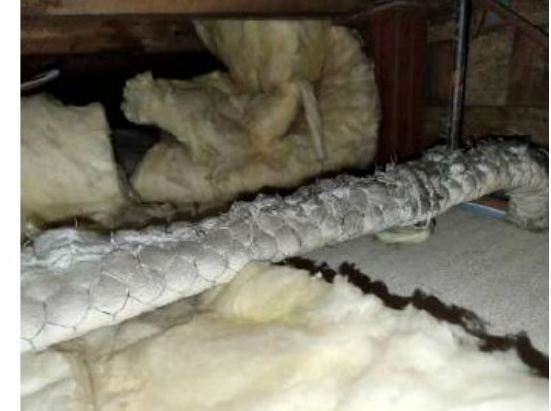
48	As RT000607	String - to pipework - Within ceiling void	KS2 Building - 25, 016 Store, G/25	Low Risk – To be checked on a 6 monthly basis

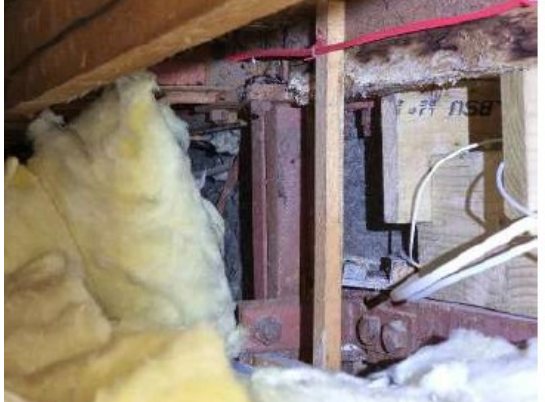
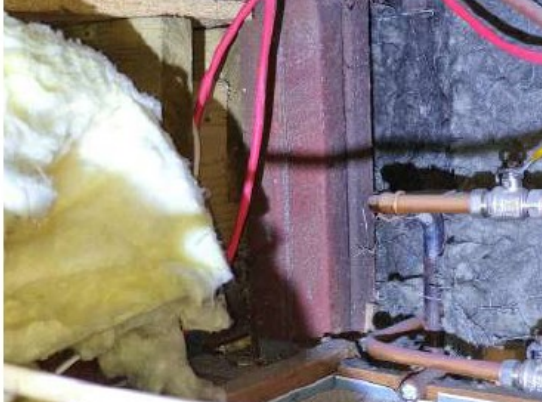
58	As RT000613	Insulating board - to columns and wall end caps	KS2 Building - 32, 038 Circulation, G/32	Low Risk – To be checked on a 6 monthly basis

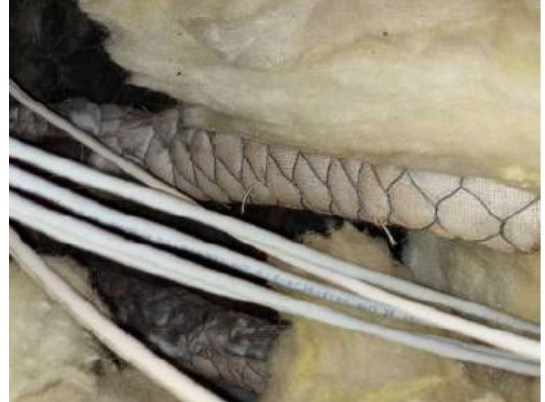
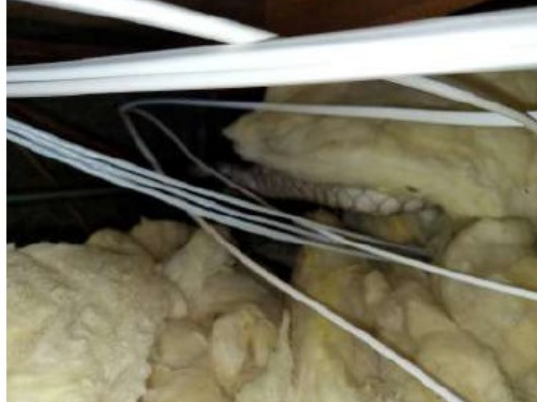
59	As RT000614	String - to pipework - Within ceiling void	KS2 Building - 32, 038 Circulation, G/32	Low Risk – To be checked on a 6 monthly basis

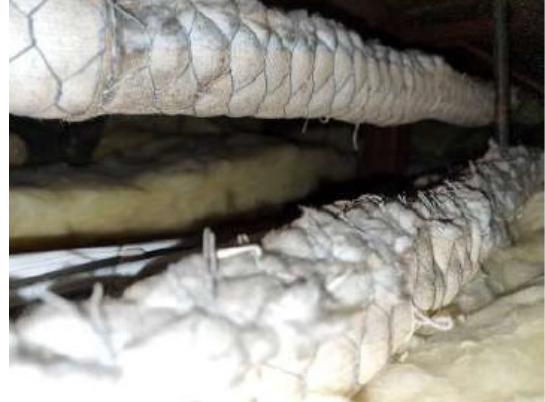
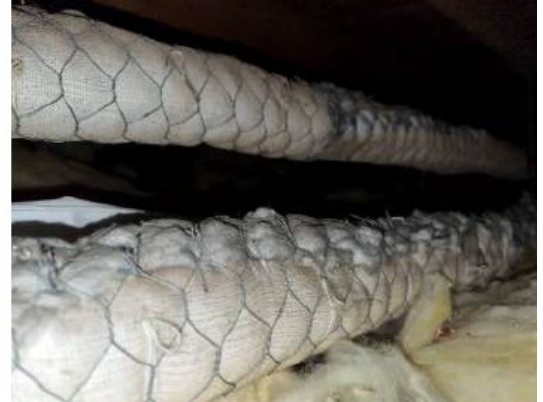
60	As RT000614	String - to pipework - Within ceiling void	KS2 Building - 33, 037 One-One, G/33	Low Risk – To be checked on a 6 monthly basis

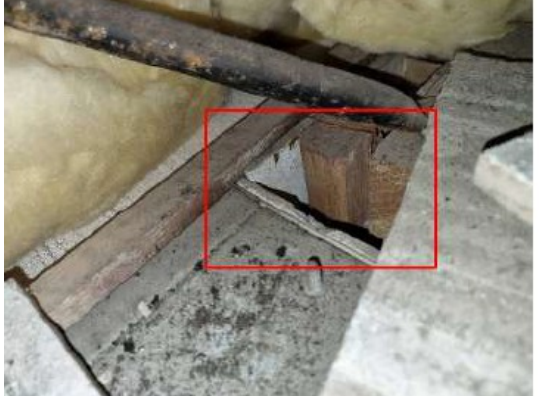
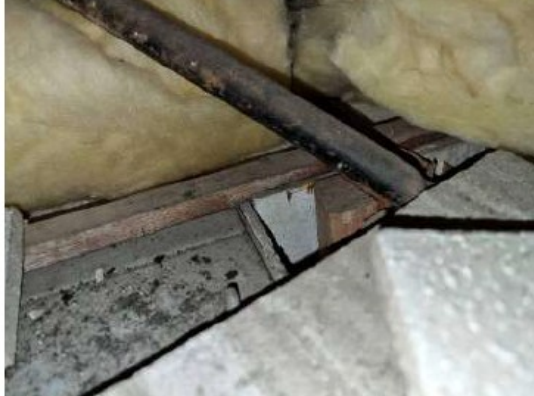
64	As RT000613	Insulating board - to columns and wall end caps	KS2 Building - 35, 029 Store, G/35	Low Risk – To be checked on a 6 monthly basis

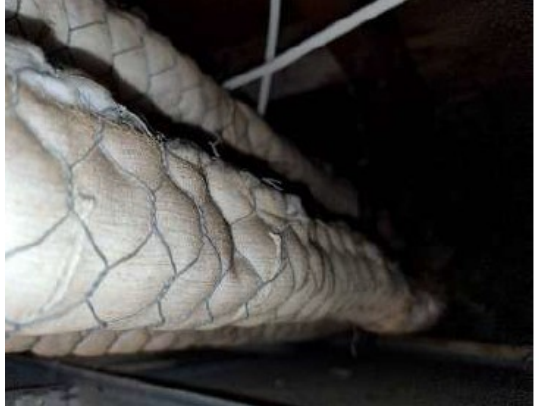
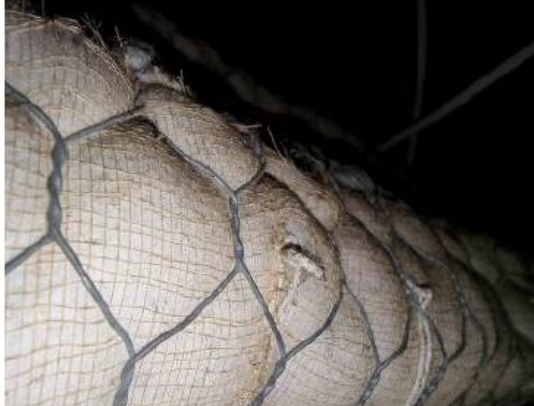
65	As RT000614	String - to pipework - Within ceiling void	KS2 Building - 35, 029 Store, G/35	Low Risk – To be checked on a 6 monthly basis

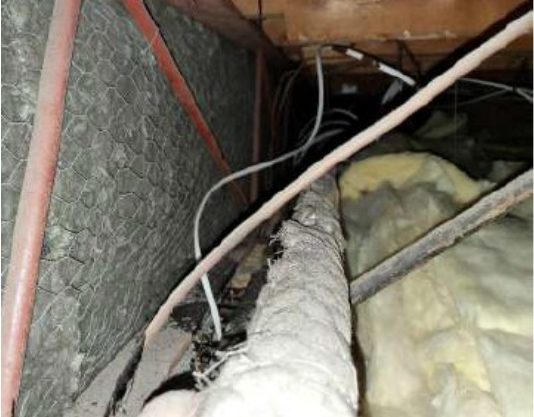
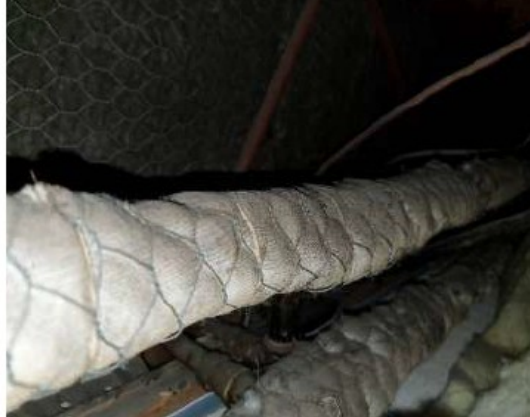
70	As RT000614	String - to pipework - Within ceiling void	KS2 Building - 37, 032 Teaching Space, G/37	Medium Risk – To be checked on a 3 monthly basis

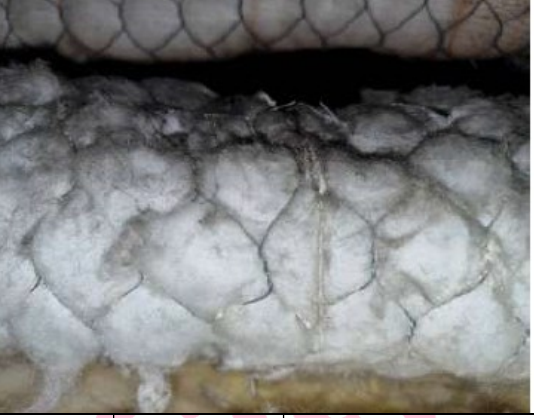
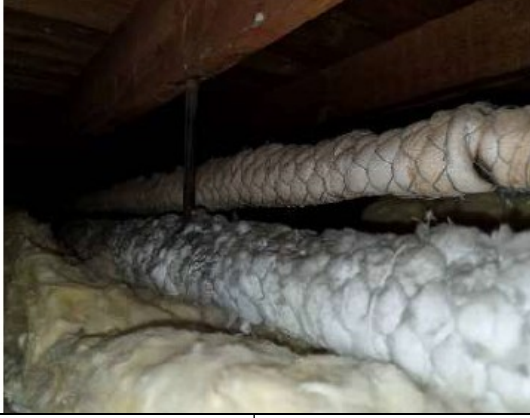
71	As RT000614	String - to pipework - Within ceiling void	KS2 Building - 38, 036 Library, G/38	Low Risk – To be checked on a 6 monthly basis

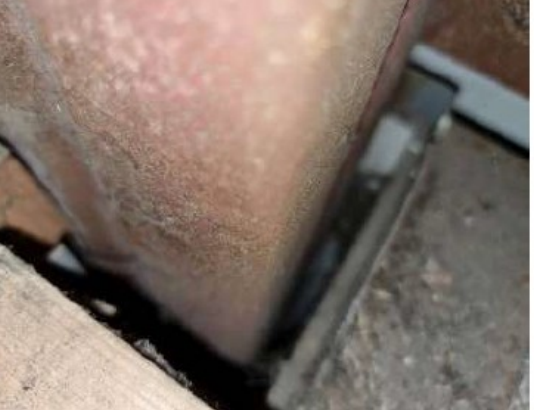
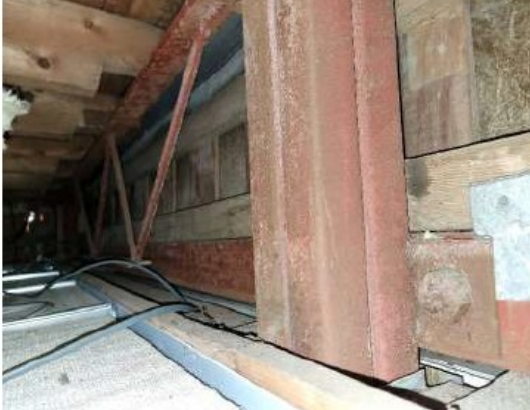
72	As RT000613	Insulating board - to columns and wall end caps	KS2 Building - 39, 034 Staffroom, G/39	Low Risk – To be checked on a 6 monthly basis

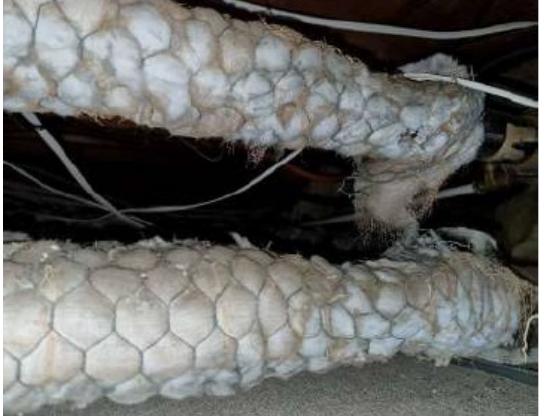
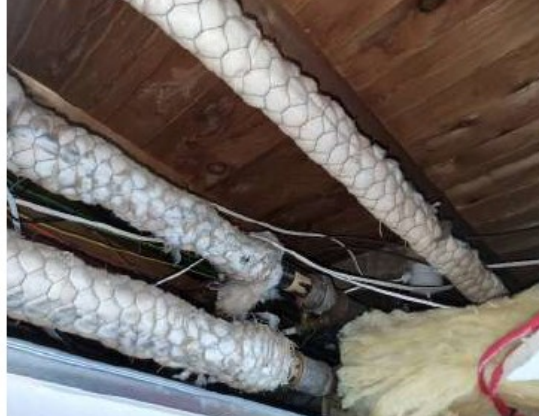
88	As RT000614	String - to pipework - Within ceiling void	KS2 Building - 46, 042 Deputy Head, G/46	Low Risk – To be checked on a 6 monthly basis

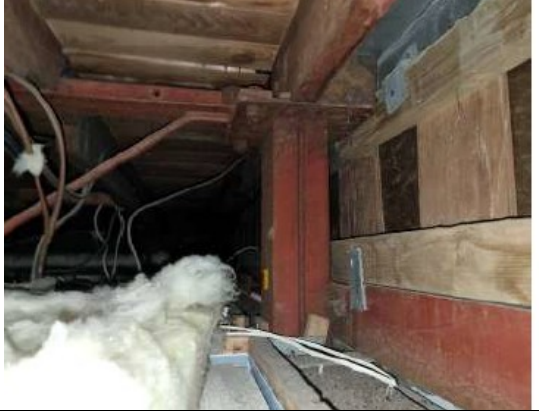
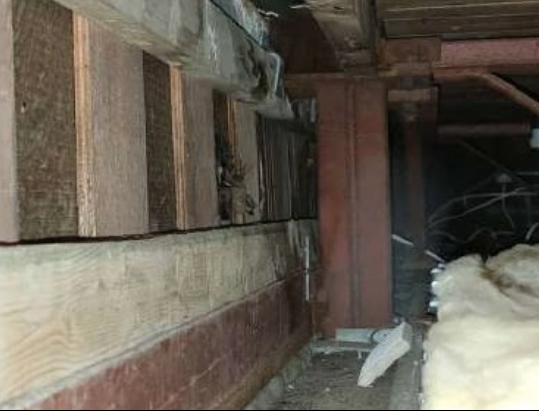
89	As RT000613	Insulating board - to columns and wall end caps	KS2 Building - 46, 042 Deputy Head, G/46	Medium Risk – To be checked on a 3 monthly basis

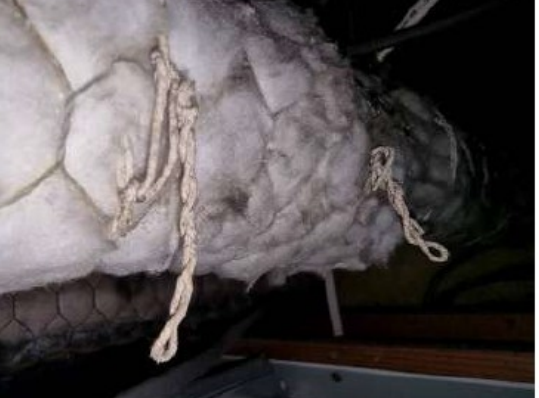
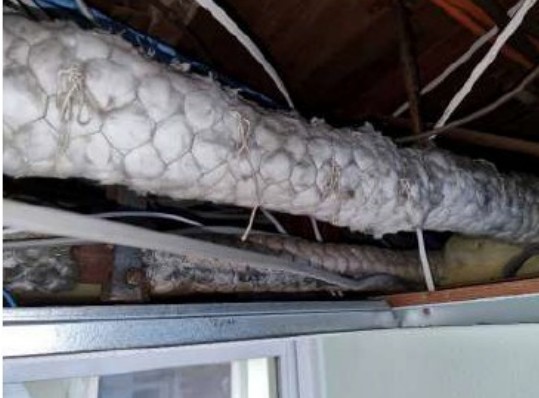
90	As RT000614	String - to pipework - Within ceiling void	KS2 Building - 47, 043 Secretary, G/47	Low Risk – To be checked on a 6 monthly basis

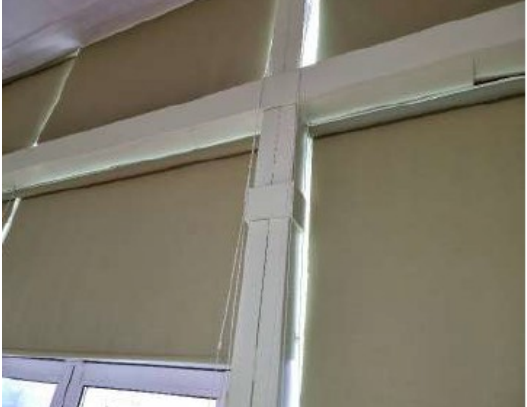
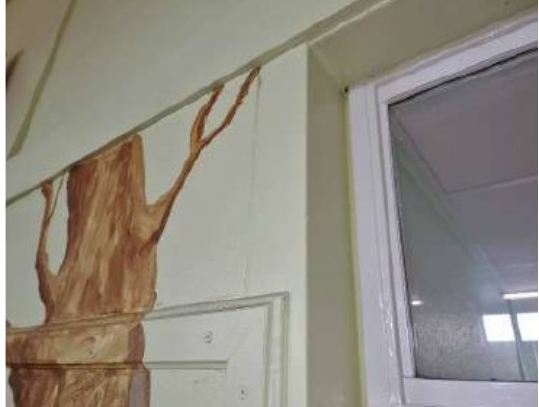
97	As RT000613	Insulating board - to columns and wall end caps	KS2 Building - 50, 022 Hall, G/50	Low Risk – To be checked on a 6 monthly basis

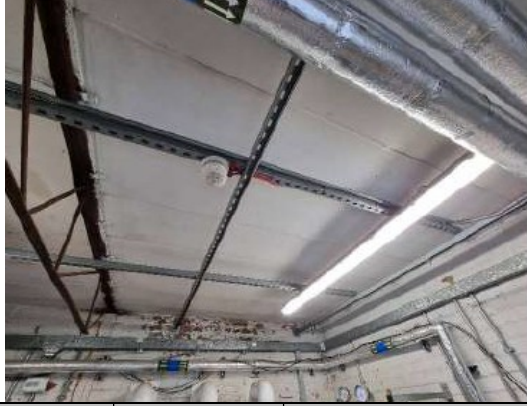
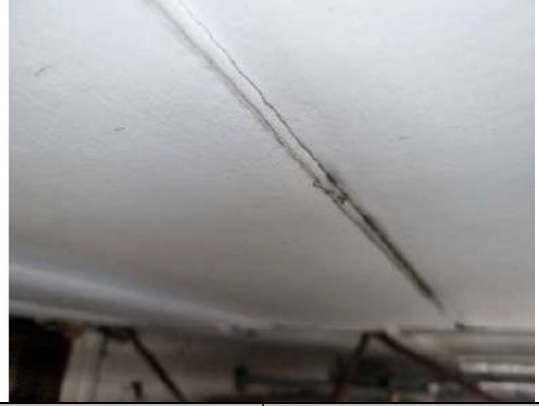
98	RT000615	Cement panel - ceiling/roof deck	Boiler House - 1, 047 Boiler Room, G/01	Low Risk – To be checked on a 6 monthly basis

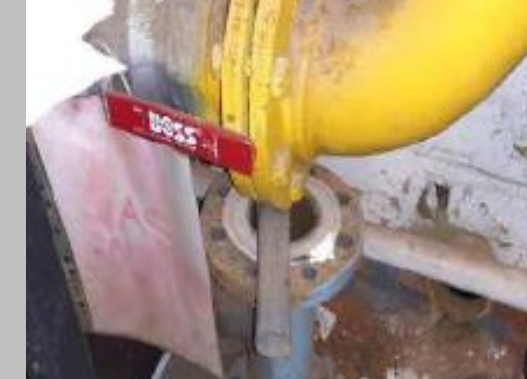
99	RT000616	Gasket - to redundant flange	Boiler House - 047 Boiler Room G/01	No Risk

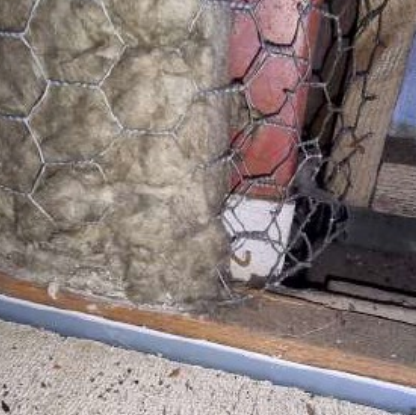
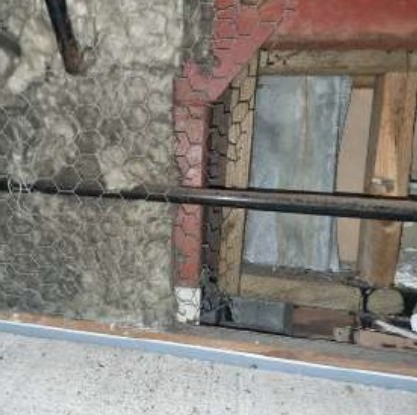
105	RT000620	Insulating board - to columns	KS1 Building - 2, 036 Office, G/02	Low Risk – To be checked on a 6 monthly basis

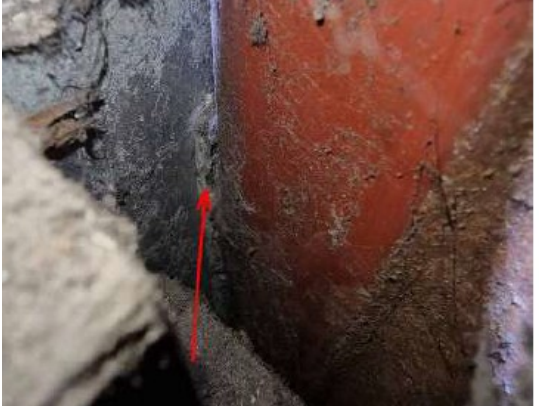
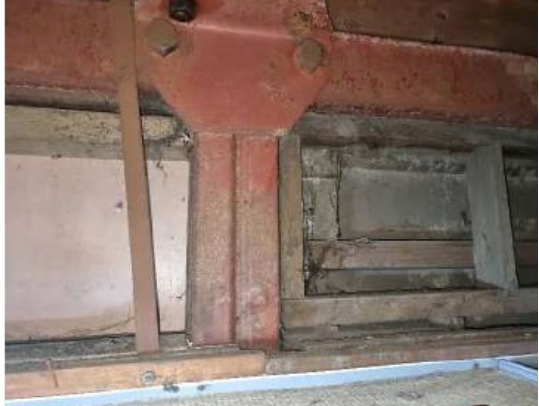
115	As RT000620	Insulating board - to columns	KS1 Building - 20, 021 Teaching Space, G/20	Low Risk – To be checked on a 6 monthly basis

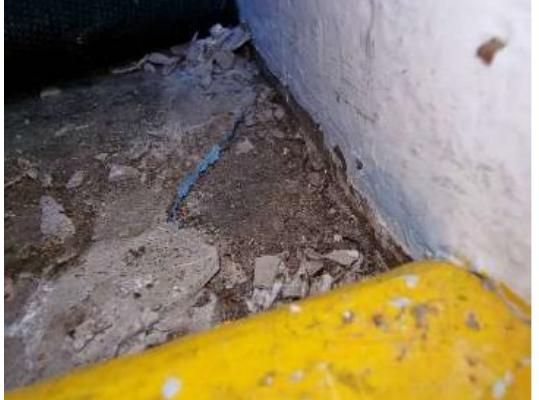
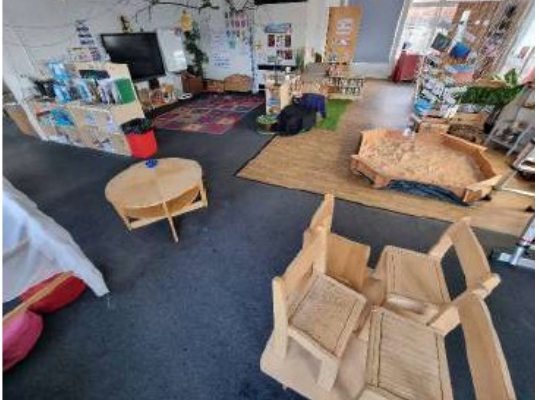
116	RT000621	Blue vinyl tiles and adhesive - to floor below other coverings	KS1 Building - 20, 021 Teaching Space, G/20	Low Risk – To be checked on a 6 monthly basis

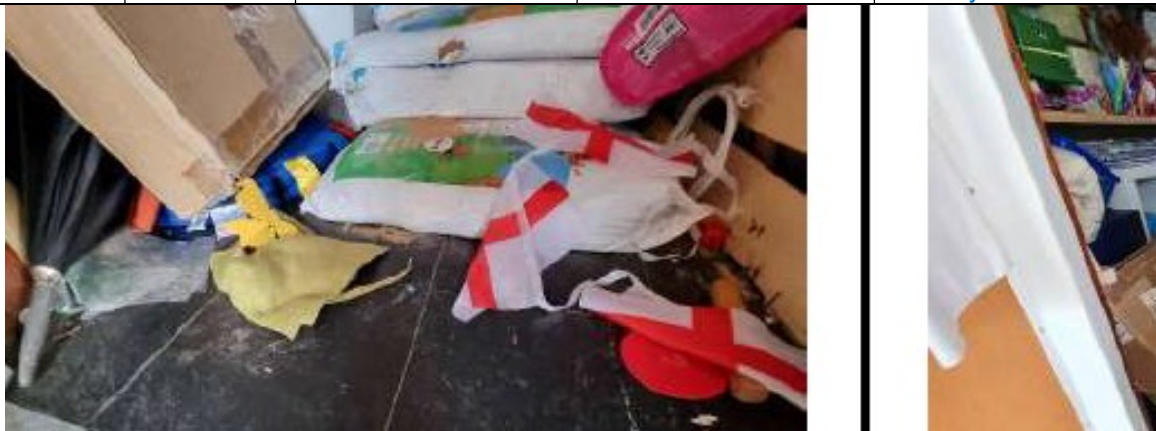
136	RT000628	Black vinyl tiles - to floor	KS1 Building - 38, 009 Store, G/38	Low Risk – To be checked on a 6 monthly basis

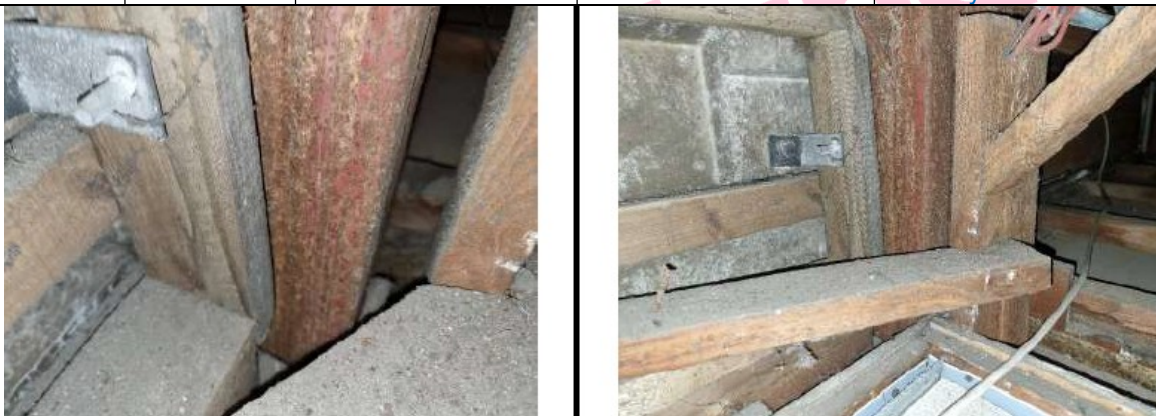
137	As RT000623	Insulating board - to columns	KS1 Building - 39, 004 Girls WC, G/39	Low Risk – To be checked on a 6 monthly basis

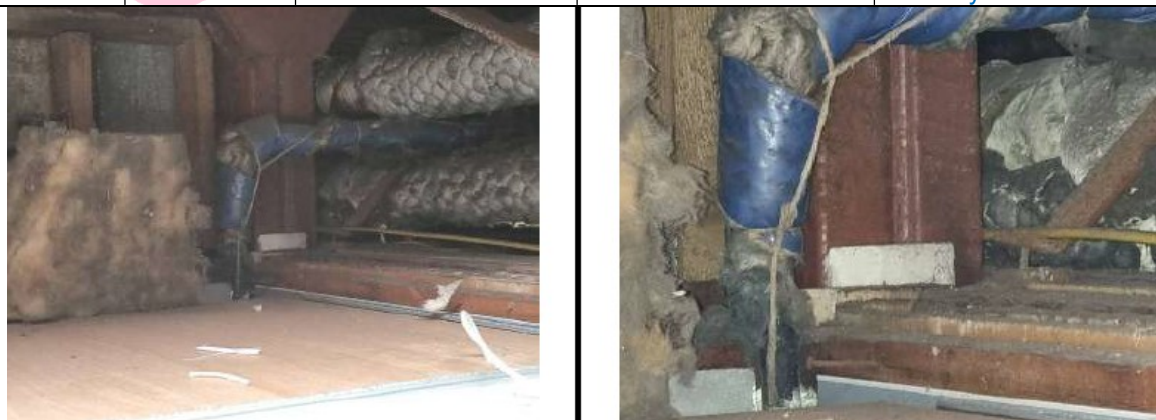
138	As RT000623	Insulating board - to columns	KS1 Building - 40, 005 DWC, G/40	Low Risk – To be checked on a 6 monthly basis

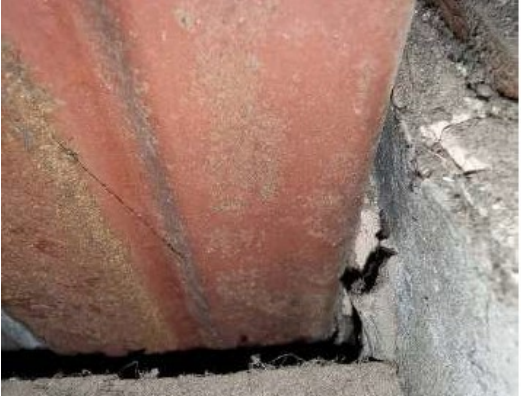
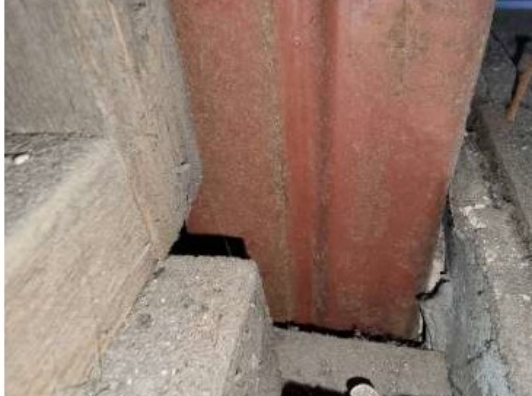
142	As RT000623	Insulating board - to columns	KS1 Building - 43, 008 Teaching Space, G/43	Low Risk – To be checked on a 6 monthly basis

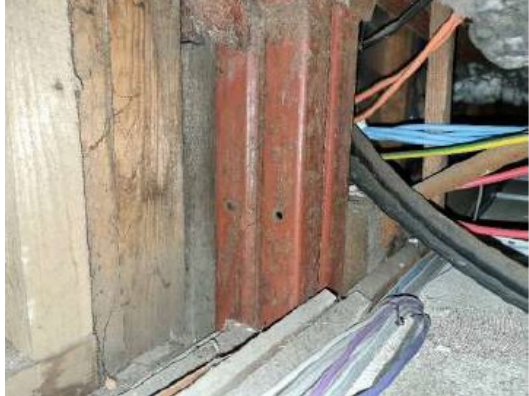
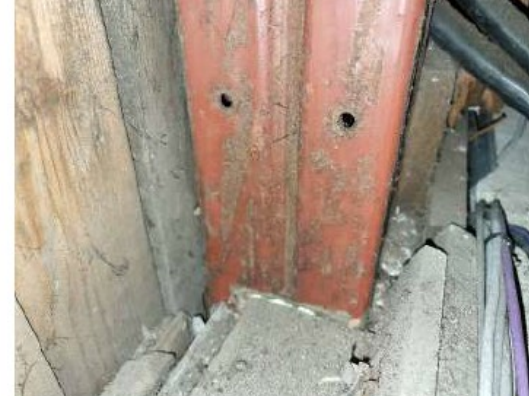
143	As RT000623	Insulating board - to columns	KS1 Building - 44, 011 Circulation, G/44	Low Risk – To be checked on a 6 monthly basis

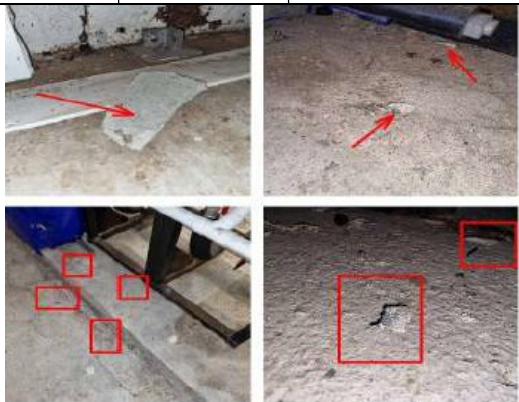
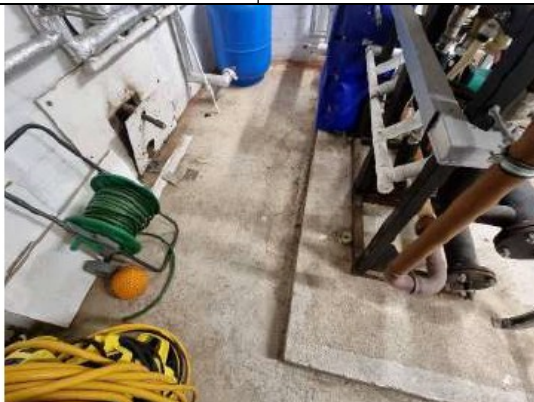
151	RT000632	Cement debris - to floor	KS1 Building - 47, 044 KS1 Boiler Room, G/47	Removed May 2026

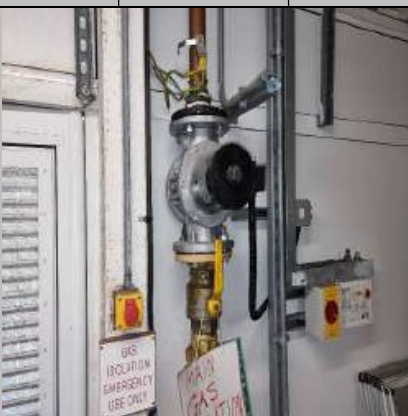
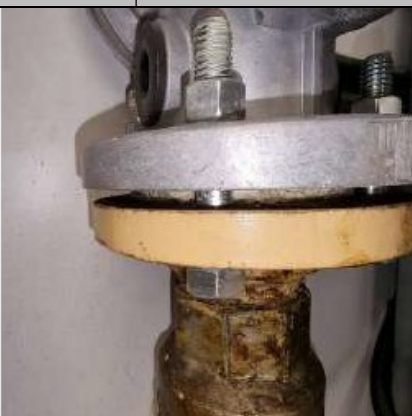
152	RT000633	Gaskets - to gas pipe	KS1 Building - 044 KS1 Boiler Room G/47	No Risk
