ASBESTOS SURVEY REPORT FOR ST HELEN'S PRIMARY SCHOOL,
DURHAM ST, HARTLEPOOL, TS24 0HR

**St Helen's Primary School, Durham St,
Hartlepool, TS24 0HR**

Date: 30 March 2026

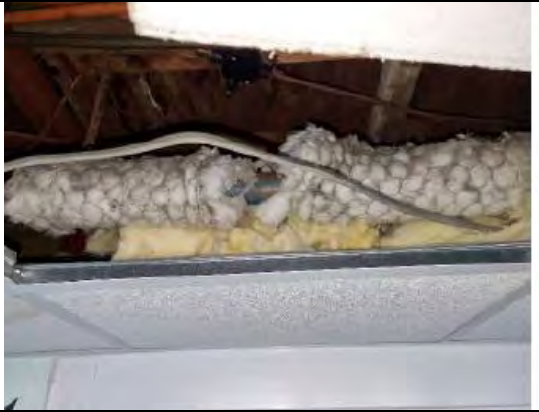
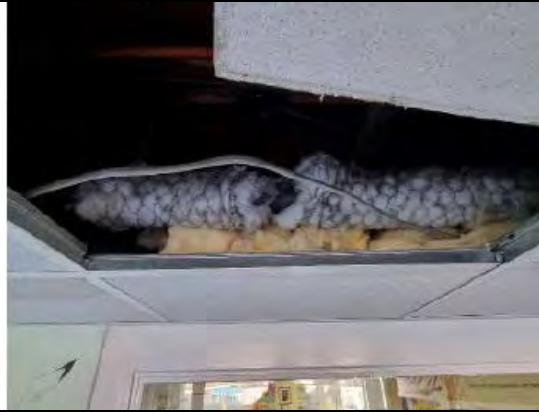
1	RT000602	String - to pipe insulation - Throughout ceiling void	KS2 Building - 1, 044 Main Entrance, G/01	Low Risk – To be checked on a 6 monthly basis

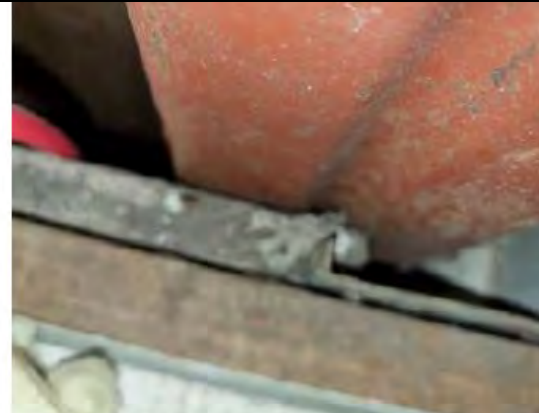
2	RT000603	Insulating board - to column – 1 column visible to area	KS2 Building - 1, 044 Main Entrance, G/01	Low Risk – To be checked on a 6 monthly basis

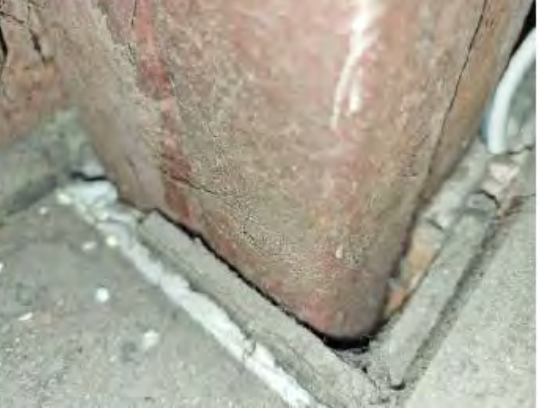
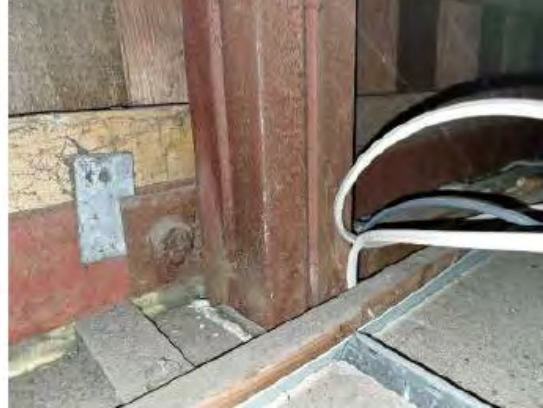
4	As RT000603	Insulating board - to column – 5 column visible to area, presumed to be to all columns	KS2 Building - 2, 001 Head Teacher, G/02	Low Risk – To be checked on a 6 monthly basis

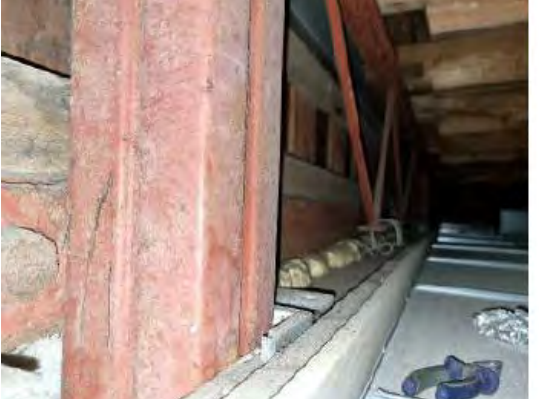
5	As RT000603	Insulating board - to column – 12 column visible to area, presumed to be to all columns	KS2 Building - 3, 003 Dining Room, G/03	Low Risk – To be checked on a 6 monthly basis

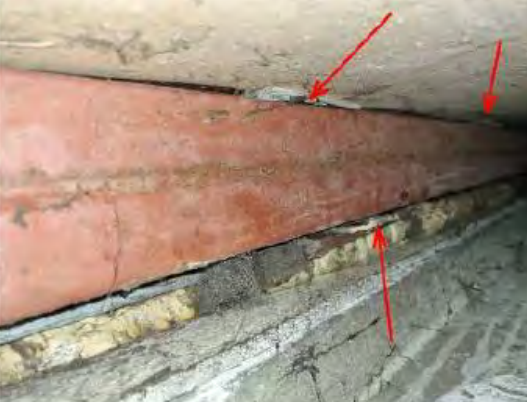
6	RT000604	Packers - to columns - Presumed to run to all columns	KS2 Building - 3, 003 Dining Room, G/03	Low Risk – To be checked on a 6 monthly basis

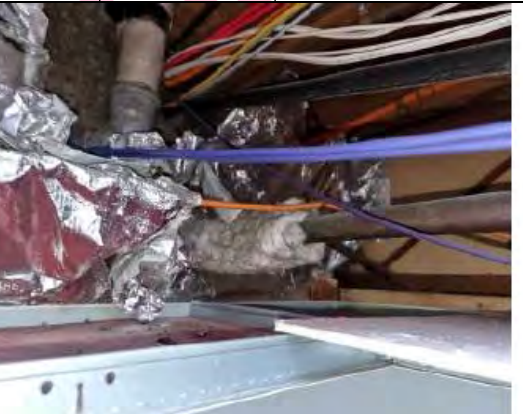
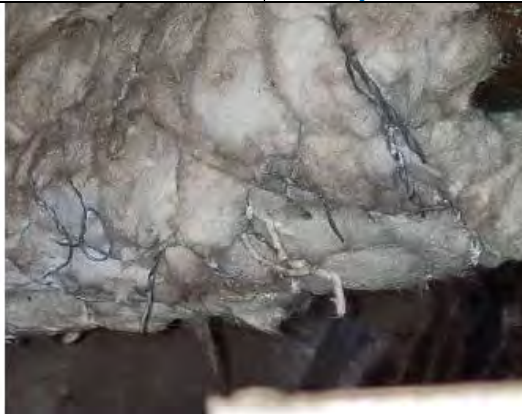
9	As RT000602	String - to pipework within ceiling void	KS2 Building - 4, 002 Kitchen, G/04	Low Risk – To be checked on a 6 monthly basis

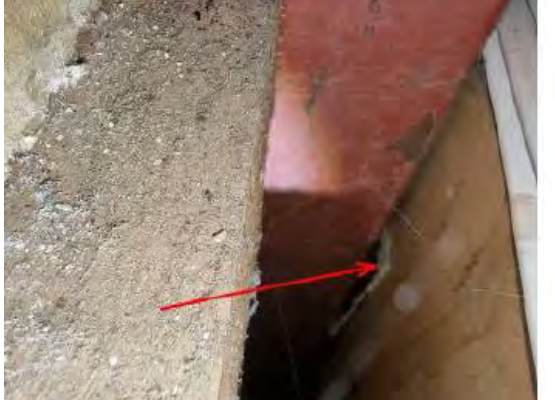
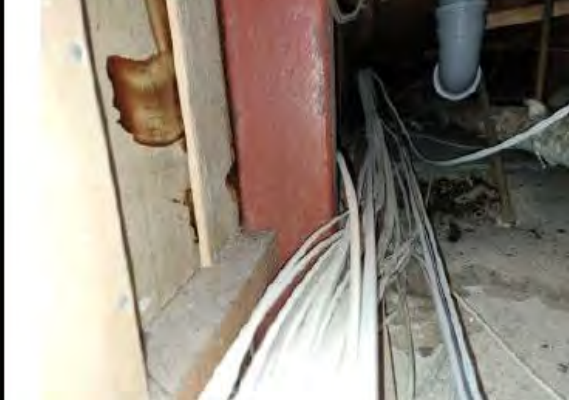
19	As RT000605	Insulating board - to columns and wall end caps - Visible to 1 column	KS2 Building - 10, 005a Circulation, G/10	Low Risk – To be checked on a 6 monthly basis

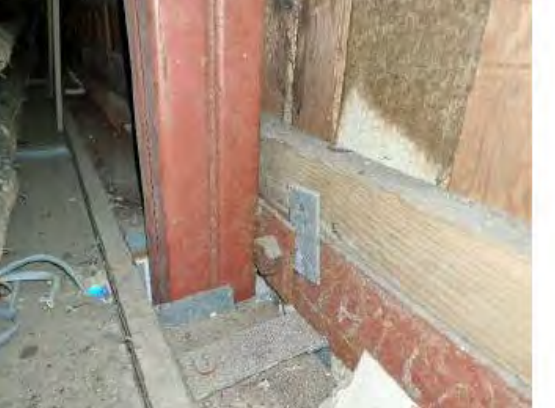
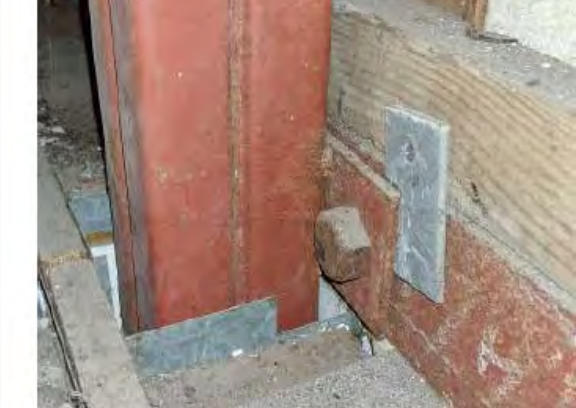
20	As RT000605	Insulating board - to columns and wall end caps	KS2 Building - 11, 005 Library, G/11	Low Risk – To be checked on a 6 monthly basis

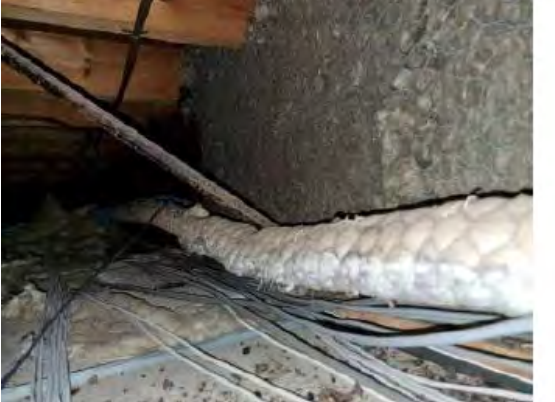
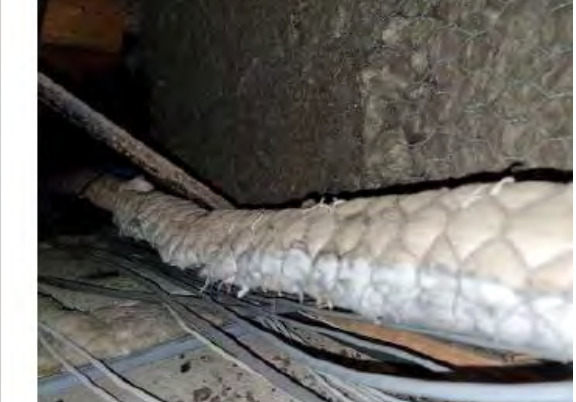
21	As RT000607	String - to pipework - Within ceiling void	KS2 Building - 11, 005 Library, G/11	Medium Risk – To be checked on a 3 monthly basis

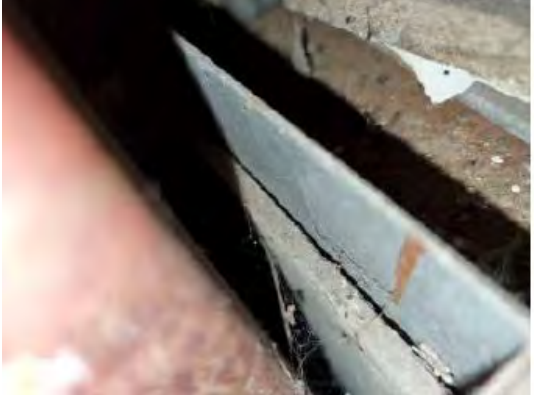
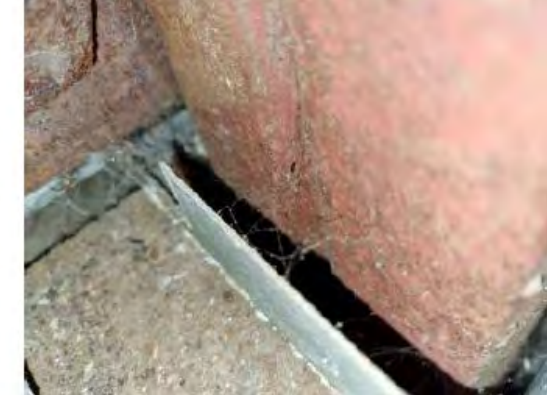
31	As RT000610	Insulating board - to columns and wall end caps	KS2 Building - 16, 009 Teaching Space, G/16	Low Risk – To be checked on a 6 monthly basis

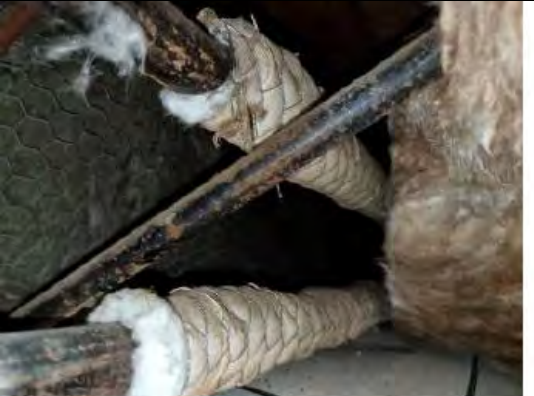
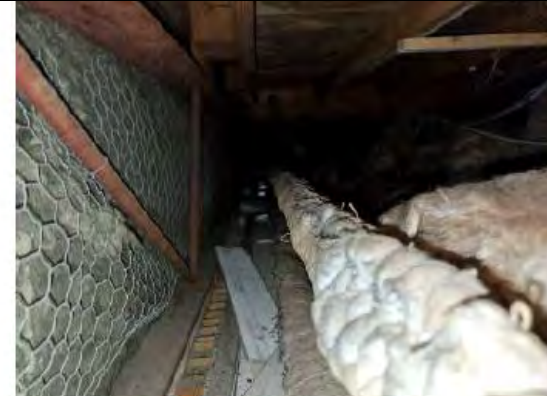
32	As RT000611	String - to pipework - Within ceiling void	KS2 Building - 16, 009 Teaching Space, G/16	Medium Risk – To be checked on a 3 monthly basis

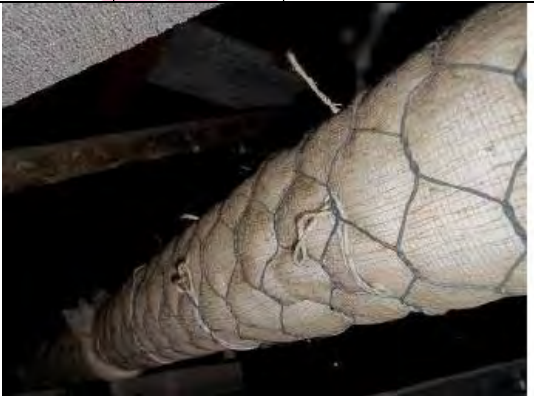
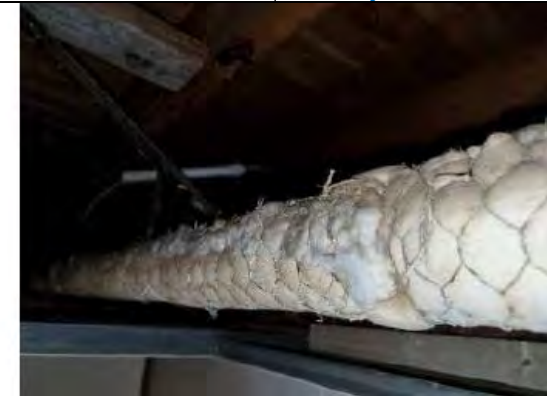
33	As RT000607	String - to pipework - Within ceiling void	KS2 Building - 17, 010 Store, G/17	Low Risk – To be checked on a 6 monthly basis

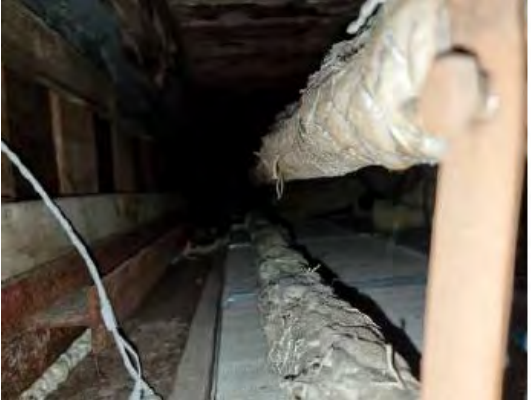
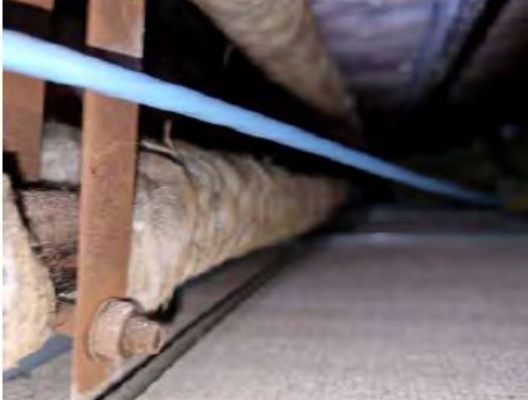
38	As RT000611	String - to pipework - Within ceiling void	KS2 Building - 19, 012 Circulation, G/19	Low Risk – To be checked on a 6 monthly basis

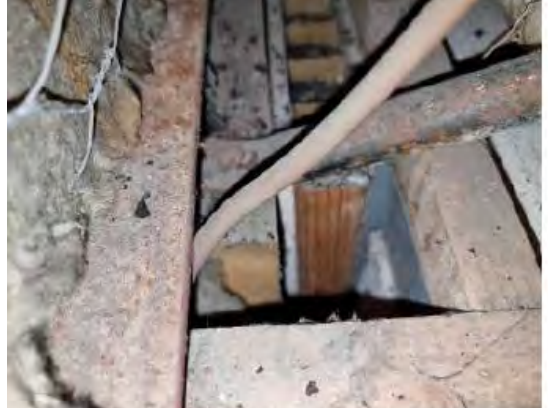
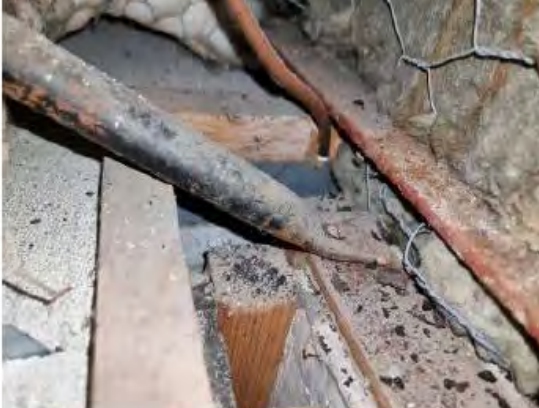
39	As RT000610	Insulating board - to columns and wall end caps	KS2 Building - 20, 019 Circulation, G/20	Low Risk – To be checked on a 6 monthly basis

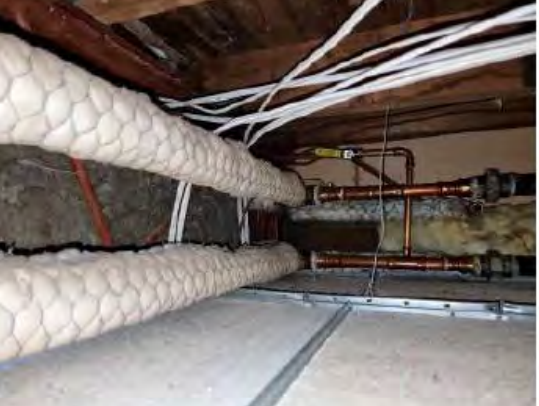
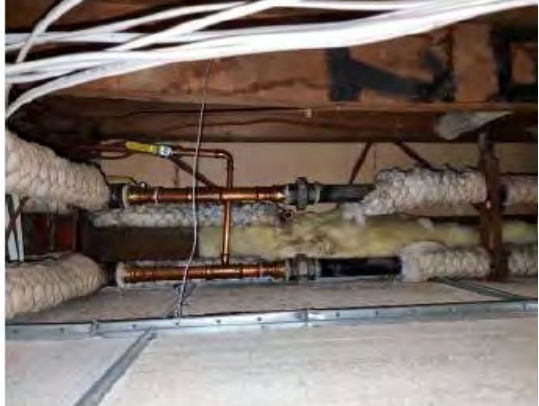
40	As RT000611	String - to pipework - Within ceiling void	KS2 Building - 20, 019 Circulation, G/20	Low Risk – To be checked on a 6 monthly basis

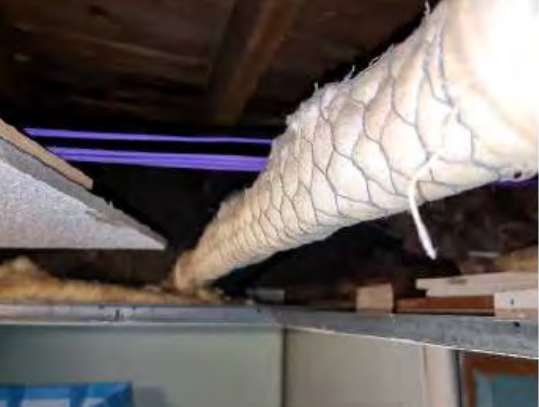
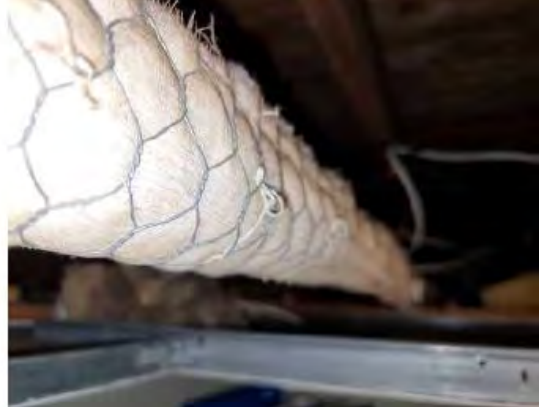
42	As RT000607	String - to pipework - Within ceiling void	KS2 Building - 22, 013 Store, G/22	Low Risk – To be checked on a 6 monthly basis

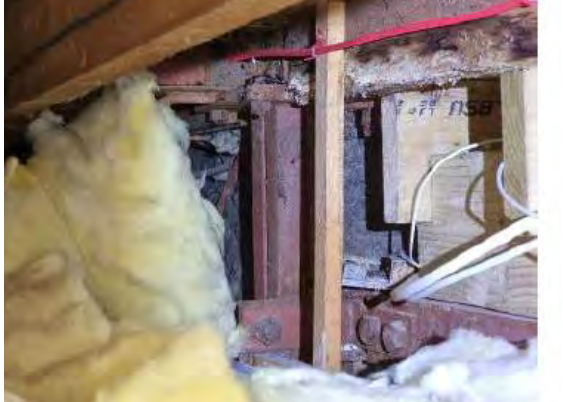
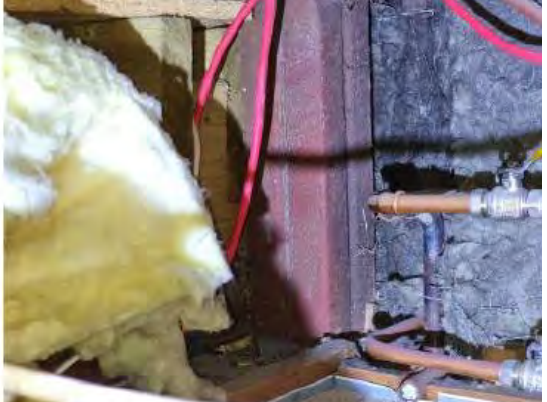
58	As RT000613	Insulating board - to columns and wall end caps	KS2 Building - 32, 038 Circulation, G/32	Low Risk – To be checked on a 6 monthly basis

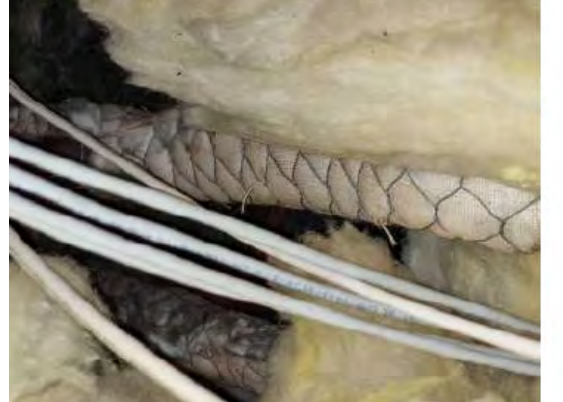
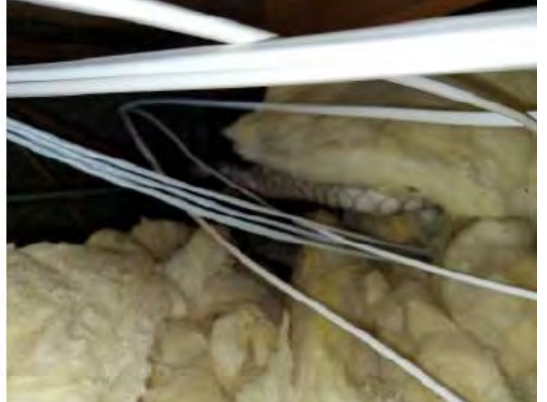
59	As RT000614	String - to pipework - Within ceiling void	KS2 Building - 32, 038 Circulation, G/32	Low Risk – To be checked on a 6 monthly basis

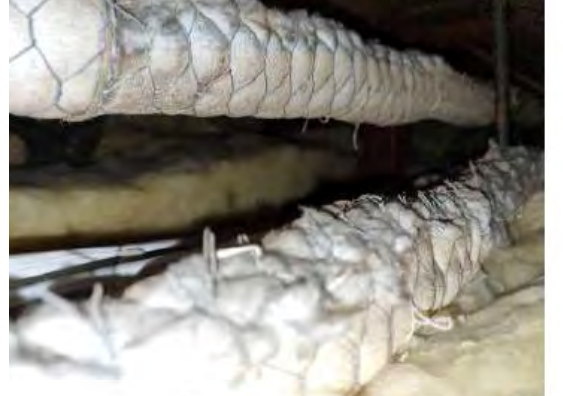
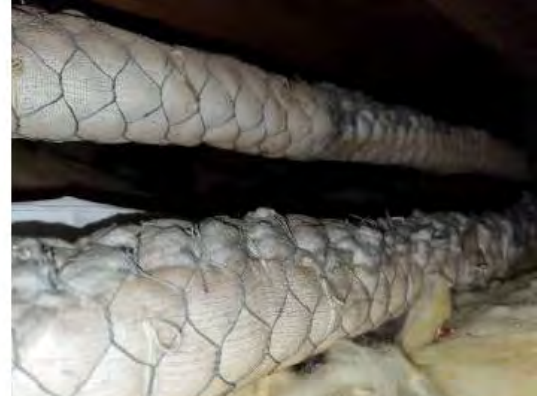
60	As RT000614	String - to pipework - Within ceiling void	KS2 Building - 33, 037 One-One, G/33	Low Risk – To be checked on a 6 monthly basis

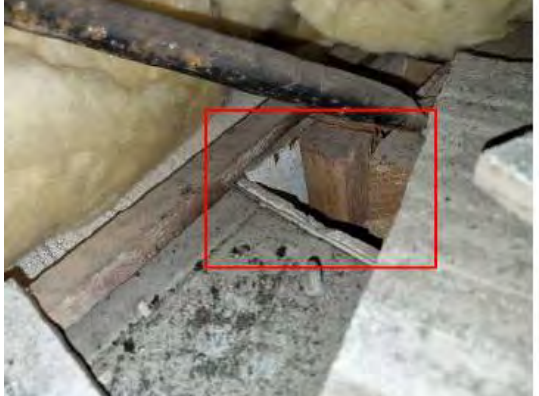
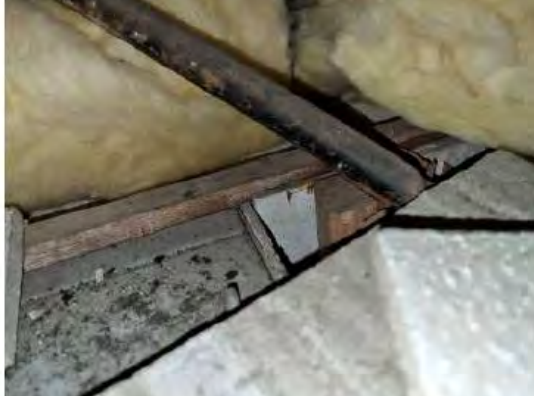
64	As RT000613	Insulating board - to columns and wall end caps	KS2 Building - 35, 029 Store, G/35	Low Risk – To be checked on a 6 monthly basis

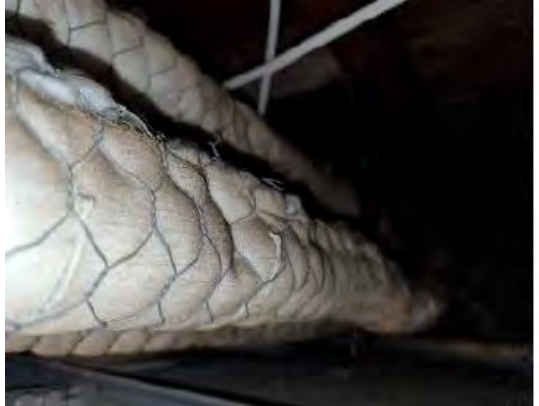
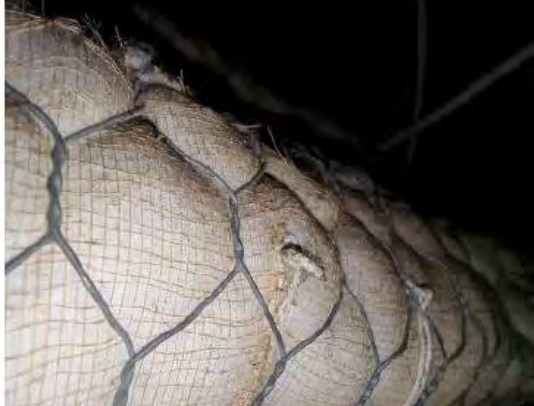
65	As RT000614	String - to pipework - Within ceiling void	KS2 Building - 35, 029 Store, G/35	Low Risk – To be checked on a 6 monthly basis

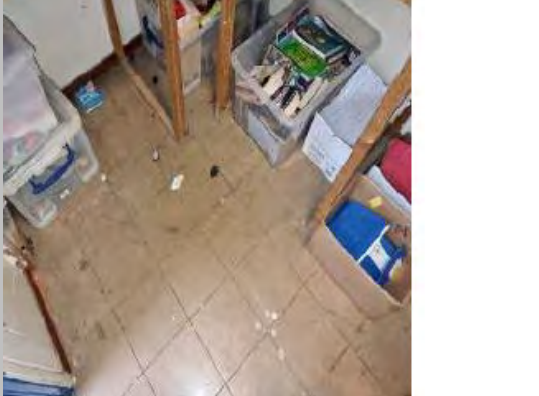
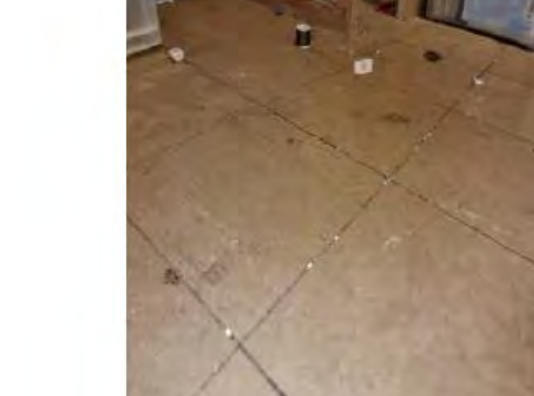
66	As RT000612	Beige vinyl tiles and adhesive - to floor	KS2 Building - 031 Store G/36	No Risk

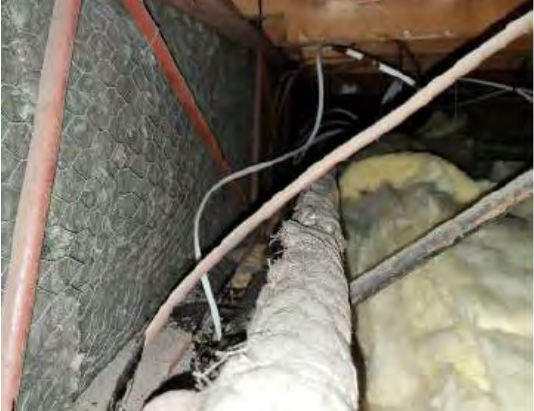
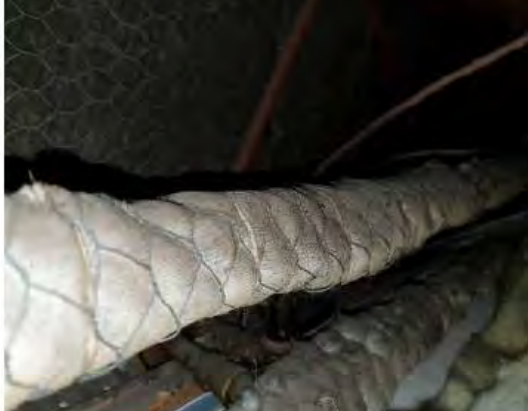
70	As RT000614	String - to pipework - Within ceiling void	KS2 Building - 37, 032 Teaching Space, G/37	Medium Risk – To be checked on a 3 monthly basis

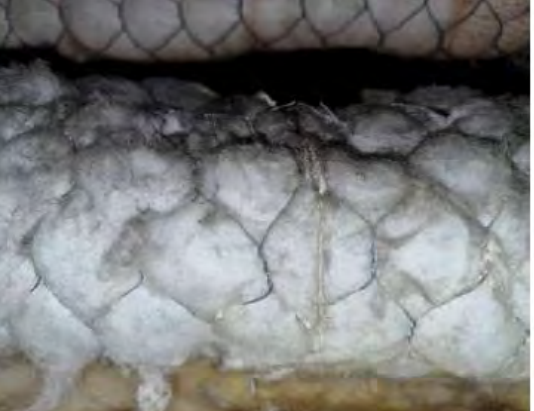
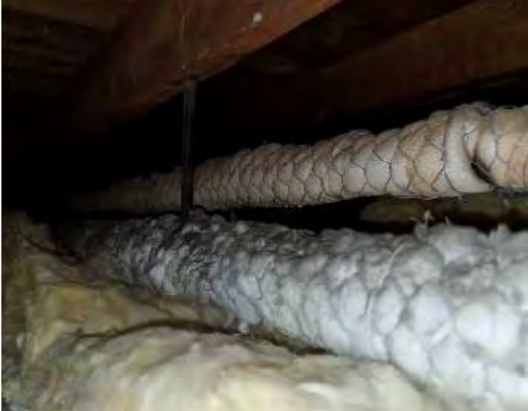
71	As RT000614	String - to pipework - Within ceiling void	KS2 Building - 38, 036 Library, G/38	Low Risk – To be checked on a 6 monthly basis

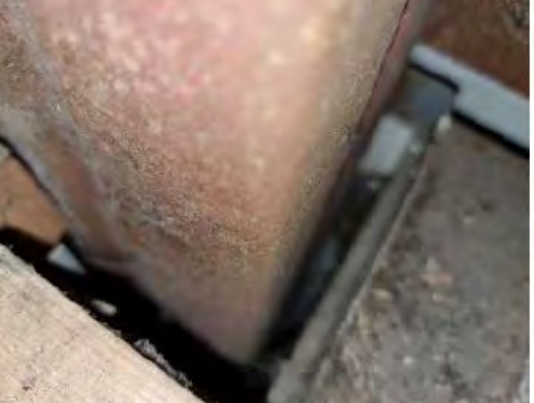
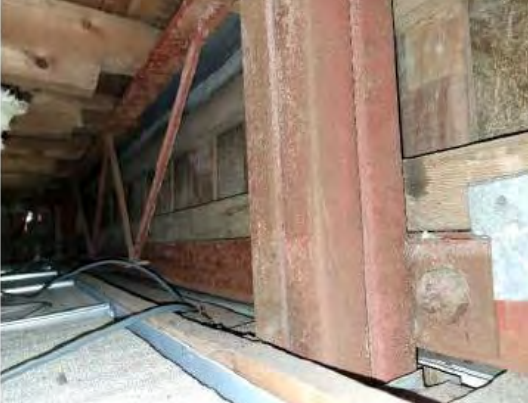
72	As RT000613	Insulating board - to columns and wall end caps	KS2 Building - 39, 034 Staffroom, G/39	Low Risk – To be checked on a 6 monthly basis

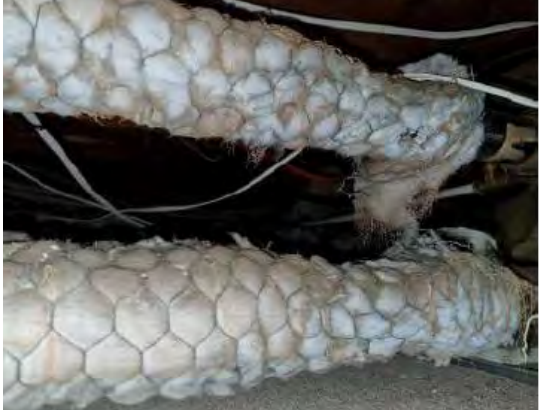
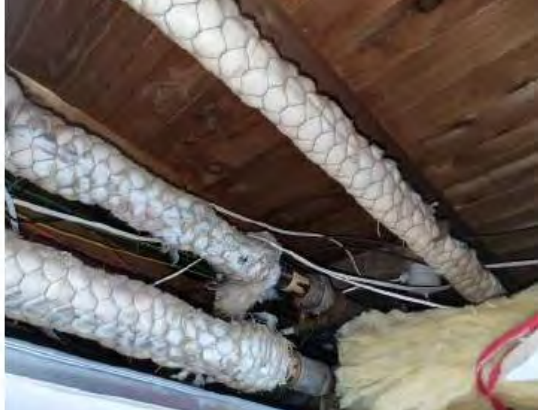
88	As RT000614	String - to pipework - Within ceiling void	KS2 Building - 46, 042 Deputy Head, G/46	Low Risk – To be checked on a 6 monthly basis

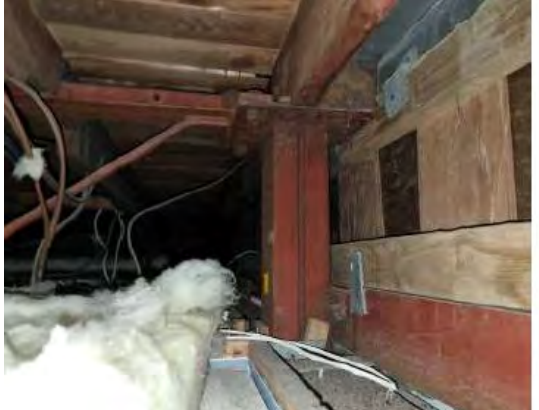
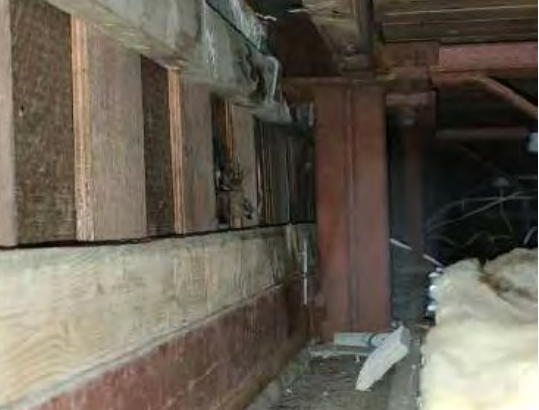
89	As RT000613	Insulating board - to columns and wall end caps	KS2 Building - 46, 042 Deputy Head, G/46	Medium Risk – To be checked on a 3 monthly basis

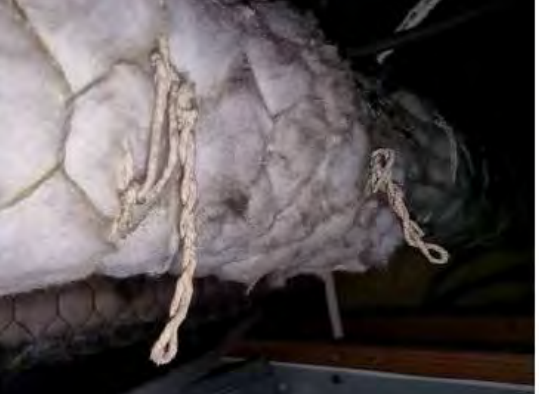
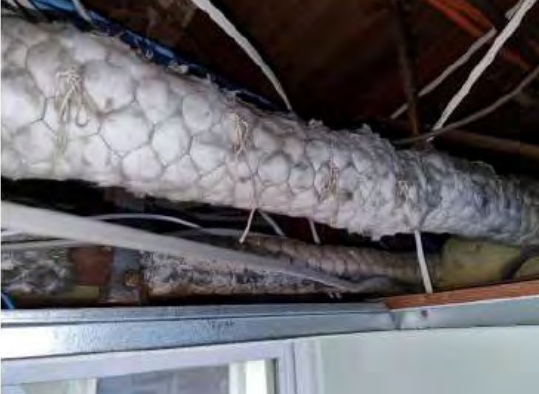
90	As RT000614	String - to pipework - Within ceiling void	KS2 Building - 47, 043 Secretary, G/47	Low Risk – To be checked on a 6 monthly basis

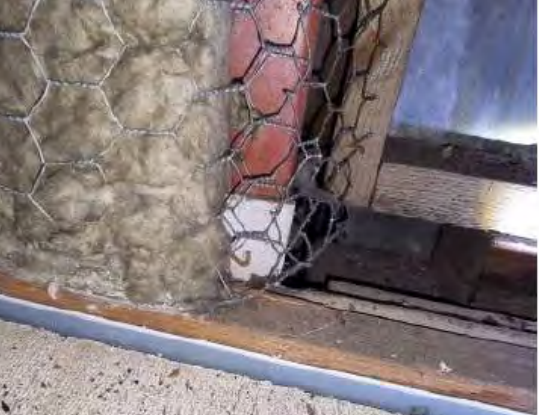
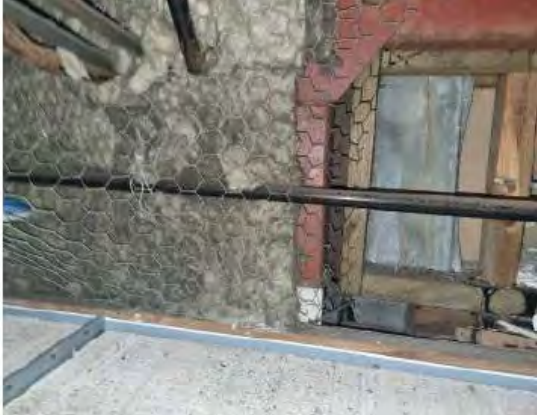
105	RT000620	Insulating board - to columns	KS1 Building - 2, 036 Office, G/02	Low Risk – To be checked on a 6 monthly basis

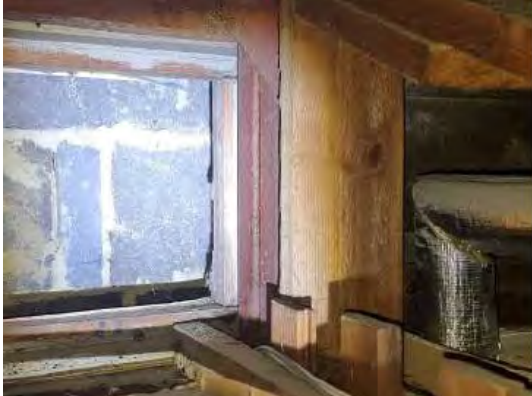
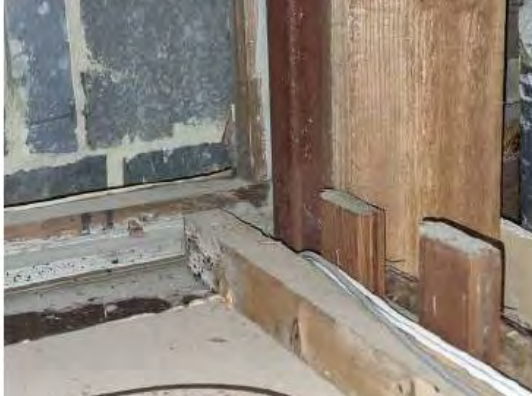
109	As RT000620	Insulating board - to columns	KS1 Building - 6, 029 Circulation, G/06	Low Risk – To be checked on a 6 monthly basis

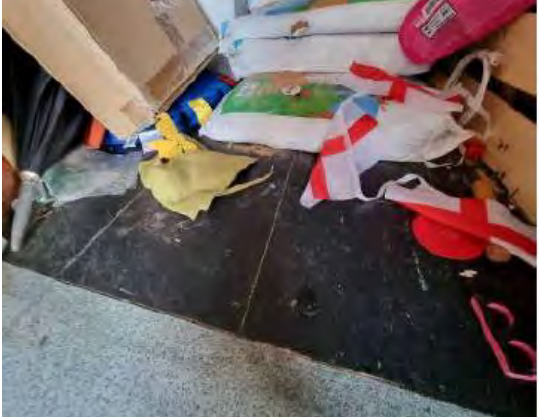
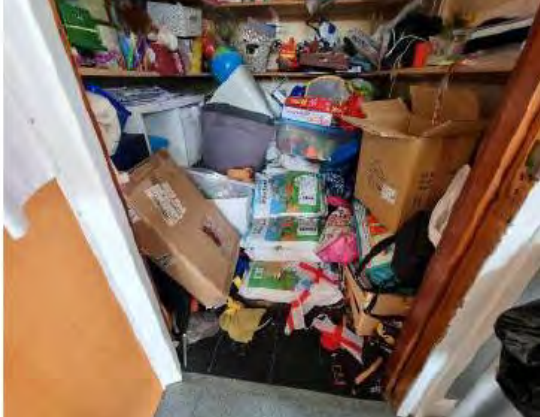
136	RT000628	Black vinyl tiles - to floor	KS1 Building - 38, 009 Store, G/38	Low Risk – To be checked on a 6 monthly basis

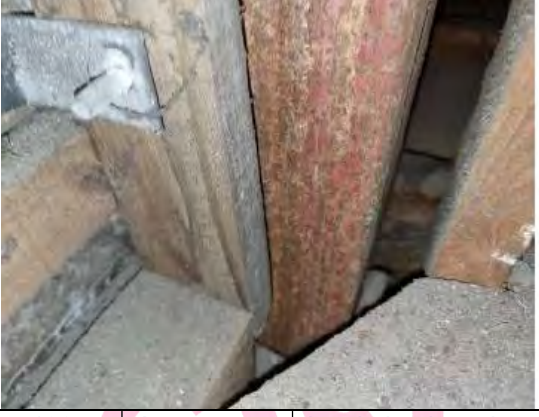
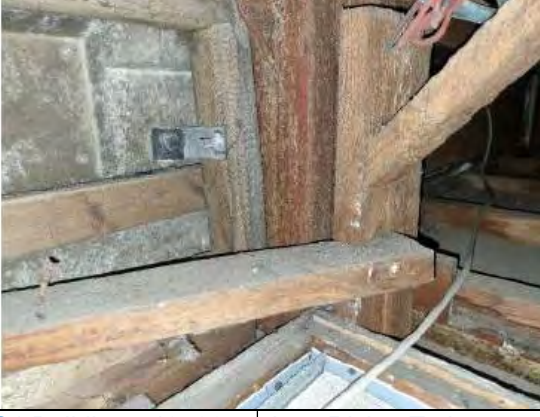
137	As RT000623	Insulating board - to columns	KS1 Building - 39, 004 Girls WC, G/39	Low Risk – To be checked on a 6 monthly basis

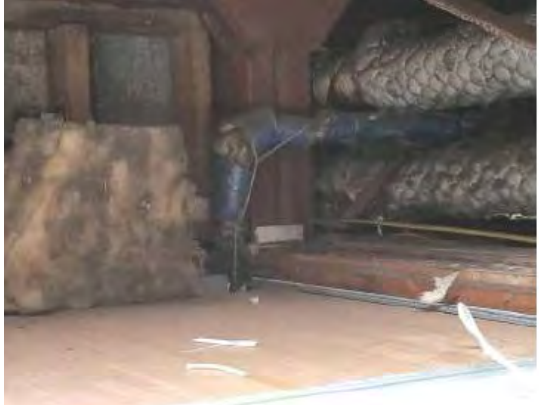
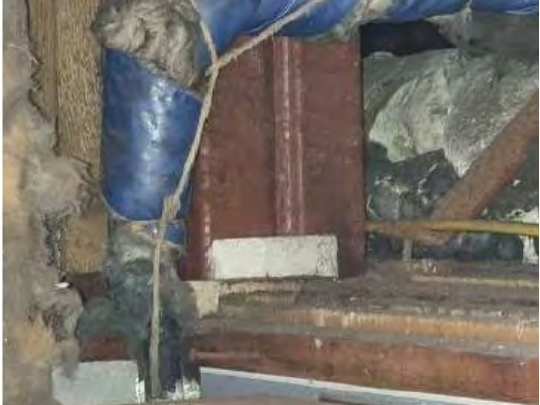
138	As RT000623	Insulating board - to columns	KS1 Building - 40, 005 DWC, G/40	Low Risk – To be checked on a 6 monthly basis

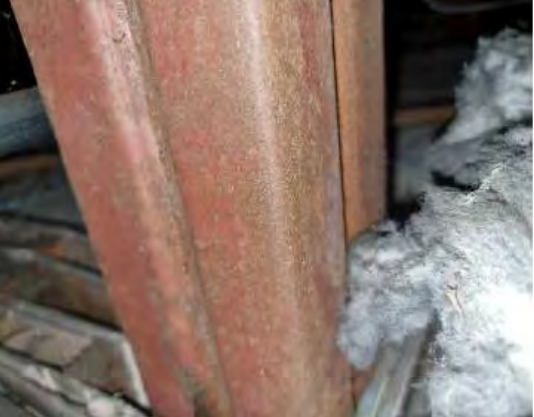
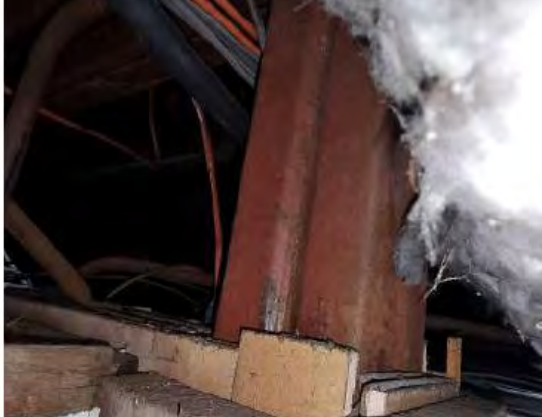
139	As RT000623	Insulating board - to columns	KS1 Building - 41, 006 Cloaks, G/41	Low Risk – To be checked on a 6 monthly basis

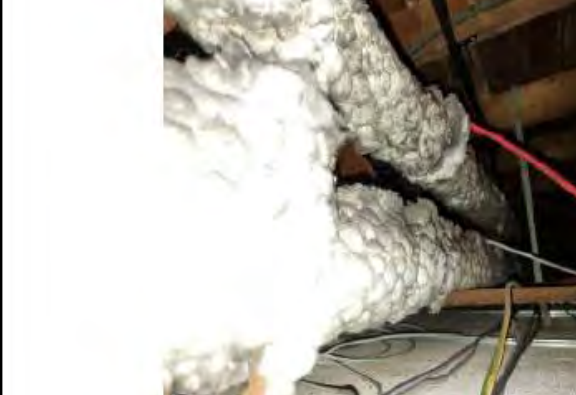
140	As RT000624	String - to pipework	KS1 Building - 006 Cloaks G/41	No Risk

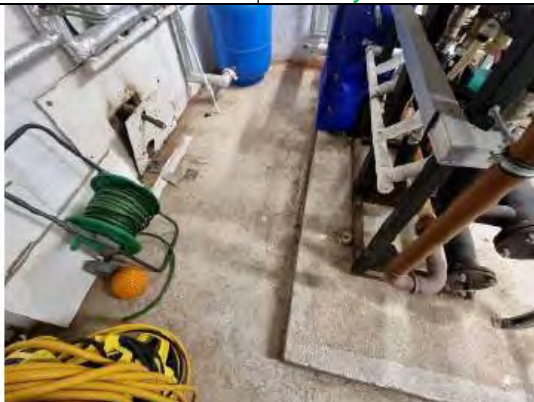
151	RT000632	Cement debris - to floor	KS1 Building - 47, 044 KS1 Boiler Room, G/47	Medium Risk – To be checked on a 3 monthly basis

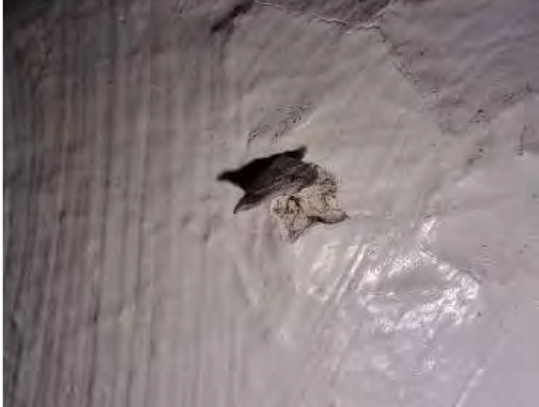
154	RT000635	Thermal Insulation residue - to walls	KS1 Building - 47, 044 KS1 Boiler Room, G/47	Medium Risk – To be checked on a 3 monthly basis
