ASBESTOS SURVEY REPORT FOR THORNLEY PRIMARY SCHOOL,  
COOPERS TERRACE, THORNLEY, DURHAM, COUNTY DURHAM, DH6 3DZ

**Thornley Primary School, Coopers Terrace, Thornley,  
Durham, DH6 3DZ**

**Date: 29 April 2026**

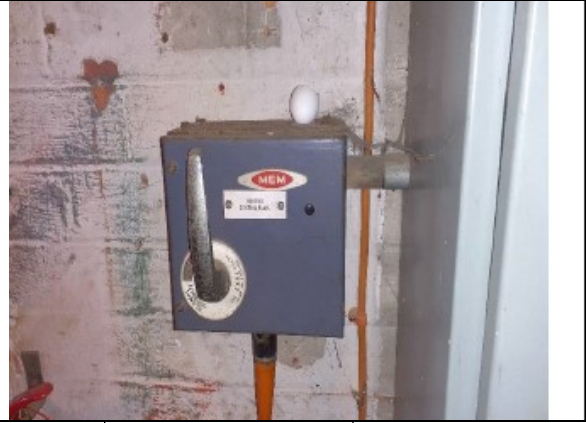
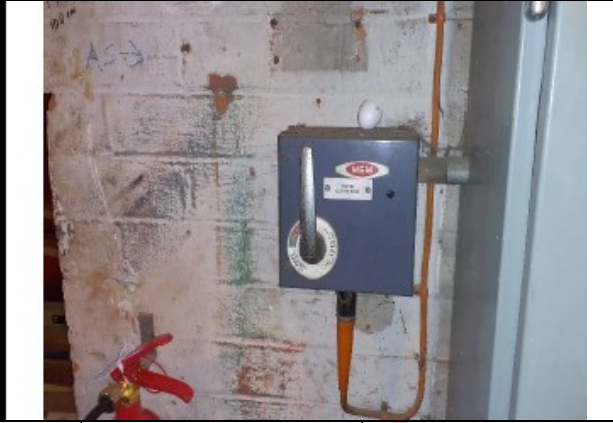
1	Presumed	Flash guards - MEM electrics	Z-Sub Level 1 Boiler House Z1/001	Low Risk

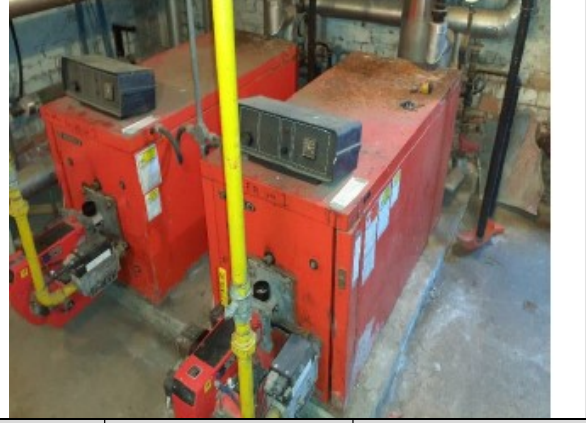
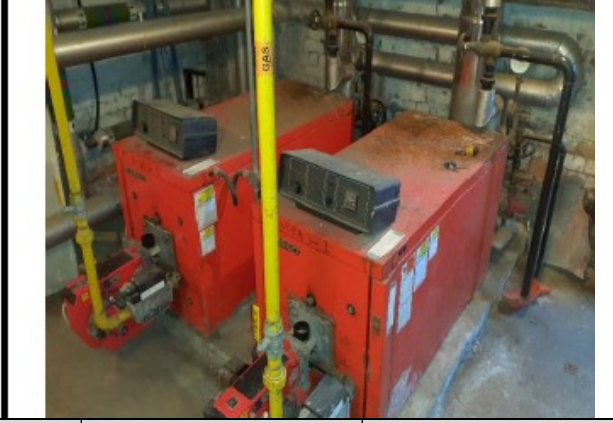
2	Presumed	Rope seal - TASSO Boilers	Z-Sub Level 1 Boiler House Z1/001	Low Risk

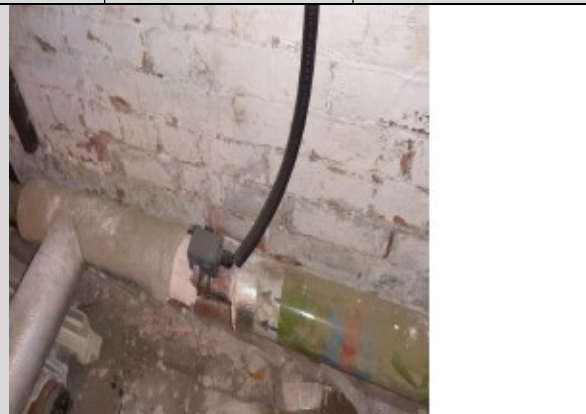
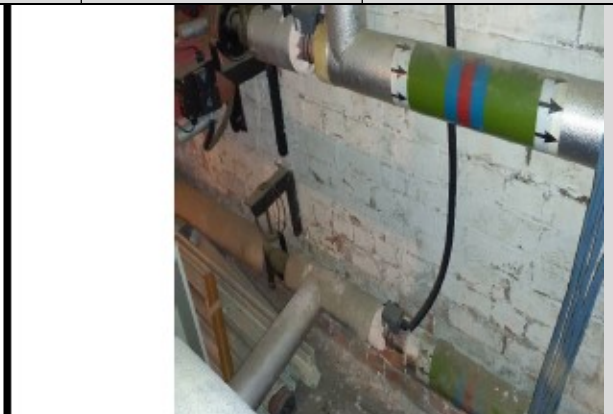
3	PK004037	Pipe insulation – Pipework and associated debris to floor	Z-Sub Level 1 Boiler House Z1/001	No Risk

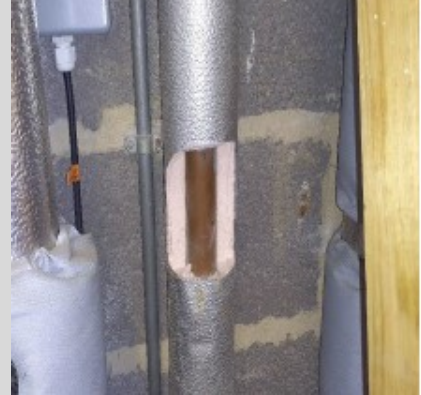
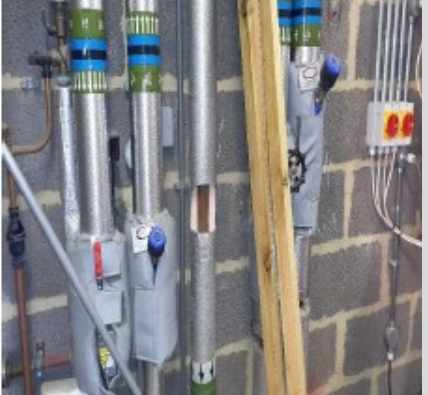
22	PK004042	Insulation – Pipework	Ground Floor Boiler Room G/067	No Risk

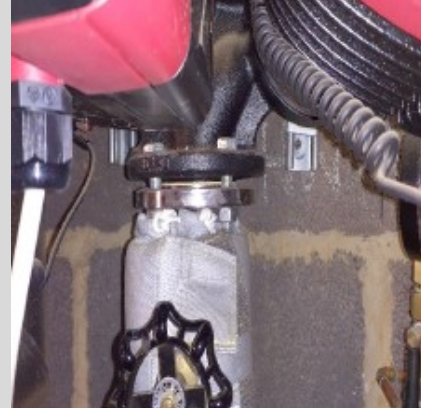
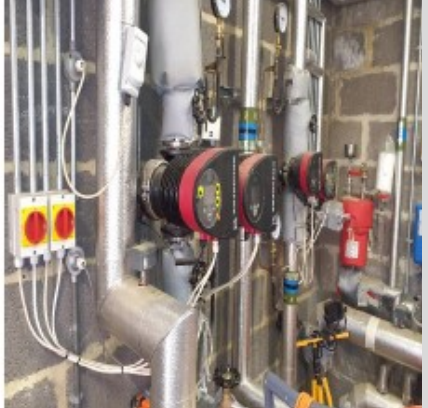
23	PK004043	Gaskets – Pipework	Ground Floor Boiler Room G/067	No Risk

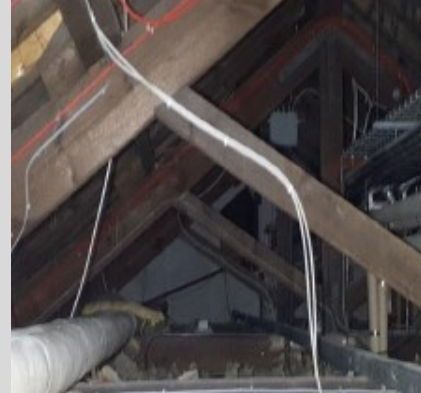
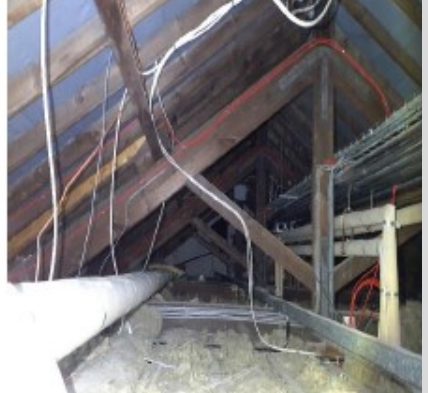
24	PK004046	Board - Firebreak wall	Roof Void Loft 1 R/001	No Risk

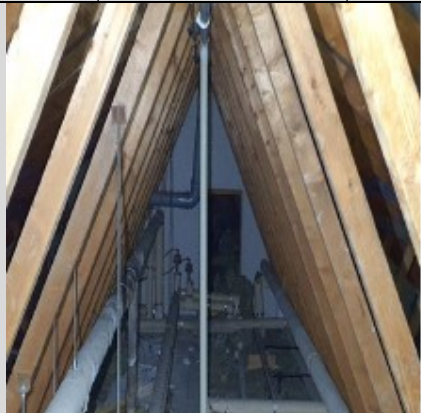
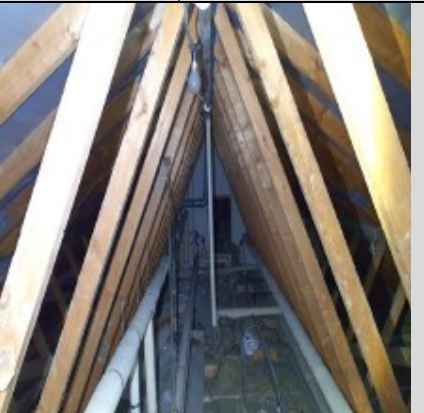
28	As PK004046	Board - Firebreak wall	Roof Void Loft 7 R/007	No Risk

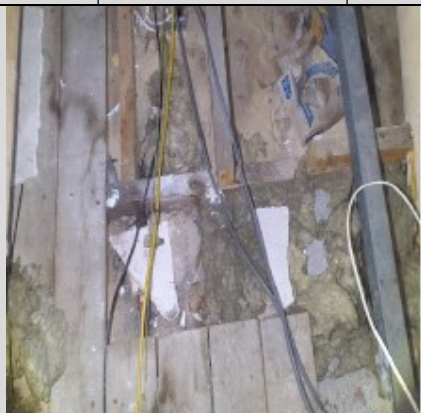
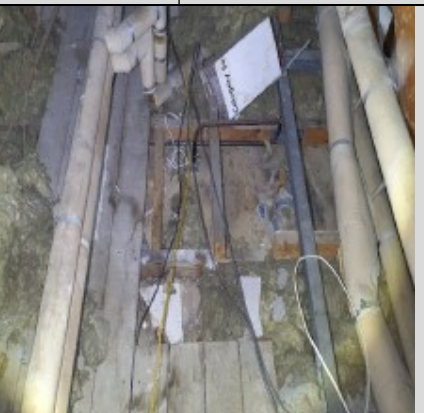
29	As PK004046	Board - Loose panel	Roof Void Loft 7 R/007	No Risk

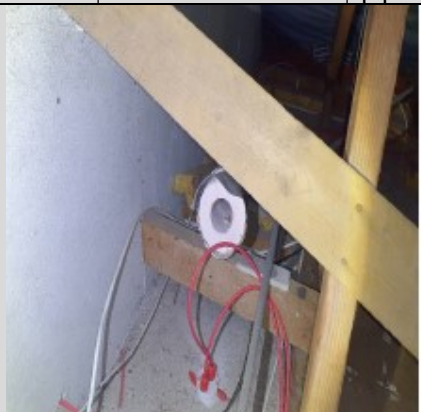
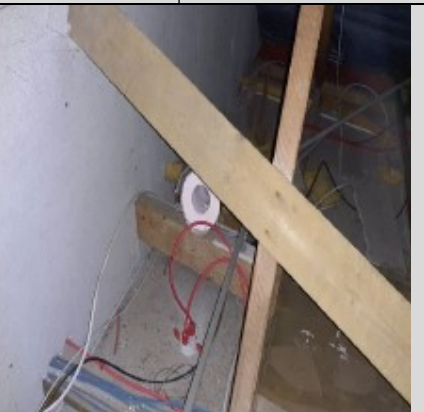
30	As PK004042	Insulation - Redundant pipework insulation	Roof Void Loft 7 R/007	No Risk
