ASBESTOS SURVEY REPORT FOR ST ANDREWS PRIMARY ACADEMY, ST ANDREWS ROAD, BISHOP AUCKLAND, DL14 6RY

Asbestos Register for

**ST ANDREWS PRIMARY ACADEMY, ST ANDREWS
ROAD**

Date: 24 April 2026

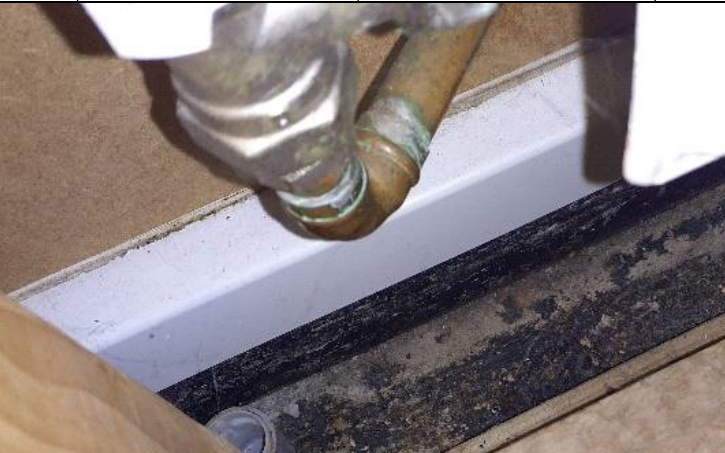
| 1. | PK003988 | Adhesive remnants – floor below window | Ground Floor, Office 010 G/004 | Very Low Risk – 12 monthly |

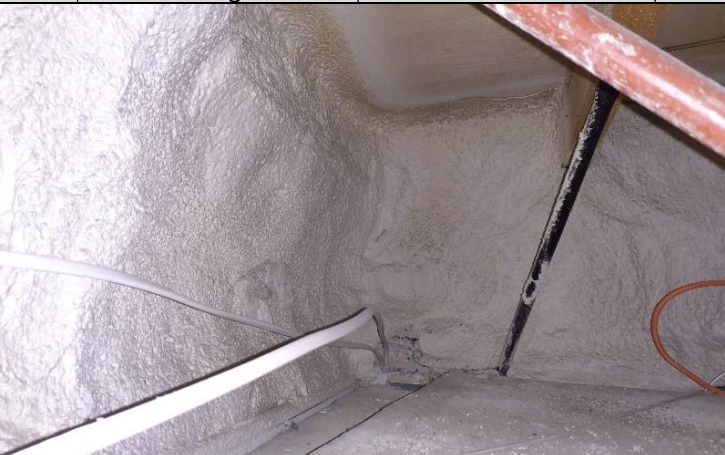
| 2. | PK003989 | Spray Coating – beams and columns within ceiling void | Ground Floor, Room 007 G/007 | No Risk |

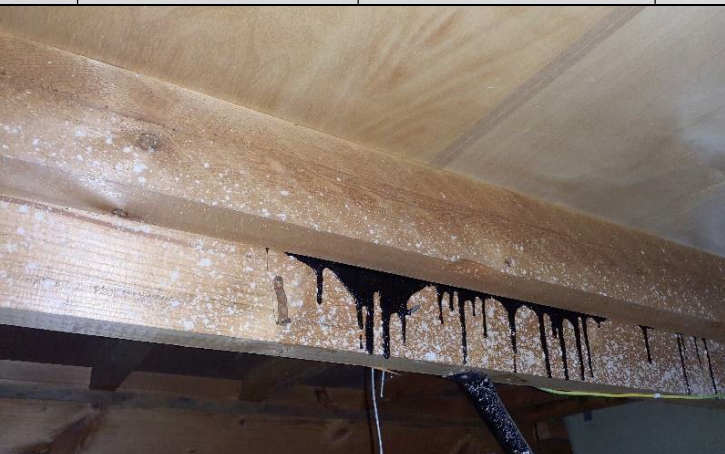
| 3. | PK003990 | Bitumen Drip – wood roof structure | Ground Floor, Room 007 G/007 | No Risk |

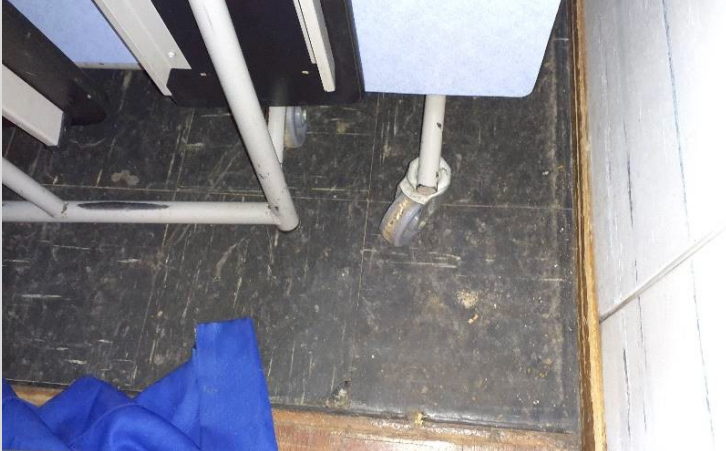
| 4. | PK003991 | Floor tiles and adhesive - floor | Ground Floor, Table Store 013 G/009 | No Risk |

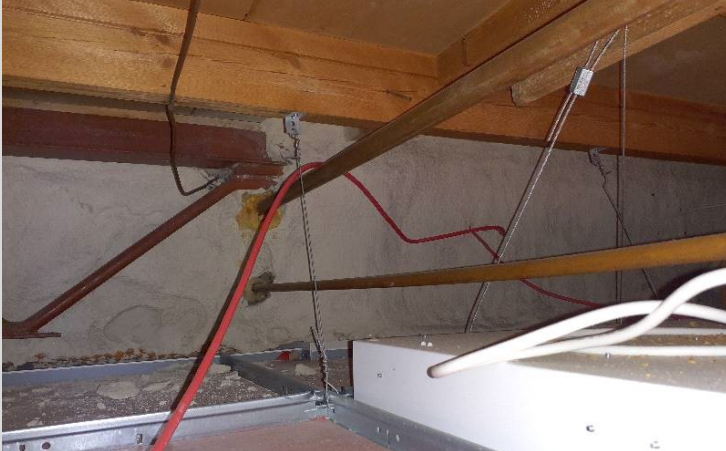
| 5. | As PK003989 | Spray Coating – beams and columns within ceiling void | Ground Floor, Kitchen 01 G/010 | No Risk |

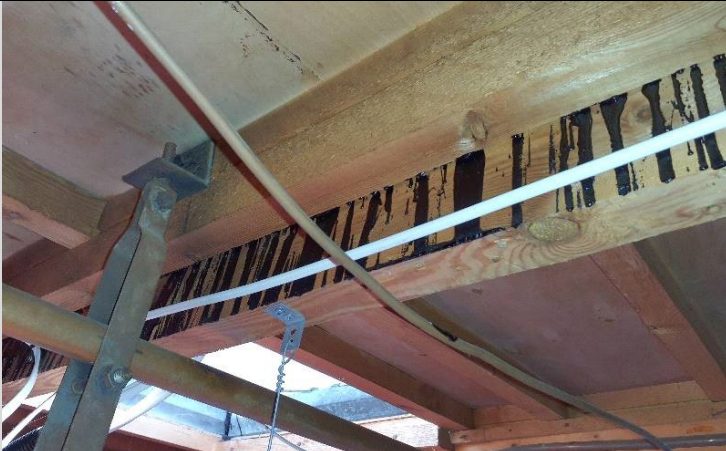
| 6. | As PK003990 | Bitumen Drip – wood roof structure | Ground Floor, Kitchen 01 G/010 | No Risk |

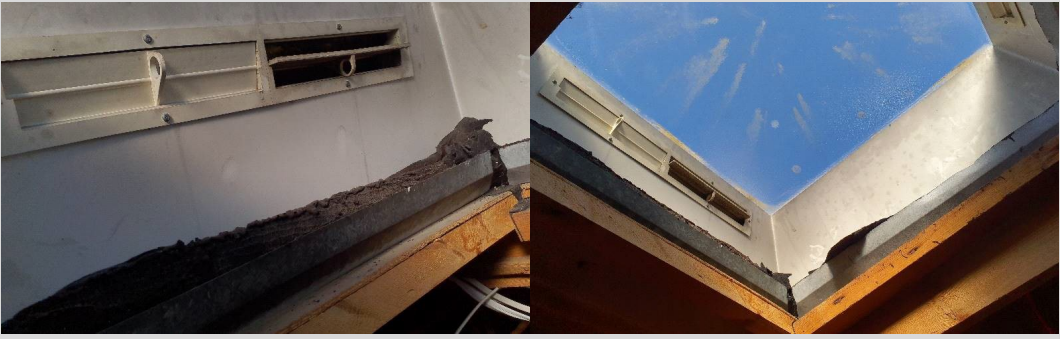
| 7. | PK003992 | Former flat roof remnants – around skylight within store above suspended ceiling | Ground Floor, Kitchen Store 02 G/011 | No Risk |

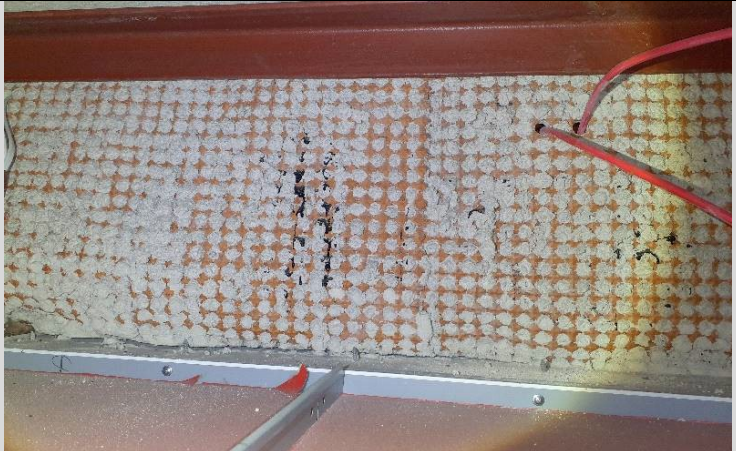
| 8. | As PK003989 | Spray Coating – metal beams and columns | Ground Floor, Kitchen Toilet 03 G/012 | No Risk |

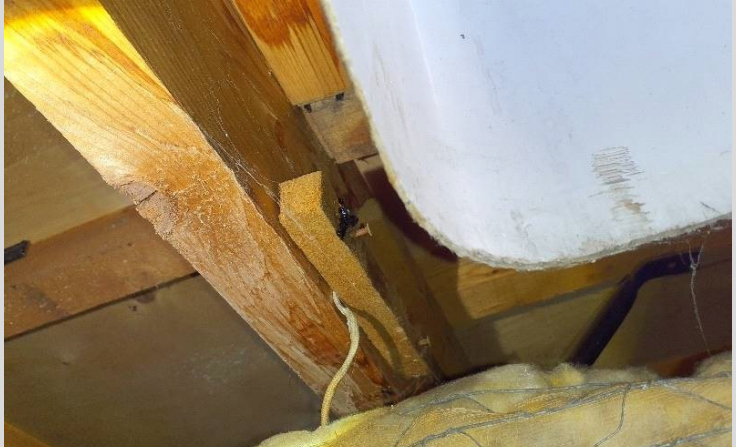
| 9. | As PK003990 | Bitumen Drip – wood and metal roof structure | Ground Floor, Kitchen Toilet 03 G/012 | No Risk |
