ASBESTOS SURVEY REPORT FOR PARK LANE MARKET, SUNDERLAND

Asbestos Register for PARK LANE MARKET, SUNDERLAND

UPRN: - 223048

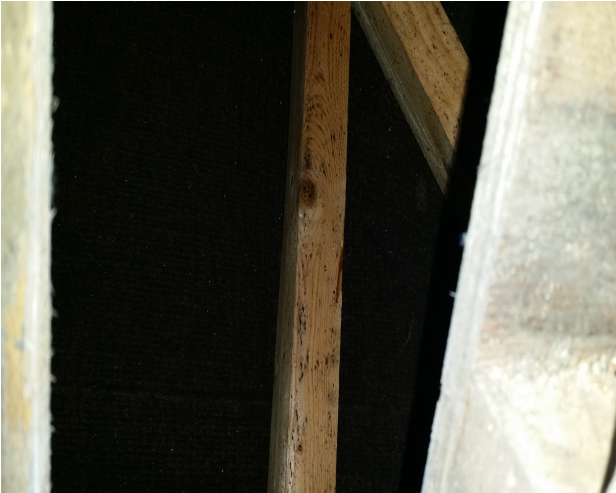
Item 1: 223048-1

The felt on the underside of the roof in the void above unit 12 does not contain asbestos.

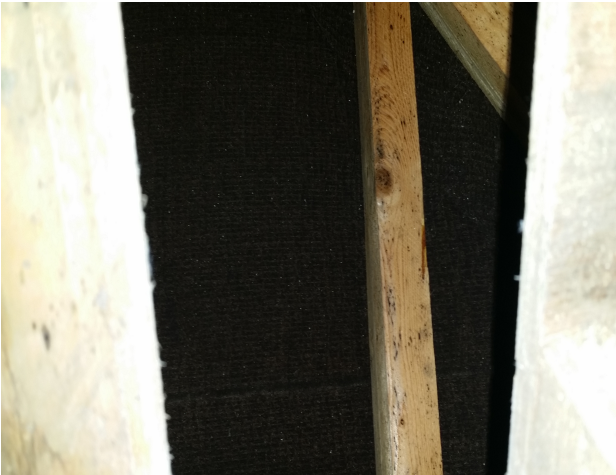
Item 2: As 223048-1

The felt on the underside of the roof in the void above unit 13 & 14 does not contain asbestos.

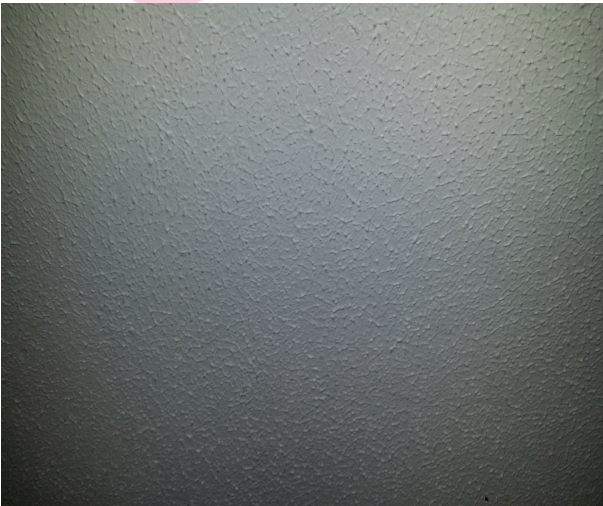
Item 3: 223048-2

The textured coating ceiling in unit 13 & 14 does not contain asbestos.

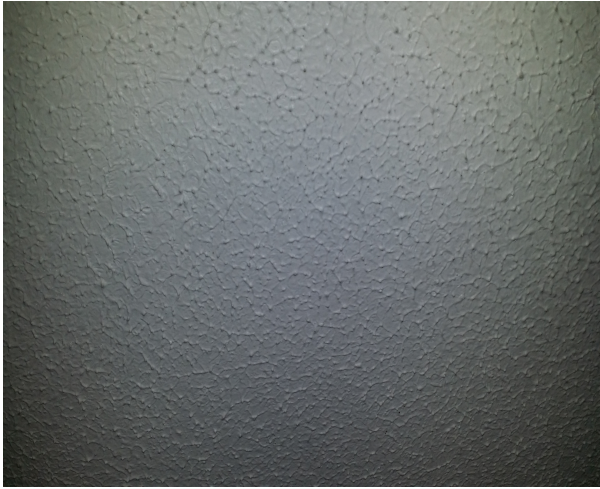
Item 4: 223048-3

The textured coating ceiling in unit 13 & 14 does not contain asbestos.

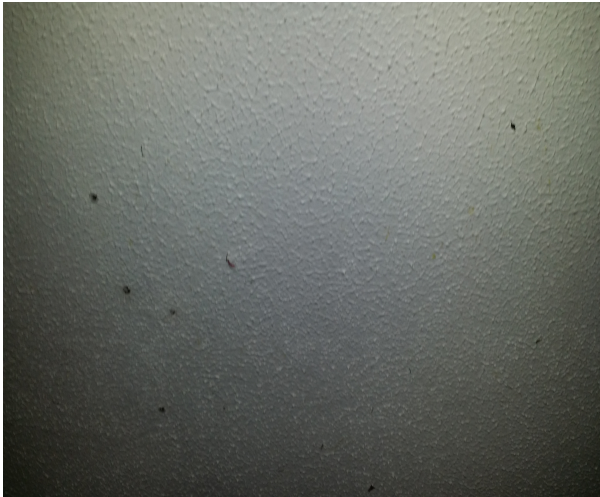
Item 5: 223048-4

The textured coating ceiling in unit 15 does not contain asbestos.

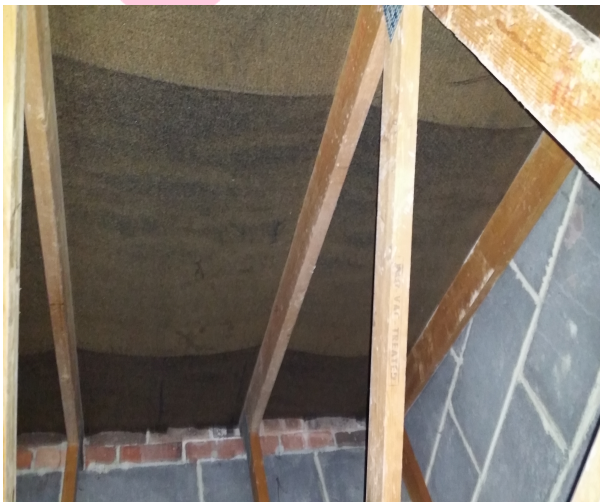
Item 6: As 223048-1

The felt on the underside of the roof in the void above unit 18 does not contain asbestos.

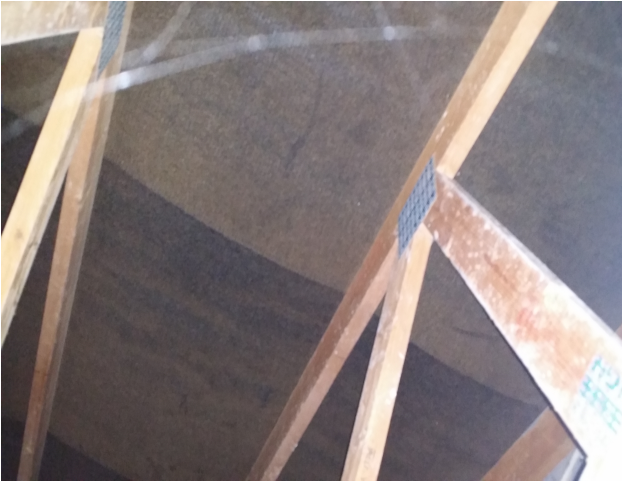
Item 7: As 223048-1

The felt on the underside of the roof in the void above unit 30 does not contain asbestos.

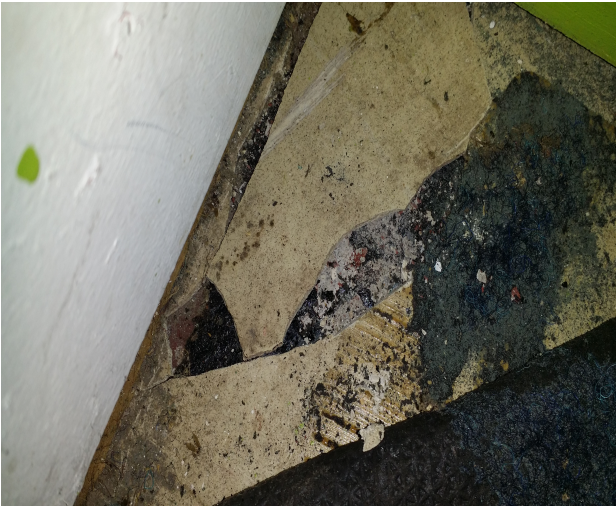
Item 8: 223048-5

The floor tiles and bitumen adhesive on the subfloor of unit 1 & 2 does not contain asbestos.

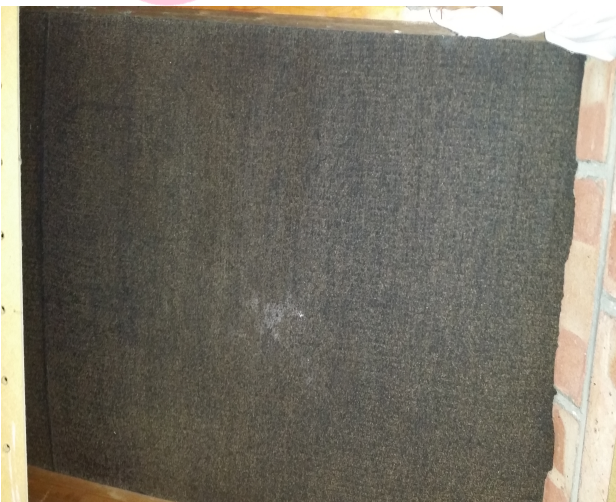
Item 9: 223048-6

The felt on the underside of the roof in the void above unit 6 does not contain asbestos.

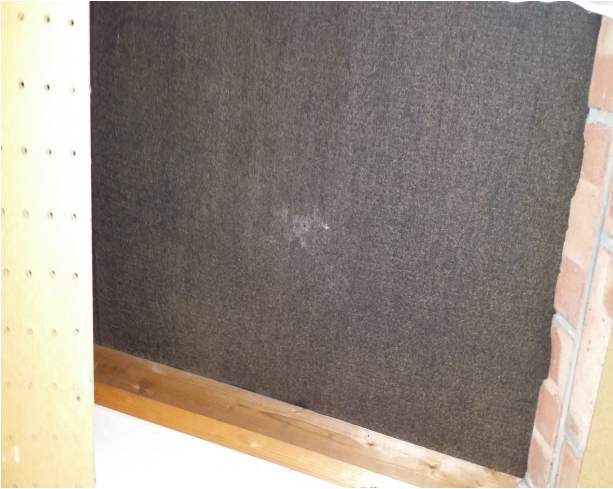
Item 10: As 223048-6

The felt on the underside of the roof in the void above unit 7 & 8 does not contain asbestos.

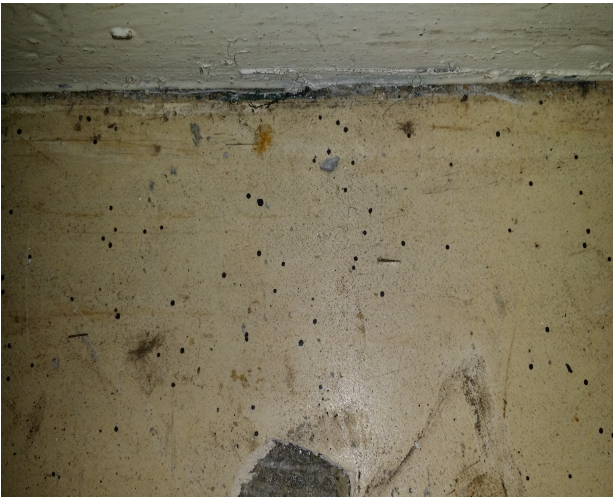
Item 11: 223048-7

The linoleum floor in the security room does not contain asbestos.

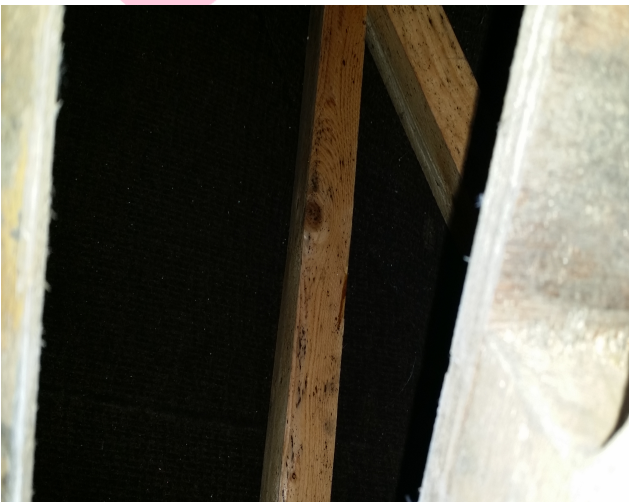
Item 12: 223048-8

The felt on the underside of the roof in the void above the security room does not contain asbestos.

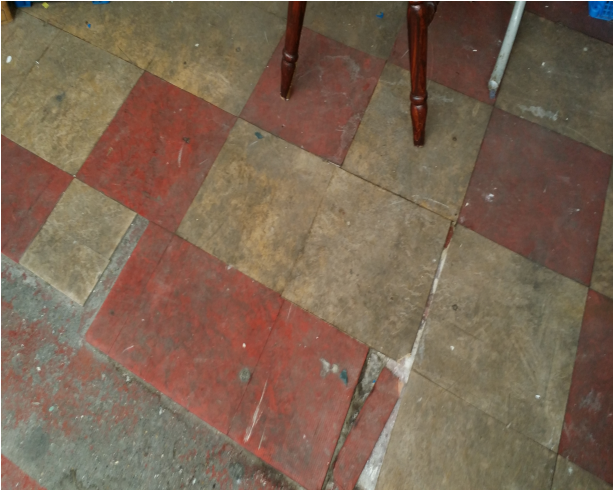
Item 13: 223048-9

The floor tiles (Red) in unit 11 does not contain asbestos.

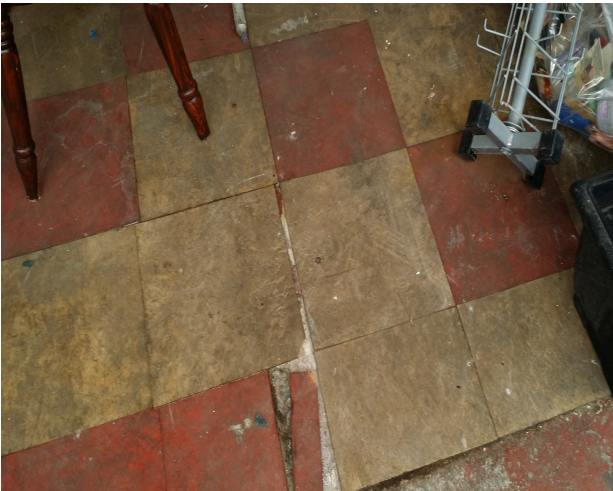
Item 14: 223048-10

The floor tiles (Yellow) in unit 11 does not contain asbestos.

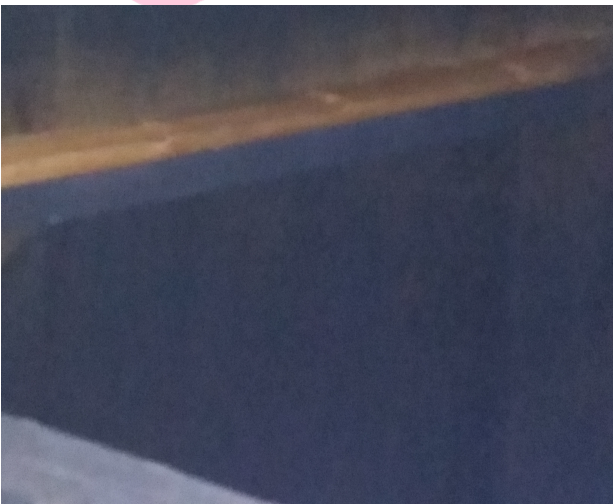
Item 15: As 223048-8

The felt on the underside of the roof in the void above unit 36 does not contain asbestos.

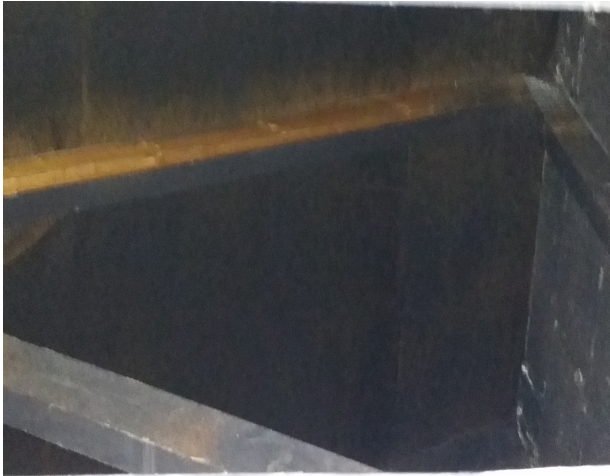
Item 16: As 223048-8

The felt on the underside of the roof in the void above unit 35 does not contain asbestos.

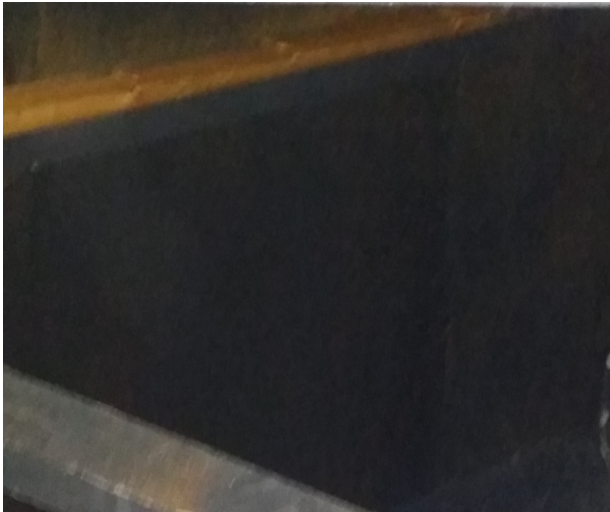
Item 17: As 223048-8

The felt on the underside of the roof in the void above unit 34 does not contain asbestos.

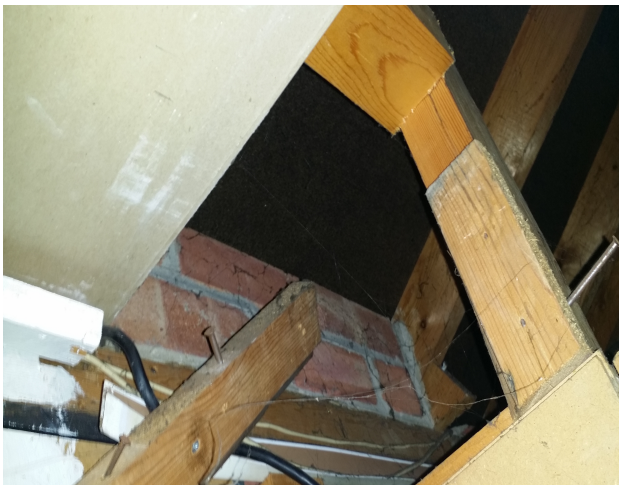
Item 18: As 223048-8

The felt on the underside of the roof in the void above unit 32 & 33 does not contain asbestos.

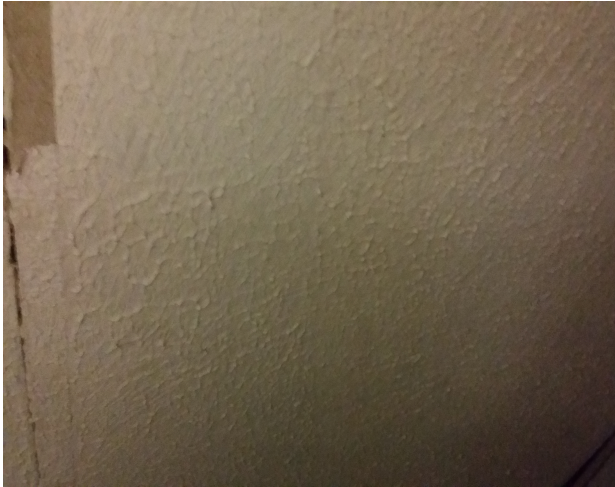
Item 19: 223048-18

The textured coating ceiling in unit 32 & 33 does not contain asbestos.

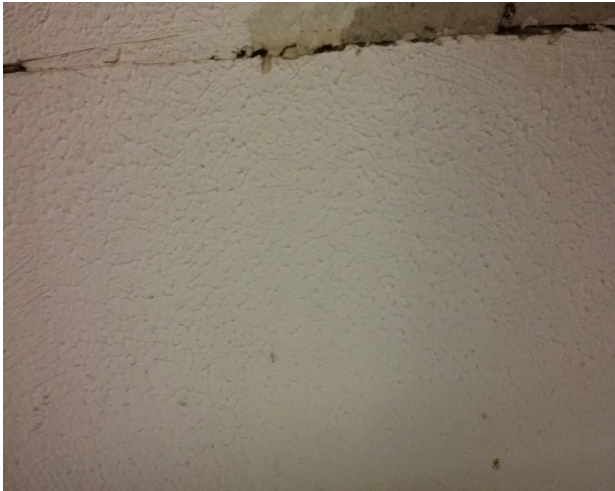
Item 20: 223048-19

The textured coating (supalux) ceiling in unit 32 & 33 does not contain asbestos.

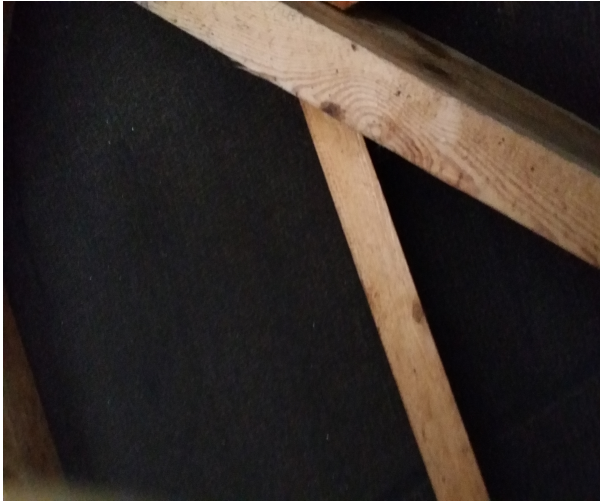
Item 22: As 223048-8

The felt on the underside of the roof in the void above unit 31 does not contain asbestos.

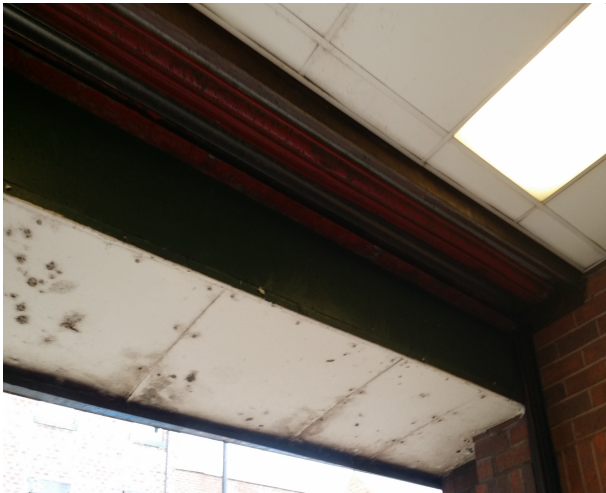
Item 23: As 223048-15

The front fascia at Holmeside Entrance does not contain asbestos.

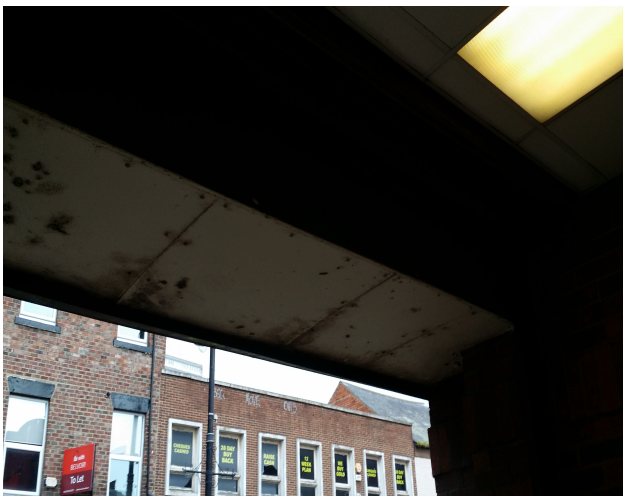
Item 24: As 223048-16

The front soffit at Holmeside Entrance does not contain asbestos.

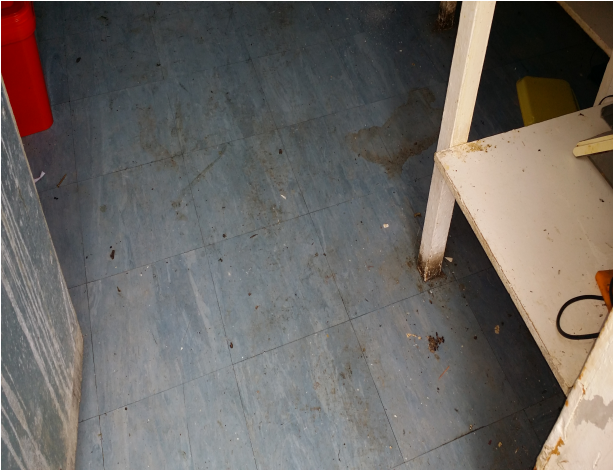
Item 25: 223048-11

The floor tiles in the butchers store does not contain asbestos.

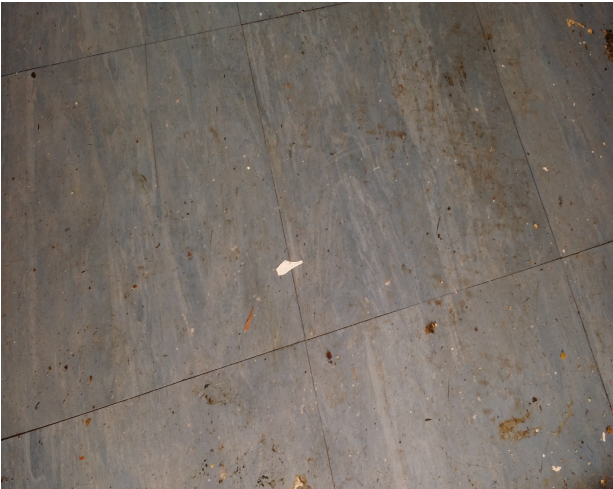
Item 26: As 223048-11

The floor tiles in the butchers store does not contain asbestos.

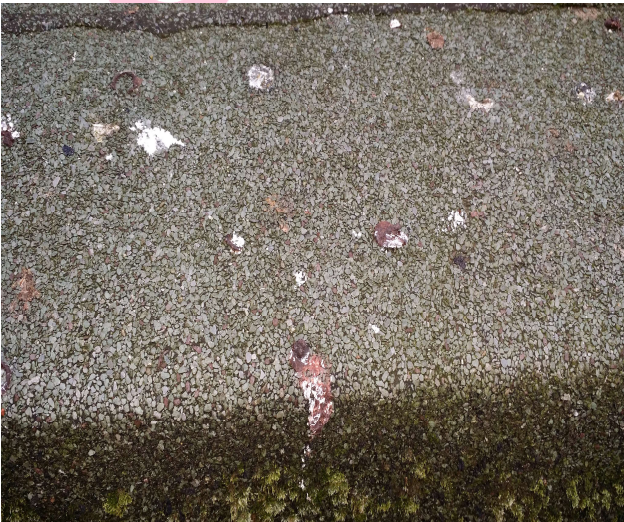
Item 27: 223048-12

The felt roof to the butchers store does not contain asbestos.

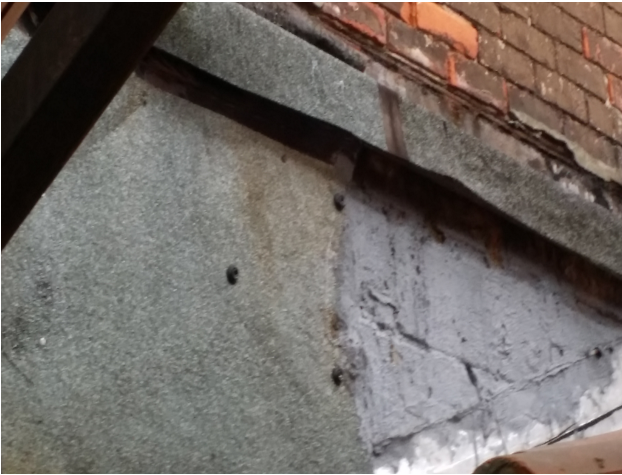
Item 28: 223048-13

The felt roof throughout the market does not contain asbestos.

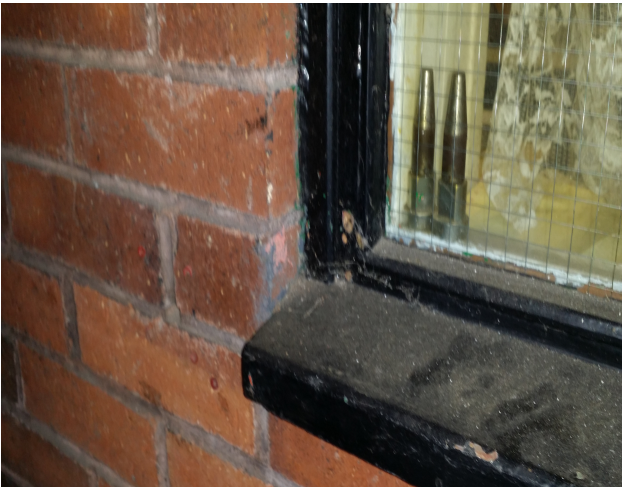
Item 29: 223048-14

The mastic to the frames does not contain asbestos.

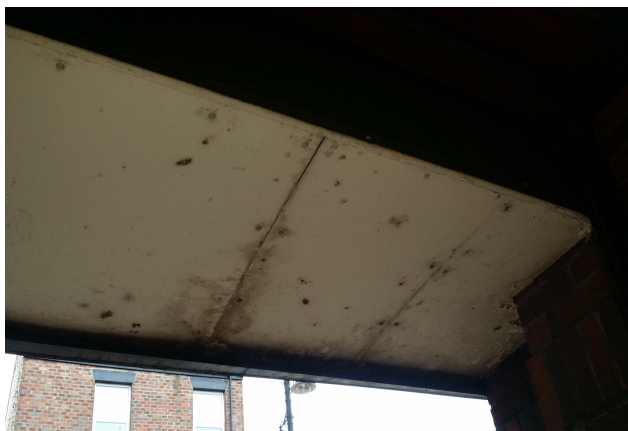
Item 30: 223048-15

The Front fascia (supalux) - Externals does not contain asbestos.

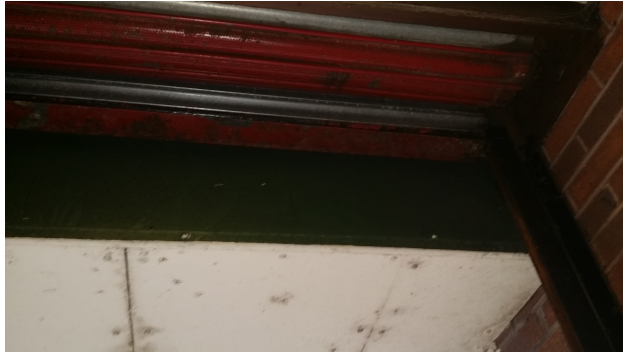
Item 31: 223048-16

The Front soffit (supalux) -
Externals does not contain
asbestos.

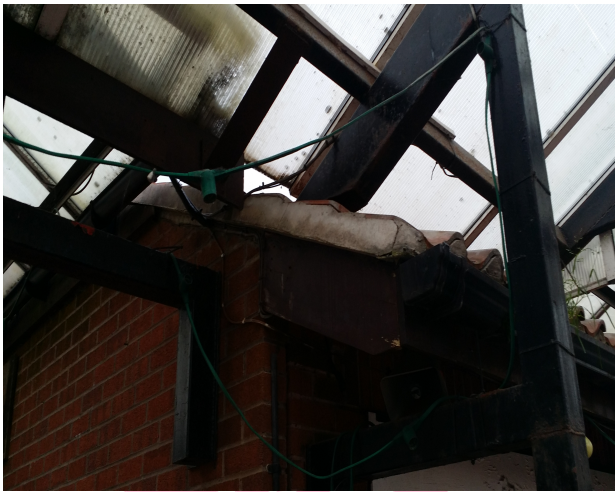
Item 32: 223048-17

The cement fillet to the roof
does contain asbestos.

Item 30	No asbestos	Is present		
Item 31	No asbestos	Is present		
Item 32	Cement Fillet to roofs	Very Low	12 Monthly	01.10.21
Item 33	No asbestos	Is present

Any change in its
appearance should be
recorded, and passed to
Property Services.

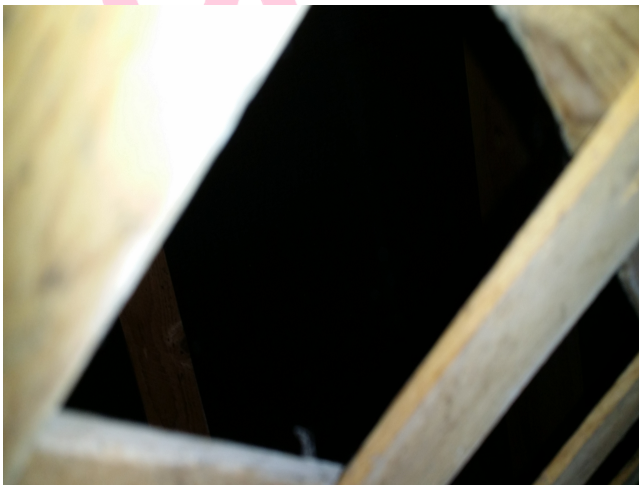
Item 33: As 223048-8

The roof felt to small
masonry canopies does not
contain asbestos.

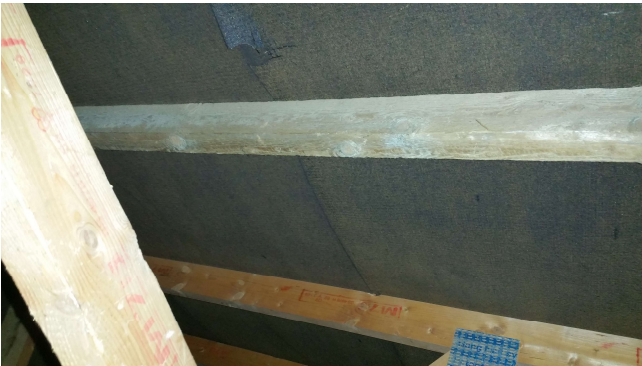
Item 34: 340941-1

The sarking in the loft void of the security office does not contain asbestos.

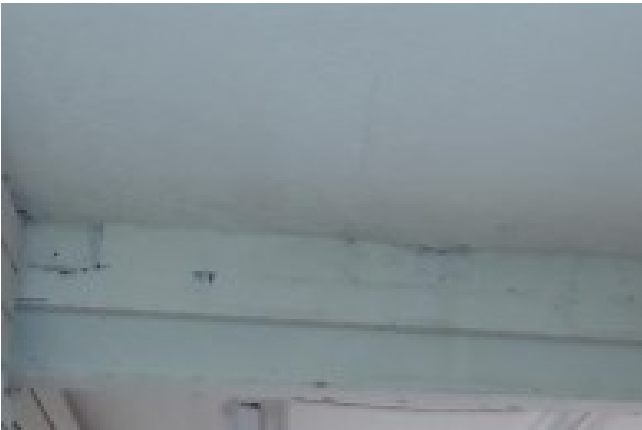
Item 35: 20-27673-3

The textured coating to ceiling in units 13-14 does contain asbestos.

Item 34	No asbestos	Is present		
Item 35	Textured coating ceiling (Unit 13 & 14)	Very Low	12 Monthly	01.10.21
Item 36	No asbestos	Is present		
Item 37	Drip Edge (External)	Very Low	12 Monthly	01.10.21

Any change in its appearance should be recorded, and passed to Property Services.

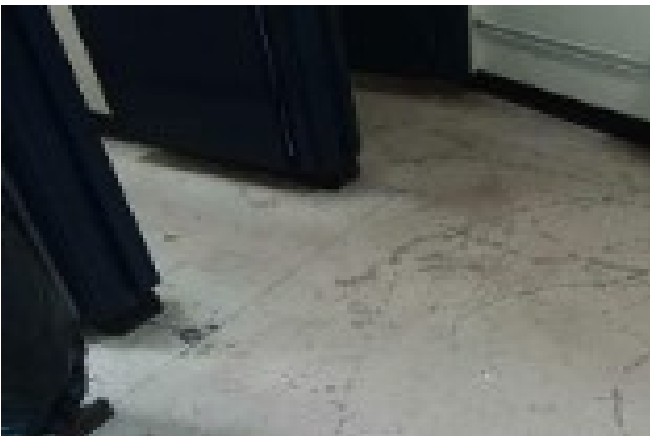
Item 36: 20-29353-2

The vinyl flooring in the Female WC does not contain asbestos.

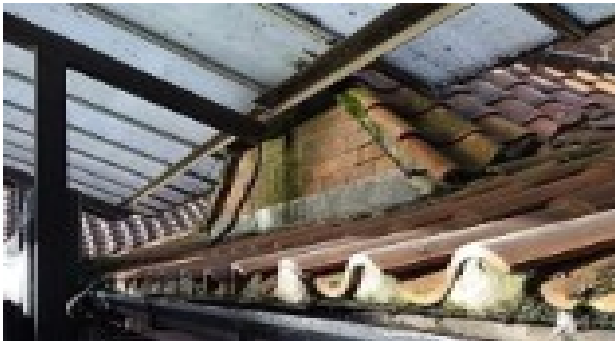
Item 37: 20-29353-5

The drip edge (External) does contain asbestos.

Any change in its appearance should be recorded, and passed to Property Services

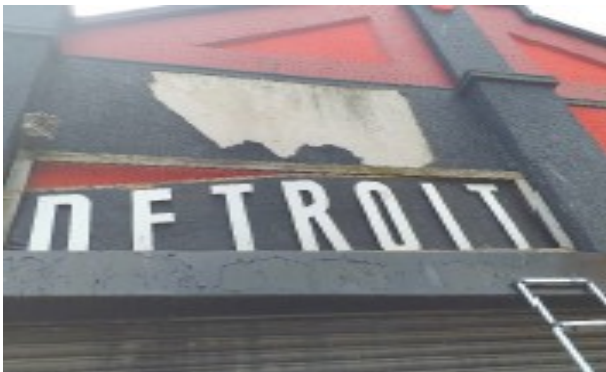
Item 38: SE000595

The render (supalux board) to the external entrance (E/01) does not contain asbestos.
