### ASBESTOS SURVEY REPORT FOR MONKWEARMOUTH ACADEMY CARETAKERS HOUSE 2, SUNDERLAND

**Asbestos Register for**

**MONKWEARMOUTH SCHOOL 2 CARETAKERS HOUSE**

**Date: 25 November 2025**

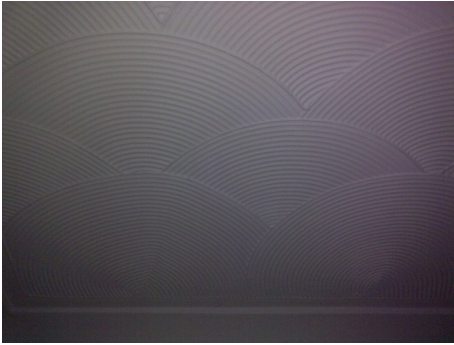
### **Item 1 Ref: DC2066/10**

The coating to the ceiling in the entrance hall (Rm 0/01) does not contain asbestos.

Similar coating is located in the lounge.

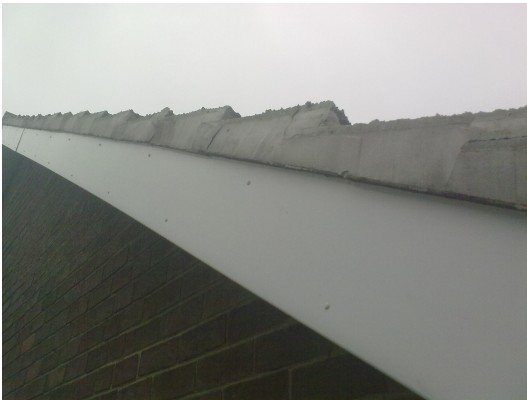
### **Item 6 - Ref: DC2068/10**

The undercloaking to the external of the house contains asbestos.

Any change in its appearance should be recorded, and passed to Property Services.

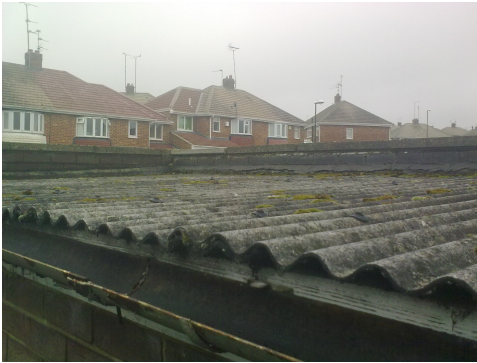
**Item 8 - Ref: DC2069/10**

The roof to the garage contains asbestos.

Any change in its appearance should be recorded, and passed to Property Services.
