ASBESTOS SURVEY REPORT FOR 11 CLAREMONT TERRACE,
SUNDERLAND, SR2 7LB.

Asbestos Register for

11 Claremont Terrace, Sunderland, SR2 7LB

Date: 28 May 2025

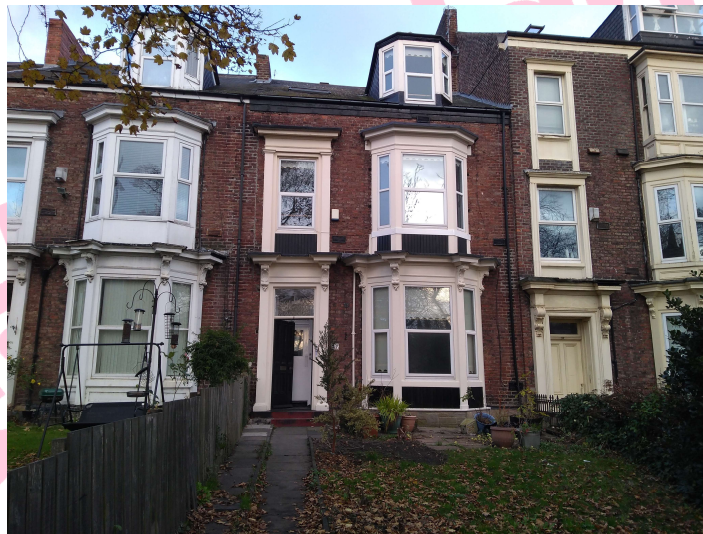
Plan of Building and Samples Location

- (Item 1) Ref: 373915-1 – Panel to rear of door (Basement area 1/Rm 001) – Low Risk
- (Item 2) Ref: As 373915-1 – Panel surrounding door (Basement area 1/Rm 001) – Low Risk
- (Item 3) Ref: 373915-2 – Panel debris to shelf (Basement area 1/Rm 001) – Removed December 2019
- (Item 4) Ref: Presumed – Electric cable (Entrance Lobby/Rm 001) – Very Low Risk
- (Item 5) Ref: 373915-3 – Paper warning sticker to electrics (Entrance Lobby/Rm 001) – No Risk

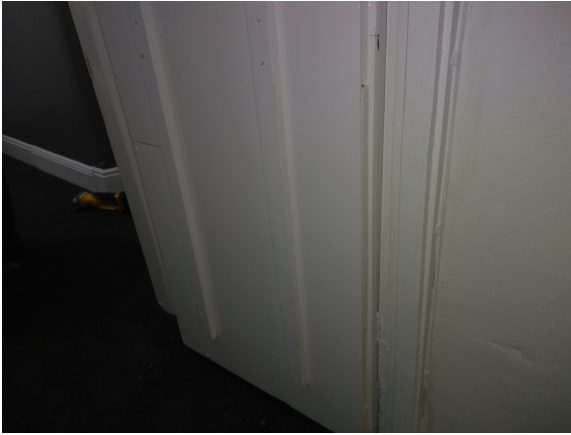
Item 1 Ref: 373915-1

The panel to rear of door in the basement area (Rm -1/01) contains asbestos.

Any change in appearance should be reported to Property Services.

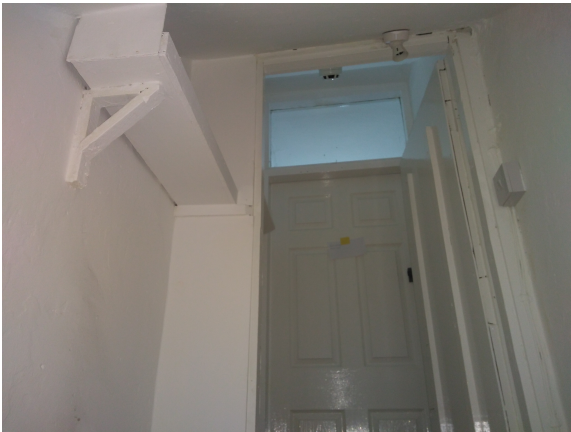
Item 2 Ref: As 373915-1

The panel surrounding door in the basement area (Rm -1/01) contains asbestos.

Any change in appearance should be reported to Property Services.

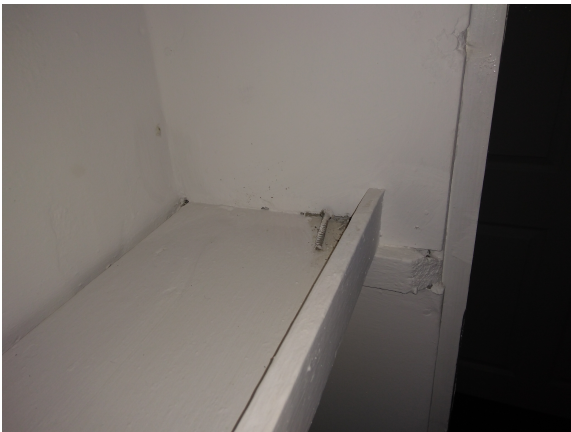
Item 3 Ref: 373915-2

The panel debris to shelf in the basement area (Rm -1/01) contains asbestos.

Removed December 2019

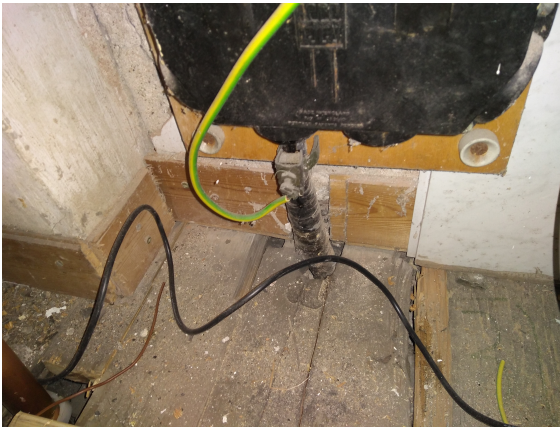
Item 4 Ref: Presumed

The electric cable in the entrance lobby (Rm 0/01) is presumed to contain asbestos.

Any change in appearance should be reported to Property Services.

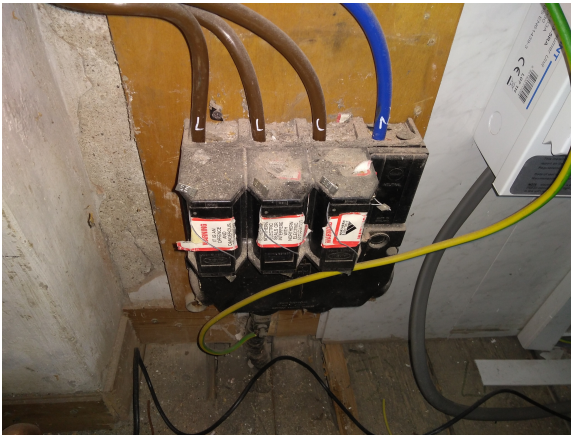
Item 5 Ref: 373915-3

The paper warning stickers to electrics in entrance lobby (Rm 0/01) do not contain asbestos.
