ASBESTOS SURVEY REPORT FOR NO 3 MACHINERY HOUSE, WEST SIDE PORT OF SUNDERLAND

**NO 3 MACHINERY HOUSE, WEST SIDE,
PORT OF SUNDERLAND**

Premises Manager / Samo: - Tenant Date: 3rd July 2025

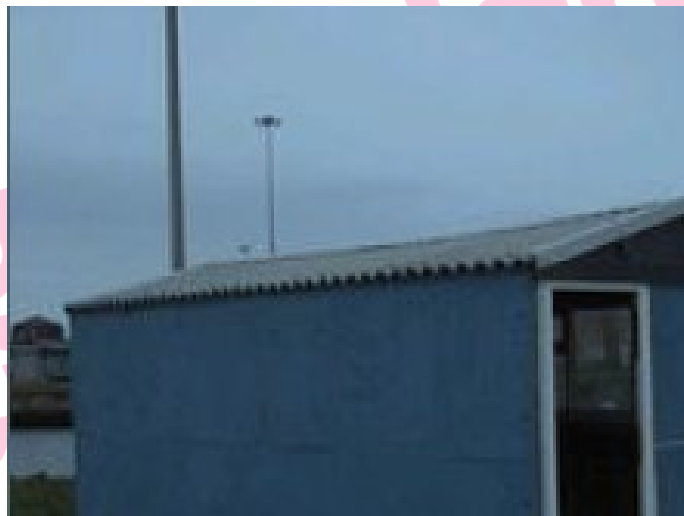
Plan of Building and Samples Location

VP002089 – Cement Roof (Room 1) (Item 1) No Risk

VP002090 – Cement Bulk heads (Room 1) (Item 2) Very Low Risk

As VP002089 - Cement Roof (External) (Item 3) No Risk

As VP002090 – Cement Bulkheads (External) (Item 4) Very Low Risk

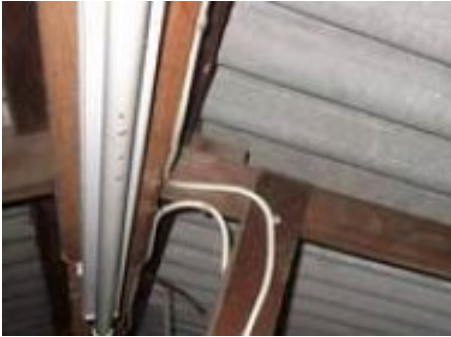
Item 1 Ref: VP002089

The cement roof to the inside of the machinery house (Room 1) does not contain asbestos.

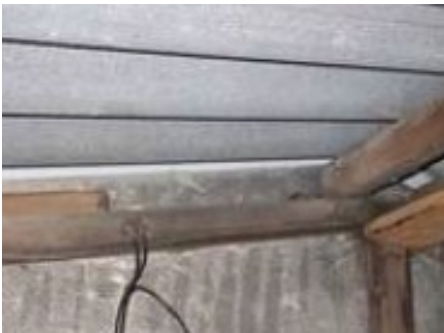
Item 2 - Ref: VP002090

The cement bulkheads to the machinery house (Room 1) contain asbestos.

Any change in its appearance should be recorded and passed to Property Services.

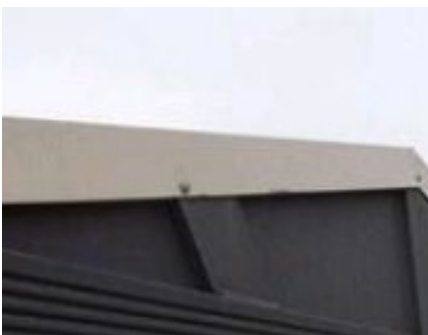
Item 4 - As VP002090

The cement bulkheads to the exterior of the machinery house contain asbestos.

Any change in its appearance should be recorded and passed to Property Services.
