### ASBESTOS SURVEY REPORT FOR A3 WEARFIELD, SUNDERLAND ENTERPRISE PARK, SUNDERLAND, TYNE AND WEAR, SR5 2TZ

### **Asbestos Register for**

### **Unit A3 Wearfield, Sunderland Enterprise Park**

**Date: 22 January 2026**

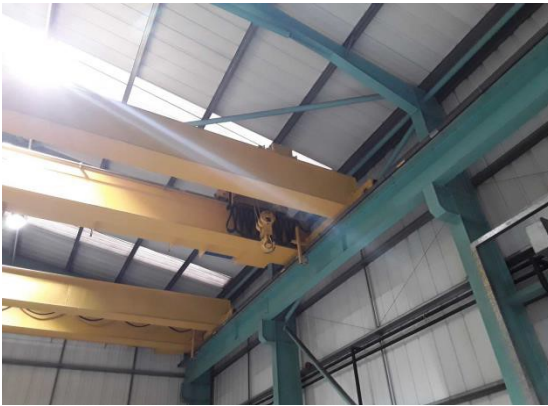
### **Item 1 Ref: Presumed**

The brake shoes to crane (Area 1/Main factory floor) are presumed to contain asbestos.

Any change in its appearance should be recorded and passed to Property Services.

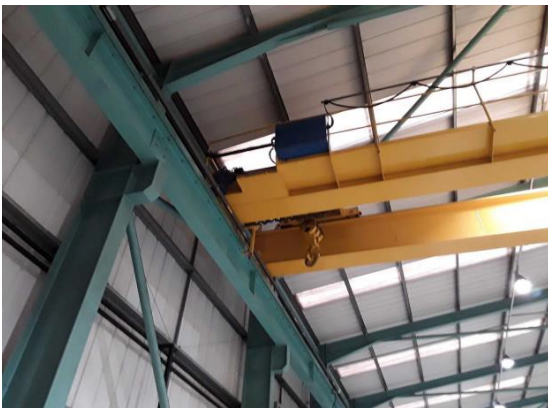
### **Item 2 Ref: Presumed**

The gaskets to crane equipment (Area 1/Main factory floor) are presumed to contain asbestos.

Any change in its appearance should be recorded and passed to Property Services.

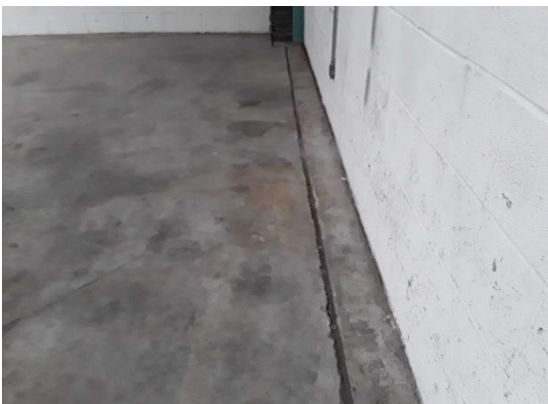
### **Item 3 Ref: 22-41694-3**

The expansion joints to floor (Area 1/Main factory floor) do not contain asbestos.

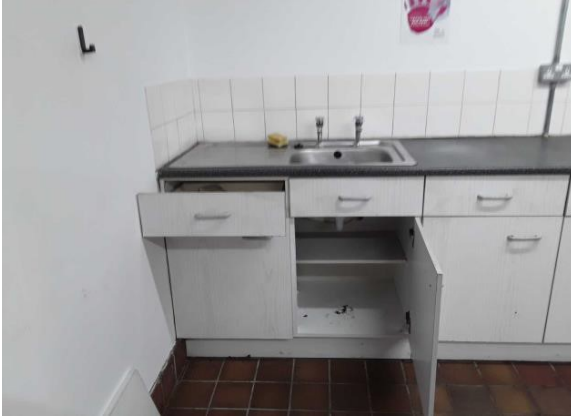
**Item 4 Ref: 22-41694-4**

The sink pad (Area 4/Changing Rooms) does not contain asbestos.
