### ASBESTOS SURVEY REPORT FOR SANDHILL VIEW – CARETAKERS HOUSE, SUNDERLAND

**Sandhill View, Caretakers House,  
Sunderland, SR3 4EN**

**Date: 16 March 2026**

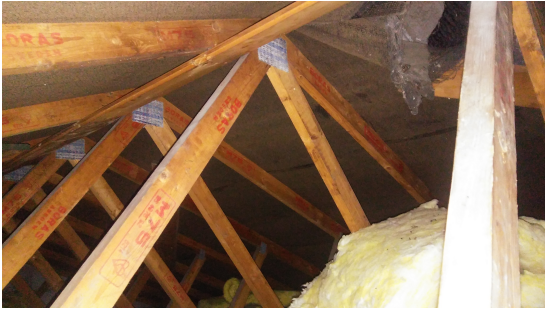
### **Item 1 Ref: 218425-1**

The sarking in the loft space (Rm 001) does not contain asbestos.

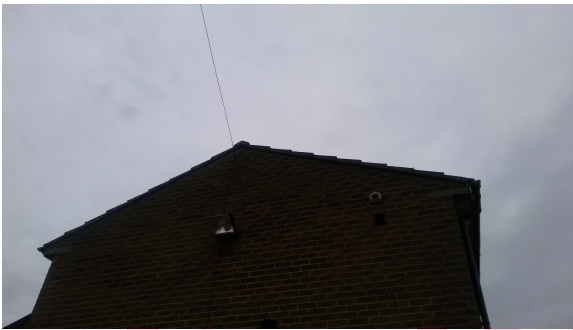
### **Item 2 Ref: 218425-2**

218425-2 Roof Undercloaking (External) (Item 2) – Removed May 2022

The roof cloaking (external) does contain asbestos.

Removed May 2022

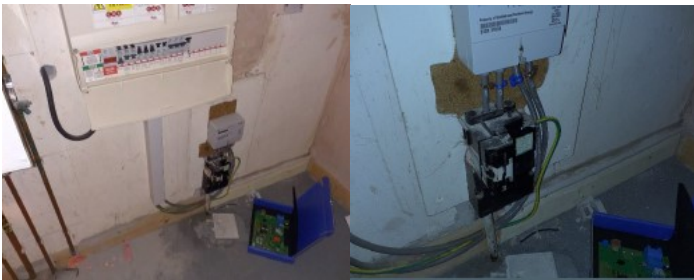
### **Item 3 Ref: Presumed**

Presumed – Flashguards – service termination (Understairs cupboard G/03)  
(Item 3) – Low Risk

The flash guards – service termination in the understairs cupboard (G/03) is presumed to contain asbestos.

Any change in appearance should be reported to Property Services.

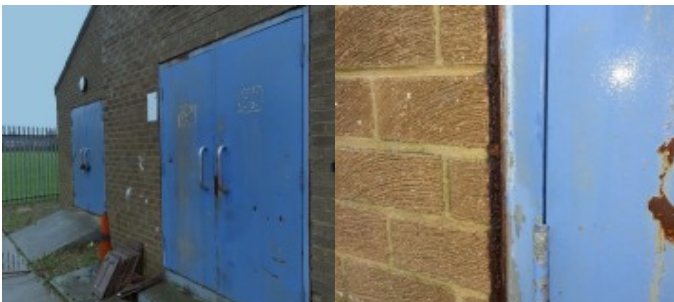
### **Item 5 Ref: SE000439**

The mastic to the door frames externally (E/01) does not contain asbestos.
