ASBESTOS SURVEY REPORT FOR 9 CLAREMONT TERRACE,  
ASHBROOKE, SUNDERLAND, SR2 7LB

## **Asbestos Register for**

**9 Claremont Terrace, Ashbrooke, SR2 7LB**

**Date: 25 September 2025**

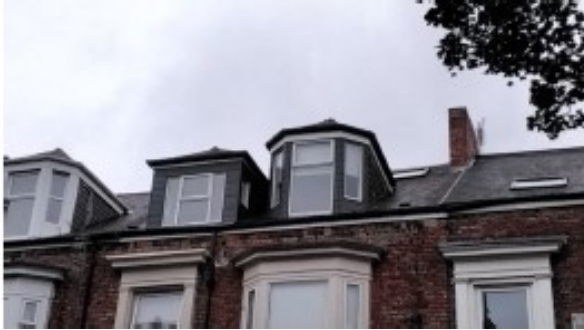
### **Item 1 Ref: Presumed**

The roof tiles to the dormer window are presumed to contain asbestos.

Any change in its appearance should be recorded and passed to Property Services.

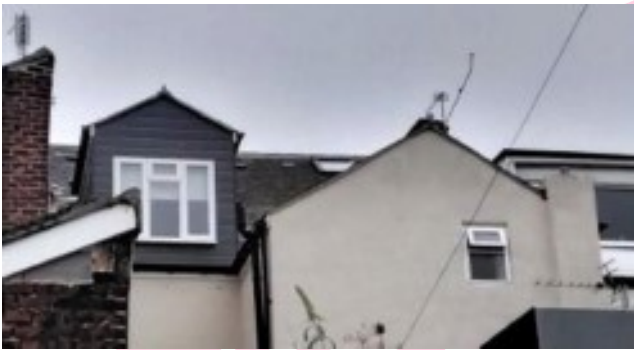
### **Item 2 Ref: Presumed**

The under cloak is presumed to contain asbestos.

Any change in its appearance should be recorded and passed to Property Services.
