ASBESTOS SURVEY REPORT FOR 1 – 4 LOMBARD STREET,
SUNDERLAND, SR1 2HS.

Asbestos Register for

1 – 4 Lombard Street, Sunderland, SR1 2HS

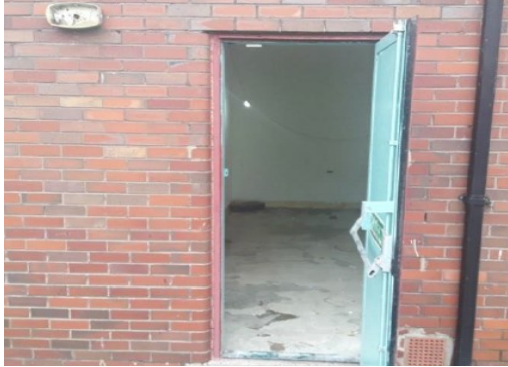
Item 1 Ref: NZ000569

The door seal gasket mastic to frame wall door and windows (External E/001) does not contain asbestos.

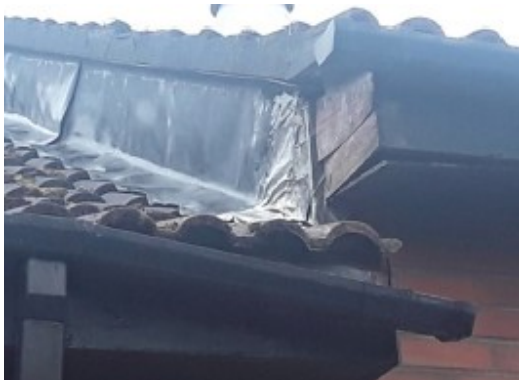
Item 2 Ref: NZ000570

The undercloak (External E/001) contains asbestos.

Any change in its appearance should be recorded and passed to Property Services.

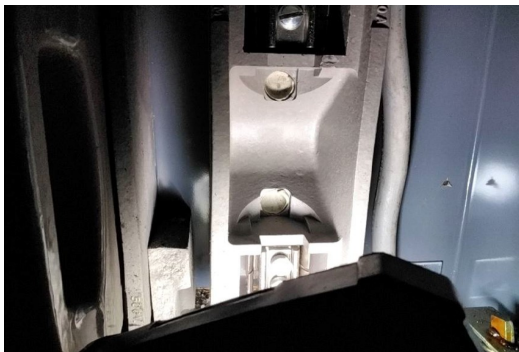
Item 3 Ref: KX001817

The putty to mounting screws in switch box in Electrical Cupboard (G/004) contains asbestos.

Any change in its appearance should be recorded and passed to Property Services.

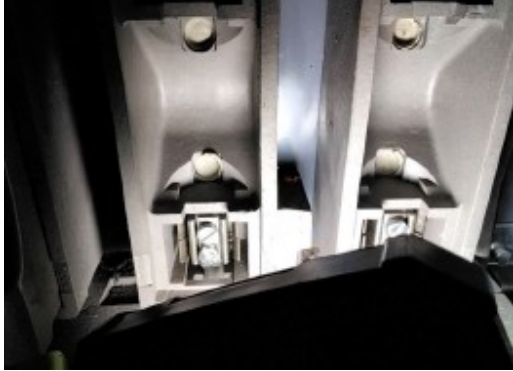
Item 4 Ref: As KX001817

The putty to mounting screws in switch box in Electrical Cupboard (G/005) contains asbestos.

Any change in its appearance should be recorded and passed to Property Services.
