# Silksworth Hall Conservation Area <sup>SP.42</sup>

## Character Appraisal and Management Strategy

January 2010

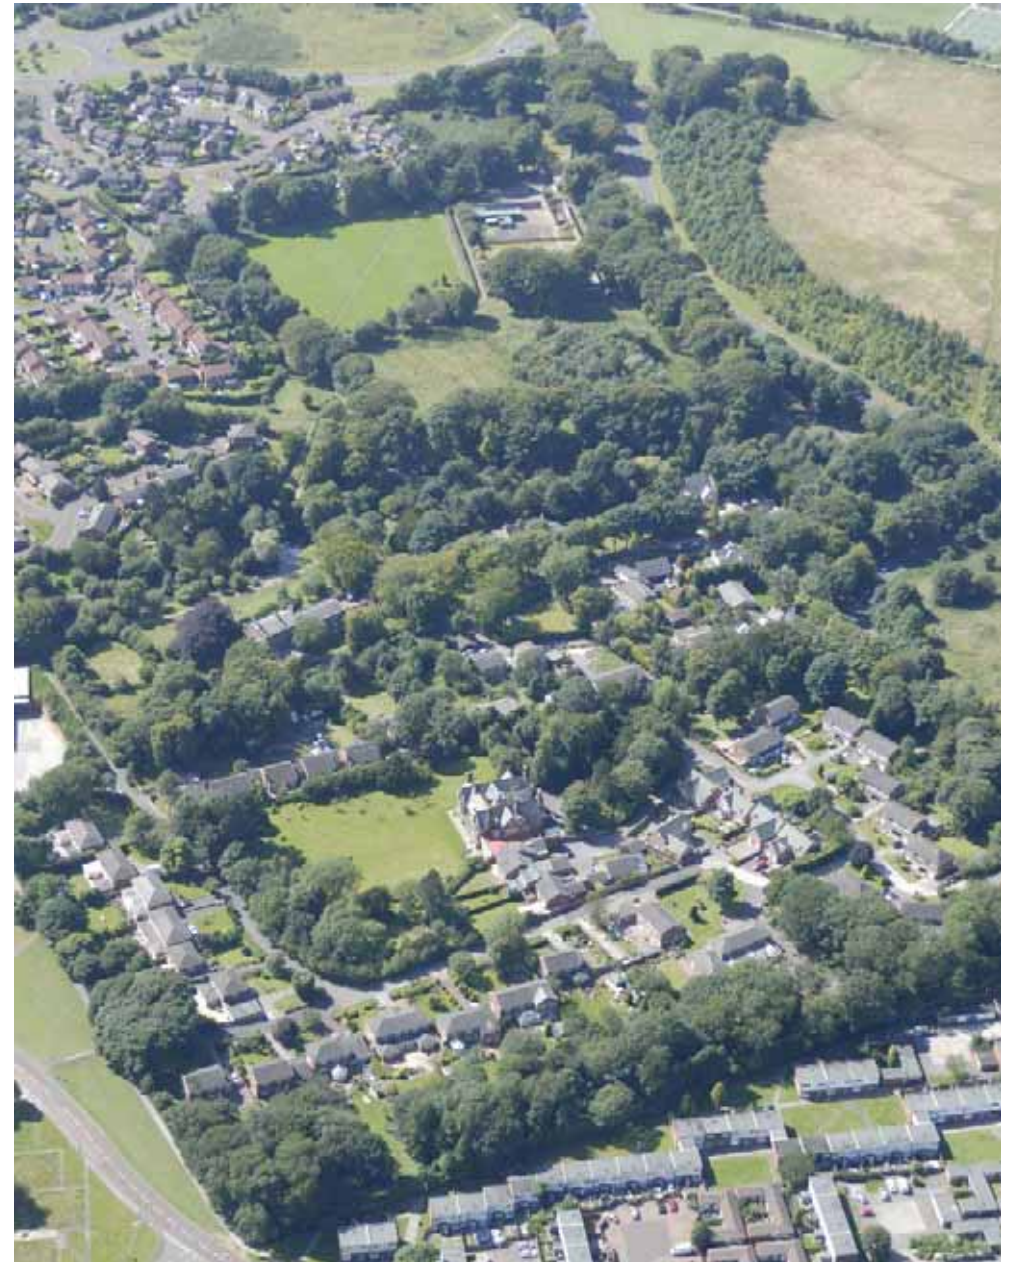
Aerial photograph of the Conservation Area, illustrating it in its wider context; the boundary of the Conservation Area is clearly defined by the heavy line of mature trees around the entire area.

The boundary of the Conservation Area follows the field pattern evident on the first edition OS map of 1856, and takes in the former grounds to Silksworth Hall and Doxford House. The Conservation Area boundary is clearly discerned from the air (right) and on the ground by the heavy tree cover that borders it.

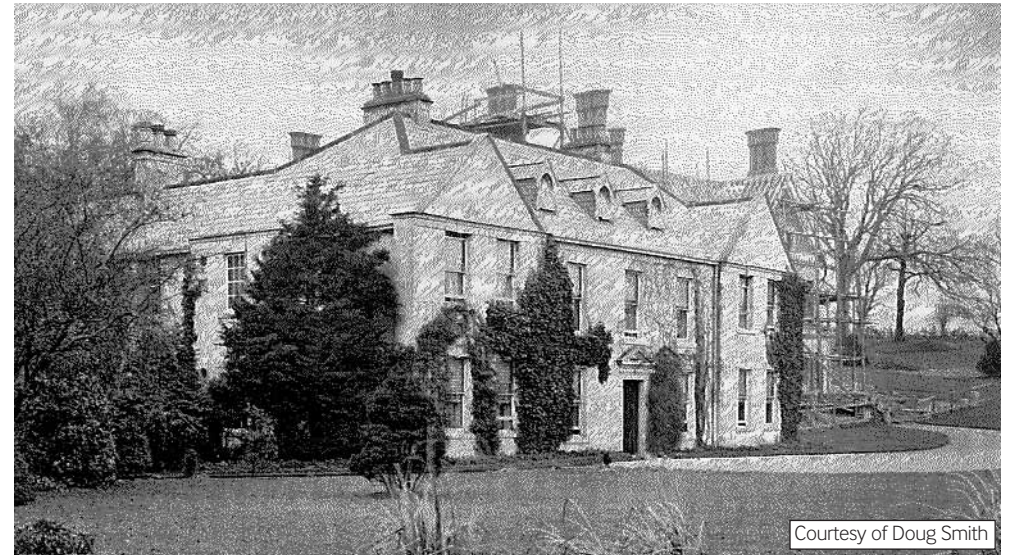
Silksworth Hall as it would have been when the Robinson family occupied the manor. This photograph was taken in 1903 by Robert Doxford and shows the current Hall under construction behind it.

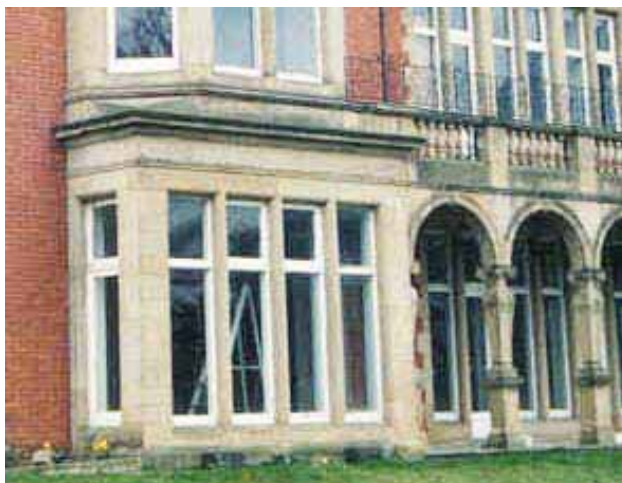
Right: red brick and sandstone at Silksworth Hall

The predominant building materials in the Conservation Area are limestone, sandstone and red brick. Doxford House features sandstone to the front (east) elevation and brick to the rear (west) elevation; Silksworth Hall is of bright red brick with sandstone terrace and dressings. Stone rubble (i.e. not regular blocks) features heavily in boundary treatments, particularly along Warden Law Lane, and in a number of the historic cottages.

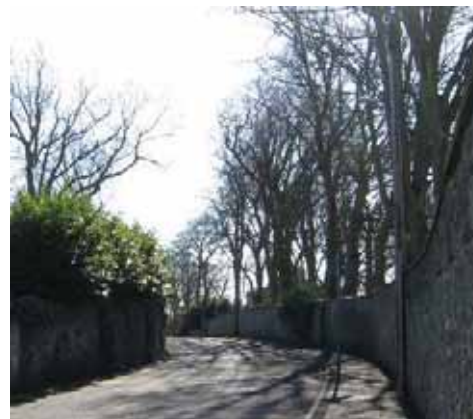
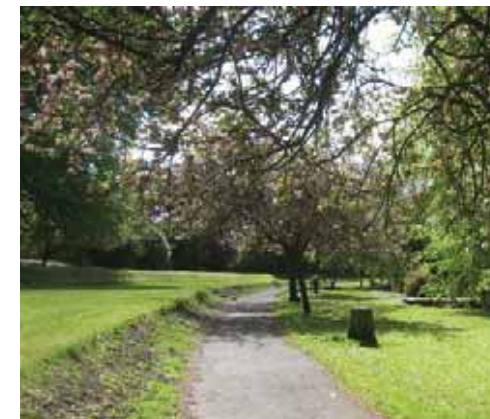
Above left: the curve of Warden Law Lane, surrounded by high walls and mature trees; above right: the formal terraces in Doxford Park, emphasising the natural valley in which the House and gardens sit.

The landscape of the Conservation Area is generally characterised by a gentle slope from east to west, divided in two by Warden Law Lane. The lane itself is narrow, curving and framed by high boundary walls and dense mature tree cover, creating a strong sense of enclosure. The east-west slope is most evident within Doxford Park, through the centre of which runs a shallow valley; this was utilised by Charles Doxford to create the artificial cascade through his gardens and emphasised with formal terraces. The slopes in the park provide views through and across to the House, as well as an attractive setting for the House and the other historic buildings. The landscape character of the Conservation Area changes from season to season as a result of the deciduous tree cover, yet at all times of year the trees have a strong presence in the area and cast interesting shadows across the lane.

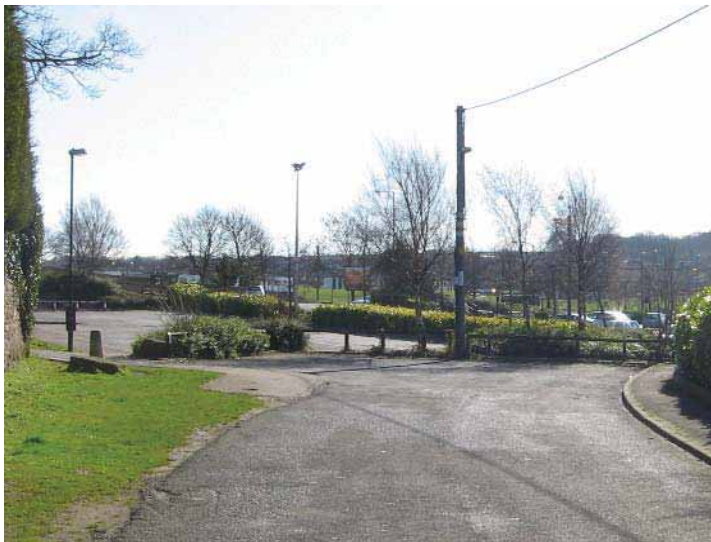
the sense of enclosure within the Conservation Area. To the south of the lane, however, views are terminated in a most unsatisfactory fashion. The lane suddenly opens out and is truncated by the large, alien concrete space of the supermarket car park, instantly destroying the rural illusion created throughout the Conservation Area.

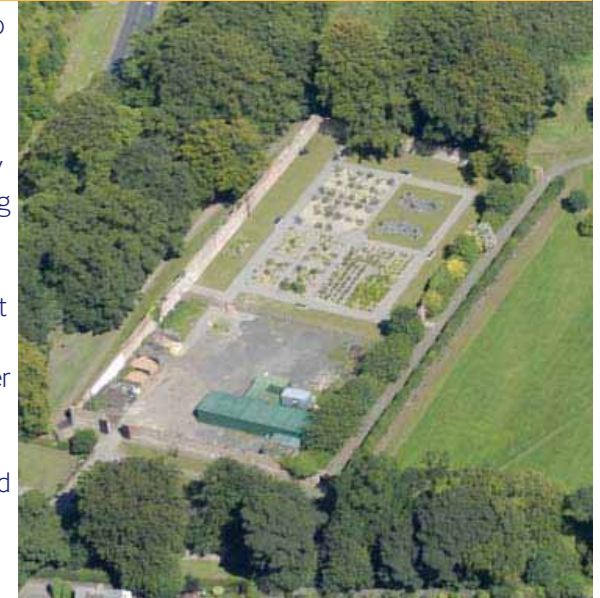
First drawn on an 1842 tithe map, to the very north of the park, next to the car park, is a walled kitchen garden, which still features an excellent example of a 19th century brick "hot wall"; a structure containing flues to heat the wall in order to cultivate exotic fruit, including Charles Doxford's preferred breakfast fruit of melons. This enabled 19th century gardeners to cultivate tender fruits that were native to warmer climes, such as peaches, apricots and figs. These hot walls were heated by boilers, located to the rear of the greenhouses, which heated a series of hot water pipes that distributed the heat evenly across the walls.

Aerial image of the walled kitchen garden, viewed from the east

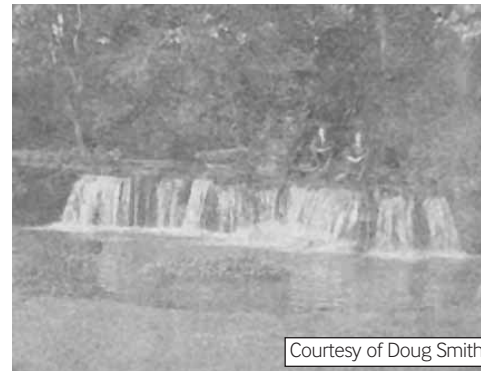
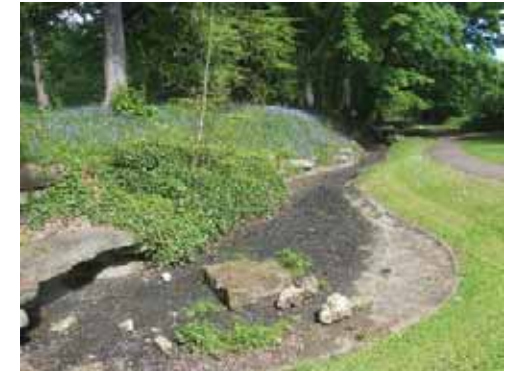
Above left: one of the lower cascades in full flow in the early 20th century. Above right: one of the empty cascade pools today.

The gardens slope away from the House, into a gentle valley, at the base of which runs a long, narrow lake. On the western side of the lake is a small cave-like structure, which was created to house the pump for the cascade, designed and installed by Charles Doxford. The cascade was designed to be seen from the House - specifically from Charles' bedroom - and ran down across a rockery (right), creating an image of rustic charm, despite its artificiality.

Sadly, today the water no longer flows and many of the cascade pools are completely devoid of water; this situation is addressed in the Management Strategy on page 39.

- Water levels in the park dropped many years ago, the cascade hasn't operated in a very long time and through-flow is no longer achieved in the stream that runs along the base of the valley.
- The walled kitchen garden is an important feature of the park and must be preserved into the future. The walled area is not fully utilised as a garden space (it is partially used as a council depot) and the glasshouses that were once a part of the kitchen garden have been demolished. The hot walls are in reasonable condition, but are damaged in some areas and would benefit from improvements or consolidation.

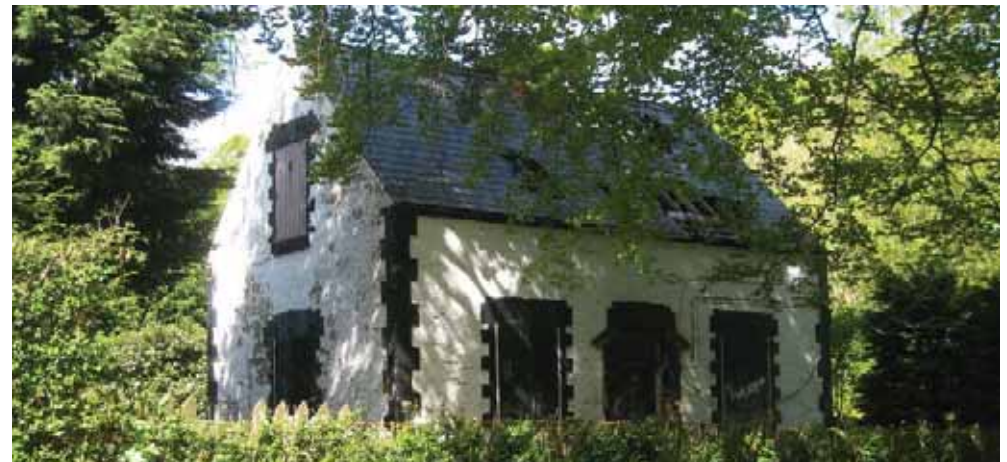
At the northern entrance to the park stand Meadow Nursery Cottage and 'The Gardens', both built as part of the Doxford estate. 'The Gardens', which is currently in extremely poor condition, could be an attractive residence or park office (see page 38). Meadow Nursery Lodge, which was derelict until fairly recently, has been renovated and is now used as offices. Elsewhere in the gardens there is an old ice house - a brick larder with the remains of iron shelves for preserving food.

'The Gardens', sadly derelict, but of considerable historic interest.

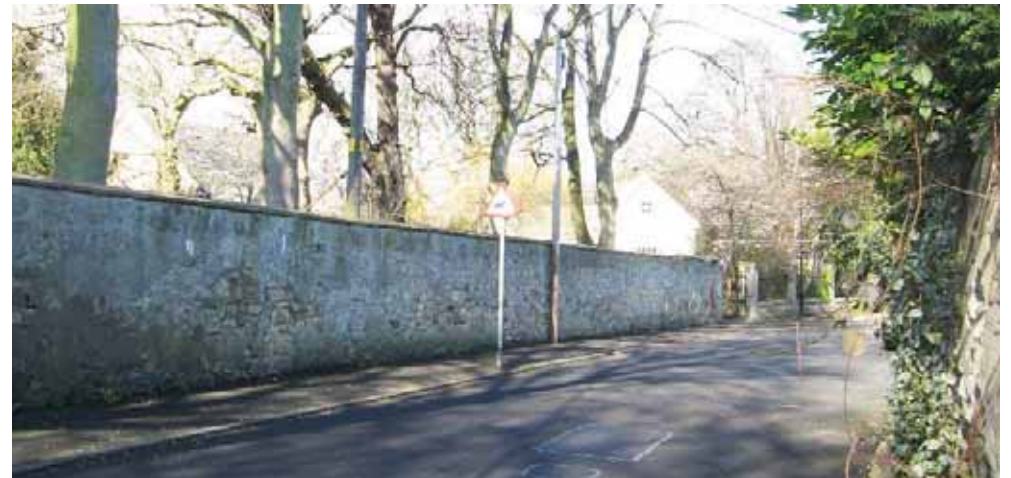
The limestone boundary walls that flank the lane dominate the streetscene in a positive fashion and contribute significantly to the character of the area. The walls have been altered in places, which detracts somewhat from their appearance, but overall they are an excellent feature. Discreet openings in the wall lead into the private houses and gardens on the lane, or through the quaint wooden gate into Silksworth Cottage. At Doxford House the lane widens, opening out into a formal forecourt with listed lamps and chains. By the entrance to The Pottery there is a charming traditional red post box, set into the wall.

Detailed guidance on the maintenance and repair of these walls can be found in the Management Strategy, on page 43.

- Guidance on the sensitive repair and maintenance of limestone walls is provided on page 43 of the Management Strategy.

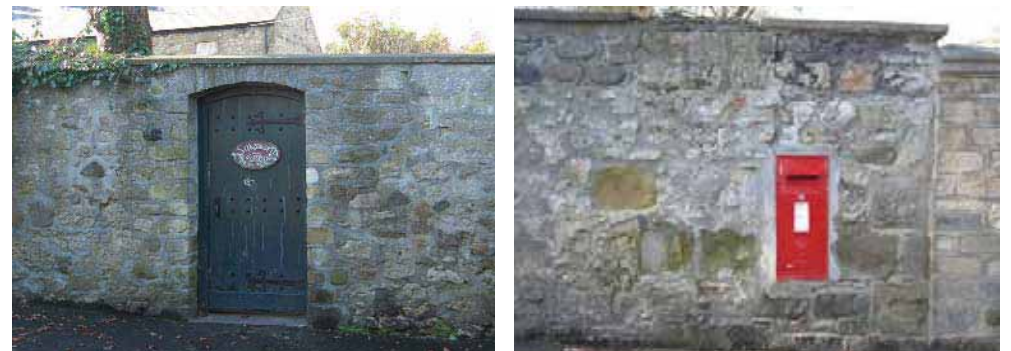
Above left: gate into Silksworth Cottage; above right: the post box

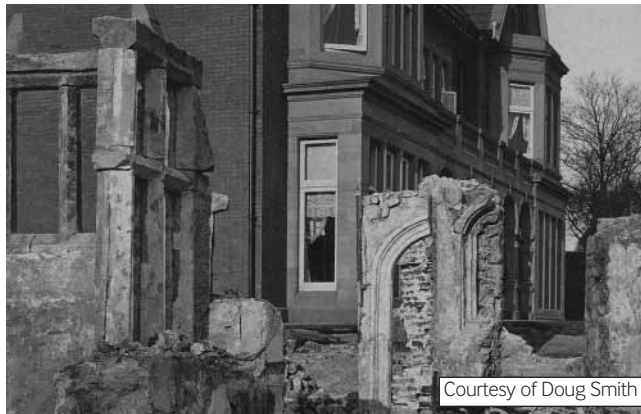
Tudor remains at Silksworth Hall

The current Hall stands in the grounds of at least two earlier Halls; Robert Doxford acquired the previous Hall in the late 19th century and is thought to have lived in the old Hall while the new one was built; Robert's own photographs show the two alongside each other. During the subsequent demolition works the remains of a Tudor mansion was uncovered (right).

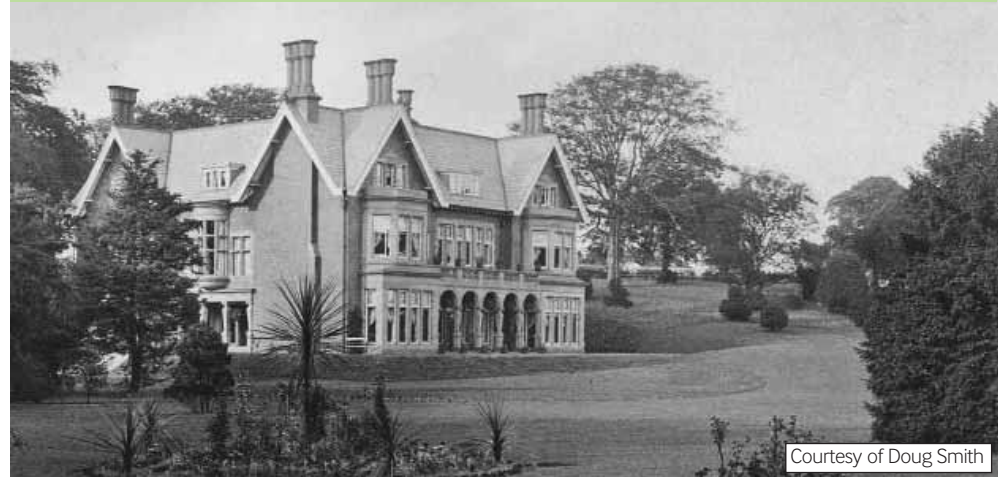
Silksworth Hall in 1905, shortly after the previous Hall was demolished

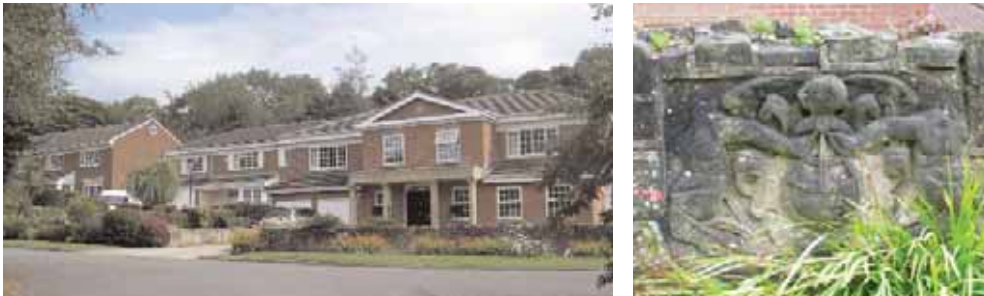
Left: Silksworth Hall Drive. Right: detail of boundary treatment featuring the coat of arms of Sunderland Town.

Although modern developments on Silksworth Hall Drive do not reflect either the style or materials of the historic elements of the Conservation Area, their front boundary walls are a particularly attractive and unifying feature that is characteristic of the Conservation Area as a whole. Local residents have been led to believe that parts of Sunderland Old Town Hall, demolished in the early 1970s, were reclaimed and used to build the boundary walls. There would certainly appear to be credence in these claims; the crest (below) is that of the old Sunderland Town, and also the crest of a Sunderland Freemason' Lodge.

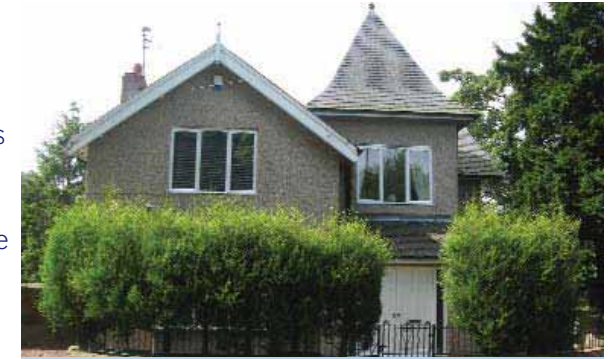
The Lodge, Silksworth Hall Drive

To the north of the Hall lie The Lodge and West Lodge. Built in a similar style to each other, with quirky rooflines and interesting arts and crafts detailing, these houses appear to date from the late 19th century, and therefore pre-date the current Hall. Although much altered, the Lodges both retain a degree of historical and architectural interest.

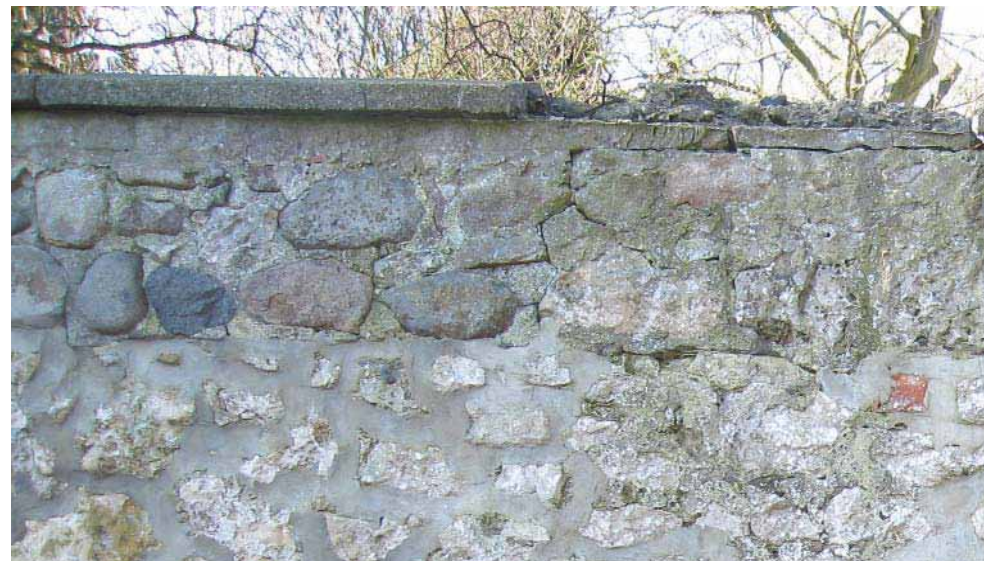
This section of wall on Warden Law Lane has had the original coping replaced, part of which is missing, and features some inappropriate cement pointing

- The random limestone walls on Warden Law Lane are a key characteristic of the Conservation Area, but are only protected from insensitive repair in certain areas, where the wall is Listed. Parts of the walls are at risk of partial or total demolition, or of being detrimentally altered, either through poor, ill-informed repair, or through a lack of maintenance. This includes the low stone boundary walls to the modern houses on Silksworth Hall Drive, which have a unifying effect within the rest of the Conservation Area.
- Other boundary treatments in the Conservation Area add little to its essential character and would benefit from replacement or improvement.

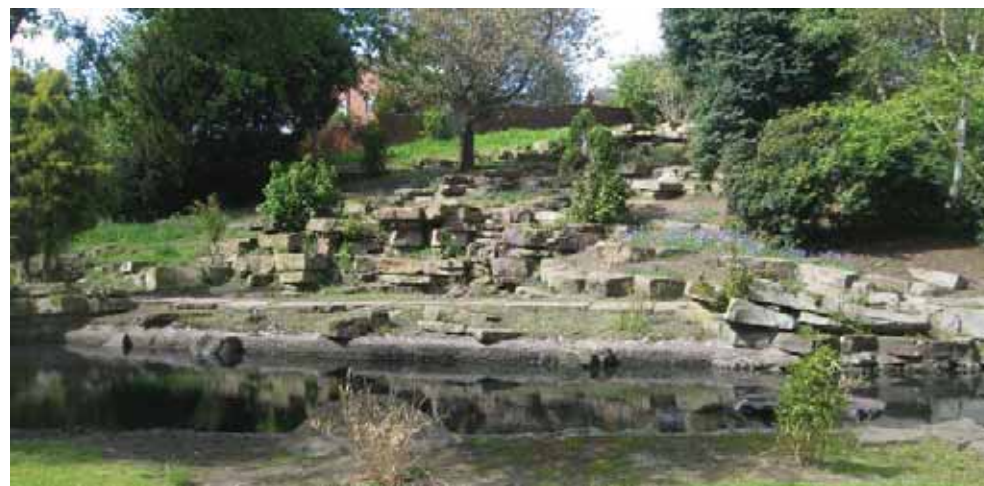
The rockery (below), to the west of the park opposite Doxford House, is also part of the cascade designed by Charles Doxford. Whether or not the flowing water can be reinstated in this location, the rockery could be planted up with alpine species in the style popular in the early 20<sup>th</sup> century when the rockery was first formed.

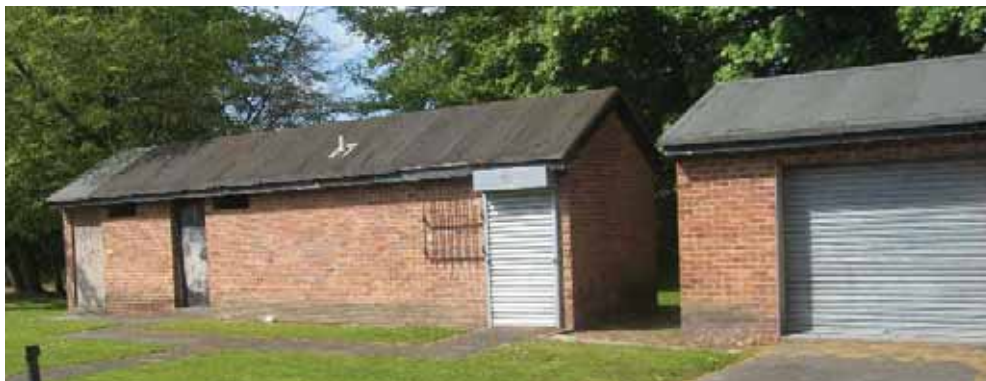
Above: the now apparently disused toilet block to the north-west of the park is of very poor appearance and detracts from the park's special interest.

Existing facilities within the park are limited; the toilet block (below) is an unattractive structure and appears to be permanently closed. The council could make provision within the park for toilets and improved car parking space. Additionally a plant nursery, café and indoor/outdoor teaching space might be appropriate inclusions: the restoration and conversion of the currently derelict 'The Gardens' cottage at the entrance to the park could provide the accommodation for a number of facilities and secure the preservation of an historic property that was once ancillary to the House.

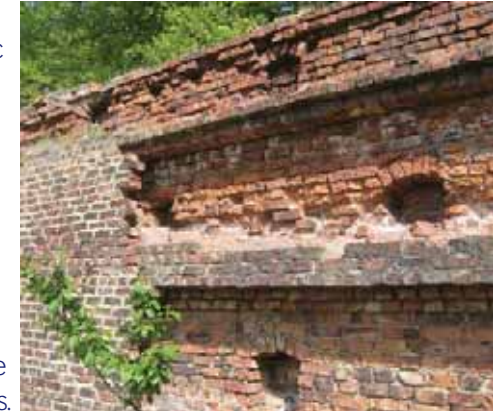
The south wall, in particular, is currently covered by a considerable amount of plant cover (including some growth in cracks in the mortar): while this gives the wall a very attractive appearance, it is likely to be causing damage to the fabric of the wall and may be undermining its structural stability. The condition of the walls should therefore be fully investigated through a structural survey to inform the preparation of a more detailed specification of repair works to ensure its sustainability into the future.

**PROPOSAL 1c:** The council will seek to prepare a schedule of repairs to consolidate the hot wall and kitchen garden and investigate the possibility of restoring this unique feature to its original form in the future

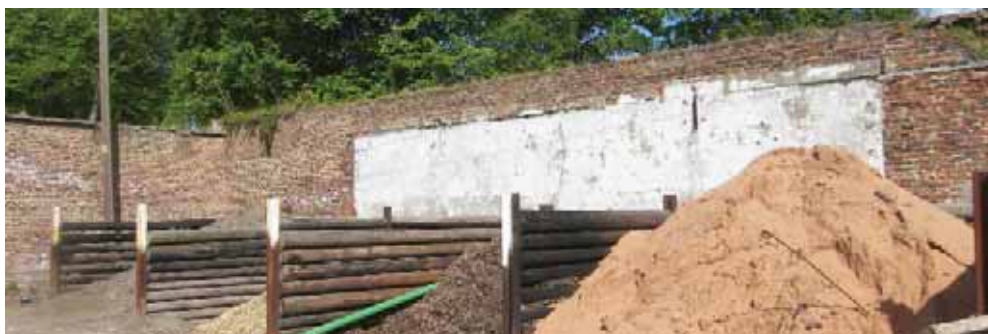
Above: the western half of the walled garden is currently used as a maintenance depot. The white section of the wall indicates the location of a structure, probably a glass house.

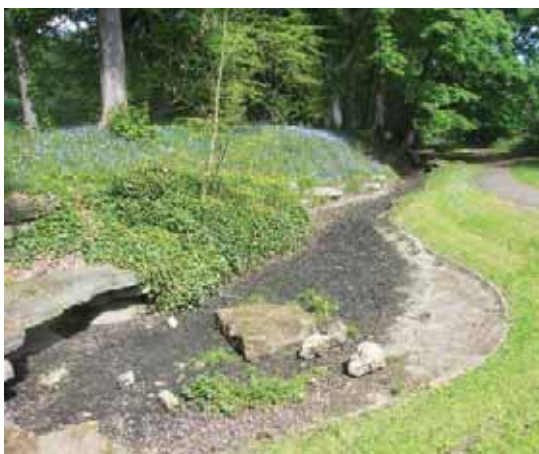
The water feature in the valley is a key component of the character of the park. It would appear from map evidence that the Beckwiths utilised the small stream that ran through the grounds to the House and created a small lake. Charles Doxford later created the cascade and cascade pools (now empty, right). The council has obtained funding to investigate the condition of the lake with a view to its general refurbishment. There would appear to be little opportunity to restore the lake to its original condition having lost the major water source, but it may be possible to control the water quality by mechanical means, either through water circulation or oxygenation. Unfortunately there is no real possibility of restoring the cascade due to the problem of water shortage. Options are currently being studied towards using the cascade as a rock or alpine garden - this would be dependent on future funding.

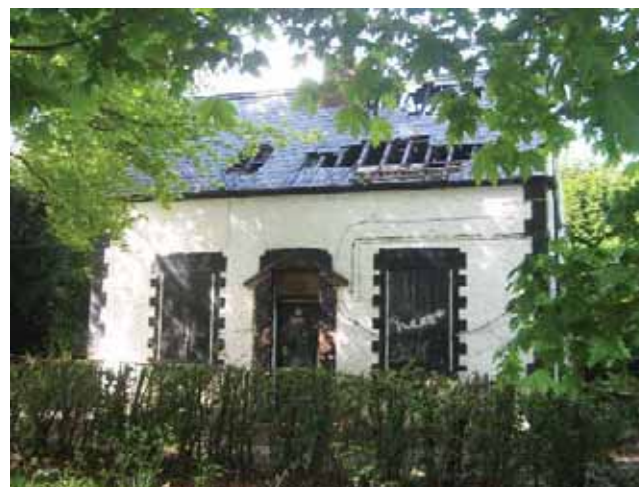
The two remaining ancillary estate buildings within the park are 'The Gardens' (left) and Meadow Nursery Cottage. The Gardens, owned by the council, is currently standing derelict and has recently suffered fire damage. The council is seeking to repair the shell of the building and refurbish its interior, and is exploring potential users that would return the building into beneficial usage and

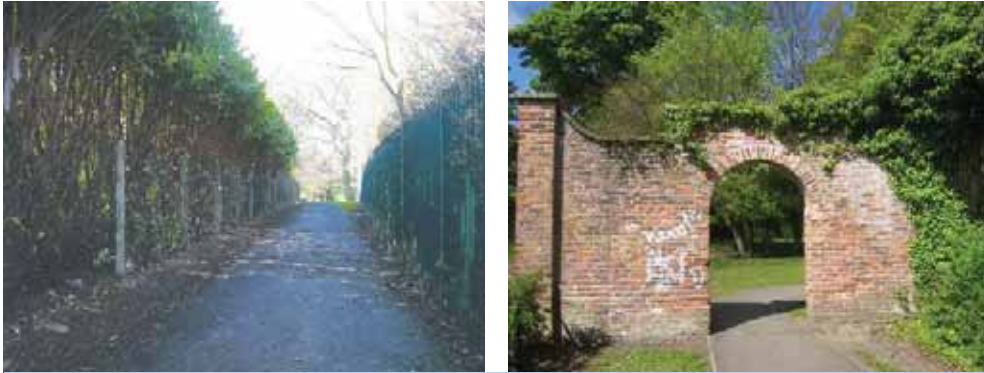
Above left: the footpath from Warden Law Lane; above right: the arch through the southern wall of the kitchen garden

The approach from Warden Law Lane is currently not of a standard appropriate to any public park, let alone an historic garden in a conservation area. The path and its general environs are extremely poor and require significant improvement. The boundary treatment, which consists of metal security fencing and patchy timber boarding, is extremely unattractive and fails to make any kind of positive impression upon the visitor. The path is enclosed and provides no natural surveillance, resulting in a distinctly unpleasant experience; this is further compounded by the negative impact at the southern end of the park of the large blank gable of the adjacent supermarket building.

To the north-west, the access into the park is completely different; a wide opening from the road into a small car park creates a far more appealing impression, although this too would benefit from improvements. Signage is poor, as is the car parking provision. Once visitors move through the parking area, however, the park proper is accessed through an attractive (but sadly vandalised) brick arch on the southern wall of the kitchen garden.

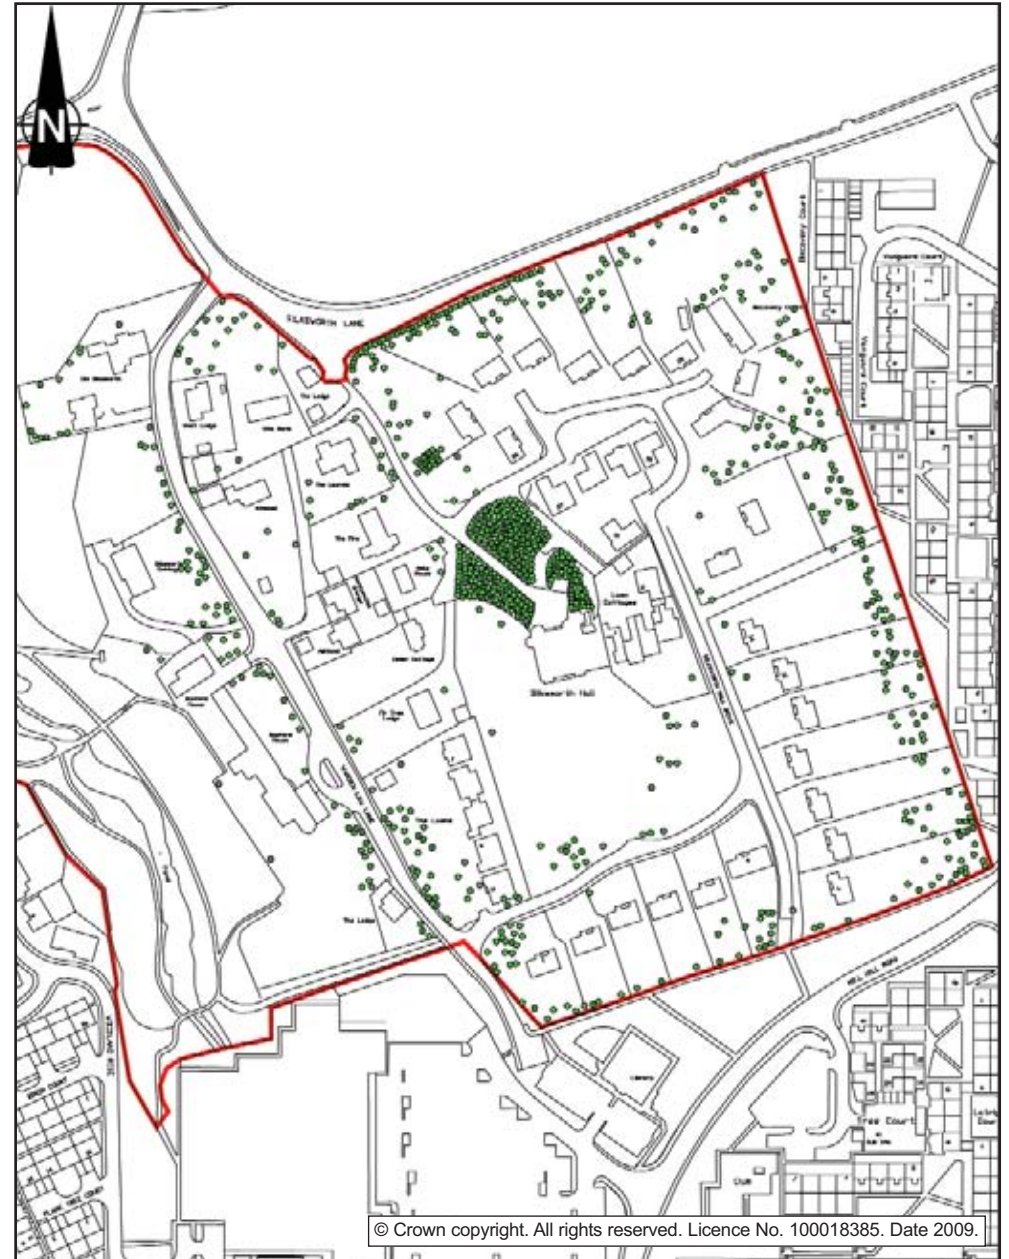
Plan illustrating the location of Tree Preservation Orders in Silksworth Hall Conservation Area - green dots are individual protected trees, green shaded areas are protected copses.

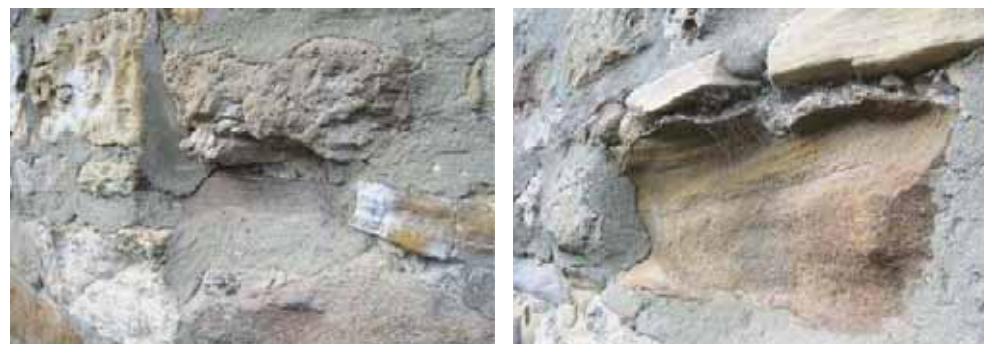
Above: the effects of using too “strong” a mortar - the stone face has eroded behind the level of the surrounding mortar joints, which are left standing proud of the stone

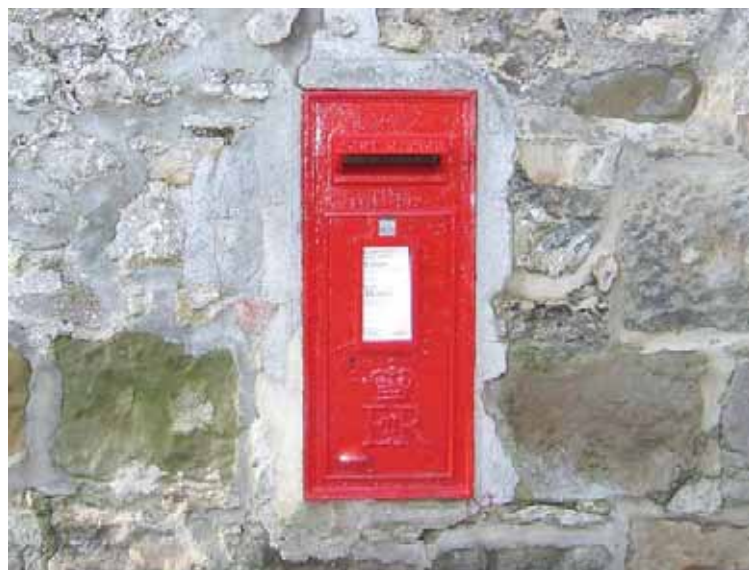
Left: although the post box is a charming and attractive feature of the wall on Warden Law Lane, the way it has been inserted into the wall has resulted in an unsightly area of poorly finished cement mortar, which may also be causing some damage to the surrounding stonework. Note the greenish discolouration on the stone to the bottom left of the post box; this is probably evidence of dampness due to water entering the stone, rather than the adjacent mortar.

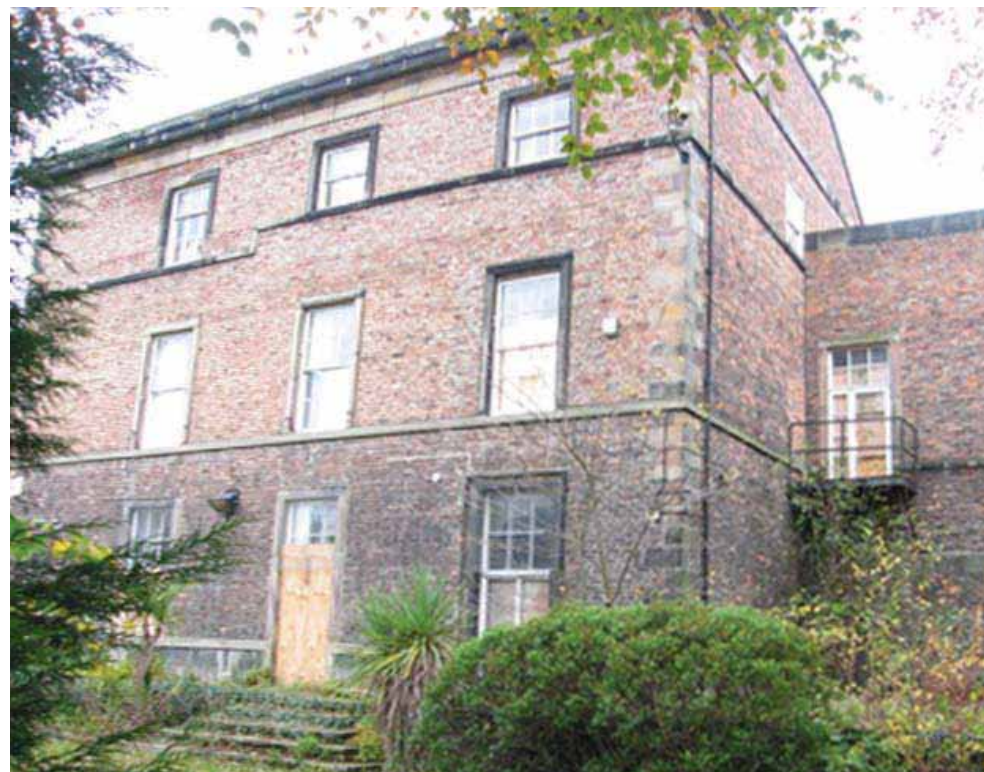
Doxford House October 2009. The building is vacant and deteriorating with doors boarded-up and window panes cracked or missing.

Doxford House is, unfortunately, on the English Heritage Buildings at Risk Register, which states that "the property is vacant and is a target for vandalism despite on-site security systems. The roof over the main house is in a poor state and the resulting leaks are causing internal damage". The House has been registered as grade C, which indicates slow decay with no solution agreed. At the time of writing the building is, however, the subject of a development proposal.
