ASBESTOS SURVEY REPORT FOR WELBECK ACADEMY, FLODDEN STREET, WALKER, NEWCASTLE, NE6 2QP

Asbestos Register for Welbeck Academy

Date: 09 May 2025

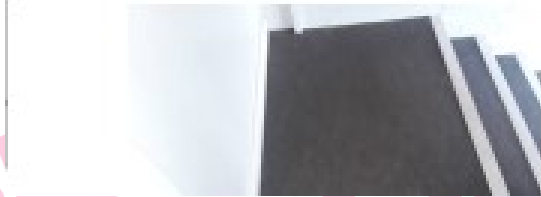
82	As NZ001798	Floor Adhesive under modern tiles	Store Room MZ/009	Very Low Risk 12 monthly
<div> <div>Photo 1: Wide Angle</div>   </div> <div> <div>Photo 2: Close Up</div>   </div>				
83	As NZ001798	Floor adhesive under carpet	Landing MZ/010	Very Low Risk 12 monthly
<div> <div>Photo 1: Wide Angle</div>
