ASBESTOS SURVEY REPORT FOR WELBECK ACADEMY, FLODDEN STREET, WALKER, NEWCASTLE, NE6 2QP

Asbestos Register for Welbeck Academy

Date: 04 March 2026

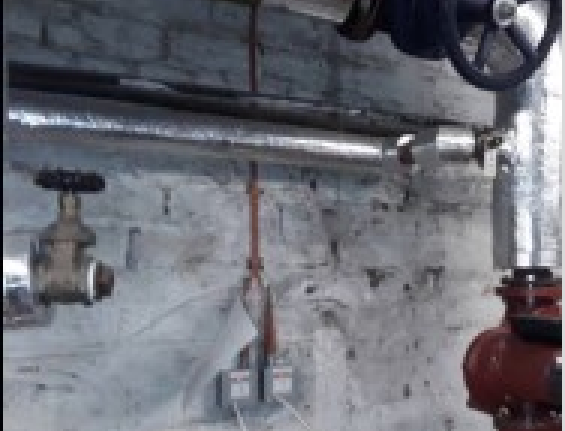
| | | | | | | | | |
|--|---|--|--|---|---|---|---|---|
| 10 | Presumed | Pipework gasket too deeply recessed to sample | Staircase/Stairwell to boiler room limited access due to stored items Z1/002 | Very Low Risk 12 monthly | | | | |
| <table border="1" style="width: 100%; border-collapse: collapse;"> <tr> <td data-bbox="380 443 1040 541" style="width: 60%;">Photo 1: Wide Angle</td> <td data-bbox="1040 443 1395 541">Photo 2: Close</td> </tr> <tr> <td data-bbox="380 541 1040 724" style="text-align: center;"> </td> <td data-bbox="1040 541 1395 724" style="text-align: center;"> </td> </tr> </table> | | | | | Photo 1: Wide Angle | Photo 2: Close | | |
| Photo 1: Wide Angle | Photo 2: Close | | | | | | | |
| | | | | | | | | |
| 11 | NZ001816 | Debris to entrance wall | Boiler room South Z1/003 | No Risk | | | | |
| | |
