ASBESTOS SURVEY REPORT FOR PLAINS FARM ACADEMY, SUNDERLAND

Asbestos Register for PLAINS FARM ACADEMY

Premises Manager / Samo: - Tenant Date: 27 January 2022

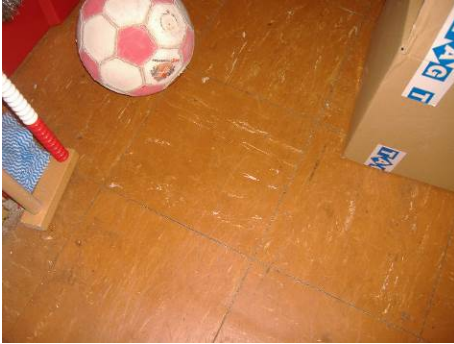
Item 4 Ref: AW0427/08

The orange floor tiles to the store room (Rm 0/03) do not contain asbestos.

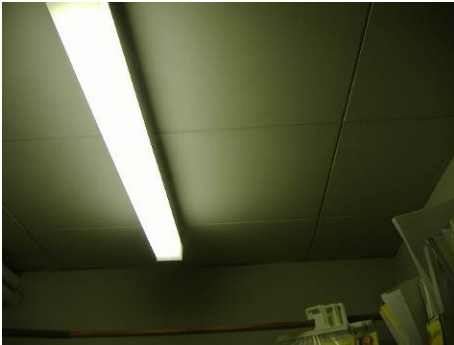
Item 5 - Ref: Presumed

The ceiling tiles to the store room (Rm 0/04) are presumed to contain asbestos.

Any change in its appearance should be recorded, and passed to Property Services.

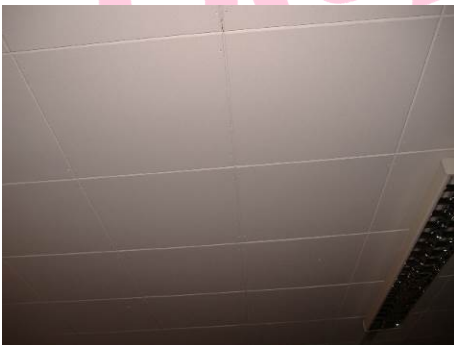
Item 6 - Ref: Presumed

The ceiling tiles to the year 5 classroom (Rm 0/05) are presumed to contain asbestos.

Any change in its appearance should be recorded, and passed to Property Services.

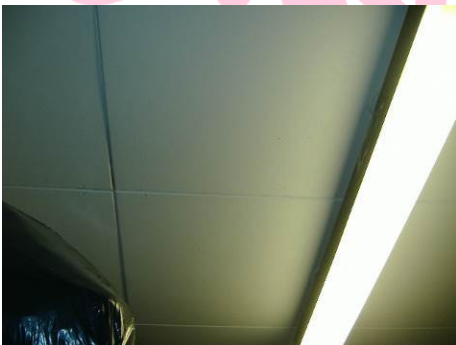
Item 10 - Ref: Presumed

The ceiling tiles to the store room (Rm 0/08) are presumed to contain asbestos.

Any change in its appearance should be recorded, and passed to Property Services.

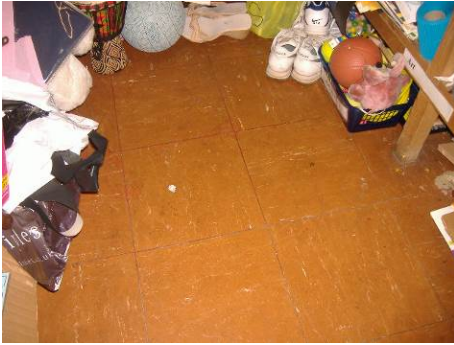
Various Ref: AW0428/08

The orange floor tiles to the store room (Rm 0/08) do not contain asbestos (Item 11).

Similar flooring is located in room 0/07 (Item 9).

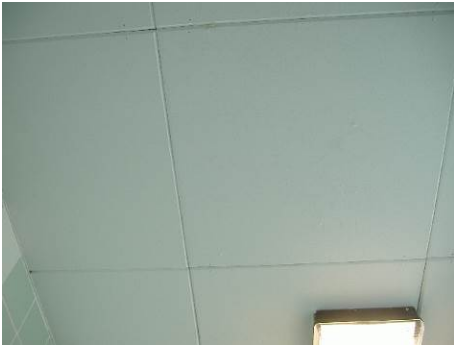
Item 12 - Ref: Presumed

The ceiling tiles to the male toilets (Rm 0/09) are presumed to contain asbestos.

Any change in its appearance should be recorded, and passed to Property Services.

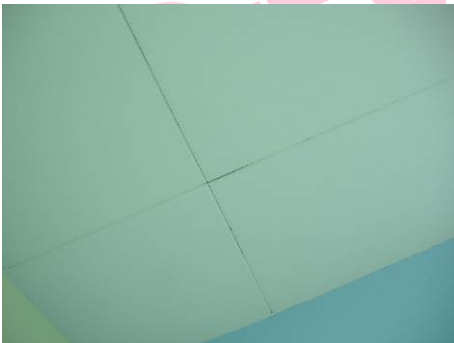
Item 13 - Ref: Presumed

The ceiling tiles to the disabled toilet (Rm 0/10) are presumed to contain asbestos.

Any change in its appearance should be recorded, and passed to Property Services.

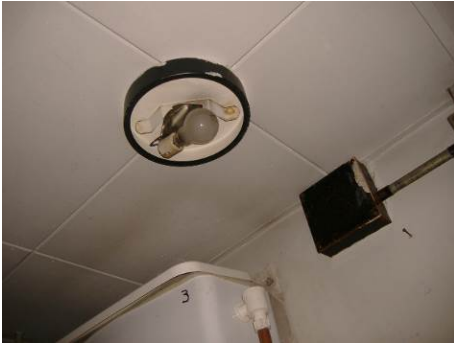
Item 17 Ref: Presumed

The ceiling tiles to the store room (Rm 0/14) are presumed to contain asbestos.

Any change in its appearance should be recorded, and passed to Property Services.

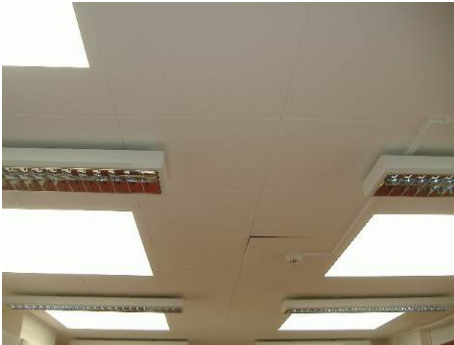
Item 18 - Ref: Presumed

The ceiling tiles to the cloakroom (Rm 0/15) are presumed to contain asbestos.

Any change in its appearance should be recorded, and passed to Property Services.

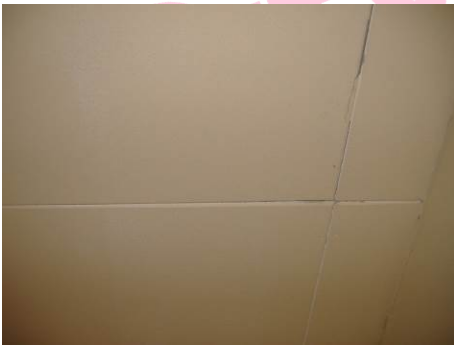
Item 19 - Ref: Presumed

The ceiling tiles to the cupboard store (Rm 0/16) are presumed to contain asbestos.

Any change in its appearance should be recorded, and passed to Property Services.

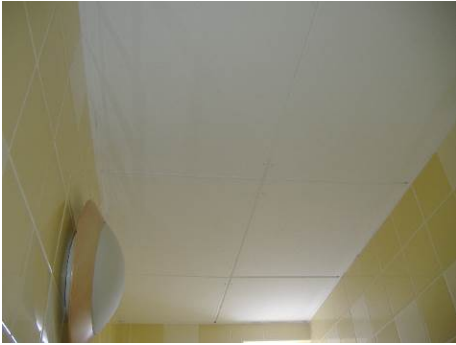
Item 20 Ref: Presumed

The ceiling tiles to the staff toilets (Rm 0/17) are presumed to contain asbestos.

Any change in its appearance should be recorded, and passed to Property Services.

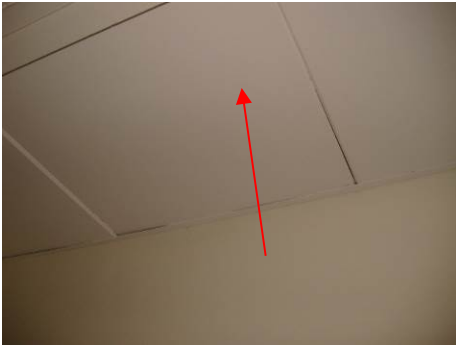
Item 21 - Ref: Presumed

The ceiling tiles to the recess in the office (Rm 0/20) are presumed to contain asbestos.

Any change in its appearance should be recorded, and passed to Property Services.

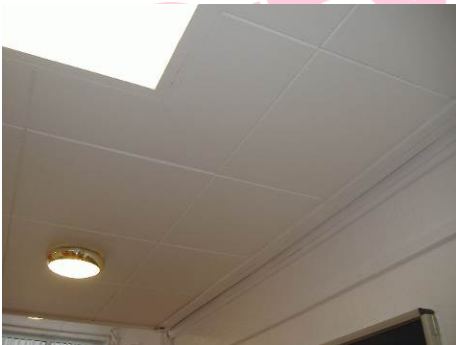
Item 22 - Ref: Presumed

The ceiling tiles to the corridor (Rm 0/21) are presumed to contain asbestos.

Any change in its appearance should be recorded, and passed to Property Services.

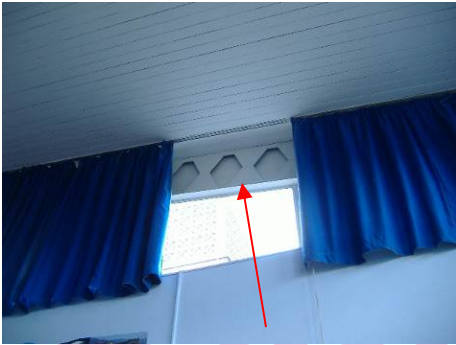
Item 24 - Ref: Presumed

The wall panels at high level behind the girder in the main hall (Rm 0/23) are presumed to contain asbestos.

Any change in its appearance should be recorded, and passed to Property Services.

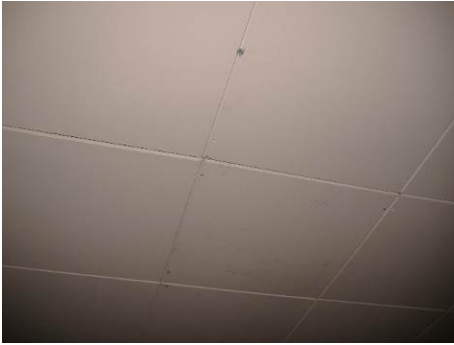
Item 26 Ref: Presumed

The ceiling tiles to the female toilets (Rm 0/25) are presumed to contain asbestos.

Any change in its appearance should be recorded, and passed to Property Services.

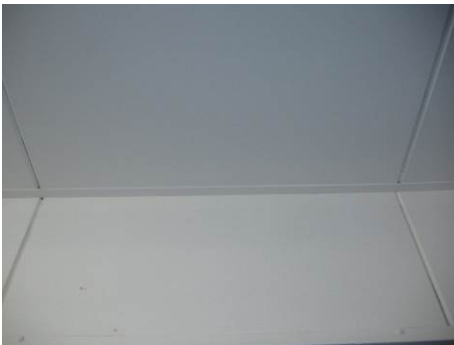
Item 27 - Ref: Presumed

The ceiling tiles to the cleaners cupboard (Rm 0/26) are presumed to contain asbestos.

Any change in its appearance should be recorded, and passed to Property Services.

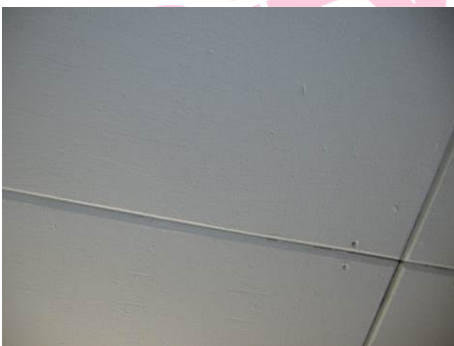
Item 28 - Ref: Presumed

The ceiling tiles to the classroom (Rm 0/27) are presumed to contain asbestos.

Any change in its appearance should be recorded, and passed to Property Services.

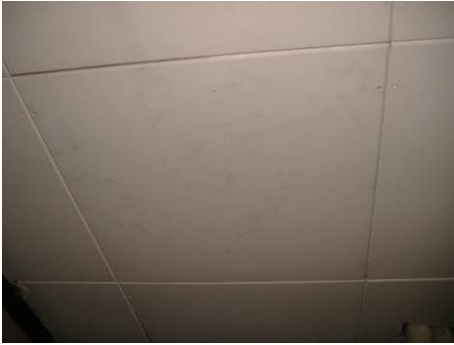
Item 29 Ref: Presumed

The ceiling tiles to the electrical cupboard (Rm 0/28) are presumed to contain asbestos.

Any change in its appearance should be recorded, and passed to Property Services.

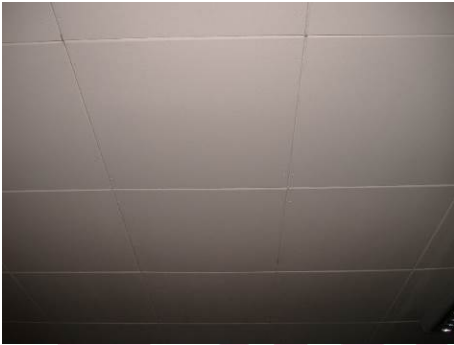
Item 30 - Ref: Presumed

The ceiling tiles to the classroom (Rm 0/29) are presumed to contain asbestos.

Any change in its appearance should be recorded, and passed to Property Services.

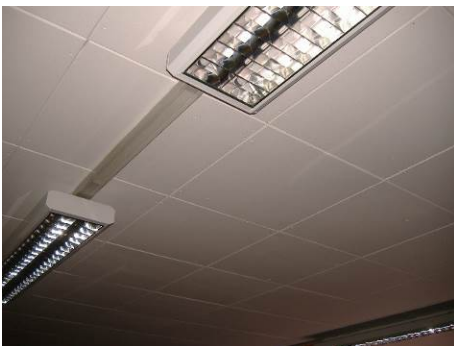
Item 31 - Ref: Presumed

The ceiling tiles to the classroom (Rm 0/30) are presumed to contain asbestos.

Any change in its appearance should be recorded, and passed to Property Services.

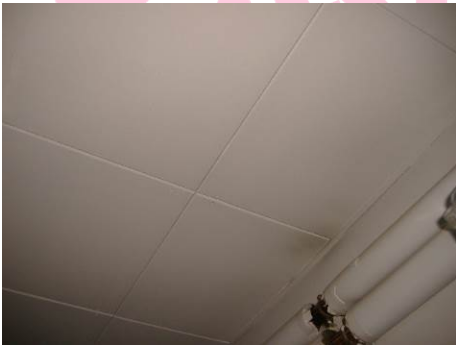
Item 34 - Ref: Presumed

The ceiling tiles to the store room (Rm 0/32) are presumed to contain asbestos.

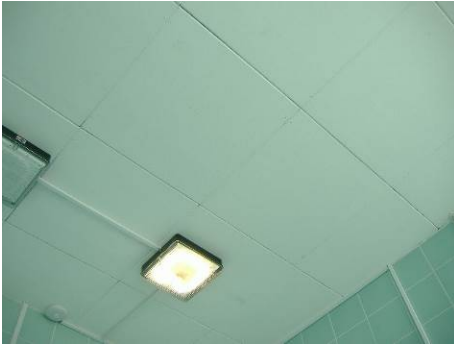
Item 38 - Ref: Presumed

The ceiling tiles to the male toilets (Rm 0/35) are presumed to contain asbestos.

Any change in its appearance should be recorded, and passed to Property Services.

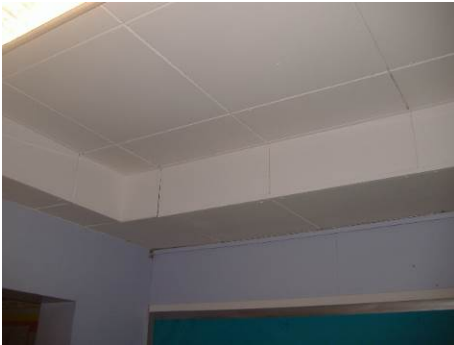
Item 39 Ref: Presumed

The ceiling tiles to the classroom (Rm 0/36) were presumed to contain asbestos.

These were removed in August 2015.

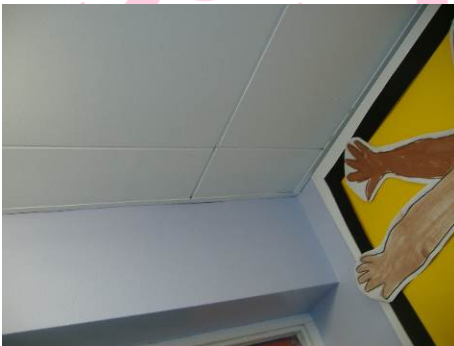
Item 40 - Ref: Presumed

The ceiling tiles to the lobby (Rm 0/37) were presumed to contain asbestos.

These ceiling tiles were removed in August 2015.

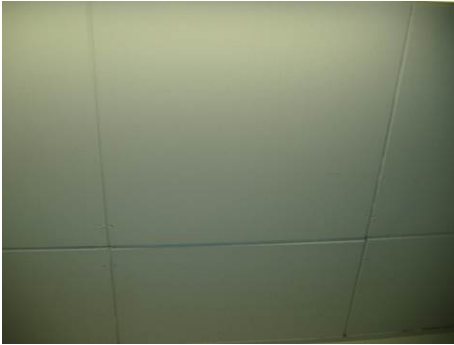
Item 45 - Ref: Presumed

The ceiling tiles to the store room (Rm 0/41) were presumed to contain asbestos.

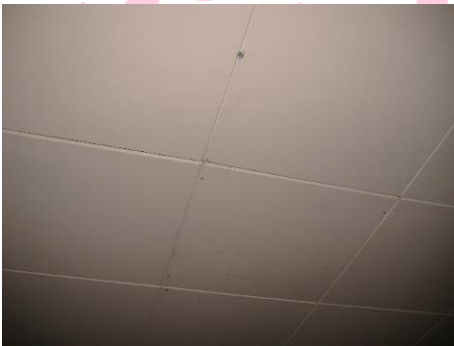
Item 47 - Ref: Presumed

The ceiling tiles to the classroom (Rm 0/43) were presumed to contain asbestos.

These ceiling tiles were removed in August 2015.

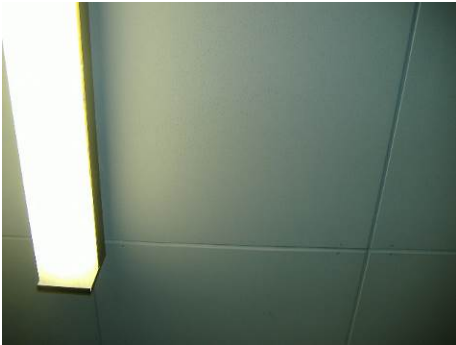
Item 48 - Ref: Presumed

The ceiling tiles to the store room (Rm 0/44) were presumed to contain asbestos.

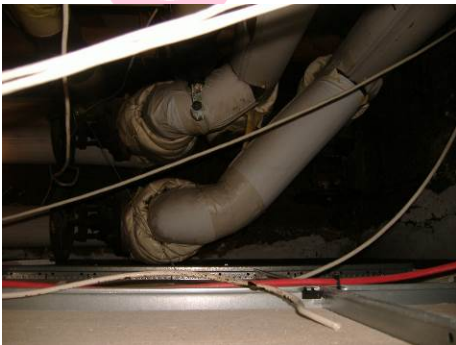
Item 53 - Ref: Presumed

The pipework flange gaskets in the ceiling void of the corridor (Rm 0/49) are presumed to contain asbestos.

Any change in its appearance should be recorded, and passed to Property Services.

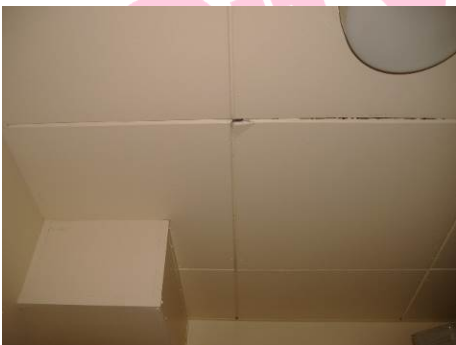
Item 56 - Ref: Presumed

The ceiling tiles to the store room (Rm 0/67) contain asbestos.

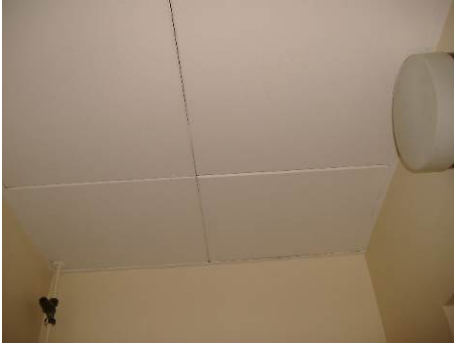
Item 57 - Ref: Presumed

The ceiling tiles to the staff toilets (Rm 0/68) are presumed to contain asbestos.

Any change in its appearance should be recorded, and passed to Property Services.

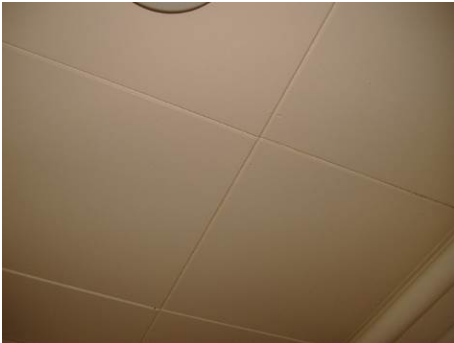
Item 58 - Ref: Presumed

The ceiling tiles to the staff room (Rm 0/69) are presumed to contain asbestos.

Any change in its appearance should be recorded, and passed to Property Services.

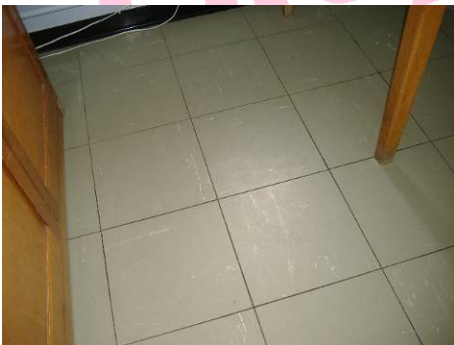
Item 59 - Ref: AW0433/08

The green floor tiles to the staff room (Rm 0/69) contain asbestos.

Any change in its appearance should be recorded, and passed to Property Services.

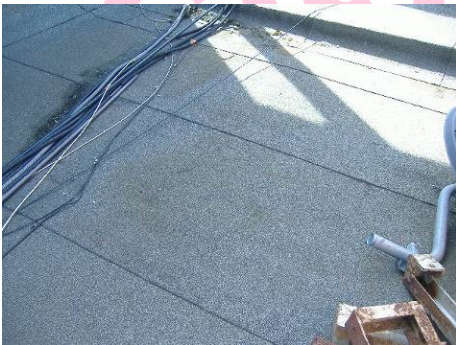
Item 65 - Ref: AW0437/08

The roof felt to the building does not contain asbestos.

(tested again on sample ref nos: 270749-1 & 270749-3 – no risk)

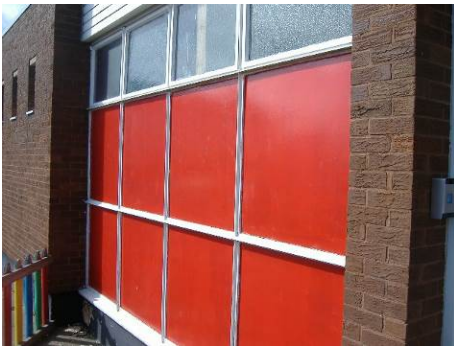
Item 67 - Ref: Presumed

The backing to the red infill panels to the exterior were presumed to contain asbestos.

These have now been removed.

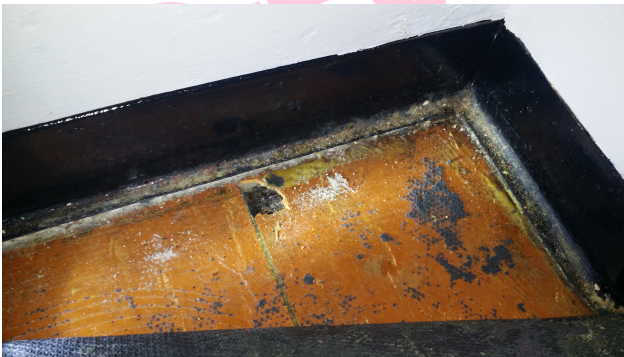
Item 68 - Ref: 266362-4

The floor tiles with bitumen adhesive in 001/ICT suite do not contain asbestos.

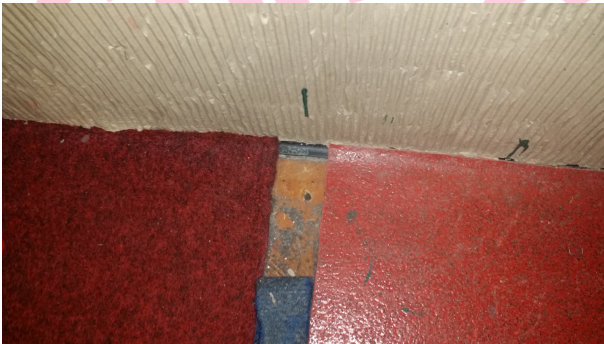
Item 71-Ref: As 266362-2

The floor screed beneath tiles in 002/Year 6 classroom does not contain asbestos.

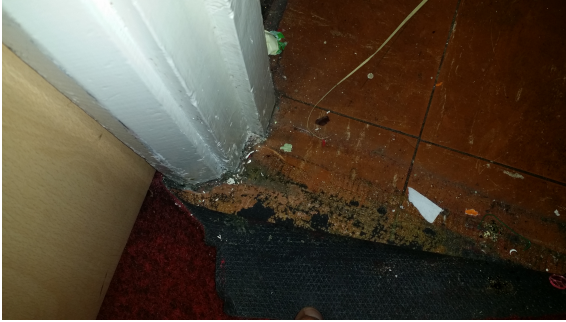
Item 72-Ref: As 266362-4

The floor tiles with bitumen adhesive in 005/Year 5 classroom do not contain asbestos.

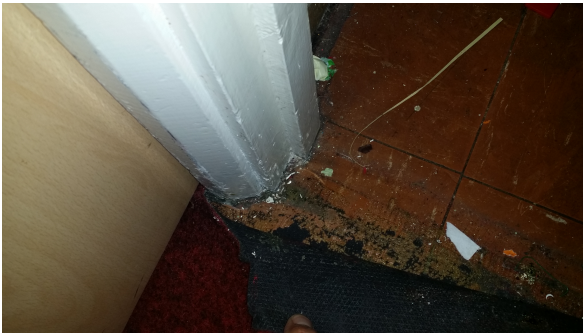
Item 73-Ref: As 266362-2

The floor screed beneath tiles in 005/Year 5 classroom does not contain asbestos.

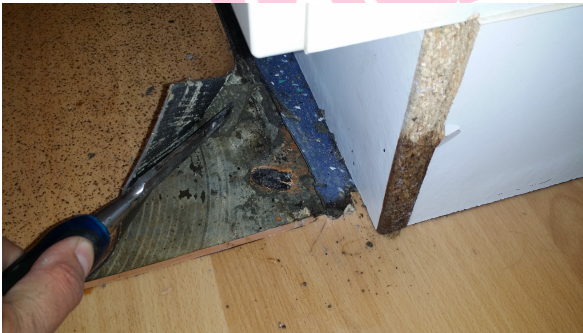
Item 74-Ref: 266362-5

The floor tiles with bitumen adhesive in 006/Staffroom do not contain asbestos.

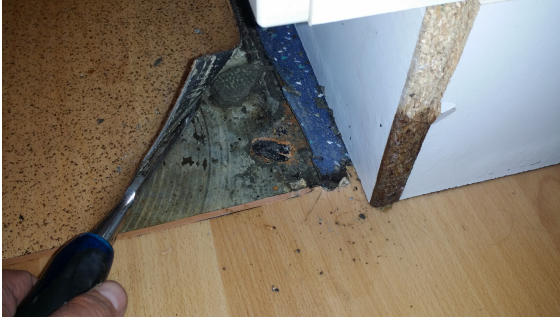
Item 75-Ref: 266362-6

The floor screed beneath tiles in 006/Staffroom does not contain asbestos.

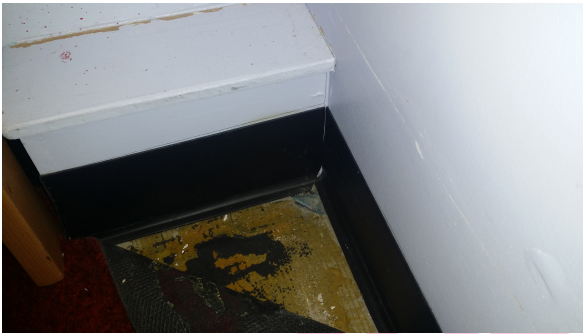
Item 76-Ref: As 266362-3

The floor tiles with bitumen adhesive in 018/Office do not contain asbestos.

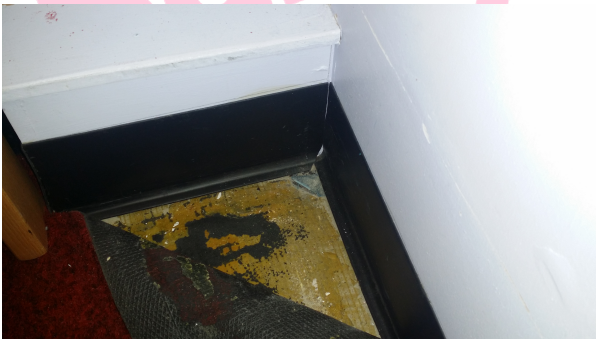
Item 77-Ref: As 266362-2

The floor screed beneath tiles in 018/Office does not contain asbestos.

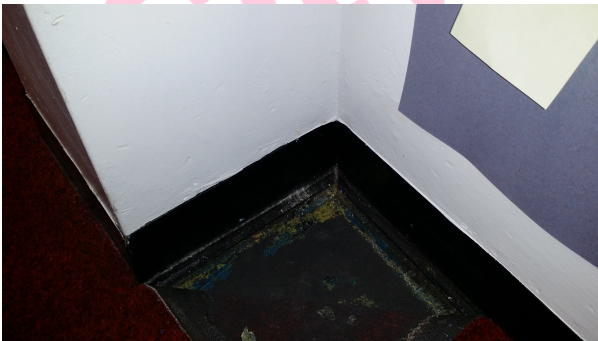
Item 80-Ref: As 266362-7

The floor tiles with bitumen adhesive in 029/Year 3 classroom do not contain asbestos.

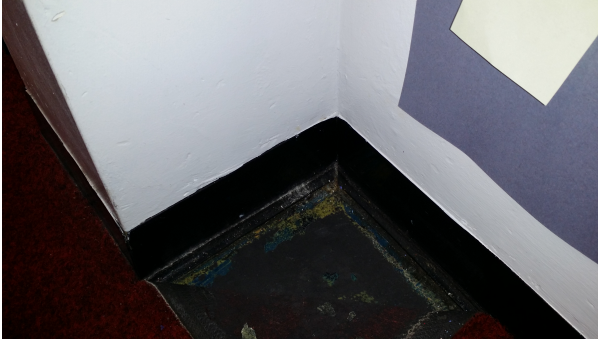
Item 81-Ref: As 266362-8

The floor screed beneath tiles in 029/Year 3 classroom does not contain asbestos.

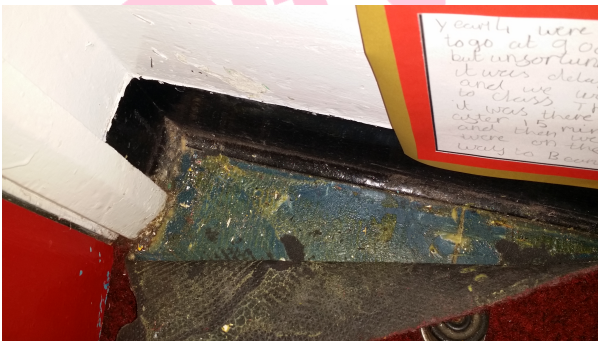
Item 83-Ref: As 266362-8

The floor screed beneath tiles in 030/Year 4 classroom does not contain asbestos.

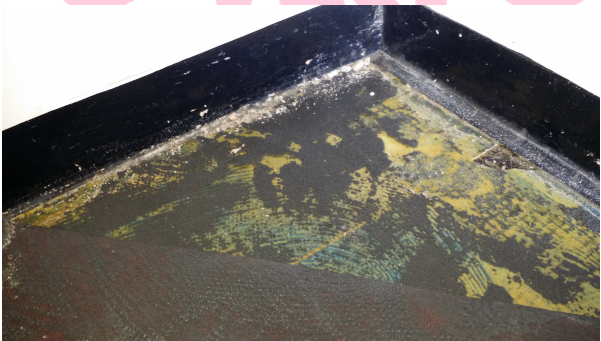
Item 86-Ref: 266362-9

The floor tiles with bitumen adhesive in 036/Breakfast club do not contain asbestos.

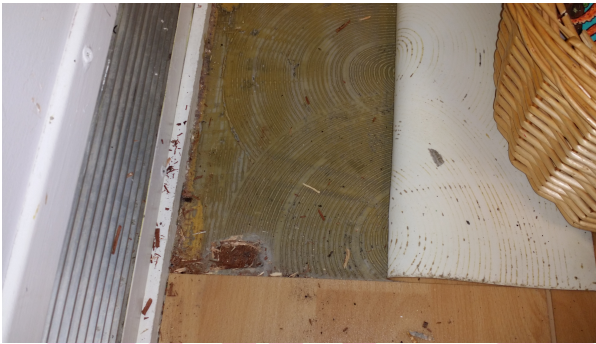
Item 88-Ref: 266362-11

The floor screed beneath tiles in 055/Reception does not contain asbestos.

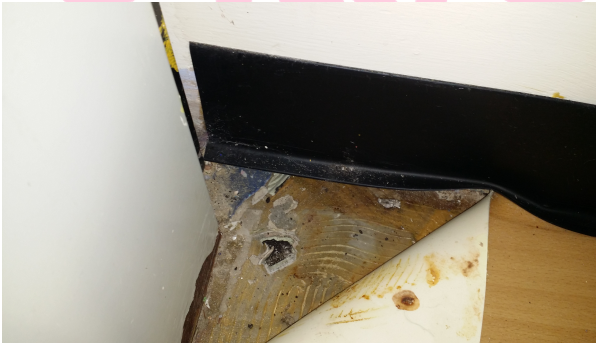
Item 89-Ref: 266362-12

The floor tiles with bitumen adhesive in 062/Nursery do not contain asbestos.

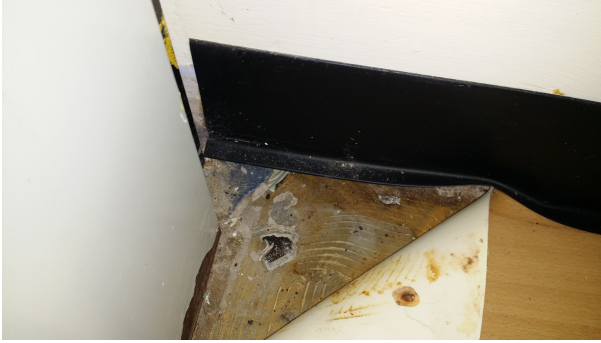
Item 90-Ref: 266362-13

The floor screed beneath tiles in 062/Nursery does not contain asbestos.

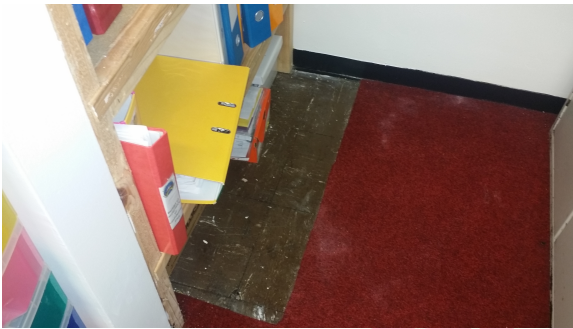
Item 91-Ref: 266362-1

The floor tiles with bitumen adhesive in 075/Main office do not contain asbestos.

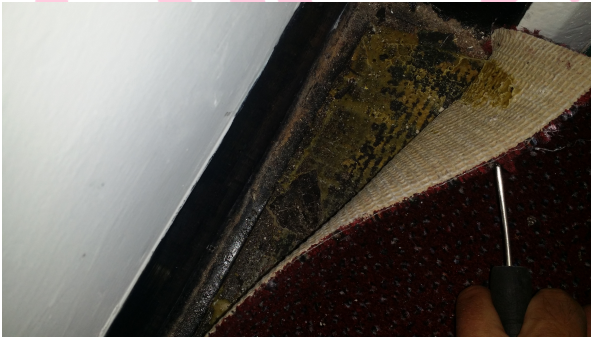
Item 92-Ref: 266362-2

The floor screed beneath tiles in 075/Main office does not contain asbestos.

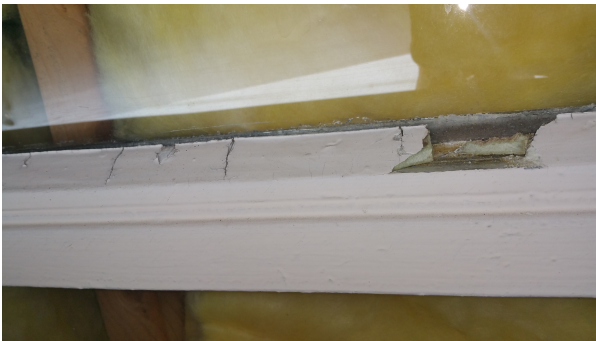
Item 94-Ref: 270749-2

The Sealant to windows to rear of plastic fascias in externals Roof B area do not contain asbestos.

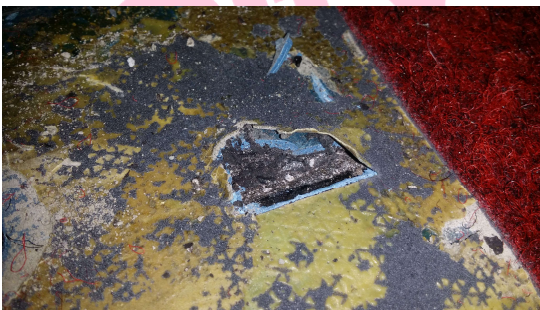
Item 101 Ref: As 173107-2

The covering below two layers of floor covering in Rm 019/Deputy heads office does not contain asbestos.

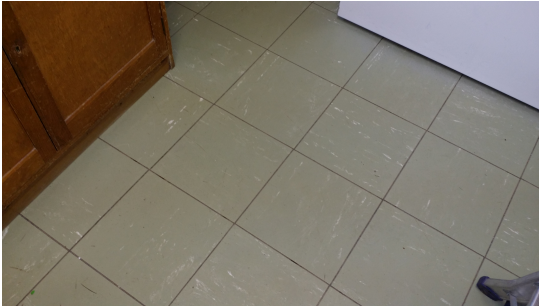
Item 111 Ref: 247623-2

The floor covering in Rm 006/Kitchen Office does not contain asbestos.

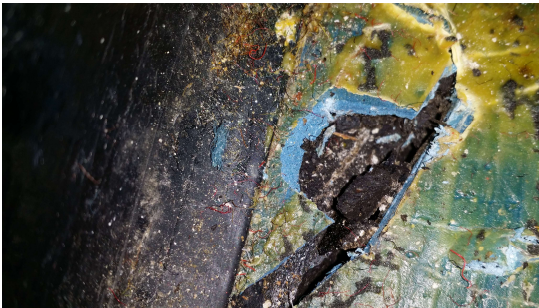
Item 112 Ref: 247623-4

The screed to floor in Rm 007/Head teachers Office does not contain asbestos.

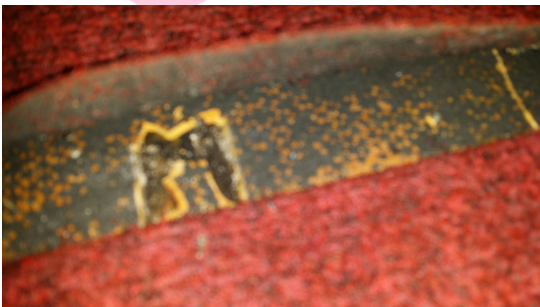
Item 116 Ref: 247623-6

The subfloor in Rm 009/IT Suite does not contain asbestos.

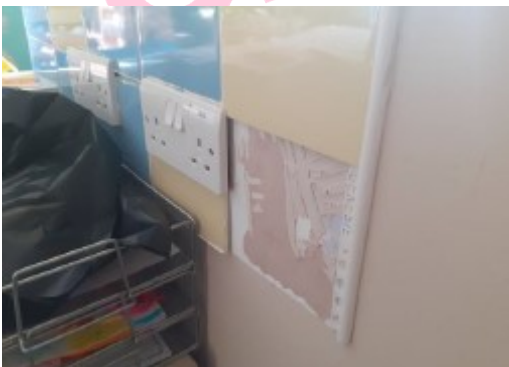
Item 119 Ref: 20-27587-1

The walls rear of ceramic tiles adhesive in Kitchen within reception area do not contain asbestos.

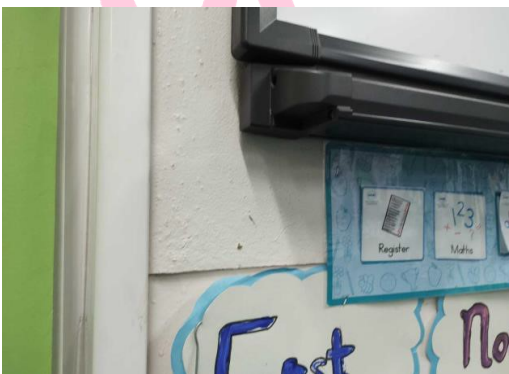
Item 122 Ref: 22-42201-1

The walls behind whiteboard (Area 5/Year 2 Classroom) do not contain asbestos.
