ASBESTOS SURVEY REPORT FOR FARRINGDON ACADEMY SCHOOL, SUNDERLAND

**FARRINGTON ACADEMY SCHOOL,
SUNDERLAND**

Date: 26 March 2026

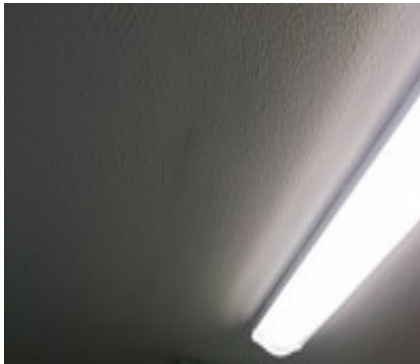
Item 2 – As 101894-1

The textured coating to the ceiling in the kitchen (Room 002) contains asbestos.

Any change in its appearance should be recorded and passed to Property Services.

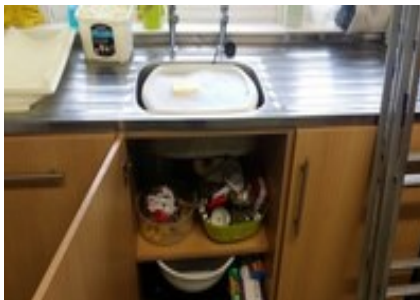
Item 3 Ref: 101894-2

The sink pad to the kitchen the behaviour unit (Rm 002) does not contain asbestos.

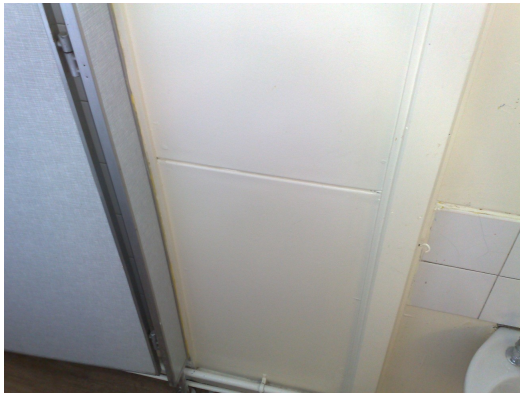
Item 146 Ref: KR09/76

The wall panels in the Behaviour Unit do not contain asbestos.

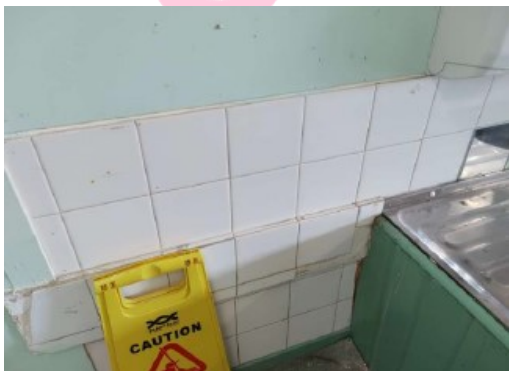
Item 157 Ref: 21-34101-2

The adhesive behind ceramic tiles (Area 1/Main Room) does not contain asbestos.

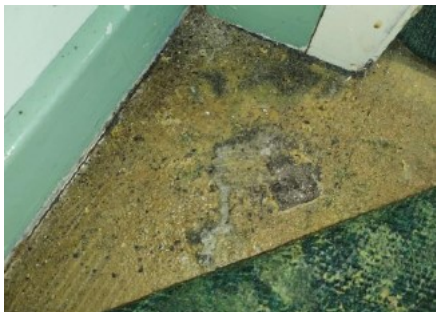
Item 160 Ref: 21-34101-4

The composite floor (Area 2/Back Office) does not contain asbestos.

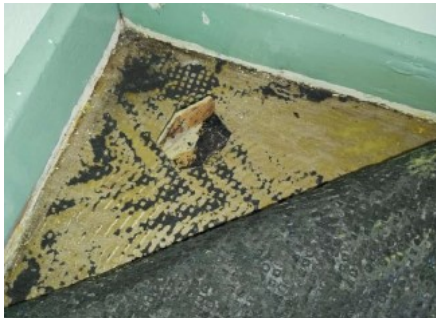
Item 162 Ref: 21-34101-4

The composite floor (Area 4/Entrance Lobby) does not contain asbestos.

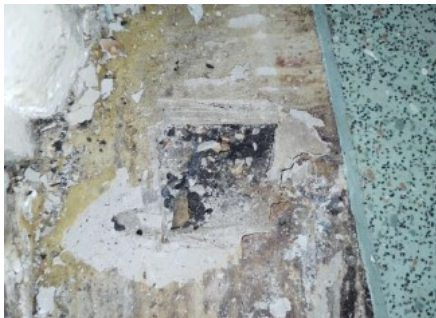
Item 163 Ref: 21-34101-4

The composite floor (Area 5/Kitchen) does not contain asbestos.

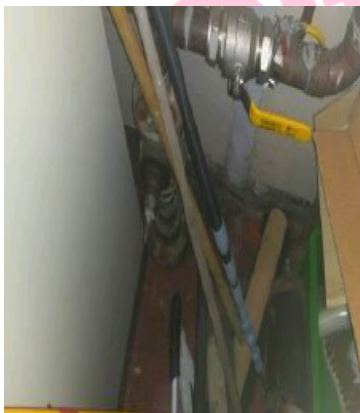
Item 23 - Ref: AW0441/08

The black floor tiles (painted red) to the store room (Rm 0/25) contain asbestos.

Any change in its appearance should be recorded and passed to Property Services.

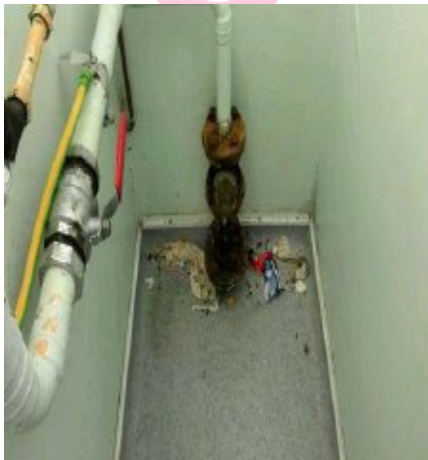
Item 27 - Ref: AW0443/08

The pipework insulation to the store room (Rm 0/45) contains asbestos.

Any change in its appearance should be recorded and passed to Property Services.

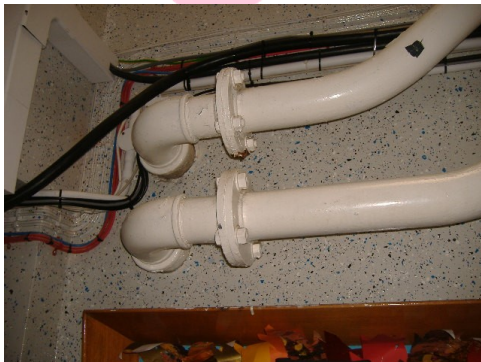
Item 30 - Ref: Presumed

The gaskets to corridor (Rm 0/59) are presumed to contain asbestos.

Any change in its appearance should be recorded and passed to Property Services.

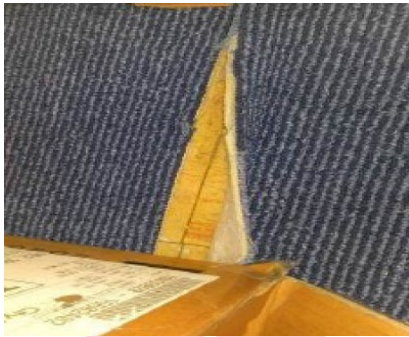
Item 32 - Ref: WC0473/08

The black/red floor tiles to the store room (Rm 0/85) contained asbestos.

These were removed in July 2015.

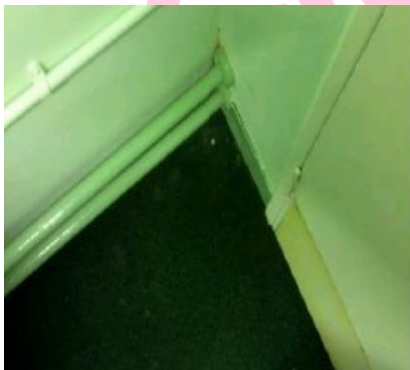
Item 36 - Ref: WC0477/08

The floor tiles to the office (Rm 0/105) contained asbestos.

These were removed in February 2016.

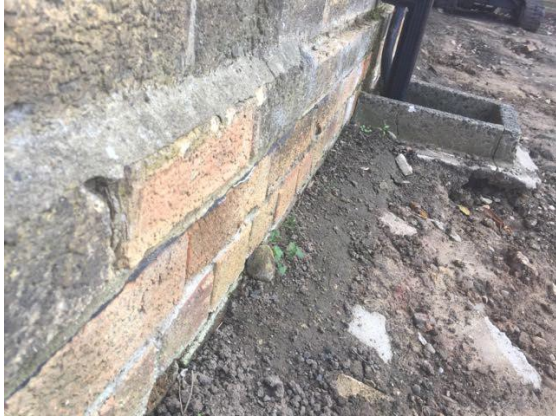
Item 53 - Ref: 741271-7

The damp proof course to the Lower Wall (External) contains asbestos.

Any change in its appearance should be recorded and passed to Property Services.

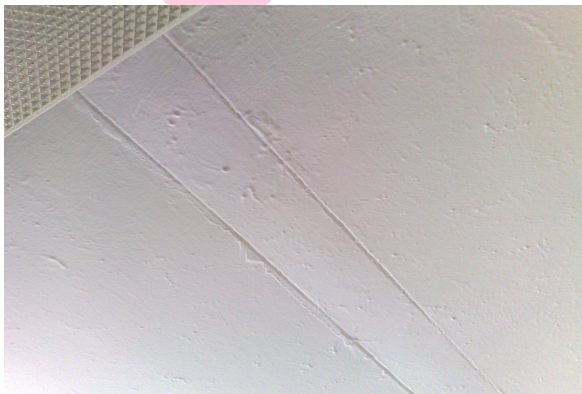
Item 94 - Ref: KR09/46

The textured coating to the ceiling in the craft area (Room 0/48) contains asbestos.

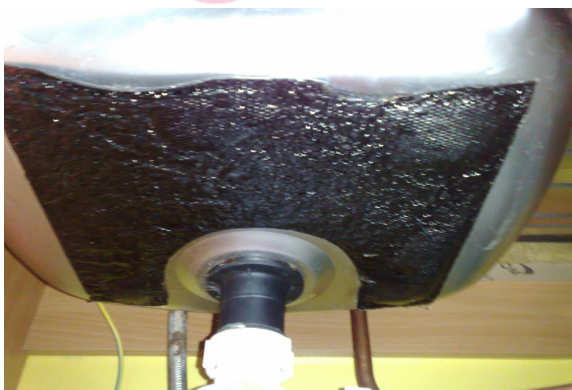
Item 138 - Ref: KR09/71

The sink pad in the Nursery and cloakroom (Room 0/97) does not contain asbestos.

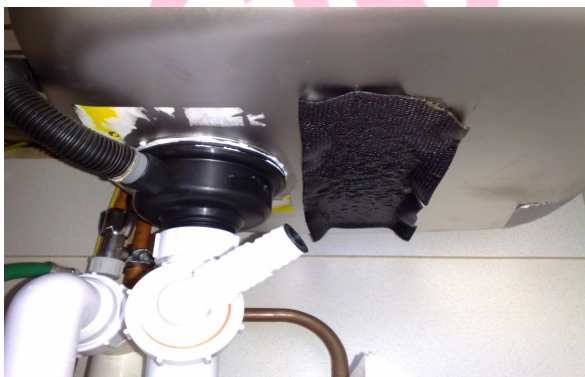
Item 141 - Ref: KR09/75

The sink pad in the extended school kitchen club (Room 0/101) does not contain asbestos.

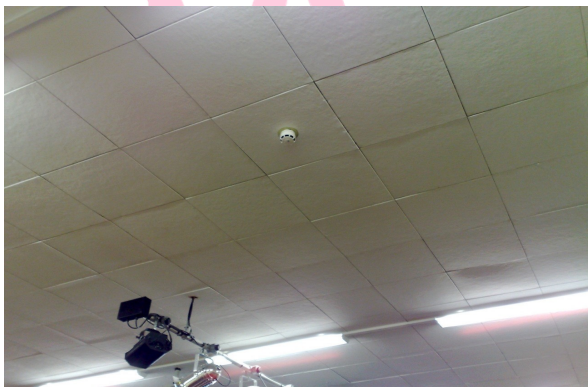
Item 144 - Ref: KR09/52A

The ceiling tiles in the hall (Room 0/30) does not contain asbestos.

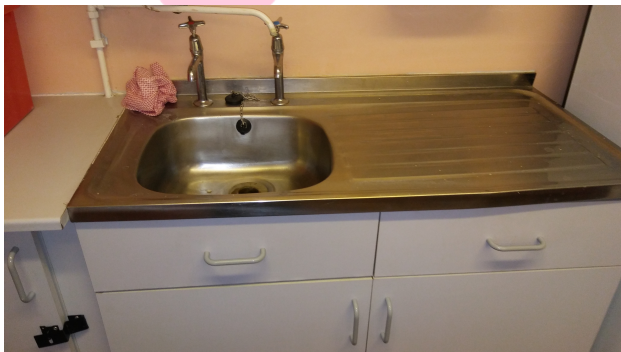
Item 156 - Ref: 383326-4

The sealant to pipe beneath sink in 005/Music Room does not contain asbestos.

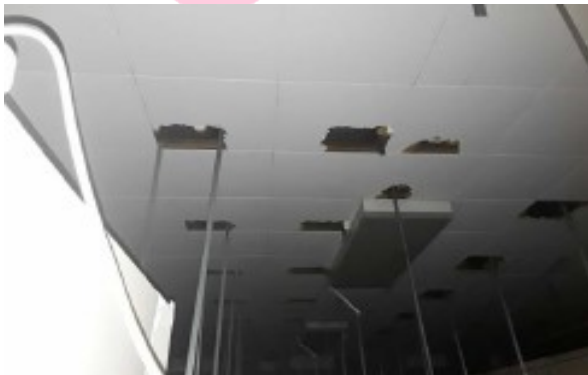
Item 180 - Ref: 22-45169-1

The fibreboard debris in Area 2 Classroom Reception ceiling void does not contain asbestos.

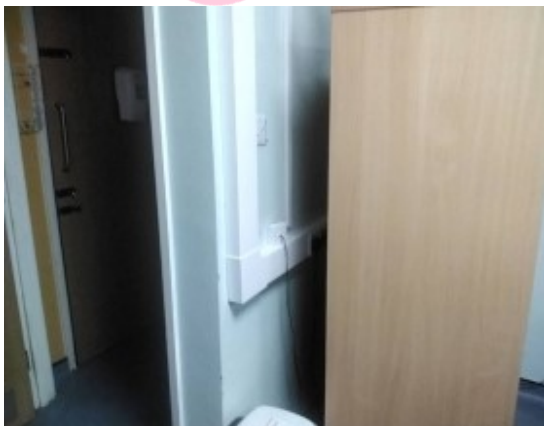
Item 192 - Ref: NG002302

The wall coating in the Canteen Office (Rm G/002) does not contain asbestos.

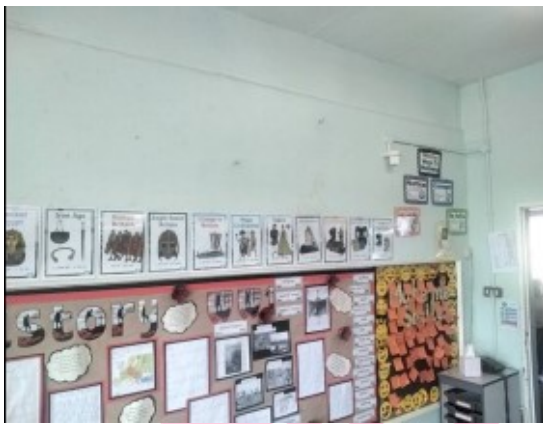
Item 200 - Ref: NG002292

The wall coating in the 5B Classroom (Rm G/010) does not contain asbestos.

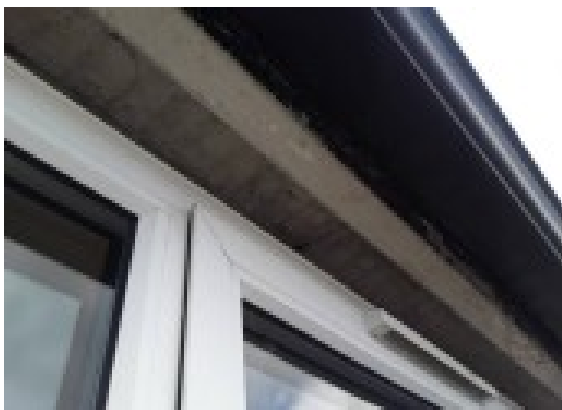
The Damp proof course (External area 1 pointing E/003).

Any change in appearance should be reported to Property Services.

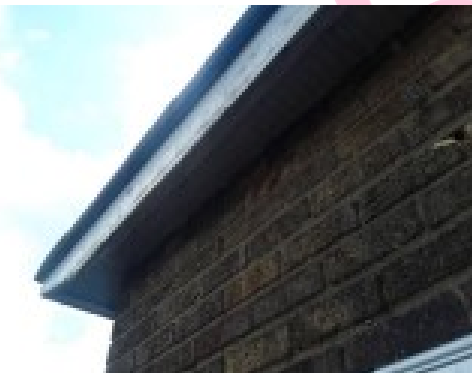
The Damp proof course
(External area 3 Roof E/004).

Any change in appearance
should be reported to Property
Services.

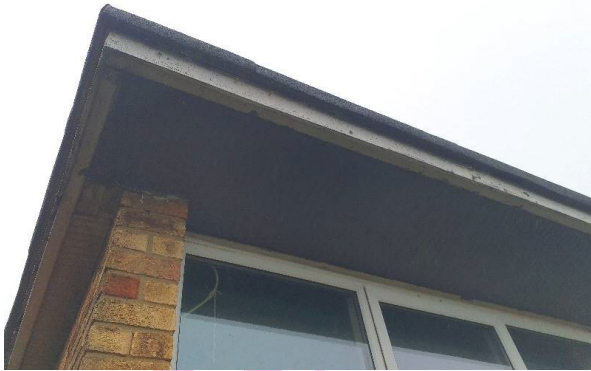
The joint capping – downpipes (External E/001) contain asbestos.

Any change in appearance should be reported to Property Services.

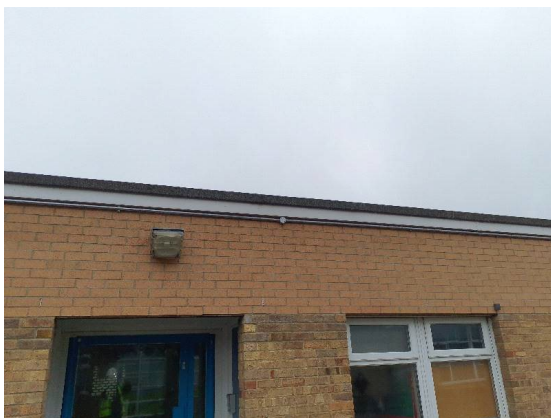
Item 243 - Ref: OU003188

The sealant around timber fascias (External E/001) does not contain asbestos.
