ASBESTOS SURVEY REPORT FOR ALBANY PRIMARY SCHOOL, CROSSGILL, WASHINGTON, NE37 1UA.

Asbestos Register for Albany Primary School, Crossgill, Washington

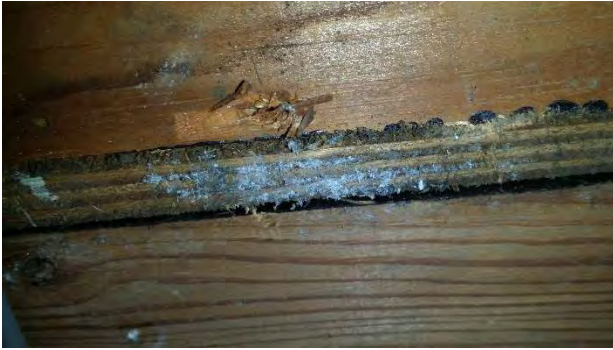
Item 1 Ref: 369386-6

- (Item 1) Ref: 369386-6 – Debris to beam and within nail holes (004/Corridor void above) - Low Risk
- (Item 2) Ref: 369386-50 – Ceiling (012/Boiler Room) – No Risk

The debris to beam and within nail holes in Rm 004/Corridor void above contains asbestos.

Any change in its appearance should be recorded and passed to Property Services.

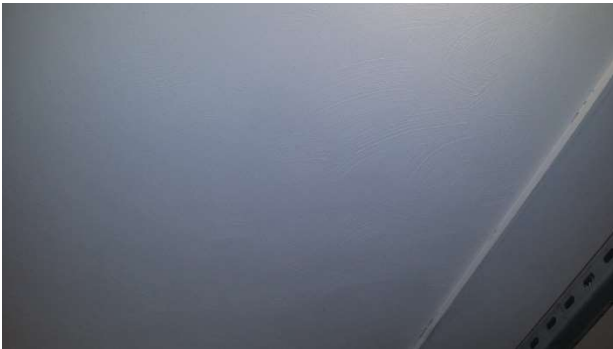
Item 2 Ref: 369386-50

The ceiling in Rm 012/Boiler Room does not contain asbestos.

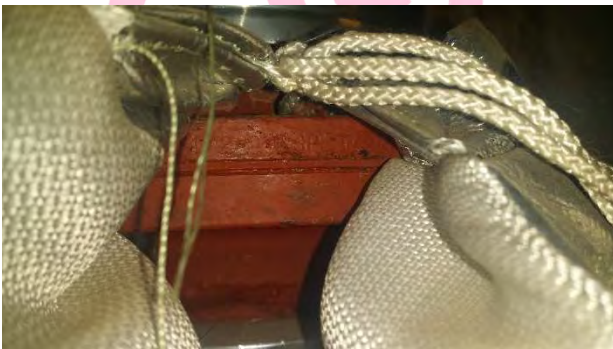
Item 3 Ref: 369386-51

The gasket to pipework in Rm 012/Boiler Room does not contain asbestos.

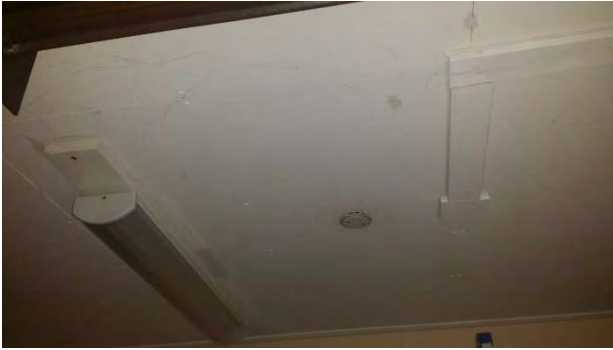
Item 4 Ref: 369386-47

The ceiling in Rm 013/Hall Store does not contain asbestos.

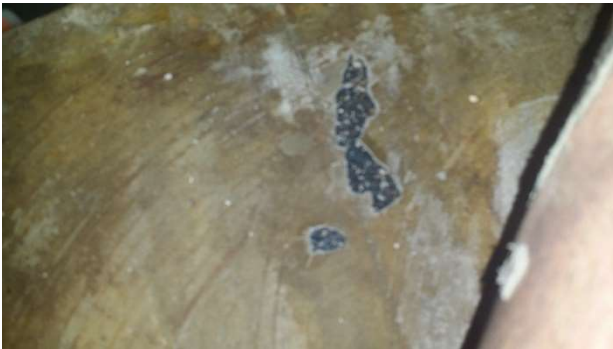
Item 5 Ref: As 369386-44

The remnant adhesive backing to floor in Rm 013/Hall Store contains asbestos.

Any change in its appearance should be recorded and passed to Property Services.

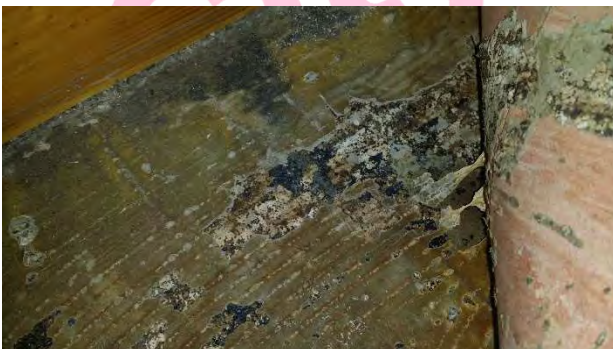
Item 6 Ref: 369386-44

The remnant adhesive backing to floor in Rm 014/Hall Dining Area contains asbestos.

Any change in its appearance should be recorded and passed to Property Services.

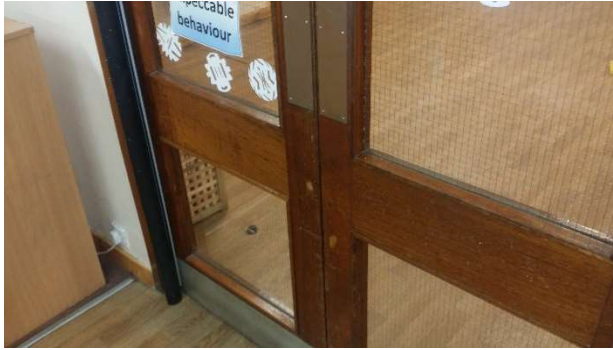
Item 7 Ref: As 369386-27

The mastic to glazing at doors in Rm 014/Hall dining area contains asbestos.

Any change in its appearance should be recorded and passed to Property Services.

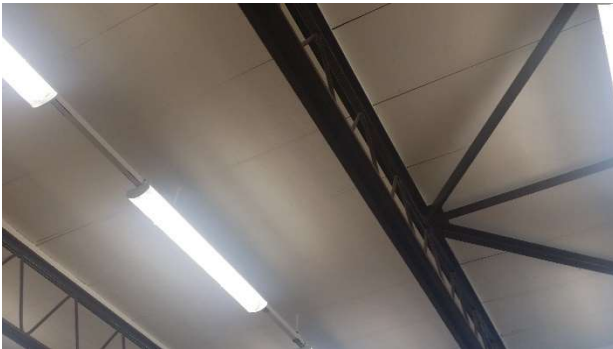
Item 8 Ref: 369386-58

The underside of roof to hall in Rm 014/Hall dining area does not contain asbestos.

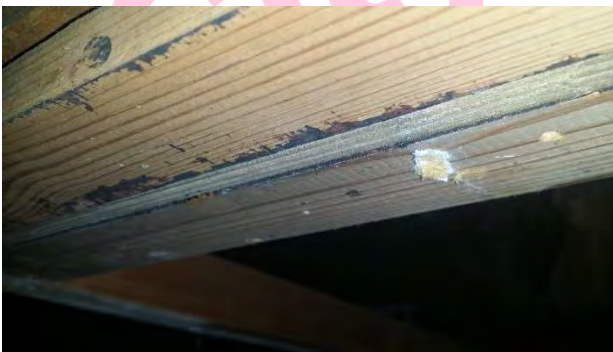
Item 9 Ref: 369386-45

The residue to beams and joists in Rm 014/Hall dining area void above contain asbestos.

Any change in its appearance should be recorded and passed to Property Services.

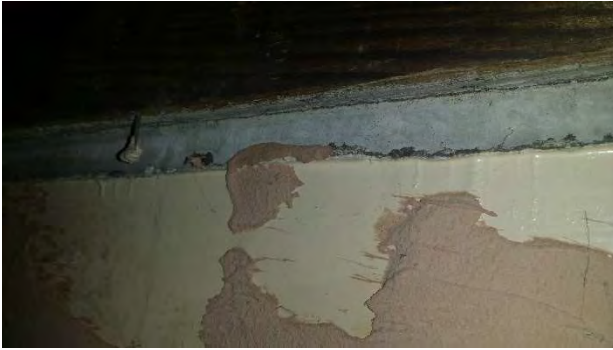
Item 10 Ref: As 369386-45

The residue to wall tops in Rm 014/Hall dining area void above contains asbestos.

Any change in its appearance should be recorded and passed to Property Services.

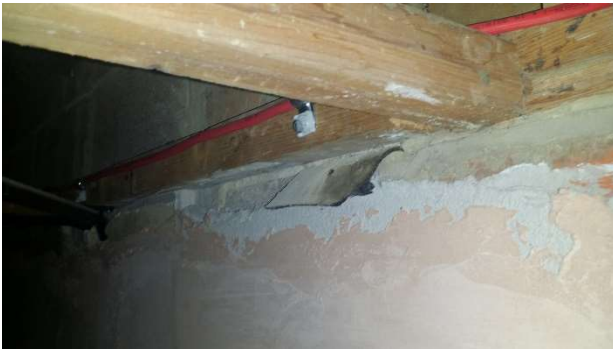
Item 11 Ref: 369386-46

The packer below beam in Rm 014/Hall dining area void above does not contain asbestos.

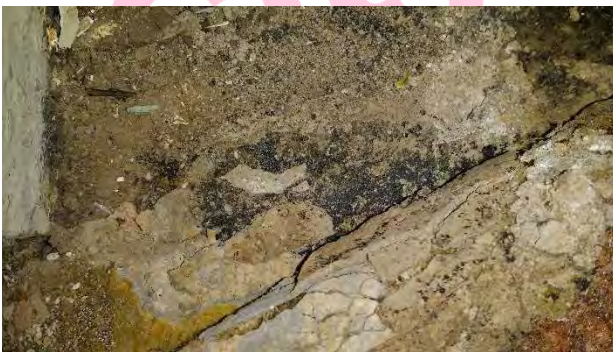
Item 12 Ref: 369386-30

The remnant adhesive backing to floor in Rm 015/Cabinet of curiosities contains asbestos.

Any change in its appearance should be recorded and passed to Property Services.

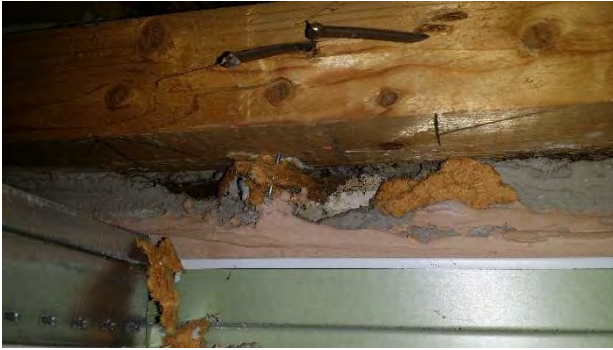
Item 13 Ref: 369386-41

The residue to perimeter walls in Rm 015/Cabinet of curiosities void above contains asbestos.

Any change in its appearance should be recorded and passed to Property Services.

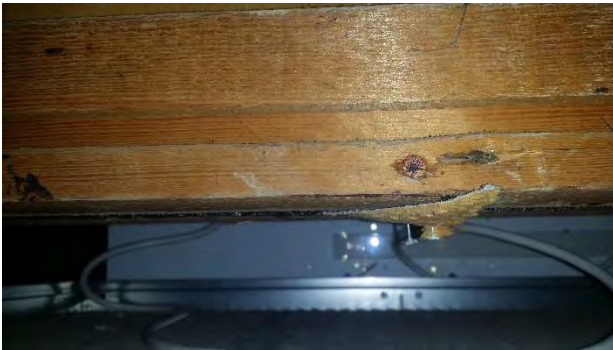
Item 14 Ref: As 369386-41

The remnant ceiling to beams in Rm 015/Cabinet of curiosities void above contains asbestos.

Any change in its appearance should be recorded and passed to Property Services.

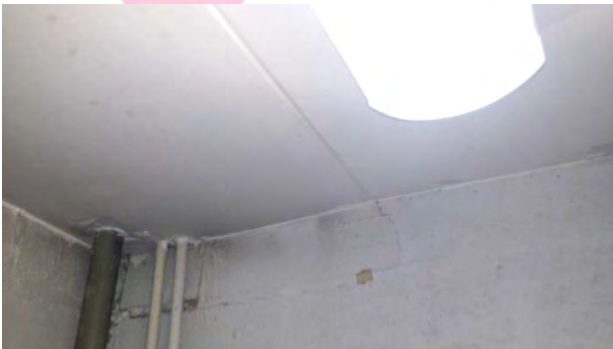
Item 15 Ref: As 369386-26

The ceiling in Rm 015b/IT cupboard does not contain asbestos.

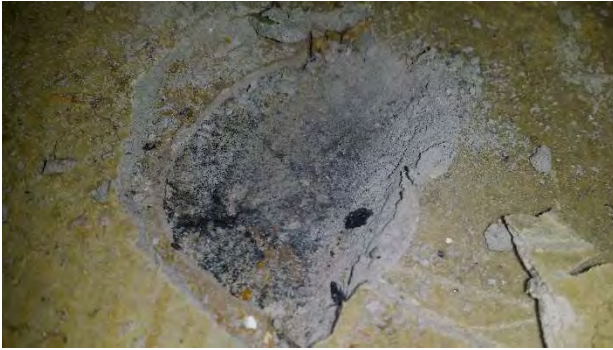
Item 16 Ref: 369386-42

The subfloor in Rm 015b/IT cupboard contains asbestos.

Any change in its appearance should be recorded and passed to Property Services.

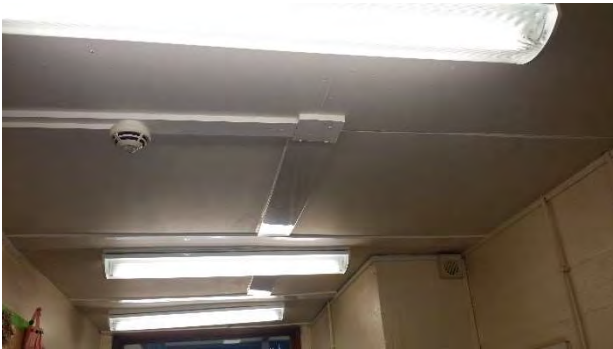
Item 17 Ref: 369386-26

The ceiling in Rm 016/Corridor does not contain asbestos.

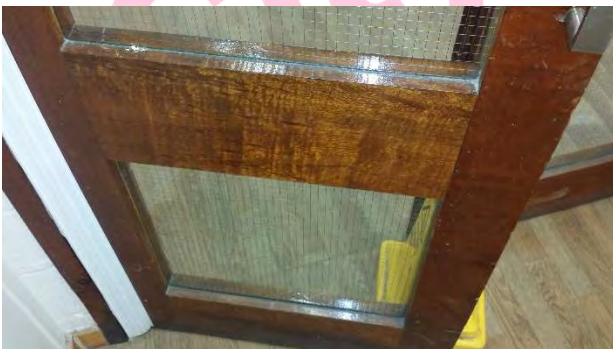
Item 18 Ref: 369386-27

The mastic to glazing at fire doors into hall in Rm 016/Corridor contains asbestos.

Any change in its appearance should be recorded and passed to Property Services.

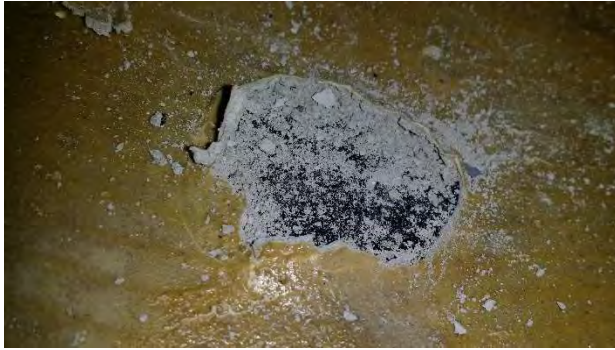
Item 19 Ref: As 369386-25

The remnant adhesive backing to floor in Rm 016/Corridor contains asbestos.

Any change in its appearance should be recorded and passed to Property Services.

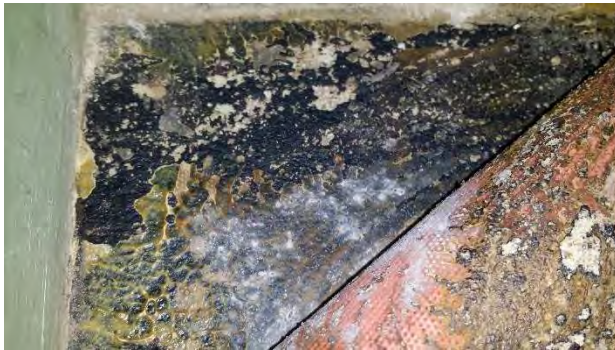
Item 20 Ref: As 369386-25

The remnant adhesive backing to floor in 016a/electrics room contains asbestos.

Any change in its appearance should be recorded and passed to Property Services.

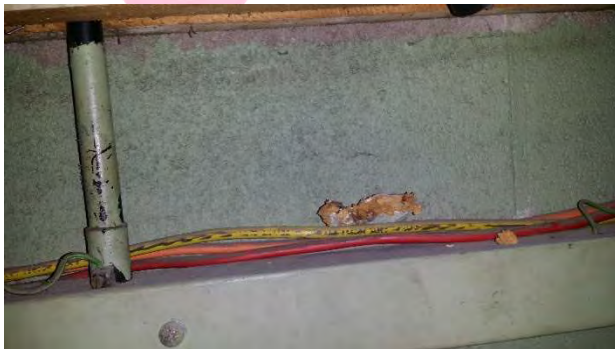
Item 21 Ref: 369386-29

The debris to top of cable trunking in Rm 016a/electrics room contains asbestos.

Any change in its appearance should be recorded and passed to Property Services.

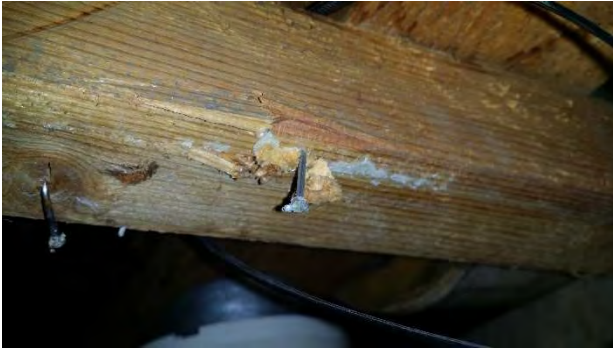
Item 22 Ref: As 369386-29

The residue to beams in Rm 016a/electrics room contains asbestos.

Any change in its appearance should be recorded and passed to Property Services.

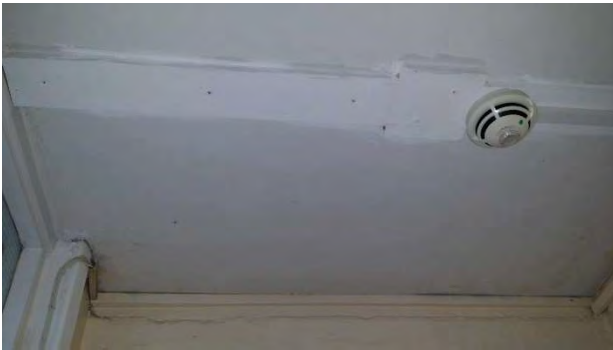
Item 23 Ref: As 369386-26

The ceiling in Rm 016b/Corridor lobby does not contain asbestos.

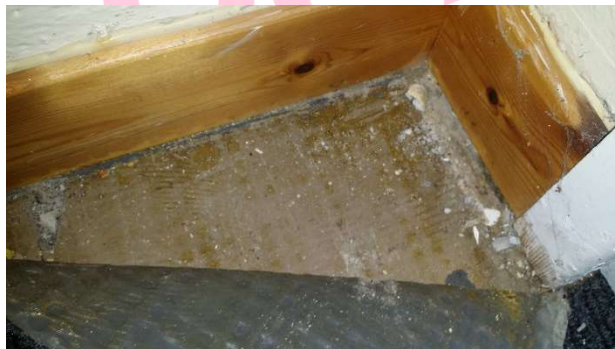
Item 24 Ref: 369386-28

The subfloor in Rm 016b/Corridor lobby contains asbestos.

Any change in its appearance should be recorded and passed to Property Services.

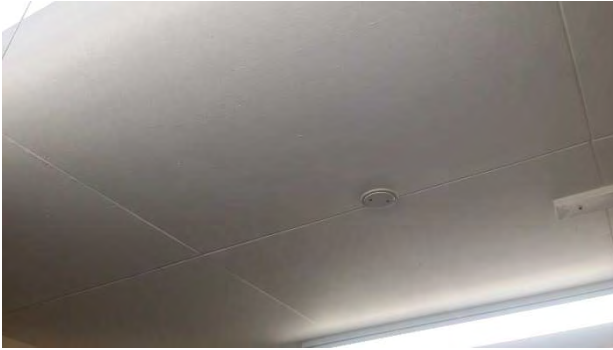
Item 25 Ref: As 369386-26

The ceiling in Rm 017/Sensory room does not contain asbestos.

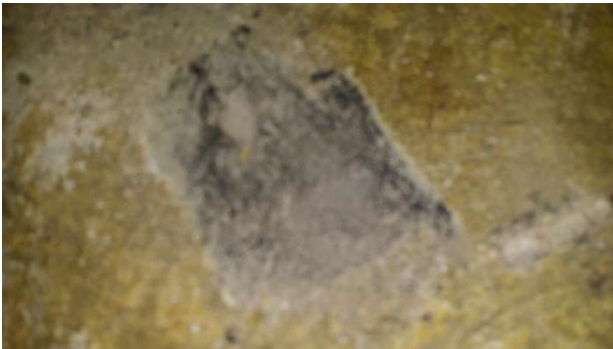
Item 26 Ref: As 369386-30

The remnant adhesive backing to floor in Rm 017/Sensory room contains asbestos.

Any change in its appearance should be recorded and passed to Property Services.

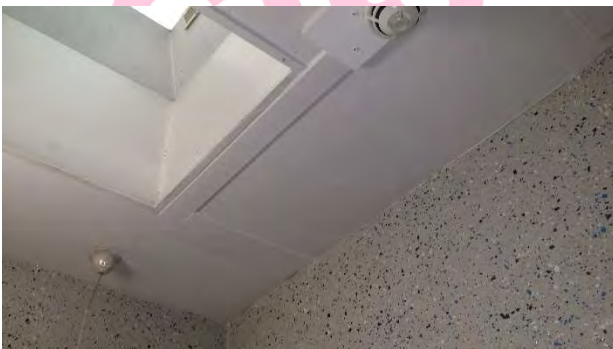
Item 27 Ref: As 369386-26

The ceiling in Rm 018/Male toilet does not contain asbestos.

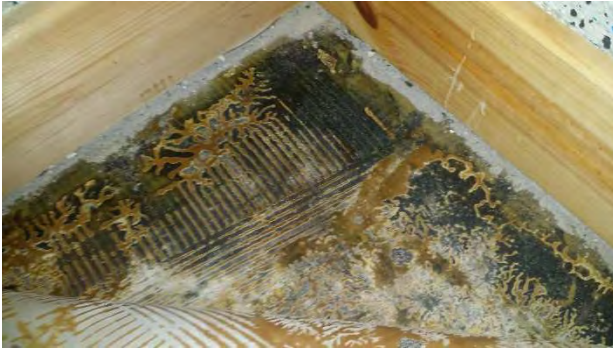
Item 28 Ref: As 369386-30

The remnant adhesive backing to floor in Rm 018/Male toilet contains asbestos.

Any change in its appearance should be recorded and passed to Property Services.

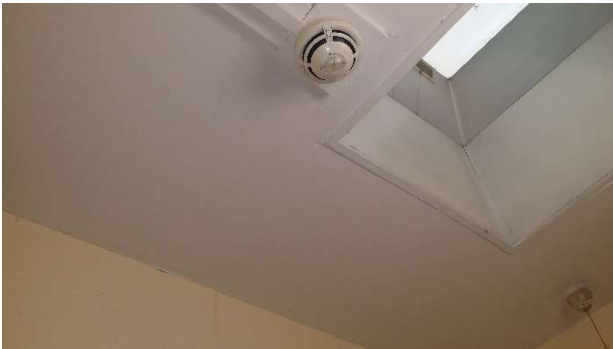
Item 29 Ref: As 369386-26

The ceiling in Rm 019/Female toilet does not contain asbestos.

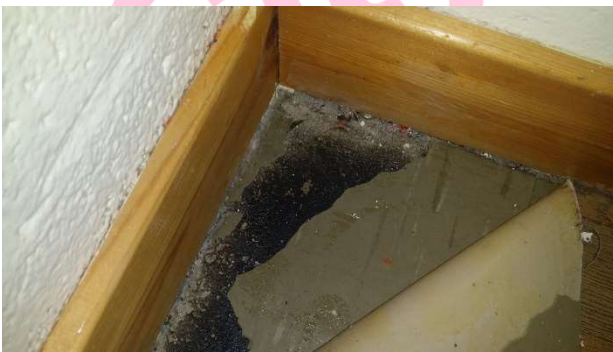
Item 30 Ref: As 369386-30

The remnant adhesive backing to floor in Rm 019/Female toilet contains asbestos.

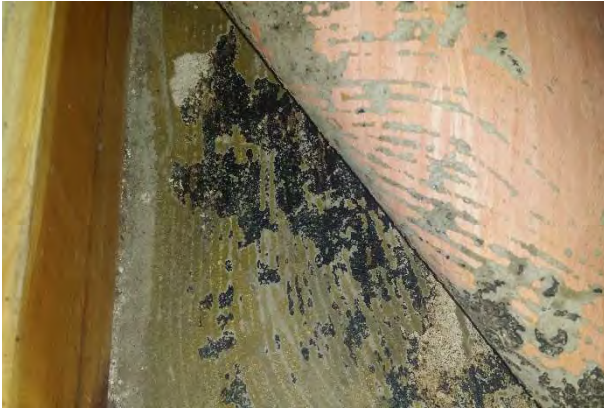
Item 34 Ref: As 369386-44

The remnant adhesive backing to floor in Rm 021/Hall Store contains asbestos.

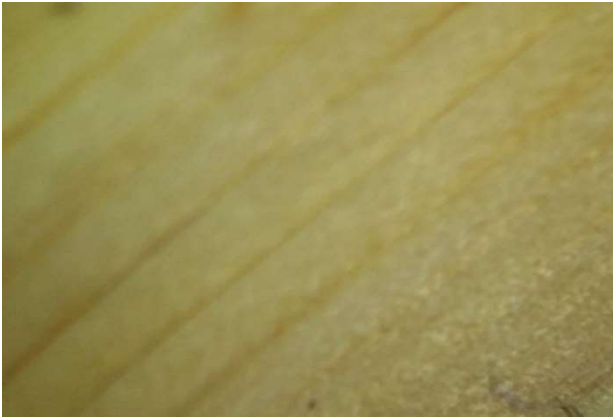
Item 37 Ref: As 369386-44

The remnant adhesive backing to floor in Rm 022/Hall Store contains asbestos.

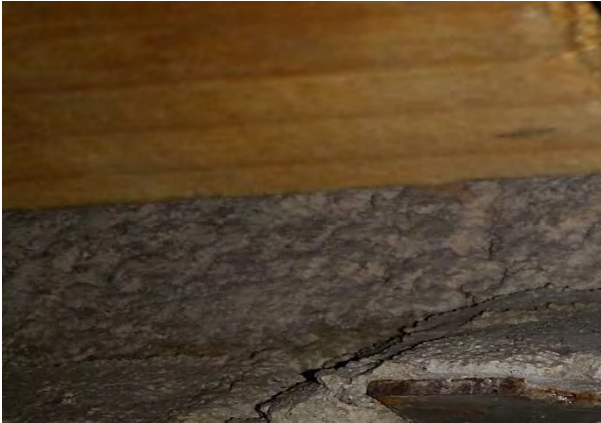
Item 40 Ref: 369386-91

The residue to joints in Rm 024/Classroom – void above contains asbestos.

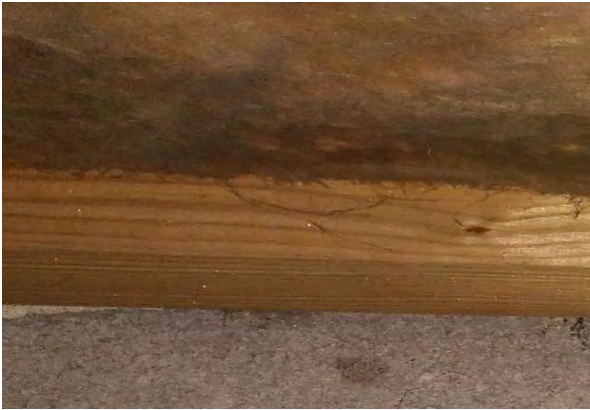
Item 46 Ref: 369386-93

The packing to underside of roof in Rm 026b/Classroom – void above contains asbestos.

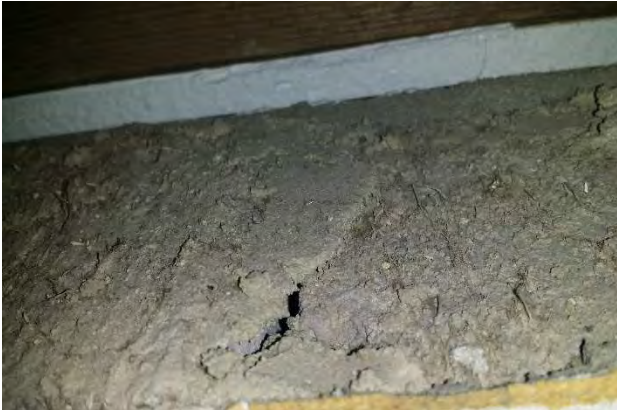
Item 71 Ref: As 369386-10

The remnant fibreboard to cupboard wall tops in Rm 035/Classroom – void above contains asbestos.

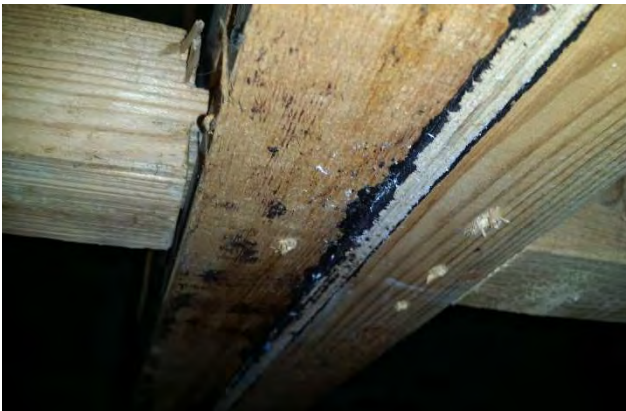
Item 74 Ref: 369386-15

The remnant fibreboard to joists in Rm 036/Classroom – void above contains asbestos.

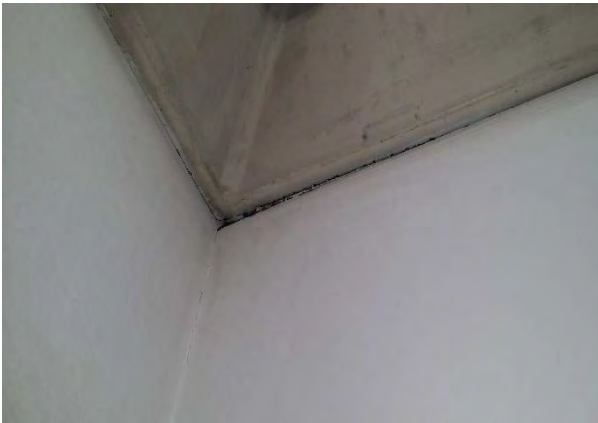
Item 77 Ref: 369386-4

The packing to skylight tops in Rm 038/Cloakroom does not contain asbestos.

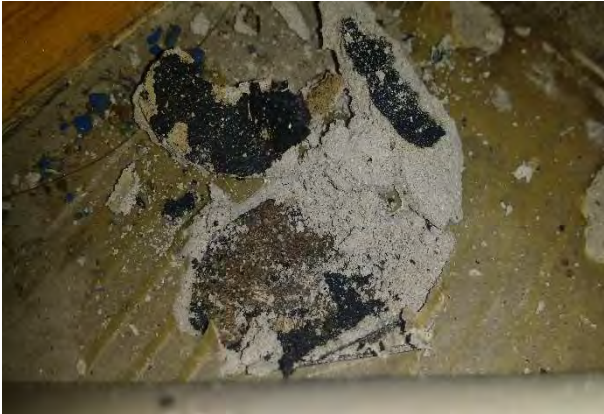
Item 88 Ref: As 369386-59

The remnant adhesive backing to floor in Rm 041/Classroom contains asbestos.

Any change in its appearance should be recorded and passed to Property Services.

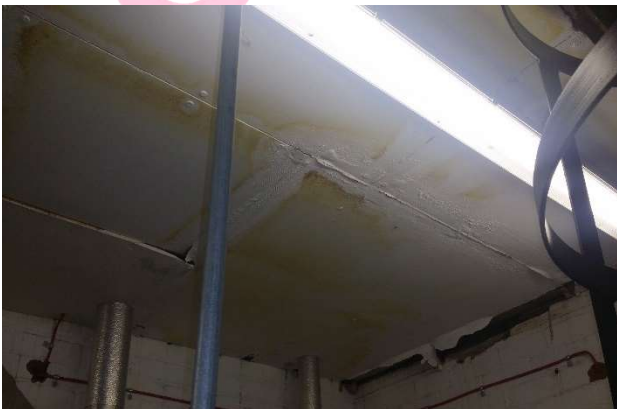
Item 93 Ref: 369386-55

The ceiling in Rm 043/Boiler Room does not contain asbestos.

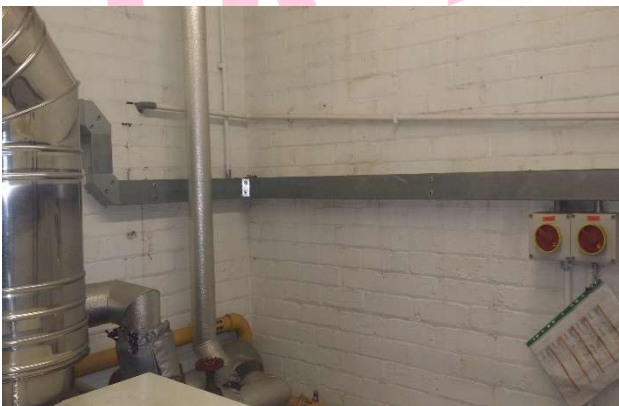
Item 96 Ref: 369386-56

The debris to walls in Rm 043/Boiler Room does not contain asbestos.

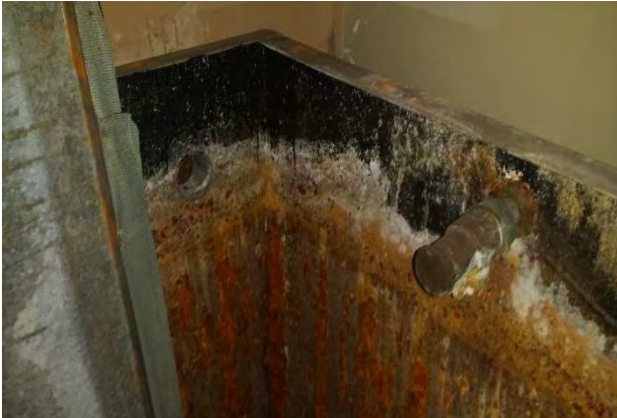
Item 97 Ref: 369386-57

The paint to metal tanks in Rm 043/Boiler Room – void above does not contain asbestos.

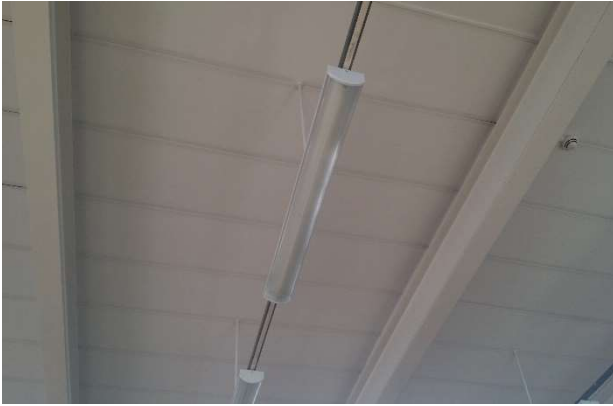
Item 103 Ref: 369386-86

The underside of roof to hall in Rm 047/Hall does not contain asbestos.

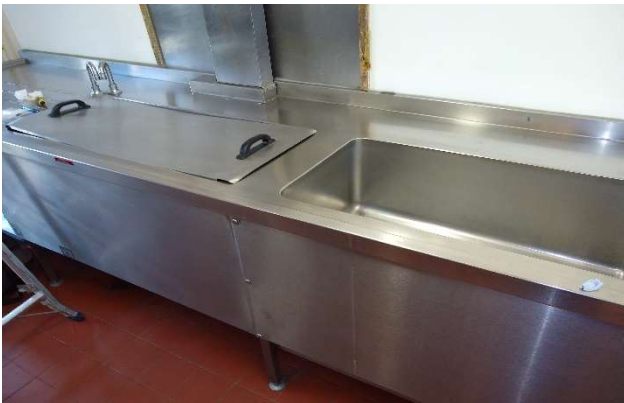
Item 107 Ref: 369386-71

The sink pad in Rm 048/Kitchen does not contain asbestos.

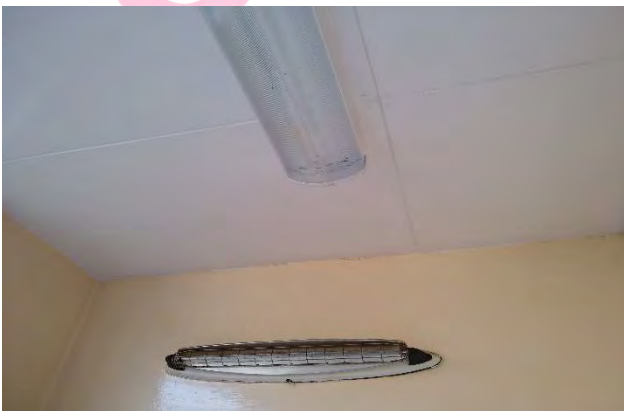
Item 108 Ref: 369386-62

The fixed ceiling tiles in Rm 048a/Kitchen Office contains asbestos.

Any change in its appearance should be recorded and passed to Property Services.

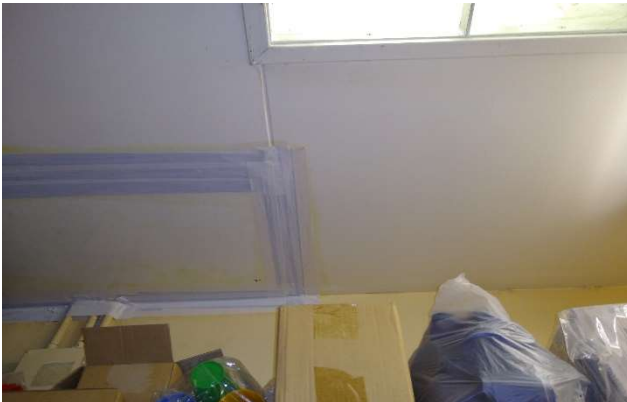
Item 110 Ref: As 369386-74

The fixed ceiling tiles in Rm 048c/Dry Store contains asbestos.

Any change in its appearance should be recorded and passed to Property Services.

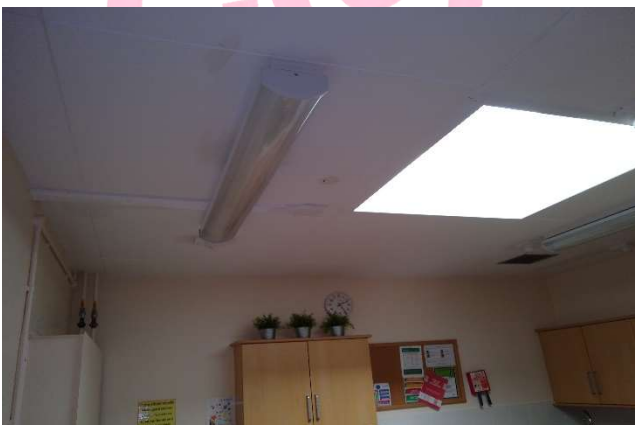
Item 111 Ref: 369386-68

The fixed ceiling tiles in Rm 050/Breakfast Room contains asbestos.

Any change in its appearance should be recorded and passed to Property Services.

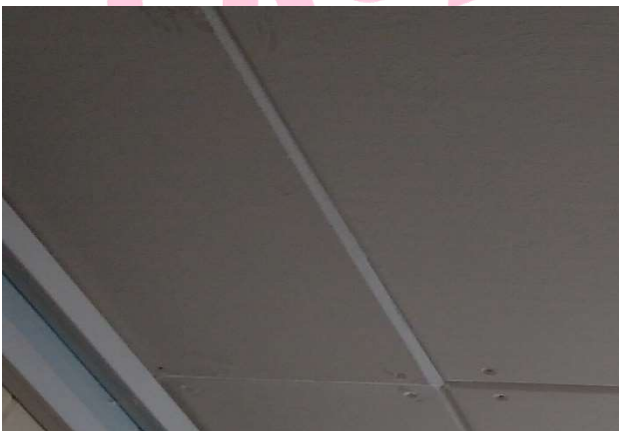
Item 114 Ref: As 369386-80

The ceiling in Rm 051/Corridor contains asbestos.

Any change in its appearance should be recorded and passed to Property Services.

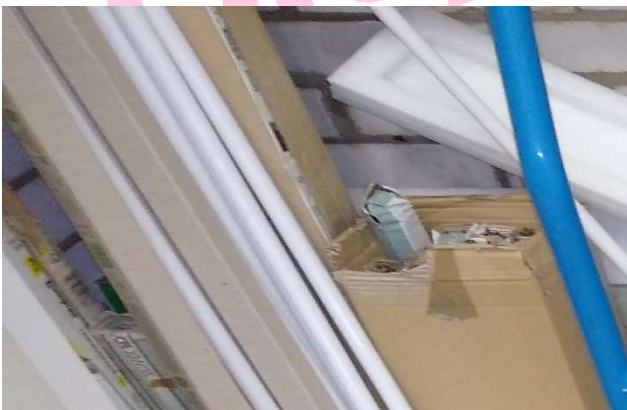
Item 117 Ref: 369386-76

The adhesive to floor in Rm 051a/Electric Cupboard contains asbestos.

Any change in its appearance should be recorded and passed to Property Services

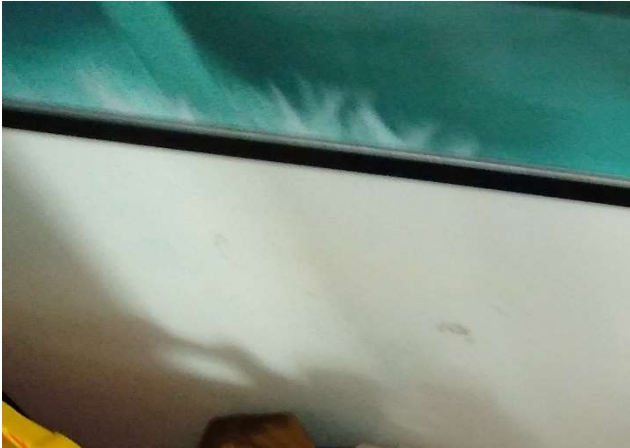
Item 118 Ref: As 369386-66

The floor under screed in Rm 051a/Store contains asbestos.

Any change in its appearance should be recorded and passed to Property Services.

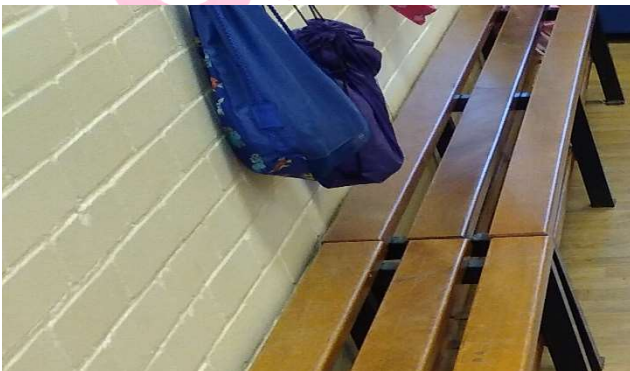
Item 120 Ref: As 369386-66

The floor under screed in Rm 051b/Corridor contains asbestos.

Any change in its appearance should be recorded and passed to Property Services.

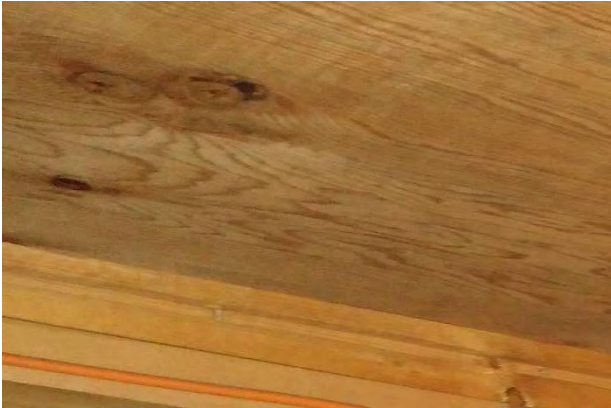
Item 121 Ref: 369386-63

The debris to beams in Rm 051b/Corridor – void above suspended ceiling contains asbestos.

Removed August 2023

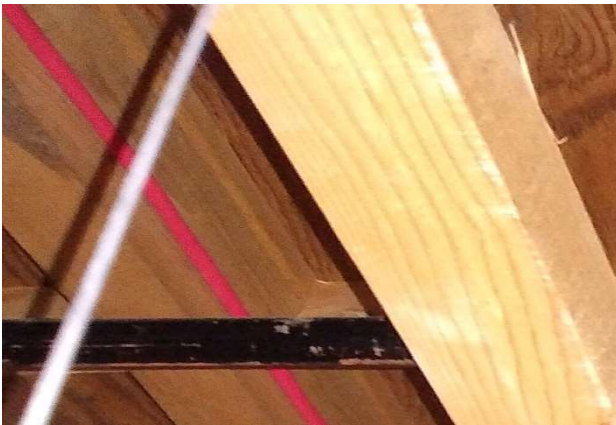
Item 122 Ref: 369386-77

The debris to nail holes in Rm 051b/Entrance Lobby – void above does not contain asbestos.

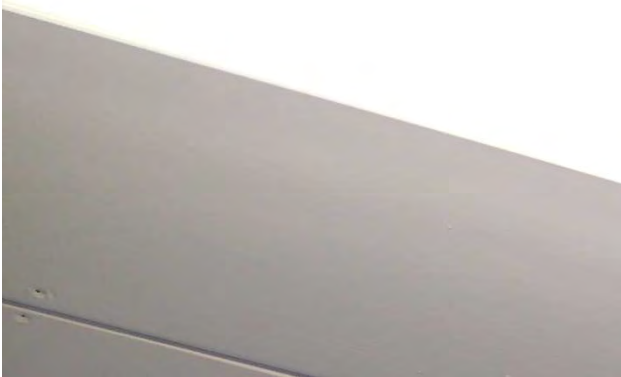
Item 123 Ref: 369386-64

The ceiling in Rm 051c/Lobby contains asbestos.

Any change in its appearance should be recorded and passed to Property Services.

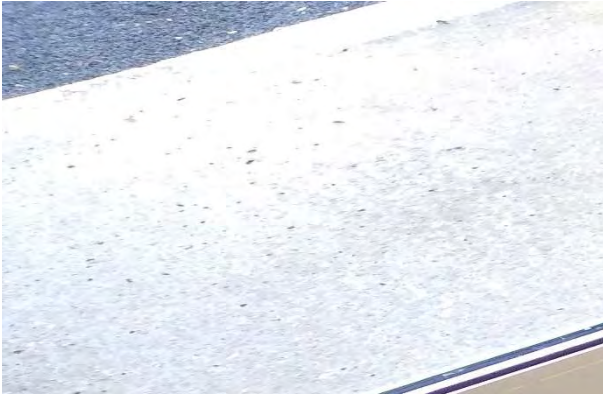
Item 124 Ref: 369386-65

The floor covering under carpet in Rm 051c/Lobby contains asbestos.

Any change in its appearance should be recorded and passed to Property Services.

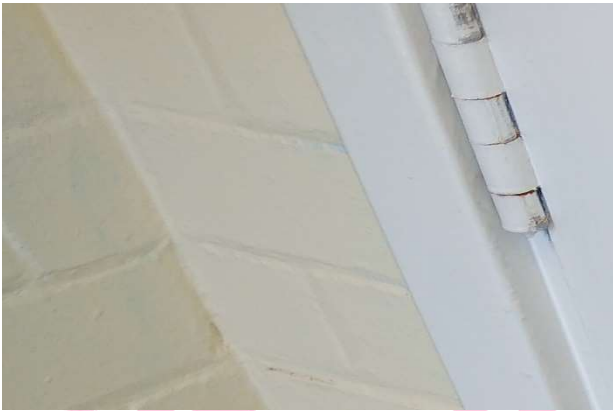
Item 125 Ref: As 369386-40

The sealant to corridor door window panels in Rm 051c/Lobby contains asbestos.

Any change in its appearance should be recorded and passed to Property Services.

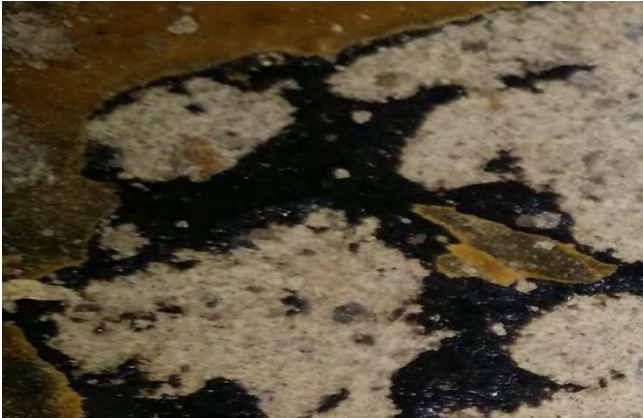
Item 127 Ref: As 369386-85

The remnant adhesive backing to floor in Rm 053/Hall Store contains asbestos.

Any change in its appearance should be recorded and passed to Property Services.

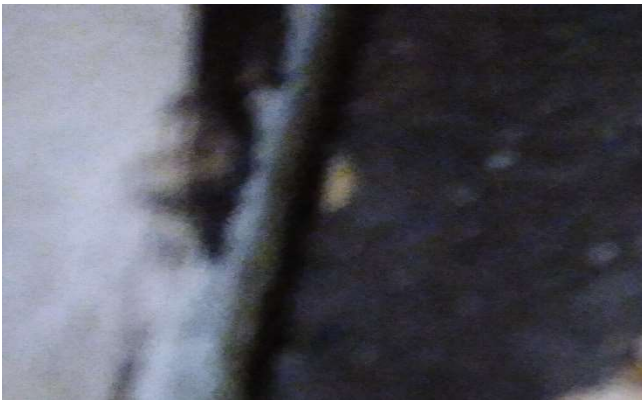
Item 128 Ref: As 369386-76

The floor in Rm 054/Cleaners Cupboard contains asbestos.

Any change in its appearance should be recorded and passed to Property Services.

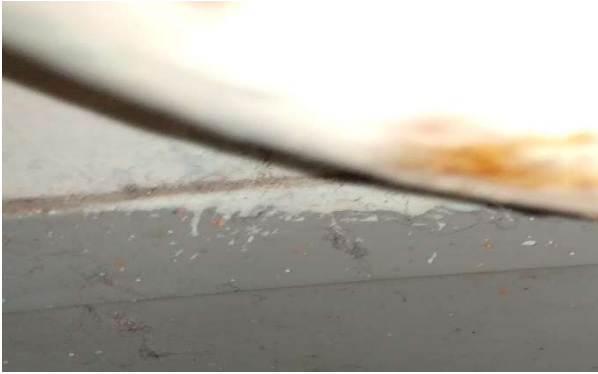
Item 130 Ref: As 369386-87

The floor in Rm 055/Staff Toilet contains asbestos.

The ceiling in Rm 055/Staff Toilet contains asbestos.

Any change in its appearance should be recorded and passed to Property Services.

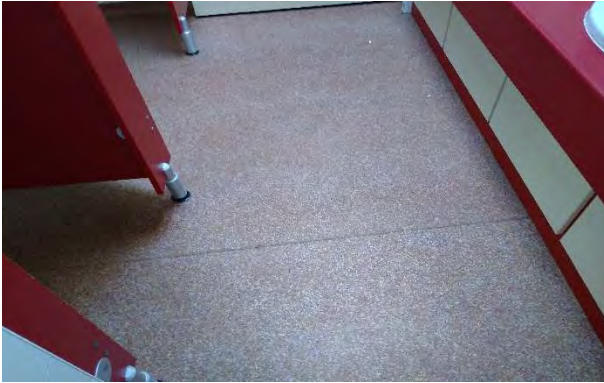
Item 133 Ref: As 369386-66

The floor under screed in Rm 058/Girls WC contains asbestos.

Any change in its appearance should be recorded and passed to Property Services.

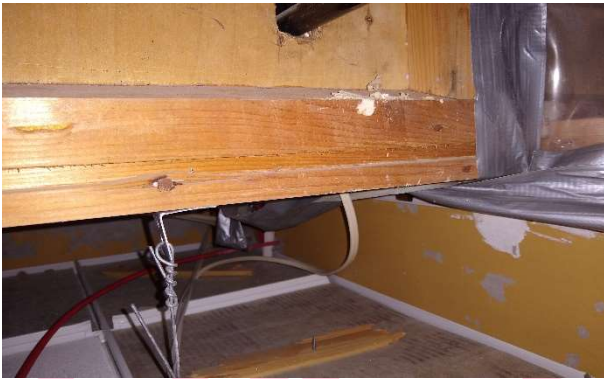
Item 134 Ref: 369386-70

The residue to beams in Rm 059/Accessible WC – void above does not contain asbestos.

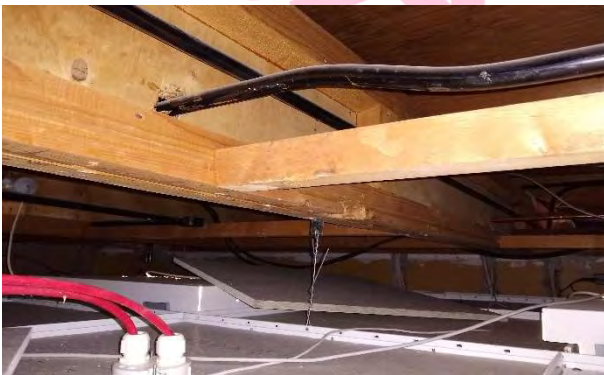
Item 135 Ref: 369386-78

The residue to beams in Rm 059/Accessible WC – void above does not contain asbestos.

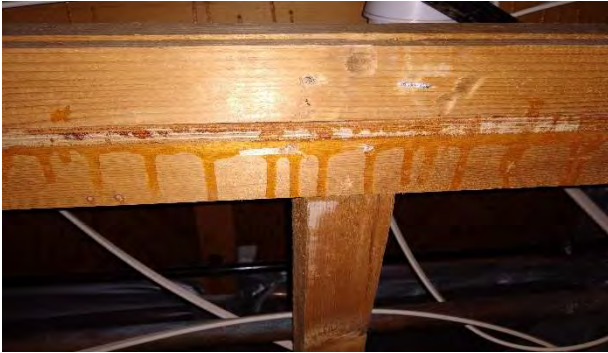
Item 136 Ref: 369386-79

The debris to nail holes in Rm 059/Accessible WC – void above does not contain asbestos.

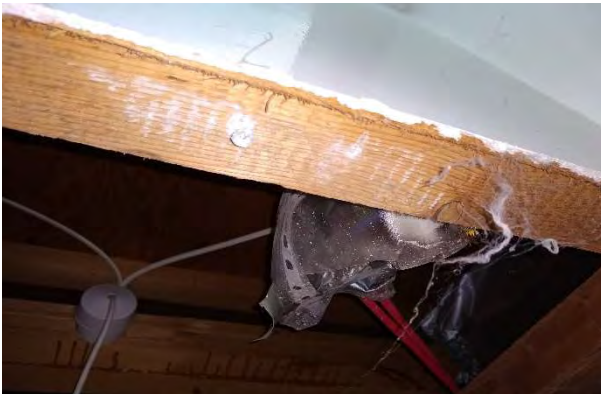
Item 137 Ref: 369386-88

The debris to screw and screw holes in Rm 060/Store – void above contains asbestos.

Any change in its appearance should be recorded and passed to Property Services.

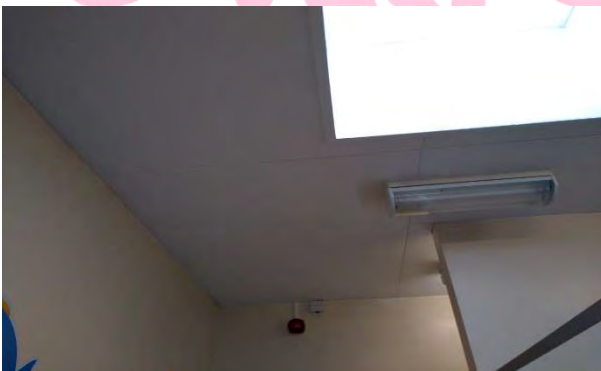
Item 138 Ref: As 369386-80

The ceiling in Rm 061/Boys Toilet contains asbestos.

Any change in its appearance should be recorded and passed to Property Services.

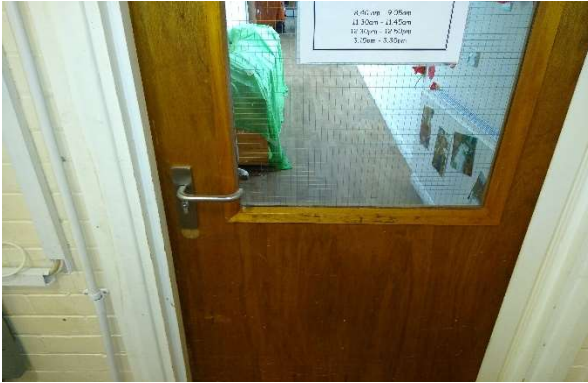
Item 139 Ref: As 369386-33

The sealant to link corridor door window panel in Rm 062/Classroom does not contain asbestos.

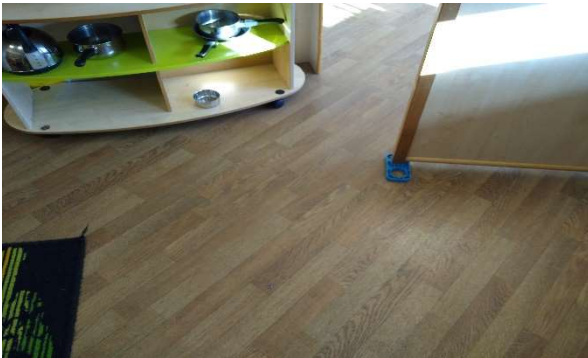
Item 140 Ref: 369386-66

The floor under screed in Rm 062/Classroom contains asbestos.

Any change in its appearance should be recorded and passed to Property Services.

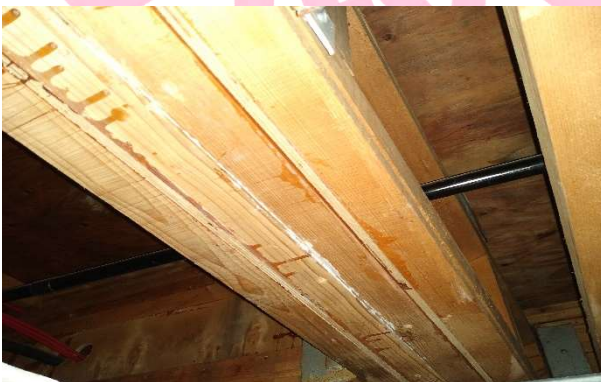
Item 141 Ref: 369386-38

The debris to beams in Rm 062/Classroom – void above suspended ceiling contains asbestos.

Removed August 2023

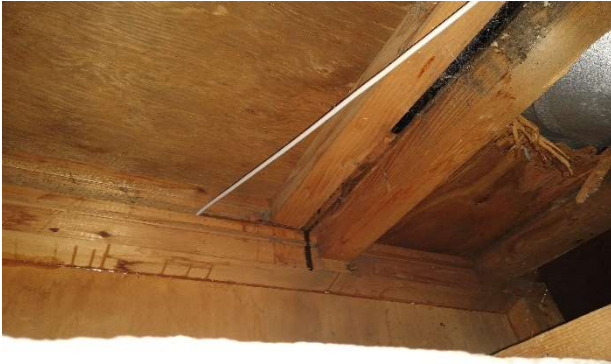
Item 142 Ref: As 369386-37

The remnants of roof covering to brick wall in Rm 062/Classroom – void above suspended ceiling does not contain asbestos.

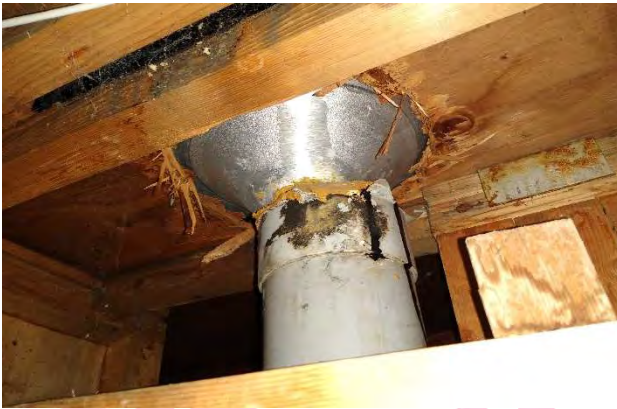
Item 143 Ref: 369386-39

The soil pipe collar sealant in Rm 062/Classroom – void above suspended ceiling does not contain asbestos.

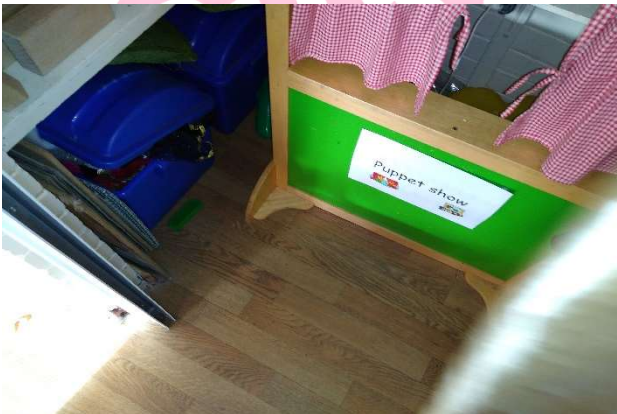
Item 144 Ref: As 369386-66

The floor under screed in Rm 062a/Store contains asbestos.

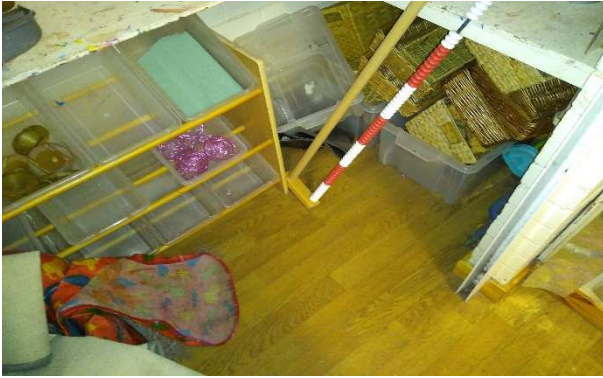
Item 145 Ref: As 369386-66

The floor under screed in Rm 063/Store contains asbestos.

Any change in its appearance should be recorded and passed to Property Services.

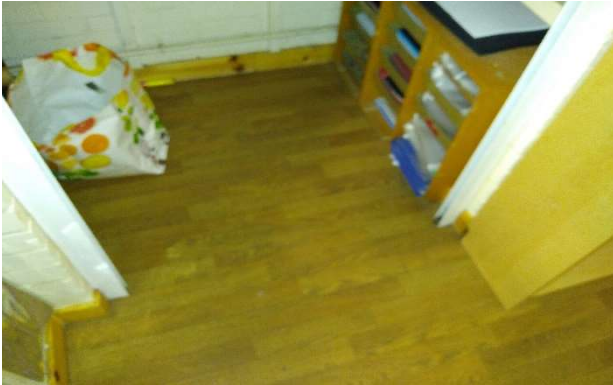
Item 146 Ref: As 369386-66

The floor under screed in Rm 064a/Store contains asbestos.

Any change in its appearance should be recorded and passed to Property Services.

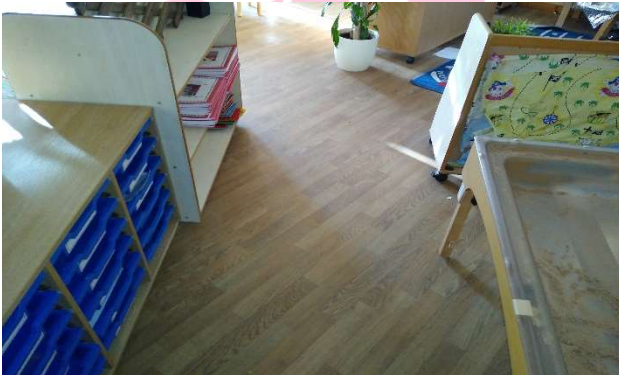
Item 147 Ref: As 369386-66

The floor under screed in Rm 064/Classroom contains asbestos.

Any change in its appearance should be recorded and passed to Property Services.

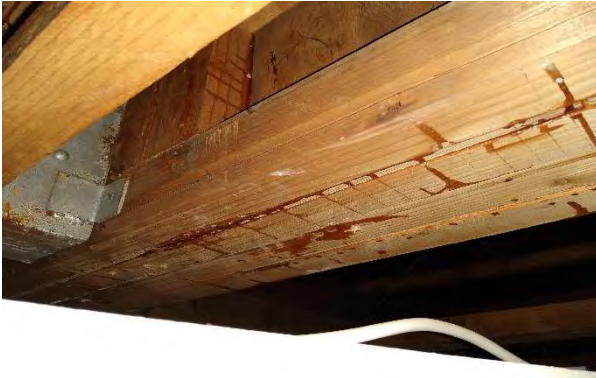
Item 148 Ref: As 369386-38

The debris to beams in Rm 064/Classroom – void above suspended ceiling contains asbestos.

Removed August 2023

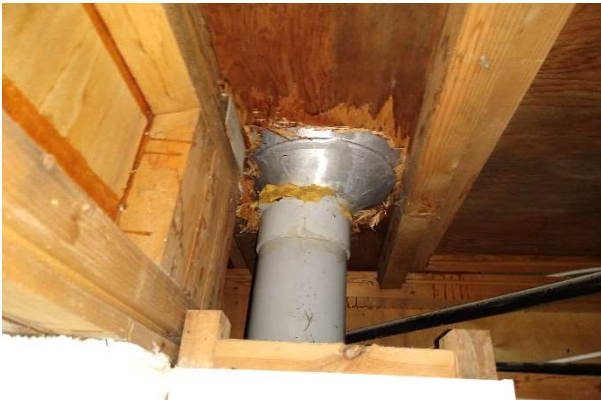
Item 149 Ref: As 369386-39

The soil pipe collar sealant in Rm 064/Classroom – void above suspended ceiling does not contain asbestos.

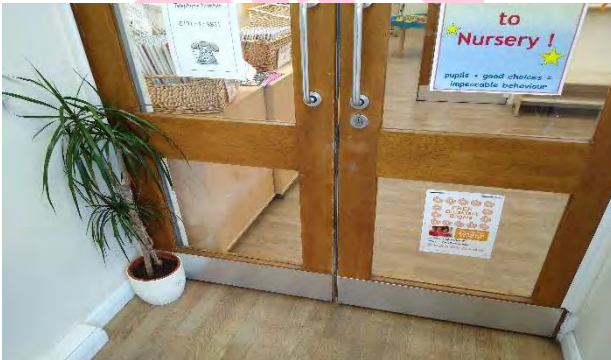
Item 150 Ref: As 369386-36

The sealant to cloakroom door window panels in Rm 065/Link Corridor does not contain asbestos.

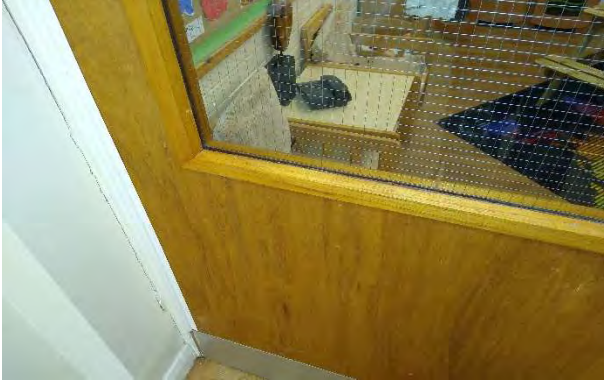
Item 151 Ref: As 369386-33

The sealant to classroom door window panels in Rm 065/Link Corridor does not contain asbestos.

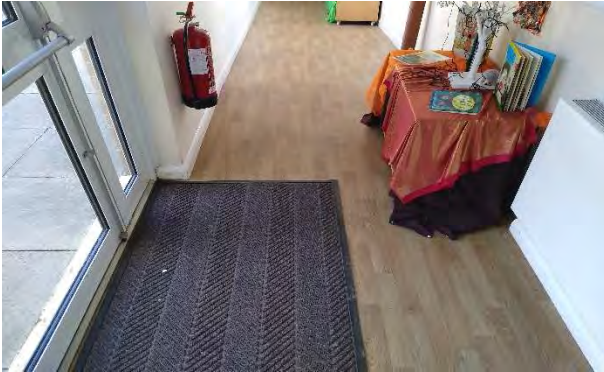
Item 152 Ref: As 369386-66

The floor under screed in Rm 065/Link Corridor contains asbestos.

Any change in its appearance should be recorded and passed to Property Services.

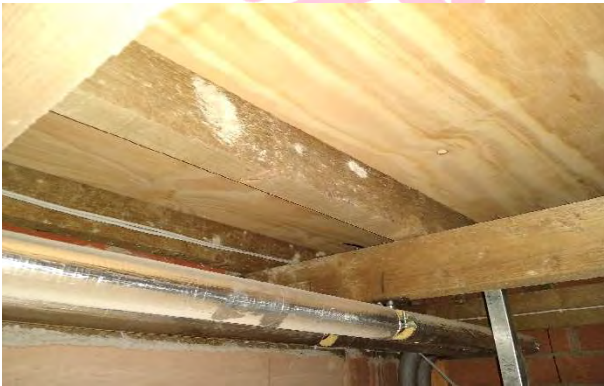
Item 153 Ref: As 369386-32

The debris to beams in Rm 065/Link Corridor – void above suspended ceiling does not contain asbestos.

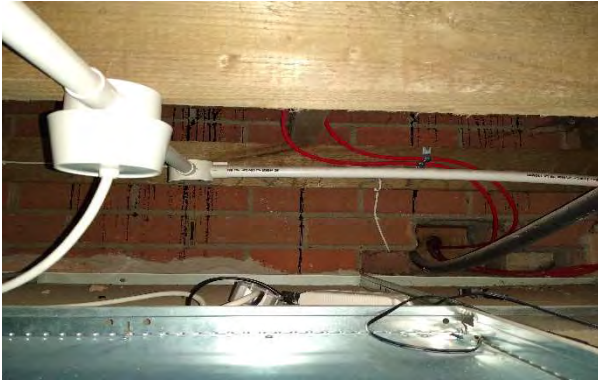
Item 154 Ref: 369386-37

The remnants of roof covering to brick wall in Rm 065/Link Corridor – void above suspended ceiling does not contain asbestos.

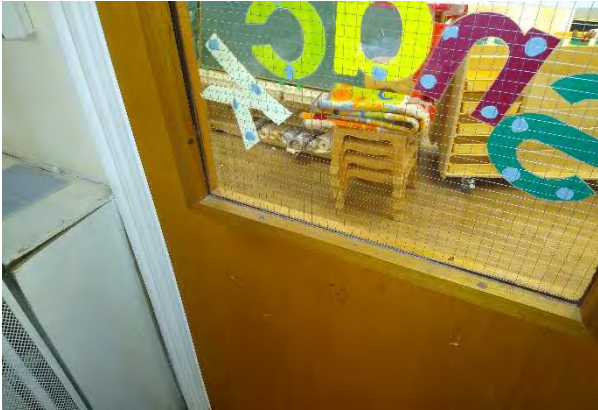
Item 155 Ref: As 369386-33

The sealant to door window panel in Rm 066/Staff Kitchen does not contain asbestos.

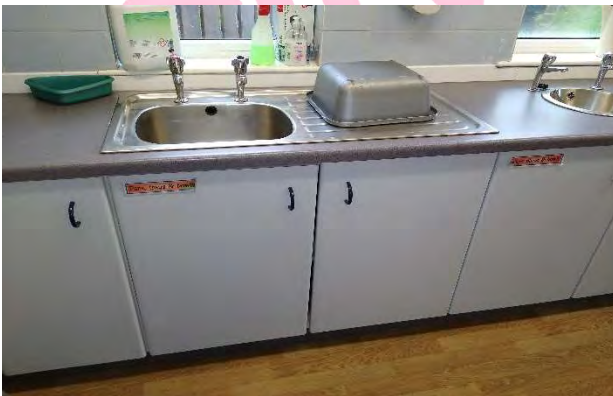
Item 156 Ref: 369386-35

The sink pads to sink and drainer in Rm 066/Staff Kitchen does not contain asbestos.

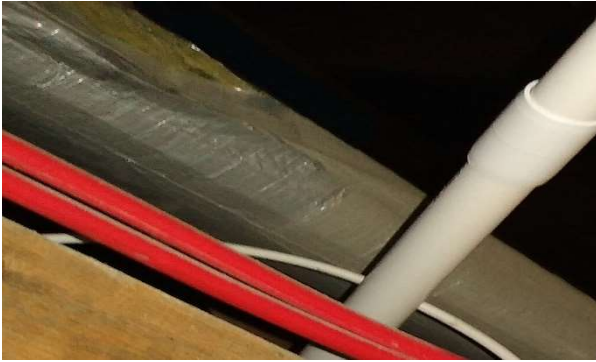
Item 157 Ref: As 369386-32

The debris to beams in Rm 066/Staff Kitchen – void above suspended ceiling does not contain asbestos.

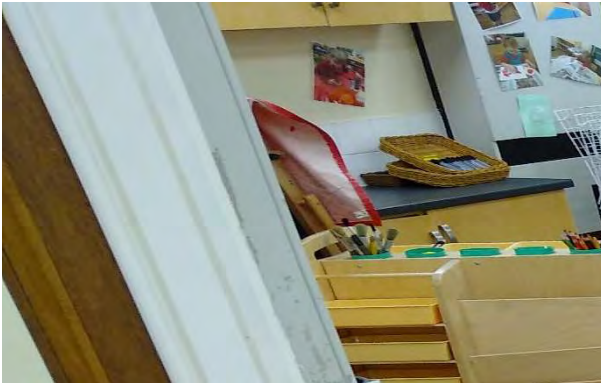
Item 158 Ref: 369386-36

The sealant to nursery door window panels in Rm 067/Cloakroom does not contain asbestos.
