ASBESTOS SURVEY REPORT FOR ALBANY PRIMARY SCHOOL, CROSSGILL, WASHINGTON, NE37 1UA.

Asbestos Register for Albany Primary School, Crossgill, Washington

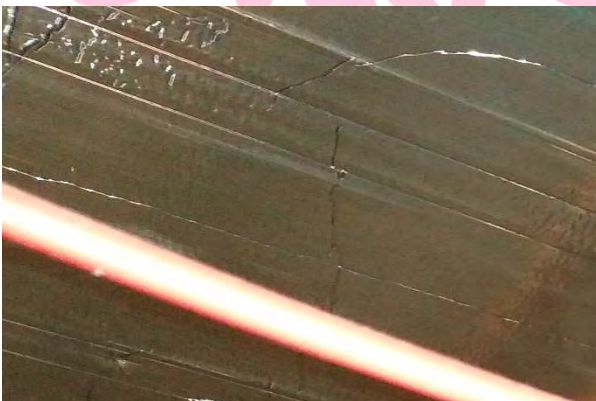
Item 159 Ref: As 369386-32

The debris to beams in Rm 067/Cloakroom – void above suspended ceiling does not contain asbestos.

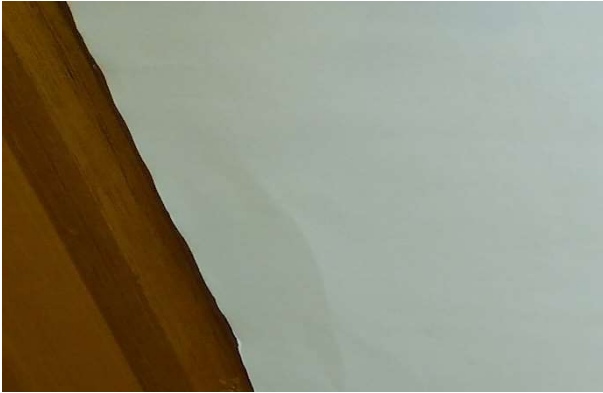
Item 160 Ref: As 369386-33

The sealant to door window panels in Rm 068/Sensory Area does not contain asbestos.

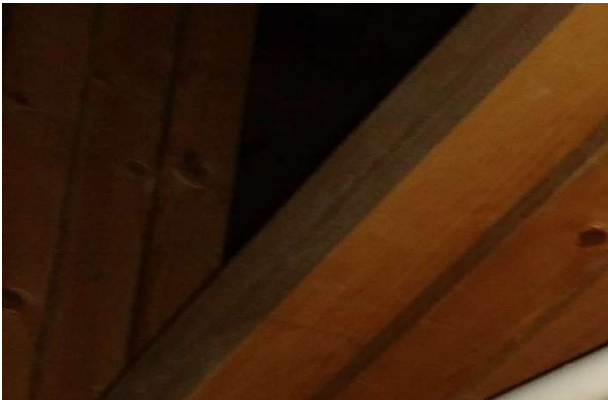
Item 161 Ref: As 369386-32

The debris to beams in Rm 068/Sensory Area – void above suspended ceiling does not contain asbestos.

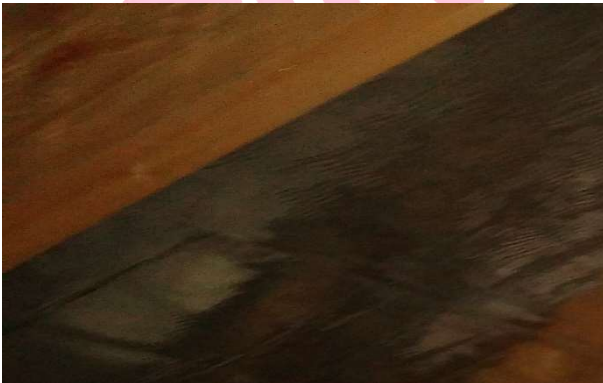
Item 162 Ref: As 369386-32

The debris to beams in Rm 068/Toilet Cubicles – void above suspended ceiling does not contain asbestos.

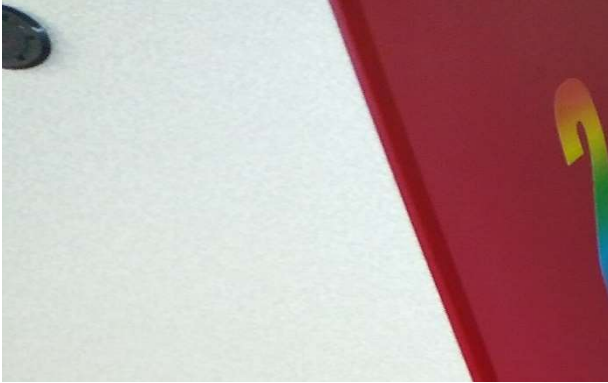
Item 163 Ref: 369386-34

The toilet seats in Rm 069/Toilet Cubicles does not contain asbestos.

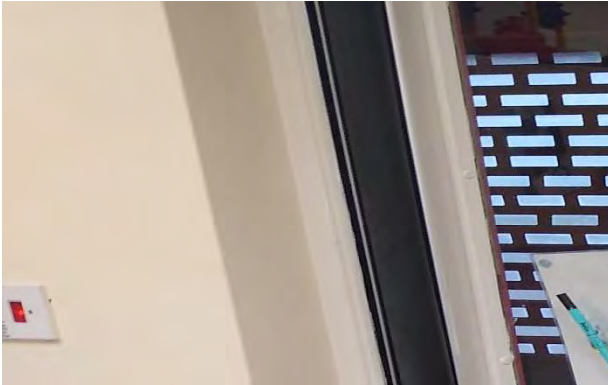
Item 164 Ref: As 369386-31

The sealant to play area door window panels in Rm 070/Nursery does not contain asbestos.

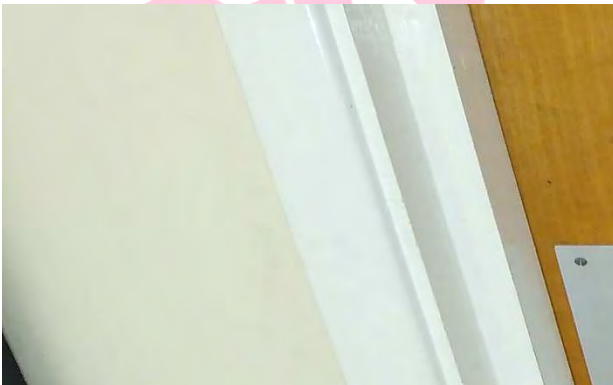
Item 165 Ref: 369386-33

The sealant to staff kitchen and sensory door window panels in Rm 070/Nursery does not contain asbestos.

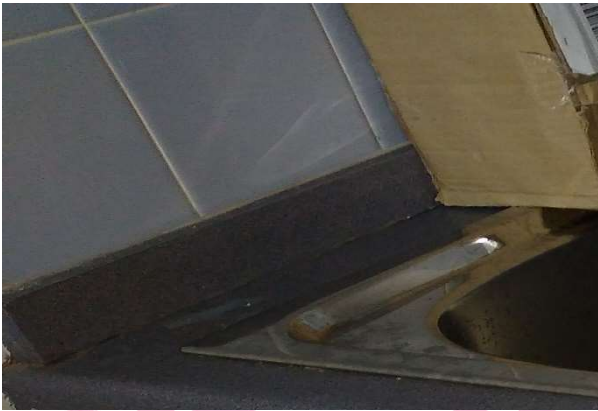
Item 167 Ref: 369386-67

The sink pads to sink and drainer in Rm 071/Wash room does not contain asbestos.

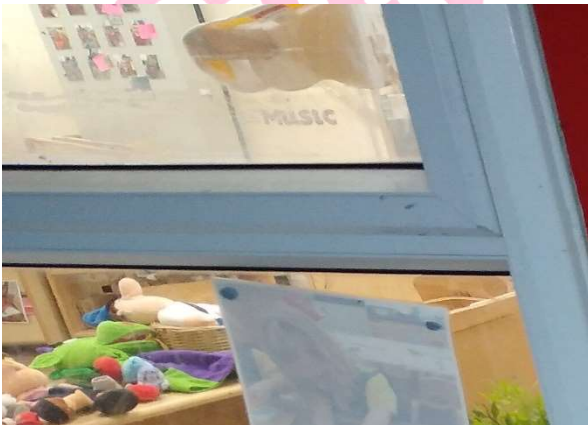
Item 168 Ref: 369386-31

The sealant to door window panels in Rm 073/Play Area does not contain asbestos.

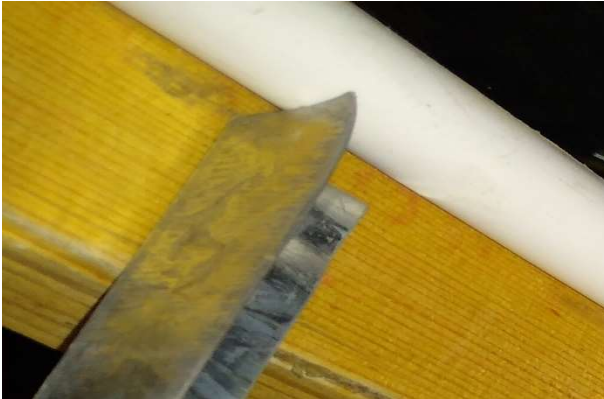
Item 169 Ref: 369386-32

The debris to beams in Rm 075/Accessible WC – void above suspended ceiling does not contain asbestos.

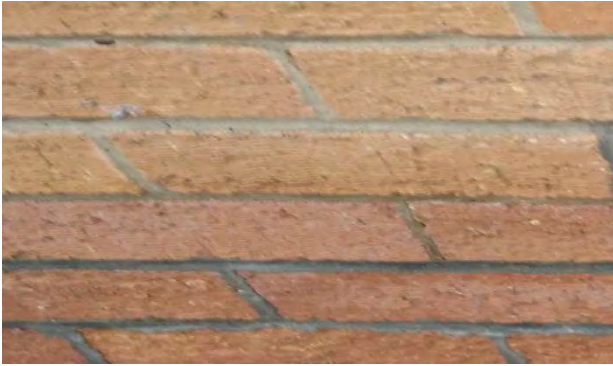
Item 172 Ref: 369386-97

The damp proof course (External) does not contain asbestos.

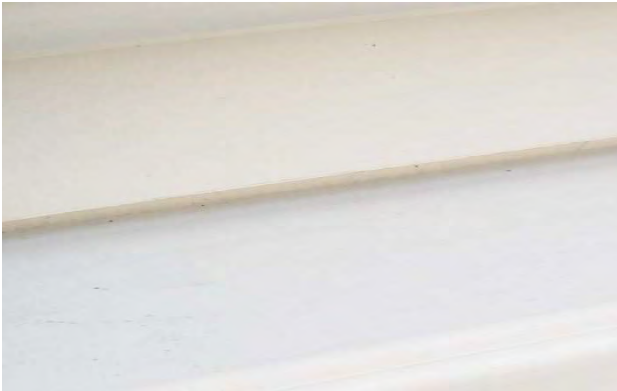
Item 173 Ref: 369386-98

The windowsills to kitchen (External) contain asbestos.

Any change in its appearance should be recorded and passed to Property Services.

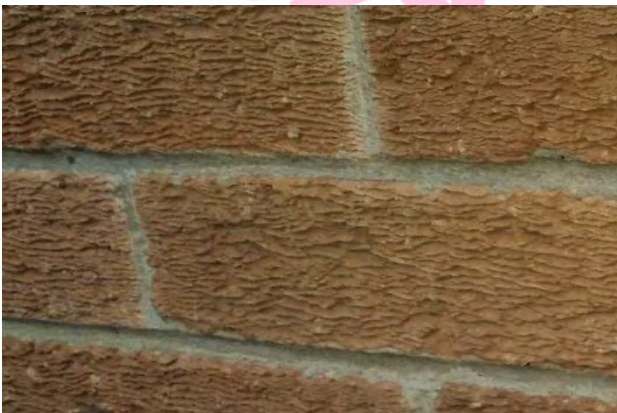
Item 174 Ref: 369386-99

The mastic to kitchen door (External) does not contain asbestos.

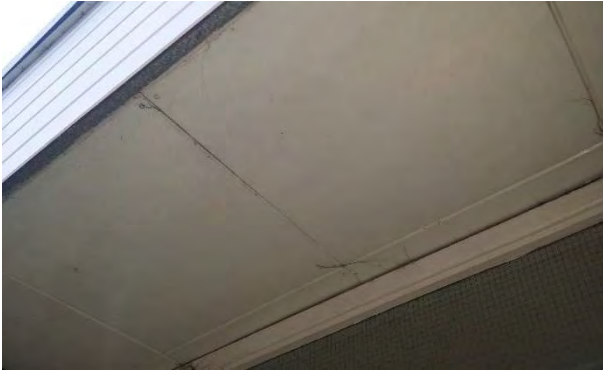
Item 175 Ref: 369386-100

The canopy's (External) contain asbestos.

Any change in its appearance should be recorded and passed to Property Services.

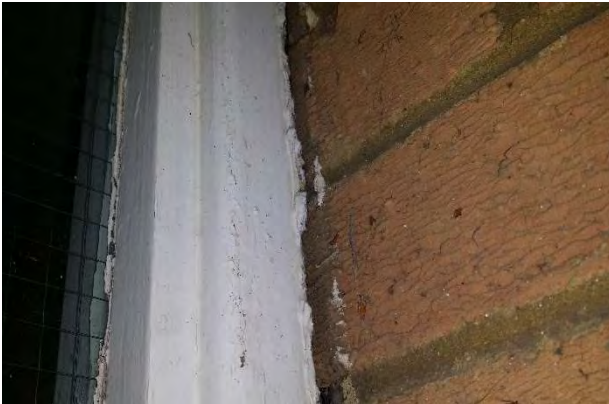
Item 176 Ref: 369386-101

The mastic to frames (External) does not contain asbestos.

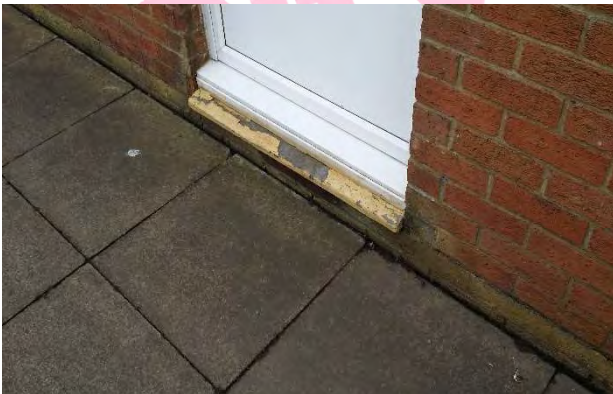
Item 177 Ref: As 369386-98

The windowsill to rear of school (External) contain asbestos.

Any change in its appearance should be recorded and passed to Property Services.

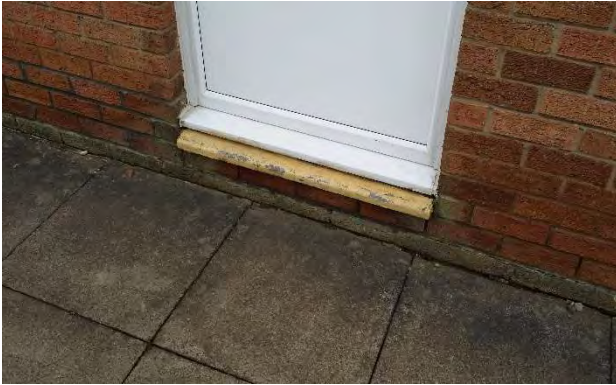
Item 178 Ref: As 369386-98

The windowsill to LHS rear of school (External) contain asbestos.

Any change in its appearance should be recorded and passed to Property Services.

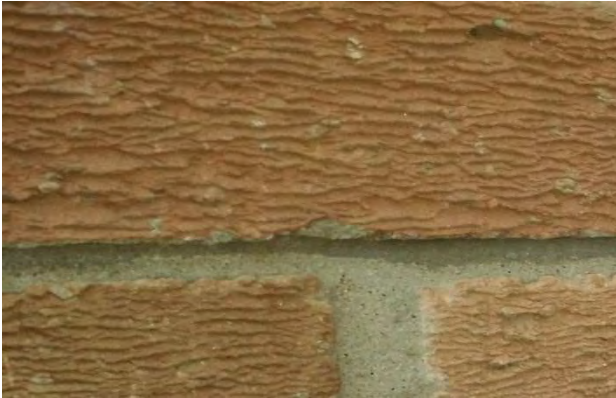
Item 179 Ref: 369386-102

The expansion gap filler to wall (External) does not contain asbestos.

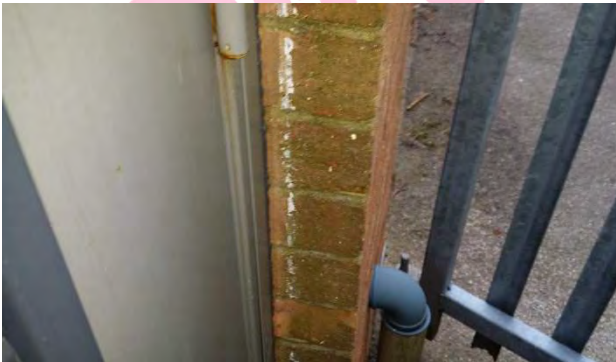
Item 180 Ref: 369386-103

The remnant mastic to walls (External) does not contain asbestos.

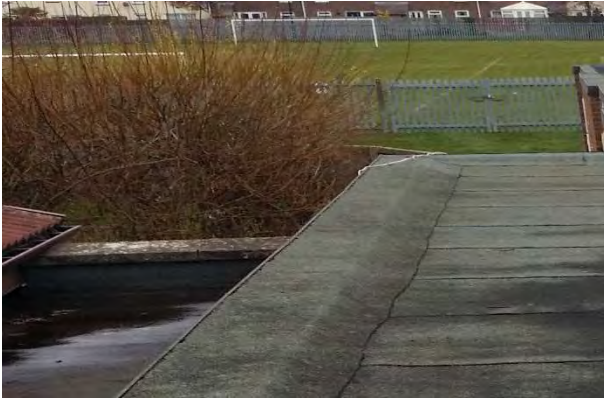
Item 181 Ref: 369386-104

The flat roof covering – top felt (External) does not contain asbestos.

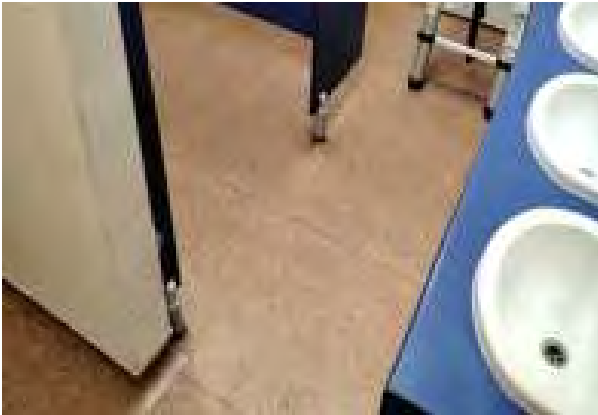
Item 182 Ref: DC0003614

The floor screed below modern covering in the male toilets (Room G/001) does not contain asbestos.

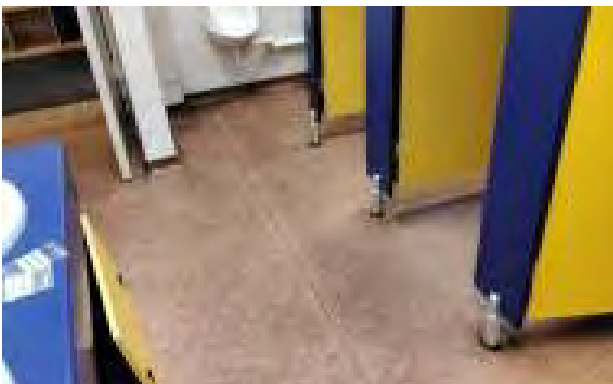
Item 183 Ref: DC0003615

The floor screed below modern covering in the male toilets (Room G/002) does not contain asbestos.

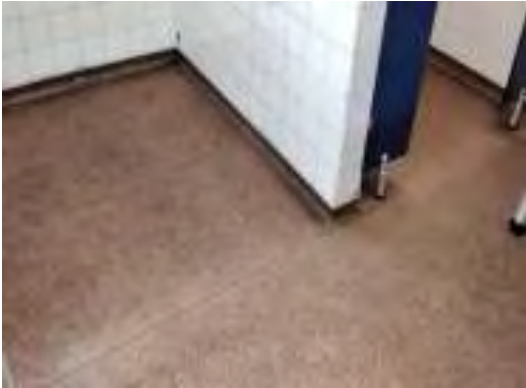
Item 184 Ref: DC0003616

The floor screed below modern covering in the male toilets (Room G/003) does not contain asbestos.
