### ASBESTOS SURVEY REPORT FOR BARMSTON VILLAGE PRIMARY SCHOOL, WASHINGTON

*Control of Asbestos  
Regulations 2012*

**BARMSTON VILLAGE PRIMARY SCHOOL**

**Date: 24 April 2026**

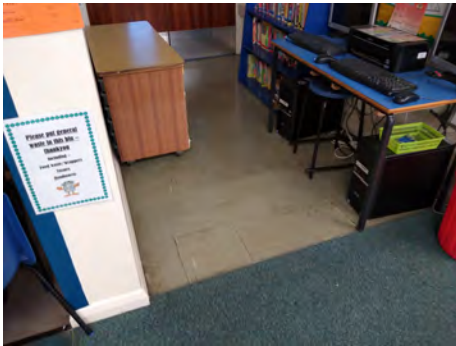
### **Item 1 Ref: As 369922-2**

- (Item 1) As 369922-2 - floor tiles removed, adhesive presumed to be still present (001/classroom) – Very Low Risk
- (Item 2) 369922-7 – green floor tile removed, adhesive presumed to be still present (001/classroom) – Very Low Risk

The floor tile & adhesive (001/classroom) contain asbestos.

***Floor tiles removed 2023 – presumed adhesive is still present***

Any change in appearance should be documented and passed to Property Services.

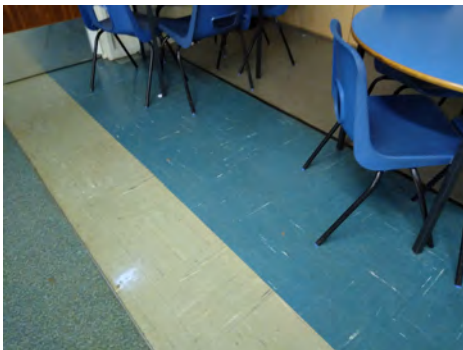
### **Item 2 Ref: 369922-7**

The green floor tile & adhesive (001/classroom) contain asbestos.

***Floor tiles removed 2023 – presumed adhesive is still present***

Any change in appearance should be documented and passed to Property Services.

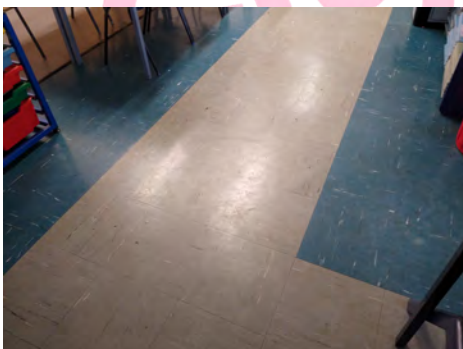
### **Item 3 Ref: As 369922-2**

The floor tile & adhesive (003/classroom) contain asbestos.

Any change in appearance should be documented and passed to Property Services.

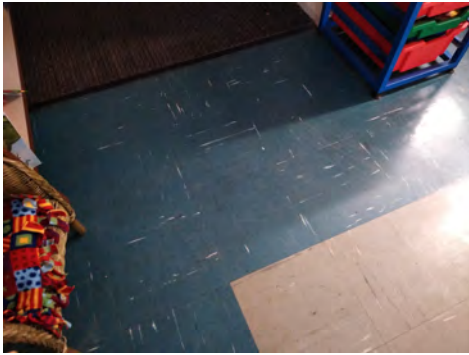
### **Item 4 Ref: As 369922-7**

The green floor tile & adhesive (003/classroom) contain asbestos.

***Floor tiles removed 2023 – presumed adhesive is still present***

Any change in appearance should be documented and passed to Property Services.

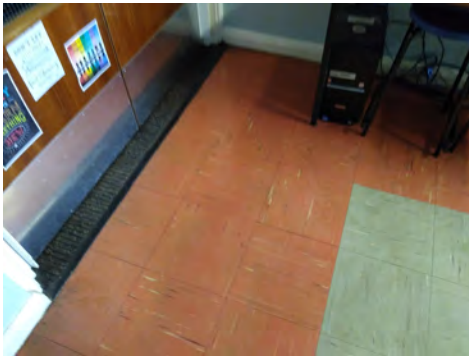
### **Item 5 Ref: As 369922-3**

The floor tile & adhesive (004/classroom) contain asbestos.

***Floor tiles removed 2021 – presumed adhesive is still present***

Any change in appearance should be documented and passed to Property Services.

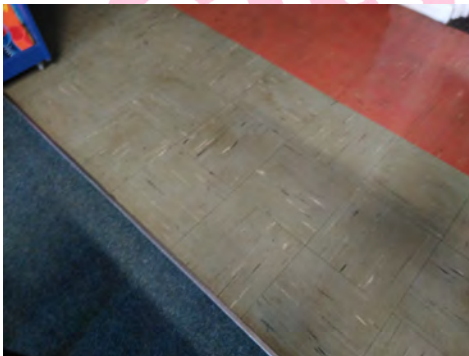
### **Item 6 Ref: As 369922-2**

The floor tile & adhesive (004/classroom) contain asbestos.

Any change in appearance should be documented and passed to Property Services.

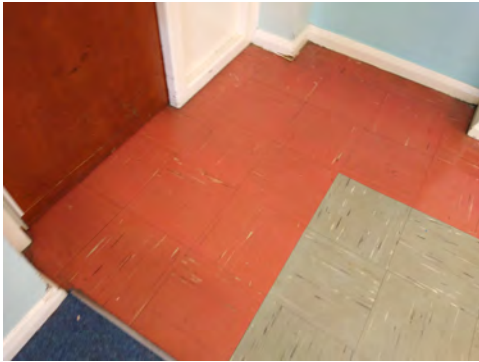
### **Item 7 Ref: As 369922-3**

The floor tile & adhesive (006/classroom) contain asbestos.

***Floor tiles removed 2021 – presumed adhesive is still present***

Any change in appearance should be documented and passed to Property Services.

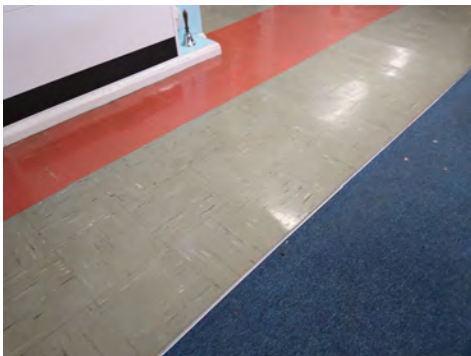
### **Item 8 Ref: As 369922-2**

The floor tile & adhesive (006/classroom) contain asbestos.

***Floor tiles removed 2021 – presumed adhesive is still present***

Any change in appearance should be documented and passed to Property Services.

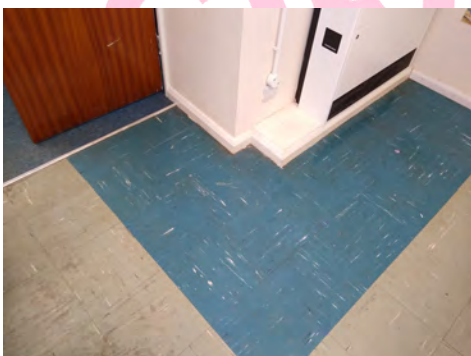
### **Item 9 Ref: 369922-37**

The blue floor tiles & adhesive (007/classroom) contain asbestos.

Any change in appearance should be documented and passed to Property Services.

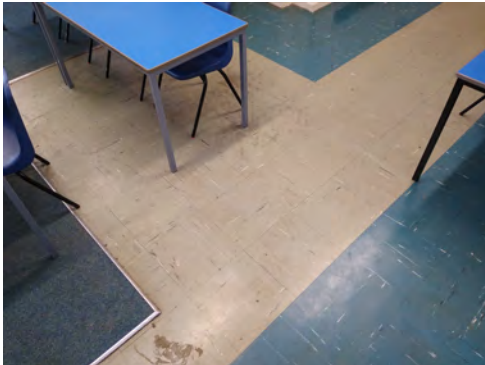
### **Item 10 Ref: 369922-38**

The grey floor tiles & adhesive (007/classroom) contain asbestos.

***Floor tiles removed 2021 – presumed adhesive is still present***

Any change in appearance should be documented and passed to Property Services.

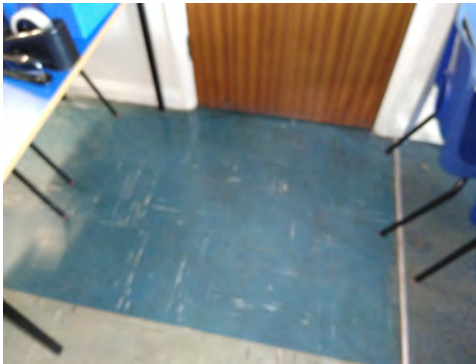
### **Item 11 Ref: As 369922-37**

The blue floor tiles & adhesive (009/classroom) contain asbestos.

***Floor tiles removed 2021 – presumed adhesive is still present***

Any change in appearance should be documented and passed to Property Services.

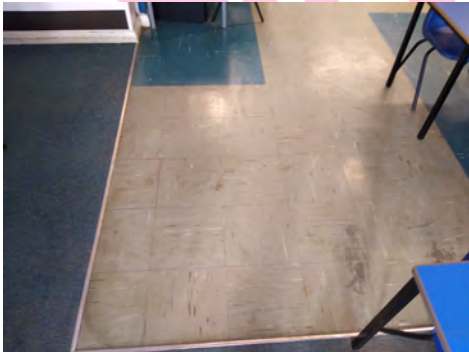
### **Item 12 Ref: As 369922-38**

The grey floor tiles & adhesive (009/classroom) contain asbestos.

Any change in appearance should be documented and passed to Property Services.

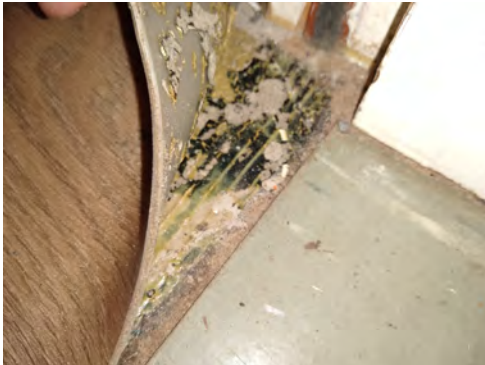
### **Item 13 Ref: As 369922-35**

The bitumen adhesive (010/classroom) contains asbestos.

***Removed March 2021***

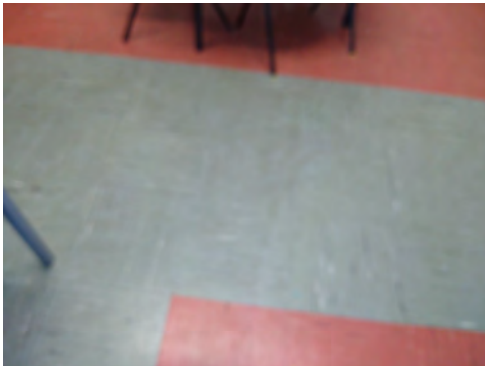
### **Item 14 Ref: As 369922-38**

The grey floor tiles & adhesive (012/classroom) contain asbestos.

***Floor tiles removed 2021 – presumed adhesive is still present***

Any change in appearance should be documented and passed to Property Services.

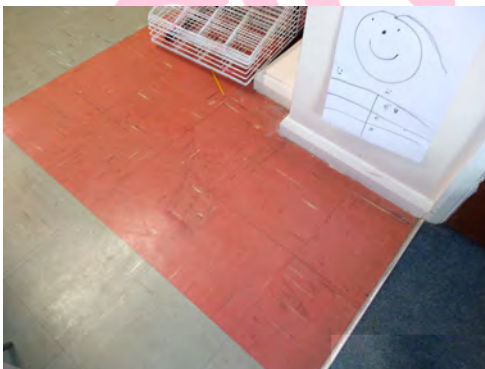
### **Item 15 Ref: As 369922-39**

The red floor tiles & adhesive (012/classroom) contain asbestos.

Any change in appearance should be documented and passed to Property Services.

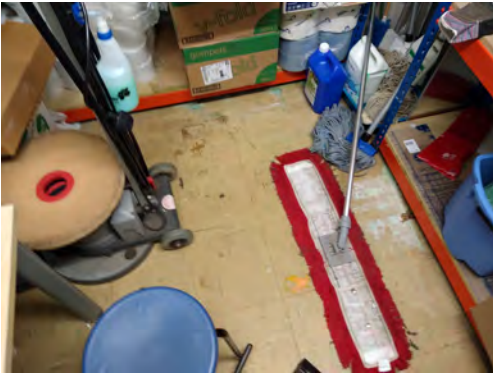
### **Item 16 Ref: 369922-5**

The cream floor tile & adhesive (013/caretaker) contain asbestos.

Any change in its appearance should be documented and passed to Property Services.

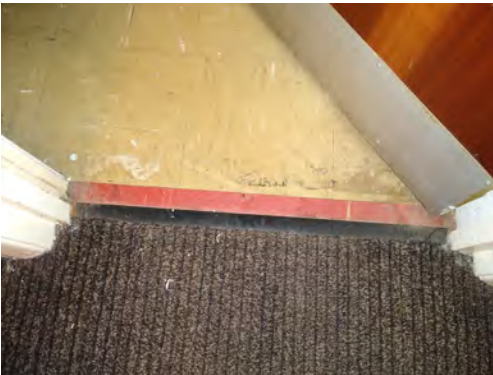
### **Item 17 Ref: As 369922-3**

The red floor tile & adhesive (013/caretaker) contain asbestos.

Any change in its appearance should be documented and passed to Property Services.

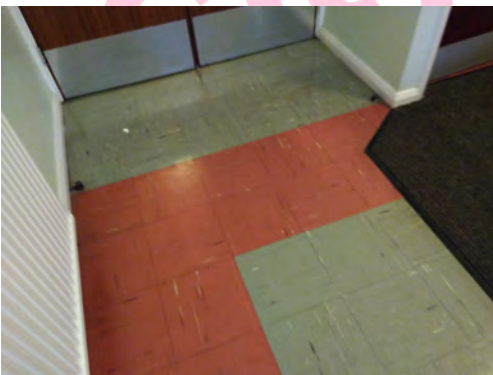
### **Item 18 Ref: 369922-2**

The grey floor tile & adhesive (014A/corridor) contain asbestos.

Any change in its appearance should be documented and passed to Property Services.

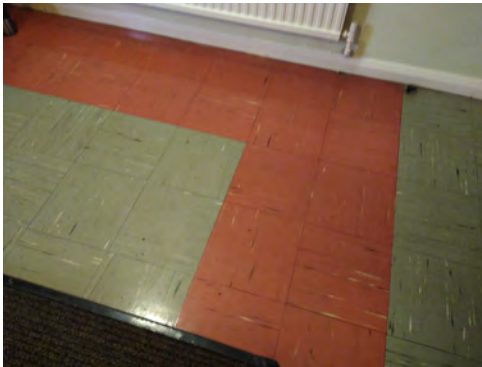
### **Item 19 Ref: 369922-3**

The red floor tile & adhesive (014A/corridor) contain asbestos.

Any change in its appearance should be documented and passed to Property Services.

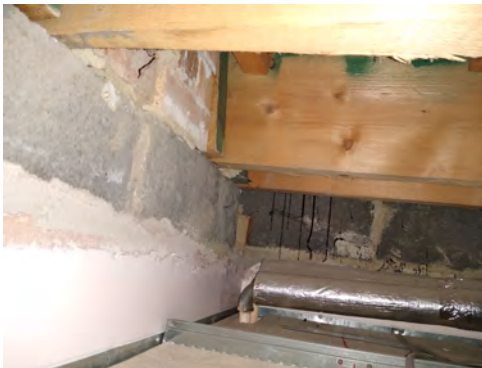
### **Item 20 Ref: 193462-8**

The packers to wood joists (016/Staff Lockers void above) contain asbestos.

Any change in its appearance should be documented and passed to Property Services.

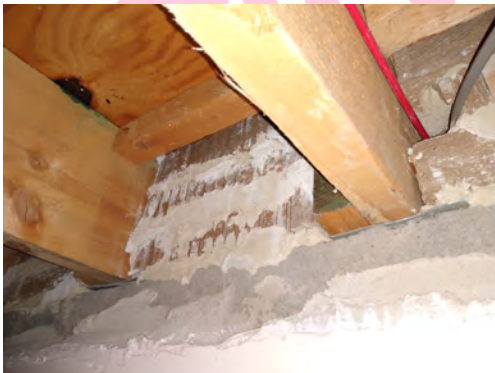
### **Item 21 Ref: As 193462-8**

The packers to wood joists (018/Staff Room void above) contain asbestos.

Any change in its appearance should be documented and passed to Property Services.

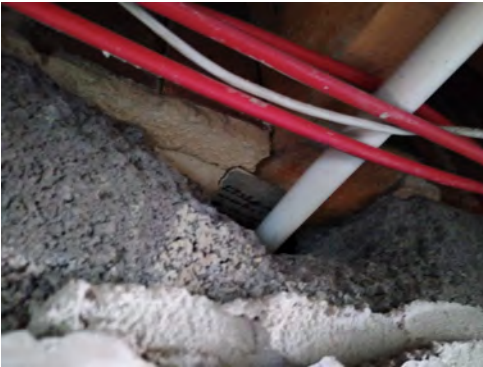
### **Item 22 Ref: As 193462-8**

The packers to wood joists (020/Corridor void above) contain asbestos.

Any change in its appearance should be documented and passed to Property Services.

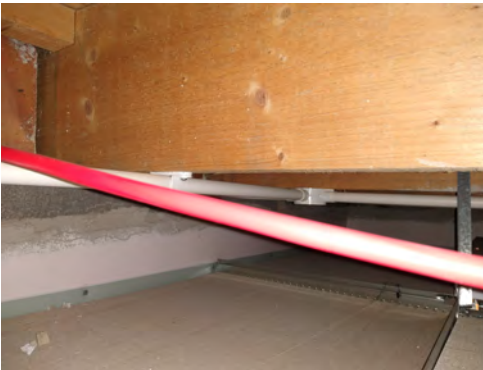
### **Item 23 Ref: As 193462-8**

The packers to wood joists (022/meeting room void above) contain asbestos.

Any change in its appearance should be documented and passed to Property Services.

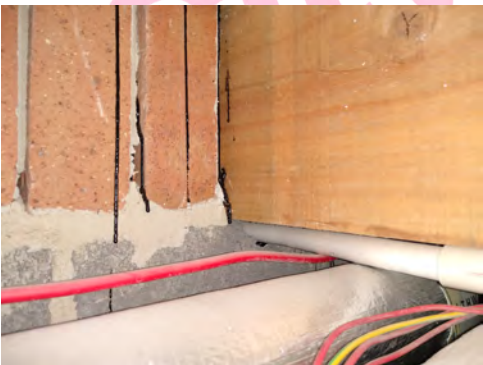
### **Item 24 Ref: As 193462-8**

The packers to wood joists (023/accessible wc void above) contain asbestos.

Any change in its appearance should be documented and passed to Property Services.

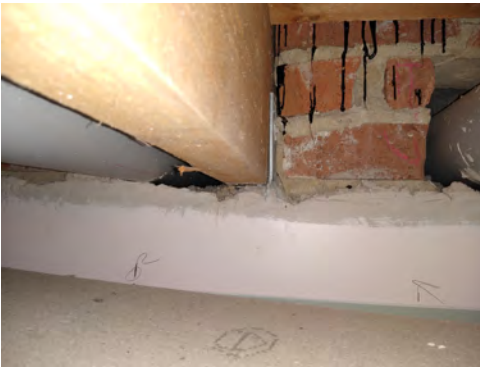
### **Item 25 Ref: As 193462-3**

The packers to wood joists (024/deputy headteacher wc void above) contain asbestos.

Any change in its appearance should be documented and passed to Property Services.

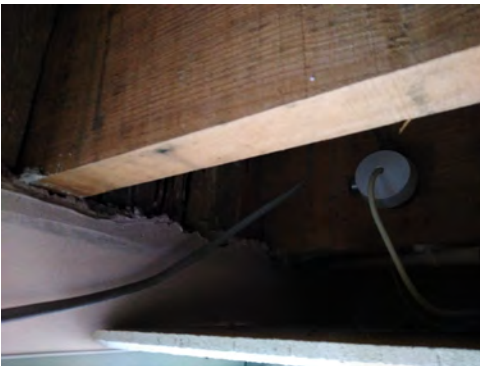
### **Item 26 Ref: As 193462-3**

The packers to wood joists (025/deputy headteacher void above) contain asbestos.

Any change in its appearance should be documented and passed to Property Services.

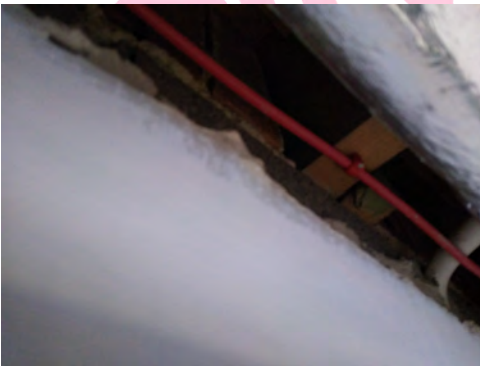
### **Item 27 Ref: As 193462-3**

The packers to wood joists (026/headteacher void above) contain asbestos.

Any change in its appearance should be documented and passed to Property Services.

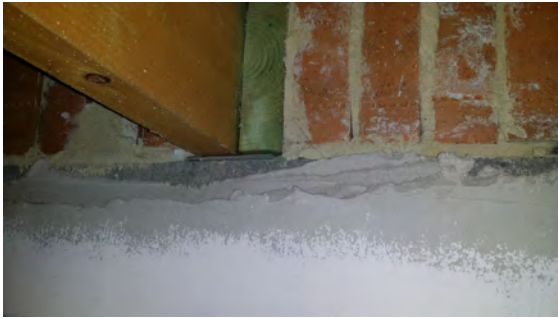
### **Item 28 Ref: As 193462-3**

The packers to wood joists (029/reception office void above) contain asbestos.

Any change in its appearance should be documented and passed to Property Services.

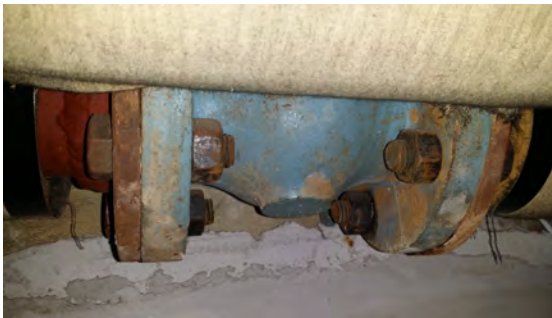
### **Item 29 Ref: Presumed**

The pipework flange gasket (030/Corridor void above) is presumed to contain asbestos.

Any change in its appearance should be documented and passed to Property Services.

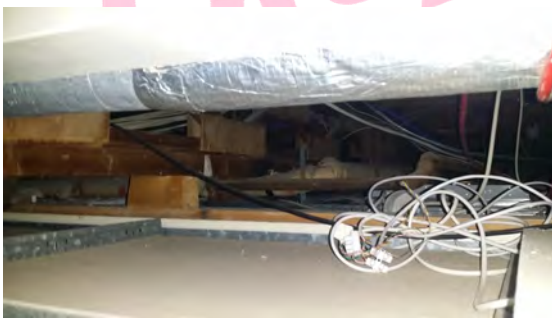
### **Item 30 Ref: As 193462-3**

The packers to wood joists (030/Corridor void above) contain asbestos.

Any change in its appearance should be documented and passed to Property Services.

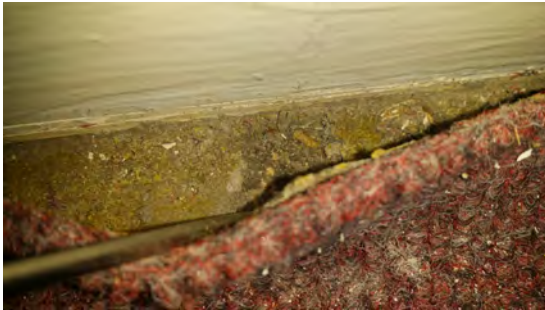
### **Item 31 Ref: 369922-34**

The remnant adhesive backing to floor (031/Computer suite) does not contain asbestos.

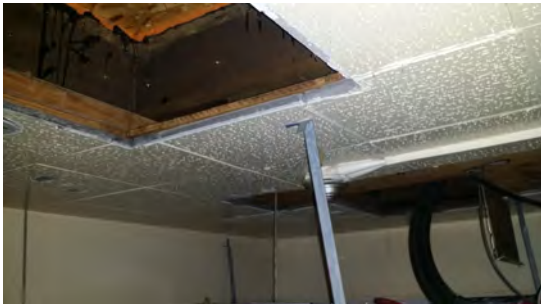
### **Item 32 Ref: 193462-7**

The adhesive to upper level ceiling tiles in former extract opening (031/Computer suite void above) contain asbestos.

Any change in its appearance should be documented and passed to Property Services.

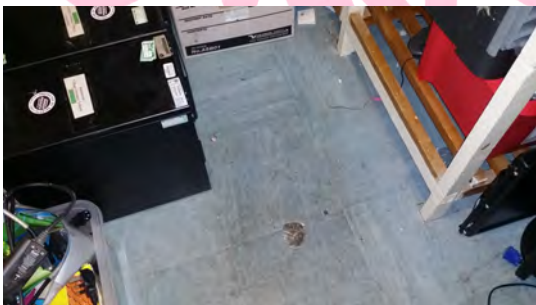
### **Item 33 Ref: 369922-11**

The floor covering (033/store) does not contain asbestos.

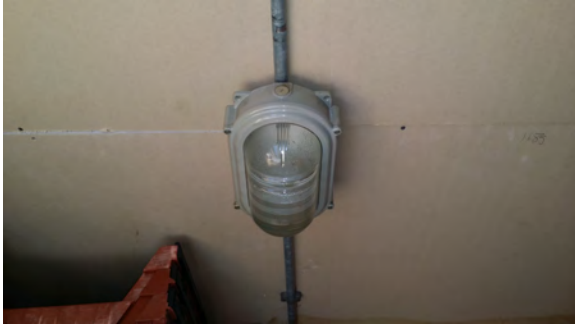
### **Item 34 Ref: 193462-10**

The sealant to glass lens in bulkhead light fitting (034/External Store) contains asbestos.

Any change in its appearance should be documented and passed to Property Services.

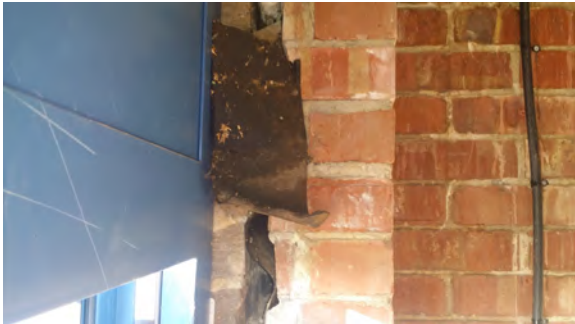
### **Item 35 Ref: 369922-41**

The damp proof membrane within wall cavity (034/External store) does not contain asbestos.

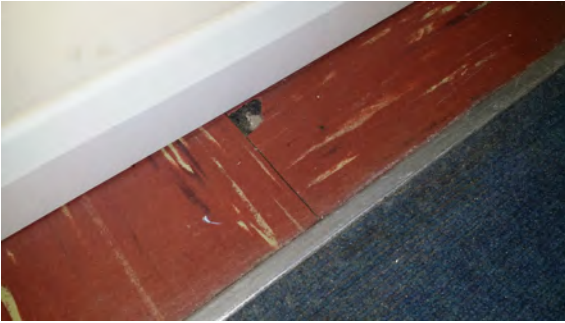
### **Item 40 Ref: As 369922-15**

The floor covering (035a/meeting room) contains asbestos.

Any change in its appearance should be documented and passed to Property Services.

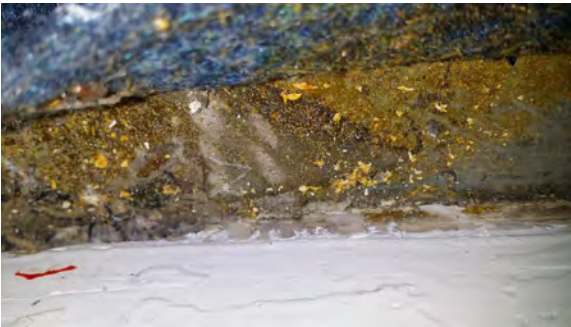
### **Item 41 Ref: 369922-17**

The subfloor (035a/meeting room) contains asbestos.

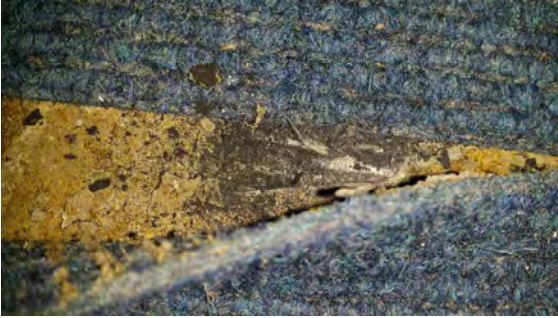
### **Item 43 Ref: 369922-18**

The adhesive backing to floor (035b/store) does not contain asbestos.

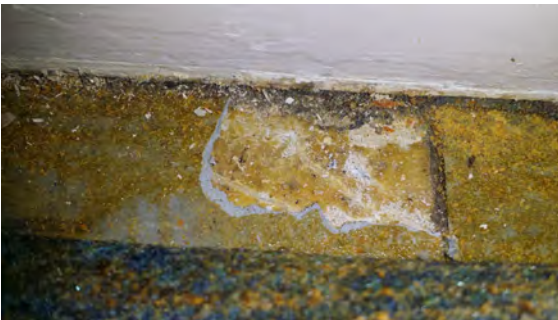
### **Item 44 Ref: 369922-12**

The subfloor (036/breakfast club) contains asbestos.

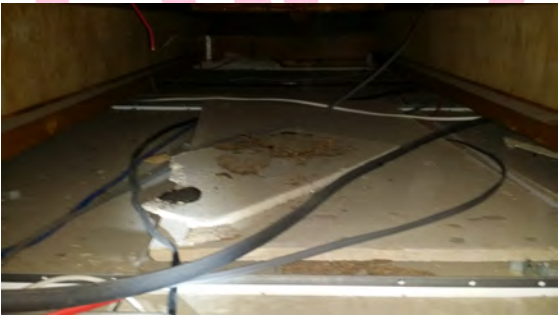
### **Item 45 Ref: 193462-1**

The roof covering debris to topside of suspended ceiling (036/breakfast club void above) does not contain asbestos.

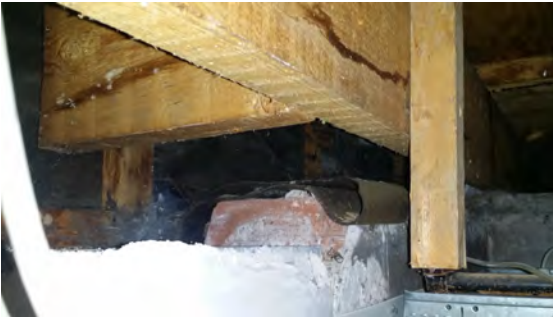
### **Item 55 Ref: 369922-26**

The felt to external wall (042/classroom area void above) does not contain asbestos.

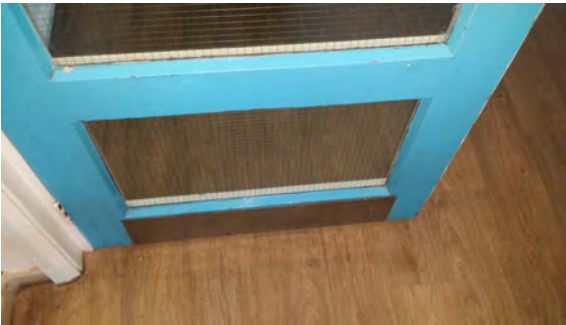
### **Item 56 Ref: 369922-29**

The sealant to window glazing at doors (043/entrance lobby) does not contain asbestos.

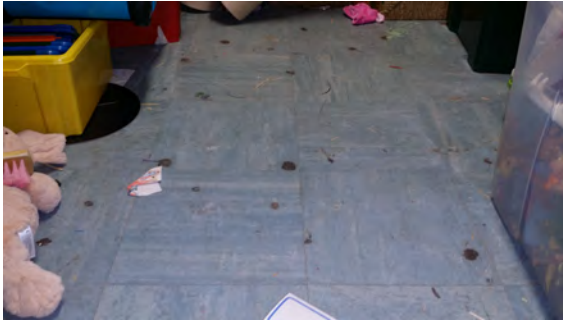
### **Item 58 Ref: 369922-27**

The floor covering (045/store) contains asbestos.

Any change in its appearance should be documented and passed to Property Services.

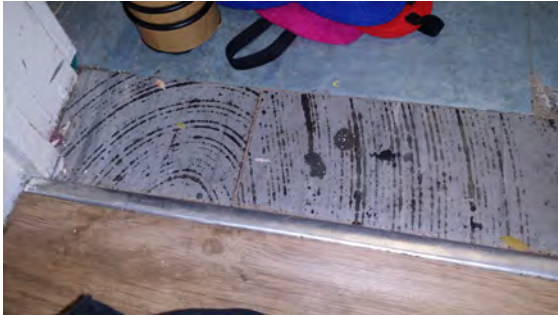
### **Item 59 Ref: 369922-28**

The floor covering (045/store) contains asbestos.

Any change in its appearance should be documented and passed to Property Services.

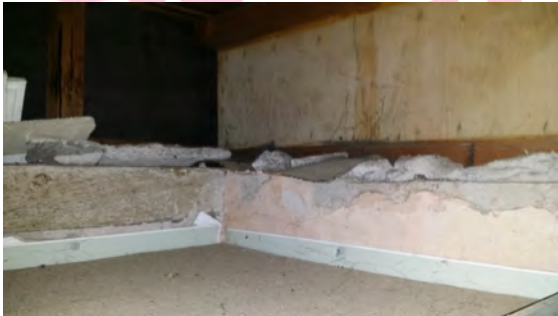
### **Item 60 Ref: As 369922-26**

The felt to external wall (045/store void above) does not contain asbestos.

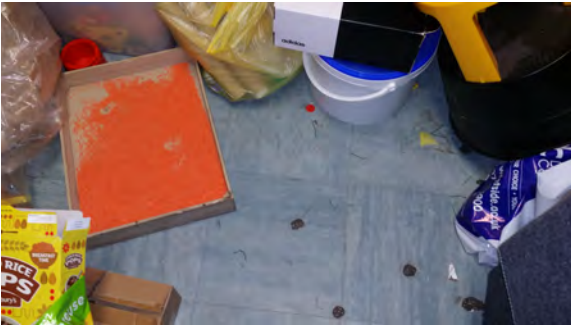
### **Item 61 Ref: As 369922-27**

The floor covering (046/store) contains asbestos.

Any change in its appearance should be documented and passed to Property Services.

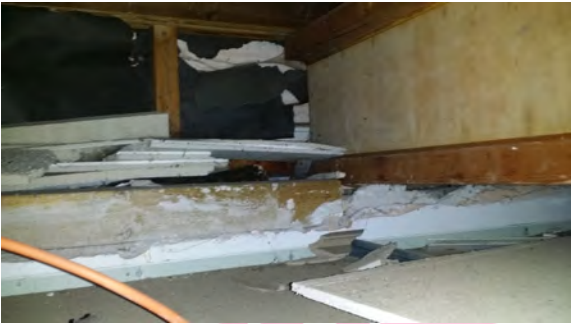
### **Item 62 Ref: As 369922-26**

The felt to external wall (046/store void above) does not contain asbestos.

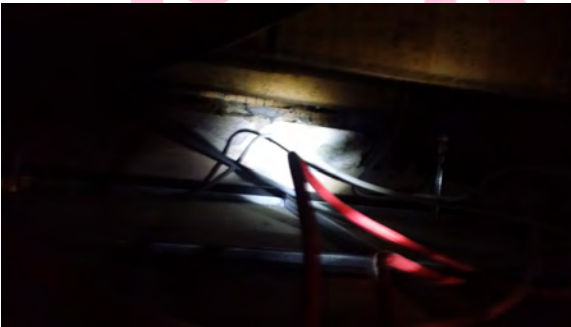
### **Item 63 Ref: As 369922-26**

The felt to external wall (047/boys wc void above) does not contain asbestos.

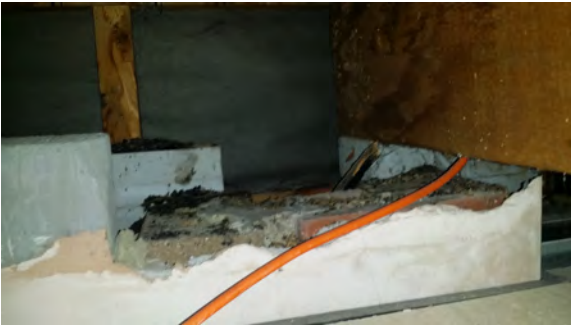
### **Item 64 Ref: As 369922-26**

The felt to external wall (048/girls wc void above) does not contain asbestos.

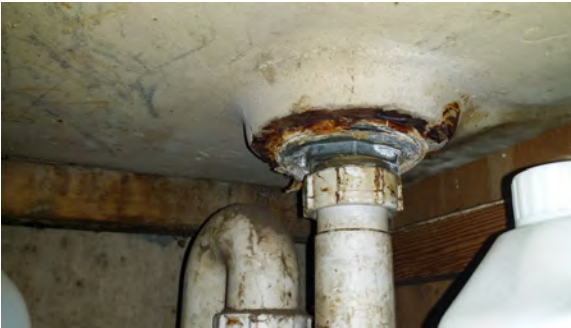
### **Item 65 Ref: 369922-25**

The seal to basin pipe (049/cleaner) does not contain asbestos.

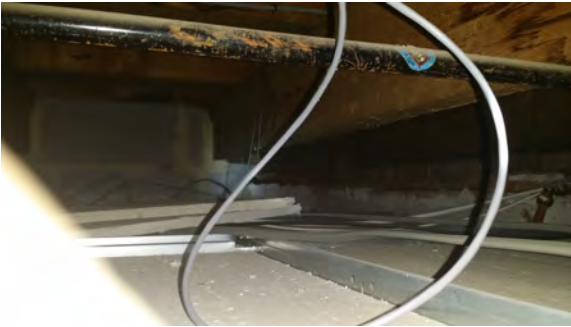
### **Item 67 Ref: As 369922-13**

The felt to external walls (050/kitchen void above) does not contain asbestos.

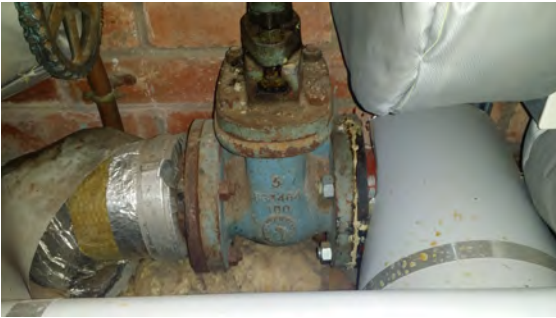
### **Item 70 Ref: Presumed**

The gasket to pipework (051/boiler room) is presumed to contain asbestos.

Any change in its appearance should be documented and passed to Property Services.

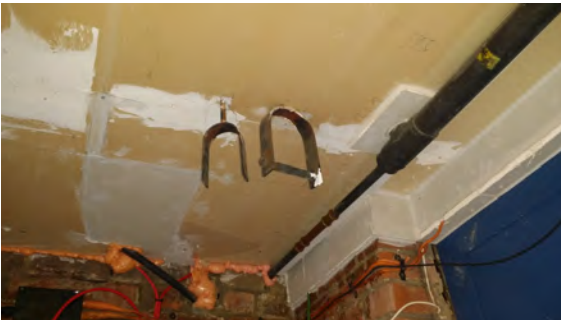
### **Item 71 Ref: 369922-43**

The debris to pipehangers (051/boiler room) do not contain asbestos.

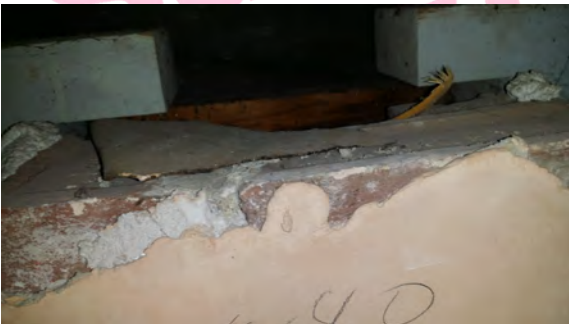
### **Item 72 Ref: As 369922-13**

The felt to external wall (052/Pupil WC void above) does not contain asbestos.

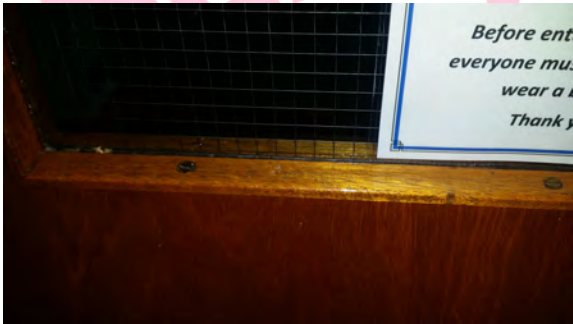
### **Item 84 Ref: 369922-19**

The sealant to glazing at doors (071/Hall) does not contain asbestos.

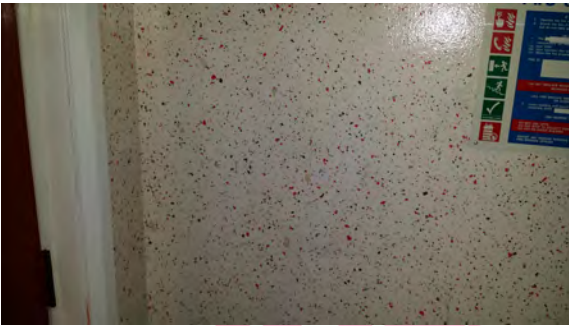
### **Item 86 Ref: 369922-22**

The coating to walls (072/Entrance lobby) does not contain asbestos.

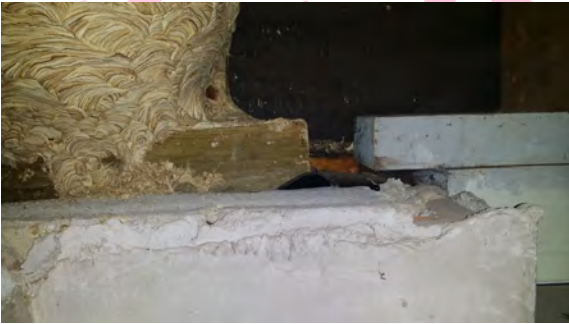
### **Item 87 Ref: As 369922-32**

The felt to external walls (073/Staff WC void above) does not contain asbestos.

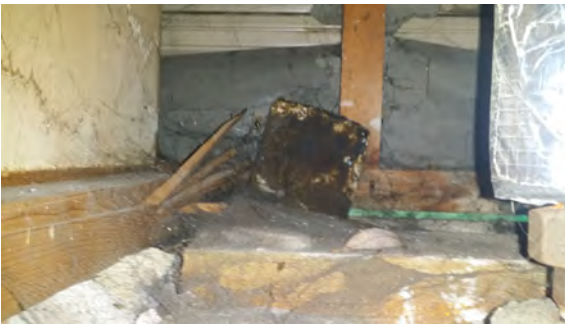
### **Item 92 Ref: As 369922-32**

The felt to external wall (076/Store void above) does not contain asbestos.

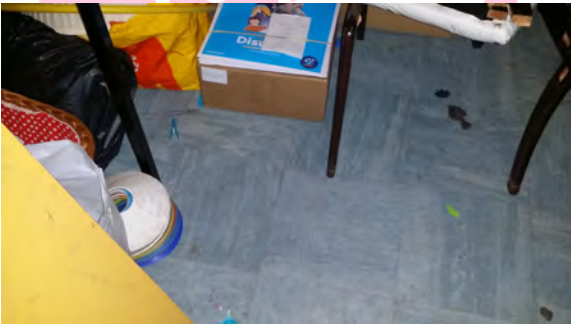
### **Item 93 Ref: As 369922-11**

The floor covering (077/Store) does not contain asbestos.

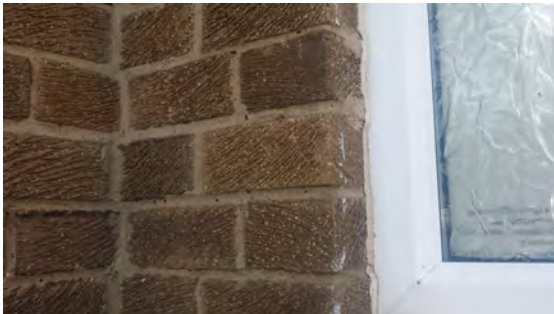
### **Item 116 Ref: 369922-40**

The remnant mastic to walls (External) does not contain asbestos.

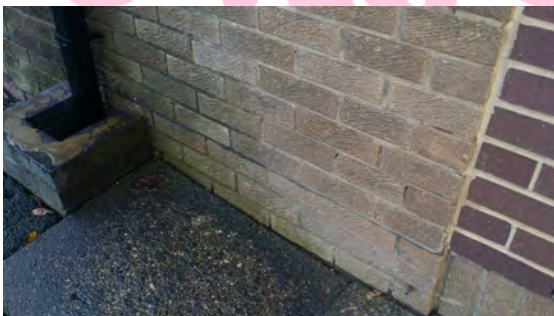
### **Item 117 Ref: 369922-44**

The damp proof course (External) does not contain asbestos.
