ASBESTOS SURVEY REPORT FOR BROADWAY JUNIOR SCHOOL,  
SPRINGWELL ROAD, SUNDERLAND, SR4 8NW.

*Control of Asbestos  
Regulations 2012*

**Broadway Junior School, Springwell Road, SR4 8NW**

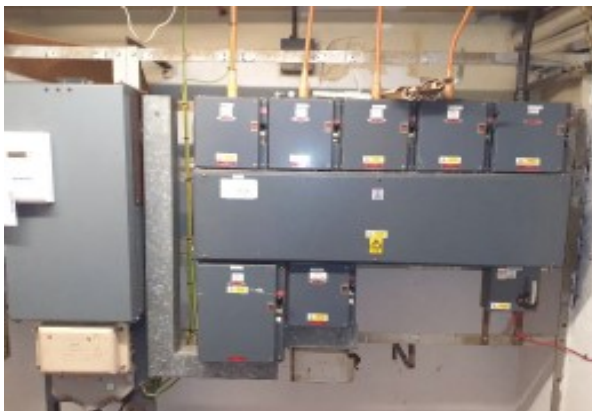
**Item 63 Ref: 22-45075-3**

The Flashguards/fuses within older MEM electrics (Electrical cupboard G/01) contain asbestos.
