ASBESTOS SURVEY REPORT FOR THE PALLION CENTRE, WAVERLEY TERRACE, SUNDERLAND

Asbestos Register for The Pallion Centre

Date: 11 February 2026

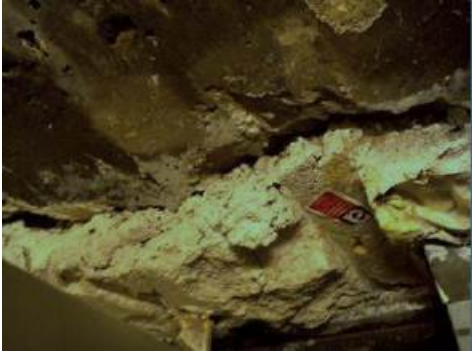
Item 1 Ref: Presumed

It is possible that there will be some asbestos fibres to the porous concrete ceiling of the boiler room (Sub level Room 1).

This should be encapsulated.

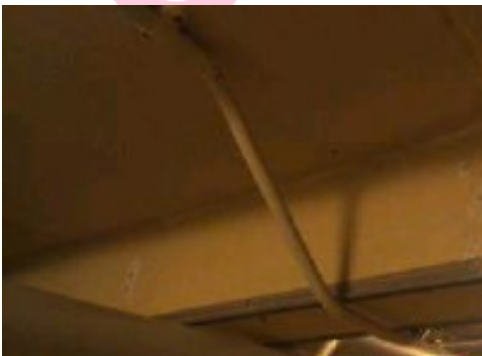
Item 3 As AP001909

The insulating board to the high level boxing to the ceiling in the boiler room (Sub level Rm 1) does not contain asbestos.

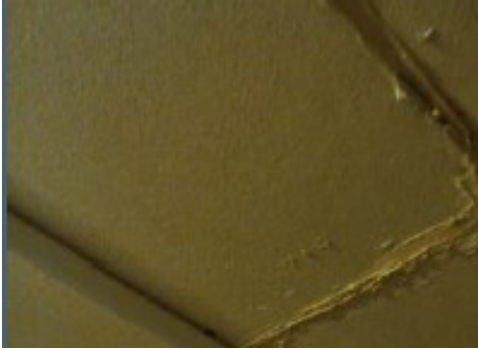
Item 4 Ref: AP001910

The mastic between the ceiling panels to the ceiling of the boiler room (Sub level Room 001) does not contain asbestos.

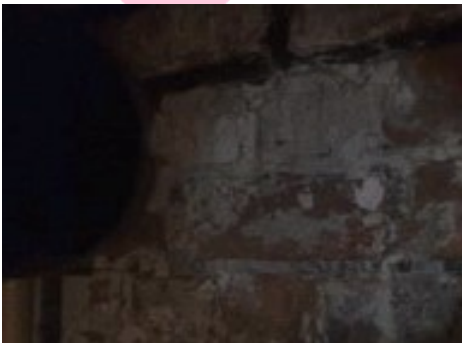
Item 6 Ref: AP001912

The residue to the wall in the boiler room (Sub level Room 1) contains asbestos.

Any change in its appearance should be recorded and passed to Property Services.

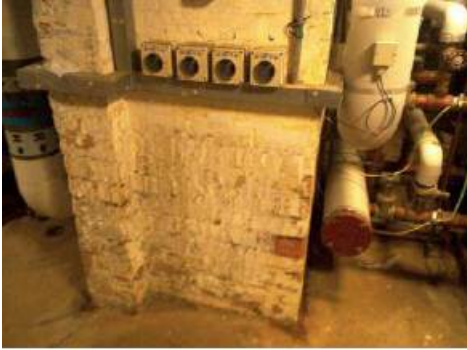
Item 7 Ref: AP001913

The residue to the central brick column to the plant room (Sub level Room 1) does not contain asbestos.

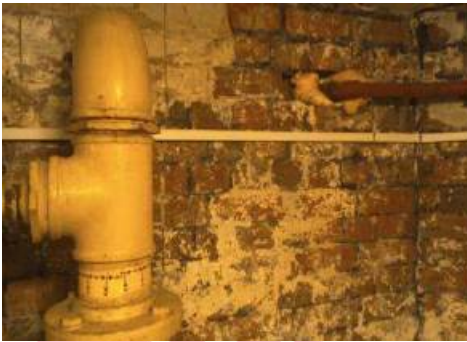
Item 8 Ref: AP001914

The residue to the wall in the boiler room (Sub level Room 1) contains asbestos.

This is encapsulated and no works should take place on the walls.

Any change in its appearance should be recorded and passed to Property Services.

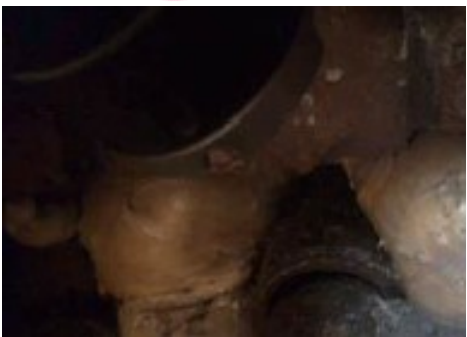
Item 9 Ref: AP001915

The residue to the pipe on the wall in the boiler room (Sub level Room 1) contains asbestos.

Any change in its appearance should be recorded and passed to Property Services.

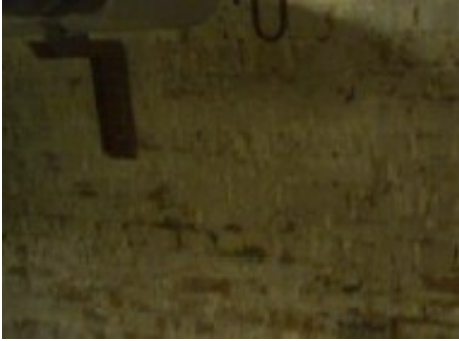
Item 10 Ref: AP001916

The residue to the wall in the plant room (Sub level Room 1) does not contain asbestos.

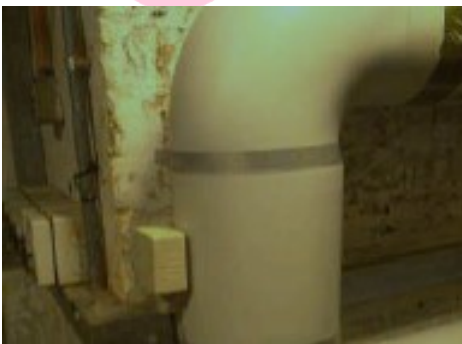
Item 12 Ref: AP001918

The large bore pipe insulation in the boiler room (Sub level Room 1) does not contain asbestos.

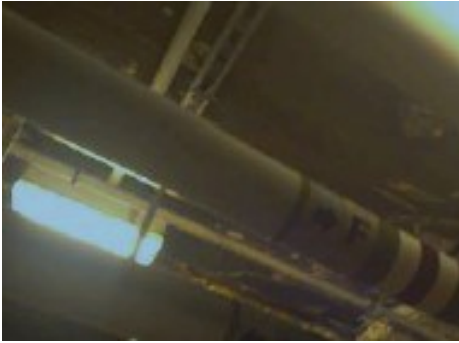
Item 13 Ref: AP001919

The small bore pipe insulation to the plant room (Sub level Room 1) does not contain asbestos.

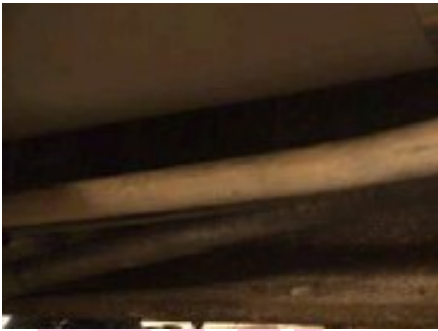
Item 14 Ref: AP001920

The debris to the horizontal surface on the beam in the boiler room (Sub level Room 1) contained asbestos.

An environmental clean should be carried out.

Any change in its appearance should be recorded and passed to Property Services.

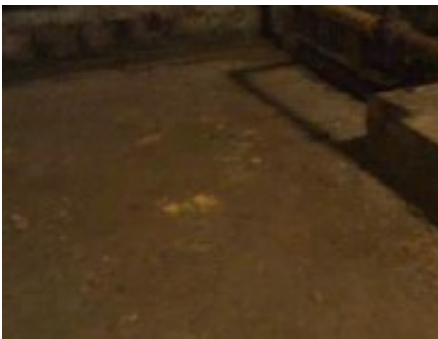
Item 15 Ref: AP001921

The general floor debris to the boiler room (Sub level Room 1) does not contain asbestos.

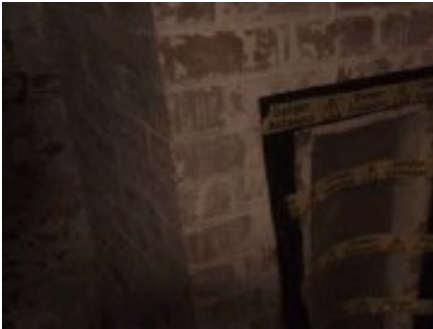
There is possibly asbestos within the sealed brick riser in the plant room (Sub level Room 1). Prior to any intrusive works, a survey must be carried out.

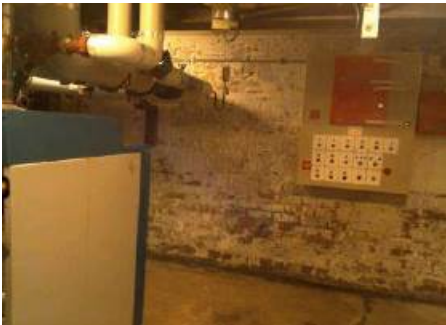
There was no access to the live electrics in the boiler room (Sub level Room 1). Prior to any work starting, carry out further surveying.

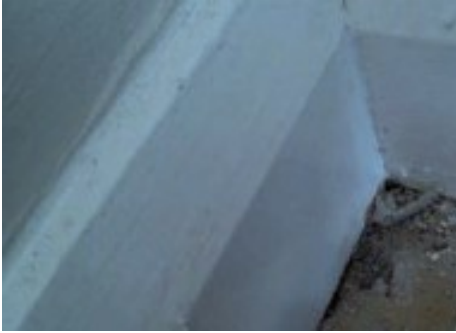
Item 17 As: AP001884

The remaining adhesive to the floor beneath the carpet and modern screed in the entrance lobby (Room 2) contains asbestos.

Any change in its appearance should be recorded and passed to Property Services.

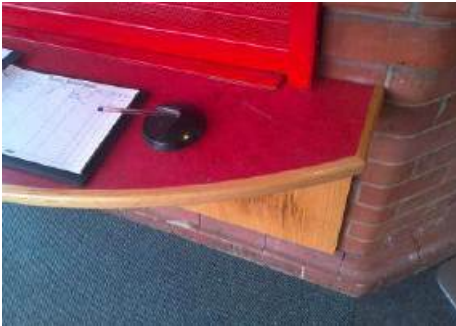
Item 18 Ref: AP001885

The vinyl to the hatch in the entrance lobby (Room 2) does not contain asbestos.

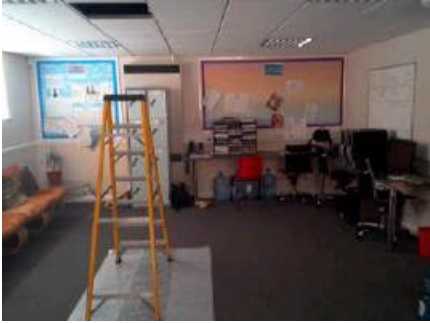
The staff room (Room 4) was accessed, and no suspect materials were found.

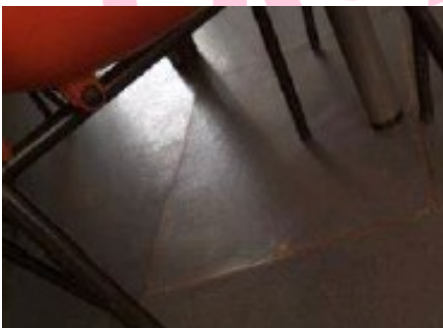
There was no access to the floor duct in the staff kitchen (Room 5).

Prior to any works, there needs to be further investigation.

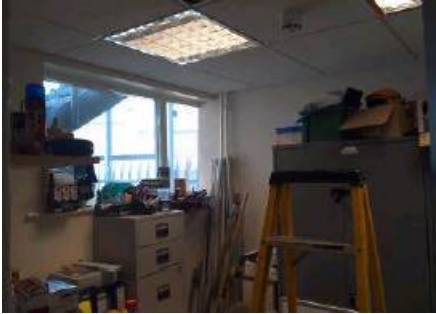
The caretakers office (Room 11) was accessed and no suspect materials were found.

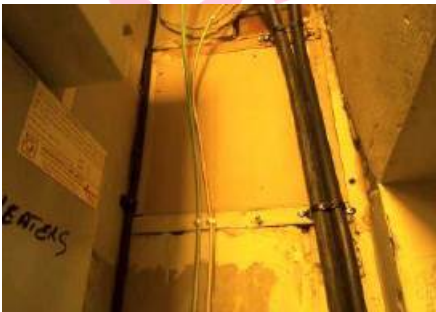
There was no access behind the plasterboard panel in the electrical store (Room 12) due to possible damage.

Prior to work taking place, prior investigation needs to be carried out.

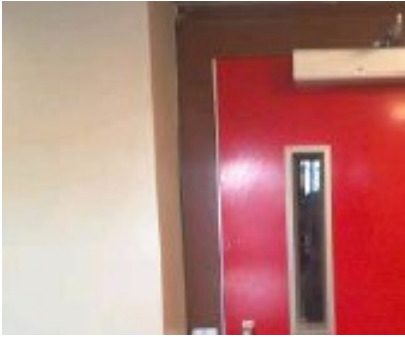
There was no access within the lift shaft (Room 13).

Prior to any works taking place, further investigation is required.

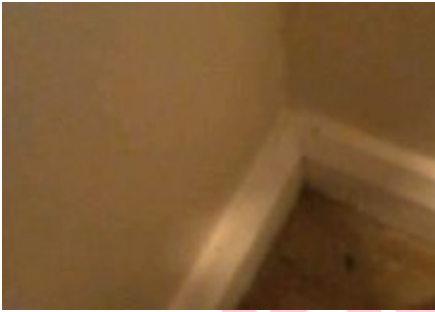
Item 19 As AP001884

The remaining adhesive to the floor beneath the carpet and modern screed in the reception lobby (Room 14) contains asbestos.

Any change in its appearance should be recorded and passed to Property Services.

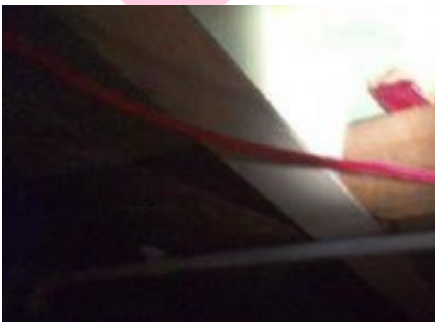
Item 20 Ref: AP001886

The fibreboard packer to between the concrete and the wood beam in the reception lobby (Room 14) does not contain asbestos.

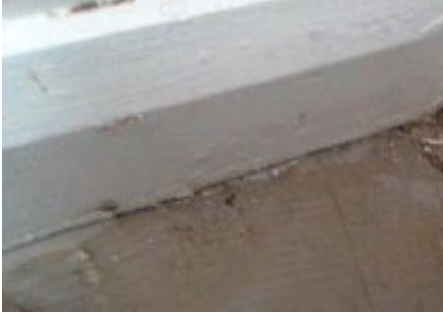
Item 21 As AP001884

The remaining adhesive to the floor beneath the carpet and modern screed in the reception (Room 15) contains asbestos.

Any change in its appearance should be recorded and passed to Property Services.

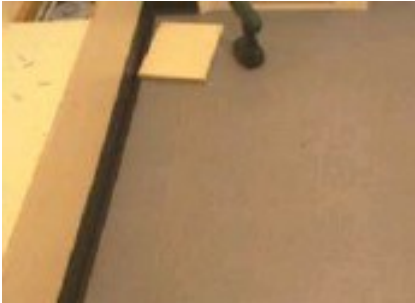
There was no access beneath the modern lino to the Disabled WC (Room 22) without causing possible damage.

Prior to any works taking place investigation should be carried out.

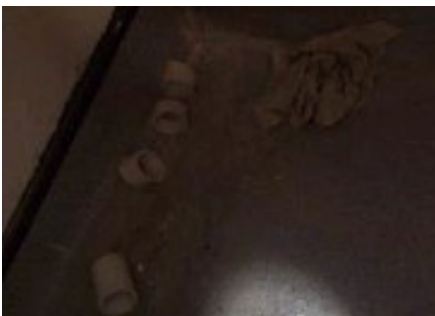
Item 26 As: AP001888

The adhesive to the concrete floor beneath the modern lino and screed to the male wc (Room 23) does not contain asbestos.

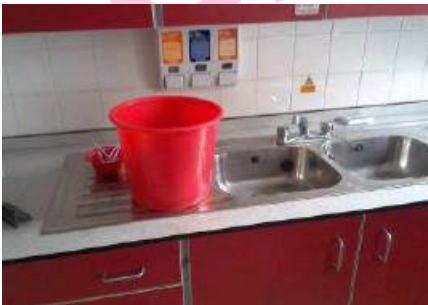
Item 28 Ref: AP001889

The bitumen sink pads to the sink in the machine shop (Room 25) do not contain asbestos.

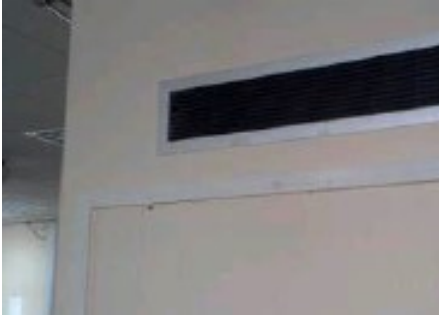
There was no access within the heater in the machine shop (Room 25) due to live plant.

Prior to any works being carried out, further investigation will be required.

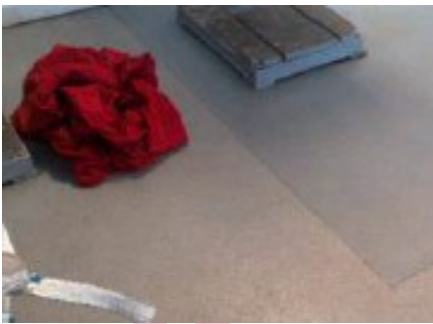
Item 29 As: AP001888

The adhesive to the concrete floor beneath the modern lino to the machine shop (Room 25) does not contain asbestos.

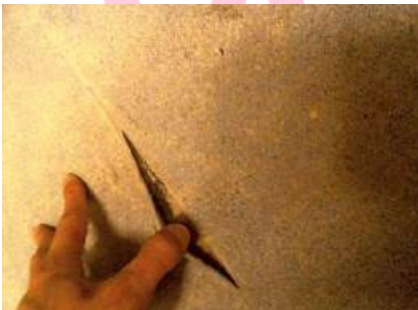
Item 30 As: AP001888

The adhesive to the concrete floor beneath the modern lino to the bar rack store (Room 26) does not contain asbestos.

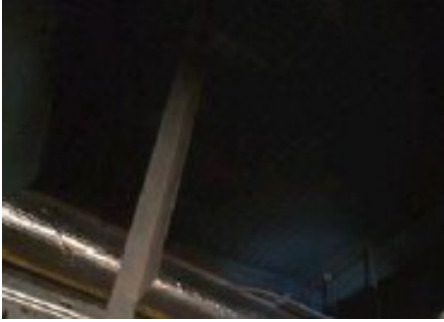
The safe store (Room 27) was accessed, and no suspect materials were found.

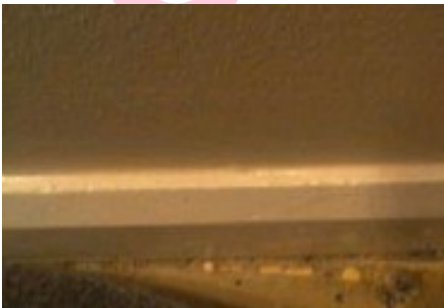
Item 31 As: AP001888

The bitumen adhesive to the concrete floor beneath the modern lino to the stairwell lobby (Room 28) does not contain asbestos.

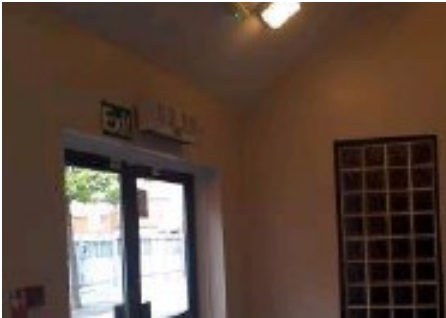
The rear porch (Room 29) was accessed, and no suspect materials were found.

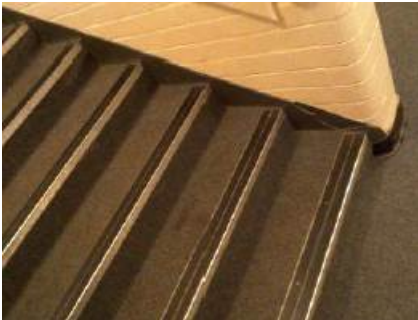
Item 32 Ref: AP001890

The stair nosing to the stairs (Room 30) does not contain asbestos.

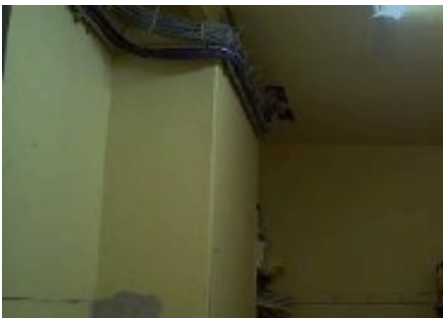
The stock room (Room 30) was accessed, and suspect materials were found.

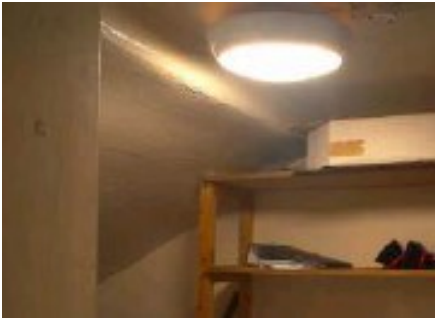
The cleaners store (Room 34) was accessed, and no suspect materials were found.

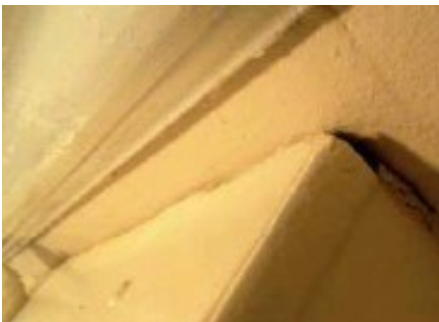
Item 36 Ref: AP001894

The foam between the metal rad hangers and brick wall in the corridor (Room 35) does not contain asbestos.

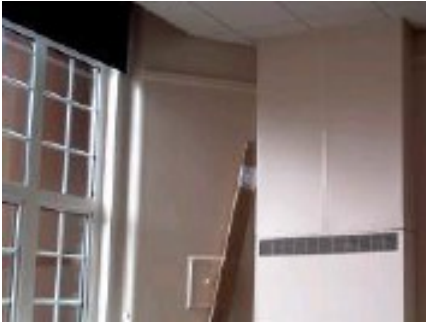
There was no access to the store heater within the plumbing room (Room 38). Prior to any work, this needs to be checked out.

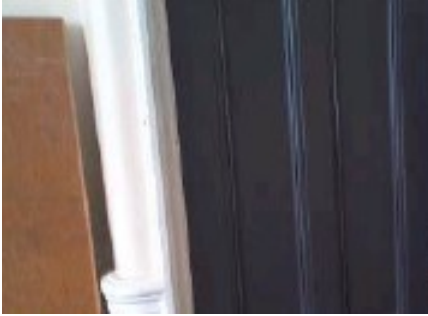
There was no access to the joinery store (Room 39), therefore it should be presumed to contain asbestos unless otherwise proven.

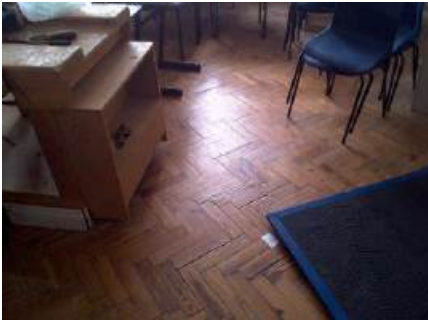
Item 41 Ref: As 41620-9

The bitumen beneath the parquet flooring in the joinery Room (Room 40) is presumed to contain asbestos.

Any change in its appearance should be recorded and passed to Property Services.

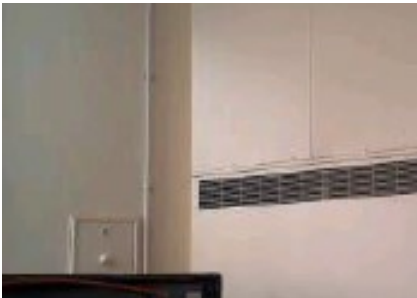
There was no access to the store heater within the joinery room (Room 40). Prior to any work, this needs to be checked out.

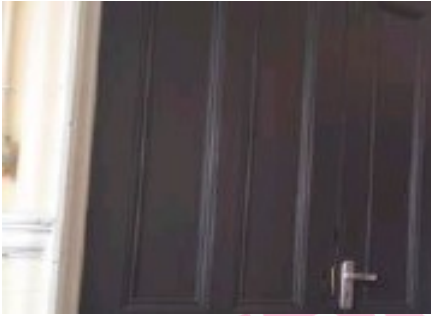
There was no access to the joinery store (Room 40), therefore it should be presumed to contain asbestos unless otherwise proven.

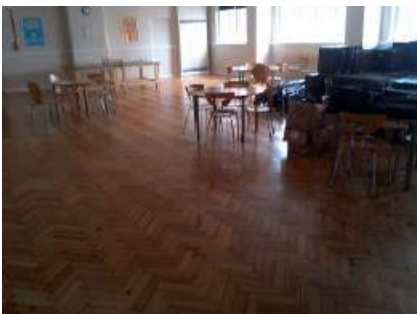
The bitumen beneath the parquet flooring in the restaurant (Room 41) is presumed to contain asbestos.

Any change in its appearance should be recorded, and passed to Property Services.

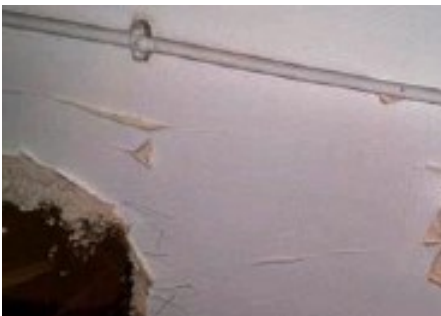
Item 43 Ref: Presumed

The textured coating to the ceiling visible within the void in the kitchen (Room 42) is presumed to contain asbestos.

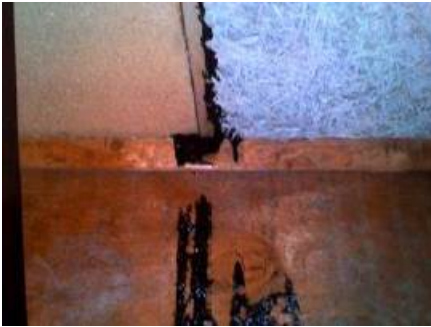
Item 44 Ref: AP001895

The bitumen to the stramit board roof in the kitchen ceiling void (Room 42) does not contain asbestos.

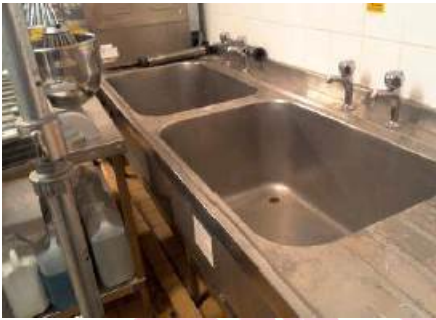
Item 45 Ref: AP001896

The bitumen sink pads to the kitchen (Room 42) do not contain asbestos.

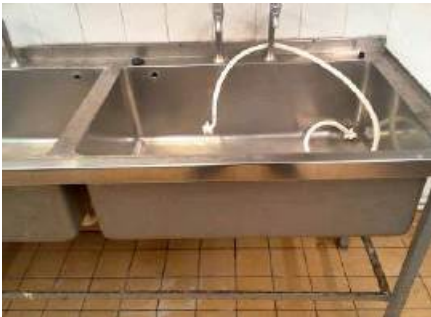
Item 46 Ref: AP001897

The bitumen sink pads to the sink and drainer sinks to the perimeter wall of the kitchen (Room 42) do not contain asbestos.

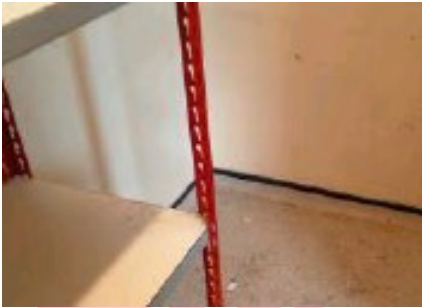
There was no access beneath the modern lino in the kitchen store (Room 43) without causing damage.

Prior to works this needs to be checked out.

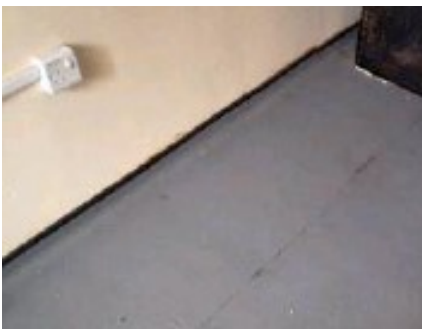
There was no access beneath the modern lino in the Kitchen office (Room 46) as it would cause damage.

Prior to any works, additional checks may need to be carried out.

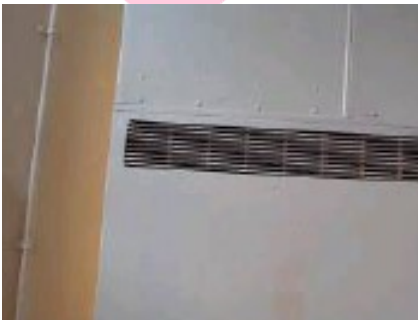
There was no access to the storage heater in the painting and decorating area (Room 49) as it was live.

Prior to any works, additional checks may need to be carried out.

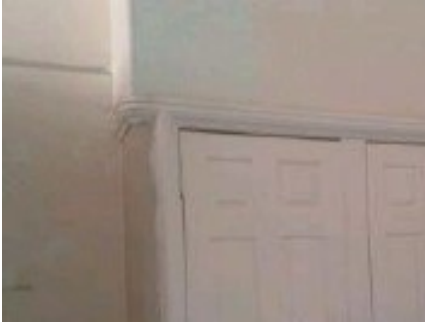
There was no access to the painting and decorating store (Room 49).

Prior to any works, additional checks may need to be carried out.

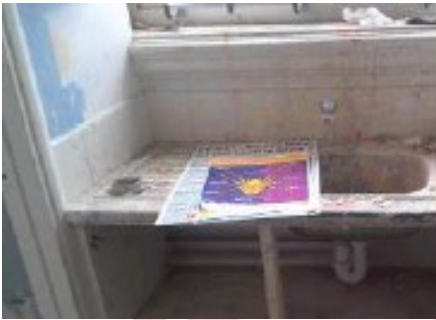
Item 47 As: AP001896

The sink pads to the underside of the sink and drainer in the Painting and decorating (Room 49) do not contain asbestos.

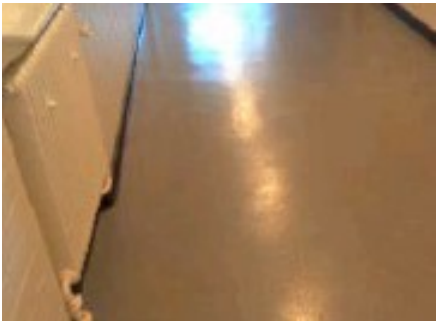
There was no access beneath the modern lino in the corridor (Room 50) as it would cause damage.

Prior to any works, additional checks may need to be carried out.

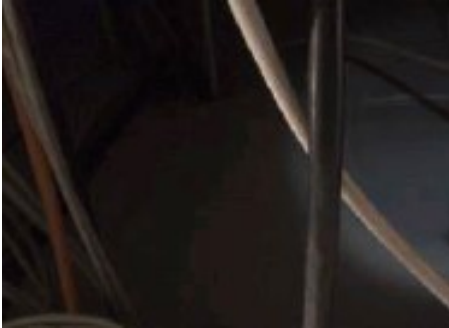
Item 48 Ref: AP001898

The firebreak between the corridor and the restaurant (Room 50) does not contain asbestos.

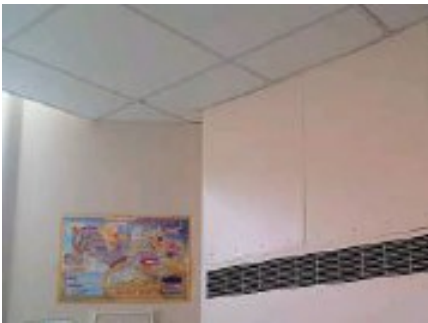
There was no access to the storage heater in the cookery area (Room 51) due to the plant being live.

Prior to any works, additional checks may need to be carried out.

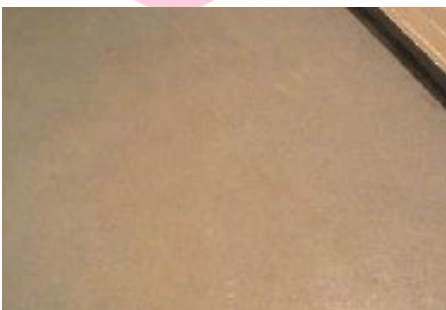
There was no access beneath the modern lino in the cookery store (Room 52) as it would cause damage.

Prior to any works, additional checks may need to be carried out.

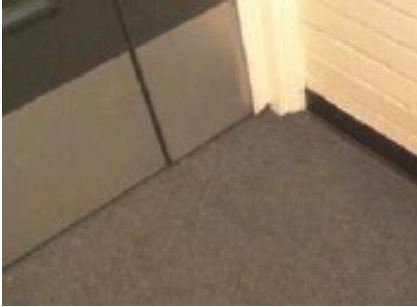
There was no access beneath the modern lino to the corridor (Room 57) as it would cause damage.

Prior to any works, additional checks may need to be carried out.

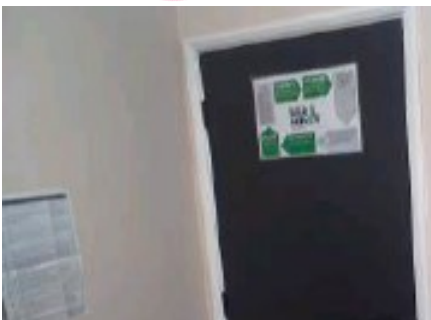
There was no access to the community room store (Room 59). Therefore, it must be presumed that it may contain asbestos.

Prior to any works being carried out, further checks will need to be done.

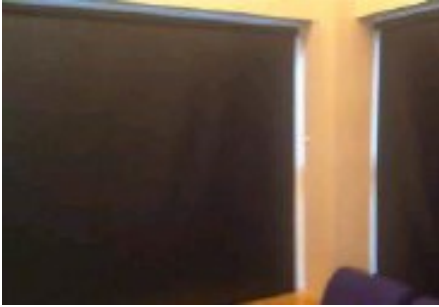
The health and development room (Room 60) was accessed, and no suspect materials were found.

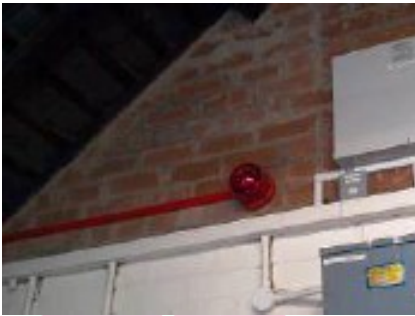
There was no access to the electrics within the bike store (Room 61) due to live plant.

Prior to accessing further checks will need to be carried out.

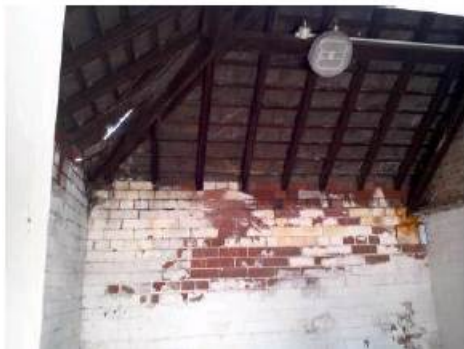
The paint store (Room 62) was accessed, and no suspect materials were found.

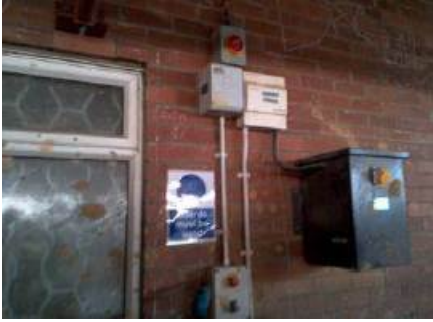
There was no access to the electrics in the brick yard (Room 63) due to being live.

Prior to accessing further checks will need to be carried out.

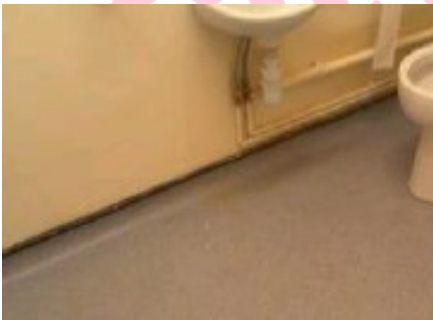
There was no access beneath the modern lino to the disabled wc (Room 1/02) as it would cause damage.

Prior to any works, additional checks may need to be carried out.

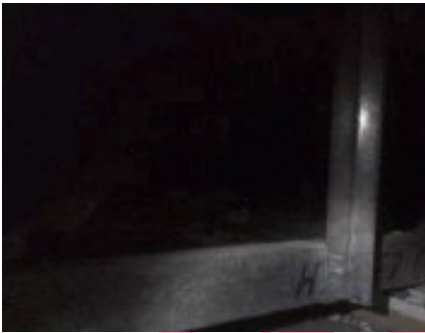
Item 56 As: AP001902

The textured coating debris to the plasterboard ceiling via the access hatch in the ladies wc (Rm 1/03) does not contain asbestos.

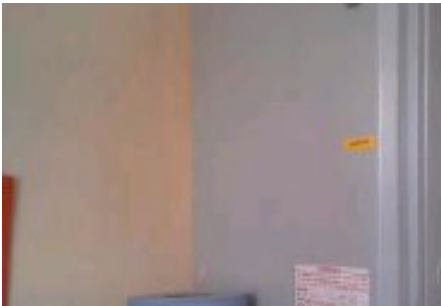
There was no access to the electrics in the cleaners store (Room 1/04) due to the plant being live.

Prior to any works, additional checks may need to be carried out.

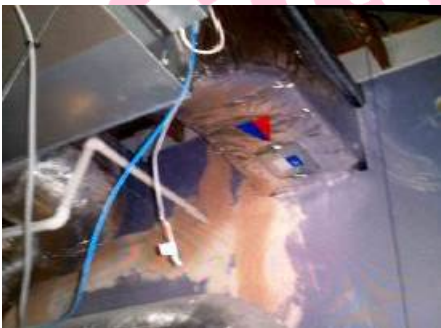
The lobby (Room 1/07) was accessed, and no suspect materials were found

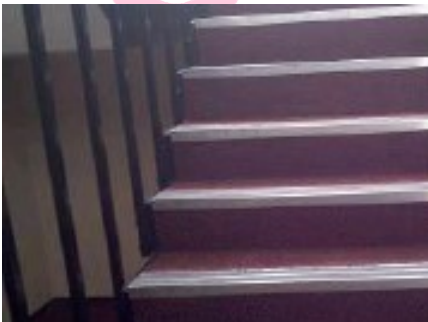
Item 57 As: AP001901

The stair nosing to the stairwell (Room 1/09) does not contain asbestos.

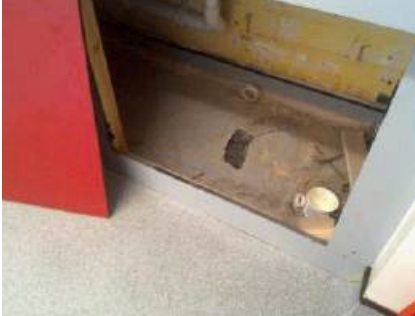
Item 58 Ref: AP001903

The bitumen adhesive to the floor accessed via panel under the sink in the ladies WC (Room 1/10) contains asbestos.

Any change in its appearance should be noted and passed to Property Services.

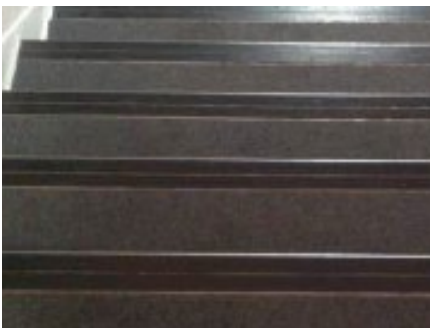
Item 63 As: AP001901

The stair nosing to the corridor in the corridor (Room 1/13) does not contain asbestos.

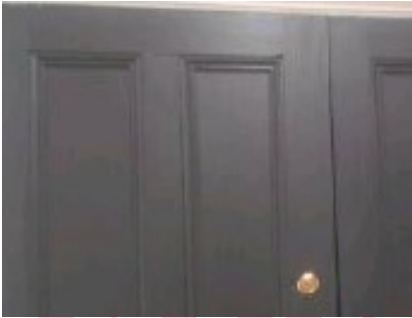
There was no access to the store in ICT (Room 1/14).

Prior to any works, further checks may need to be carried out.

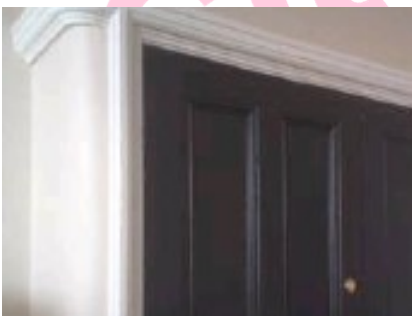
There was no access to the store in the hair salon (Room 1/17).

Prior to any works, further checks may need to be carried out.

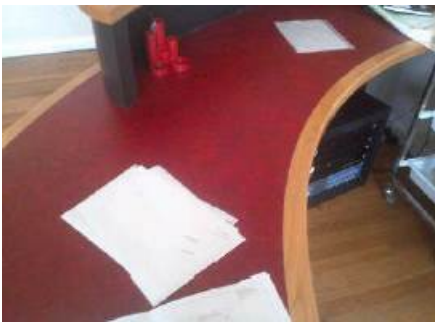
Item 64 Ref: AP001905

The vinyl to the reception desk in the beauty salon (Room 1/18) does not contain asbestos.

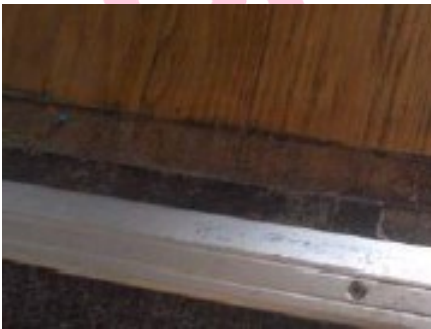
Item 65 Ref: AP001906

The floor tiles beneath the modern carpet to the corridor (Room 1/21) contain asbestos.

SGS confirmed removed.

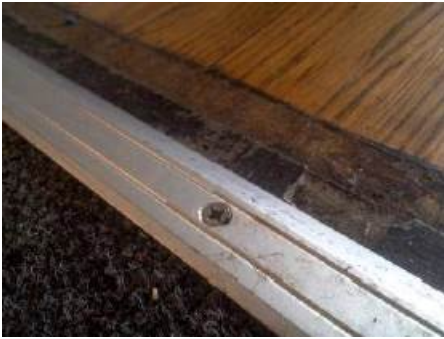
Item 66 Ref: AP001907

The bitumen adhesive to the floor tiles in the corridor (Room 1/21) contains asbestos.

SGS confirmed removed.

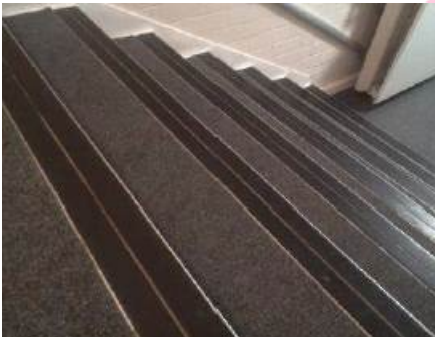
Item 67 As: AP001901

The stair nosing to the corridor (Room 1/21) does not contain asbestos.

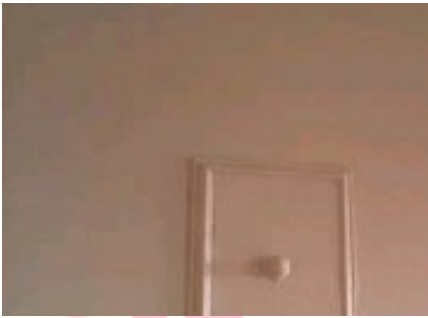
There was no access within the metal hatches to the wall in classroom (Room 1/24) without causing possible damage.

Prior to any works, further checks may need to be carried out.

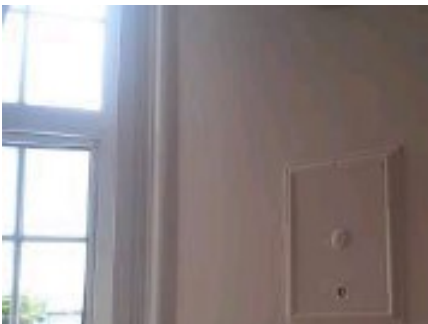
There was no access within the metal hatches to the wall in classroom (Room 1/25) without causing possible damage.

Prior to any works, further checks may need to be carried out.

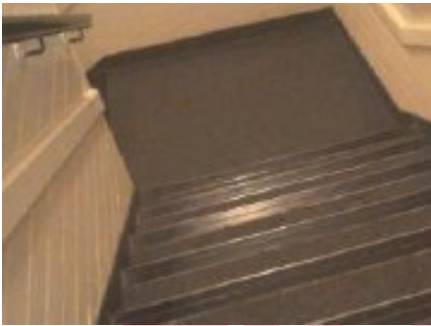
Item 68 As: AP001901

The stair nosing to the stairwell (Room 1/27) does not contain asbestos.

Prior to any works, further checks may need to be carried out.

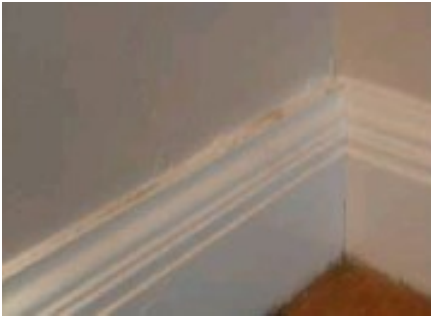
There was no access beneath the newly fitted carpet to the WC lobby (Room 1/28) without causing possible damage.

Prior to any works, further checks may need to be carried out.

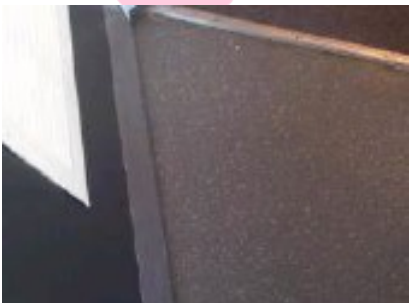
There was no access beneath the lino to the female WC (Room 1/30) without causing possible damage.

Prior to any works, further checks may need to be carried out.

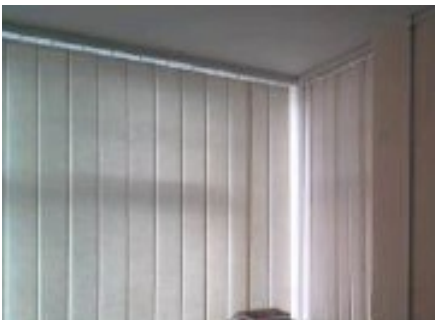
The office (Room 1/33) was accessed, and no suspect materials were found.

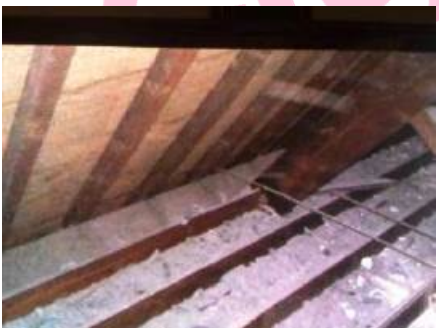
The roof void 1 was accessed and no suspect materials were found.

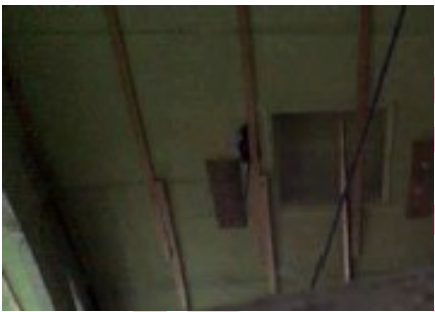
The roof void 3 was unable to be accessed due to health and safety reasons.

Prior to any works, further checks will need to be carried out.

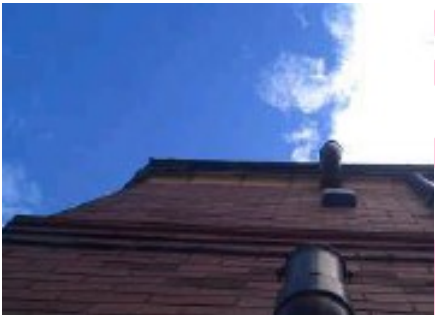
Item 70 Ref: AP001922

The cement flue to the north elevation to the external contains asbestos.

Any change in its appearance should be noted and passed to Property Services.

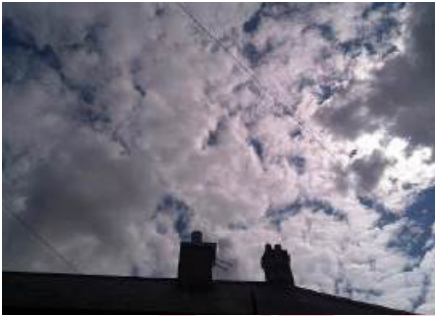
Item 73 Ref: Presumed

The cement cowl to the chimney stack is presumed to contain asbestos.

Removed 2014

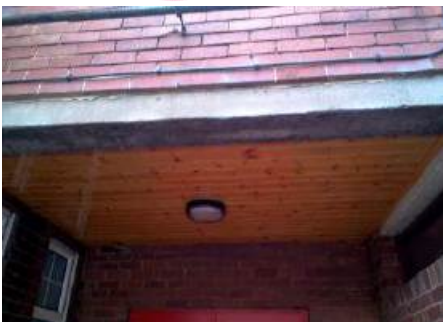
The wood canopy to the external was accessed and no suspect materials were found.

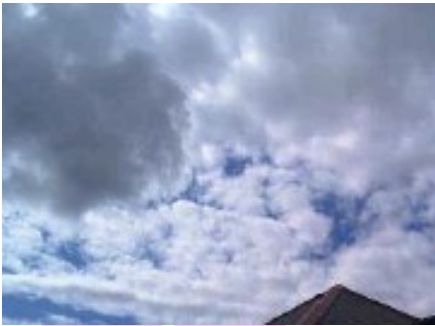
Item 74 Ref: AP001924

The slate roof to the engineers block does not contain asbestos.

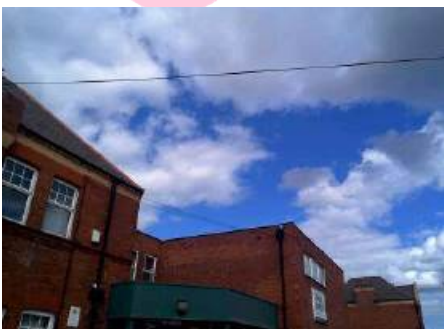
Item 75 Ref: Presumed

All flat felt roofs were presumed to have asbestos in.

Prior to any works being carried out on site, further testing should be carried out.

Any change in its appearance should be noted and passed to Property Services.

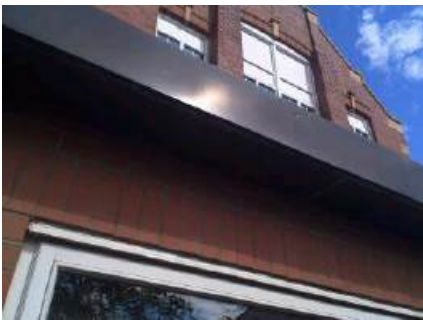
The soffits to the external of Roof 1 are metal.

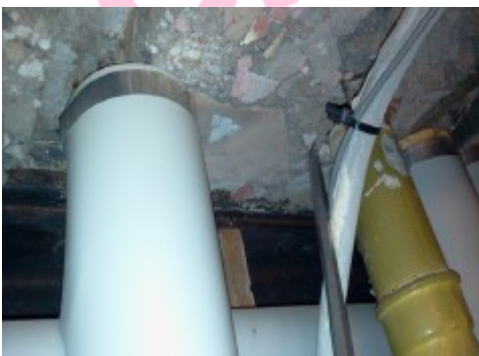
Item 80 Ref: As 41620-15

The remnant board to yellow gas pipe in the Boiler Room/Rm 001 contains asbestos.

Removed 2014

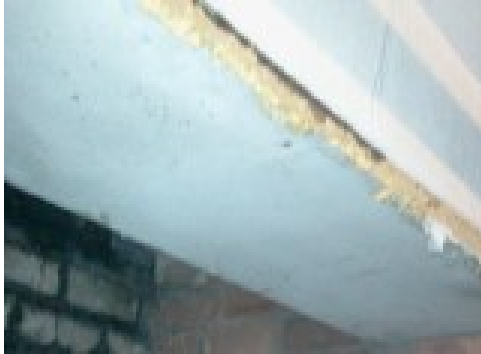
Item 81 Ref: 41620-18

The shuttering to underside of beam in the Boiler Room/Rm 001 contains asbestos.

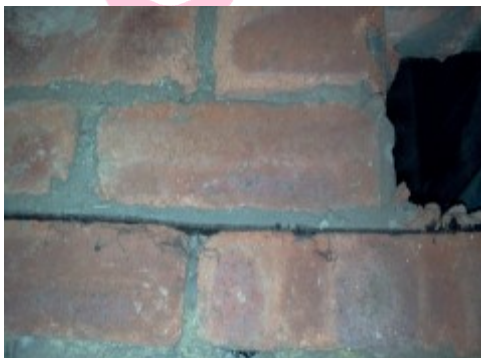
Item 83 Ref: 41620-20

The damp proof course in the Boiler Room/Rm 001 does not contain asbestos.

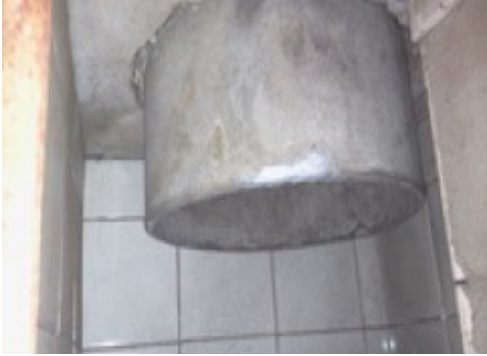
Item 84 Ref: 41620-31

The flue situated within riser in the Boiler Room/Rm 001 contains asbestos.

Removed 2014

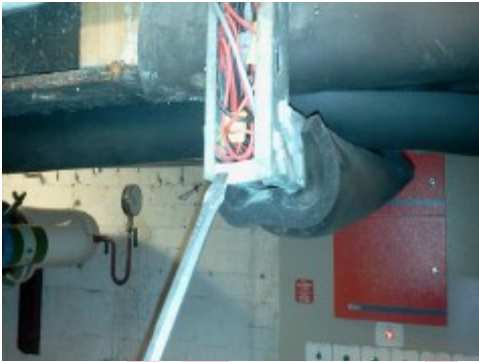
Item 85 Ref: As 41620-14

The board within cable tray in the Boiler Room/Rm 001 does not contain asbestos.

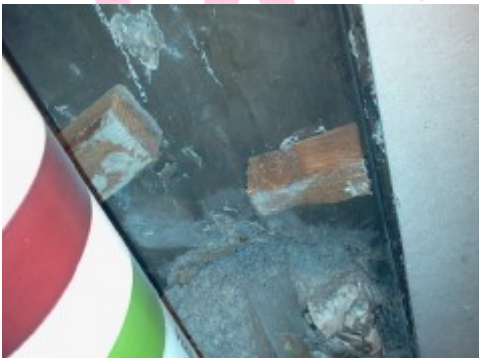
Item 86 Ref: 41620-21

The insulation board debris in the Boiler Room/Rm 001 contains asbestos.

Removed 2014

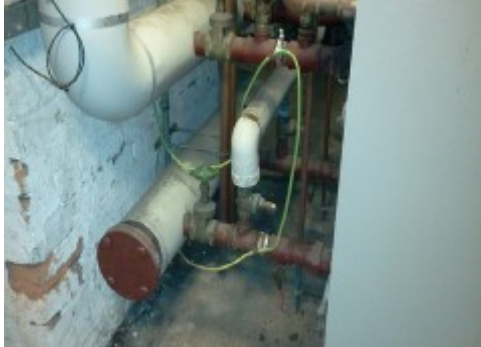
Item 87 Ref: 41620-22

The pipework flange gasket in the Boiler Room/Rm 001 contains asbestos.

Removed 2014

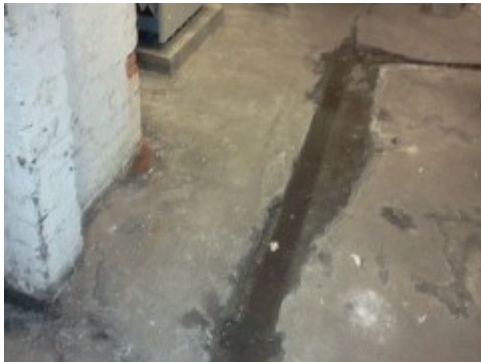
Item 88 Ref: 41620-23

The general debris to floor in the Boiler Room/Rm 001 does not contain asbestos.

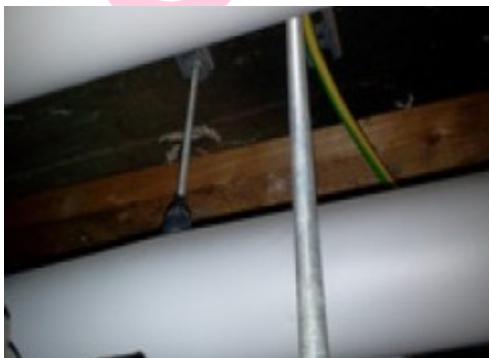
Item 89 Ref: Presumed

The insulation board debris in the Boiler Room/Rm 001 is presumed to contain asbestos.

Removed 2014

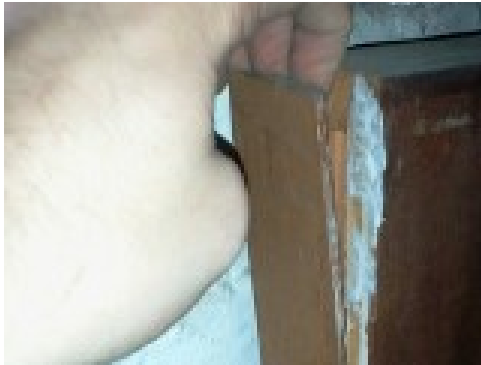
Item 90 Ref: 41620-24

The panel within door in the Boiler Room/Rm 001 contains asbestos.

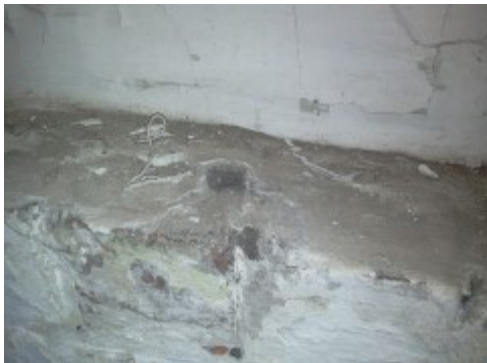
Item 91 Ref: 41620-25

The string debris to wall in the Boiler Room/Rm 001 does not contain asbestos.

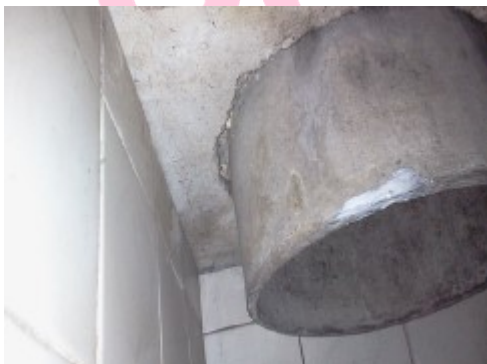
Item 92 Ref: 41620-32

The shuttering to cement flue in the Boiler Room/Rm 001 contains asbestos.

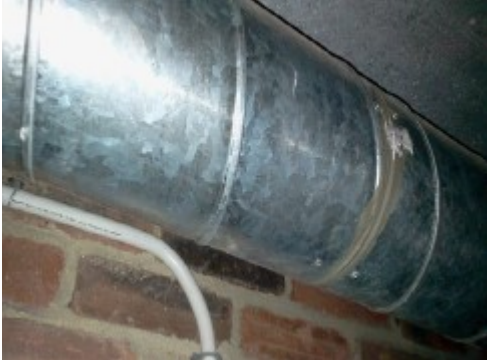
Item 93 Ref: 41620-1

The mastic to air handling ductwork joints in the Staff Room/Rm 005 ceiling void above - does not contain asbestos.

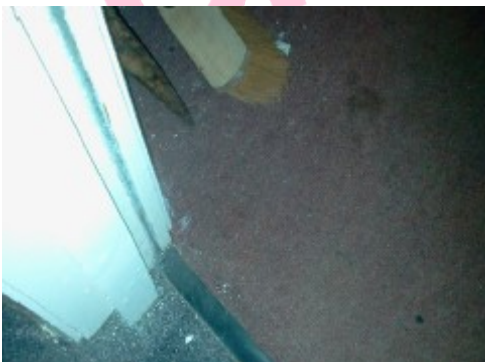
Item 98 Ref: 41620-2

The subfloor in the Caretakers Store/Rm 012 does not contain asbestos.

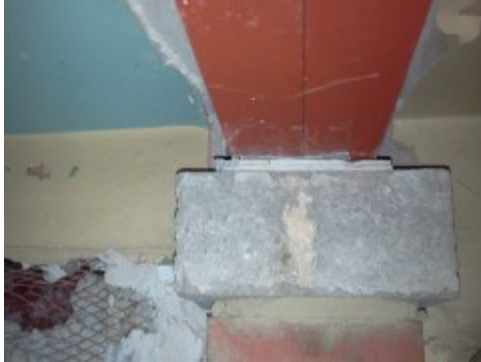
Item 99 Ref: 41620-3

The packing to underside of beam in the Office/Rm 015 contains asbestos.

Removed 2014

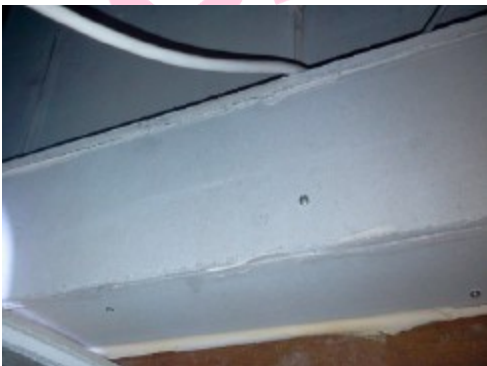
Item 101 Ref: As 41620-5

The boxing to beam above door in the Corridor ceiling void above/Rm 017 does not contain asbestos.

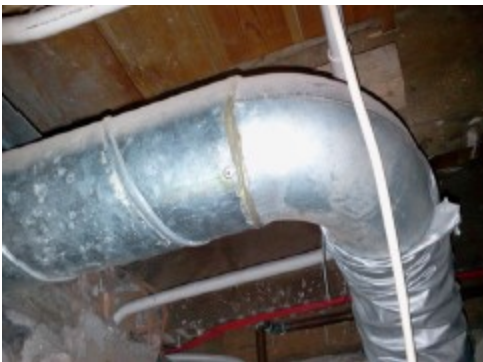
Item 103 Ref: As 41620-1

The mastic to air handling ductwork joints in the WC/Rm 019 ceiling void above does not contain asbestos.

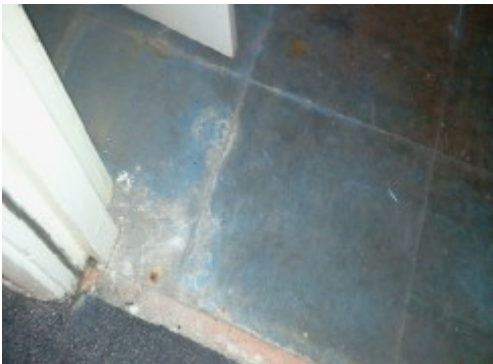
Item 106 Ref: 41620-7

The floor covering in the Cleaners cupboard/Rm 026 does not contain asbestos.

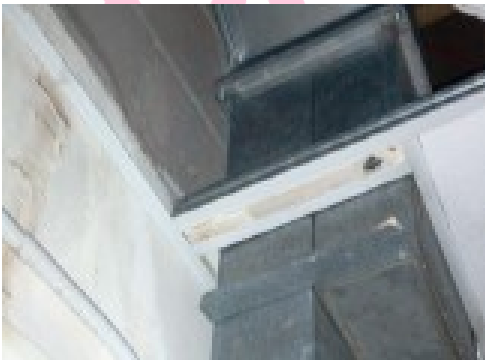
Item 107 Ref: As 41620-1

The mastic to air handling ductwork joints in the Cleaners Cupboard/Rm 026 does not contain asbestos.

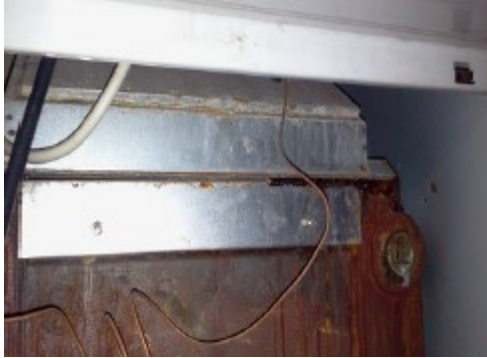
Item 108 Ref: 41620-8

The mastic to top of boiler plate in the Cleaners Cupboard/Rm 026 does not contain asbestos.

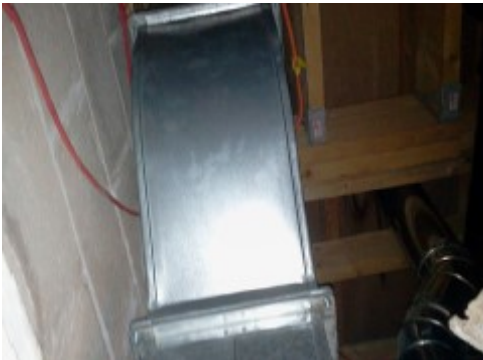
Item 109 Ref: As 41620-1

The mastic to air handling ductwork joints in the Cleaners Cupboard/Rm 026 ceiling void above - does not contain asbestos.

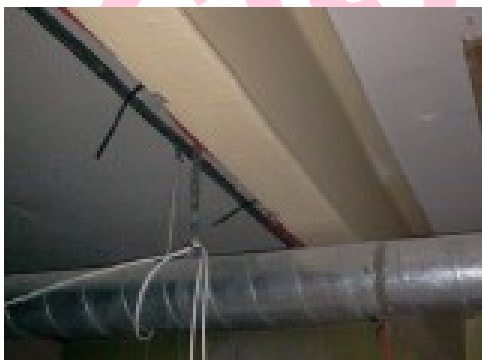
Item 110 Ref: As 41620-1

The mastic to air handling ductwork joints in the Community Room/Rm 032 ceiling void above - does not contain asbestos.

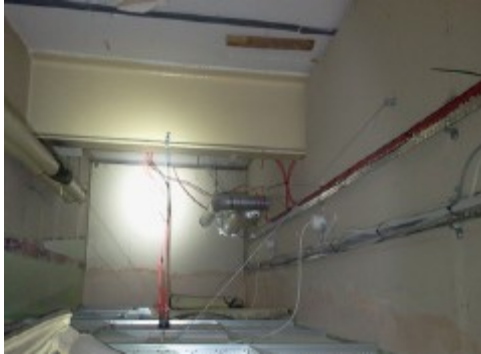
Item 111 Ref: As 41620-1

The mastic to air handling ductwork joints in the Store Cupboard /Rm 033 ceiling void above - does not contain asbestos.

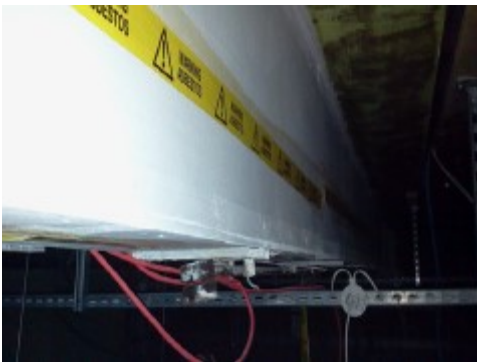
Item 112 Ref: 41620-11

The boxing to beams in the Restaurant/Rm 040 ceiling voids above contains asbestos.

Removed 2014

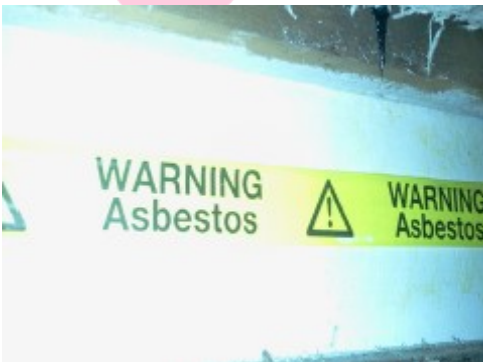
Item 113 Ref: As 41620-11

The extractor hood surround in the Kitchen/Rm 041 ceiling voids above contains asbestos.

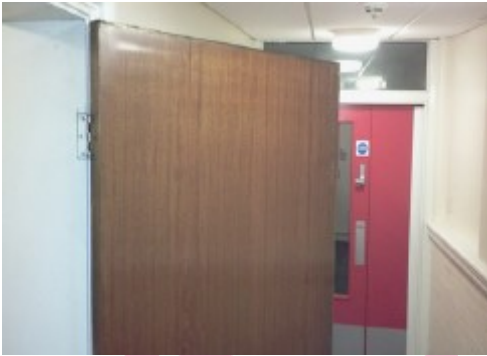
Item 115 Ref: As 41620-24

The panel within door in the Stairwell leading to boiler Room/Rm 057 contains asbestos.

Removed 2014

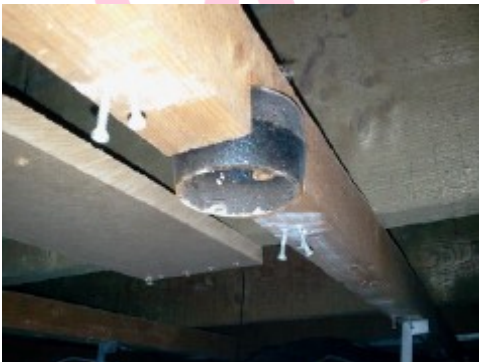
Item 116 Ref: 41620-26

The debris to beams in the audio room/Rm 1/001 ceiling void above contains asbestos.

Removed 2014

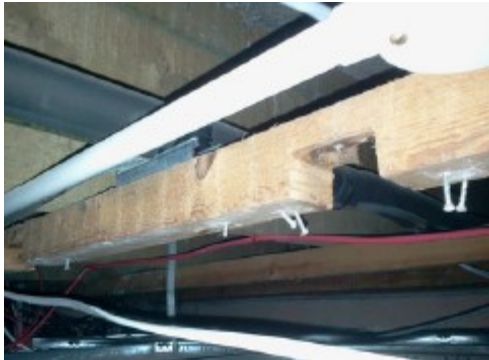
Item 117 Ref: As 41620-26

The debris to beams in the audio room/Rm 1/002 ceiling void above contains asbestos.

Removed 2014

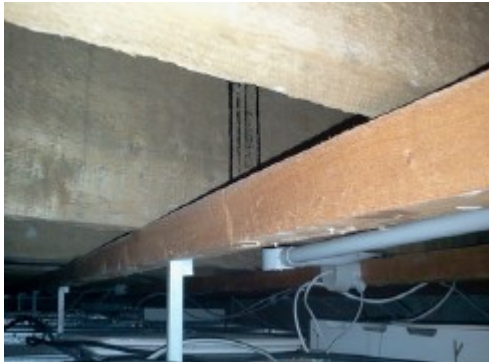
Item 118 Ref: As 41620-26

The debris to beams in the computer room/Rm 1/003 ceiling void above contains asbestos.

Removed 2014

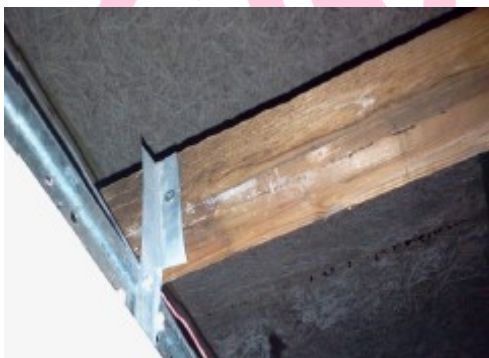
Item 119 Ref: As 41620-26

The debris to beams in the Corridor/Rm 1/004 ceiling void above contains asbestos.

Removed 2014

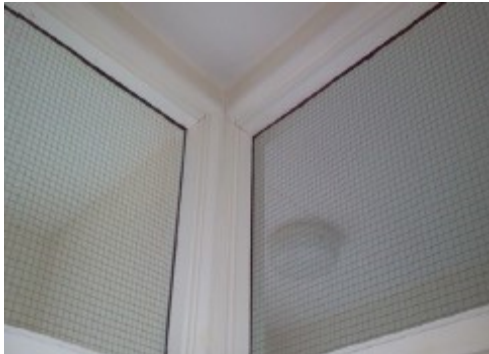
Item 120 Ref: 41620-27

The mastic to glass panels above door in the Corridor/Rm 1/011 does not contain asbestos.

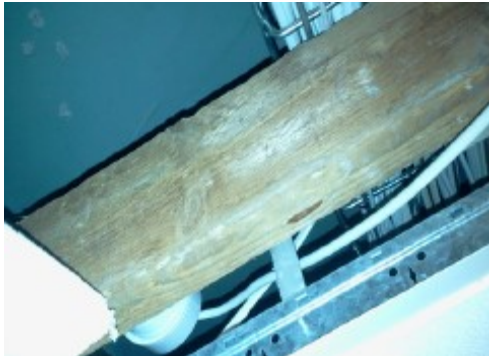
Item 121 Ref: As 41620-26

The debris to beams in the Corridor/Rm 1/014 ceiling void above contains asbestos.

Removed 2014

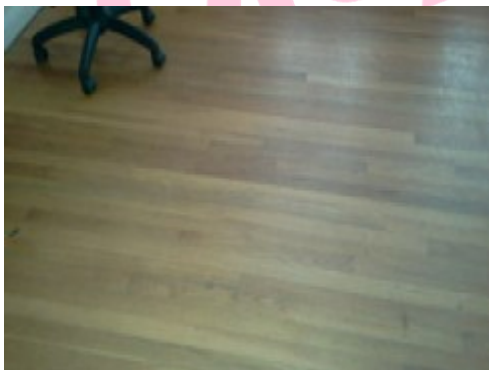
Item 122 Ref: Presumed

The adhesive to parquet flooring in Classroom/Rm 1/016 is presumed to contain asbestos.

Any change in its appearance should be noted and passed to Property Services.
