ASBESTOS SURVEY REPORT FOR THE PALLION CENTRE, WAVERLEY TERRACE, SUNDERLAND

Asbestos Register for The Pallion Centre

Date: 11 February 2026

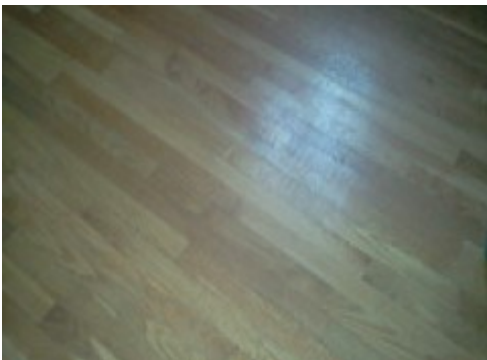
Item 124 Ref: Presumed

The adhesive to parquet flooring in Classroom/Rm 1/020 is presumed to contain asbestos.

Any change in its appearance should be noted and passed to Property Services.

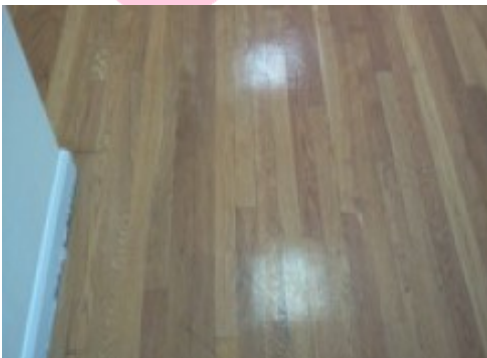
Item 125 Ref: Presumed

The adhesive to parquet flooring in Classroom/Rm 1/021 is presumed to contain asbestos.

Any change in its appearance should be noted and passed to Property Services.

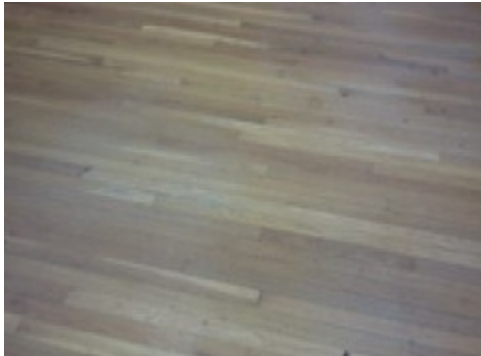
Item 126 Ref: Presumed

The adhesive to parquet flooring in Classroom/Rm 1/022 is presumed to contain asbestos.

Any change in its appearance should be noted and passed to Property Services.

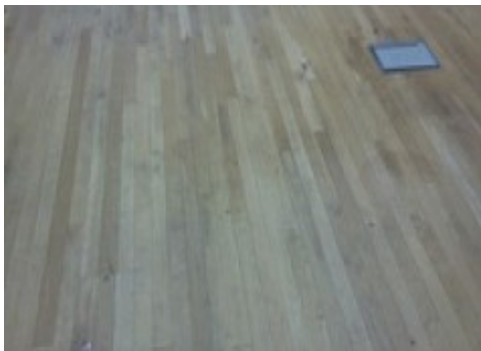
Item 127 Ref: Presumed

The adhesive to parquet flooring in Classroom/Rm 1/023 is presumed to contain asbestos.

Any change in its appearance should be noted and passed to Property Services.

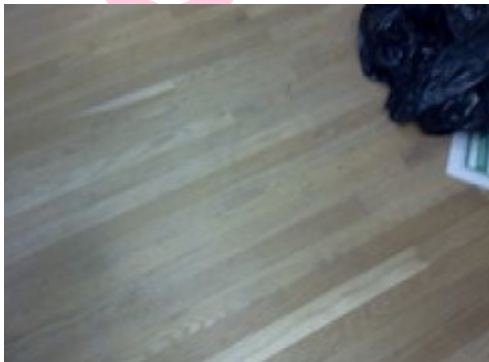
Item 128 Ref: Presumed

The adhesive to parquet flooring in Classroom/Rm 1/024 is presumed to contain asbestos.

Any change in its appearance should be noted and passed to Property Services.

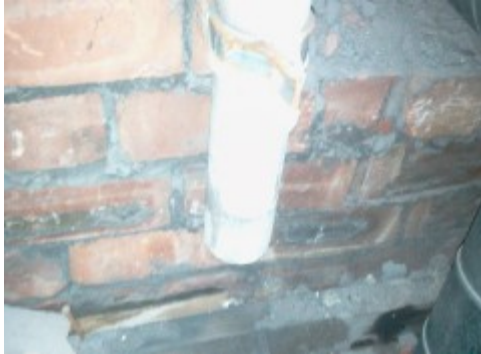
Item 129 Ref: 41620-30

The redundant pipework to wall in the Male WC/Rm1/036 roof void contains asbestos.

Removed 2014

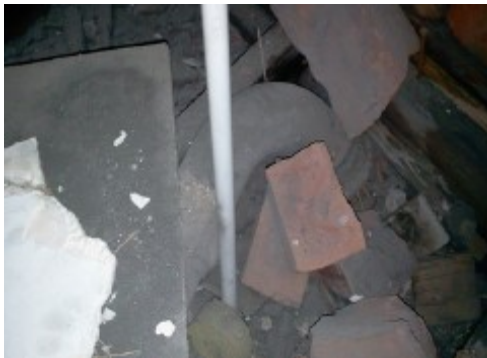
Item 130 Ref: As 41620-29

The redundant pipework to floor in the Male WC/Rm1/036 roof void contains asbestos.

Removed 2014

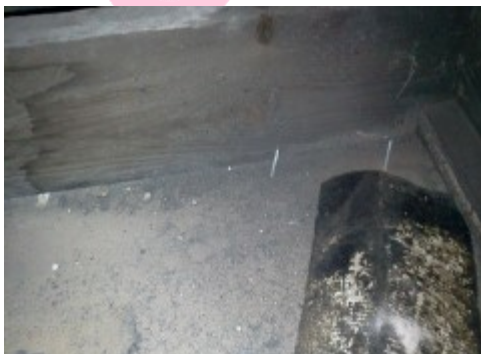
Item 131 Ref: 41620-29

The remnant roof felt in the Male WC/Rm1/036 roof void contains asbestos.

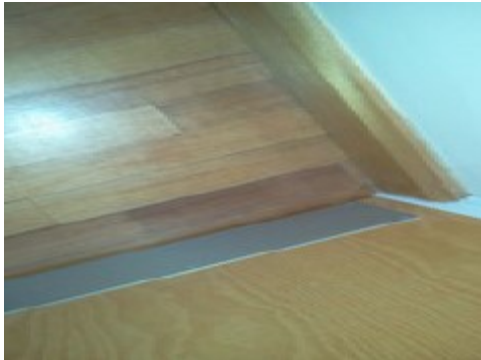
Item 132 Ref: Presumed

The adhesive to parquet flooring in the Store/Rm 1/040 is presumed to contain asbestos.

Any change in its appearance should be noted and passed to Property Services.

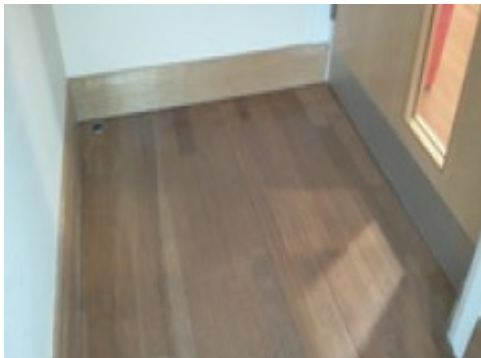
Item 133 Ref: Presumed

The adhesive to parquet flooring in the Stairwell/Rm 1/041 is presumed to contain asbestos.

Any change in its appearance should be noted and passed to Property Services.

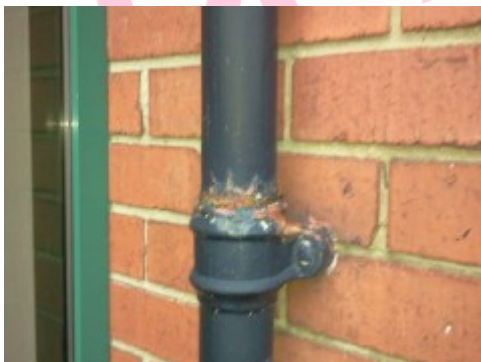
Item 134 Ref: 41620-33

The sealant to downpipe collars (External) does not contain asbestos.

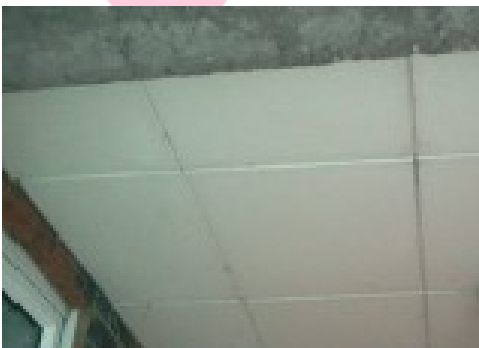
Item 137 Ref: 41620-36

The tiles to rear canopy exit from corridor (External) contains asbestos.

Removed 2014

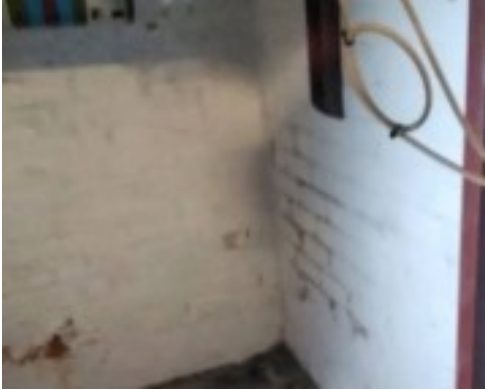
Item 141 Ref: KX001000

The debris/residue to the stairwell wall in the Boiler Room does not contain asbestos.

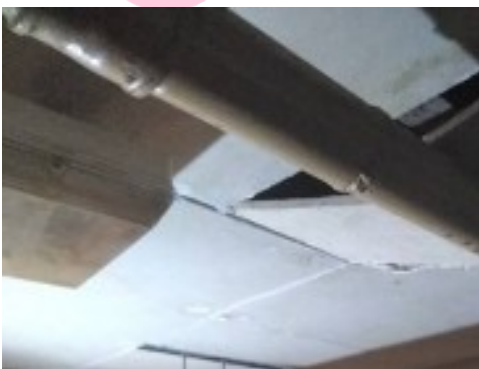
Item 149 Ref: KX000996

The beam cladding in the Boiler Room does not contain asbestos. (Limited inspection within)

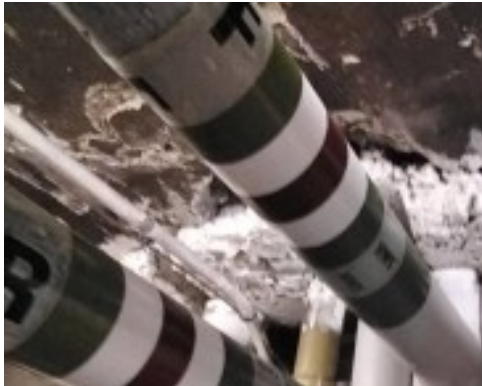
Item 150 Ref: KX001011

The debris/residue to the floor nearer the rear wall in the Boiler Room does not contain asbestos.

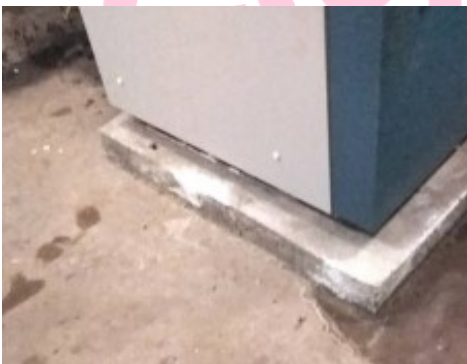
Item 152 Ref: KX001909

The debris/residue to floor plinths under boilers nearest stairs (Boiler Room) does not contain asbestos.

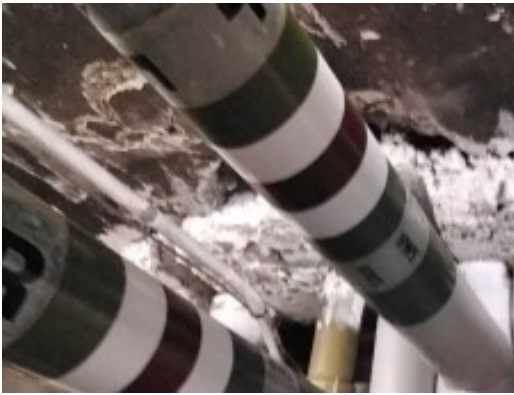
Item 153 Ref: KX001013

The debris/residue shuttering remnants from pipe penetration (Boiler Room) does not contain asbestos.

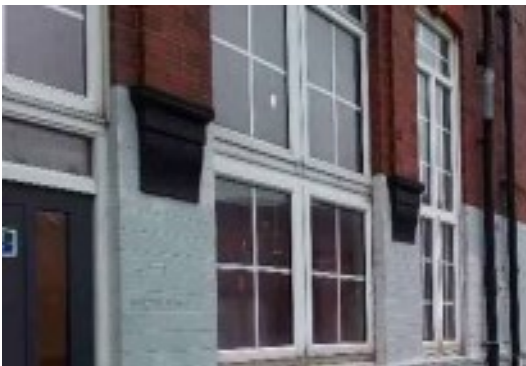
Item 154 Ref: OQ000417

The window sealant to wall (External) does not contain asbestos.

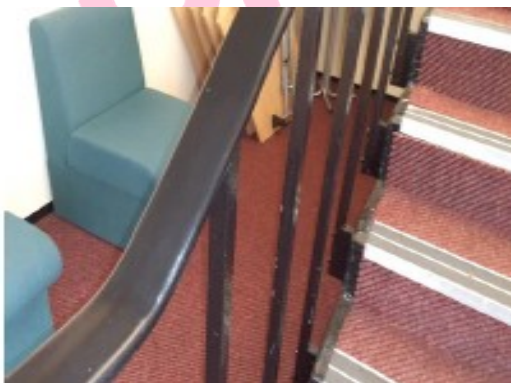
Item 155 Ref: OU004465

The composite handrail over to the stairwell (G/01) does not contain asbestos.

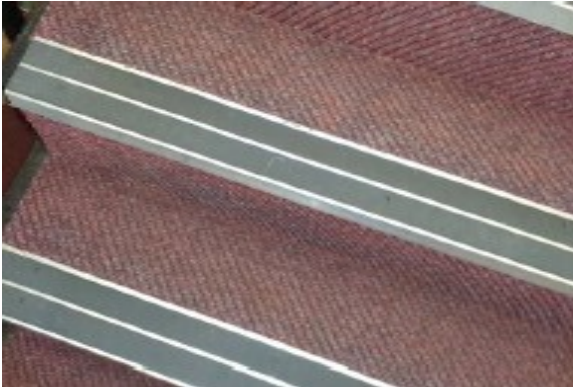
Item 156 Ref: OU004466

The composite stair nosing to the stairwell (G/01) does not contain asbestos.

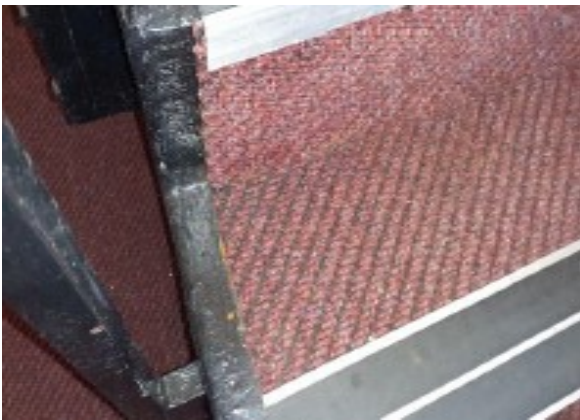
Item 157 Ref: OU004467

The bitumen beneath carpet on stair riser and treads in the stairwell (G/01) does not contain asbestos.

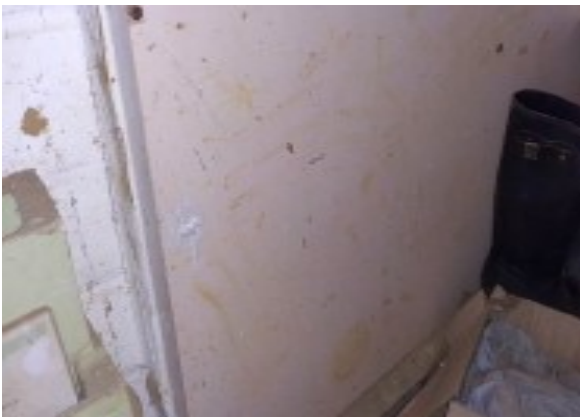
Item 158 Ref: OU004469

The paperbacked fibreboard to the wall in the Brick workshop (G/02) does not contain asbestos.

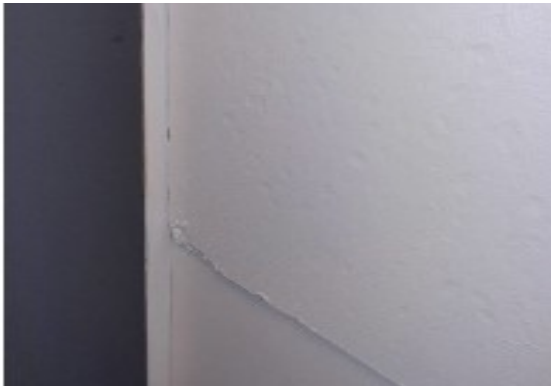
Item 159 Ref: OU004468

The paperbacked fibreboard to the wall in Corridor 1 (1/04) does not contain asbestos.

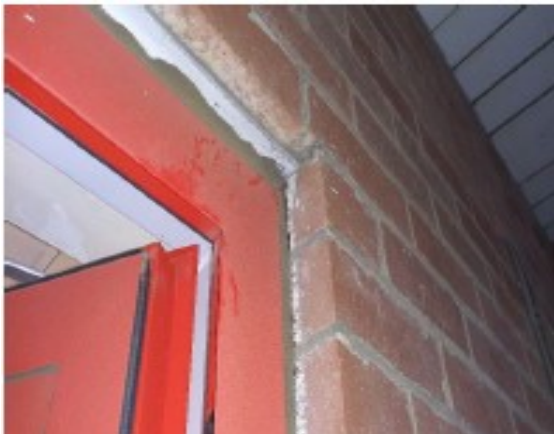
Item 160 Ref: OU004470

The putty to the door (External E/01) does not contain asbestos.

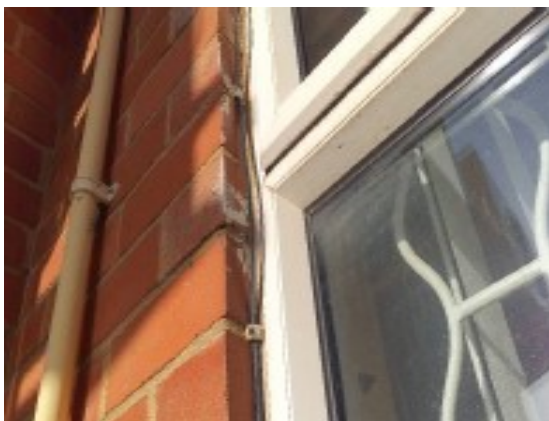
Item 161 Ref: As OU004470

The putty to the door (External E/01) does not contain asbestos.

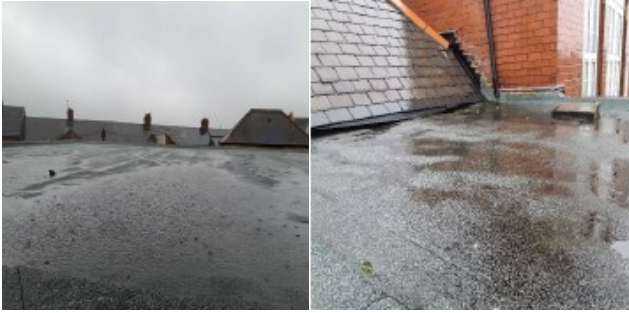
Item 162 Ref: KG001114

The bitumen roof felt
External (E/01) does not
contain asbestos.
