ASBESTOS SURVEY REPORT FOR GRANGE PARK PRIMARY SCHOOL, SWAN STREET, SUNDERLAND, SR5 1EA.

## Asbestos Register for

**Grange Park Primary School, Swan Street, Sunderland,  
SR5 1EA**

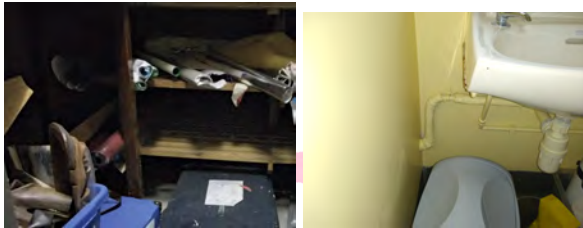
**Item 44 Ref: As 47505-4**

The pipework from WC 0/058 (item 42) is presumed to run into the adjoining Store 0/059. Therefore, the pipe lagging in 0/059 Store contains asbestos.

Any change in its appearance should be recorded and passed to Property Services.

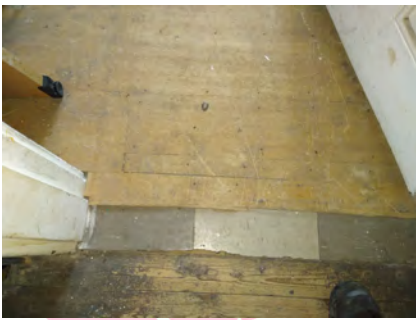
**Item 59 Ref: As 429759-3**

The floor covering under wood in 1/003 Office and Store does not contain asbestos.

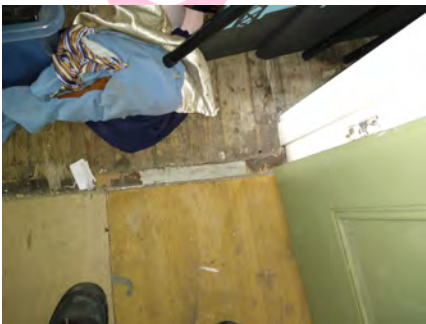
**Item 60 Ref: 429759-3**

The remnant floor tiles below wood panels in 1/005 Office and Store does not contain asbestos.

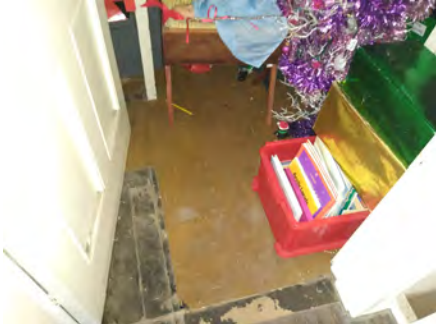
**Item 61 Ref: 429759-4**

The floor covering in 1/006 Store contains asbestos.

Any change in its appearance should be recorded and passed to Property Services.

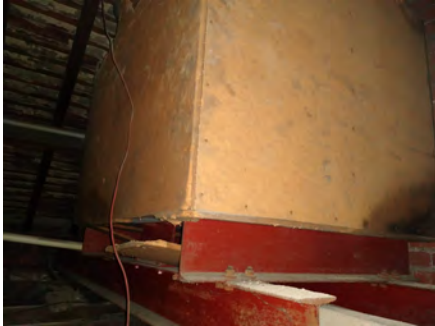
**Item 64 Ref: 78139-23**

The insulation to tank in 2/001 Loft space tank location does not contain asbestos.

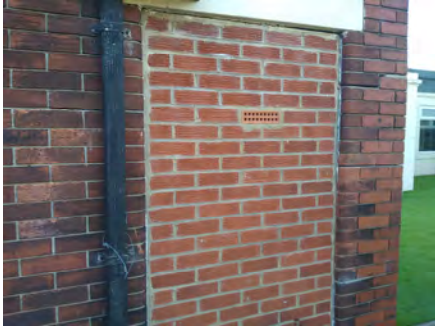
**Item 67 Ref: 429759-30**

The remnant mastic to redundant doorway (External) contains asbestos.

Any change in its appearance should be recorded and passed to Property Services.

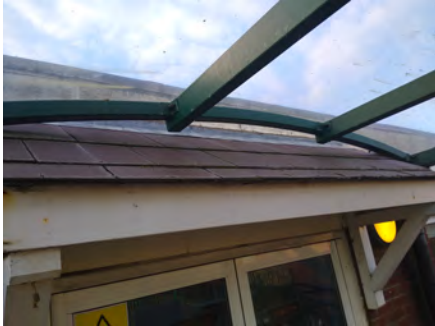
**Item 70 Ref: 429759-33**

The roof tiles to small door canopy adjacent 0/030 (External) does not contain asbestos.
