### ASBESTOS SURVEY REPORT FOR NORTHERN SAINTS C OF E PRIMARY SCHOOL, SUNDERLAND

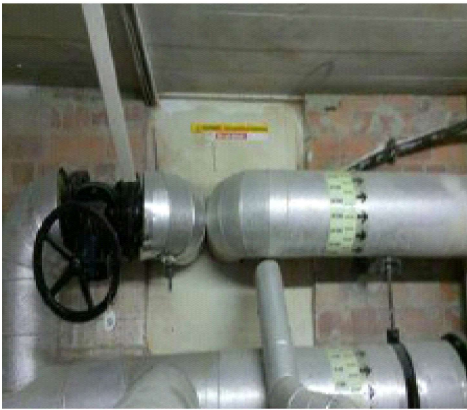
### **Item 1: Presumed**

The duct entrances to the boiler room (Sub level 1 Room 1) are sealed and are presumed to contain asbestos lagging.

Any changes in its appearance should be noted and passed to Property Services.

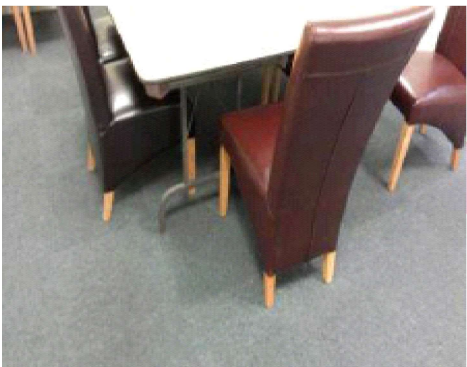
### **Item 2: Presumed**

The bitumen adhesive to the floor below the cement skim to the floor in the meeting room (Room 2) is presumed to contain asbestos.

Any changes in its appearance should be noted and passed to Property Services.

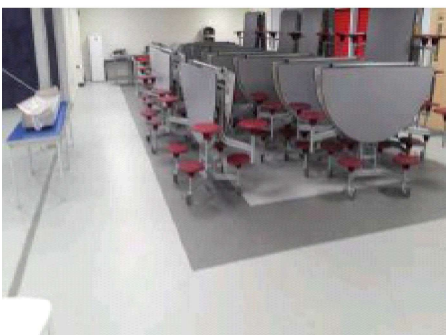
### **Item 3: Presumed**

The bitumen adhesive to the floor below the cement skim to the floor in the dining area (Room 4) is presumed to contain asbestos.

Any changes in its appearance should be noted and passed to Property Services.

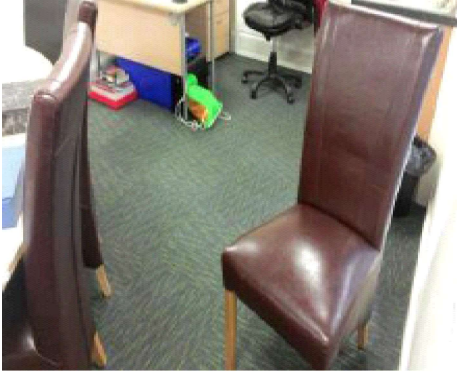
### **Item 4: Presumed**

The bitumen adhesive to the floor below the cement skim to the floor in the office (Room 5) is presumed to contain asbestos.

Any changes in its appearance should be noted and passed to Property Services.

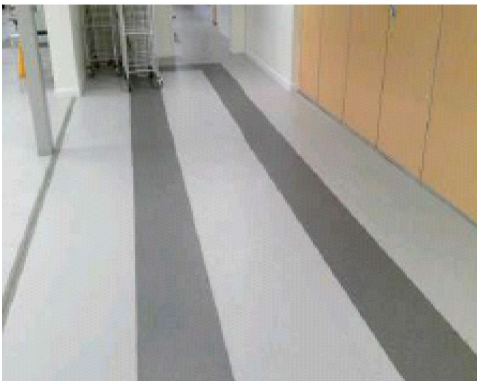
### **Item 5: Presumed**

The bitumen adhesive to the floor below the cement skim to the floor in the main hall lobby (Room 6) is presumed to contain asbestos.

Any changes in its appearance should be noted and passed to Property Services.

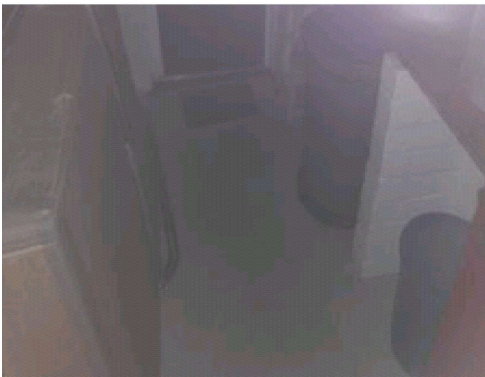
### **Item 6: Presumed**

The bitumen adhesive to the floor below the cement skim to the floor in the kitchen vestibule /store (Room 8) is presumed to contain asbestos.

Any changes in its appearance should be noted and passed to Property Services.

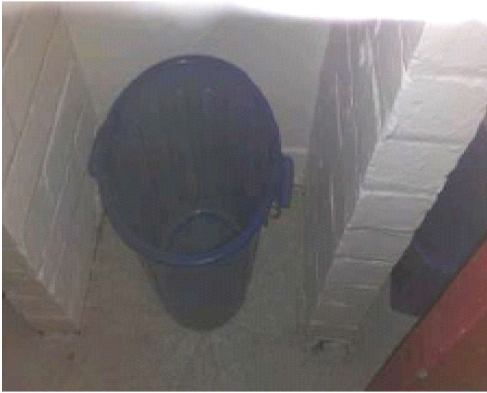
### **Item 7: As KR09/86**

The skirting to the base of the wall in the kitchen vestibule / store (Room 8) contains asbestos.

Any changes in its appearance should be noted and passed to Property Services.

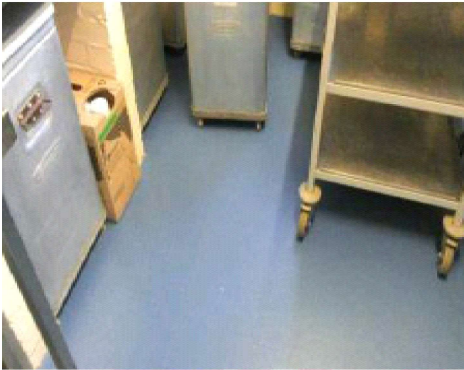
### **Item 8: Presumed**

The bitumen adhesive to the floor below the cement skim to the floor in the kitchen store (Room 9) is presumed to contain asbestos.

Any changes in its appearance should be noted and passed to Property Services.

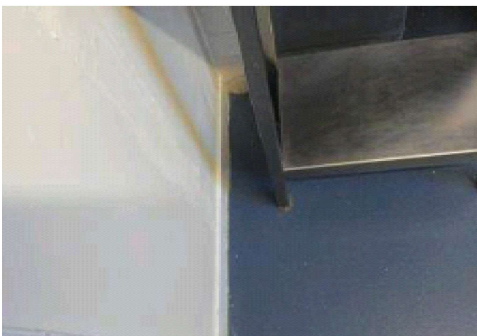
### **Item 9: As KR09/86**

The skirting to the base of the wall in the kitchen store (Rooms 9) contains asbestos.

Any changes in its appearance should be noted and passed to Property Services.

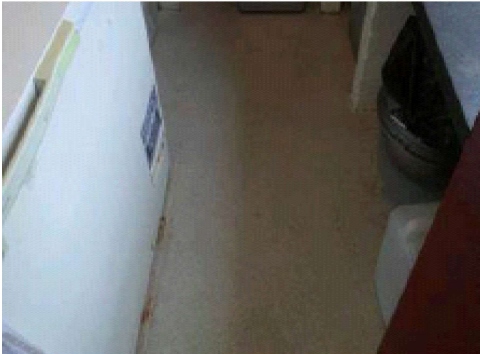
### **Item 10: Presumed**

The bitumen adhesive to the floor below the cement skim to the floor in the kitchen store (Room 10) is presumed to contain asbestos.

Any changes in its appearance should be noted and passed to Property Services.

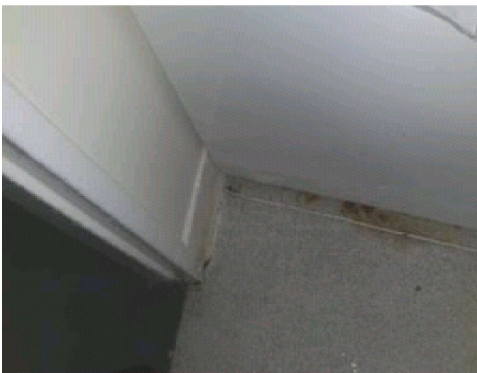
### **Item 11: NSPS/002**

The skirting to the base of the wall in the kitchen store (Room 005) contains asbestos.

Any changes in its appearance should be noted and passed to Property Services.

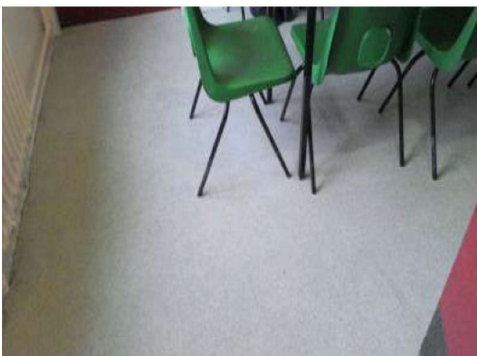
### **Item 12: Presumed**

The bitumen adhesive below flooring in the kitchen staff room (Room 11) is presumed to contain asbestos.

Any changes in its appearance should be noted and passed to Property Services.

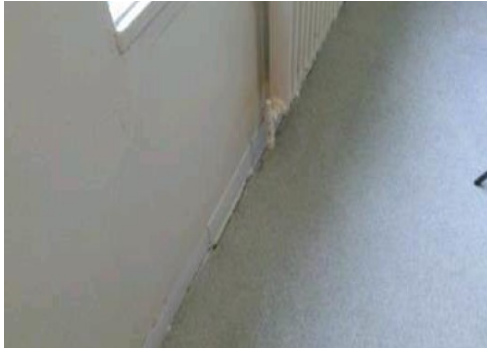
### **Item 13: As KR09/86**

The skirting to the base of the wall in the kitchen staff room (Room 11) contains asbestos.

Any changes in its appearance should be noted and passed to Property Services.

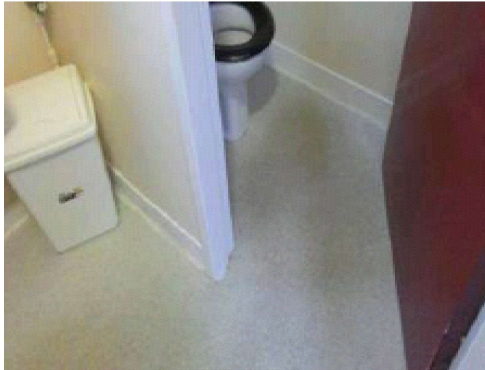
### **Item 14: Presumed**

The bitumen adhesive below flooring in the kitchen staff toilet (Room 12) is presumed to contain asbestos.

Any changes in its appearance should be noted and passed to Property Services.

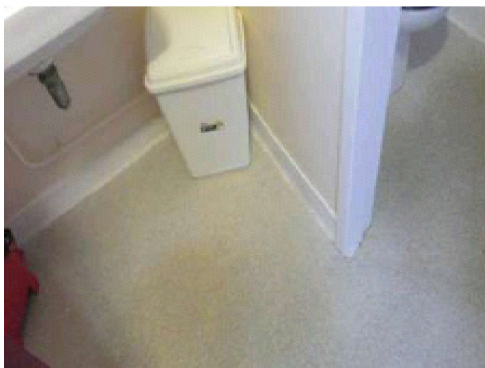
### **Item 15: As KR09/86**

The skirting to the base of the wall in the kitchen staff toilet (Room 12) contains asbestos.

Any changes in its appearance should be noted and passed to Property Services.

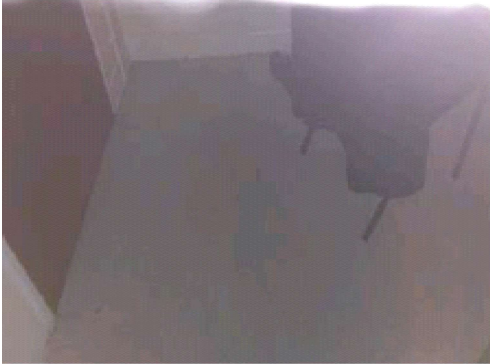
### **Item 16: Presumed**

The bitumen adhesive below modern lino in the kitchen office (Room 14) is presumed to contain asbestos.

Any changes in its appearance should be noted and passed to Property Services.

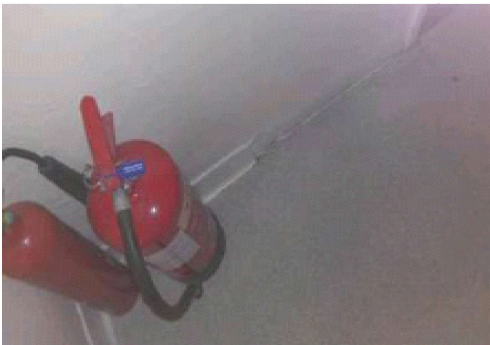
### **Item 17: As KR09/86**

The skirting to the base of the wall in the kitchen office (Room 14) contains asbestos.

Any changes in its appearance should be noted and passed to Property Services.

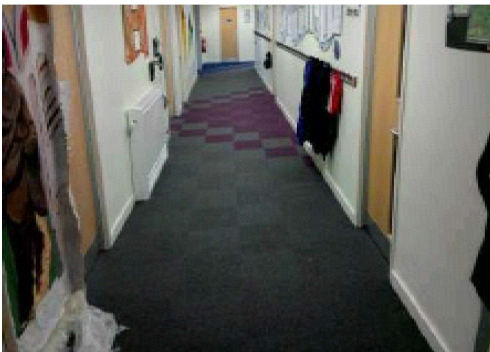
### **Item 18: Presumed**

The bitumen adhesive to the floor below the cement skim to the floor in the corridor (Room 18) is presumed to contain asbestos.

Any changes in its appearance should be noted and passed to Property Services.

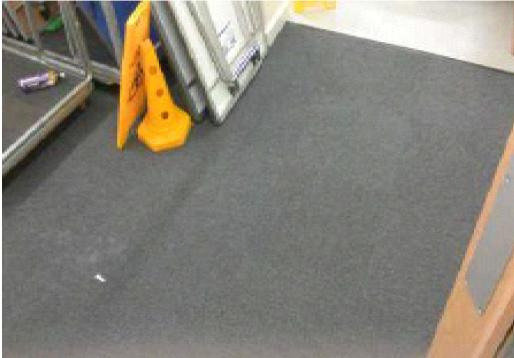
### **Item 19: Presumed**

The bitumen adhesive to the floor below the cement skim to the floor in the gym lobby (Room 21) is presumed to contain asbestos.

Any changes in its appearance should be noted and passed to Property Services.

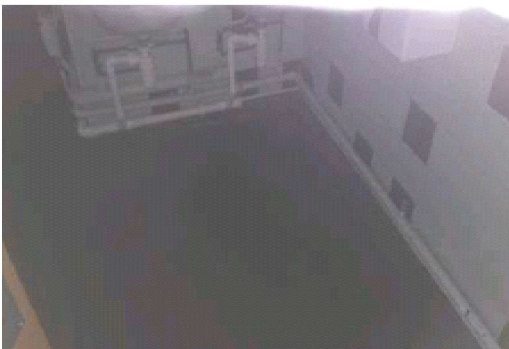
### **Item 20: Presumed**

The vinyl floor tiles beneath the lino in the boys toilet (Room 23) contained asbestos.

***These were removed in July 2015.***

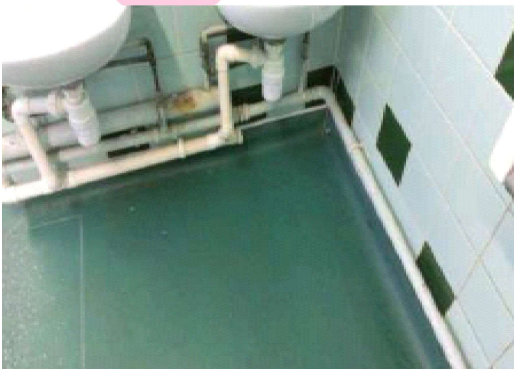
### **Item 21: Presumed**

The skirting to the base of the wall beneath the lino in the boys wc (Room 23) contained asbestos.

***These were removed in July 2015.***

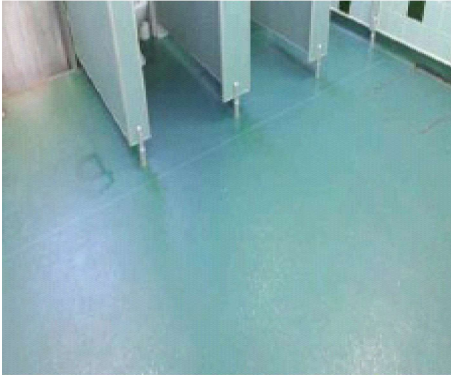
### **Item 22: Presumed**

The bitumen adhesive beneath lino in the boys wc (Room 23) is presumed to contain asbestos.

Any changes in its appearance should be noted and passed to Property Services.

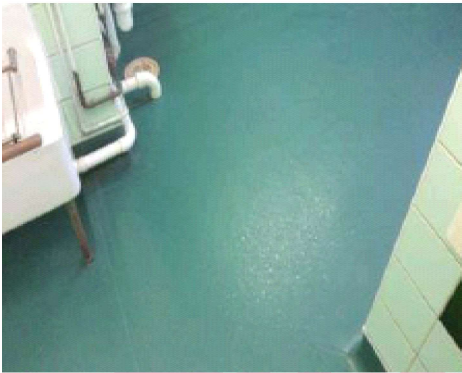
### **Item 23: Presumed**

The vinyl floor tiles beneath the lino in the Girls toilet (Room 26) contain asbestos.

Any changes in its appearance should be noted and passed to Property Services.

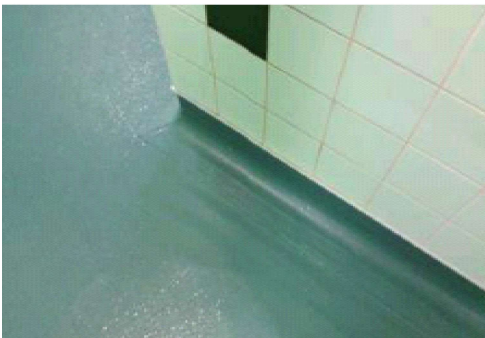
### **Item 24: Presumed**

The skirting to the base of the wall beneath the lino in the Girls wc (Room 26) contains asbestos.

Any changes in its appearance should be noted and passed to Property Services.

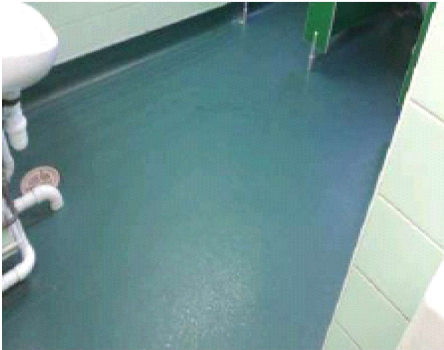
### **Item 25: Presumed**

The bitumen adhesive beneath lino to the floor in the Girls wc (Room 26) is presumed to contain asbestos.

Any changes in its appearance should be noted and passed to Property Services.

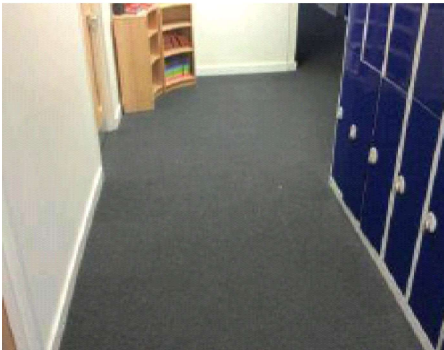
### **Item 26: Presumed**

The bitumen adhesive to the floor below the cement skim to the floor in the corridor (Room 27) is presumed to contain asbestos.

Any changes in its appearance should be noted and passed to Property Services.

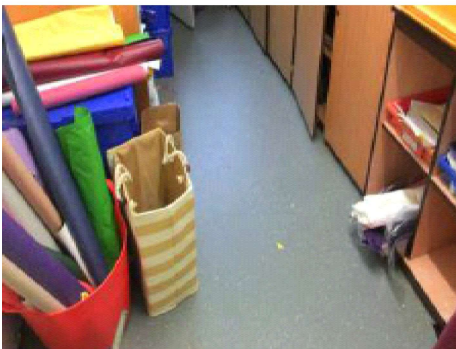
### **Item 27: Presumed**

The bitumen adhesive to the floor below the cement skim to the floor in the store (Room 28) is presumed to contain asbestos.

Any changes in its appearance should be noted and passed to Property Services.

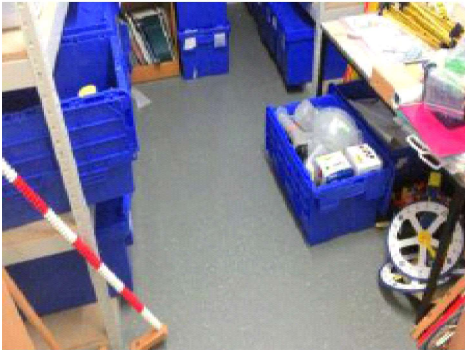
### **Item 28: Presumed**

The bitumen adhesive to the floor below the cement skim to the floor in the store (Room 29) is presumed to contain asbestos.

Any changes in its appearance should be noted and passed to Property Services.

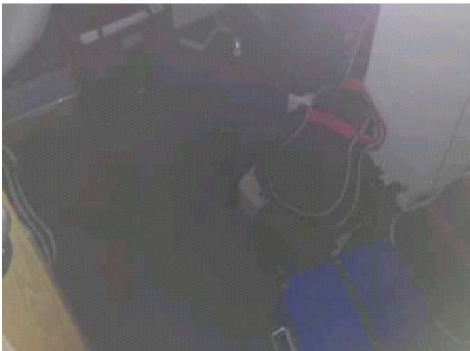
### **Item 29: Presumed**

The bitumen adhesive to the floor below the cement skim to the floor in the store (Room 30) is presumed to contain asbestos.

Any changes in its appearance should be noted and passed to Property Services.

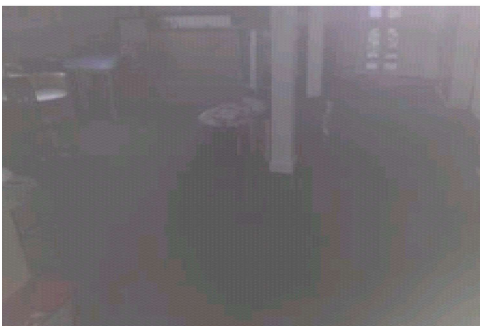
### **Item 30: Presumed**

The bitumen adhesive to the floor below the cement skim to the floor in the classroom (Room 31) is presumed to contain asbestos.

Any changes in its appearance should be noted and passed to Property Services.

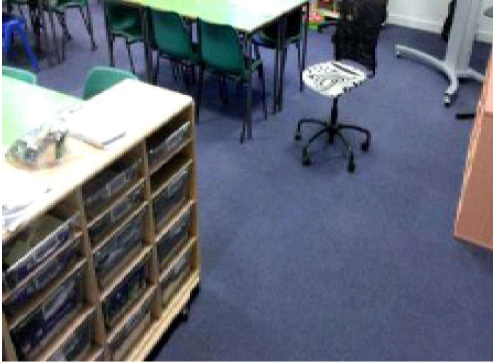
### **Item 31: Presumed**

The bitumen adhesive to the floor below the cement skim to the floor in the classroom (Room 32) is presumed to contain asbestos.

Any changes in its appearance should be noted and passed to Property Services.

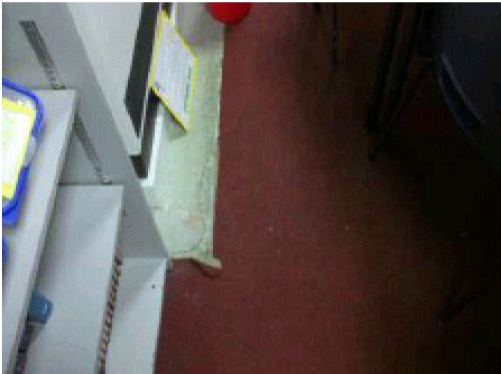
### **Item 32: Presumed**

The bitumen adhesive to the floor in the classroom (Room 33) is presumed to contain asbestos.

Any changes in its appearance should be noted and passed to Property Services.

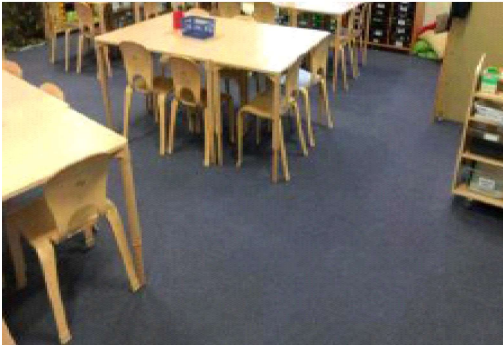
### **Item 34: Presumed**

The bitumen adhesive to the floor below the cement skim to the floor in the classroom (Room 34) is presumed to contain asbestos.

Any changes in its appearance should be noted and passed to Property Services.

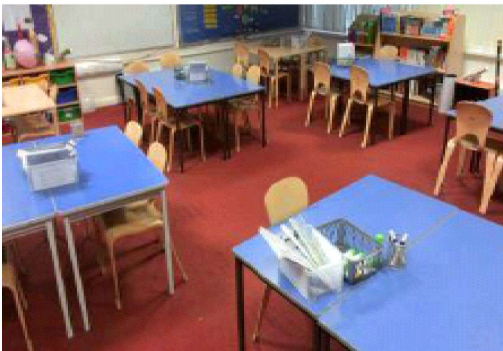
### **Item 35: Presumed**

The bitumen adhesive to the floor in the classroom (Room 35) is presumed to contain asbestos.

Any changes in its appearance should be noted and passed to Property Services.

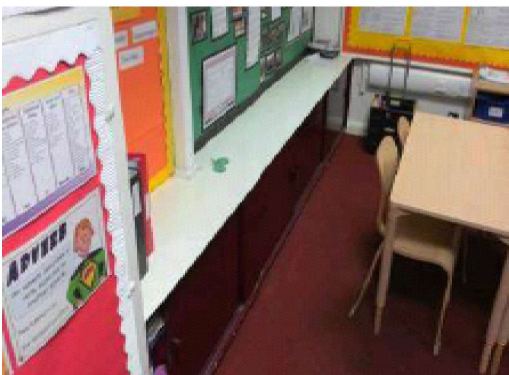
### **Item 36: Presumed**

The skirting to the base of the wall behind the cupboards in the classroom (Room 35) was presumed to contain asbestos.

***This was removed in July 2015.***

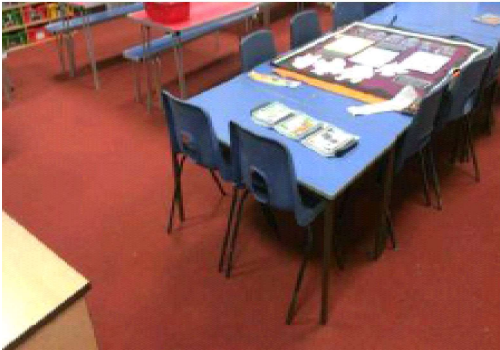
### **Item 37: Presumed**

The bitumen adhesive to the floor in the classroom (Room 36) is presumed to contain asbestos.

Any changes in its appearance should be noted and passed to Property Services.

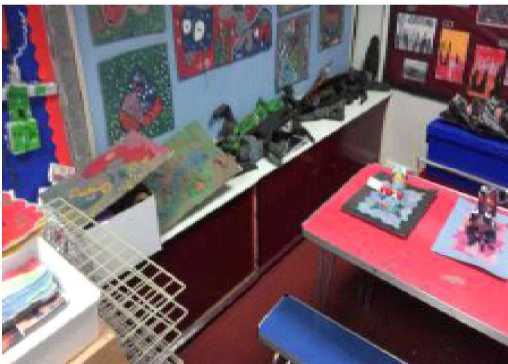
### **Item 38: Presumed**

The skirting to the base of the wall behind the cupboards in the classroom (Room 36) was presumed to contain asbestos.

***This was removed in July 2015.***

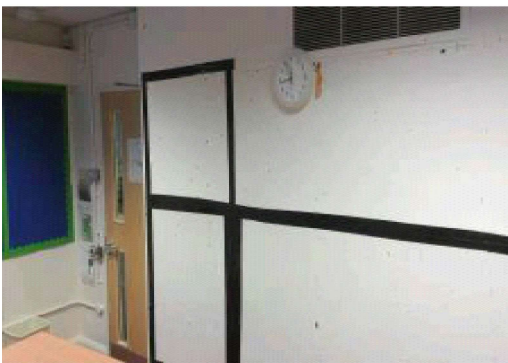
### **Item 39: Presumed**

The lagging to the pipework within the heater boxing in the classroom (Room 36) was presumed to contain asbestos.

**This was removed by Building Needs in July 2015.**

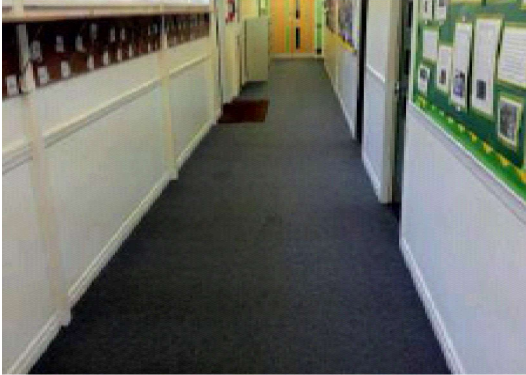
### **Item 40: Presumed**

The bitumen adhesive to the floor below the cement skim to the floor in the corridor (Room 40) is presumed to contain asbestos.

Any changes in its appearance should be noted and passed to Property Services.

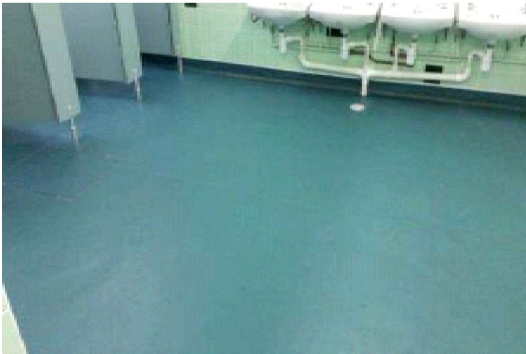
### **Item 41: Presumed**

The vinyl floor tiles beneath the modern lino in the girls wc (Room 41) is presumed to contain asbestos.

Any changes in its appearance should be noted and passed to Property Services.

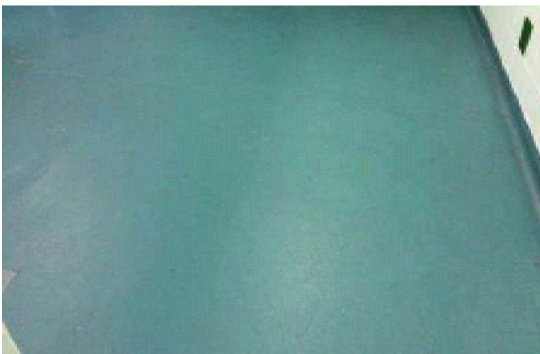
### **Item 42: Presumed**

The bitumen adhesive beneath the modern lino in the girls wc (Room 41) is presumed to contain asbestos.

Any changes in its appearance should be noted and passed to Property Services.

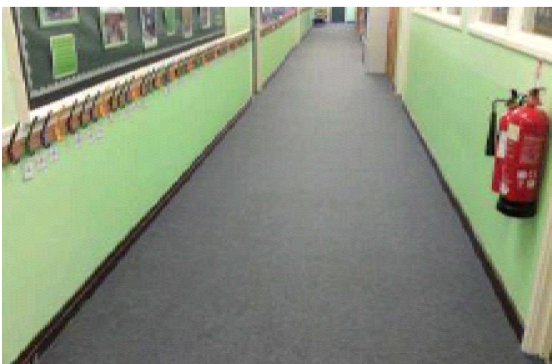
### **Item 45: Presumed**

The bitumen adhesive to the floor in the corridor (Room 43) is presumed to contain asbestos.

Any changes in its appearance should be noted and passed to Property Services.

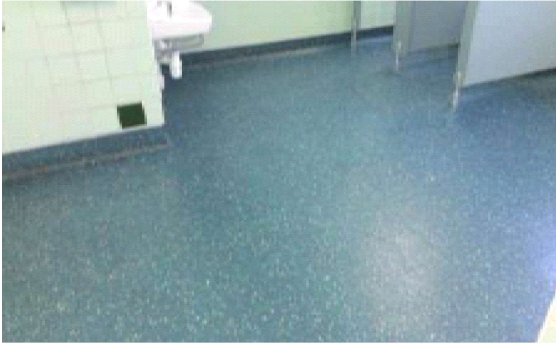
### **Item 46: Presumed**

The vinyl floor tiles beneath the modern lino in the Boys wc (Room 44) were presumed to contain asbestos.

***These were removed in July 2015.***

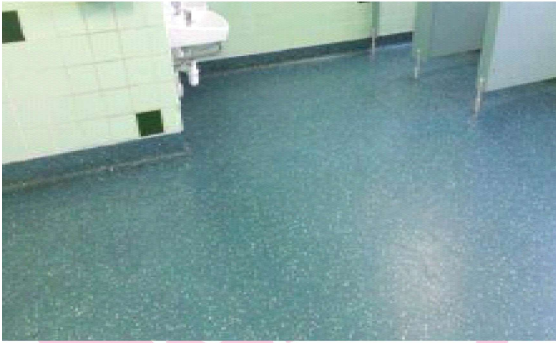
### **Item 47: Presumed**

The bitumen adhesive beneath modern lino in the Boys wc (Room 44) is presumed to contain asbestos.

***This was removed in July 2015.***

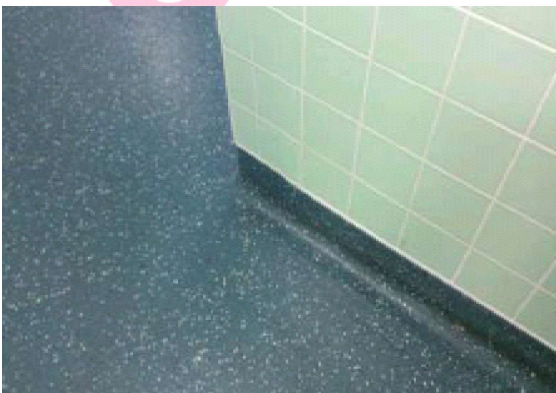
### **Item 48: As KR09/86**

The skirting to wall beneath the lino in the Boys wc (Room 44) was presumed to contain asbestos.

***This was removed in July 2015.***

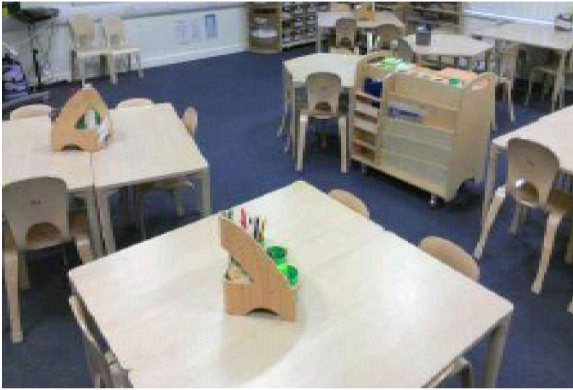
### **Item 49: Presumed**

The bitumen adhesive to the floor below the cement skim to the floor in the classroom (Room 45) is presumed to contain asbestos.

Any changes in its appearance should be noted and passed to Property Services.

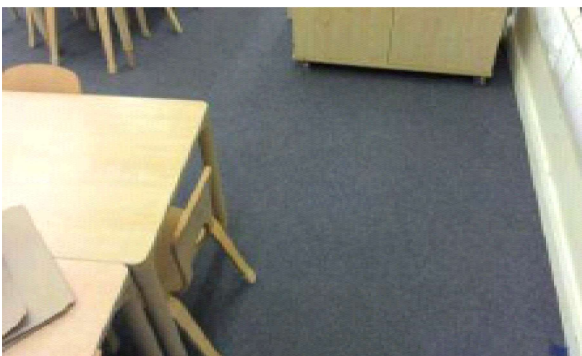
### **Item 51: Presumed**

The bitumen adhesive beneath carpet in the classroom (Room 46) is presumed to contain asbestos.

Any changes in its appearance should be noted and passed to Property Services.

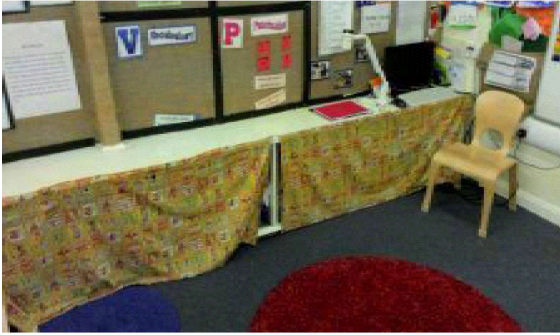
### **Item 52: Presumed**

The skirting to wall beneath the lino in the classroom behind the cupboards (Room 46) was presumed to contain asbestos.

***This was removed in July 2015.***

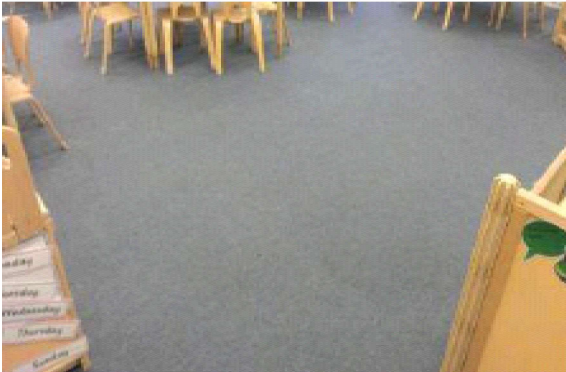
### **Item 53: Presumed**

The vinyl floor tiles beneath the carpet in the classroom (Room 47) are presumed to contain asbestos.

***This was removed August 2017.***

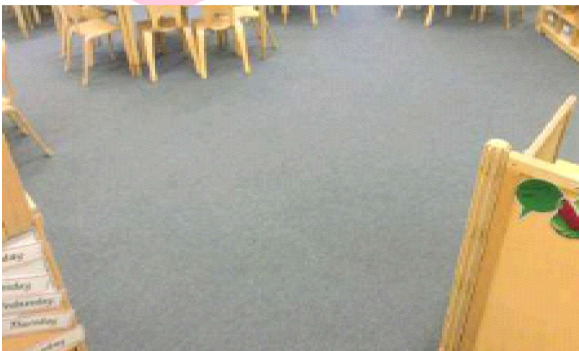
### **Item 54: Presumed**

The bitumen adhesive beneath carpet in the classroom (Room 47) is presumed to contain asbestos.

Any changes in its appearance should be noted and passed to Property Services.

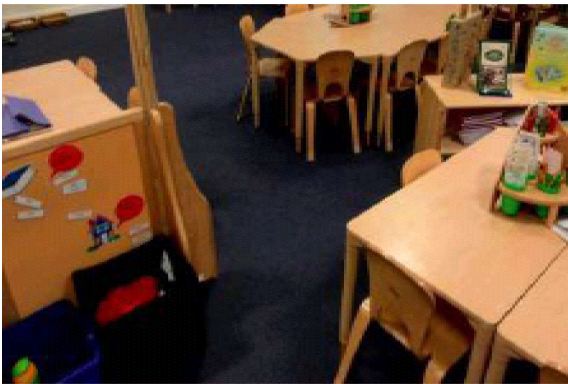
### **Item 56: Presumed**

The bitumen adhesive to the floor below the cement skim to the floor in the classroom (Room 48) is presumed to contain asbestos.

Any changes in its appearance should be noted and passed to Property Services.

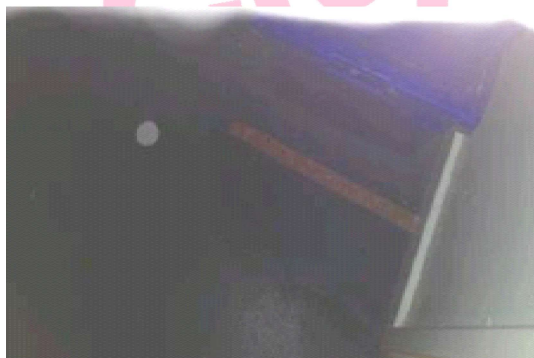
### **Item 63: Presumed**

The vinyl floor tiles beneath the carpet in the store (Room 55) were presumed to contain asbestos.

***These were removed in July 2015.***

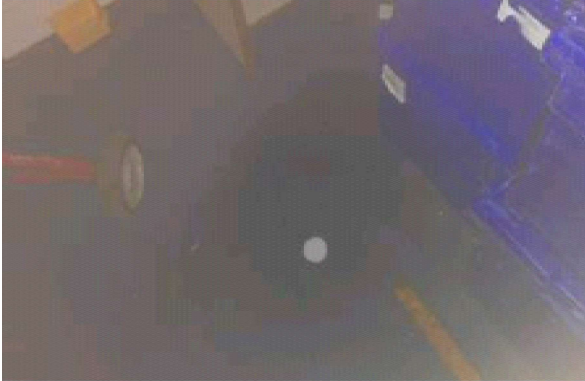
### **Item 64: Presumed**

The bitumen adhesive to the floor in the store room (Room 55) is presumed to contain asbestos.

Any changes in its appearance should be noted and passed to Property Services.

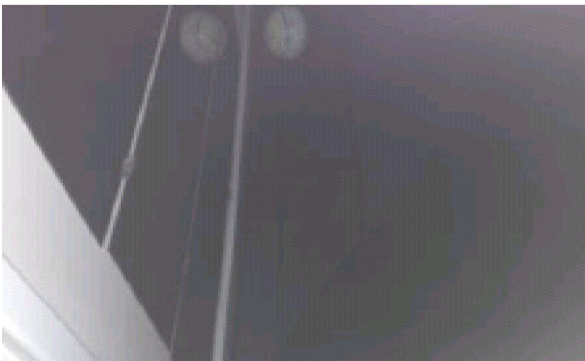
### **Item 66: Presumed**

The bitumen adhesive to the floor in the office (Room 56) is presumed to contain asbestos.

Any changes in its appearance should be noted and passed to Property Services.

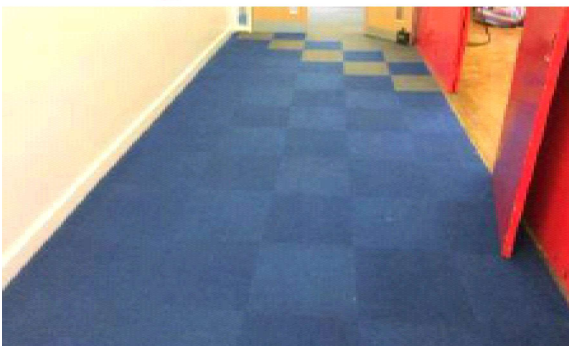
### **Item 81: Presumed**

The bitumen adhesive to the floor in the corridor (Room 74) is presumed to contain asbestos.

Any changes in its appearance should be noted and passed to Property Services.

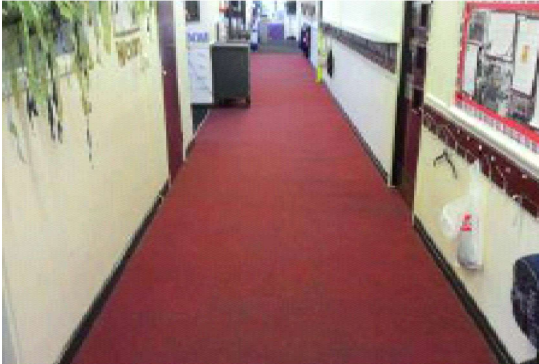
### **Item 85: Presumed**

The bitumen adhesive to the floor in the corridor (Room 79) is presumed to contain asbestos.

Any changes in its appearance should be noted and passed to Property Services.

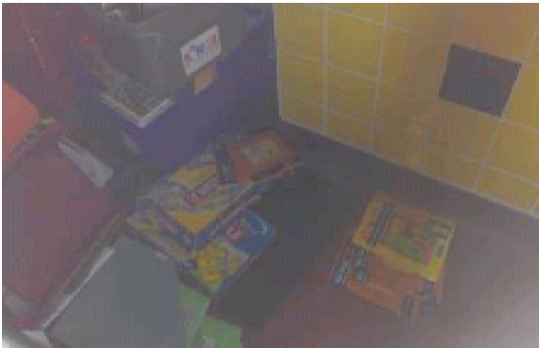
### **Item 86: Presumed**

The vinyl floor tiles beneath the lino in the store (Room 80) are presumed to contain asbestos.

***This was removed August 2017.***

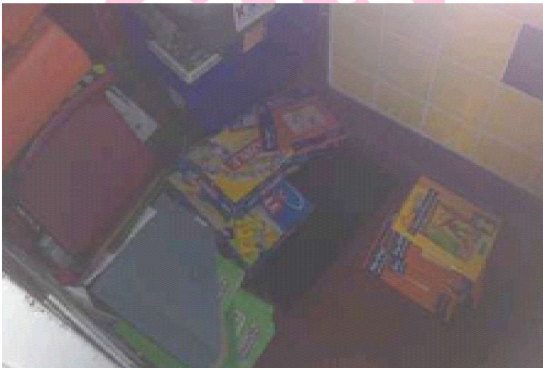
### **Item 87: Presumed**

The bitumen adhesive to the floor in the store (Room 80) is presumed to contain asbestos.

Any changes in its appearance should be noted and passed to Property Services.

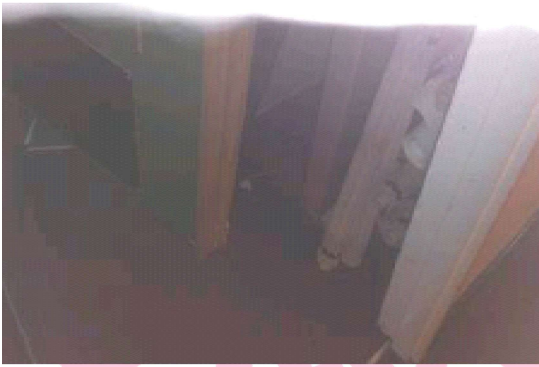
### **Item 89: Presumed**

The bitumen adhesive to the floor in the store (Room 81) is presumed to contain asbestos.

Any changes in its appearance should be noted and passed to Property Services.

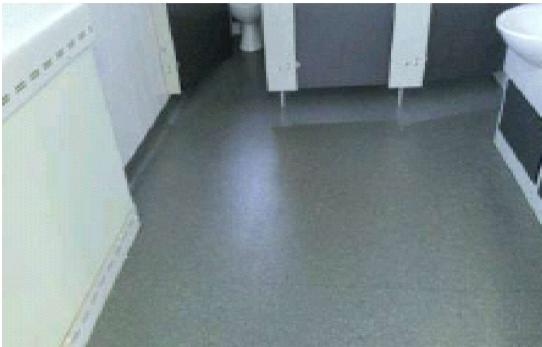
### **Item 92: Presumed**

The bitumen adhesive to the floor below the cement skim to the floor in the Girls toilet (Room 85) is presumed to contain asbestos.

Any changes in its appearance should be noted and passed to Property Services.

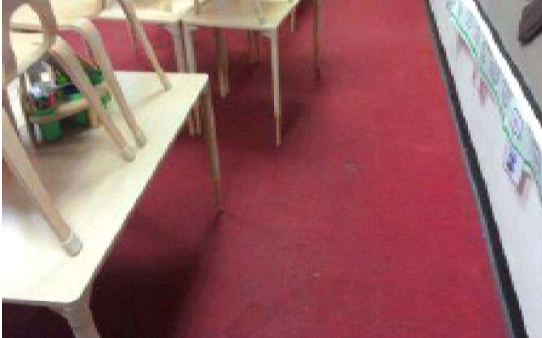
### **Item 94: Presumed**

The vinyl floor tiles beneath the carpet in the classroom (Room 87) are presumed to contain asbestos.

***This was removed August 2017.***

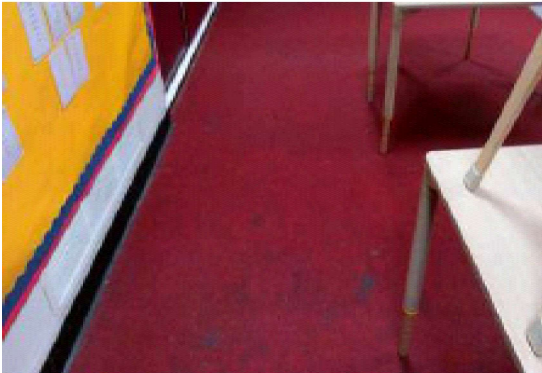
### **Item 95: Presumed**

The bitumen adhesive to the floor in the classroom (Room 87) is presumed to contain asbestos.

Any changes in its appearance should be noted and passed to Property Services.

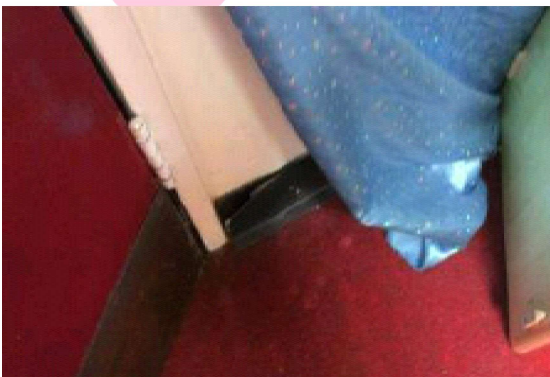
### **Item 96: Presumed**

The skirting to base of wall behind modern in the classroom (Room 87) is presumed to contain asbestos.

***This was removed August 2017.***

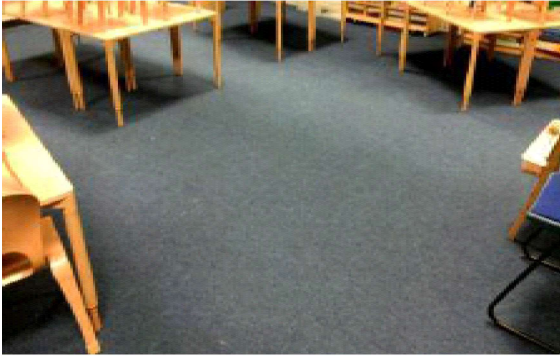
### **Item 97: Presumed**

The bitumen adhesive beneath the carpet in the classroom (Room 88) is presumed to contain asbestos.

Any changes in its appearance should be noted and passed to Property Services.

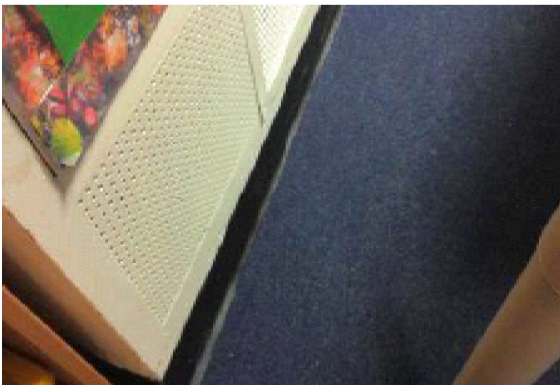
### **Item 98: Presumed**

The skirting to base of wall behind modern in the classroom (Room 88) is presumed to contain asbestos.

***This was removed August 2017.***

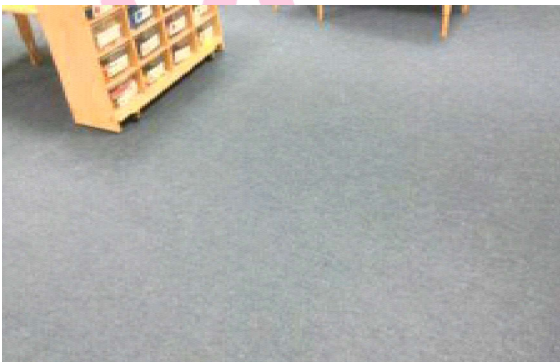
### **Item 99: Presumed**

The bitumen adhesive beneath the carpet in the classroom (Room 89) is presumed to contain asbestos.

Any changes in its appearance should be noted and passed to Property Services.

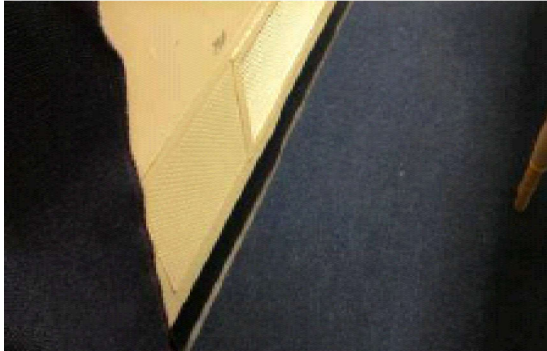
### **Item 100: Presumed**

The skirting to base of wall behind modern in the classroom (Room 89) is presumed to contain asbestos.

***This was removed August 2017.***

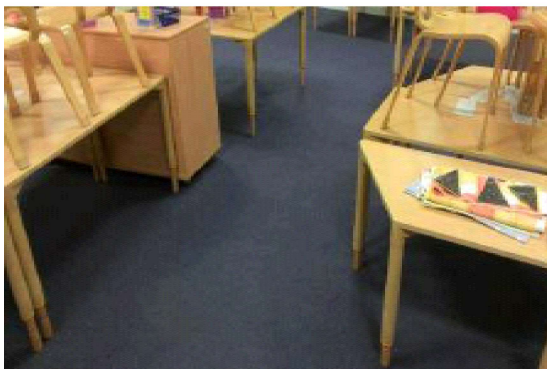
### **Item 101: Presumed**

The bitumen adhesive below the cement skim to the floor in the classroom (Room 90) is presumed to contain asbestos.

Any changes in its appearance should be noted and passed to Property Services.

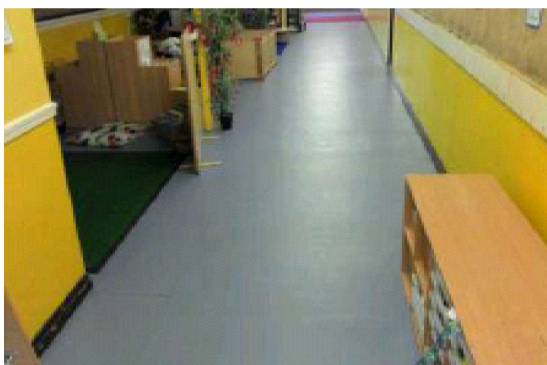
### **Item 102: Presumed**

The vinyl floor tiles beneath the modern lino in the corridor (Room 94) are presumed to contain asbestos.

Any changes in its appearance should be noted and passed to Property Services.

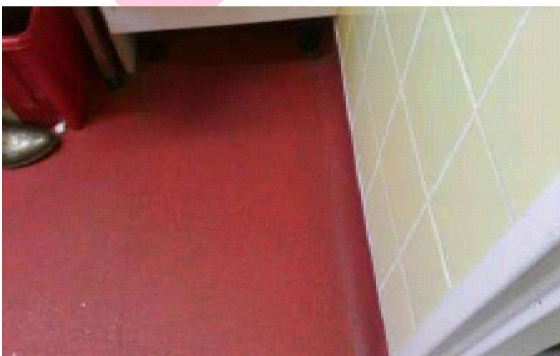
### **Item 105: As KR09/86**

The skirting to base of wall in the store (Room 95) is presumed to contain asbestos.

Any changes in its appearance should be noted and passed to Property Services.

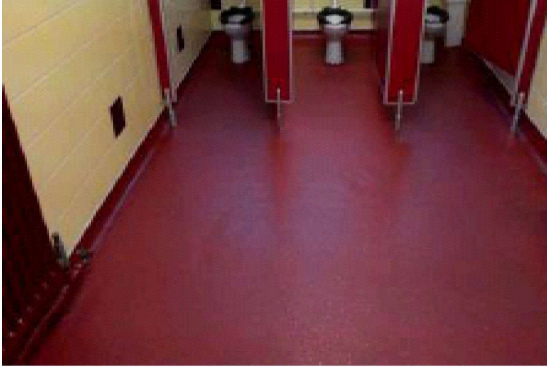
### **Item 106: Presumed**

The vinyl floor tiles beneath the modern lino in the Girls toilets (Room 96) are presumed to contain asbestos.

Any changes in its appearance should be noted and passed to Property Services.

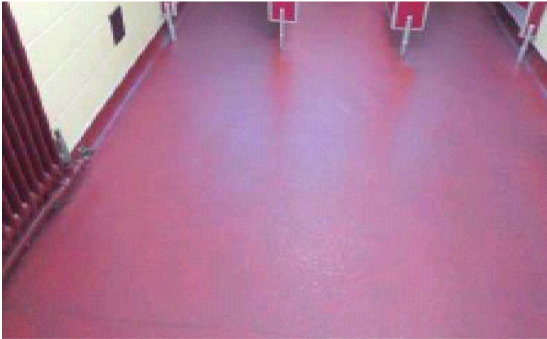
### **Item 107: Presumed**

The bitumen adhesive beneath the modern lino to the Girls toilets (Room 96) is presumed to contain asbestos.

Any changes in its appearance should be noted and passed to Property Services.

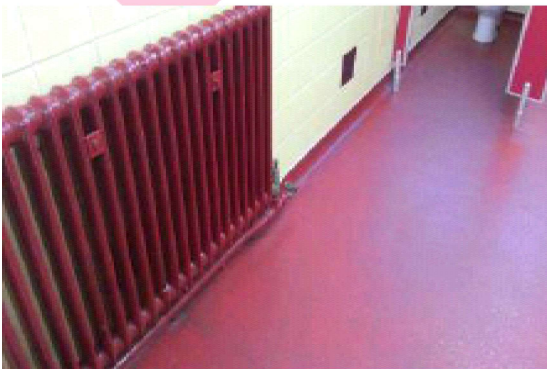
### **Item 108: Presumed**

The skirting to base of wall behind modern lino in the Girls toilets (Room 96) is presumed to contain asbestos.

Any changes in its appearance should be noted and passed to Property Services.

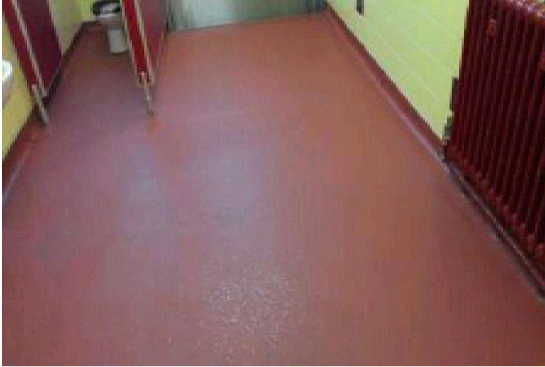
### **Item 109: Presumed**

The vinyl floor tiles beneath the modern lino in the Boys toilets (Room 97) are presumed to contain asbestos.

Any changes in its appearance should be noted and passed to Property Services.

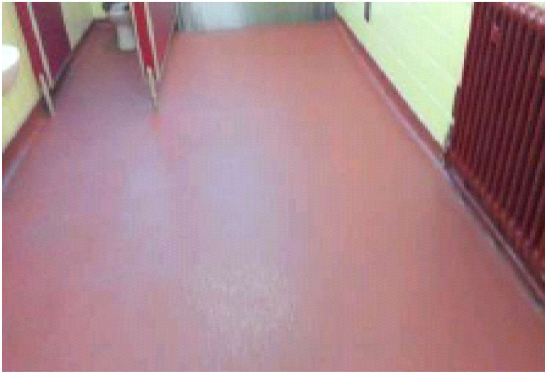
### **Item 110: Presumed**

The bitumen adhesive beneath the modern lino to the Boys toilets (Room 97) is presumed to contain asbestos.

Any changes in its appearance should be noted and passed to Property Services.

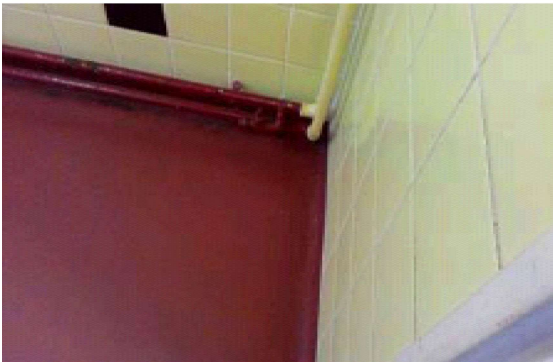
### **Item 111: Presumed**

The skirting to base of wall behind modern lino in the Boys toilets (Room 97) is presumed to contain asbestos.

Any changes in its appearance should be noted and passed to Property Services.

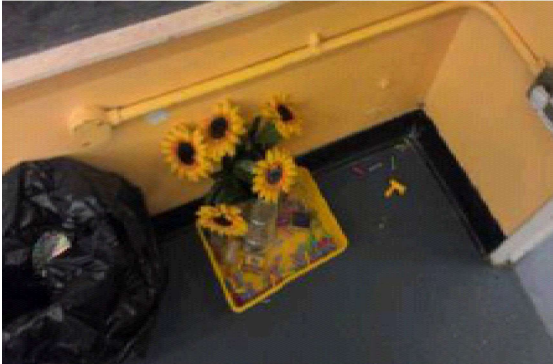
### **Item 112: NSPS/003**

The skirting to base of wall behind modern lino in the classroom (Room 007) does not contain asbestos.

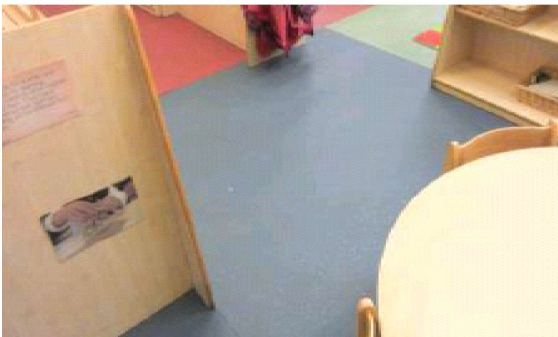
### **Item 113: NSPS/002**

The bitumen adhesive beneath the modern lino to the classroom (Room 007) contains asbestos.

Any changes in its appearance should be noted and passed to Property Services.

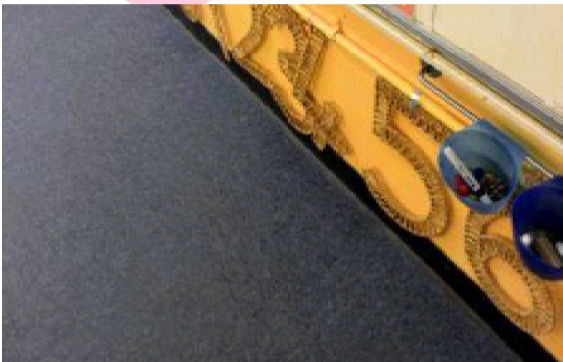
### **Item 114: NSPS/003**

The skirting to base of wall behind modern in the classroom (Room 006) does not contain asbestos.

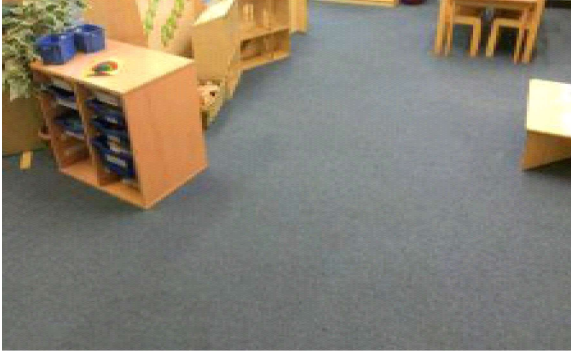
### **Item 115: NSPS/002**

The bitumen adhesive beneath the carpet in the classroom (Room 006) contains asbestos.

Any changes in its appearance should be noted and passed to Property Services.

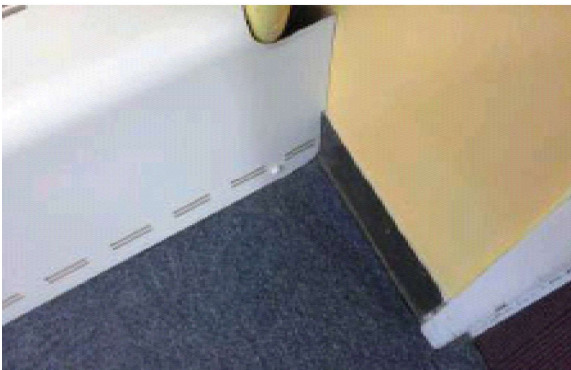
### **Item 116: NSPS/003**

The skirting to base of wall in the classroom (Room 005) does not contain asbestos.

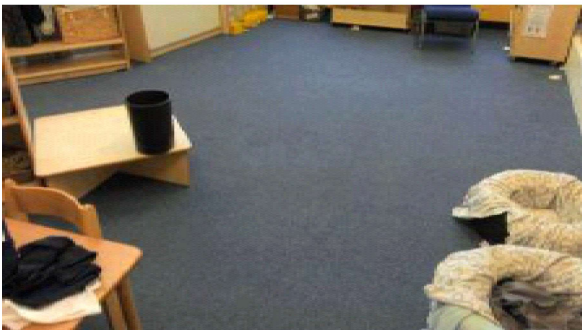
### **Item 117: Presumed**

The bitumen adhesive beneath the carpet in the classroom (Room 102) is presumed to contain asbestos.

Any changes in its appearance should be noted and passed to Property Services.

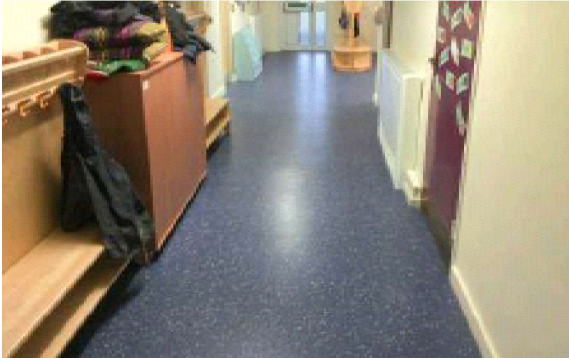
### **Item 118: Presumed**

The bitumen adhesive below the cement skim to the corridor / lobby (Room 103) is presumed to contain asbestos.

Any changes in its appearance should be noted and passed to Property Services.

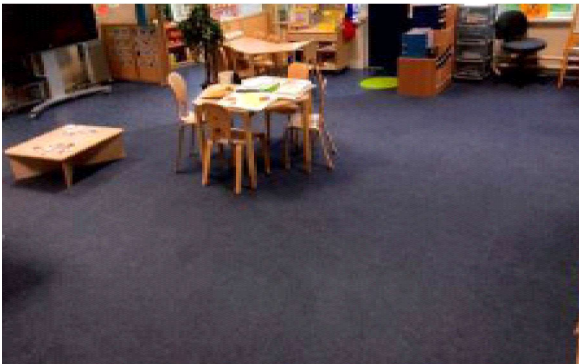
### **Item 119: Presumed**

The bitumen adhesive beneath the cement skim to the classroom (Room 104) is presumed to contain asbestos.

Any changes in its appearance should be noted and passed to Property Services.

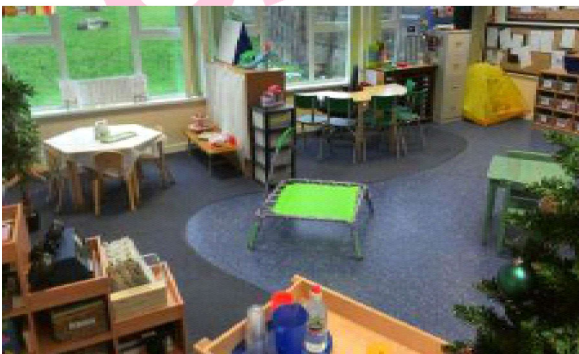
### **Item 120: Presumed**

The bitumen adhesive beneath the cement skim to the classroom (Room 105) is presumed to contain asbestos.

Any changes in its appearance should be noted and passed to Property Services.

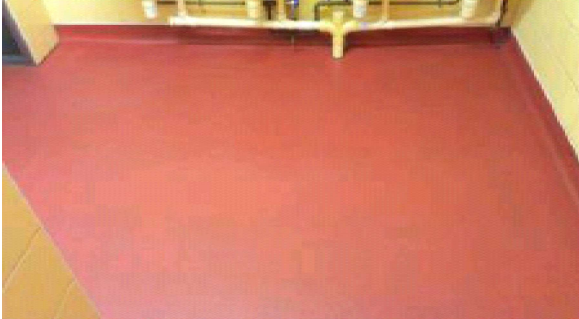
### **Item 121: Presumed**

The vinyl floor tiles beneath the modern lino in the Boys toilets (Room 108) are presumed to contain asbestos.

Any changes in its appearance should be noted and passed to Property Services.

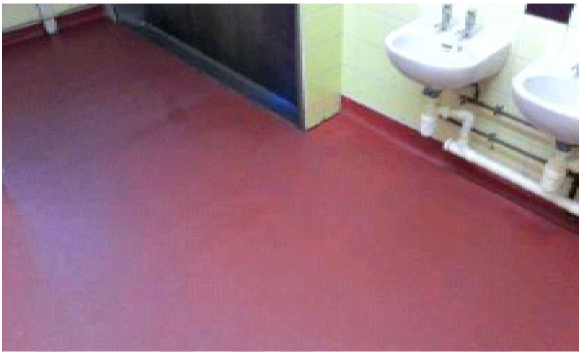
### **Item 122: Presumed**

The bitumen adhesive beneath the modern lino to the Boys toilet (Room 108) is presumed to contain asbestos.

Any changes in its appearance should be noted and passed to Property Services.

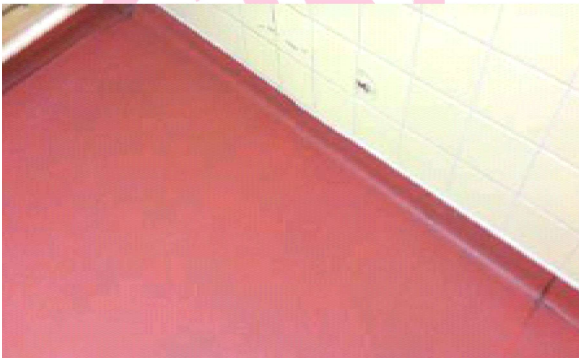
### **Item 123: Presumed**

The skirting to base of wall behind modern lino in the boys toilet (Room 108) is presumed to contain asbestos.

Any changes in its appearance should be noted and passed to Property Services.

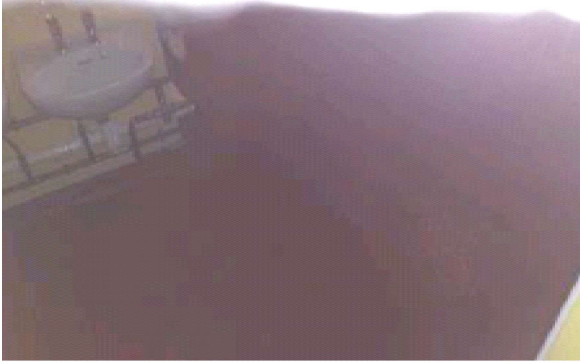
### **Item 124: Presumed**

The vinyl floor tiles beneath the modern lino in the Girls toilets (Room 110) are presumed to contain asbestos.

Any changes in its appearance should be noted and passed to Property Services.

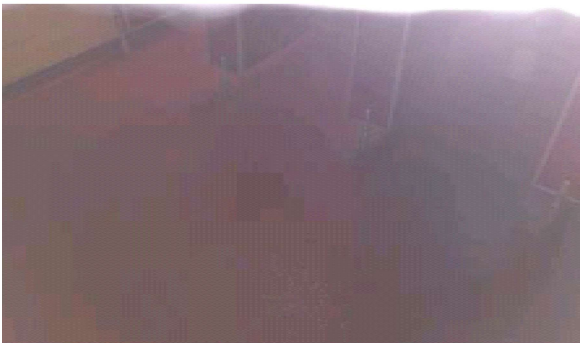
### **Item 125: Presumed**

The bitumen adhesive beneath the modern lino to the Girls toilets (Room 110) is presumed to contain asbestos.

Any changes in its appearance should be noted and passed to Property Services.

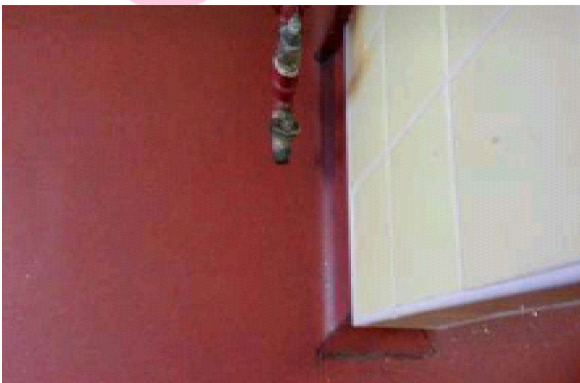
### **Item 126: Presumed**

The skirting to base of wall behind modern lino in the Girls toilet (Room 110) is presumed to contain asbestos.

Any changes in its appearance should be noted and passed to Property Services.

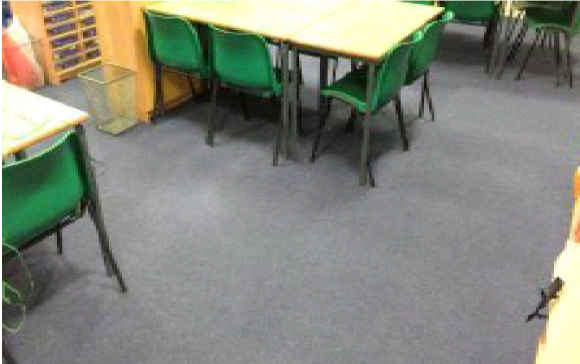
### **Item 127: Presumed**

The bitumen adhesive to the floor below the cement skim to the classroom (Room 112) is presumed to contain asbestos.

Any changes in its appearance should be noted and passed to Property Services.
