### ASBESTOS SURVEY REPORT FOR NORTHERN SAINTS C OF E PRIMARY SCHOOL, SUNDERLAND

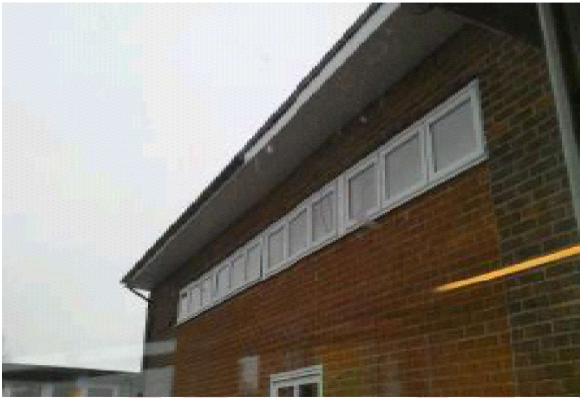
### **Item 128: NSPS/004**

The corrugated soffits (throughout) to the external of the building contain asbestos.

Any changes in its appearance should be noted and passed to Property Services.

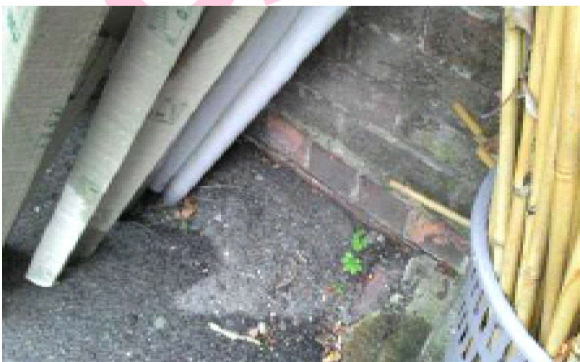
### **Item 129: KR09/140**

The damp proof course to the external of the building contains asbestos.

Any changes in its appearance should be noted and passed to Property Services.

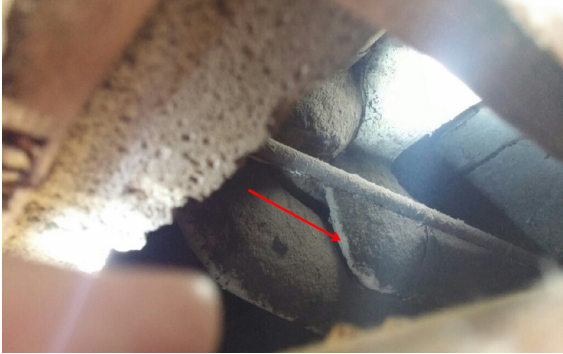
### **Item 130: Presumed**

The pipe lagging within the heater cupboard is presumed to contain asbestos.

Any changes in its appearance should be noted and passed to Property Services.

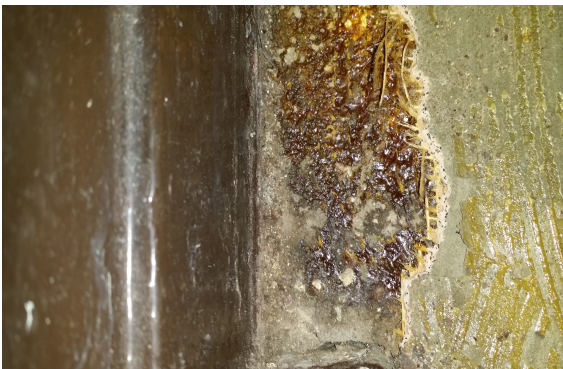
### **Item 132: 107693-1**

The adhesive backing to lino subfloor to the ramped corridor does contain asbestos.

Any changes in its appearance should be noted and passed to Property Services.

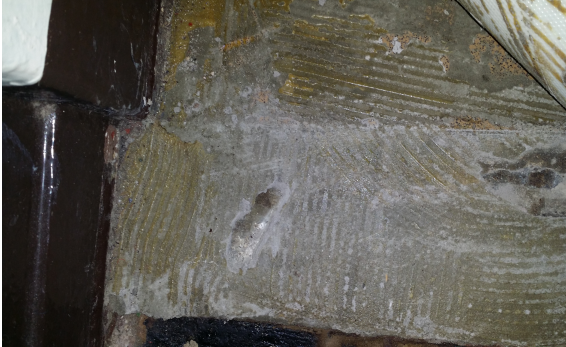
**Item 133: 107693-2**

The subfloor to the ramped corridor does not contain asbestos.

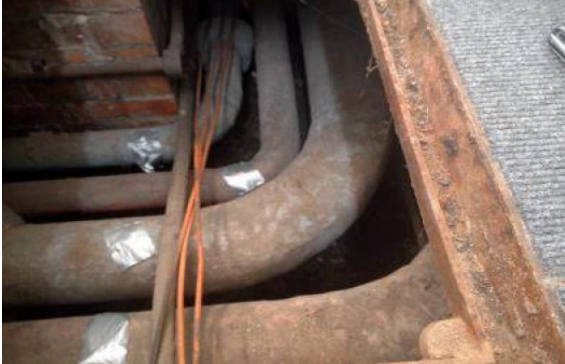
### **Item 142: BH000580**

The debris to duct hatch lip at duct entrance in the duct adjacent head teacher's office does not contain asbestos.

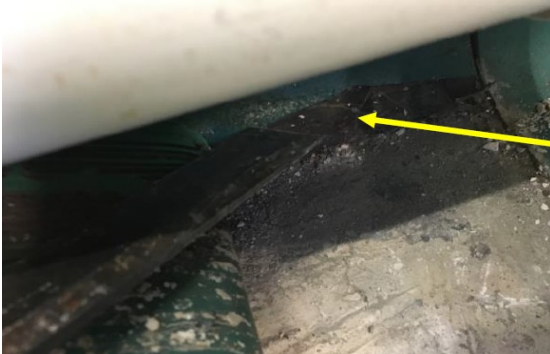
**Item 145: BS001667**

The black skirting beneath lino in the Year 6 Girls toilets does not contain asbestos.

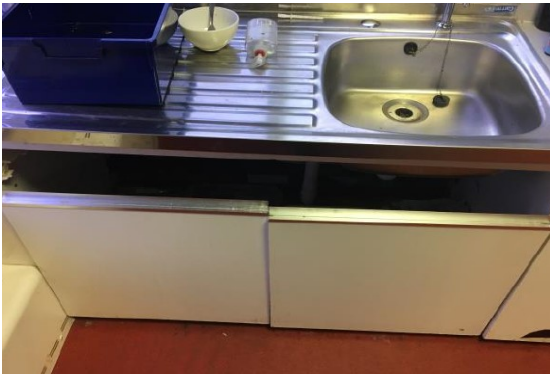
**Item 146: BS001670**

The sink pad in the year 4 Classroom does not contain asbestos.

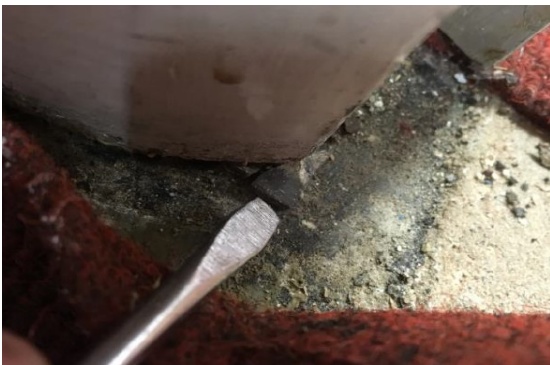
**Item 147: BS001671**

The floor tile remnants beneath carpet in the year 4 Classroom does not contain asbestos.

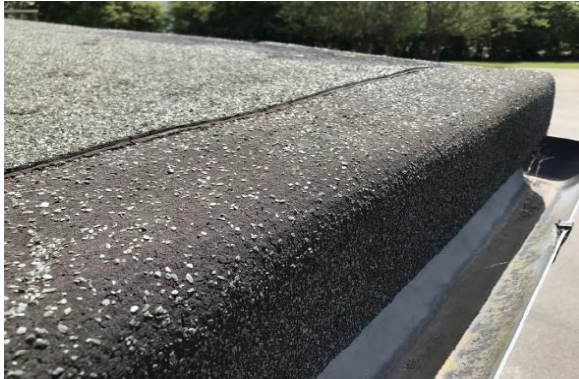
**Item 148: BS017804**

The roof felt (External) does not contain asbestos.

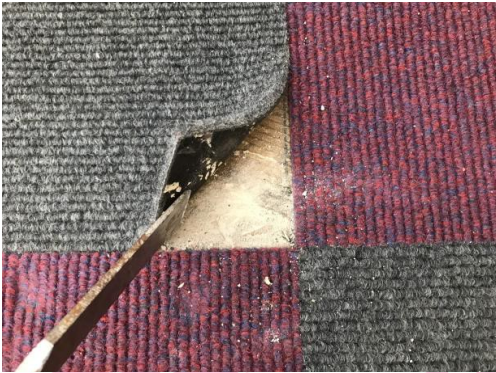
**Item 149: BS017806**

The floor screed to the floor below the carpet tiles in Internal cloakroom (to be WC) contains asbestos.

Any changes in its appearance should be noted and passed to Property Services.

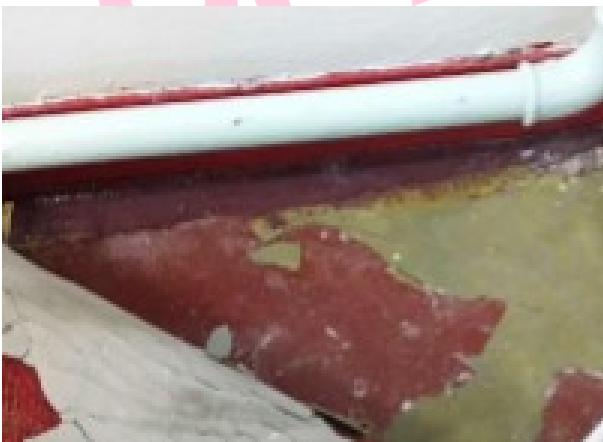
**Item 150: 21-30151-1**

The floor below carpet and screed (bitumen) in the classroom does not contain asbestos.

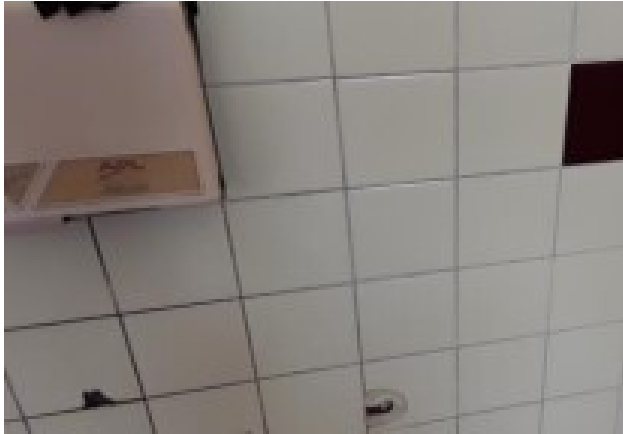
**Item 151: 21-36878-1**

The adhesive to the ceramic tiles to walls in (Area 1/Boys toilet) does not contain asbestos.

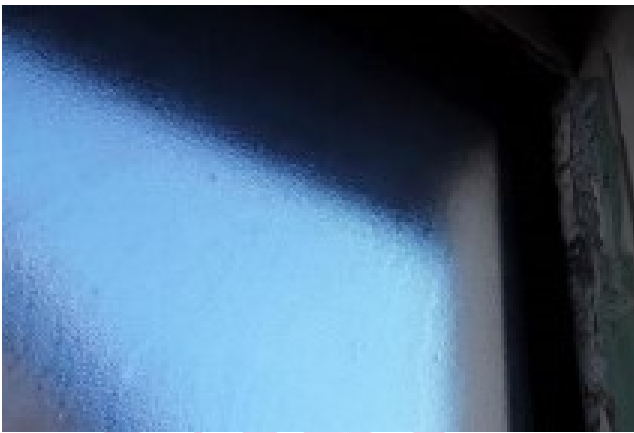
**Item 152: 21-36878-2**

The sealant to the old window frame (Area 1/Boys toilet) does not contain asbestos.

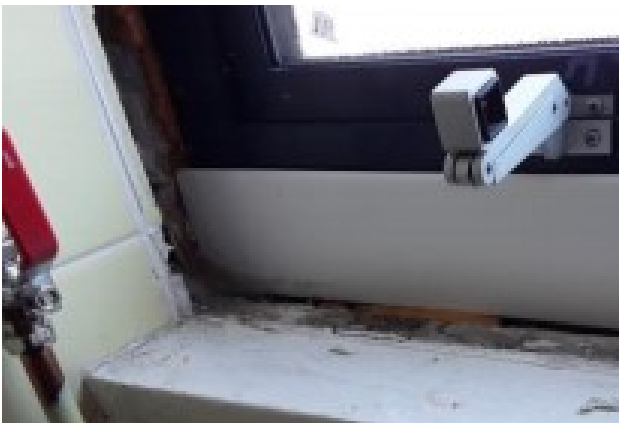
**Item 153: 21-36878-2**

The sealant to the old window frame (Area 2/Girls toilet) does not contain asbestos.

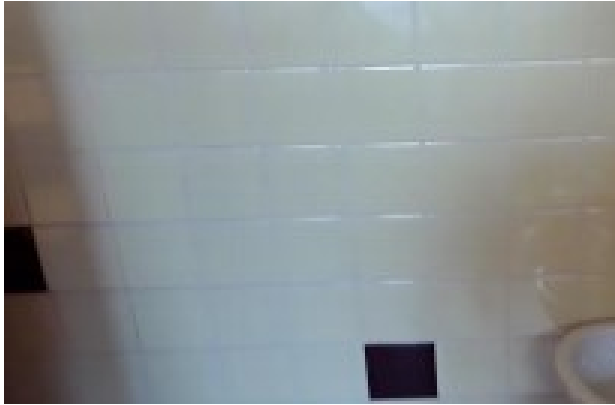
**Item 154: 21-36878-3**

The adhesive to the ceramic tiles to walls in (Area 2/Girls toilet) does not contain asbestos.

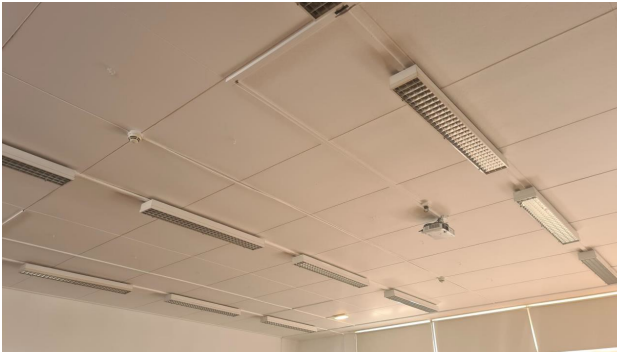
**Item 155: NSPS/001**

The ceiling tiles (G/001/Hall) does not contain asbestos.

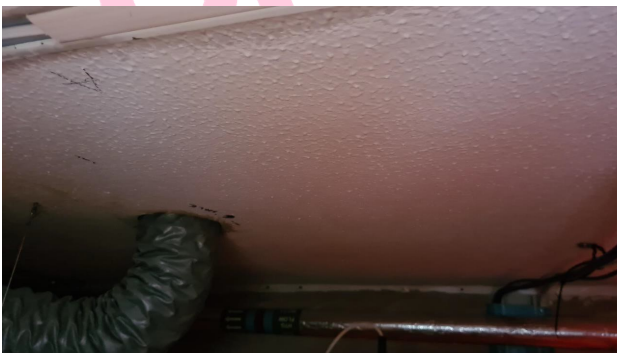
**Item 156: NSPS/005**

The textured coating to ceiling above suspended ceiling (G/013/Office) does not contain asbestos.

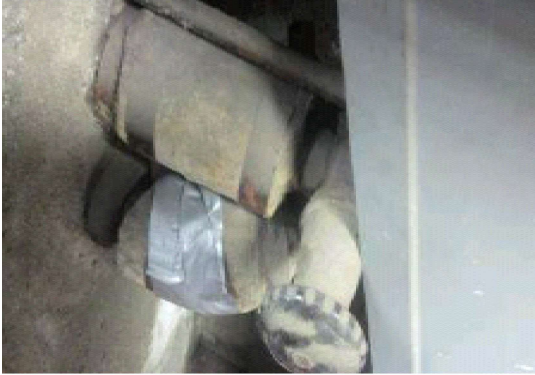
**Ref: EV001734**

The insulation pipe lagging to the heater in Classroom 3/4 contained asbestos.

**This was removed by Building Needs in July 2015.**

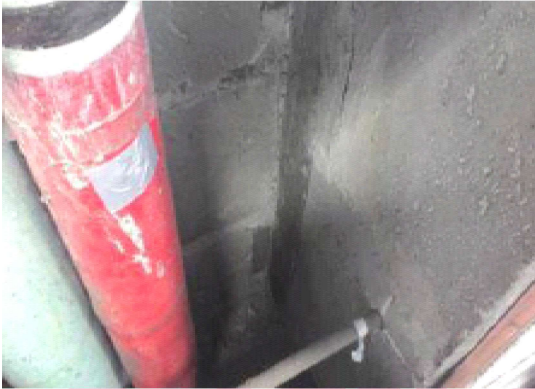
**Ref: EV001735**

The red pipework in the void to the left of the heater in classroom 3/4 contained asbestos.

**This was removed by Building Needs in July 2015.**

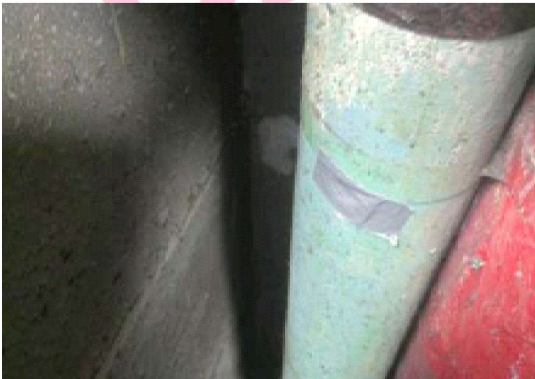
**Ref: EV001736**

The green pipework in the void to the left of the heater in classroom 3/4 contained asbestos.

**This was removed by Building Needs in July 2015.**

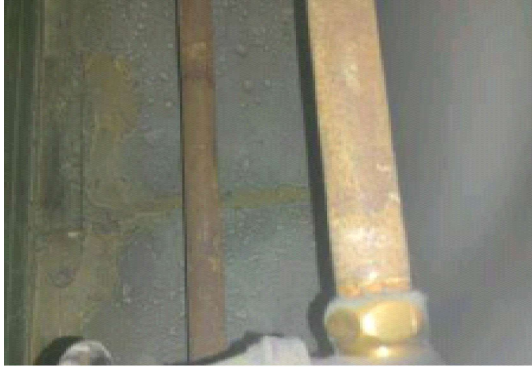
**Ref: EV001737**

A swab sample of the pipework to the upright heater in Year 5 room 2 does not contain asbestos.

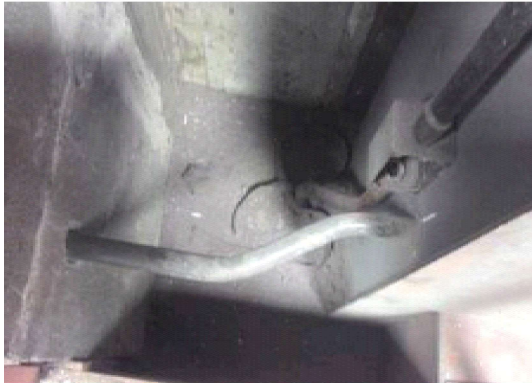
**Ref: EV001738**

A swab sample of the floor to the void to the upright heater in Year 5 room 2 does not contain asbestos.

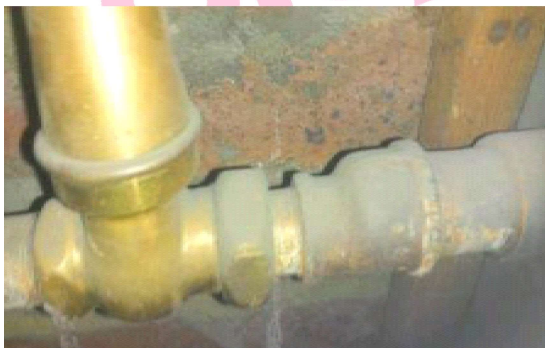
**Ref: EV001739**

The residue to the pipework to the void to the upright heater in Year 2 room 3 does not contain asbestos.

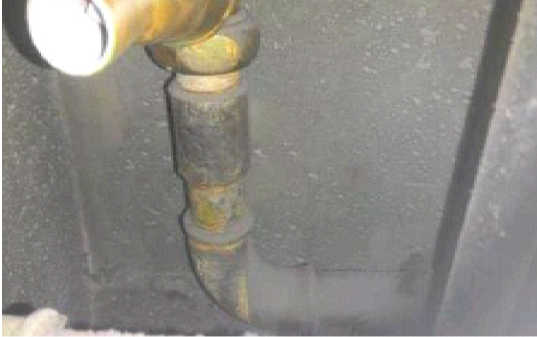
**Ref: EV001740**

The residue to the pipework to the void to the upright heater in Year 2 room 4 does not contain asbestos.

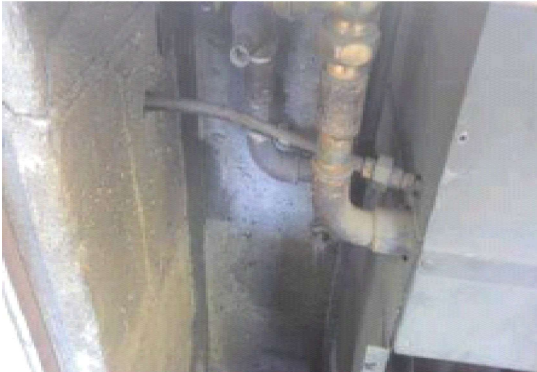
**Ref: EV001741**

The debris on the pipework to the void to the upright heater in Year 1 room 5 does not contain asbestos.

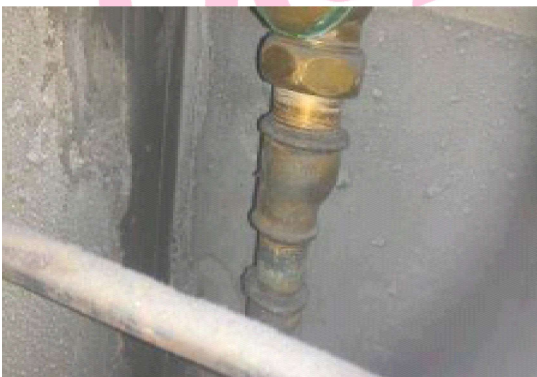
**Ref: EV001742**

The debris on the pipework to the void to the upright heater in Year 1 room 6 does not contain asbestos.

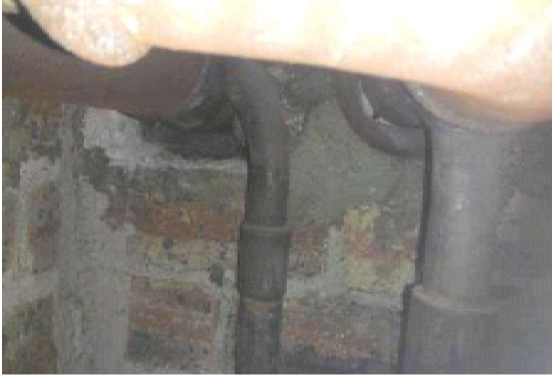
**Ref: EV001743**

The residue to the pipework going into the brickwork at the top of the heaters in Infant Hall unit 1 does not contain asbestos.
