Foreward

ASBESTOS SURVEY REPORT FOR NORTHERN SAINTS C OF E PRIMARY SCHOOL, SUNDERLAND

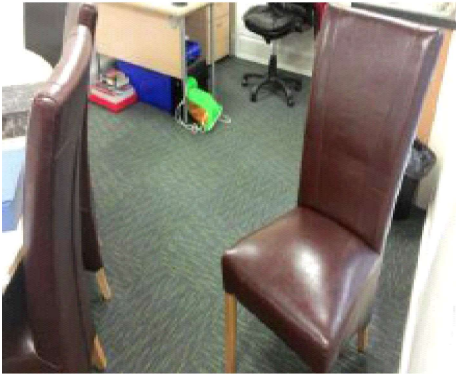
Item 4: Presumed

The bitumen adhesive to the floor below the cement skim to the floor in the office (Room 5) is presumed to contain asbestos.

Any changes in its appearance should be noted and passed to Property Services.

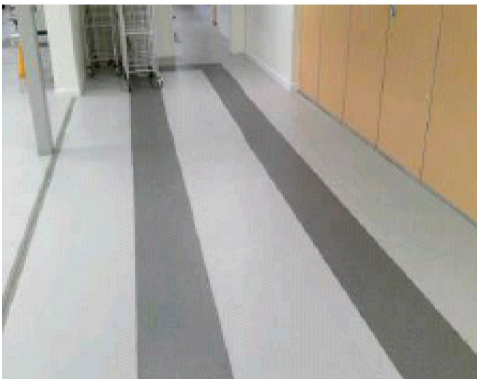
Item 5: Presumed

The bitumen adhesive to the floor below the cement skim to the floor in the main hall lobby (Room 6) is presumed to contain asbestos.

Any changes in its appearance should be noted and passed to Property Services.

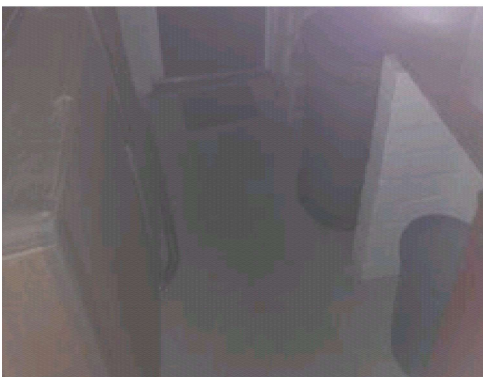
Item 6: Presumed

The bitumen adhesive to the floor below the cement skim to the floor in the kitchen vestibule /store (Room 8) is presumed to contain asbestos.

Any changes in its appearance should be noted and passed to Property Services.

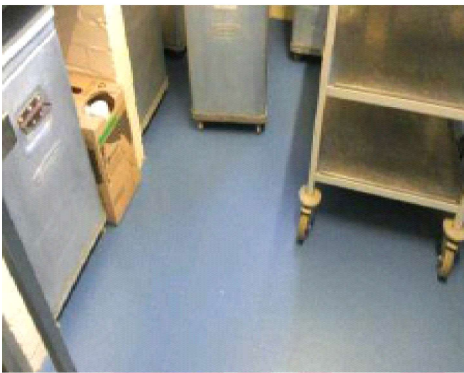
Item 8: Presumed

The bitumen adhesive to the floor below the cement skim to the floor in the kitchen store (Room 9) is presumed to contain asbestos.

Any changes in its appearance should be noted and passed to Property Services.

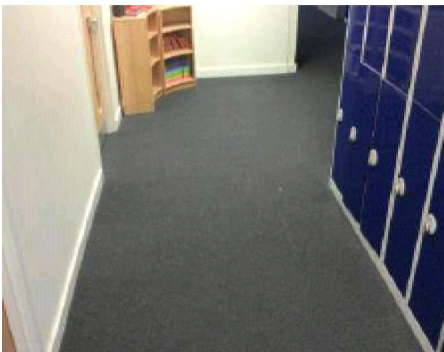
Item 26: Presumed

The bitumen adhesive to the floor below the cement skim to the floor in the corridor (Room 27) is presumed to contain asbestos.

Any changes in its appearance should be noted and passed to Property Services.

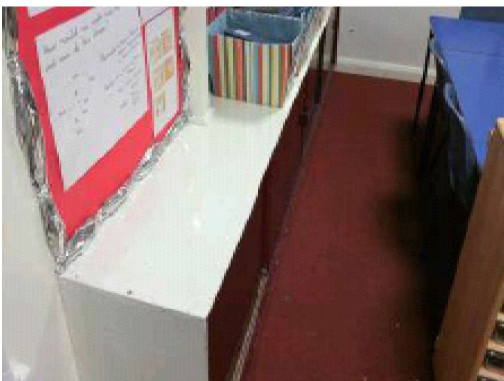
Item 33: Presumed

The skirting to the base of the wall behind the cupboards in the classroom (Room 33) was presumed to contain asbestos.

This was removed in July 2015.

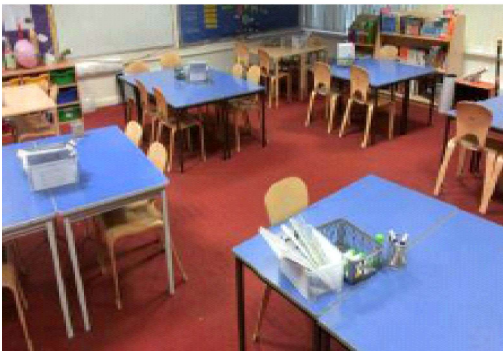
Item 35: Presumed

The bitumen adhesive to the floor in the classroom (Room 35) is presumed to contain asbestos.

Any changes in its appearance should be noted and passed to Property Services.

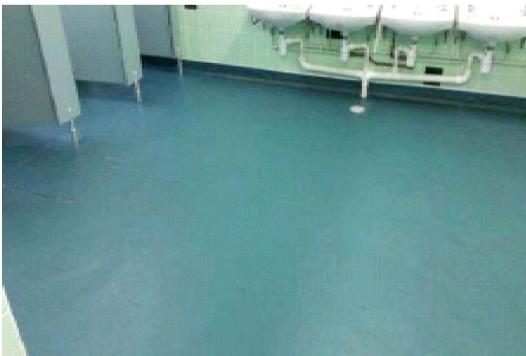
Item 41: Presumed

The vinyl floor tiles beneath the modern lino in the girls wc (Room 41) is presumed to contain asbestos.

Any changes in its appearance should be noted and passed to Property Services.

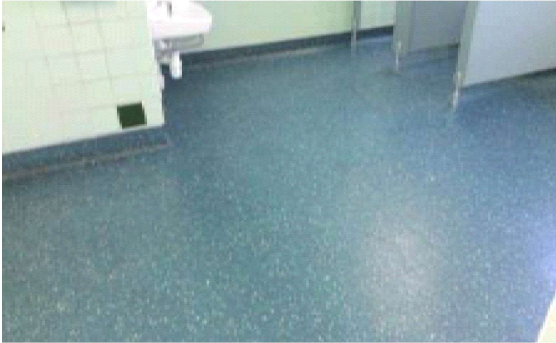
Item 46: Presumed

The vinyl floor tiles beneath the modern lino in the Boys wc (Room 44) were presumed to contain asbestos.

These were removed in July 2015.

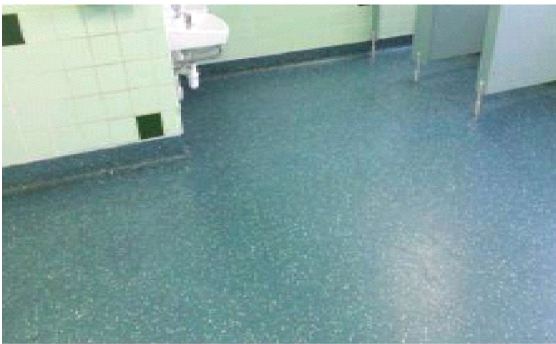
Item 47: Presumed

The bitumen adhesive beneath modern lino in the Boys wc (Room 44) is presumed to contain asbestos.

This was removed in July 2015.

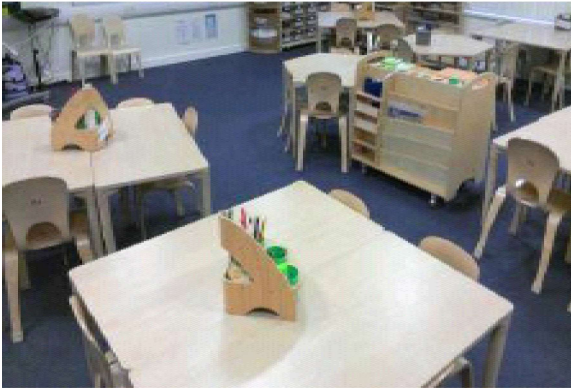
Item 49: Presumed

The bitumen adhesive to the floor below the cement skim to the floor in the classroom (Room 45) is presumed to contain asbestos.

Any changes in its appearance should be noted and passed to Property Services.

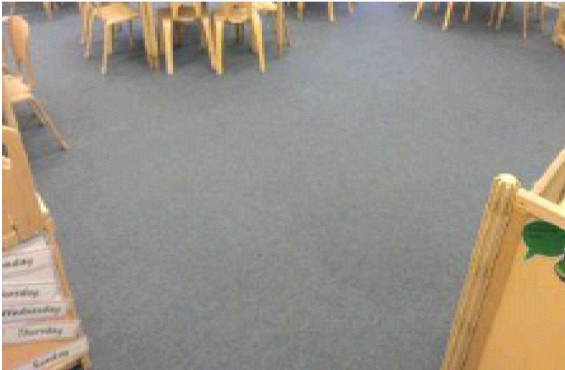
Item 53: Presumed

The vinyl floor tiles beneath the carpet in the classroom (Room 47) are presumed to contain asbestos.

This was removed August 2017.

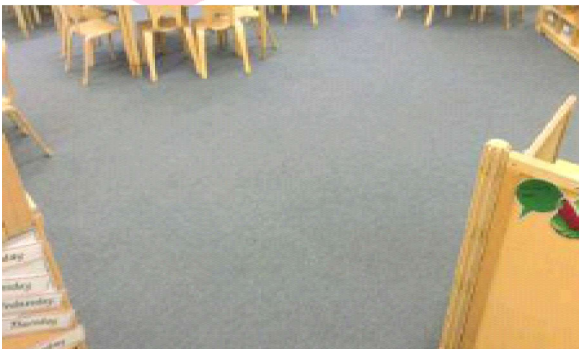
Item 54: Presumed

The bitumen adhesive beneath carpet in the classroom (Room 47) is presumed to contain asbestos.

Any changes in its appearance should be noted and passed to Property Services.

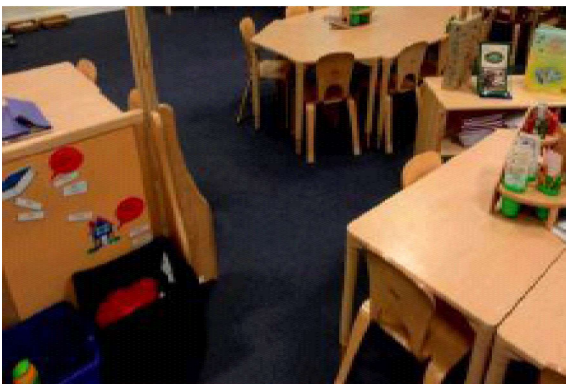
Item 56: Presumed

The bitumen adhesive to the floor below the cement skim to the floor in the classroom (Room 48) is presumed to contain asbestos.

Any changes in its appearance should be noted and passed to Property Services.

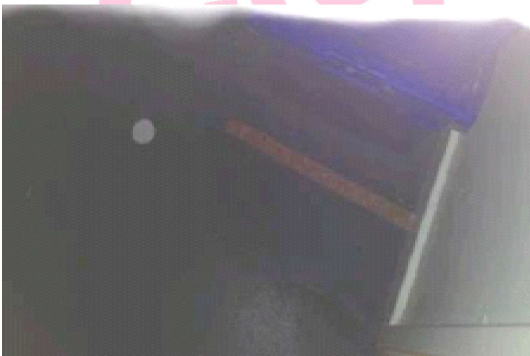
Item 63: Presumed

The vinyl floor tiles beneath the carpet in the store (Room 55) were presumed to contain asbestos.

These were removed in July 2015.

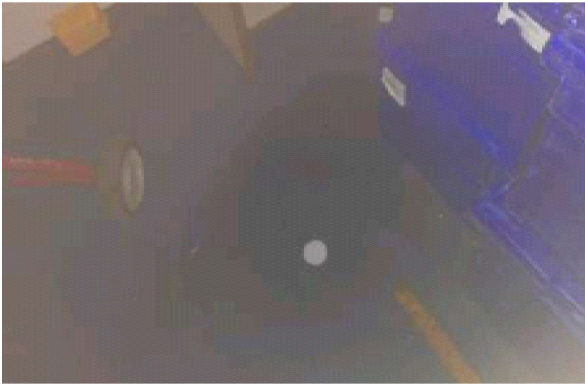
Item 64: Presumed

The bitumen adhesive to the floor in the store room (Room 55) is presumed to contain asbestos.

Any changes in its appearance should be noted and passed to Property Services.

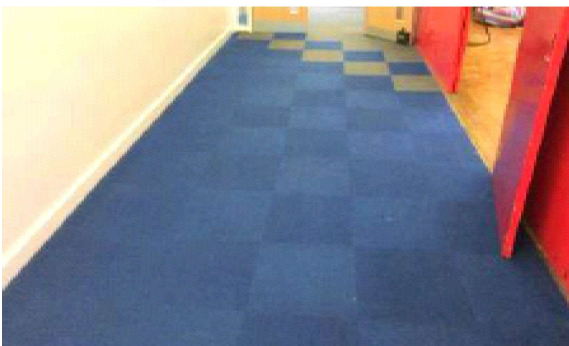
Item 81: Presumed

The bitumen adhesive to the floor in the corridor (Room 74) is presumed to contain asbestos.

Any changes in its appearance should be noted and passed to Property Services.

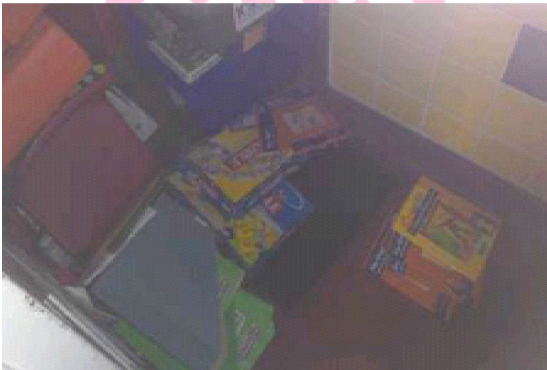
Item 87: Presumed

The bitumen adhesive to the floor in the store (Room 80) is presumed to contain asbestos.

Any changes in its appearance should be noted and passed to Property Services.

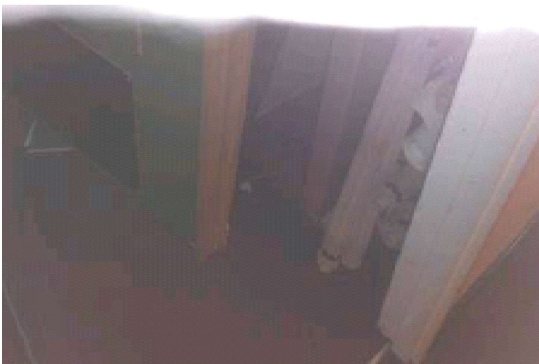
Item 89: Presumed

The bitumen adhesive to the floor in the store (Room 81) is presumed to contain asbestos.

Any changes in its appearance should be noted and passed to Property Services.

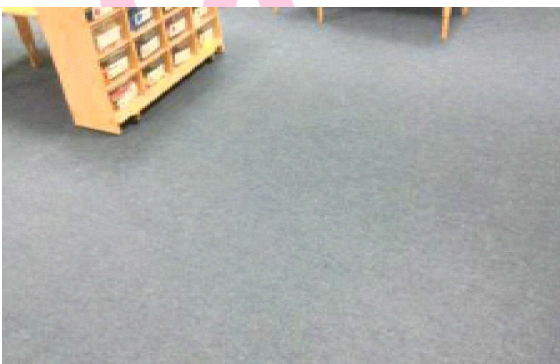
Item 99: Presumed

The bitumen adhesive beneath the carpet in the classroom (Room 89) is presumed to contain asbestos.

Any changes in its appearance should be noted and passed to Property Services.

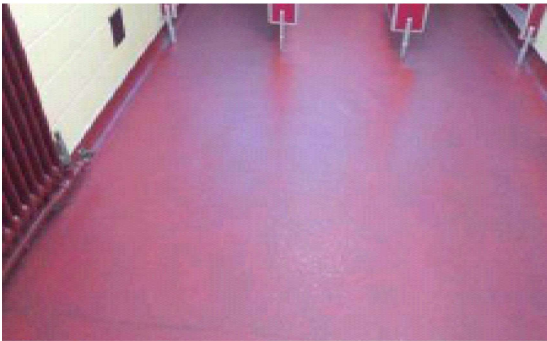
Item 107: Presumed

The bitumen adhesive beneath the modern lino to the Girls toilets (Room 96) is presumed to contain asbestos.

Any changes in its appearance should be noted and passed to Property Services.

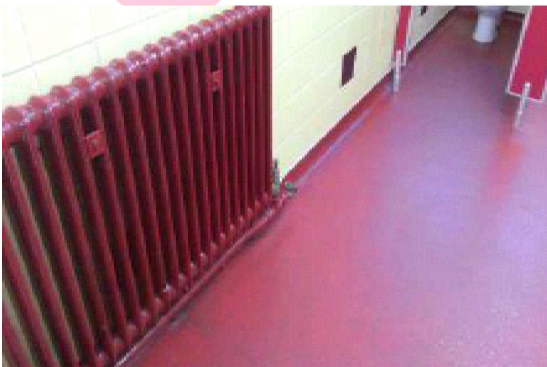
Item 108: Presumed

The skirting to base of wall behind modern lino in the Girls toilets (Room 96) is presumed to contain asbestos.

Any changes in its appearance should be noted and passed to Property Services.

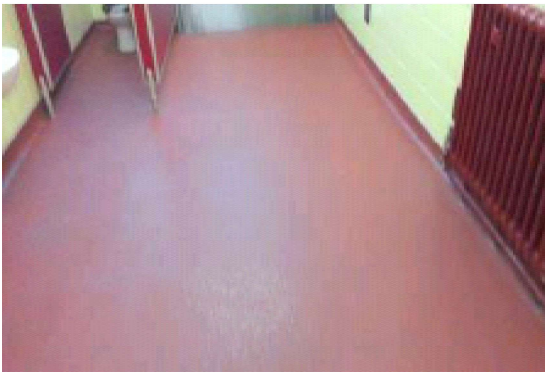
Item 110: Presumed

The bitumen adhesive beneath the modern lino to the Boys toilets (Room 97) is presumed to contain asbestos.

Any changes in its appearance should be noted and passed to Property Services.

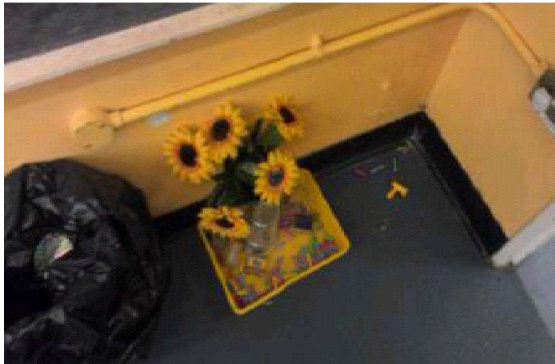
Item 112: NSPS/003

The skirting to base of wall behind modern lino in the classroom (Room 007) does not contain asbestos.

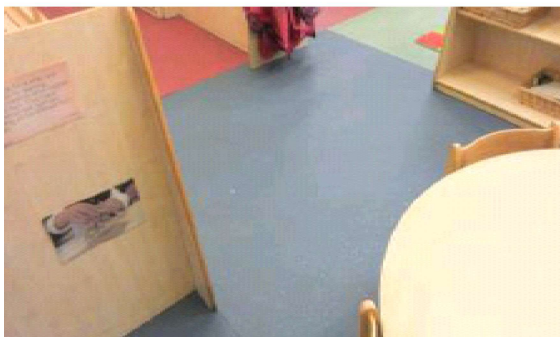
Item 113: NSPS/002

The bitumen adhesive beneath the modern lino to the classroom (Room 007) contains asbestos.

Any changes in its appearance should be noted and passed to Property Services.

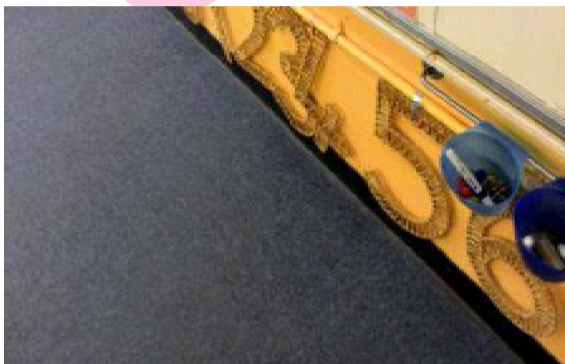
Item 114: NSPS/003

The skirting to base of wall behind modern in the classroom (Room 006) does not contain asbestos.

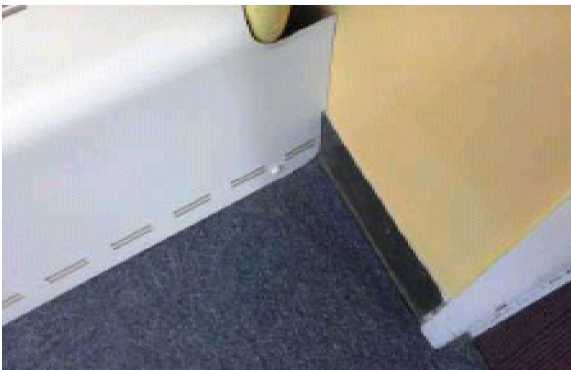
Item 116: NSPS/003

The skirting to base of wall in the classroom (Room 005) does not contain asbestos.

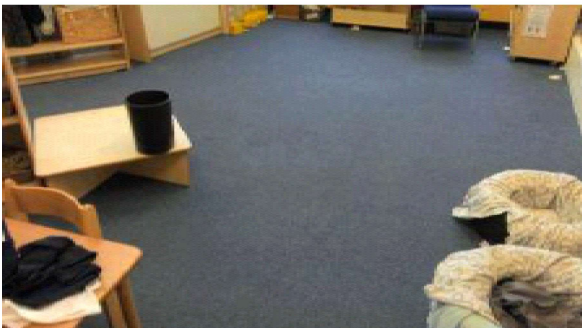
Item 117: Presumed

The bitumen adhesive beneath the carpet in the classroom (Room 102) is presumed to contain asbestos.

Any changes in its appearance should be noted and passed to Property Services.

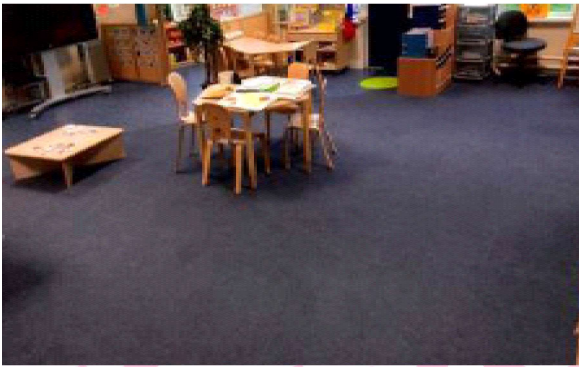
Item 119: Presumed

The bitumen adhesive beneath the cement skim to the classroom (Room 104) is presumed to contain asbestos.

Any changes in its appearance should be noted and passed to Property Services.

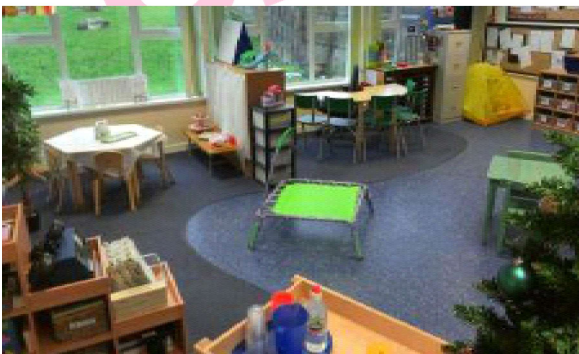
Item 120: Presumed

The bitumen adhesive beneath the cement skim to the classroom (Room 105) is presumed to contain asbestos.

Any changes in its appearance should be noted and passed to Property Services.

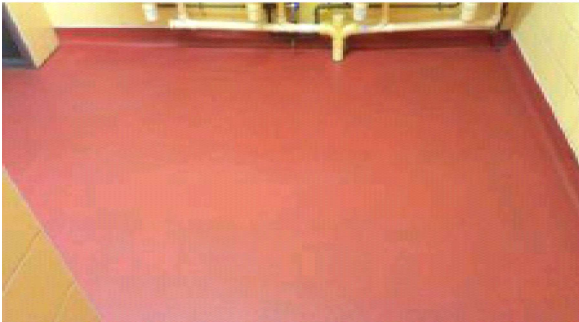
Item 121: Presumed

The vinyl floor tiles beneath the modern lino in the Boys toilets (Room 108) are presumed to contain asbestos.

Any changes in its appearance should be noted and passed to Property Services.

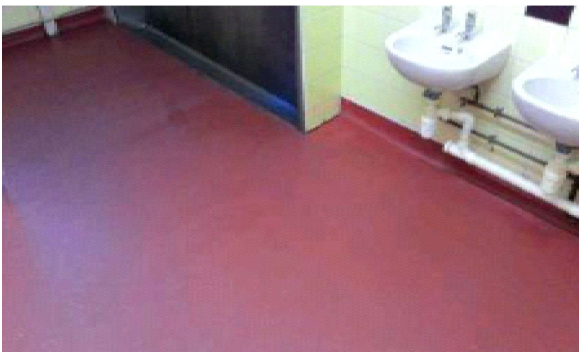
Item 122: Presumed

The bitumen adhesive beneath the modern lino to the Boys toilet (Room 108) is presumed to contain asbestos.

Any changes in its appearance should be noted and passed to Property Services.

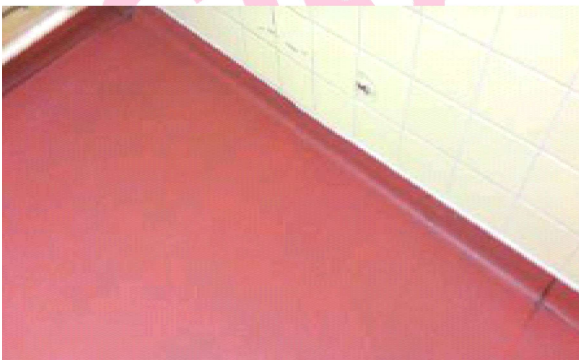
Item 123: Presumed

The skirting to base of wall behind modern lino in the boys toilet (Room 108) is presumed to contain asbestos.

Any changes in its appearance should be noted and passed to Property Services.

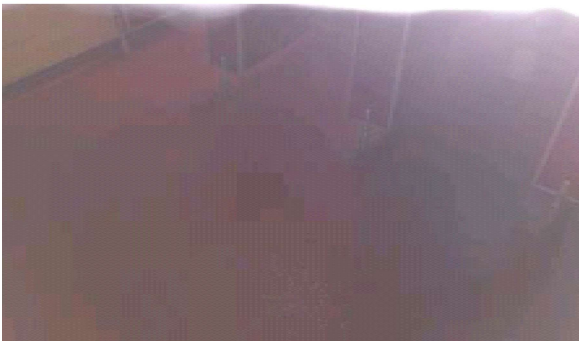
Item 125: Presumed

The bitumen adhesive beneath the modern lino in the Girls toilets (Room 110) is presumed to contain asbestos.

Any changes in its appearance should be noted and passed to Property Services.

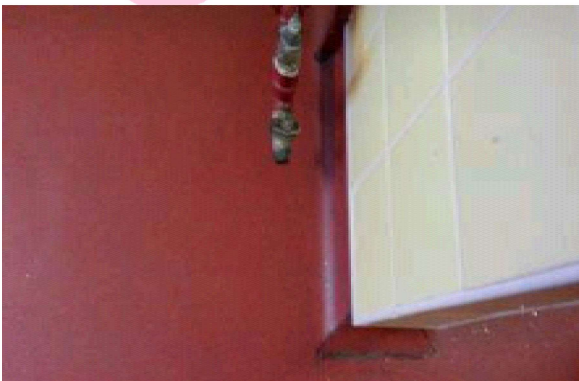
Item 126: Presumed

The skirting to base of wall behind modern lino in the Girls toilet (Room 110) is presumed to contain asbestos.

Any changes in its appearance should be noted and passed to Property Services.

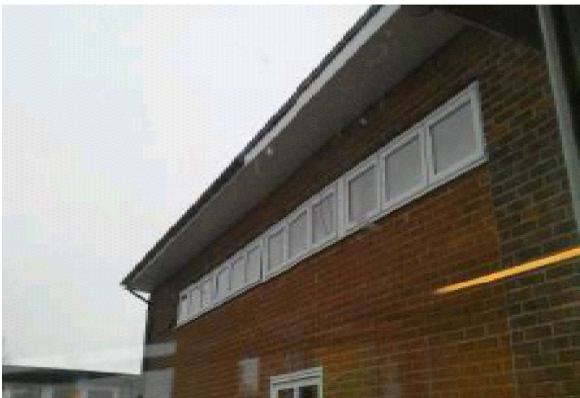
Item 128: NSPS/004

The corrugated soffits (throughout) to the external of the building contain asbestos.

Any changes in its appearance should be noted and passed to Property Services.

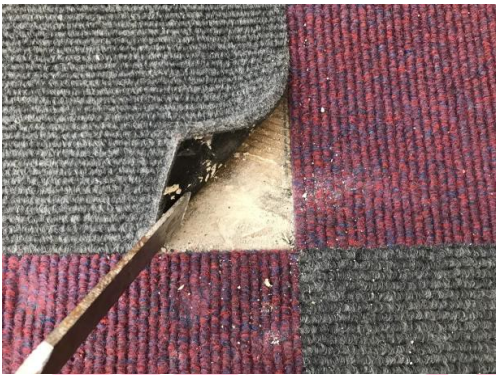
Item 149: BS017806

The floor screed to the floor below the carpet tiles in Internal cloakroom (to be WC) contains asbestos.

Any changes in its appearance should be noted and passed to Property Services.

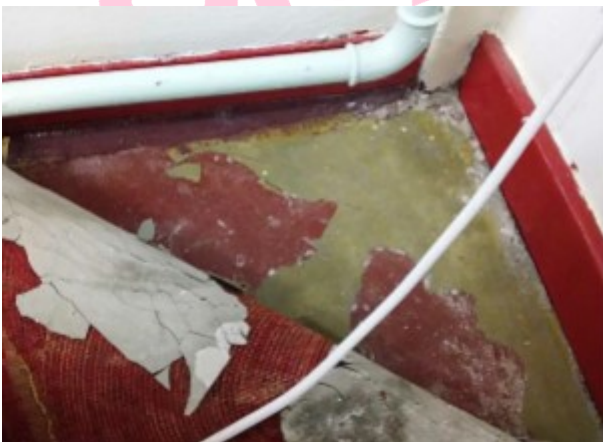
Item 150: 21-30151-1

The floor below carpet and screed (bitumen) in the classroom does not contain asbestos.

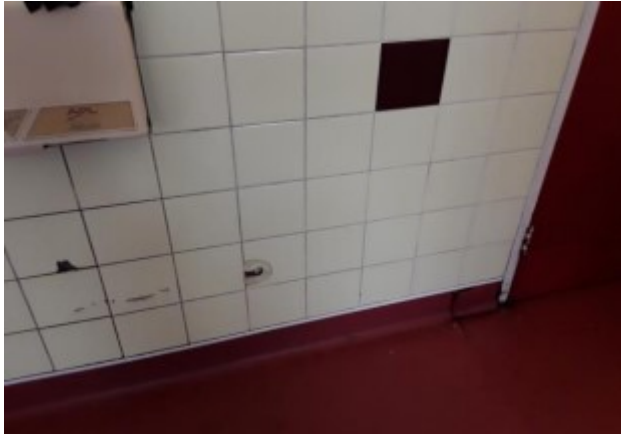
Item 151: 21-36878-1

The adhesive to the ceramic tiles to walls in (Area 1/Boys toilet) does not contain asbestos.

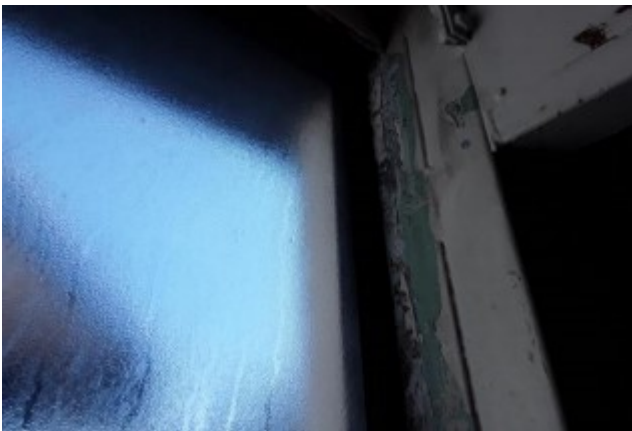
Item 152: 21-36878-2

The sealant to the old window frame (Area 1/Boys toilet) does not contain asbestos.

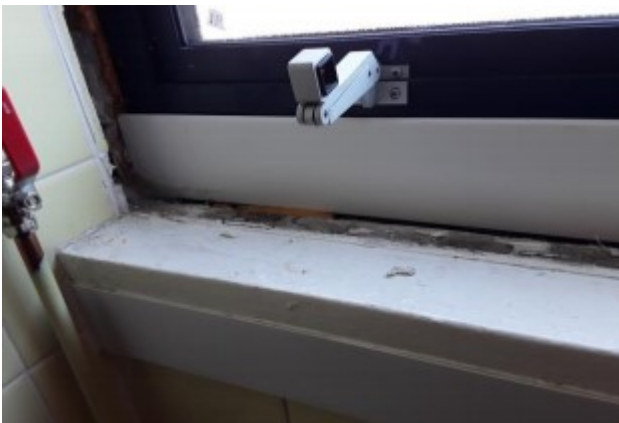
Item 153: 21-36878-2

The sealant to the old window frame (Area 2/Girls toilet) does not contain asbestos.

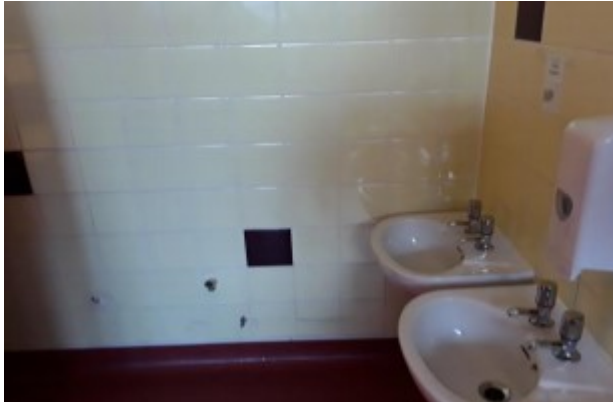
Item 154: 21-36878-3

The adhesive to the ceramic tiles to walls in (Area 2/Girls toilet) does not contain asbestos.

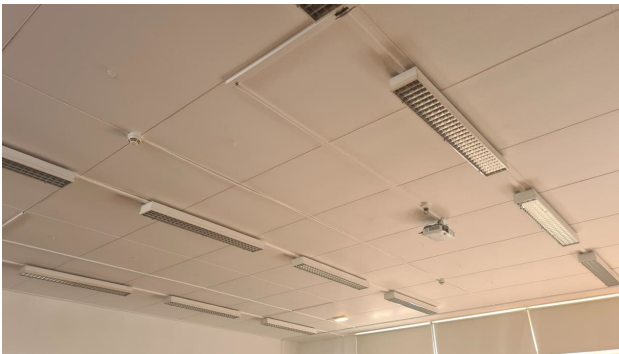
Item 155: NSPS/001

The ceiling tiles (G/001/Hall) does not contain asbestos.

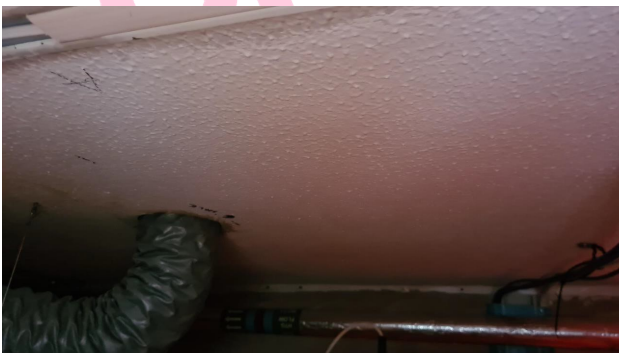
Item 156: NSPS/005

The textured coating to ceiling above suspended ceiling (G/013/Office) does not contain asbestos.

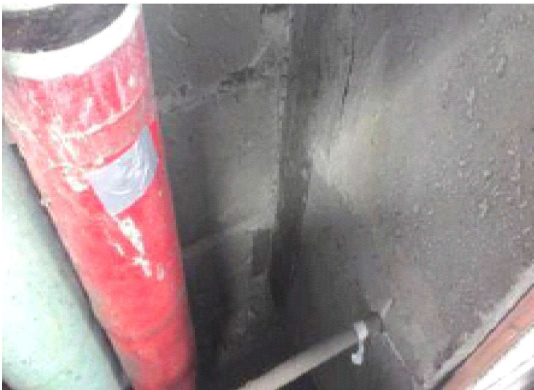
Ref: EV001735

The red pipework in the void to the left of the heater in classroom 3/4 contained asbestos.

This was removed by Building Needs in July 2015.

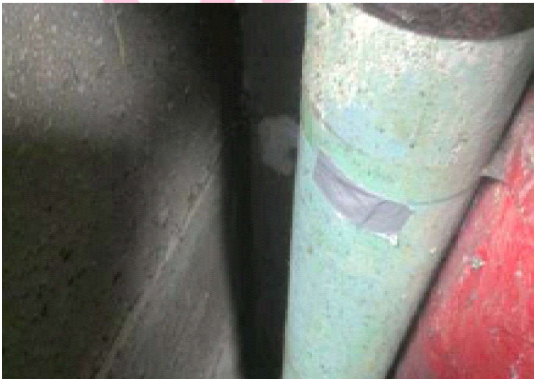
Ref: EV001736

The green pipework in the void to the left of the heater in classroom 3/4 contained asbestos.

This was removed by Building Needs in July 2015.

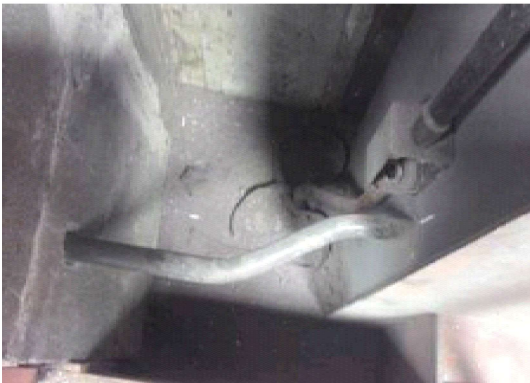
Ref: EV001738

A swab sample of the floor to the void to the upright heater in Year 5 room 2 does not contain asbestos.

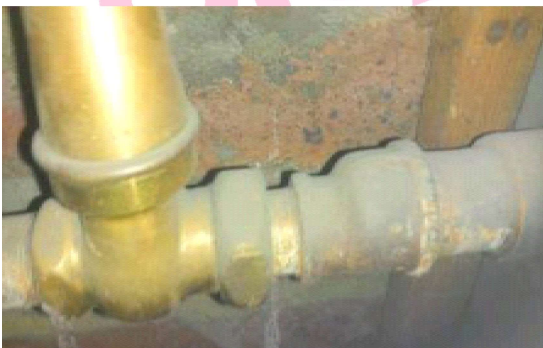
Ref: EV001739

The residue to the pipework to the void to the upright heater in Year 2 room 3 does not contain asbestos.

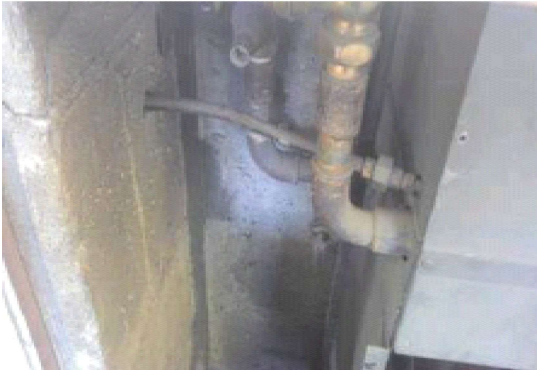
Ref: EV001741

The debris on the pipework to the void to the upright heater in Year 1 room 5 does not contain asbestos.

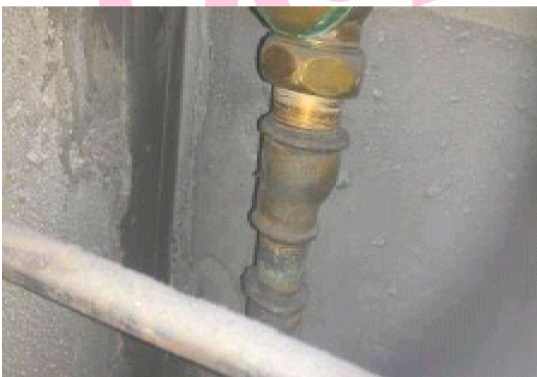
Ref: EV001742

The debris on the pipework to the void to the upright heater in Year 1 room 6 does not contain asbestos.

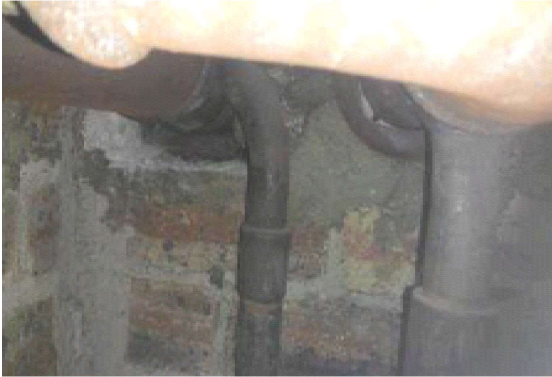
Ref: EV001743

The residue to the pipework going into the brickwork at the top of the heaters in Infant Hall unit 1 does not contain asbestos.
