ASBESTOS SURVEY REPORT FOR RICKLETON PRIMARY SCHOOL,  
WASHINGTON, NE38 9EZ.

*Control of Asbestos  
Regulations 2012*

**Rickleton Primary School, Washington, NE38 9EZ**

**Date: 05 June 2026**

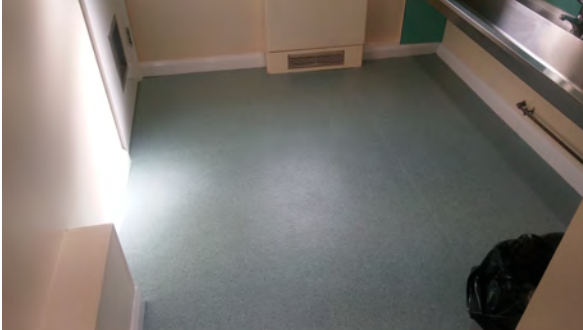
### **Item 1 Ref: As 412937-1**

- (Item 1) Ref: As 412937-1 – Floor screed beneath lino (0/002 Nursery WC) – Very Low Risk
- (Item 2) Ref: As 412937-1 – Floor screed beneath lino (0/003 Nursery Classroom) – Very Low Risk

The floor screed beneath lino in Rm 0/002 Nursery WC contains asbestos.

Any change in its appearance should be recorded and passed to Property Services.

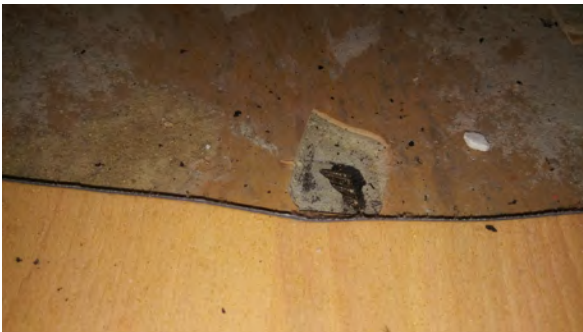
### **Item 2 Ref: As 412937-1**

The floor screed beneath lino in Rm 0/003 Nursery Classroom contains asbestos.

Any change in its appearance should be recorded and passed to Property Services.

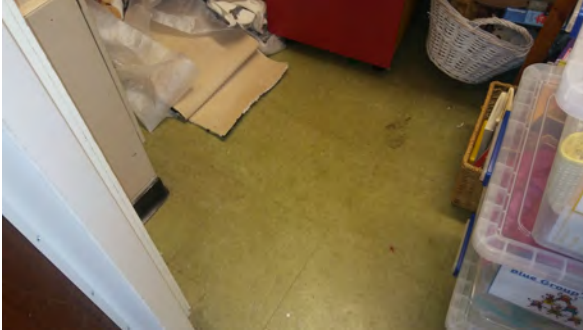
### **Item 4 Ref: As 412937-3**

The floor covering in Rm 0/003a Store contains asbestos.

Any change in its appearance should be recorded and passed to Property Services.

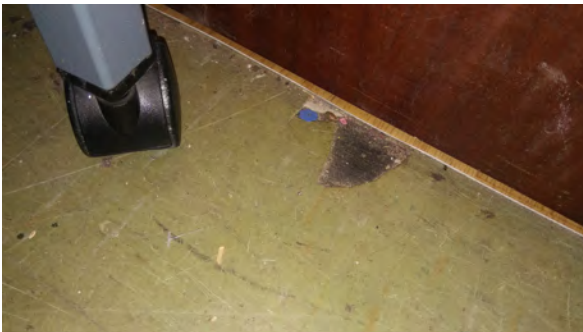
### **Item 5 Ref: As 412937-1**

The floor screed in Rm 0/003a Store contains asbestos.

Any change in its appearance should be recorded and passed to Property Services.

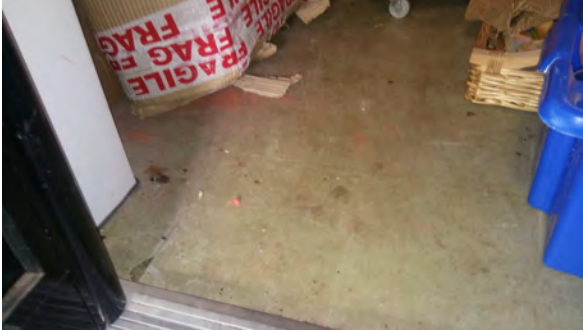
### **Item 7 Ref: 412937-3**

The floor covering in Rm 0/005 Store contains asbestos.

Any change in its appearance should be recorded and passed to Property Services.

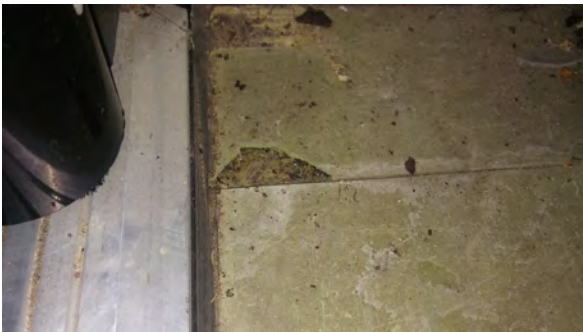
### **Item 8 Ref: As 412937-1**

The floor screed in Rm 0/005 Store contains asbestos.

Any change in its appearance should be recorded and passed to Property Services.

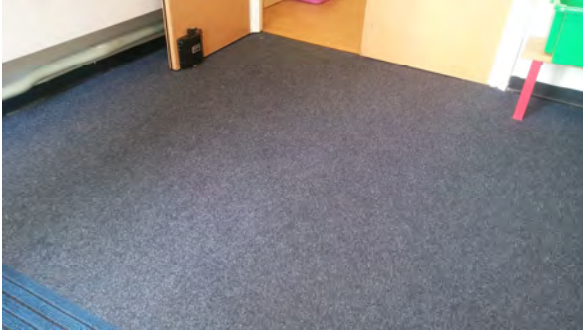
### **Item 10 Ref: As 412937-1**

The floor screed beneath lino in Rm 0/008 Cloakroom contains asbestos.

Any change in its appearance should be recorded and passed to Property Services.

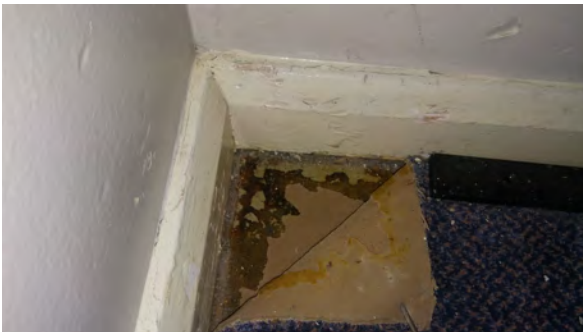
### **Item 11 Ref: As 412937-1**

The floor screed in Rm 0/009 Office contains asbestos.

Any change in its appearance should be recorded and passed to Property Services.

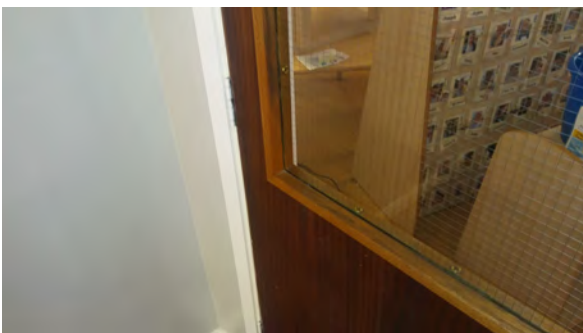
### **Item 12 Ref: 412937-4**

The sealant to glazed door panel in Rm 0/009 Office contains asbestos.

Any change in its appearance should be recorded and passed to Property Services.

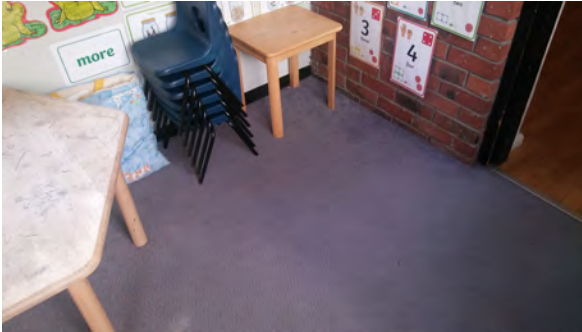
### **Item 13 Ref: As 412937-1**

The floor screed beneath lino in 0/10 Link Corridor contains asbestos.

Any change in its appearance should be recorded and passed to Property Services.

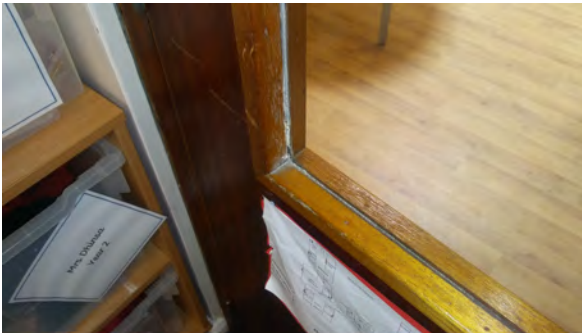
### **Item 14 Ref: As 412937-4**

The sealant to glazed panels to door in Rm 0/11 Classroom contains asbestos.

Any change in its appearance should be recorded and passed to Property Services.

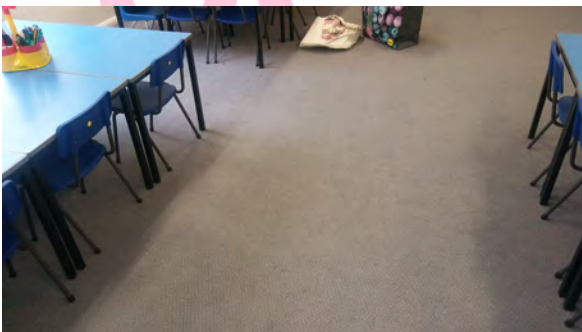
### **Item 15 Ref: As 412937-5**

The floor screed beneath carpet in Rm 0/11 Classroom does not contain asbestos.

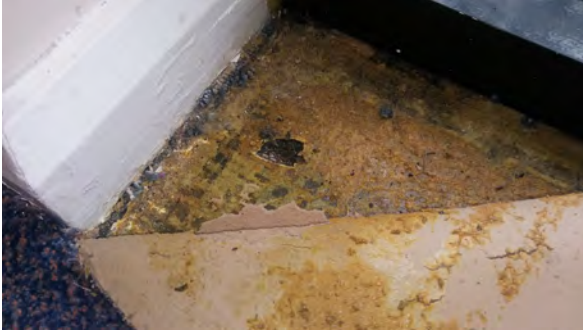
### **Item 16 Ref: 412937-5**

The floor screed beneath lino in Rm 0/12 Reception does not contain asbestos.

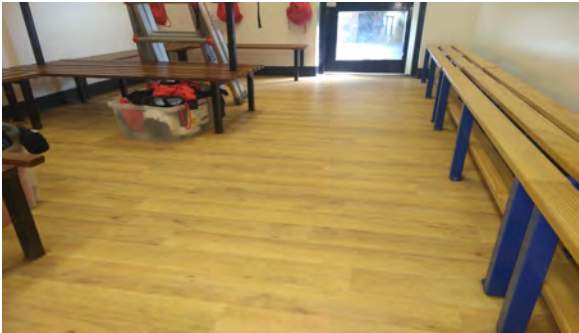
### **Item 17 Ref: As 412937-5**

The floor screed in Rm 0/12a Cloakroom does not contain asbestos.

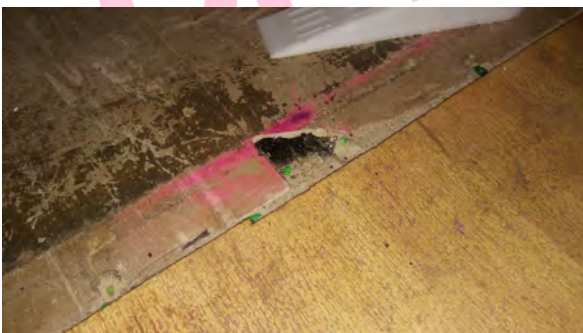
### **Item 18 Ref: As 412937-5**

The floor screed beneath lino in Rm 0/12b Switch Cupboard does not contain asbestos.

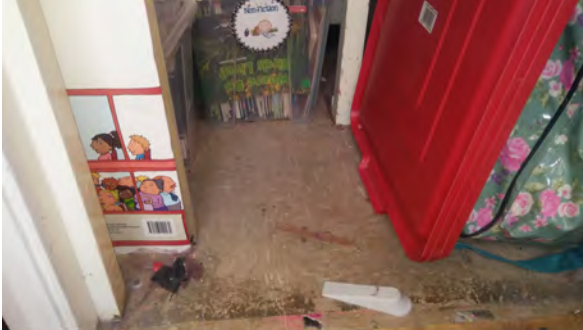
### **Item 19 Ref: 412937-6**

The floor covering in Rm 0/12b Switch Cupboard contains asbestos.

Any change in its appearance should be recorded and passed to Property Services.

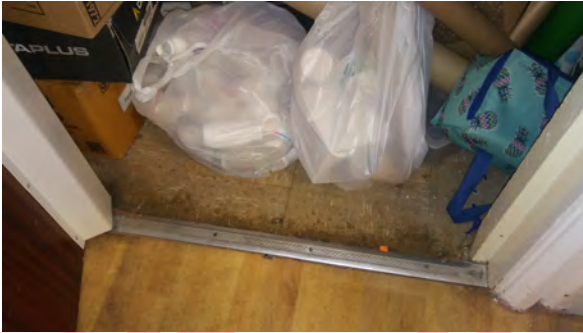
### **Item 20 Ref: As 412937-5**

The floor screed beneath lino in Rm 0/12c Switch Cupboard does not contain asbestos.

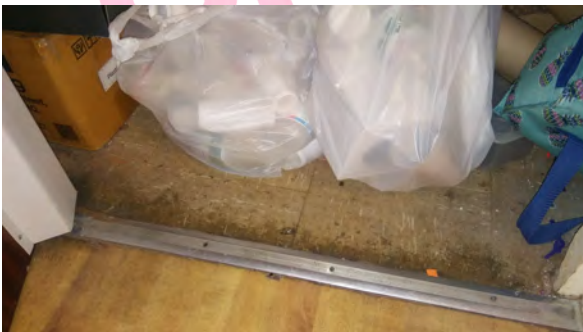
### **Item 21 Ref: As 412937-6**

The floor covering in Rm 0/12c Switch Cupboard contains asbestos.

Any change in its appearance should be recorded and passed to Property Services.

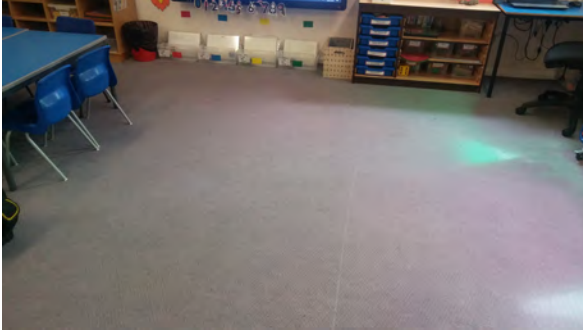
### **Item 22 Ref: As 412937-5**

The floor screed beneath carpet in Rm 0/13 Classroom does not contain asbestos.

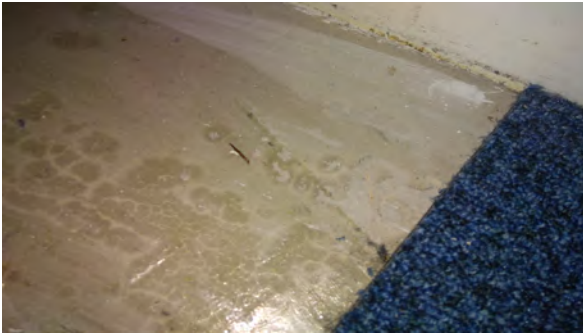
### **Item 23 Ref: As 412937-5**

The floor screed (beneath modern grey screed) in Rm 0/14 small Classroom does not contain asbestos.

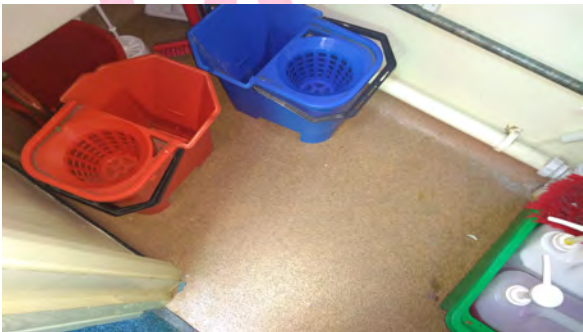
### **Item 24 Ref: As 412937-5**

The floor screed (beneath modern grey screed) in Rm 00/14a Cleaners Cupboard does not contain asbestos.

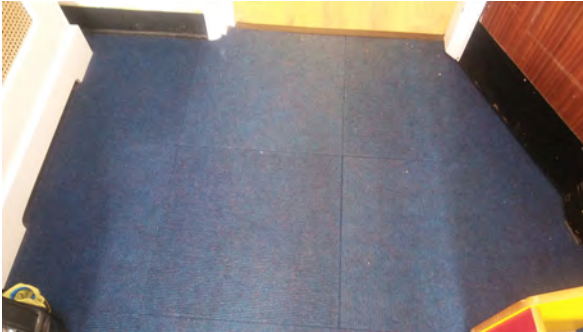
### **Item 25 Ref: As 412937-5**

The floor screed in Rm 0/15 Lobby does not contain asbestos.

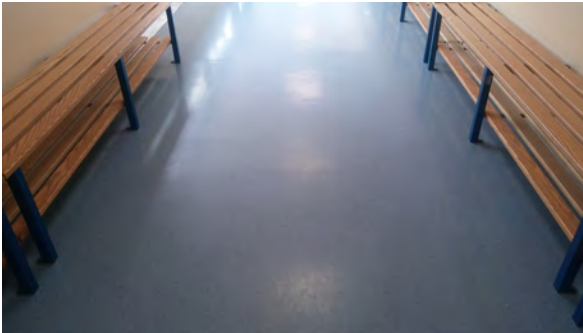
### **Item 26 Ref: 412937-8**

The floor screed beneath lino in Rm 0/17 Link Corridor does not contain asbestos.

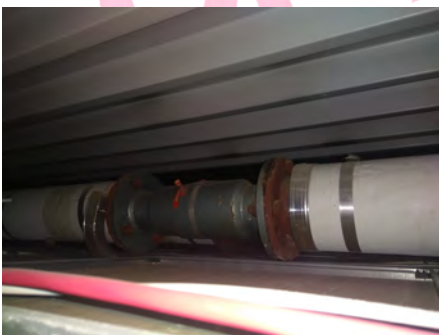
### **Item 27 Ref: Presumed**

The pipework flange gasket in Rm 0/17 link corridor void above is presumed to contain asbestos.

Any change in its appearance should be recorded and passed to Property Services.

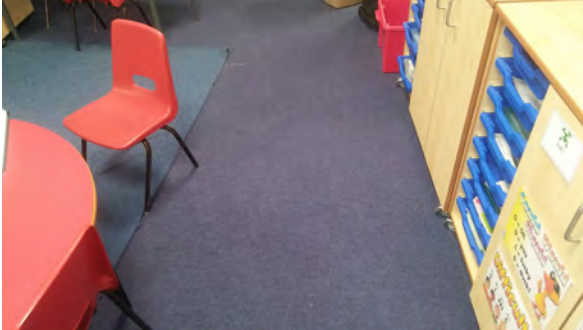
### **Item 28 Ref: As 412937-7**

The floor screed in Rm 0/18 Classroom does not contain asbestos.

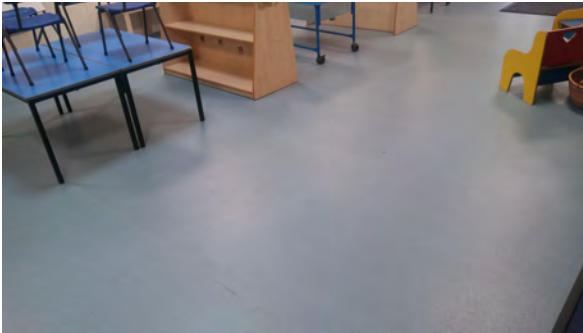
### **Item 29 Ref: As 412937-7**

The floor screed below carpet and lino in Rm 0/21 Classroom does not contain asbestos.

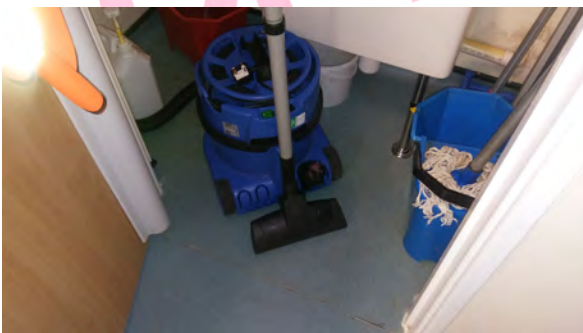
### **Item 30 Ref: As 412937-7**

The floor screed in Rm 021a Cleaners Store does not contain asbestos.

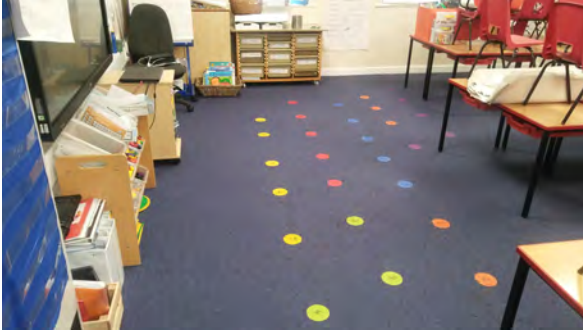
### **Item 31 Ref: As 412937-7**

The floor screed in Rm 0/22 Classroom does not contain asbestos.

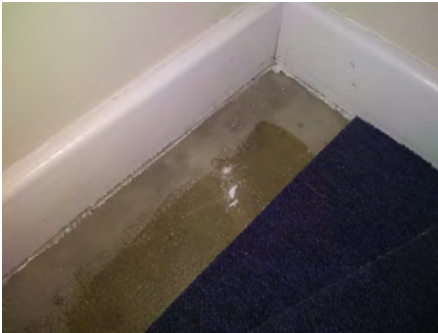
### **Item 32 Ref: 412937-7**

The floor screed (beneath grey screed) in Rm 0/25 Classroom does not contain asbestos.

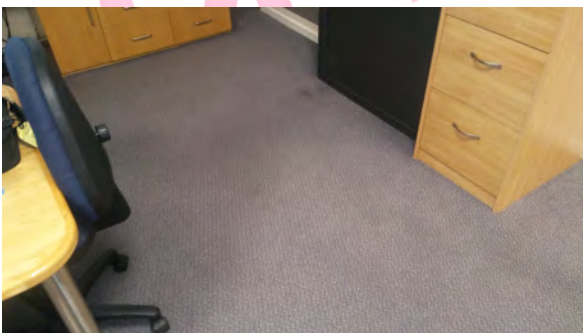
### **Item 33 Ref: As 412937-8**

The floor screed in Rm 0/26 Deputy Head's Office does not contain asbestos.

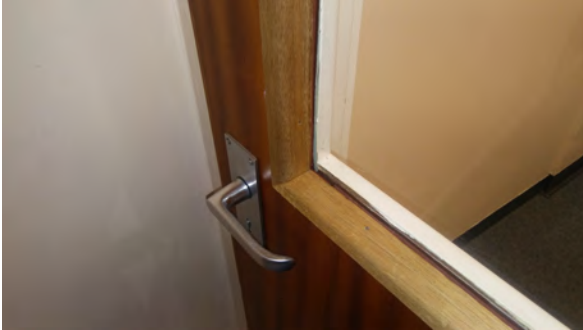
### **Item 34 Ref: 412937-13**

The sealant to glazed door panel in Rm 0/26 Deputy Head's Office does not contain asbestos.

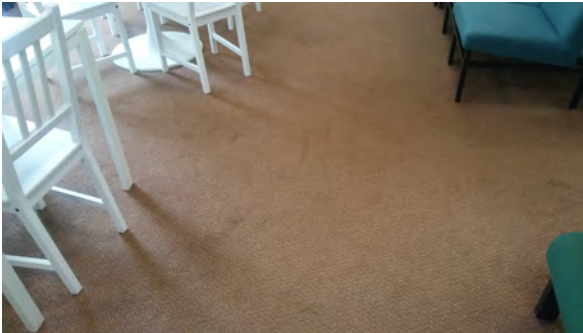
### **Item 35 Ref: As 412937-8**

The floor screed in Rm 0/27 Staff Room does not contain asbestos.

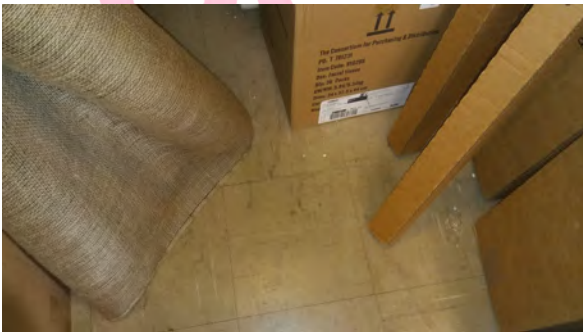
### **Item 36 Ref: As 412937-8**

The floor screed in Rm 0/27a Store does not contain asbestos.

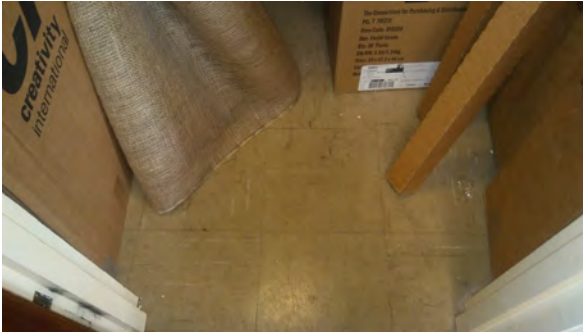
### **Item 37 Ref: As 412937-12**

The floor covering in Rm 0/27a Store contains asbestos.

Any change in its appearance should be recorded and passed to Property Services.

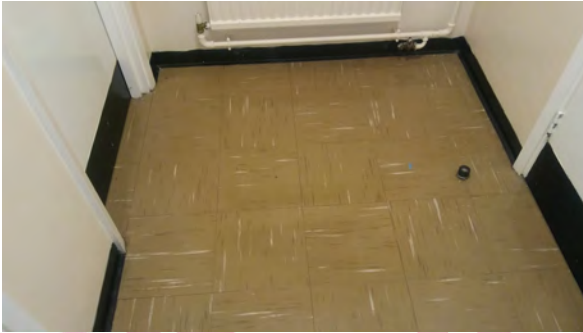
### **Item 38 Ref: 412937-14**

The floor covering in Rm 0/28 Male Staff WC contains asbestos.

***Removed March 2021***

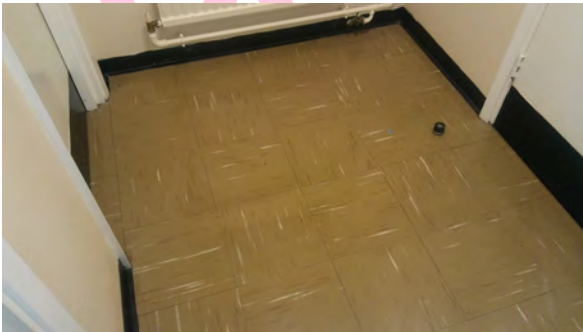
### **Item 39 Ref: As 412937-8**

The floor screed in Rm 0/28 Male Staff WC does not contain asbestos.

***Removed March 2021***

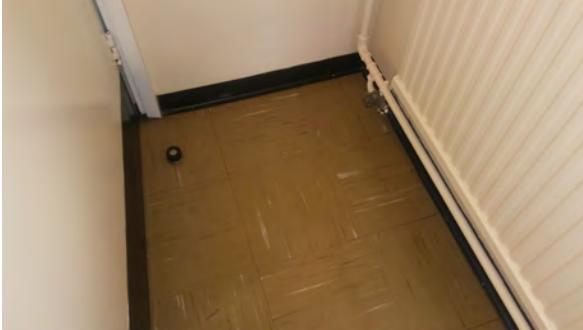
### **Item 40 Ref: As 412937-14**

The floor covering in Rm 0/29 Female Staff WC contains asbestos.

***Removed March 2021***

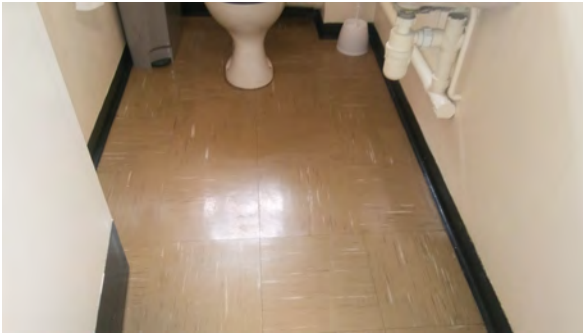
### **Item 41 Ref: As 412937-8**

The floor screed in Rm 0/29 Female Staff WC does not contain asbestos.

***Removed March 2021***

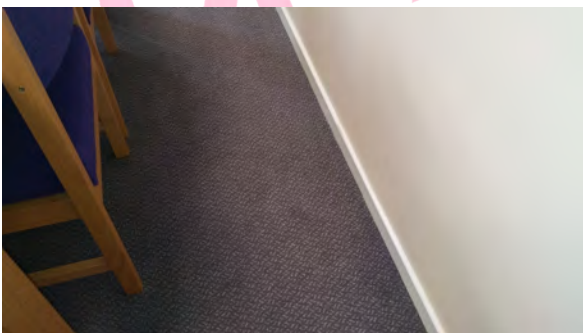
### **Item 42 Ref: As 412937-8**

The floor screed in Rm 0/30 Head Teachers Office does not contain asbestos.

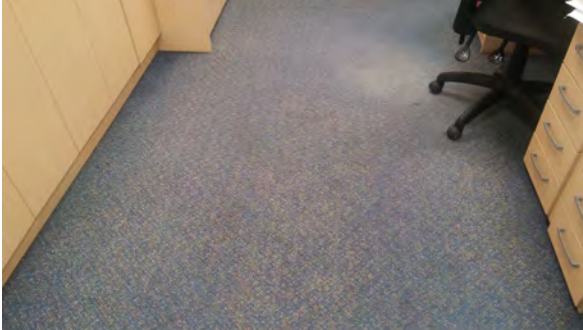
### **Item 43 Ref: As 412937-8**

The floor screed in Rm 0/31 Reception Office does not contain asbestos.

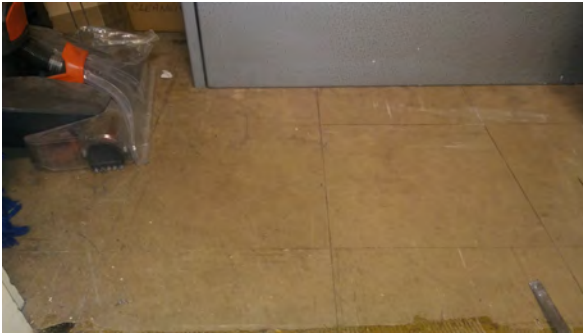
### **Item 44 Ref: 412937-9**

The floor covering in Rm 0/31b Battery Cupboard contains asbestos.

Any change in its appearance should be recorded and passed to Property Services.

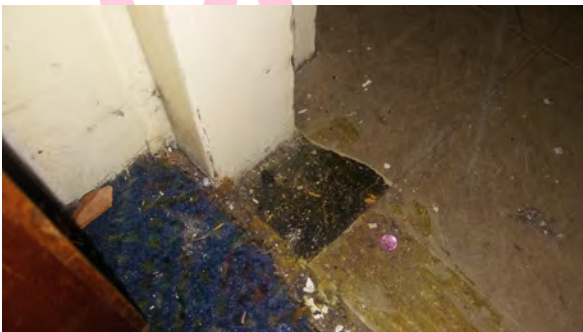
### **Item 45 Ref: As 412937-8**

The floor screed in Rm 0/31b Battery Cupboard does not contain asbestos.

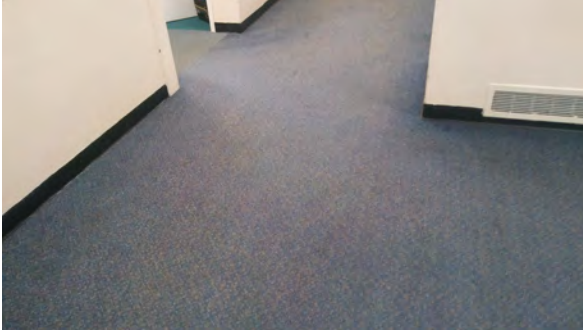
### **Item 46 Ref: As 412937-8**

The floor screed beneath carpet in Rm 0/32 Corridor does not contain asbestos.

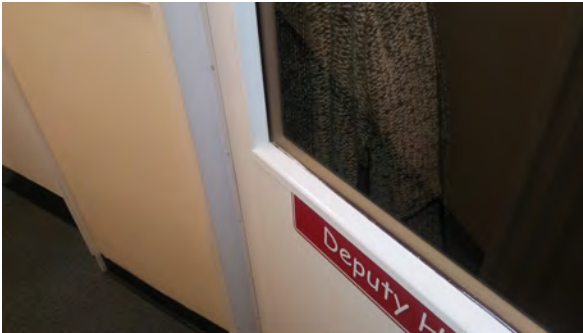
### **Item 47 Ref: As 412937-13**

The sealant to glazed door panel to 0/26 in Rm 0/32 Corridor does not contain asbestos.

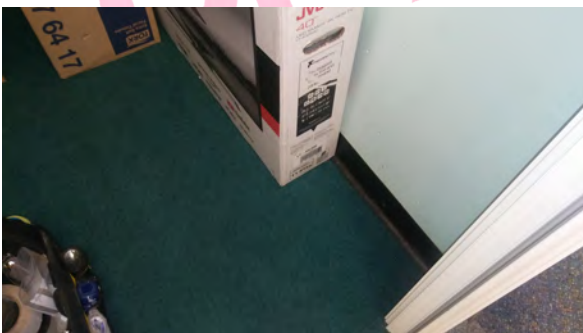
### **Item 48 Ref: As 412937-8**

The floor screed beneath lino in Rm 0/32a Store does not contain asbestos.

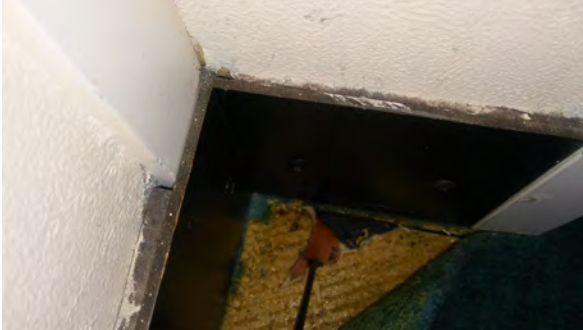
### **Item 49 Ref: As 412937-8**

The floor screed in Rm 0/33 Photocopier Room does not contain asbestos.

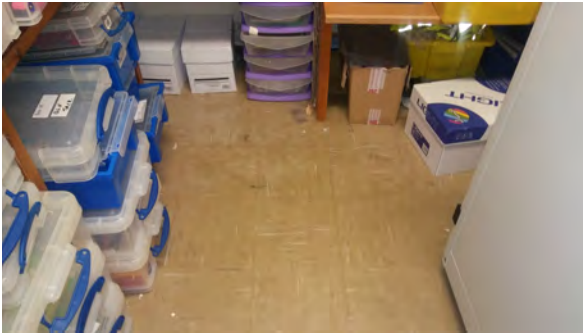
### **Item 50 Ref: As 412937-8**

The floor screed in Rm 0/34 Server Room does not contain asbestos.

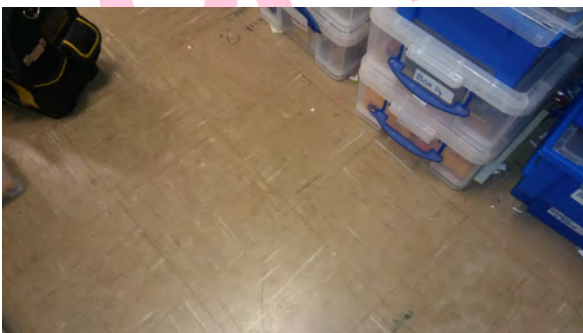
### **Item 51 Ref: As 412937-12**

The floor covering in Rm 0/34 Server Room contains asbestos.

Any change in its appearance should be recorded and passed to Property Services.

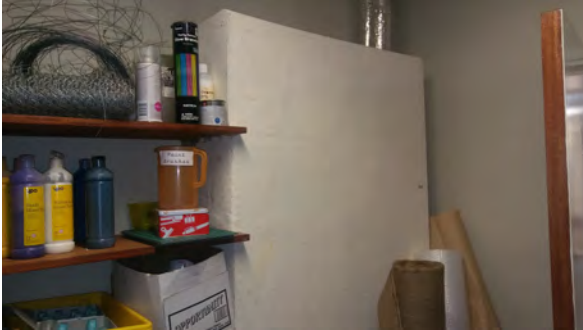
### **Item 52 Ref: 412937-11**

The heater insulation in Rm 0/35 Store does not contain asbestos.

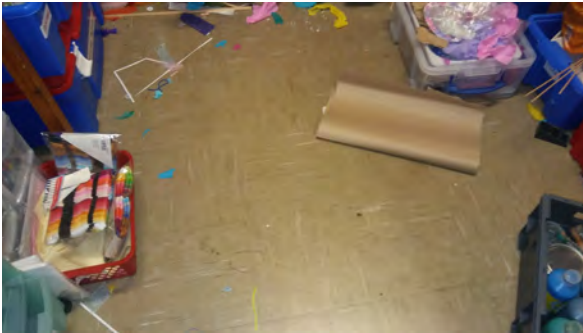
### **Item 53 Ref: As 412937-8**

The floor screed in Rm 0/35 Store does not contain asbestos.

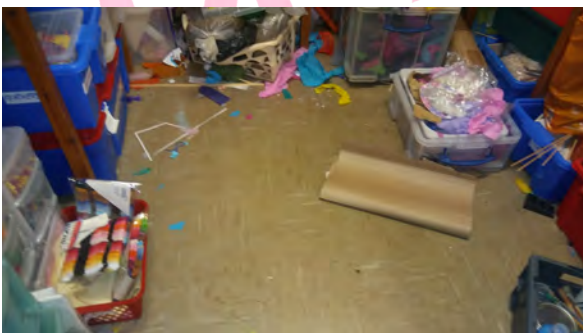
### **Item 54 Ref: 412937-12**

The floor covering in Rm 0/35 Store contains asbestos.

Any change in its appearance should be recorded and passed to Property Services.

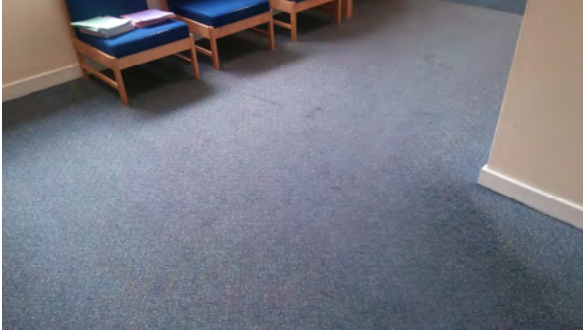
### **Item 55 Ref: As 412937-8**

The floor screed beneath carpet in Rm 0/36 Reception corridor does not contain asbestos.

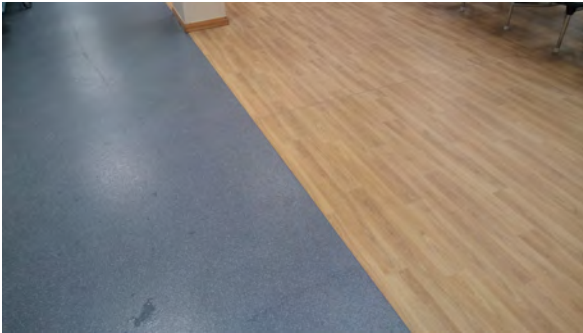
### **Item 56 Ref: As 412937-15**

The floor screed in Rm 0/38 Main hall does not contain asbestos.

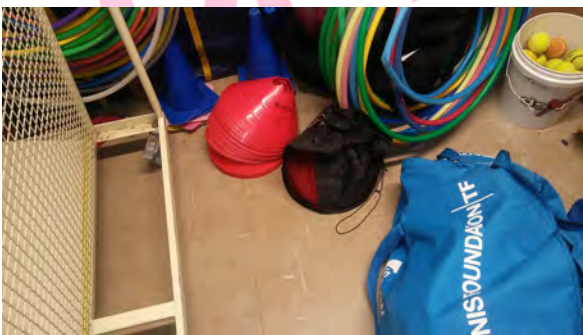
### **Item 57 Ref: As 412937-15**

The floor screed in Rm 0/39 PE Store does not contain asbestos.

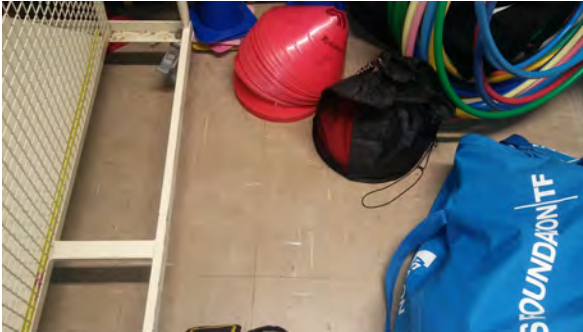
### **Item 58 Ref: As 412937-16**

The floor covering in Rm 0/39 PE Store contains asbestos.

Any change in its appearance should be recorded and passed to Property Services.

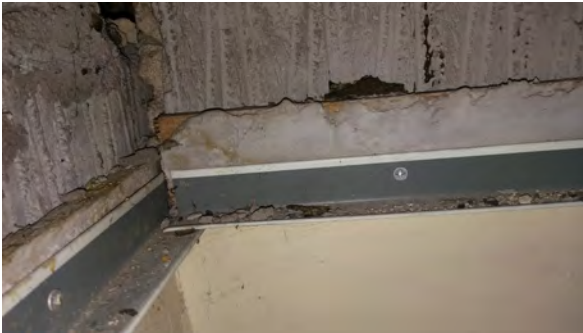
### **Item 59 Ref: 412937-17**

The packers to perimeter of suspended ceiling in Rm 0/39 PE Store void above do not contain asbestos.

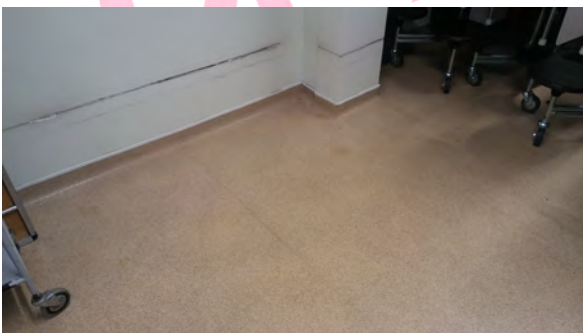
### **Item 60 Ref: As 412937-15**

The floor screed beneath lino in Rm 0/40 Store does not contain asbestos.

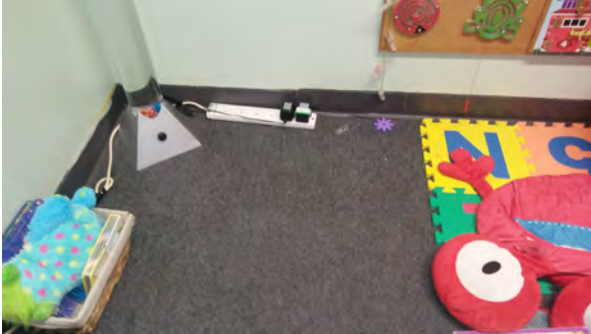
### **Item 61 Ref: 412937-15**

The floor screed in Rm 0/41 Store does not contain asbestos.

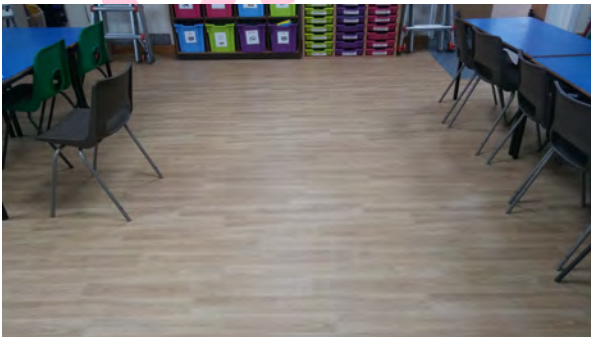
### **Item 63 Ref: As 412937-15**

The floor screed beneath lino in Rm 0/42 Annexe Classroom does not contain asbestos.

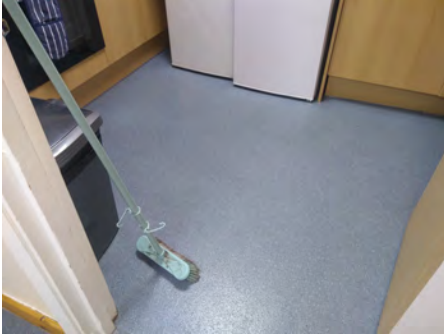
### **Item 64 Ref: As 412937-15**

The floor screed beneath modern lino in Rm 0/42a Breakfast club kitchen does not contain asbestos.

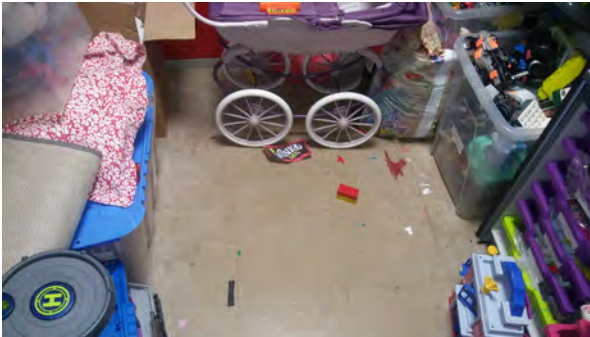
### **Item 65 Ref: As 412937-15**

The floor screed in Rm 0/42b Store does not contain asbestos.

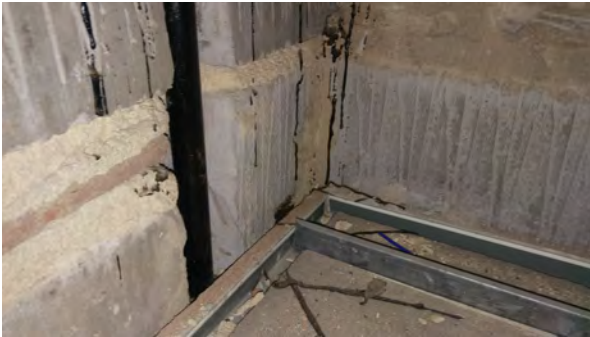
### **Item 68 Ref: As 412937-17**

The packing to perimeter of suspended ceiling in Rm 0/42b Store cupboard void above does not contain asbestos.

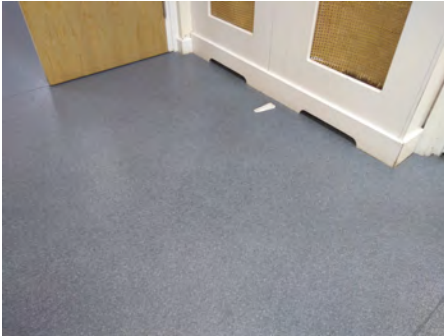
### **Item 70 Ref: As 412937-15**

The floor screed beneath modern lino in Rm 0/43 Lobby does not contain asbestos.

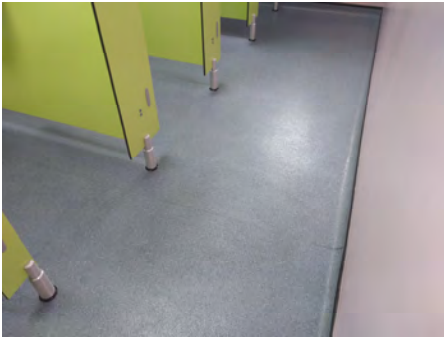
### **Item 71 Ref: As 412937-15**

The floor screed beneath lino in Rm 0/44 Unisex WC does not contain asbestos.

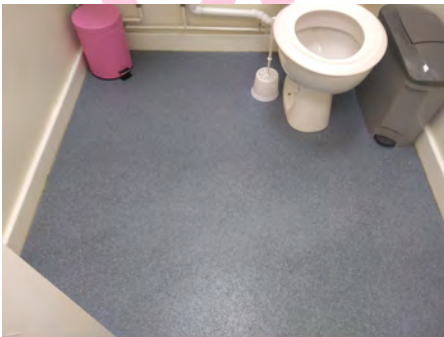
### **Item 72 Ref: As 412937-15**

The floor screed beneath modern lino in Rm 0/45 Disabled WC does not contain asbestos.

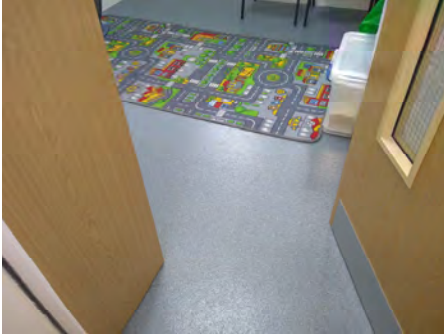
### **Item 73 Ref: As 412937-15**

The floor screed beneath modern lino in Rm 0/45a Playroom does not contain asbestos.

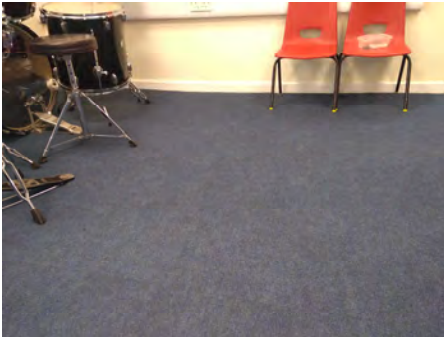
### **Item 74 Ref: As 412937-15**

The floor screed beneath carpet Rm 0/46 Music Room does not contain asbestos.

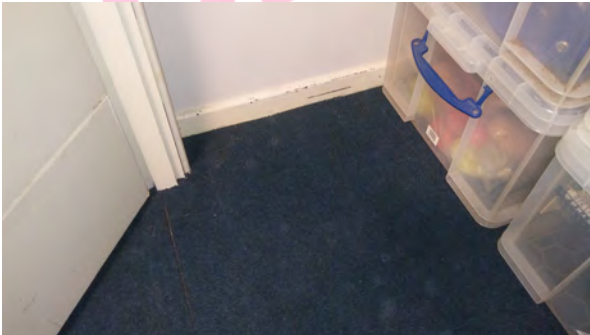
### **Item 75 Ref: As 412937-15**

The floor screed in Rm 0/45a Store does not contain asbestos.

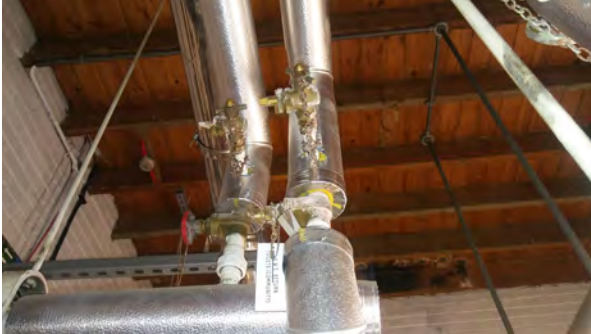
### **Item 76 Ref: 412937-29**

The remnant lagging to pipework beneath MMMF in Rm 0/47 Boiler Room does not contain asbestos.

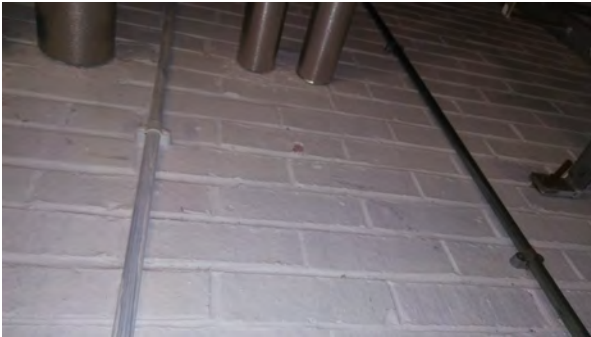
### **Item 77 Ref: 412937-30**

The residue to wall (adj ladder) in Rm 0/47 Boiler Room does not contain asbestos.

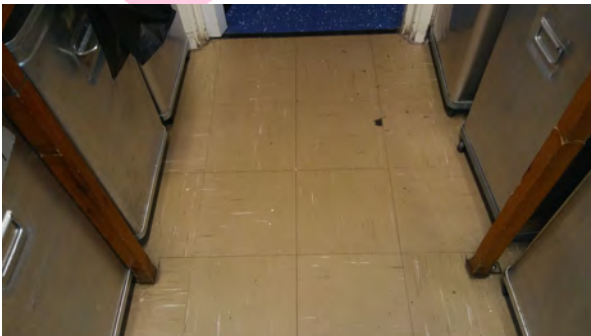
### **Item 81 Ref: As 412937-15**

The floor screed in Rm 0/48 Kitchen Store and void above does not contain asbestos.

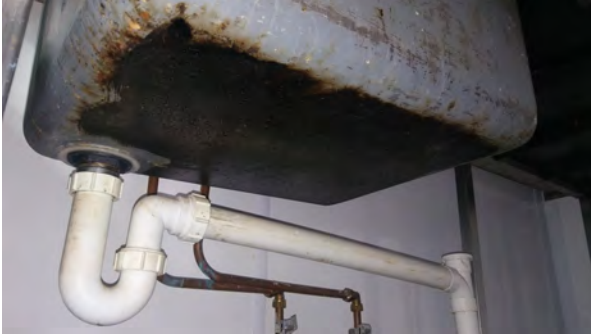
### **Item 82 Ref: 412937-19**

The sink paint in Rm 0/48a Kitchen does not contain asbestos.

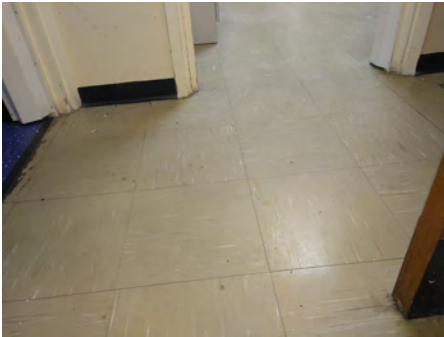
### **Item 83 Ref: As 412937-20**

The beige floor tiles in Rm 0/49 Lobby contain asbestos.  
Any change in its appearance should be recorded and passed to Property Services.

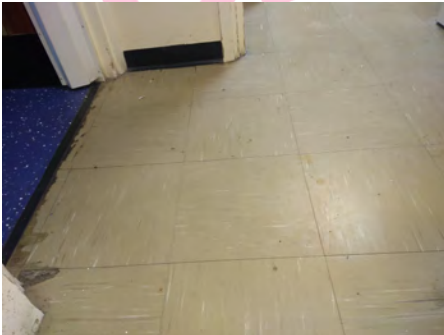
### **Item 84 Ref: As 412937-15**

The floor screed beneath vinyl tiles in Rm 0/49 Lobby does not contain asbestos.

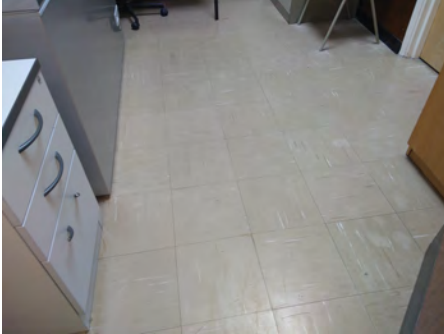
### **Item 85 Ref: As 412937-20**

The beige floor tiles in Rm 0/49a Locker Room contain asbestos.

Any change in its appearance should be recorded and passed to Property Services.

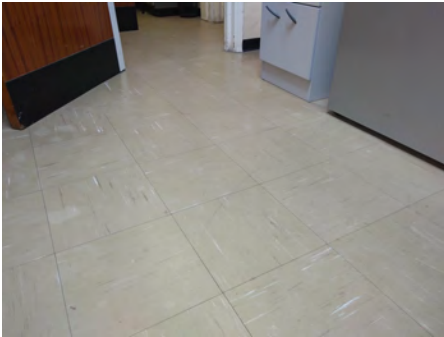
### **Item 86 Ref: As 412937-15**

The floor screed beneath vinyl tiles in Rm 0/49a Locker Room does not contain asbestos.

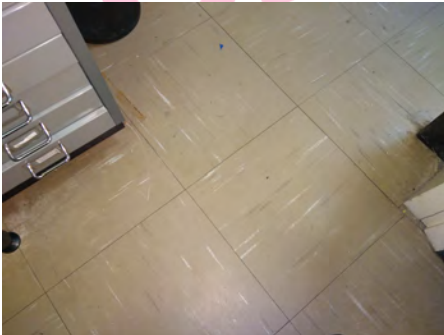
### **Item 87 Ref: 412937-20**

The beige floor tiles in Rm 0/49b Kitchen Office contain asbestos.

Any change in its appearance should be recorded and passed to Property Services.

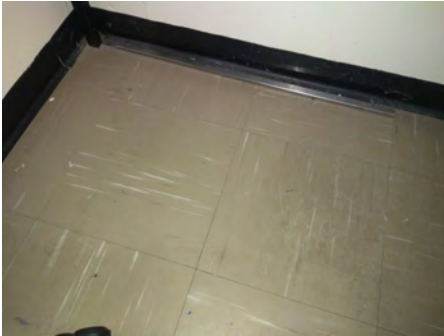
### **Item 88 Ref: As 412937-15**

The floor screed beneath vinyl tiles in Rm 0/49b Kitchen Office does not contain asbestos.

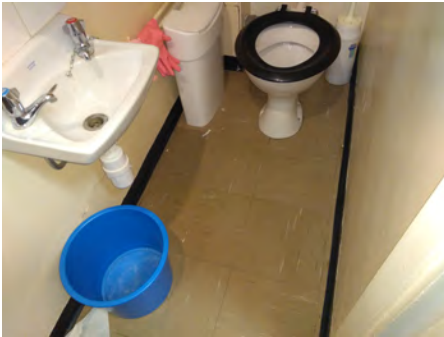
### **Item 89 Ref: As 412937-20**

The beige floor tiles in Rm 0/49c Staff WC contain asbestos.

Any change in its appearance should be recorded and passed to Property Services.

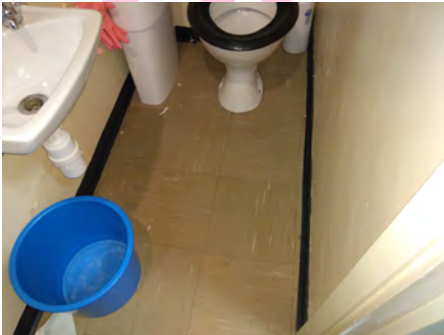
### **Item 90 Ref: As 412937-15**

The floor screed beneath vinyl tiles in Rm 0/49c Staff WC does not contain asbestos.

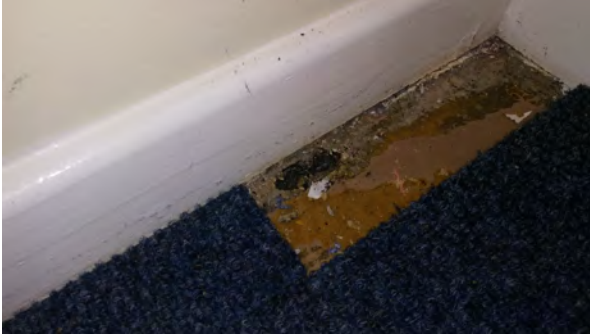
### **Item 91 Ref: 412937-21**

The floor screed in Rm 0/50 Classroom does not contain asbestos.

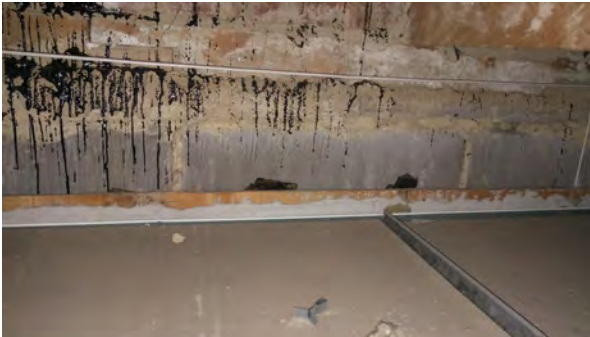
### **Item 92 Ref: 412937-22**

The packing to perimeter of suspended ceiling in Rm 0/50 Classroom void above suspended ceiling adj skylight does not contain asbestos.

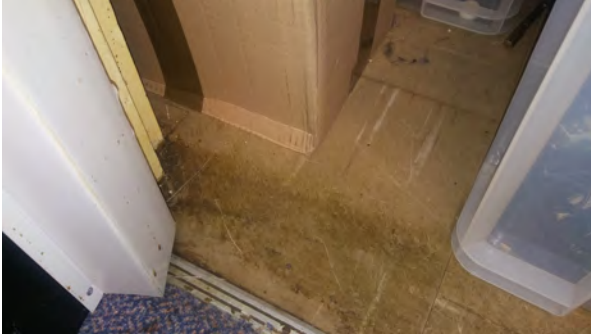
### **Item 94 Ref: As 412937-21**

The floor screed in Rm 0/50a Store does not contain asbestos.

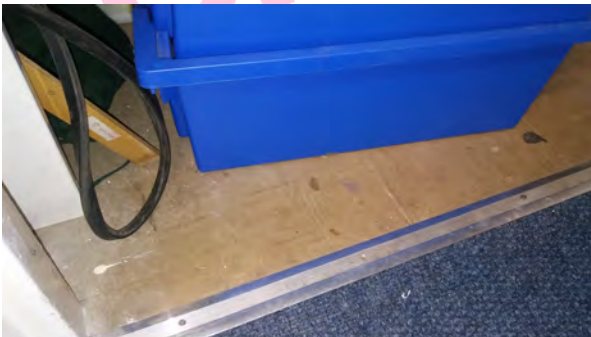
### **Item 96 Ref: As 412937-21**

The floor screed beneath tiles in Rm 0/50b Electric cupboard does not contain asbestos.

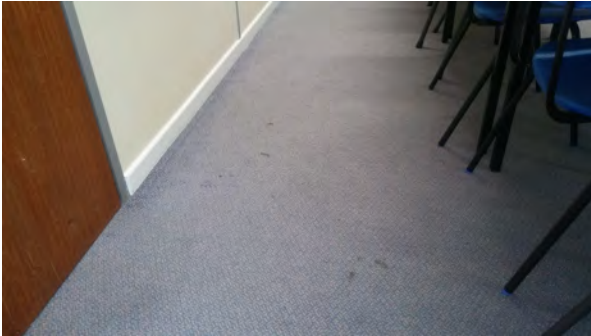
### **Item 97 Ref: As 412937-21**

The floor screed in Rm 0/51 Classroom does not contain asbestos.

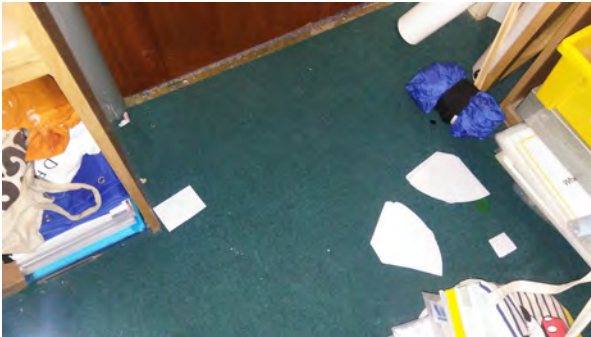
### **Item 98 Ref: As 412937-21**

The floor screed in Rm 0/51a Store does not contain asbestos.

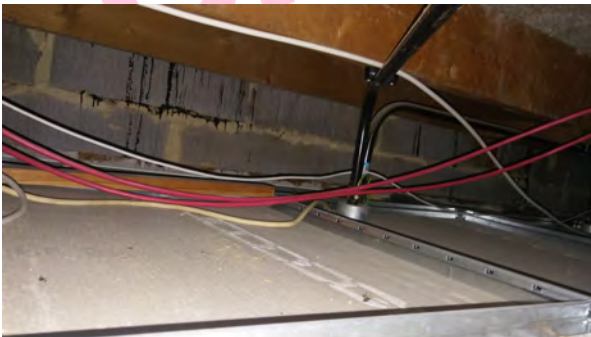
### **Item 99 Ref: As 412937-22**

The packing to perimeter of suspended ceiling in Rm 051a Store void above does not contain asbestos.

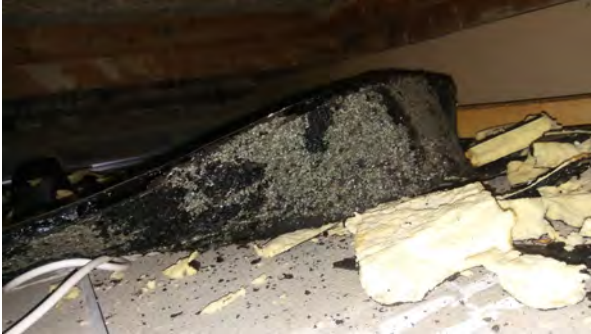
### **Item 100 Ref: 412937-23**

The debris in Rm 051a Store void above does not contain asbestos.

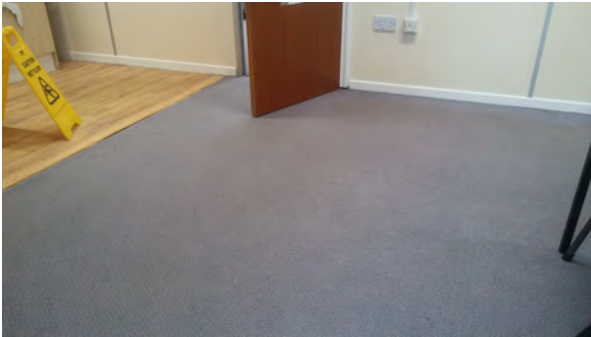
### **Item 101 Ref: As 412937-21**

The floor screed beneath floor covering in Rm 0/52 Classroom does not contain asbestos.

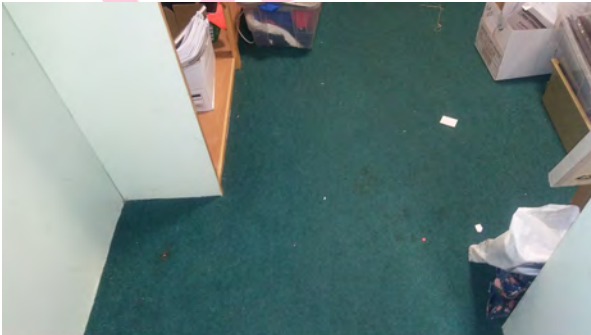
### **Item 102 Ref: As 412937-21**

The floor screed beneath carpet in Rm 0/52a Store does not contain asbestos.

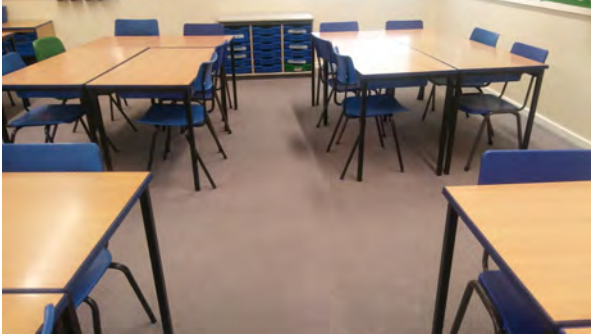
### **Item 103 Ref: As 412937-21**

The floor screed beneath carpet in Rm 0/53 Classroom does not contain asbestos.

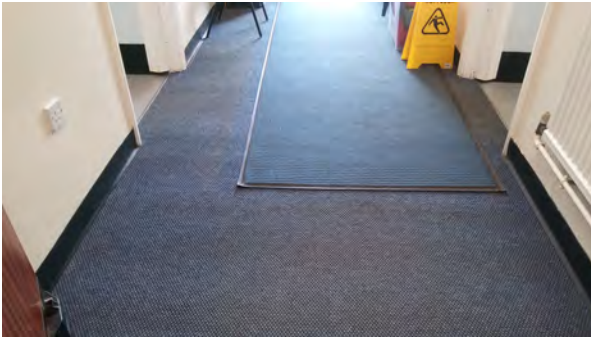
### **Item 104 Ref: As 412937-21**

The floor screed beneath carpet in Rm 0/55 Lobby does not contain asbestos.

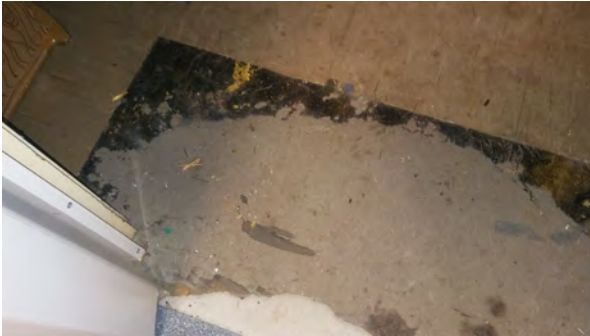
### **Item 106 Ref: As 412937-21**

The floor screed in Rm 0/57  
Store does not contain  
asbestos.

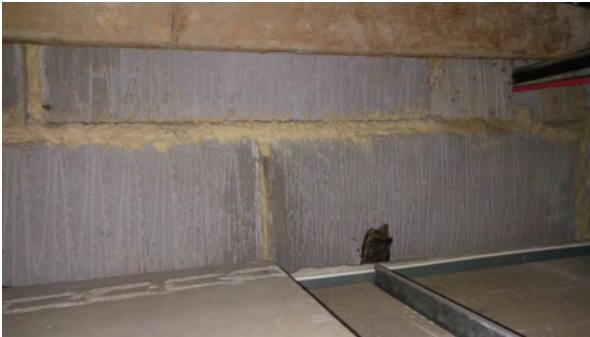
### **Item 107 Ref: As 412937-22**

The packing to perimeter of  
suspended ceiling in Rm 0/57  
Store void above does not  
contain asbestos.

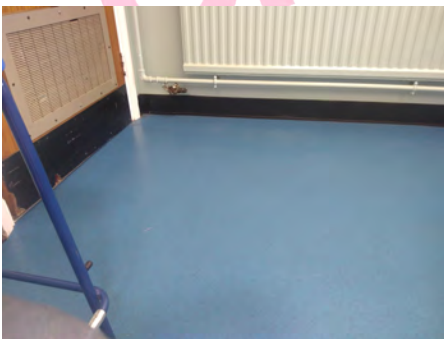
### **Item 108 Ref: As 412937-25**

The floor screed beneath  
modern lino in Rm 0/58  
Medical Room does not  
contain asbestos.

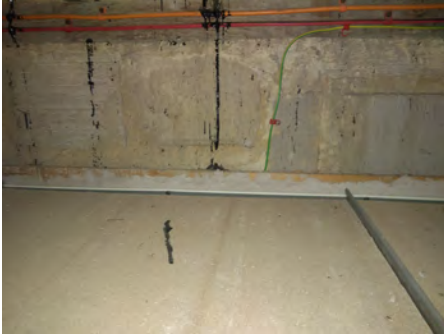
### **Item 109 Ref: As 412937-26**

The packing to perimeter of suspended ceiling in Rm 0/58 Medical Room void above does not contain asbestos.

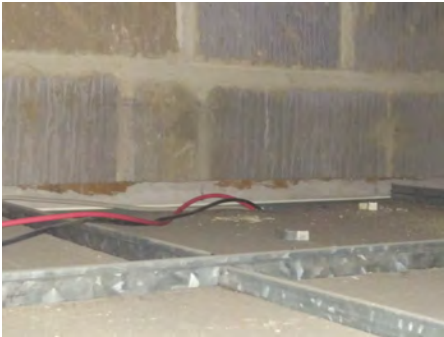
### **Item 110 Ref: As 412937-26**

The packing to perimeter of suspended ceiling in Rm 0/59 Cleaners Office void above does not contain asbestos.

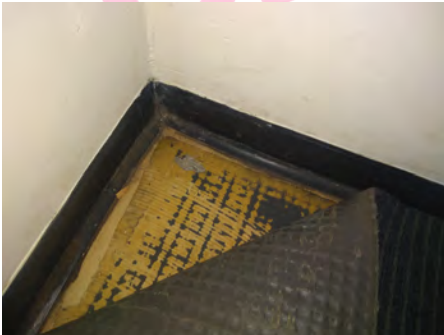
### **Item 111 Ref: As 412937-25**

The floor screed beneath carpet and modern lino in Rm 0/60 Entrance Lobby does not contain asbestos.

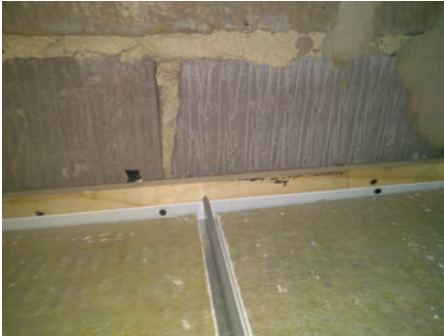
### **Item 112 Ref: As 412937-26**

The packing to perimeter of suspended ceiling in Rm 0/60 Entrance lobby void above does not contain asbestos.

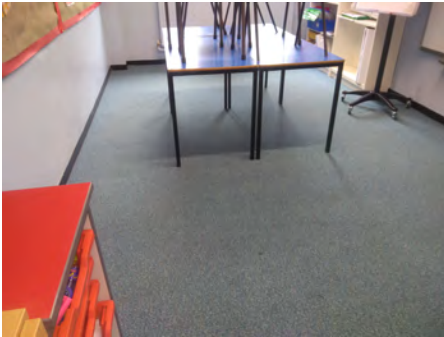
### **Item 113 Ref: 412937-25**

The floor screed beneath carpet and modern lino in Rm 0/61 Classroom does not contain asbestos.

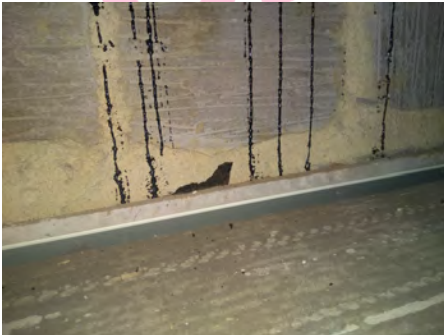
### **Item 114 Ref: As 412937-26**

The packing to perimeter of suspended ceiling in Rm 0/61 Classroom void above does not contain asbestos.

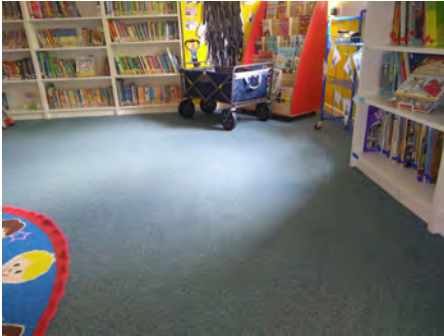
### **Item 115 Ref: As 412937-25**

The floor screed beneath carpet in Rm 0/62 Classroom does not contain asbestos.

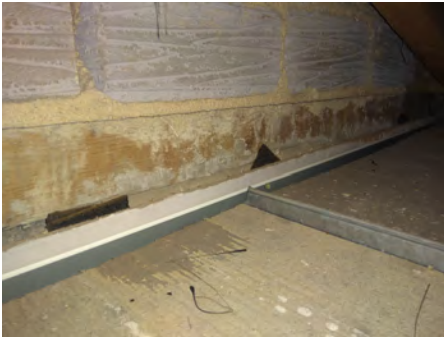
### **Item 116 Ref: As 412937-26**

The packing to perimeter of suspended ceiling in Rm 0/62 Classroom void above does not contain asbestos.

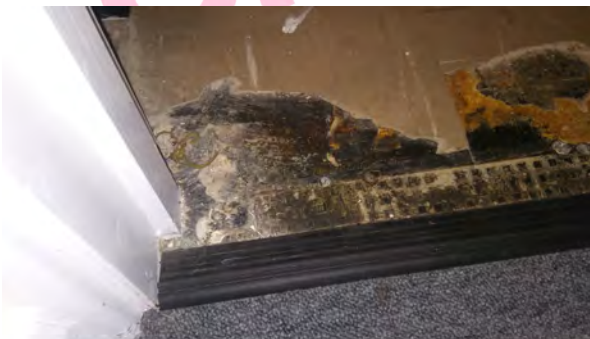
### **Item 117 Ref: As 412937-25**

The floor screed in Rm 0/63 Store does not contain asbestos.
