ASBESTOS SURVEY REPORT FOR RICKLETON PRIMARY SCHOOL,  
WASHINGTON, NE38 9EZ.

*Control of Asbestos  
Regulations 2012*

**Rickleton Primary School, Washington, NE38 9EZ**

**Date: 05 June 2026**

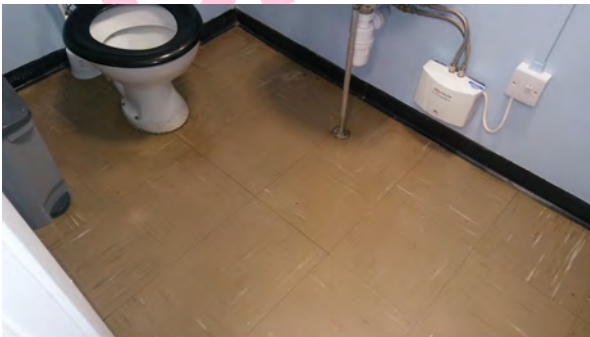
### Item 120 Ref: As 412937-25

The floor screed in Rm 0/64 Accessible WC does not contain asbestos.

***Removed March 2021***

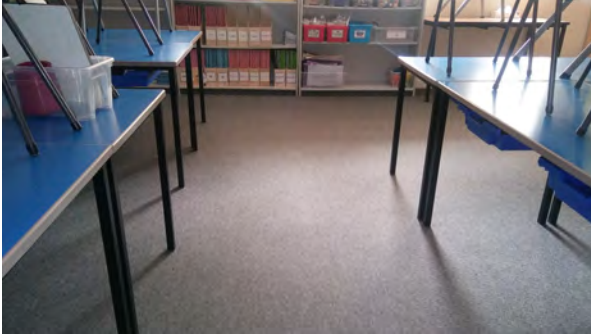
### **Item 121 Ref: As 412937-25**

The floor screed beneath carpet in Rm 0/65 Classroom does not contain asbestos.

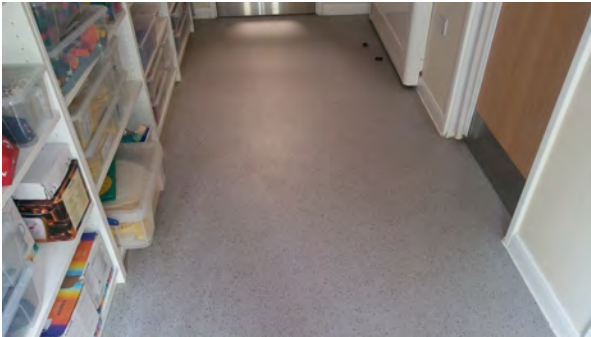
### **Item 122 Ref: As 412937-25**

The floor screed beneath lino in Rm 0/67 Lobby does not contain asbestos.

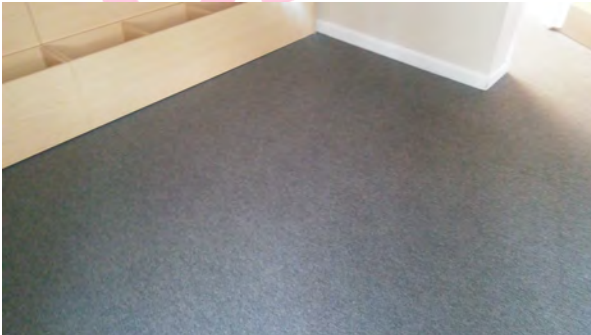
### **Item 123 Ref: As 412937-25**

The floor screed beneath carpet in Rm 0/69 Classroom does not contain asbestos.

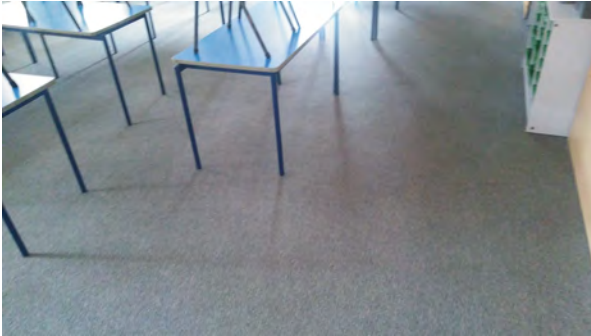
### **Item 124 Ref: As 412937-25**

The floor screed beneath carpet in Rm 0/70 Classroom does not contain asbestos.

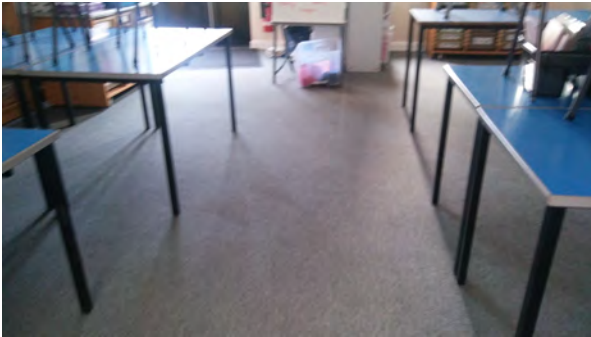
### **Item 125 Ref: As 412937-25**

The floor screed beneath carpet in Rm 0/71 Classroom does not contain asbestos.

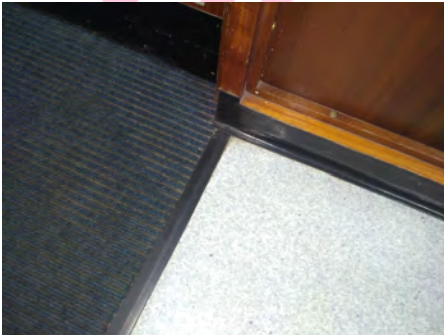
### **Item 126 Ref: As 412937-25**

The floor screed beneath carpet and modern lino in Rm 0/72 Classroom does not contain asbestos.

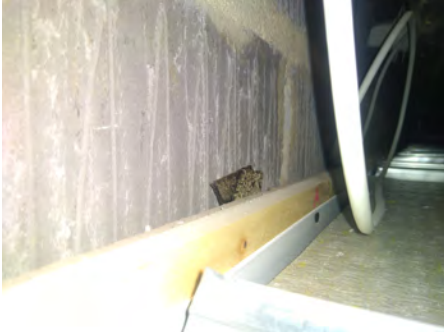
### **Item 127 Ref: As 412937-26**

The packing to perimeter of suspended ceiling in Rm 0/72 Corridor void above does not contain asbestos.

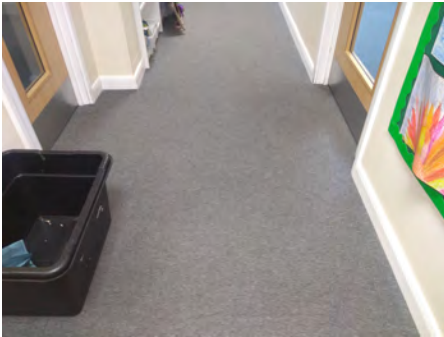
### **Item 128 Ref: As 412937-25**

The floor screed beneath carpet in Rm 0/72a Corridor does not contain asbestos.

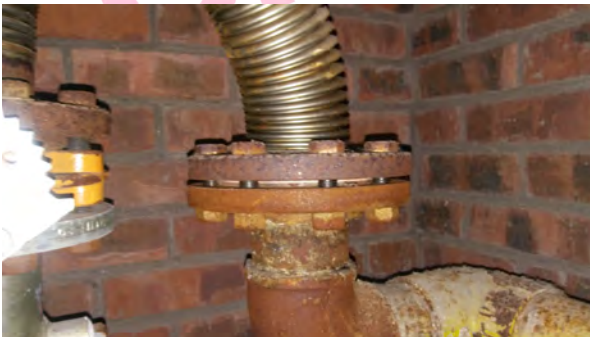
### **Item 129 Ref: 412937-27**

The pipework flange gasket in Rm 0/75 Gas meter store does not contain asbestos.

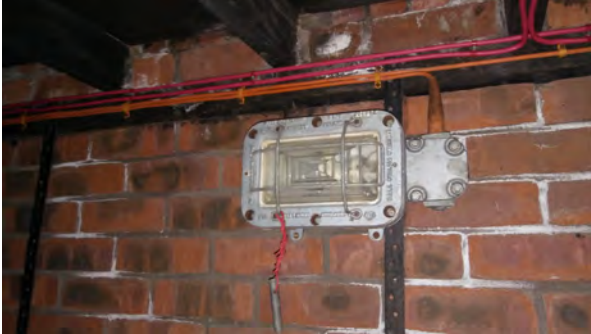
### **Item 130 Ref: 412937-28**

The seal to wall light in Rm 0/75 Gas meter store does not contain asbestos.

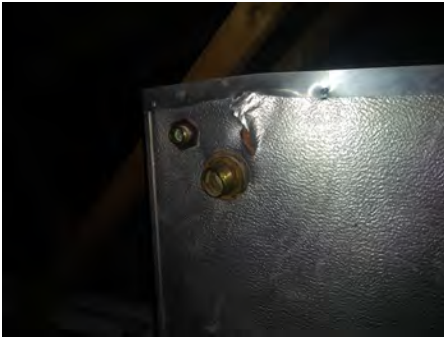
### **Item 131 Ref: 412937-2**

The gaskets to redundant calorifier unit in Rm 1/001 Nursery block loft void contain asbestos.

Any change in its appearance should be recorded and passed to Property Services.

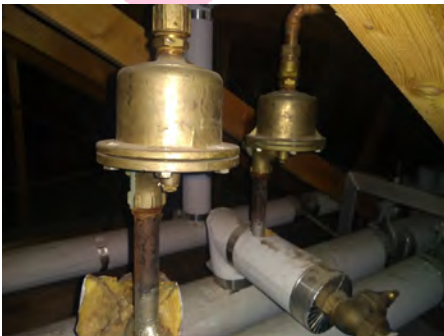
### **Item 132 Ref: Presumed**

The gaskets to bleed valves in Rm 1/001 Nursery block loft void are presumed to contain asbestos.

Any change in its appearance should be recorded and passed to Property Services.

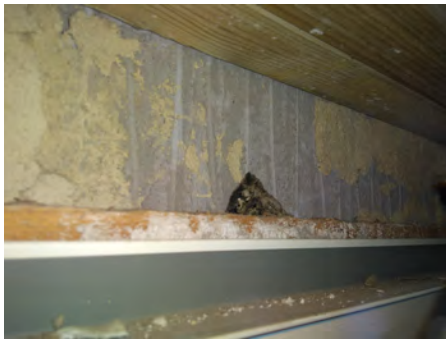
### **Item 134 Ref: As 412937-17**

The packing perimeter of suspended ceilings (including ad hoc use to beams) in Rm 1/003 Area 3 Loft void does not contain asbestos.

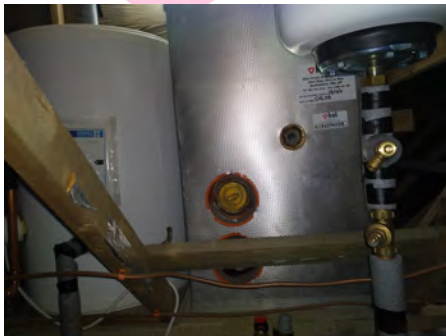
### **Item 135 Ref: As 412937-10**

The gasket to redundant calorifier unit (1/003 Area 3 Loft void) - (1/001 Nursery block loft void) contains asbestos.

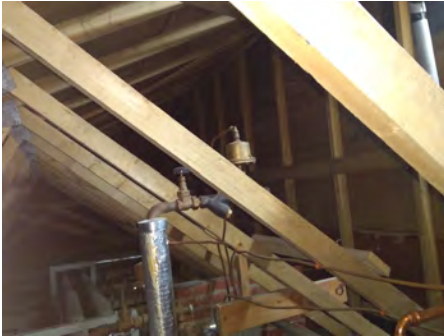
### **Item 136 Ref: Presumed**

The gasket to bleed valves in Rm 1/003 Area 3 Loft void is presumed to contain asbestos.

Any change in its appearance should be recorded and passed to Property Services.

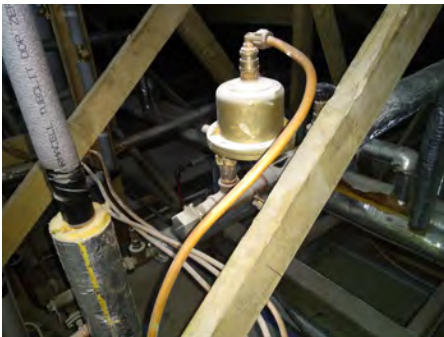
### **Item 137 Ref: Presumed**

The gasket to bleed valves in Rm 1/004 Area 4 Loft void is presumed to contain asbestos.

Any change in its appearance should be recorded and passed to Property Services.

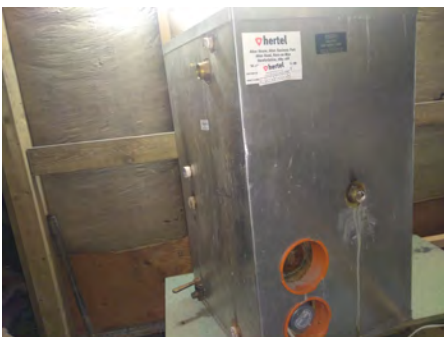
### **Item 138 Ref: 412937-10**

The gaskets to redundant calorifier unit 1/005 Staff Area loft void contain asbestos.

Any change in its appearance should be recorded and passed to Property Services.

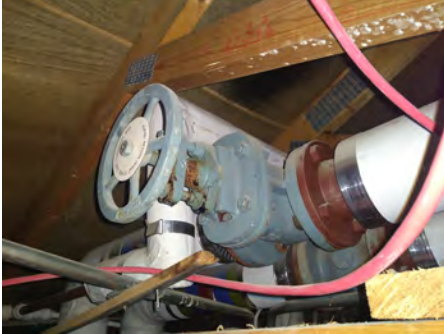
### **Item 139 Ref: Presumed**

The pipework flange gasket in Rm 1/006 Reception block loft void is presumed to contain asbestos.

Any change in its appearance should be recorded and passed to Property Services.

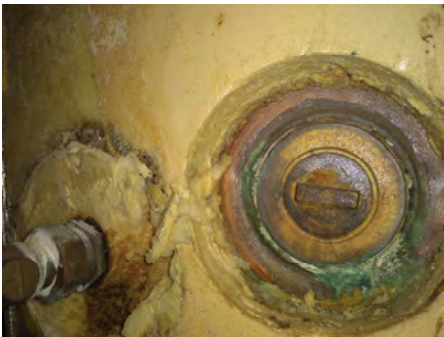
### **Item 140 Ref: As 412937-2**

The gasket to redundant calorifier unit in Rm 1/006 Reception block loft void contains asbestos.

Any change in its appearance should be recorded and passed to Property Services.

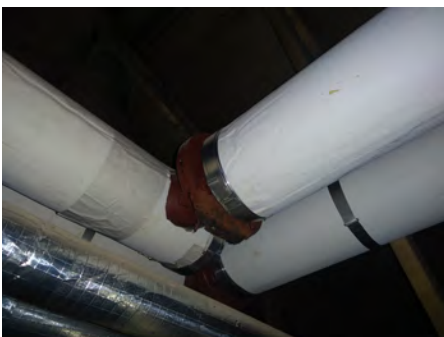
### **Item 141 Ref: Presumed**

The pipework flange gasket in Rm 1/007 Annexe block loft void is presumed to contain asbestos.

Any change in its appearance should be recorded and passed to Property Services.

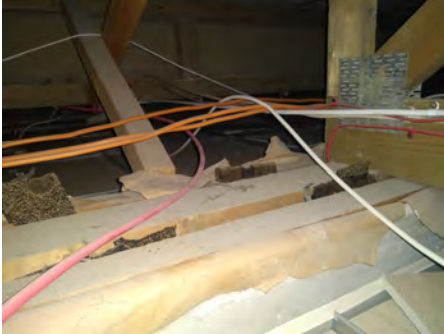
### **Item 142 Ref: 412937-18**

The packing material to beam claddings in Rm 1/007 Annex block loft void does not contain asbestos.

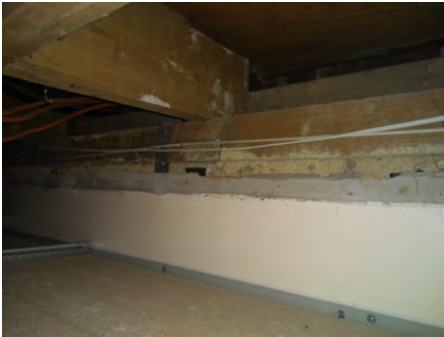
### **Item 143 Ref: As 412937-18**

The packing perimeter of suspended ceiling (including ad hoc use to beams) in Rm 1/007 Annex block loft void does not contain asbestos.

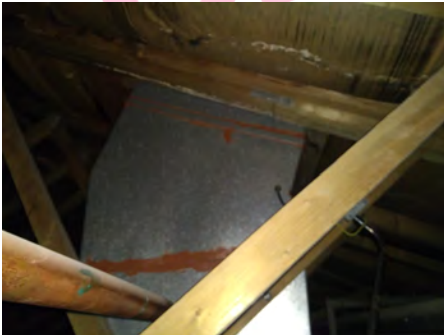
### **Item 144 Ref: Presumed**

The red mastic to ductwork (above kitchen 0/048a extract hood) in Rm 1/007 Annex block loft void was originally presumed to contain asbestos.

***Survey J141088 states no asbestos.***

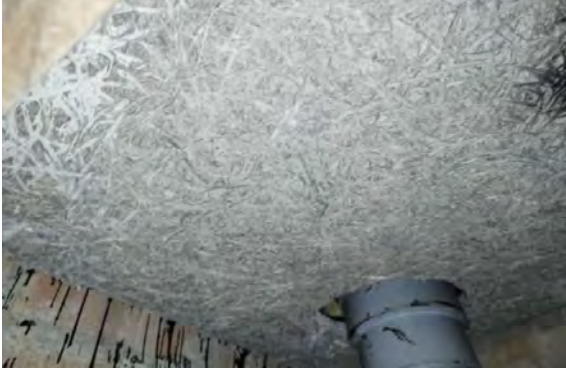
### **Item 145 Ref: 21-35983-1**

The roof underside above the suspended ceiling in Rm 1 PE Store void does not contain asbestos.

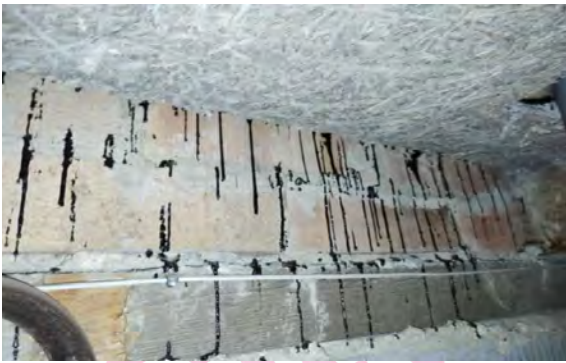
### **Item 146 Ref: 21-35983-2**

The bitumen residue from roof above suspended ceiling in Rm 1 PE Store void does not contain asbestos.

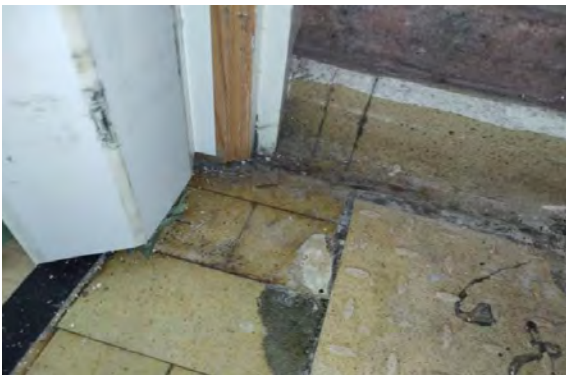
### **Item 147 Ref: 21-35983-3**

The beige concrete composite tiles at doorway floor and skirting in Rm 1 PE Store does not contain asbestos.

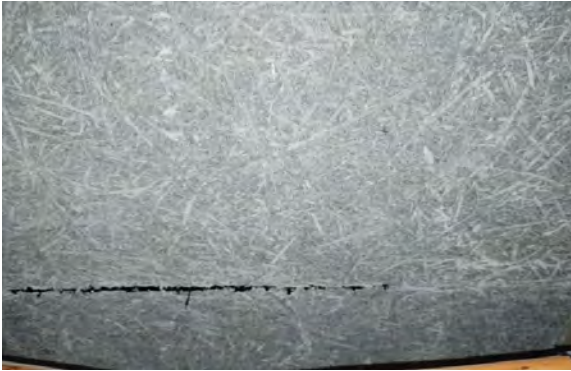
**Item 148 Ref: 21-35983-1**

The roof underside above the suspended ceiling in Rm 2 Sensory room void does not contain asbestos.

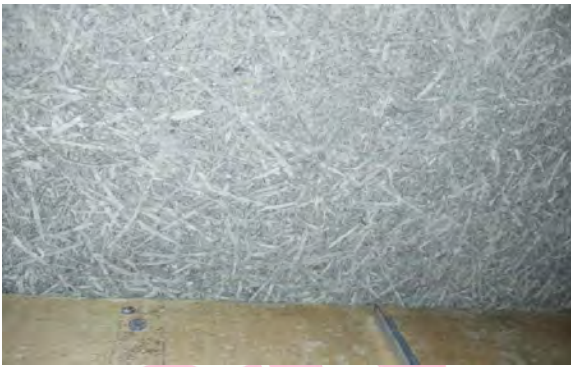
**Item 149 Ref: 21-35983-1**

The roof underside above the suspended ceiling in Rm 2 Sensory room void does not contain asbestos.

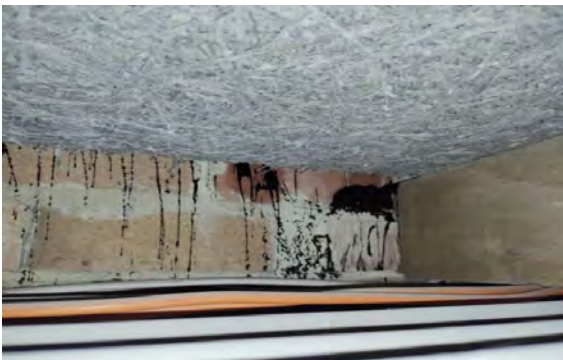
**Item 150 Ref: 21-35983-2**

The bitumen residue from roof above suspended ceiling in Rm 2 Sensory room void does not contain asbestos.

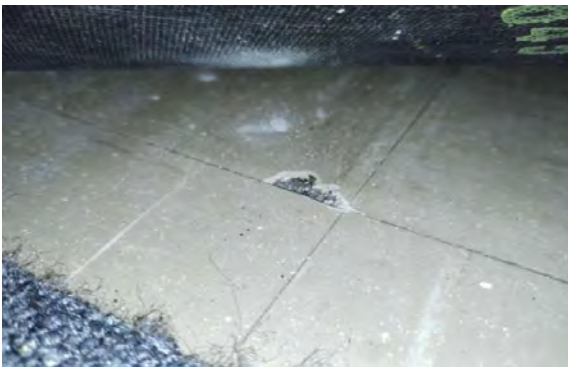
### **Item 152 Ref: 21-35983-5**

The black resin composite floor covering below tiles in Rm 2 Sensory room does not contain asbestos.

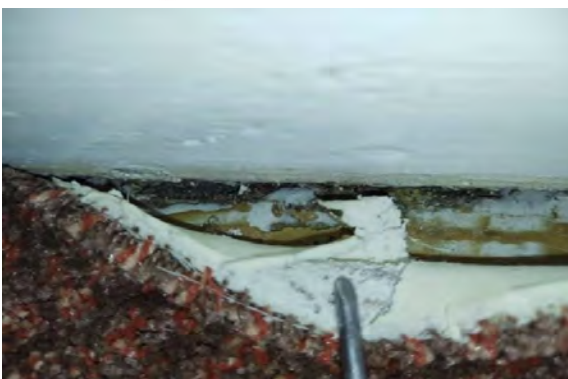
### **Item 153 Ref: 21-35983-6**

The black resin composite floor covering in Rm 3 Staff room does not contain asbestos.

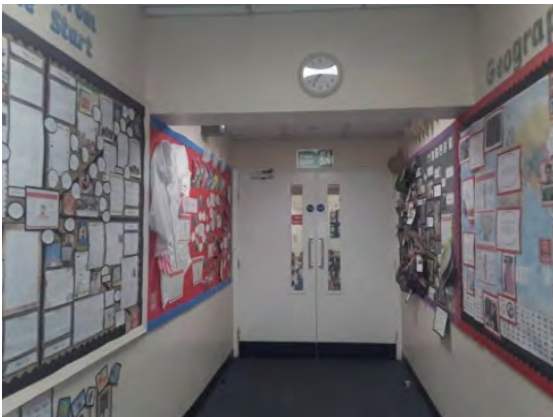
### **Item 155 Ref: NX001617**

Ceiling void packers to ceiling track (Corridor lights 1, 3, 5, 6, 7 G/007) does not contain asbestos.

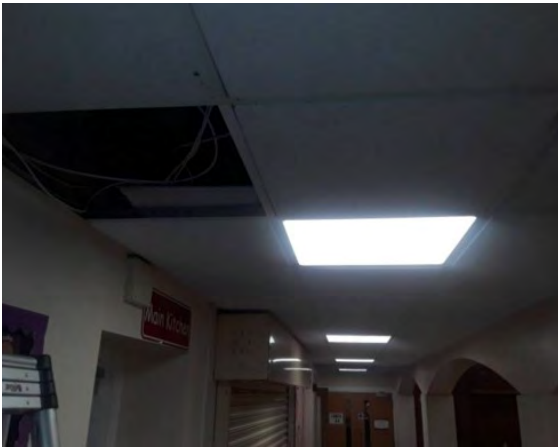
### **Item 157 Ref: As NZ001617**

The ceiling void packers to ceiling track (Main hall lights 8, 9, 10, 11, 12, 13 G/011) does not contain asbestos.

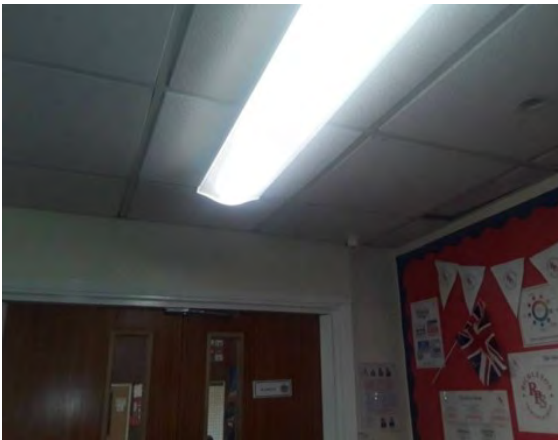
### **Item 158 Ref: NX001619**

The ceiling void packers to ceiling track (Classroom lights 14, 15, 17 G/012) does not contain asbestos.

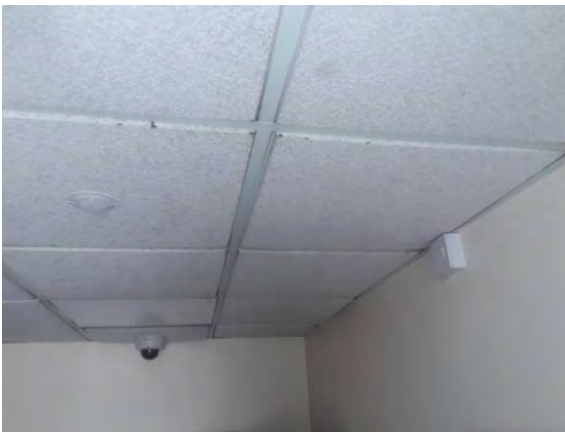
### **Item 159 Ref: As NX001619**

The ceiling void packers to ceiling track (Cloak room light 16 G/013) does not contain asbestos.

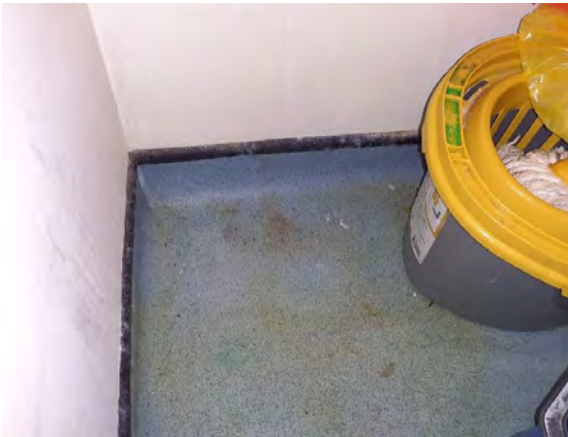
### **Item 160 Ref: OU003099**

The bitumen beneath modern vinyl and screed in the cleaners cupboard G/01 does not contain asbestos.

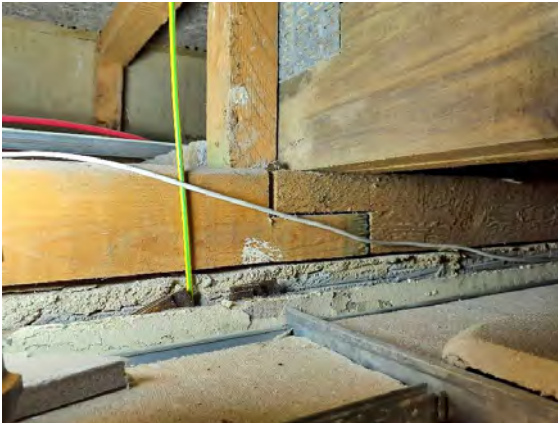
### **Item 161 Ref: RO001330**

The bitumen packer – wall in the Kitchen G/01 does not contain asbestos.

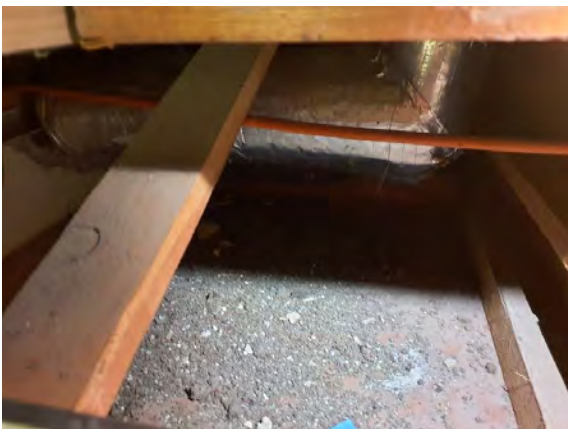
### **Item 162 Ref: RO001331**

The insulation residue – Ceiling void in the Kitchen G/01 does not contain asbestos.

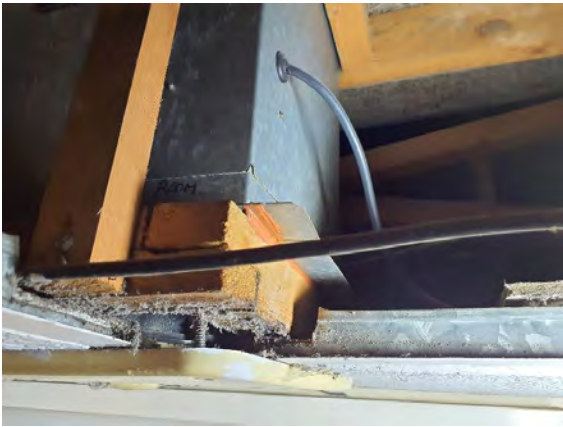
**Item 163 Ref: RO001328**

The red mastic – ducting in the Store G/02 does not contain asbestos.

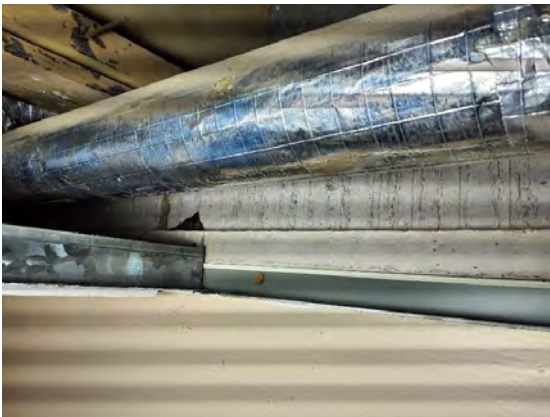
**Item 164 Ref: RO001329**

The bitumen packer – wall in the Store G/02 does not contain asbestos.

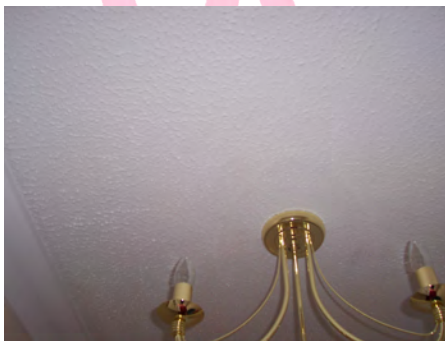
**Item 3 Ref: As 1000855**

The textured coating in Living Room (Room 4) contains asbestos.

Any change in its appearance should be recorded and passed to Property Services.
