### ASBESTOS SURVEY REPORT FOR SEABURN DENE PRIMARY SCHOOL, SUNDERLAND

## **Asbestos Register for Seaburn Dene Primary School**

Last updated 29/04/2026 V.2.0

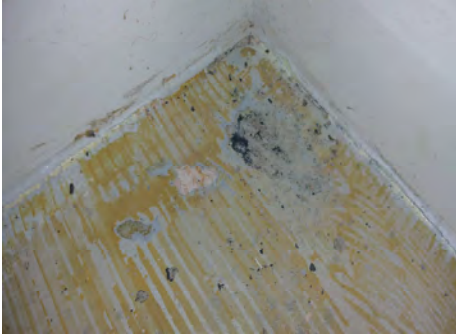
### **Item 1 Ref: 179537-1**

The subfloor covering (Rm 0/01) containing remnant bitumen contains asbestos.

Any change in its appearance should be recorded and passed to Property Services.

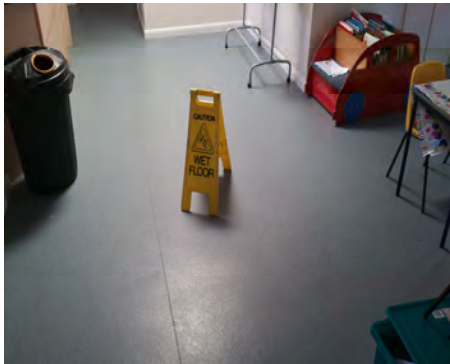
### **Item 2 Ref: As 179537-1**

The subfloor covering (Rm 0/02) containing remnant bitumen contains asbestos.

Any change in its appearance should be recorded and passed to Property Services.

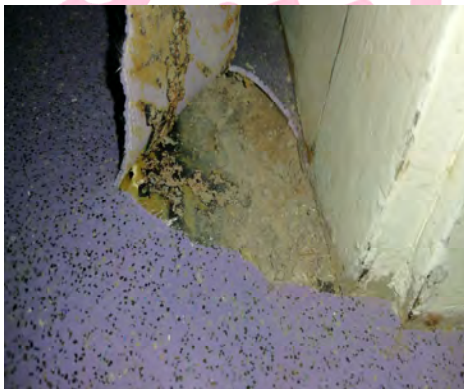
### **Item 3 Ref: As 179537-1**

The subfloor covering (Rm 0/03) containing remnant bitumen contains asbestos.

Any change in its appearance should be recorded and passed to Property Services.

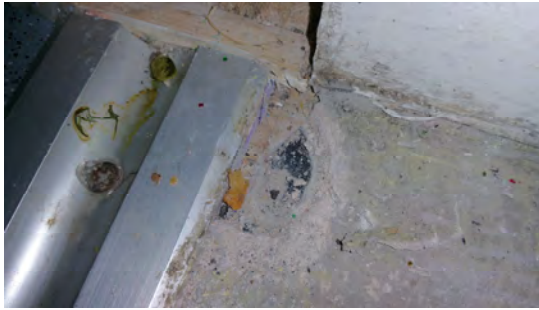
### **Item 4 Ref: As 179537-1**

The subfloor covering (Rm 0/09) containing remnant bitumen contains asbestos.

Any change in its appearance should be recorded and passed to Property Services.

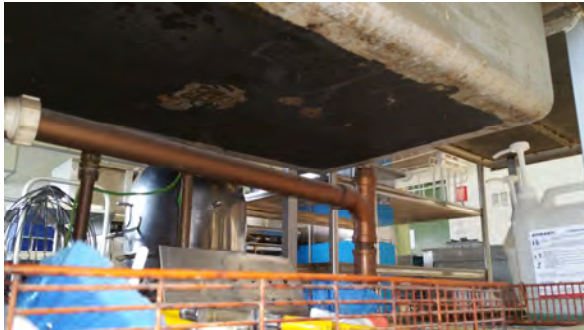
### **Item 10 Ref: 179537-4**

The Sink Pad (Rm 0/36) does not contain asbestos.

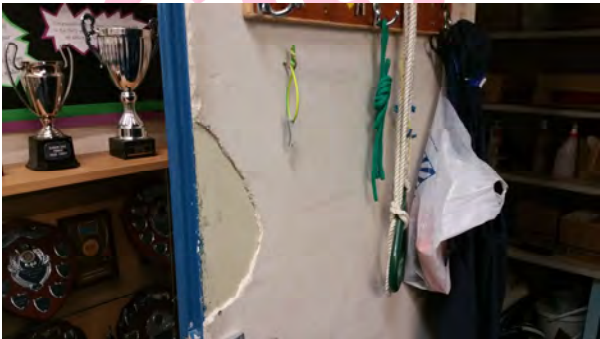
### **Item 18 Ref: 179537-9**

The panels to back of doors (Rm 0/58) do not contain asbestos.

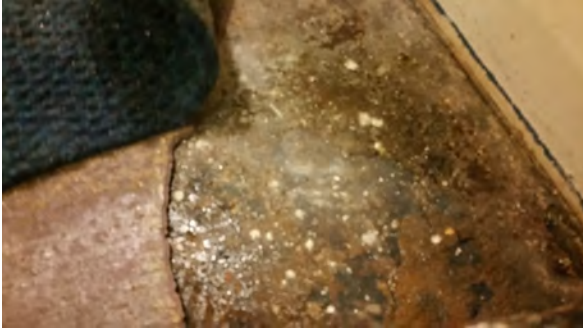
### **Item 19 Ref: 179537-10**

The bitumen adhesive (Rm 0/59) contains asbestos.

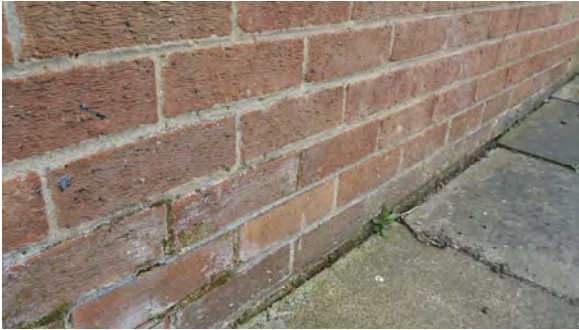
### **Item 22 Ref: 179537-13**

The damp proof course (external) does not contain asbestos.

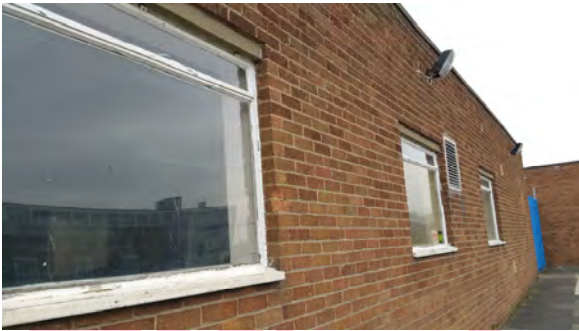
### **Item 23 Ref: 179537-14**

The putty to windows (external) do not contain asbestos.

*Removed August 2022*

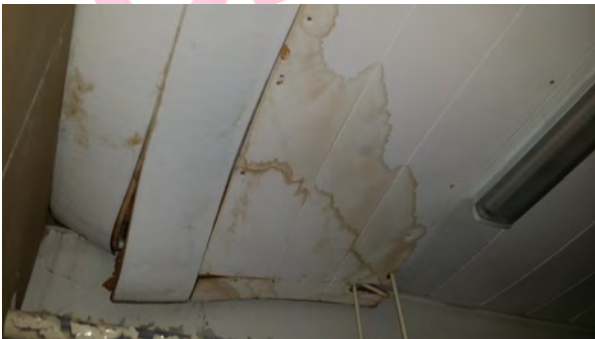
### **Item 24 Ref: 209718-1**

The fixed ceiling (Rm 032a/Stage Store) does not contain asbestos.

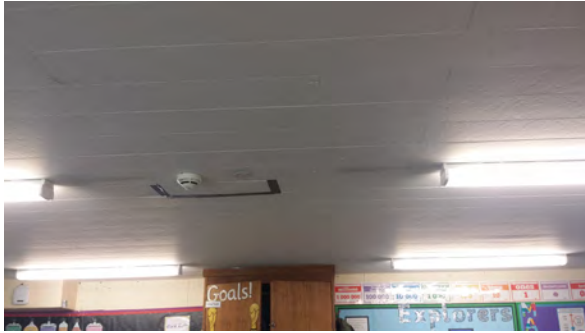
### **Item 25 Ref: As 209718-1**

The fixed ceiling (Rm 078/Classroom) does not contain asbestos.

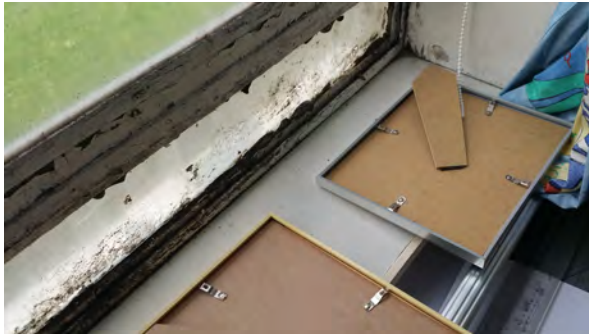
### **Item 26 Ref: 209718-2**

The Sealant to window glazing (Rm 078/Classroom) does not contain asbestos.

*Removed August 2022*

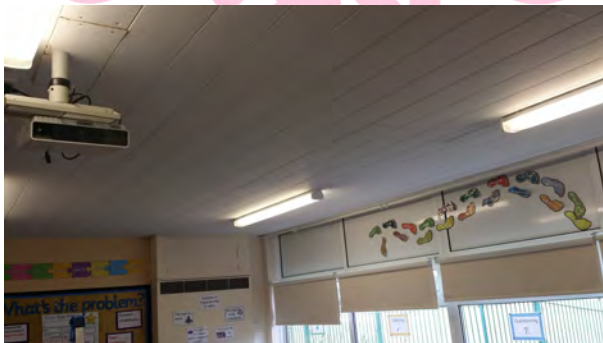
### **Item 27 Ref: As 209718-1**

The Fixed ceiling tiles (Rm 079/Classroom) do not contain asbestos.

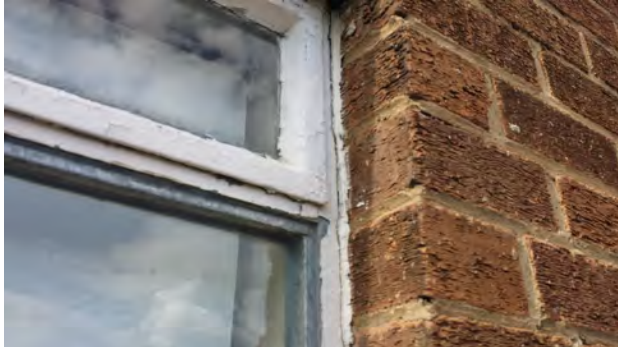
### **Item 28 Ref: 209718-3**

The Sealant to window surround (External-localised to classroom 78 & 79 window replacement works)

Item 25	No asbestos	Is present		
Item 26	No asbestos	Is present		
Item 27	No asbestos	Is present		
Item 28	Sealant – External (localised to classroom 78 & 79 window replacement works)	Very Low		Removed August 2022

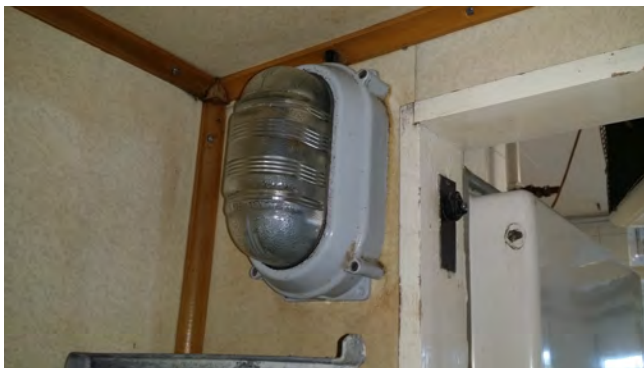
### **Item 35 Ref: 277554-9**

The seal to diffuser of bulkhead light fitting in the kitchen fridge (Room 036a) does not contain asbestos.

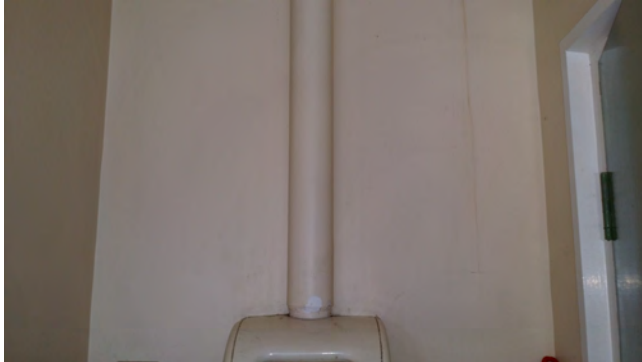
### **Item 37 Ref: 277554-11**

The incinerator flue collar in the WC (Room 040) does not contain asbestos.

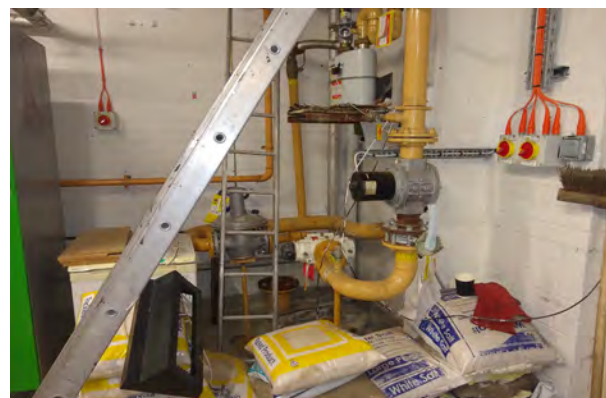
### **Item 42 Ref: 342052-4**

The gas pipework and flange gasket in the Boiler Room (Room 0/81) does not contain asbestos.

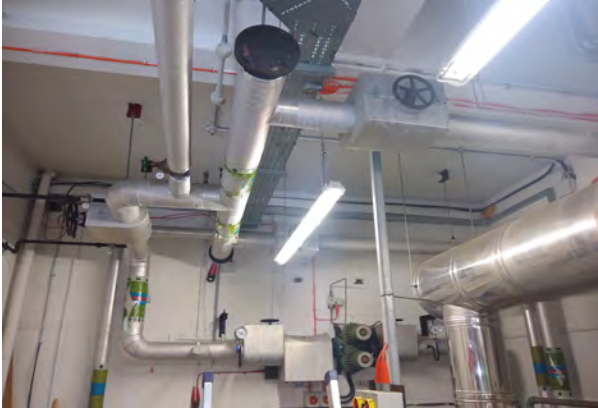
### **Item 43 Ref: 342052-5**

The HTG pipework and flange gasket in the Boiler Room (Room 0/81) does not contain asbestos.

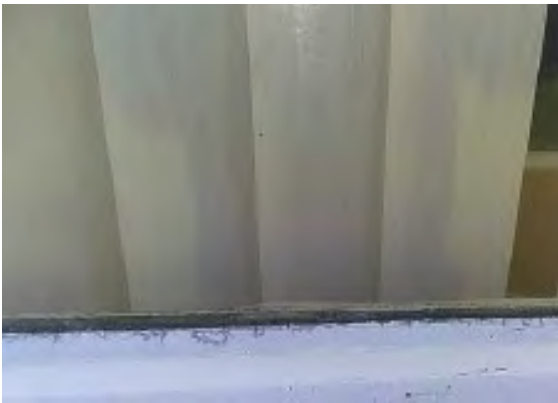
### **Item 47 Ref: 22-47237-1**

The putty around the glass in the windows in Area 2 – Junior Class 1 /Point A does not contain asbestos.

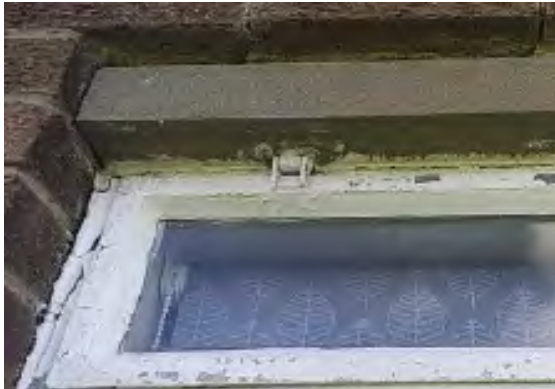
**Item 50 Ref: 22-47237-4**

The putty around the window in Area 3 – Junior Class 3 /Point B does not contain asbestos.

*Removed August 2022*

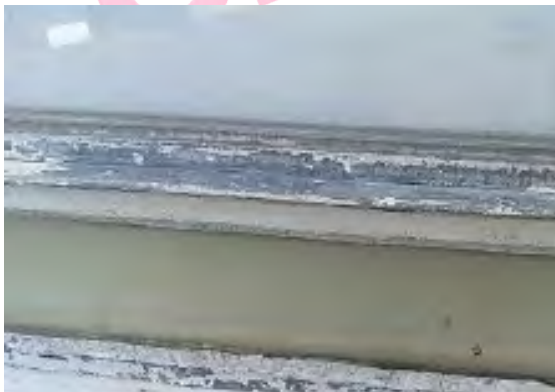
**Item 51 Ref: 22-47237-5**

The putty around the glass in the windows in Area 4 – Junior Class 4 /Point B does not contain asbestos.

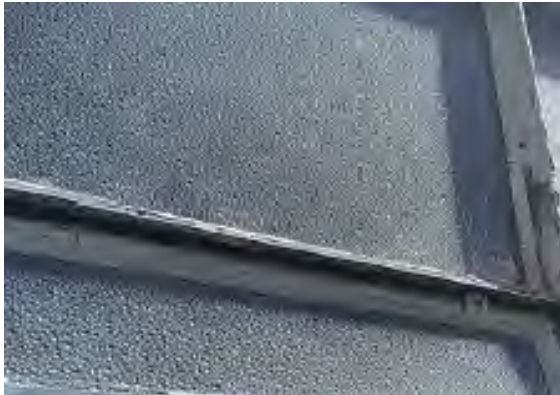
**Item 53 Ref: 22-47237-5**

The putty around the glass in the windows in Area 5 – WC 1 /Point C does not contain asbestos.

*Removed August 2022*

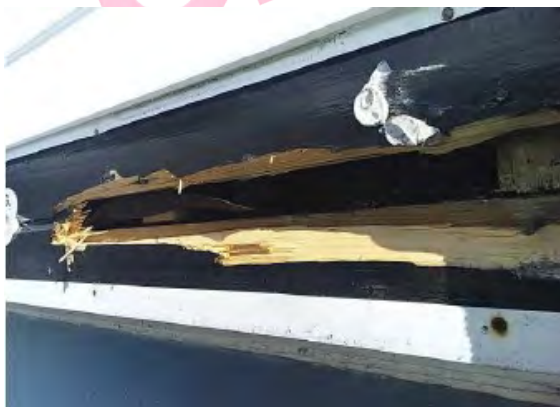
**Item 54 Ref: 22-47237-7**

The felt behind pvc and wood headers in Area 5 – WC 1 /Point C does not contain asbestos.

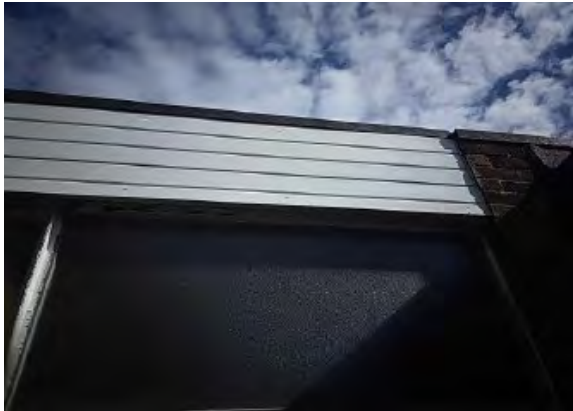
### **Item 56 Ref: 22-47237-7**

The felt behind pvc and wood headers in Area 6 – WC 2 /Point C does not contain asbestos.

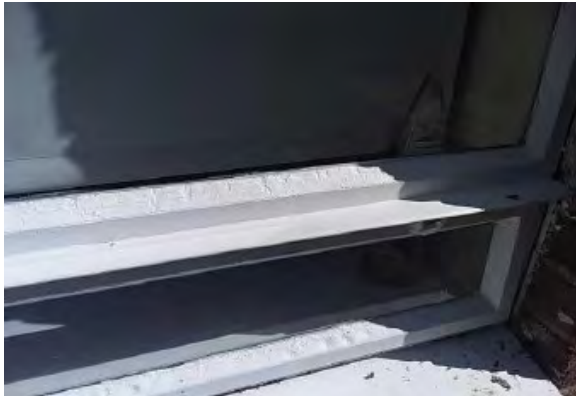
**Item 58 Ref: 22-47237-4**

The putty around the window in Area 7 – Head Teacher /Point D does not contain asbestos.

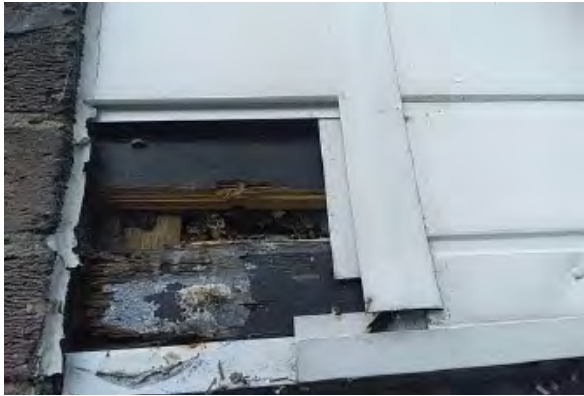
**Item 61 Ref: 22-47237-8**

The felt behind pvc and wood headers in Area 9 – Main Hall /Point E does not contain asbestos.

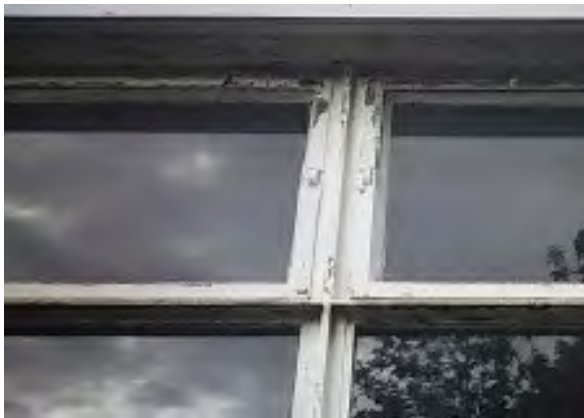
**Item 62 Ref: 22-47237-9**

The putty around the glass in the windows in Area 9 – Main Hall /Point E does not contain asbestos.

*Removed August 2022*

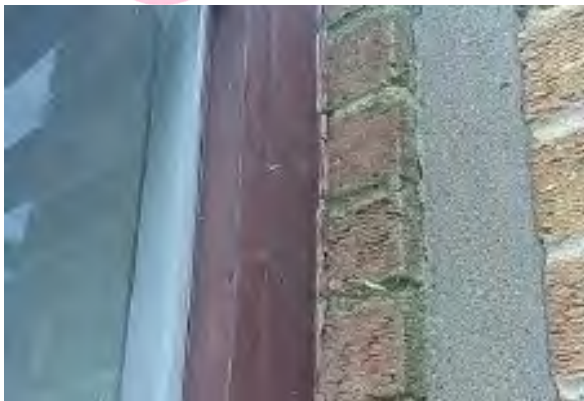
**Item 63 Ref: 22-47237-10**

The residual frame sealant around windows in Area 10 – Point F does not contain asbestos.

*Removed August 2022*

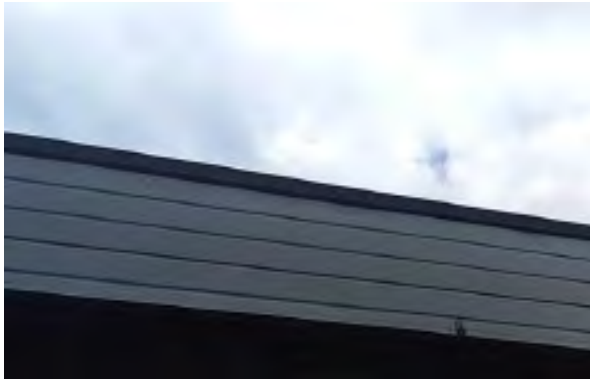
**Item 64 Ref: 22-47237-7**

The felt behind pvc and wood headers in Area 10 – Point F does not contain asbestos.

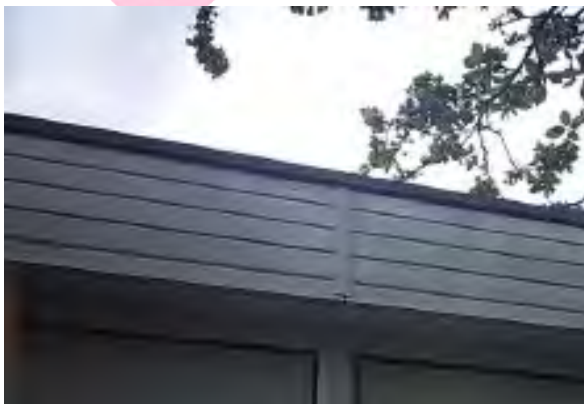
**Item 66 Ref: 22-47237-8**

The felt behind pvc and wood headers in Area 11 – Library /Point G does not contain asbestos.

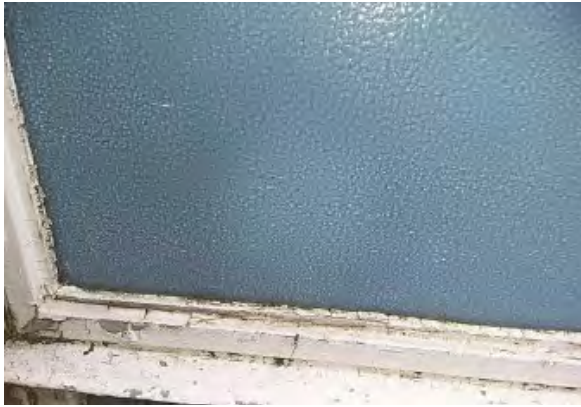
**Item 67 Ref: 22-47237-9**

The putty around the glass in the windows in Area 11 – Library /Point G does not contain asbestos.

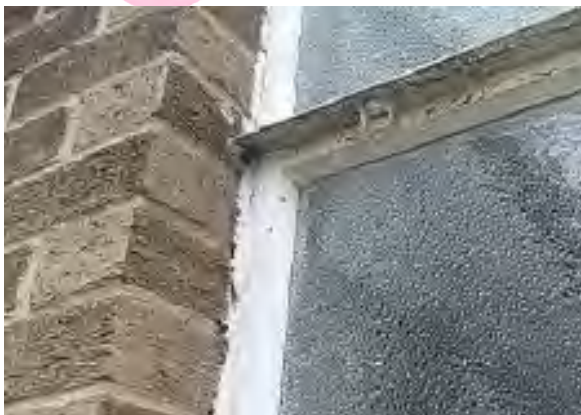
**Item 69 Ref: 22-47237-12**

The putty around the glass in the windows in Area 12 – Kitchen 1 /Point H does not contain asbestos.

*Removed August 2022*

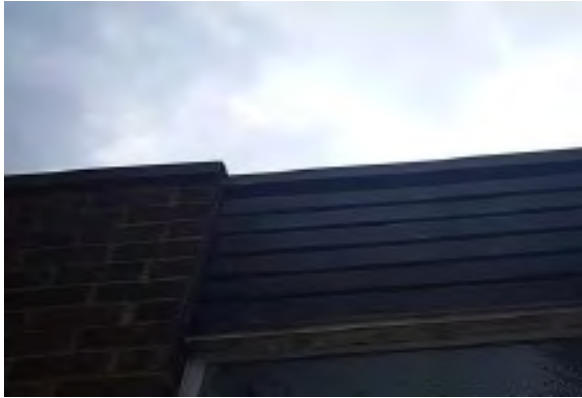
**Item 70 Ref: 22-47237-8**

The felt behind wood headers in Area 12 – Kitchen 1 /Point H does not contain asbestos.

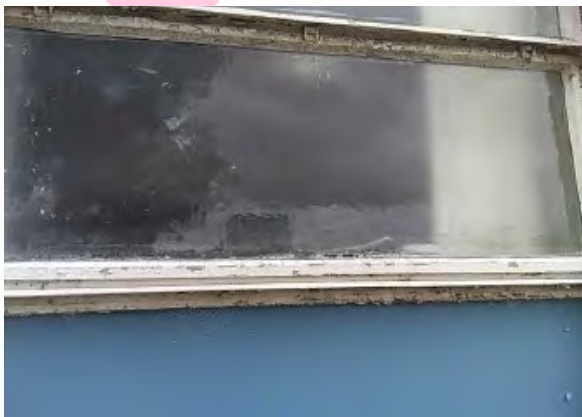
**Item 72 Ref: 22-47237-12**

The putty around the glass in the windows in Area 13 – WC 3 /Point H does not contain asbestos.

*Removed August 2022*

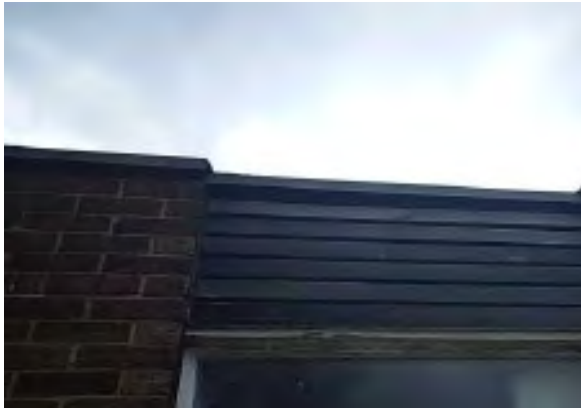
**Item 73 Ref: 22-47237-8**

The felt behind wood headers in Area 13 – WC 3 /Point H does not contain asbestos.

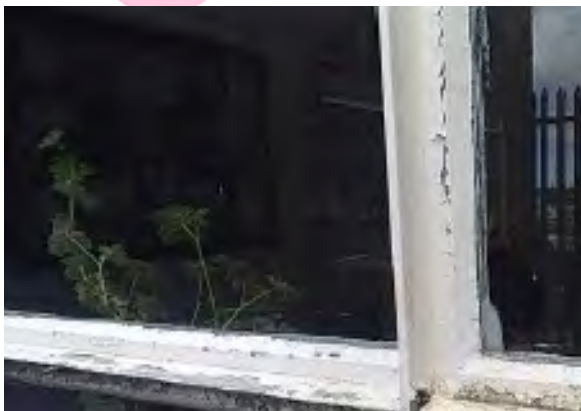
**Item 75 Ref: 22-47237-14**

The putty around the glass in the windows in Area 15 – Point I, J, K does not contain asbestos.

*Removed August 2022*

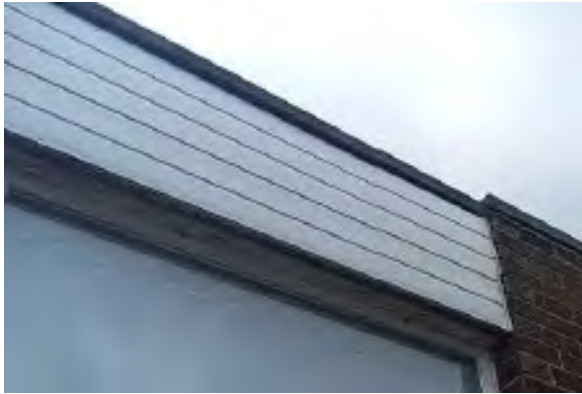
**Item 76 Ref: 22-47237-8**

The felt behind pvc and wood headers in Area 15 – Point I, J, K does not contain asbestos.

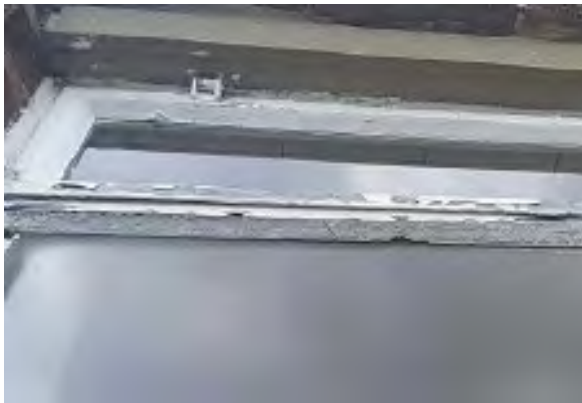
**Item 77 Ref: 22-47237-15**

The putty around the glass in the windows in Area 16 – Kitchen 2 /Point J does not contain asbestos.

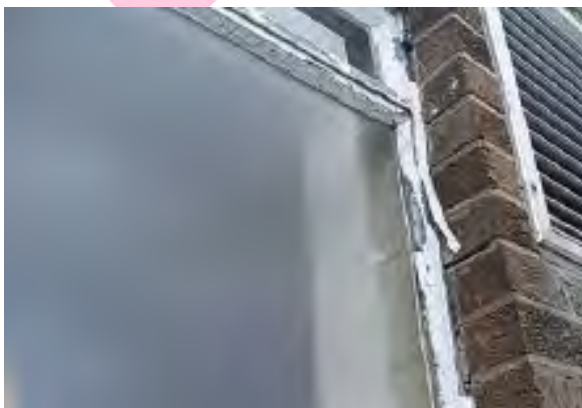
**Item 78 Ref: 22-47237-16**

The residual frame sealant around windows in Area 16 – Kitchen 2 /Point J does not contain asbestos.

*Removed August 2022*

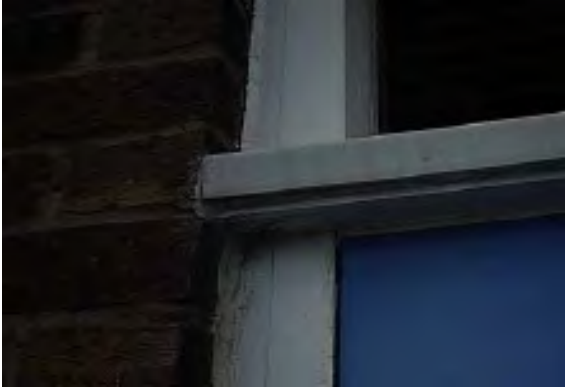
**Item 79 Ref: 22-47237-17**

The residual frame sealant around door in Area 17 – D1 does not contain asbestos.
