ASBESTOS SURVEY REPORT FOR BENEDICT BISCOP, SUNDERLAND

Asbestos Register for BENEDICT BISCOP, SUNDERLAND

Date: 16 March 2026

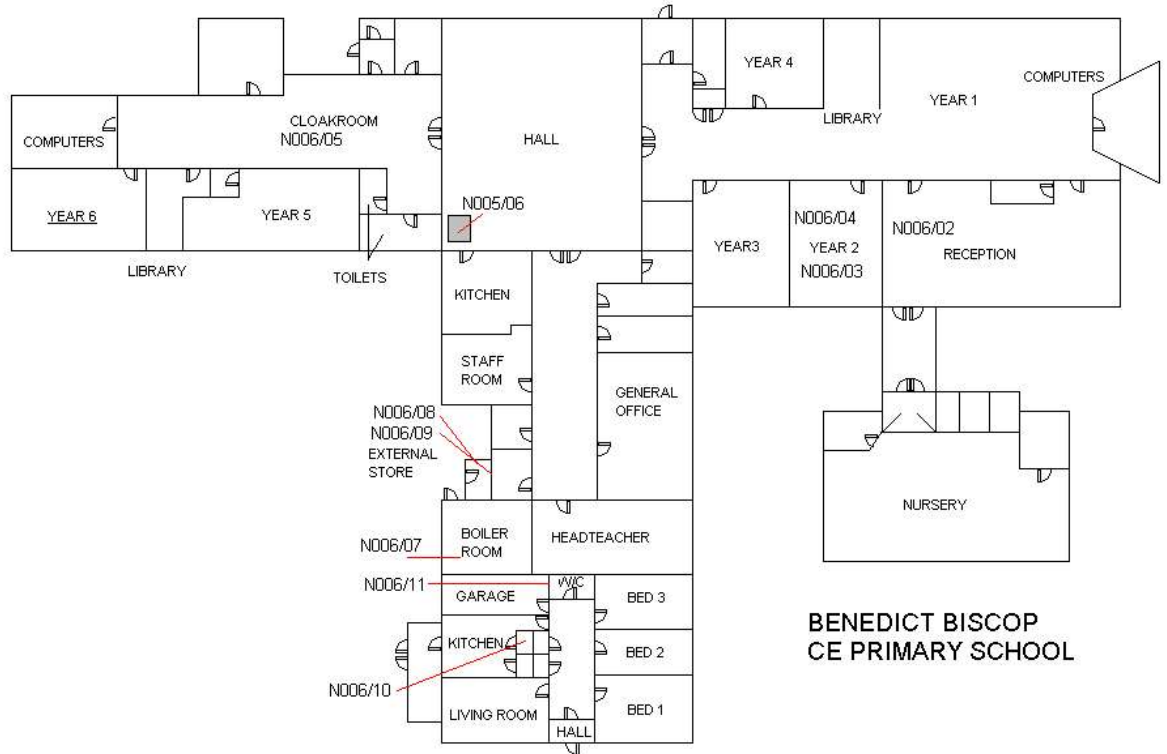
Plan of Building and Samples Location- Cont.

Computer Room/Reception Cloakroom/Nursery Cloakroom/Nursery Disabled Toilet/Nursery/Year 3 Class/Year 4 Class/Corridor Adjacent to Reception/Years 1-4 Library/Chemical Store/Boys WC 1/Girls WC 1/Year 1-4 Cloakrooms/Hall/Year 5 & 6 Boys Toilets/Year 5 & 6 Girls Toilets/Years 5 & 6 Small Cloakroom/Years 5 & 6 Toy Stores/Years 5 & 6 Main Corridor/Year 5 Class/Year 6 Class/Years 5 & 6 Library/Years 5 & 6 Computers/Kitchen/Staff Room/Disabled Toilet 2/Staff Toilet Male/Staff Toilet Female/Reception Foyer/General Office/Head Teachers Office/Corridor Adjacent to Heads Office/General Office Stationary Store/Main Switch Room/Caretakers House Kitchen/Caretakers House Bathroom/Caretakers House Heater Cupboard/Caretakers House Conservatory - No Suspect Asbestos Containing Materials Noted

Please note the survey carried out was non-intrusive. Should major refurbishment be planned for the property, further investigation will be required.
