ASBESTOS SURVEY REPORT FOR EAST RAINTON PRIMARY SCHOOL,
SCHOOL ROAD, EAST RAINTON, DH5 9RA.

**East Rainton Primary School, School Road, East
Rainton, Houghton, DH5 9RA**

Date: 22 May 2026

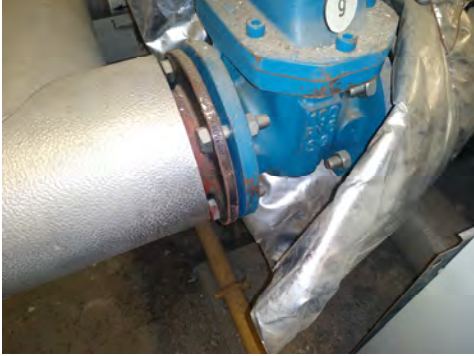
Item 1 Ref: 427459-15

The gasket to pipework in -1/013 Plant Room does not contain asbestos.

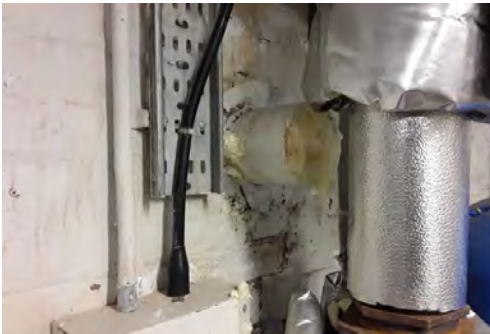
Item 47 Ref: Presumed

The insulation inside pipe penetration to wall in Main Boiler Room is presumed to contain asbestos.

Any change in its appearance should be recorded and passed to Property Services.
