ASBESTOS SURVEY REPORT FOR HILL VIEW JUNIOR SCHOOL ACADEMY,
QUEEN ALEXANDRA ROAD, SUNDERLAND, TYNE AND WEAR, SR2 9HE.

**Hill View Junior School Academy, Queen Alexandra
Road, Sunderland, SR2 9HE**

Date: 16 April 2026

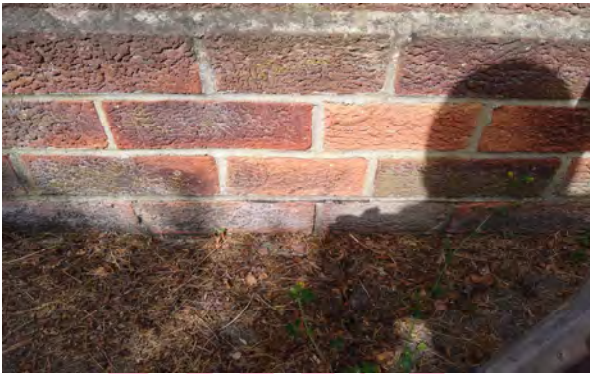
Item 2 Ref: 422644-14

The damp proof course to Bungalow (External) does not contain asbestos.

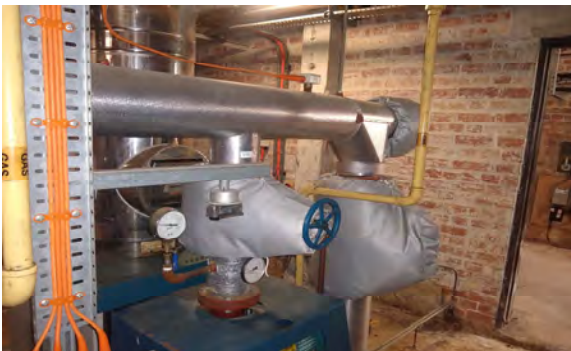
Item 6 Ref: 422644-4

The HTG pipework flange gaskets in the Boiler House (Rm -1/01) does not contain asbestos.

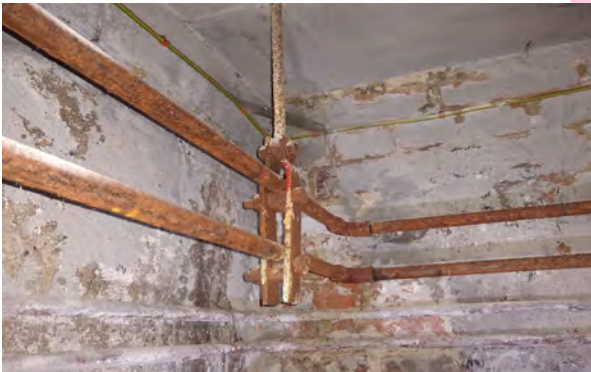
Item 11 Ref: 422644-8

- (Item 11) Ref: 422644-8 – Residue to pipework and hangers (Former coal bunker -1/002) -Very Low Risk
- (Item 12) Ref: 422644-9 - Loose lying gasket to floor (Former coal bunker -1/002) – Low Risk

The residue to pipework & hangers in the Former Coal Bunker (Rm -1/02) contains asbestos.

Item 11	Residue to pipework and hangers (Former coal bunker -1/002)	Medium Risk	3 monthly	13/07/2026
Item 12	Loose lying gasket to floor	Low Risk	6 monthly	13/10/2026 – noted as

Any change in its appearance should be recorded and passed to Property Services.

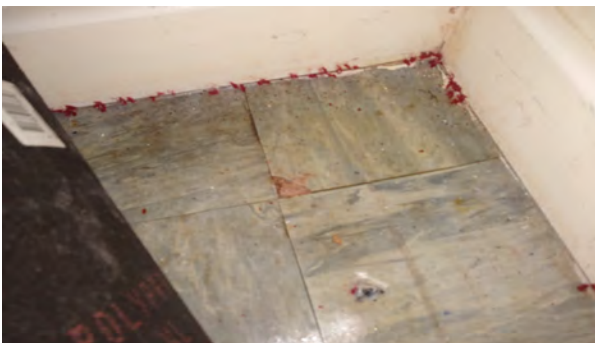
Item 21 Ref: As 422644-21

- (Item 21) Ref: As 422644-21 -Screed beneath carpet and modern vinyl tiles (Main office 0/004) – No Risk
- (Item 22) Ref: 422644-18 – Red floor screed (Office 0/006) -Very Low Risk

The screed beneath carpet & modern vinyl tiles in the Main Office (Rm 0/04) does not contain asbestos.

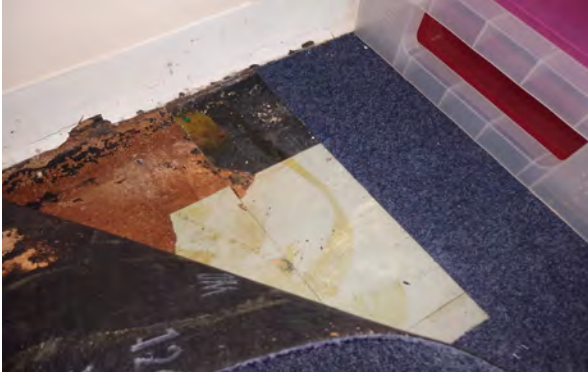
Item 25 Ref: 422644-20

The subfloor in the Classroom (Rm 0/08) contains asbestos.

Removed August 2022

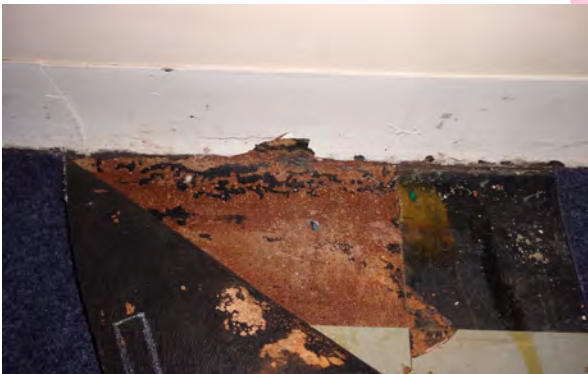
Item 26 Ref: 422644-21

The floor screed in the Classroom (Rm 0/08) does not contain asbestos.

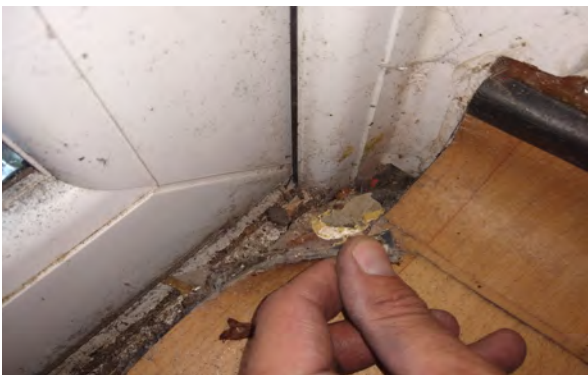
Item 27 Ref: As 422644-16

The subfloor & skirting in the Dining Hall (Rm 0/09) does not contain asbestos.

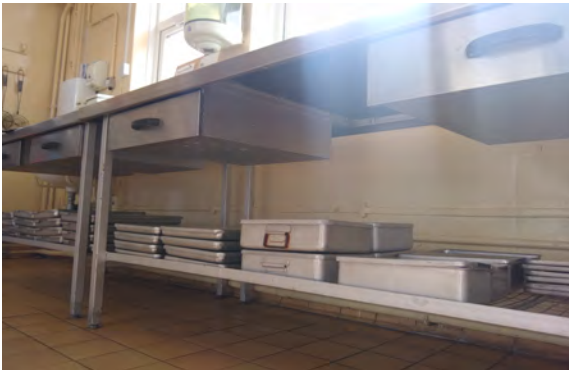
Item 29 Ref: 422644-22

The coating to underside of units in the Kitchen (Rm 0/10) does not contain asbestos.

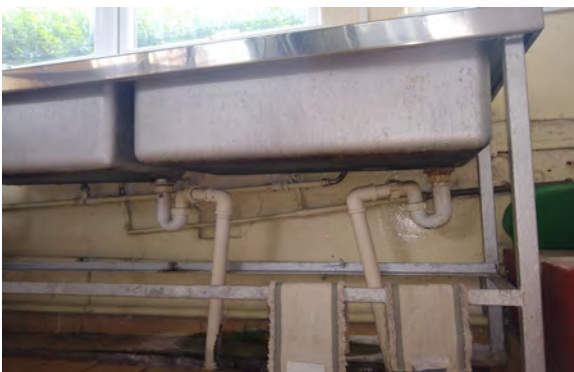
Item 30 Ref: 422644-23

The gasket to sink waste traps in the Kitchen (Rm 0/10) contains asbestos.

Any change in its appearance should be recorded and passed to Property Services.

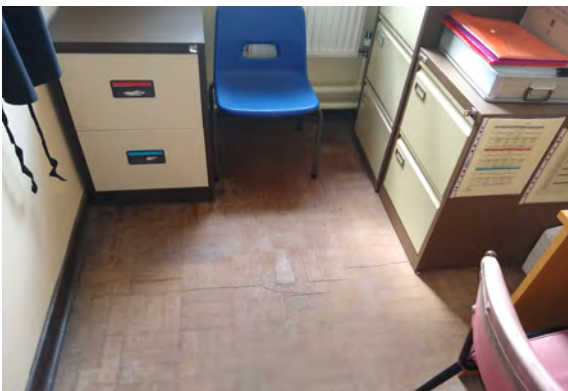
Item 33 Ref: As 422644-25

The floor covering & skirting in the Kitchen Office (Rm 0/16) does not contain asbestos.

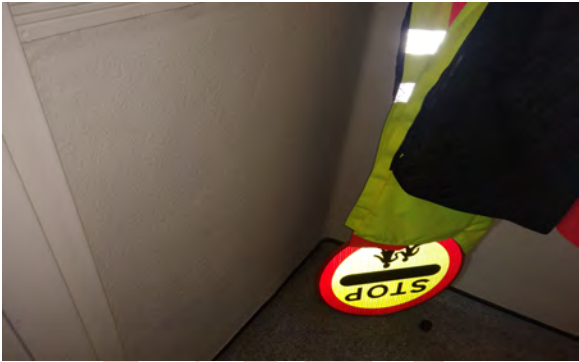
Item 35 Ref: As 422644-17

The decorative finish to low level walls in the Female Staff WC (Rm 0/18) does not contain asbestos.

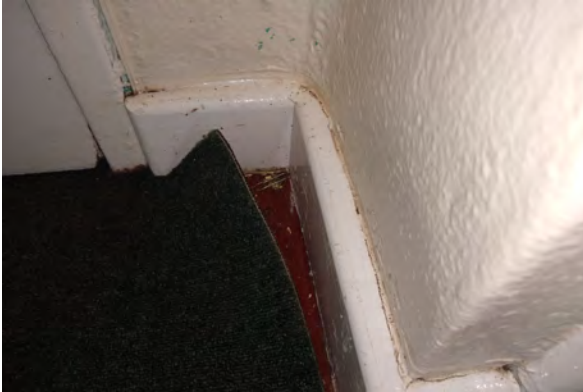
Item 46 Ref: As 422644-29

The floor screed in the Staff Room (Rm 0/29) does not contain asbestos.

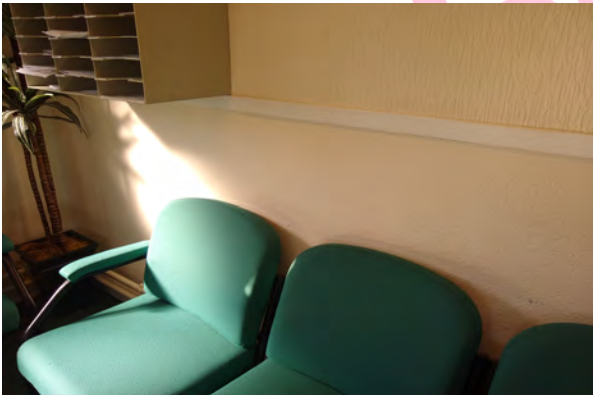
Item 47 Ref: As 422644-26

The decorative finish to low level walls in the Staff Room (Rm 0/29) does not contain asbestos.

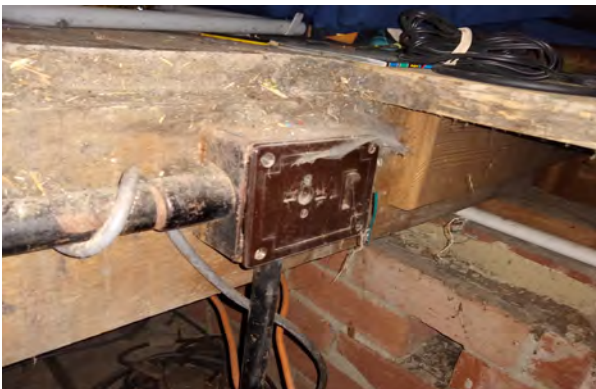
Item 48 Ref: 422644-35

The electrical sockets in the Stage – void below (Rm 0/31) does not contain asbestos.

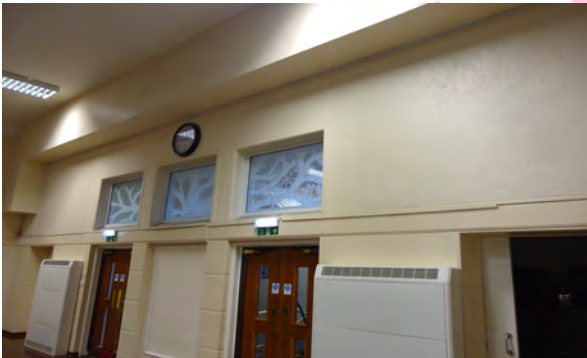
Item 50 Ref: 422644-32

The textured coating to south wall at high level in the Hall (Rm 0/32) contains asbestos.

Any change in its appearance should be recorded and passed to Property Services.

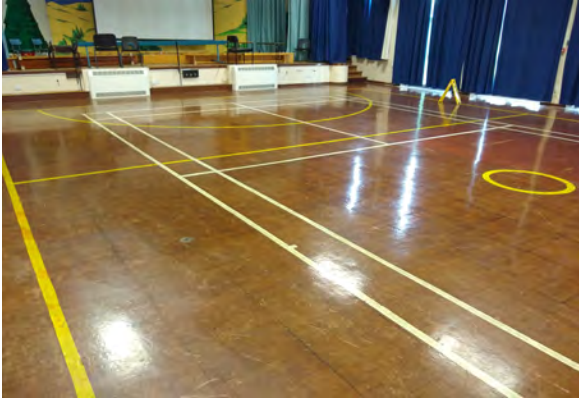
Item 52 Ref: 422644-34

The floor covering in the Hall (Rm 0/32) does not contain asbestos.

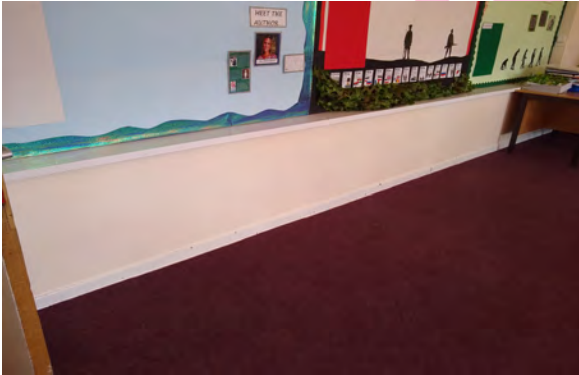
Item 53 Ref: 422644-36

The decorative finish to low level walls in the Classroom 1 (Rm 0/36) does not contain asbestos.

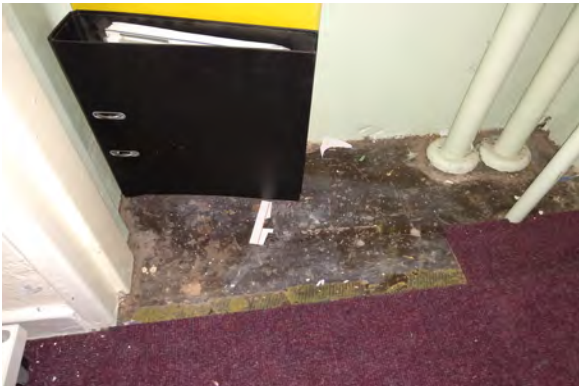
Item 54 Ref: 422644-37

The subfloor & skirting in the Classroom 1 (Rm 0/36) does not contain asbestos.

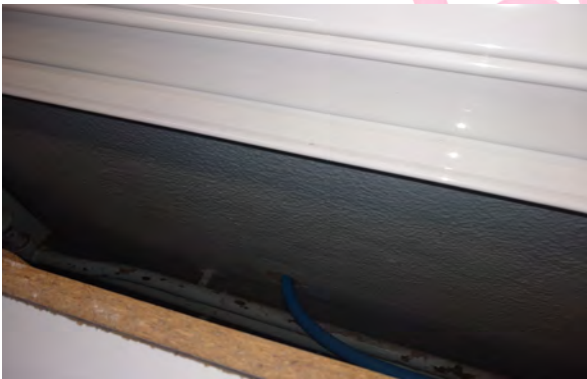
Item 62 Ref: As 422644-36

The decorative finish to low level walls in the IT room (Rm 0/50) does not contain asbestos.

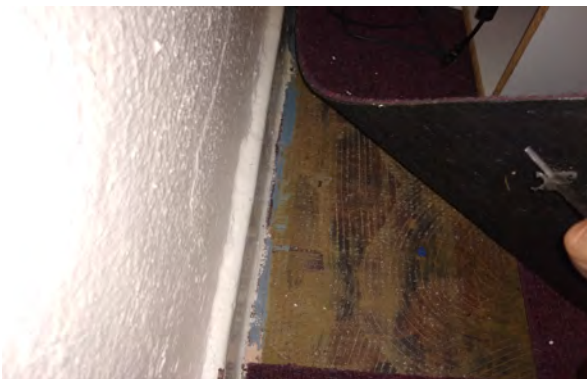
Item 63 Ref: As 422644-37

The subfloor & skirting in the IT room (Rm 0/50) does not contain asbestos.

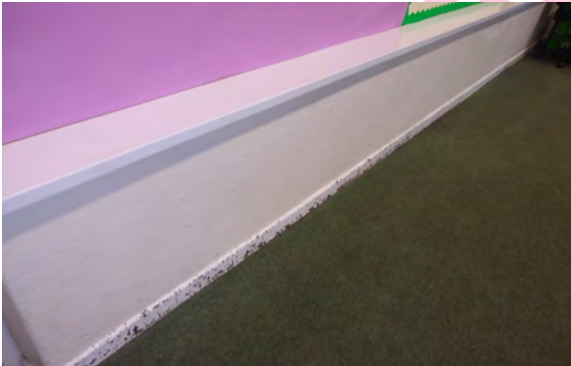
Item 74 Ref: As 422644-43

The decorative finish to low level walls in Classroom 7 (Rm 0/60) does not contain asbestos.

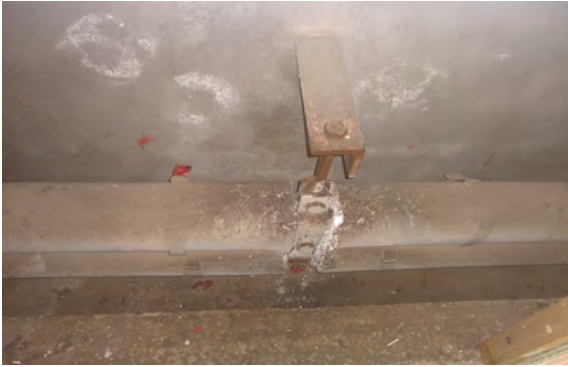
Item 76 Ref: 422644-45

The pipe lagging in Classroom 7 – void within pipework boxing between redundant heaters (Rm 0/60) contains asbestos.

Any change in its appearance should be recorded and passed to Property Services.

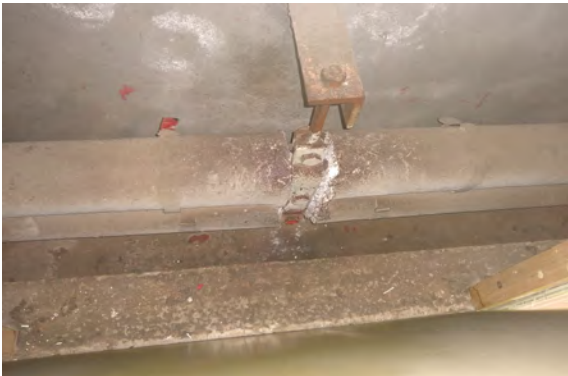
Item 77 Ref: 422644-46

The debris to floor in Classroom 7 – void within pipework boxing between redundant heaters (Rm 0/60) contains asbestos.

Any change in its appearance should be recorded and passed to Property Services.

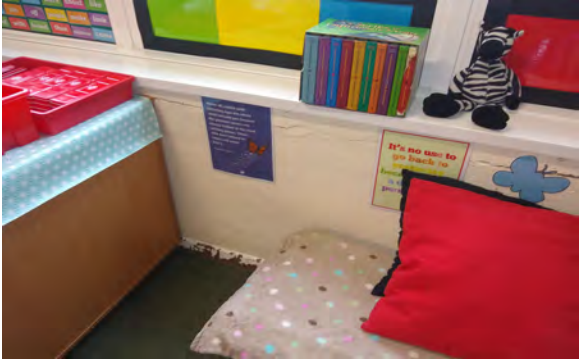
Item 79 Ref: As 422644-43

The decorative finish to low level walls in Classroom 8 (Rm 0/61) does not contain asbestos.

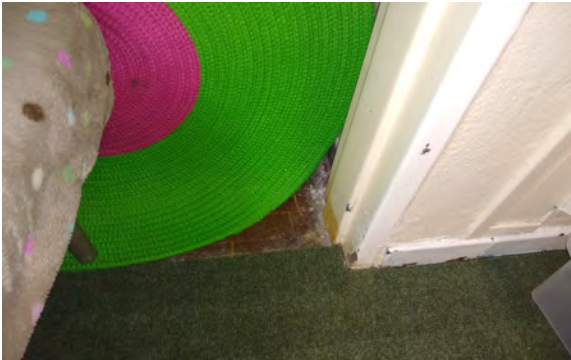
Item 80 Ref: As 422644-44

The subfloor and skirting in Classroom 8 (Rm 0/61) do not contain asbestos.

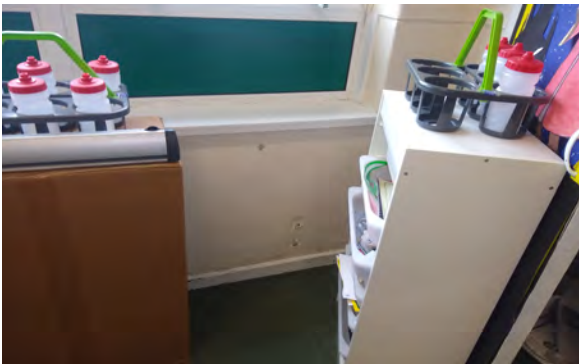
Item 81 Ref: As 422644-43

The decorative finish to low level walls in Classroom 9 (Rm 0/64) does not contain asbestos.

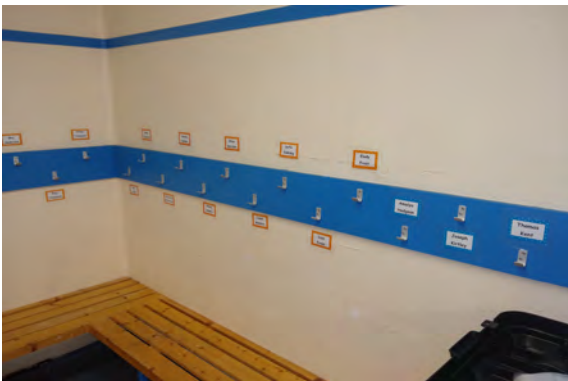
Item 87 Ref: 422644-49

The decorative finish to low level walls in Cloaks area (Rm 0/74) does not contain asbestos.

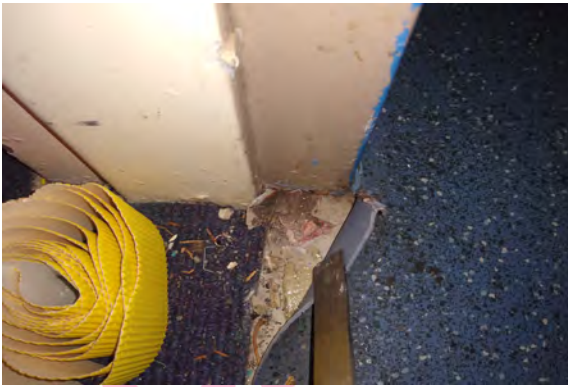
Item 92 Ref: As 422644-48

The floor screed in the Cloaks area (Rm 0/79) does not contain asbestos.

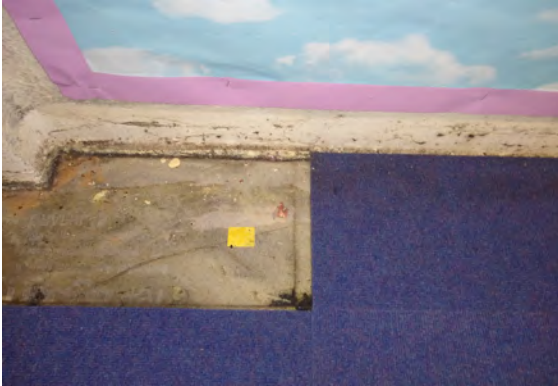
Item 94 Ref: As 422644-48

The floor screed in the Year 3 Classroom (Rm 0/80) does not contain asbestos.

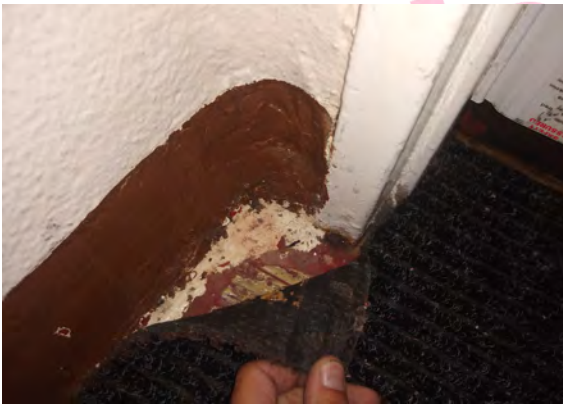
Item 95 Ref: As 422644-48

The floor screed in the Corridor (Rm 0/81) does not contain asbestos.

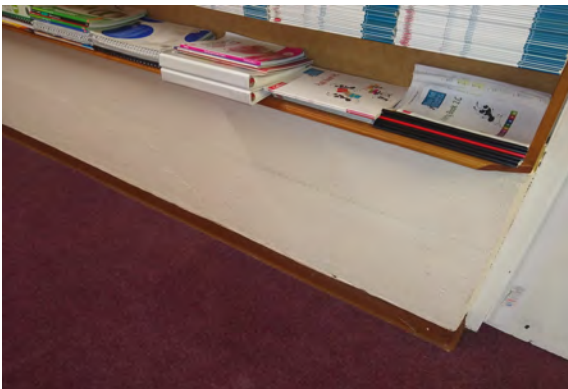
Item 96 Ref: As 422644-43

The decorative finish to low level walls in the Corridor (Rm 0/81) does not contain asbestos.

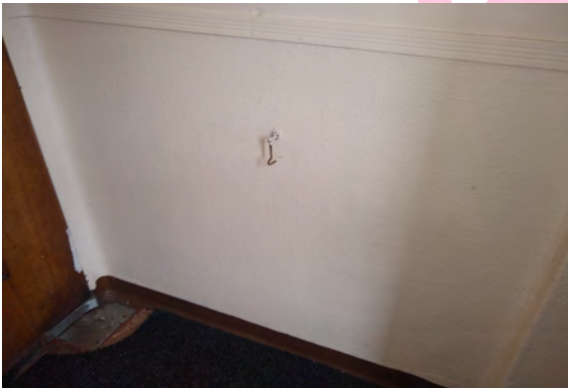
Item 98 Ref: As 422644-43

The decorative finish to low level walls in the Lobby (Rm 0/82) does not contain asbestos.

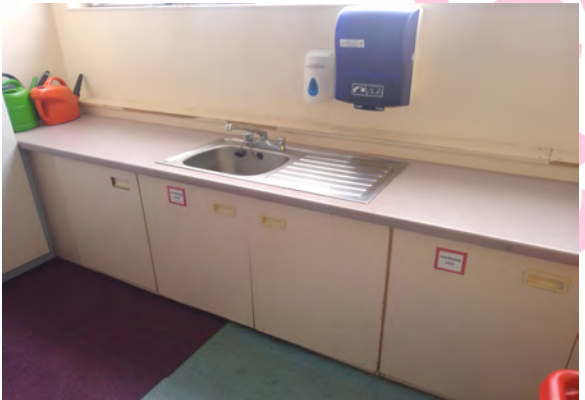
Item 101 Ref: 422644-50

The sink pad in the Intervention Room 3 (Rm 0/83) does not contain asbestos.

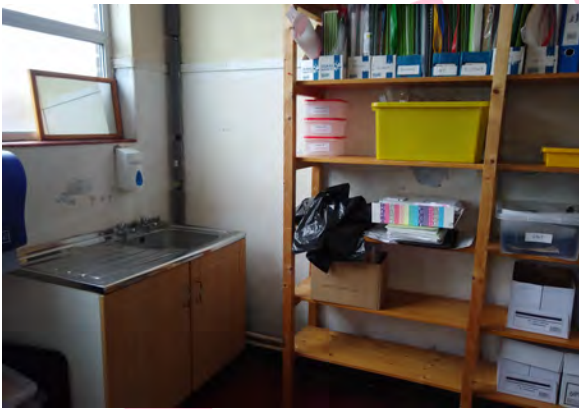
Item 110 Ref: As 422644-51

The decorative finish to low level walls in the Store (Rm 0/90) does not contain asbestos.

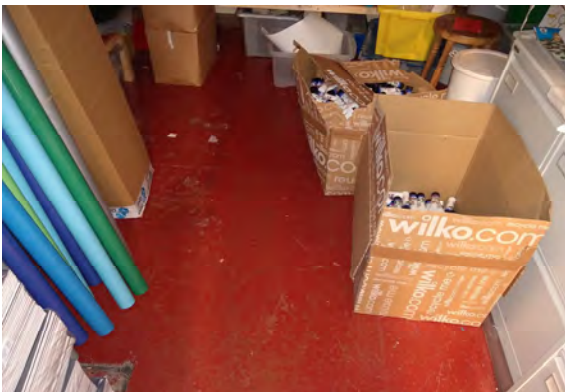
Item 114 Ref: As 422644-52

The floor screed in the Store (Rm 0/91) does not contain asbestos.

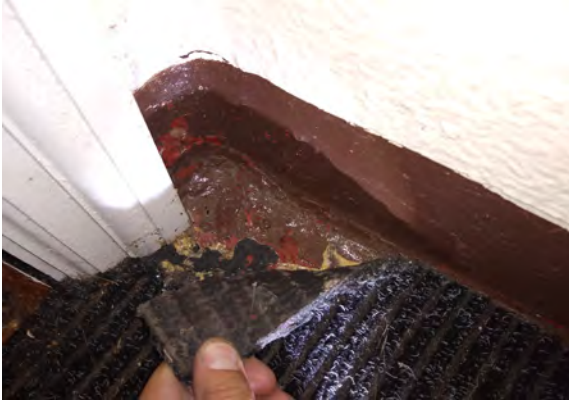
Item 121 Ref: As 422644-52

The floor screed in the Lobby (Rm 0/97) does not contain asbestos.

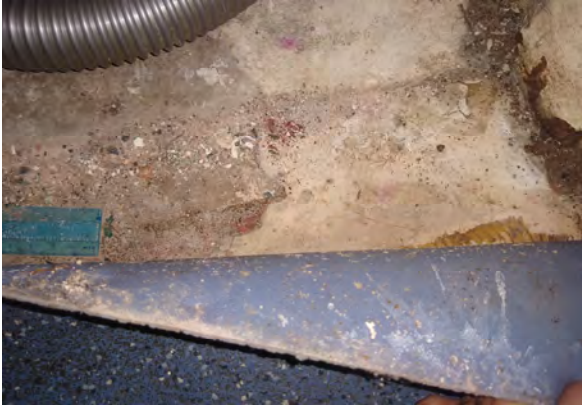
Item 124 Ref: As 422644-52

The floor screed in the Cloaks area (Rm 0/99) does not contain asbestos.

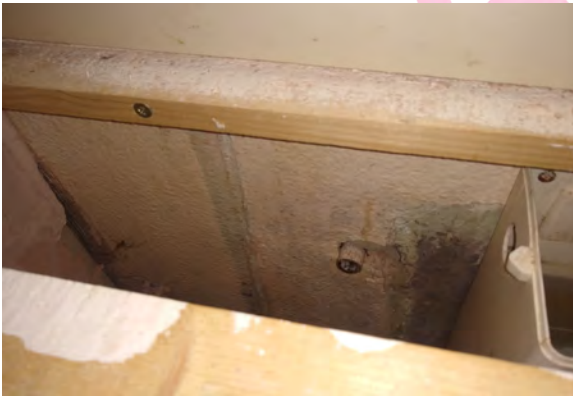
Item 125 Ref: As 422644-51

The decorative finish to low level walls within toilet cistern boxing in the Girls/ Boys WC (Rm 0/101) does not contain asbestos.

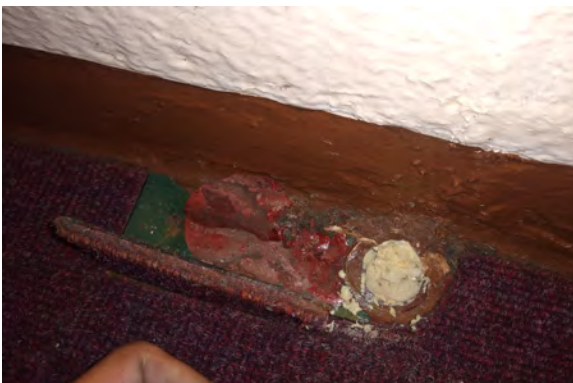
Item 126 Ref: As 422644-52

The floor screed in the Corridor (Rm 0/104) does not contain asbestos.

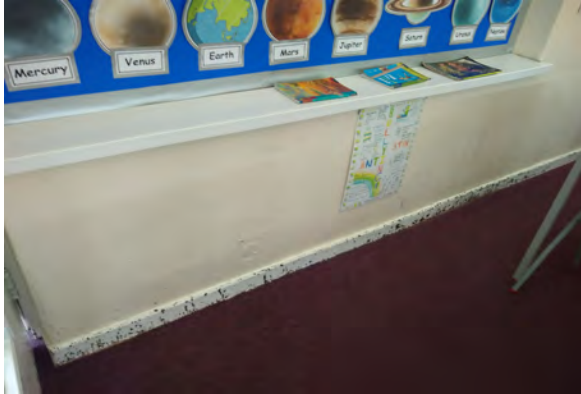
Item 136 Ref: As 422644-56

The decorative finish to low level walls in Classroom 11 (Rm 1/008) does not contain asbestos.

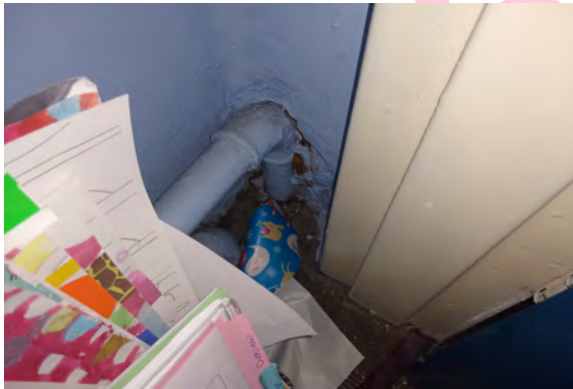
Item 137 Ref: As 422644-58

The subfloor and skirting in Classroom 11 (Rm 1/008) do not contain asbestos.

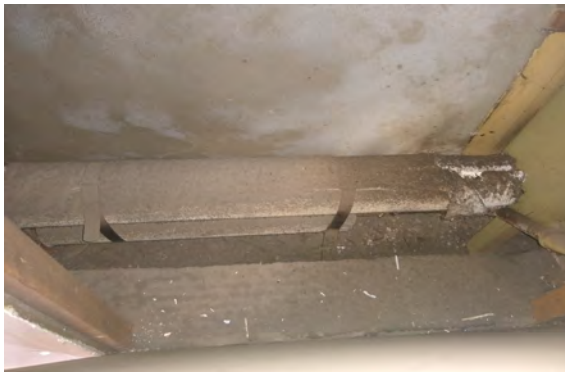
Item 138 Ref: 422644-59

The pipe lagging in Classroom 11 – void within pipework boxing between redundant heaters (Rm 1/008) contains asbestos.

Any change in its appearance should be recorded and passed to Property Services.

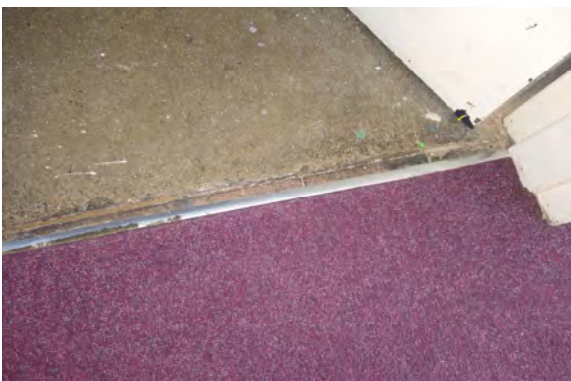
Item 141 Ref: As 422644-58

The subfloor and skirting in Classroom 12 (Rm 1/009) do not contain asbestos.

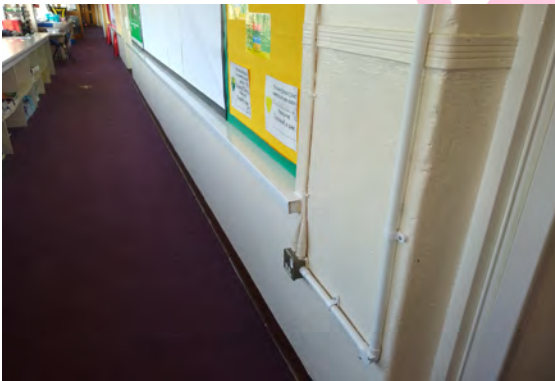
Item 146 Ref: As 422644-56

The decorative finish to low level walls in Classroom 13 (Rm 1/013) does not contain asbestos.

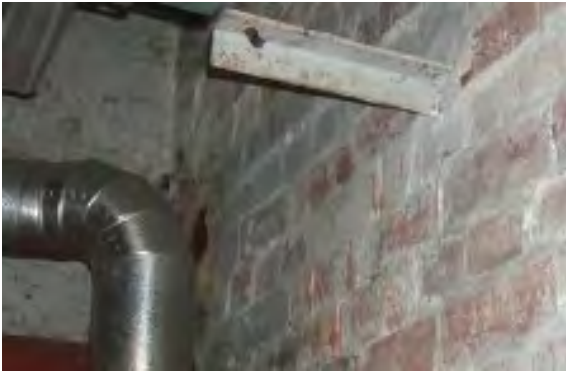
Item 158 Ref: SC17526

The insulation residue in the Plant Room (Basement) does not contain asbestos.

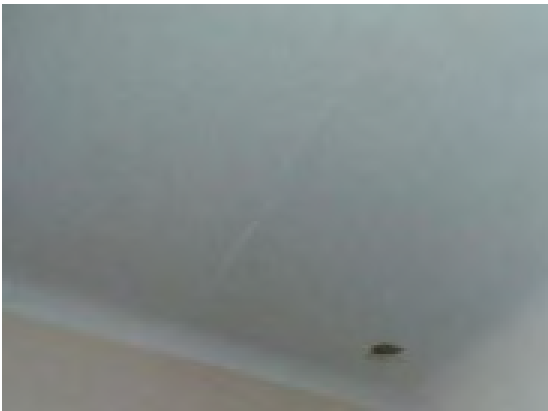
Item 161 Ref: VK001498

The concrete and plaster finishes to ceilings (Ground Floor / 02 / Area 2) do not contain asbestos.

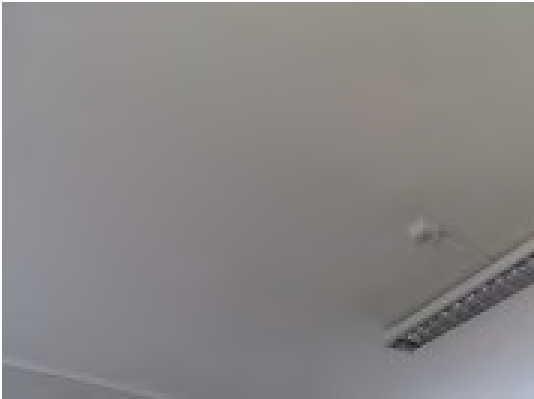
Item 164 Ref: VK001501

The concrete and plaster finishes to ceilings (Ground Floor / 05 / Area 5) do not contain asbestos.

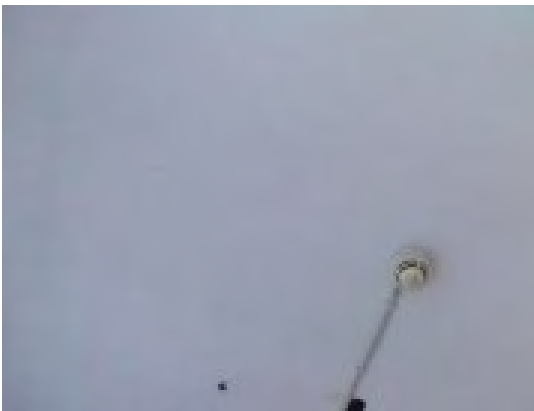
Item 165 Ref: VK001502

The concrete and plaster finishes to ceilings (Ground Floor / 06 / Area 6) do not contain asbestos.

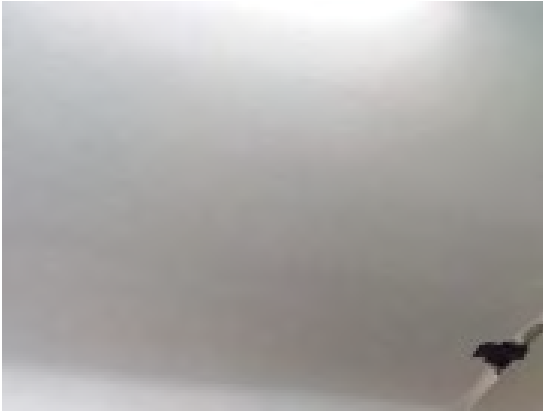
Item 166 Ref: VK001503

The concrete and plaster finishes to ceilings (Ground Floor / 07 / Area 7) do not contain asbestos.

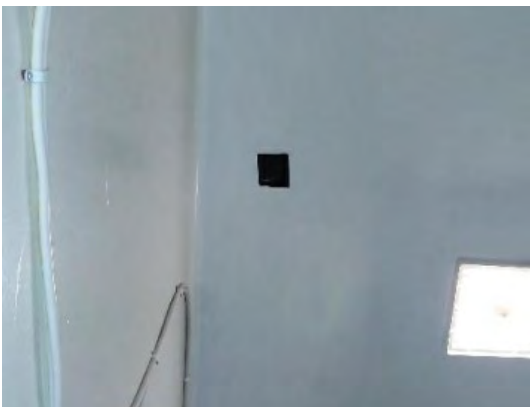
Item 168 Ref: VK001507

The concrete and plaster finishes to ceilings (Ground Floor / 09 / Area 9) do not contain asbestos.

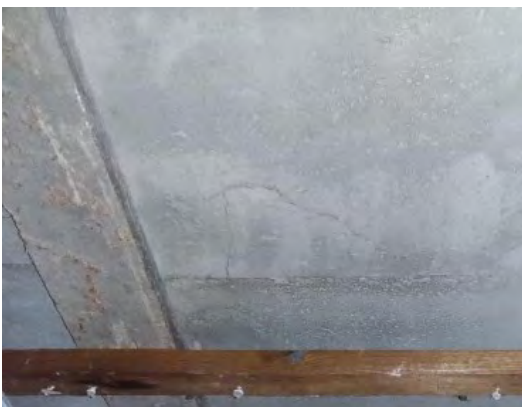
Item 171 Ref: VK001510

The concrete and plaster finishes to ceilings (Ground Floor / 12 / Area 12) do not contain asbestos.
