ASBESTOS SURVEY REPORT FOR HILL VIEW JUNIOR SCHOOL ACADEMY,  
QUEEN ALEXANDRA ROAD, SUNDERLAND, TYNE AND WEAR, SR2 9HE.

**Hill View Junior School Academy, Queen Alexandra Road, Sunderland, SR2 9HE**

**Date: 24 April 2025**

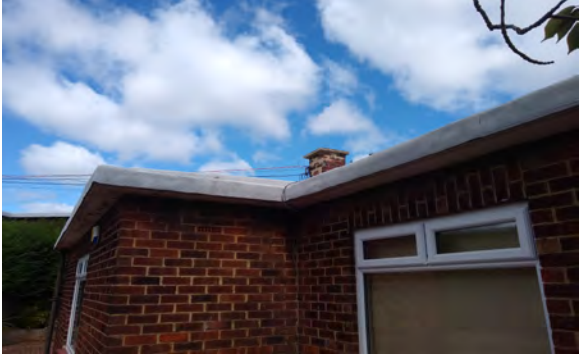
### **Item 1 Ref: 422644-13**

The flat roof covering to Bungalow (External) does not contain asbestos.

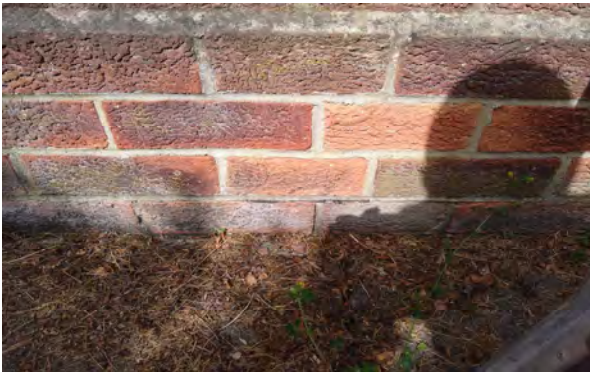
### **Item 2 Ref: 422644-14**

The damp proof course to Bungalow (External) does not contain asbestos.

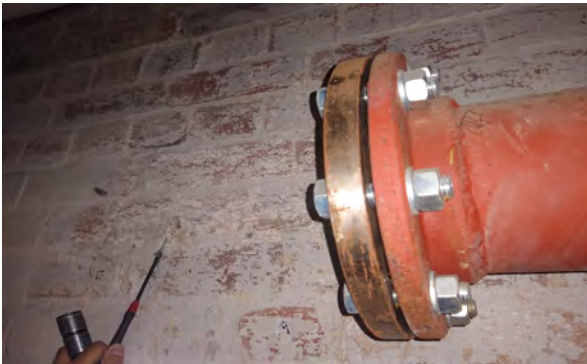
### **Item 3 Ref: 422644-1**

- (Item 3) Ref: 422644-1 – Un-encapsulated residue to walls (Boiler House -1/001) – Medium Risk
- (Item 4) Ref: 422644-2 – Encapsulated residue to walls at high level (Boiler House -1/001) – Low Risk

The un-encapsulated residue to walls in the Boiler House (Rm -1/01) contains asbestos.

Any change in its appearance should be recorded and passed to Property Services.

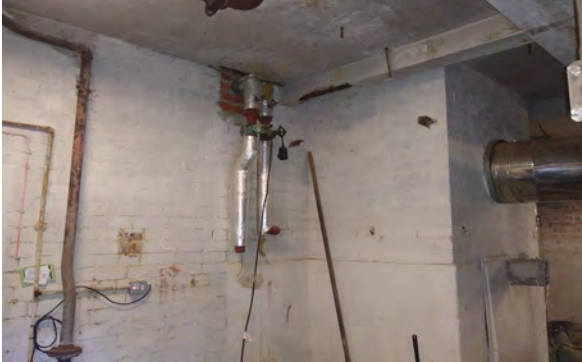
### **Item 4 Ref: 422644-2**

The encapsulated residue to walls at high level in the Boiler House (Rm -1/01) contains asbestos.

Any change in its appearance should be recorded and passed to Property Services.

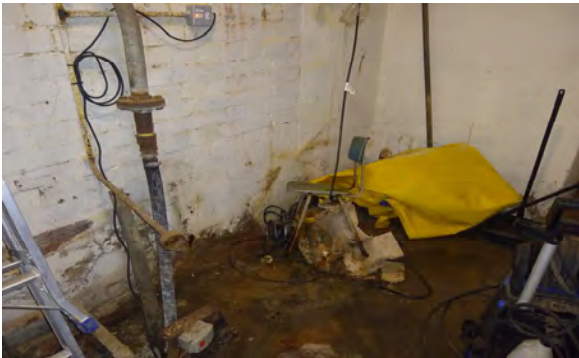
### **Item 5 Ref: 422644-3**

The encapsulated residue to walls at low level in the Boiler House (Rm -1/01) contains asbestos.

Any change in its appearance should be recorded and passed to Property Services.

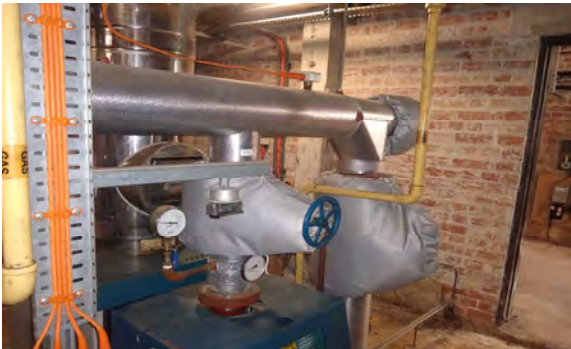
### **Item 6 Ref: 422644-4**

The HTG pipework flange gaskets in the Boiler House (Rm -1/01) does not contain asbestos.

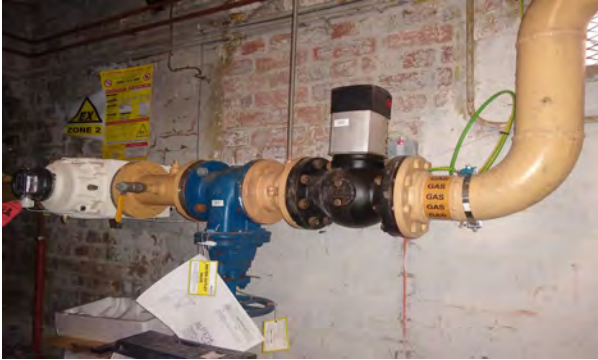
### **Item 7 Ref: 422644-5**

The gas pipework flange gaskets in the Boiler House (Rm -1/01) contains asbestos.

Any change in its appearance should be recorded and passed to Property Services.

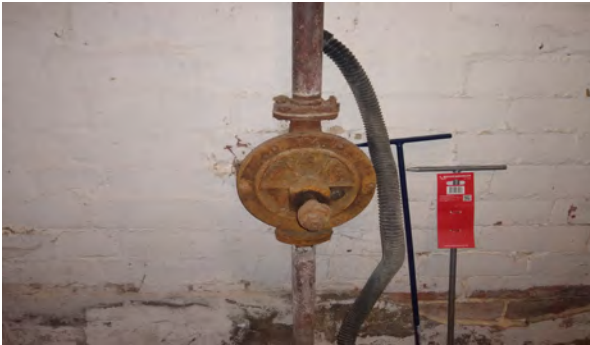
### **Item 8 Ref: 422644-6**

The manual sump pump flange gaskets in the Boiler House (Rm -1/01) contains asbestos.

Any change in its appearance should be recorded and passed to Property Services.

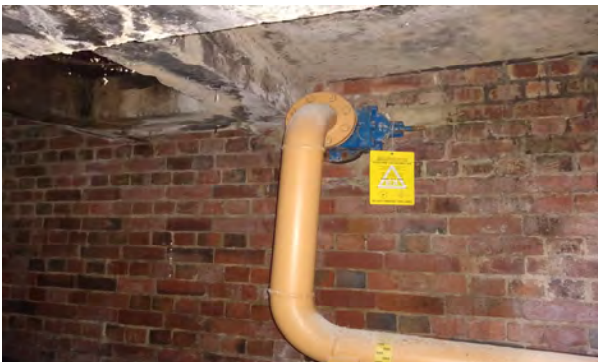
### **Item 9 Ref: As 422644-5**

The gas pipework flange gaskets in the Former Coal Bunker (Rm -1/02) contains asbestos.

Any change in its appearance should be recorded and passed to Property Services.

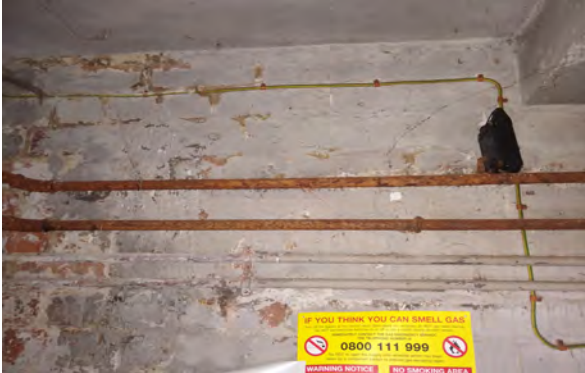
### **Item 10 Ref: 422644-7**

The residue to walls adjacent to pipework in the Former Coal Bunker (Rm -1/02) contains asbestos.

Any change in its appearance should be recorded and passed to Property Services.

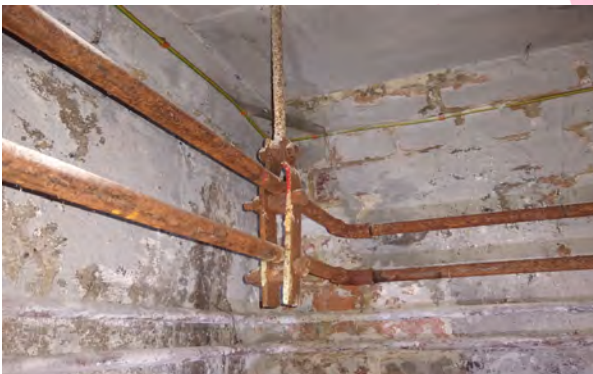
### **Item 11 Ref: 422644-8**

The residue to pipework & hangers in the Former Coal Bunker (Rm -1/02) contains asbestos.

Any change in its appearance should be recorded and passed to Property Services.

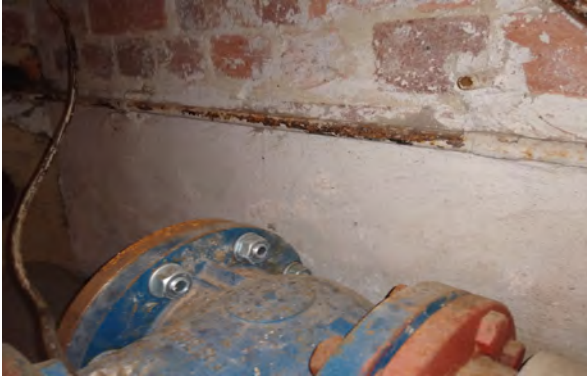
### **Item 13 Ref: 422644-10**

The residue to walls at high level in the Switch Room (Rm -1/03) contains asbestos.

Any change in its appearance should be recorded and passed to Property Services.

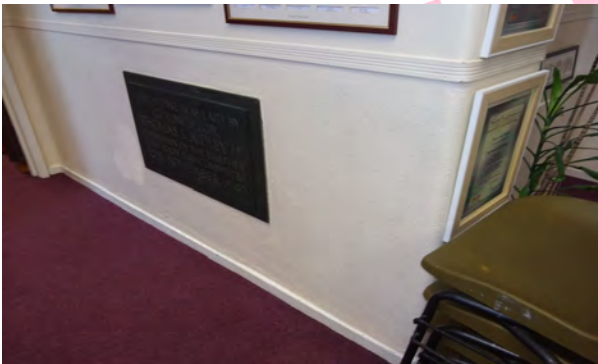
### **Item 20 Ref: 422644-17**

The decorative finish to low level walls in the Foyer (Rm 0/02) does not contain asbestos.

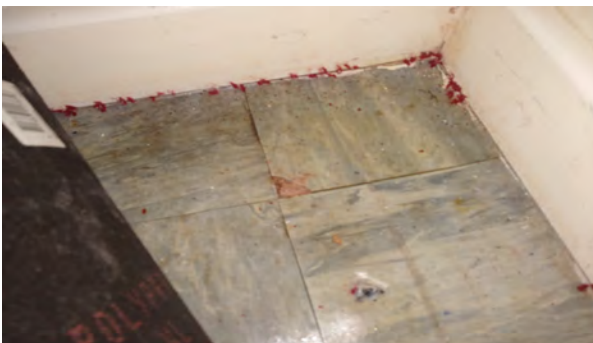
### **Item 21 Ref: As 422644-21**

The screed beneath carpet & modern vinyl tiles in the Main Office (Rm 0/04) does not contain asbestos.

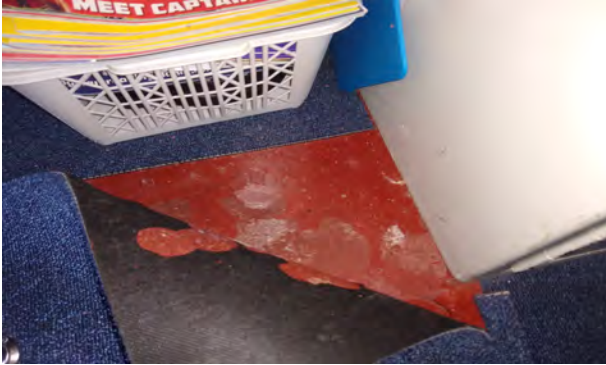
### **Item 22 Ref: 422644-18**

The red floor screed in the Office (Rm 0/06) contains asbestos.

Any change in its appearance should be recorded and passed to Property Services.

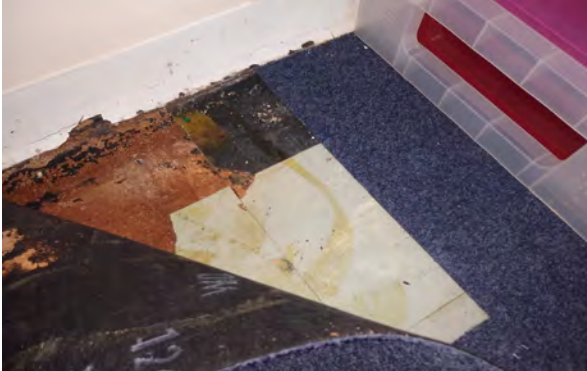
### **Item 25 Ref: 422644-20**

The subfloor in the Classroom (Rm 0/08) contains asbestos.

***Removed August 2022***

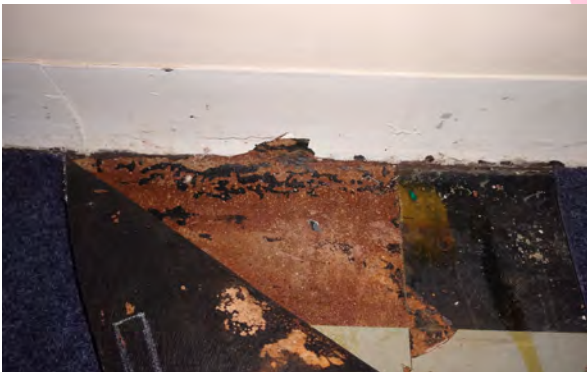
### **Item 26 Ref: 422644-21**

The floor screed in the Classroom (Rm 0/08) does not contain asbestos.

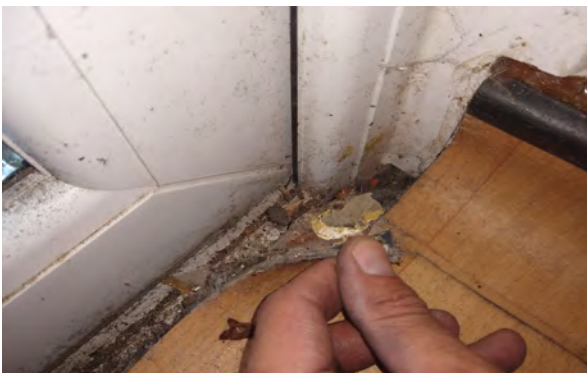
### **Item 27 Ref: As 422644-16**

The subfloor & skirting in the Dining Hall (Rm 0/09) does not contain asbestos.

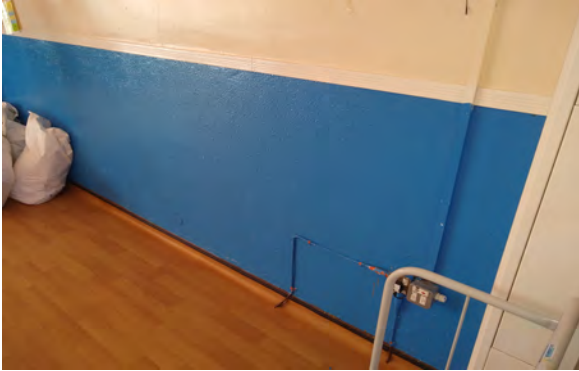
### **Item 28 Ref: As 422644-17**

The decorative finish to low level walls in the Dining Hall (Rm 0/09) does not contain asbestos.

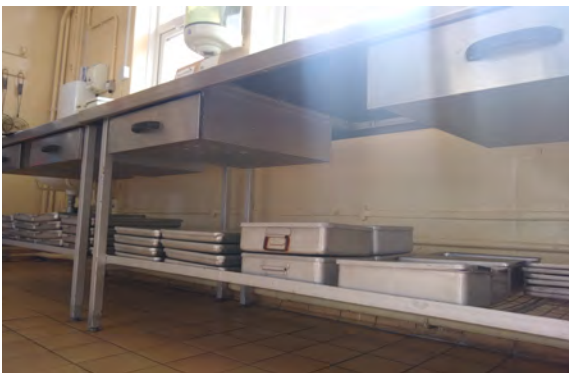
### **Item 29 Ref: 422644-22**

The coating to underside of units in the Kitchen (Rm 0/10) does not contain asbestos.

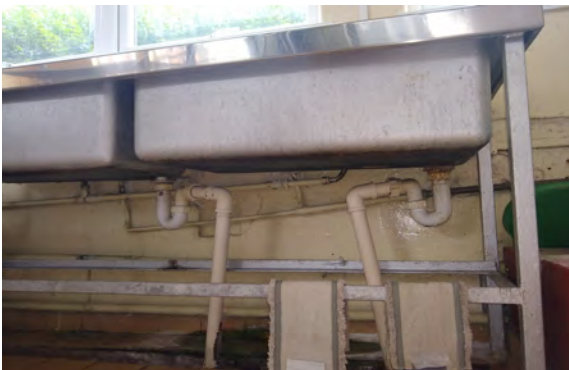
### **Item 30 Ref: 422644-23**

The gasket to sink waste traps in the Kitchen (Rm 0/10) contains asbestos.

Any change in its appearance should be recorded and passed to Property Services.

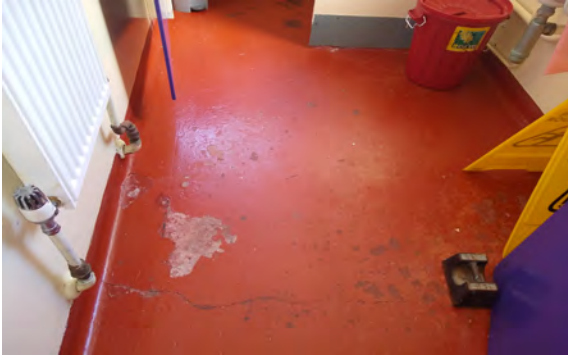
### **Item 31 Ref: 422644-24**

The red floor screed in the Kitchen WC (Rm 0/13) contains asbestos.

Any change in its appearance should be recorded and passed to Property Services.

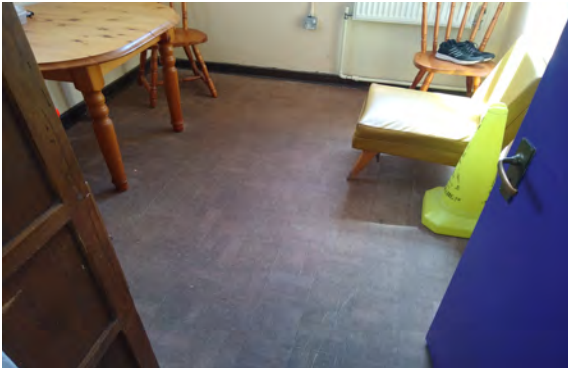
### **Item 32 Ref: 422644-25**

The floor covering & skirting in the Kitchen Changing (Rm 0/14) does not contain asbestos.

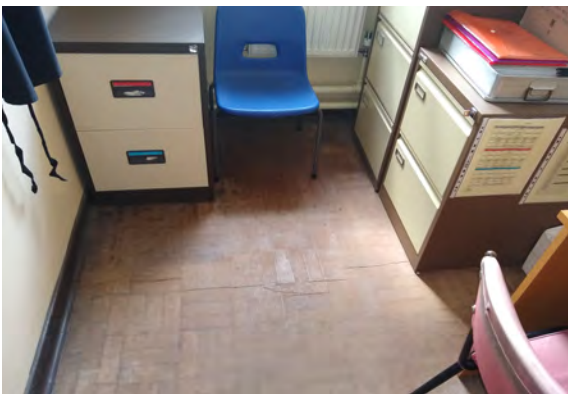
### **Item 33 Ref: As 422644-25**

The floor covering & skirting in the Kitchen Office (Rm 0/16) does not contain asbestos.

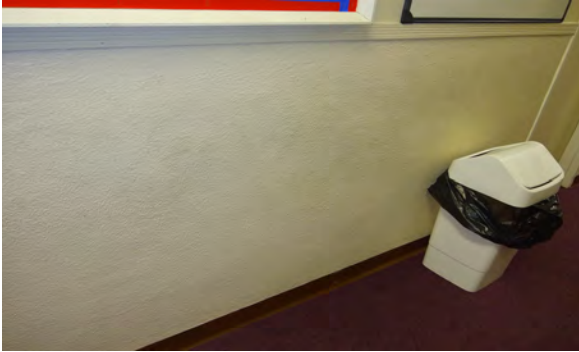
### **Item 34 Ref: As 422644-17**

The decorative finish to low level walls in the Corridor (Rm 0/17) does not contain asbestos.

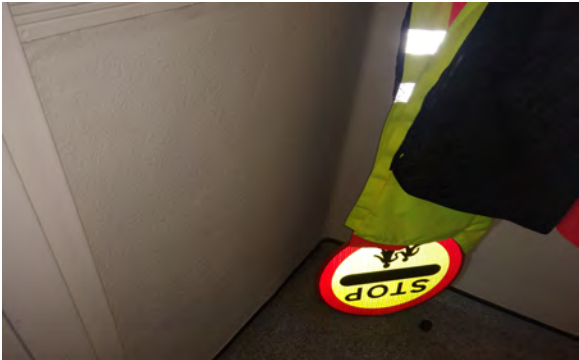
### **Item 35 Ref: As 422644-17**

The decorative finish to low level walls in the Female Staff WC (Rm 0/18) does not contain asbestos.

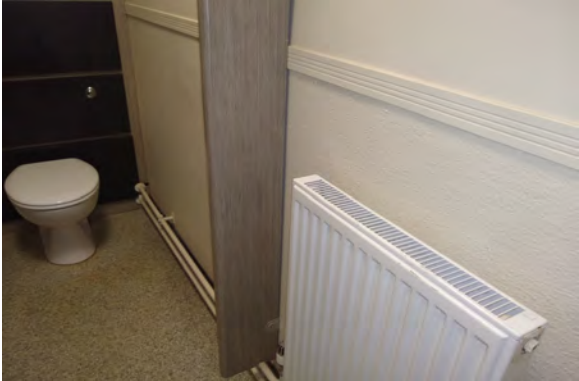
### **Item 37 Ref: 422644-26**

The decorative finish to low level walls in the Male Staff WC & Lobby (Rm 0/20) does not contain asbestos.

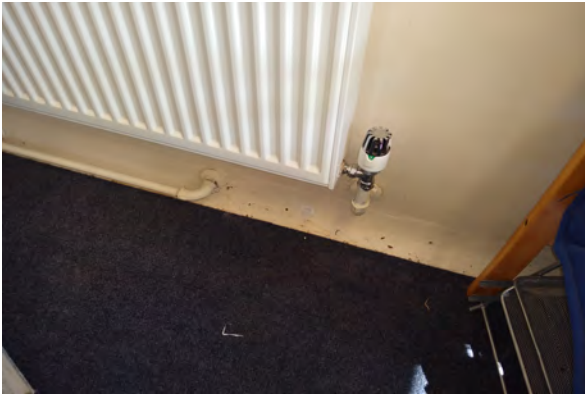
### **Item 40 Ref: As 422644-25**

The skirting in the Assistant Head Teachers room (Rm 0/21) does not contain asbestos.

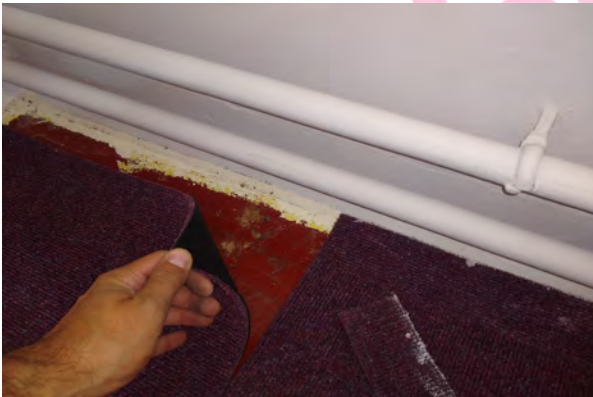
### **Item 41 Ref: As 422644-25**

The subfloor & skirting in the Deputy Head Teachers room (Rm 0/23) does not contain asbestos.

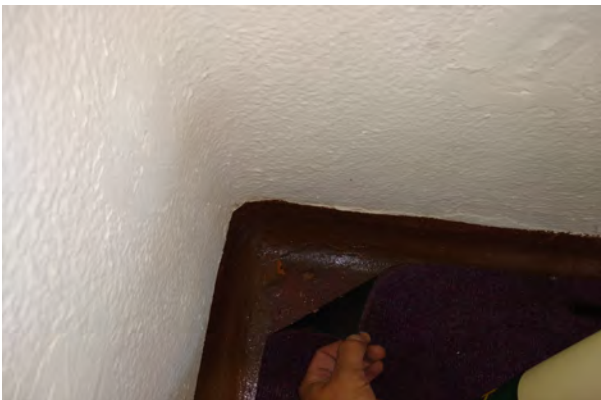
### **Item 42 Ref: As 422644-25**

The subfloor & skirting in the Business & Finance Managers room (Rm 0/26) does not contain asbestos.

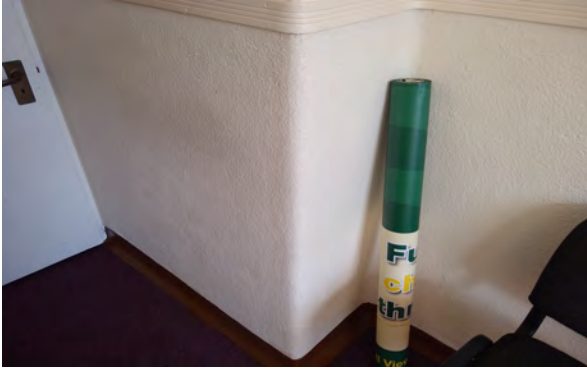
### **Item 43 Ref: As 422644-26**

The decorative finish to low level walls in the Business & Finance Managers room (Rm 0/26) does not contain asbestos.

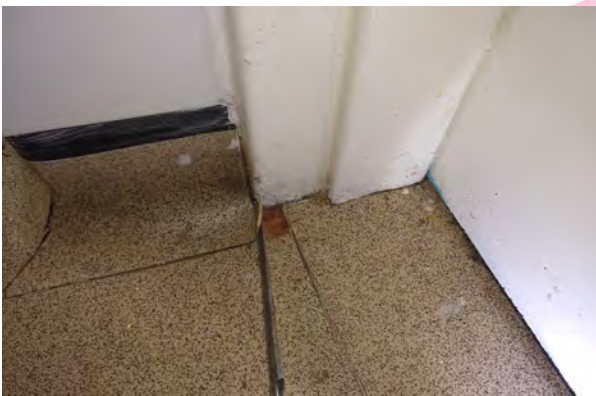
### **Item 44 Ref: 422644-29**

The floor screed in the Kitchen (Rm 0/28) does not contain asbestos.

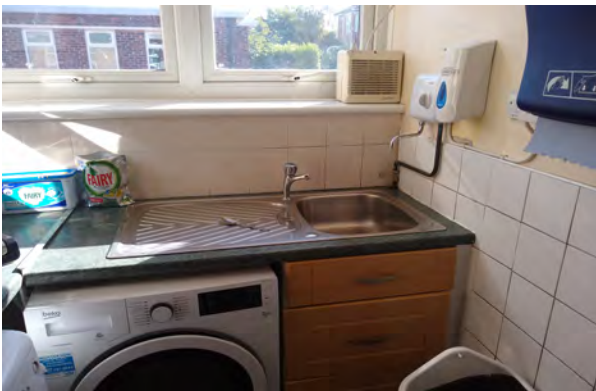
### **Item 45 Ref: 422644-30**

The sink pad in the Kitchen (Rm 0/28) does not contain asbestos.

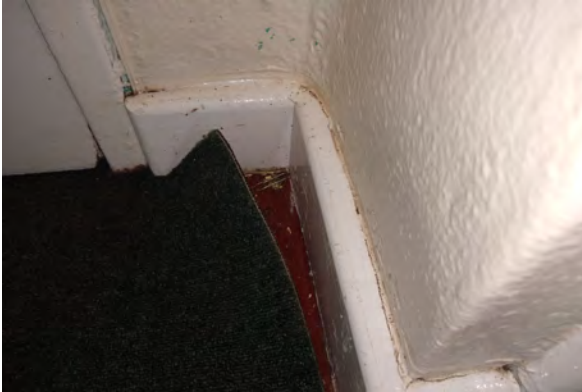
### **Item 46 Ref: As 422644-29**

The floor screed in the Staff Room (Rm 0/29) does not contain asbestos.

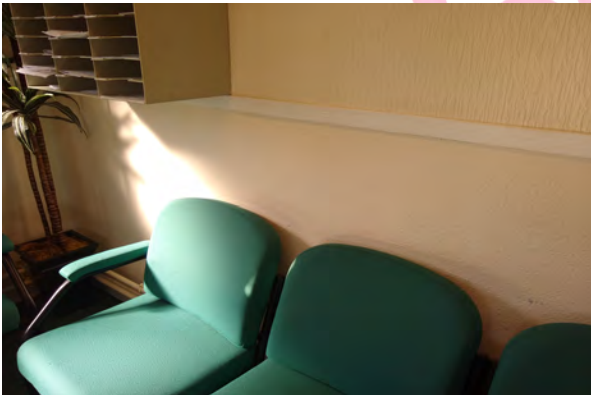
### **Item 47 Ref: As 422644-26**

The decorative finish to low level walls in the Staff Room (Rm 0/29) does not contain asbestos.

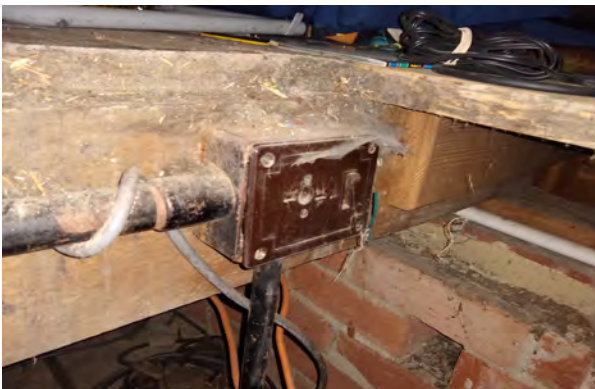
### **Item 48 Ref: 422644-35**

The electrical sockets in the Stage – void below (Rm 0/31) does not contain asbestos.

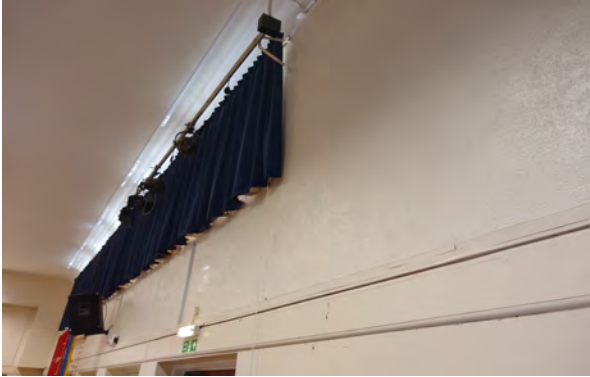
### **Item 49 Ref: 422644-31**

The textured coating to west wall at high level in the Hall (Rm 0/32) contains asbestos.

Any change in its appearance should be recorded and passed to Property Services.

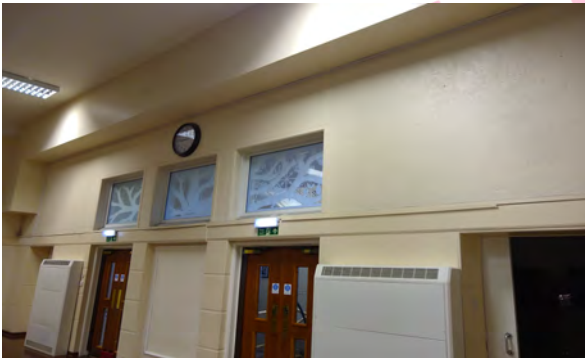
### **Item 50 Ref: 422644-32**

The textured coating to south wall at high level in the Hall (Rm 0/32) contains asbestos.

Any change in its appearance should be recorded and passed to Property Services.

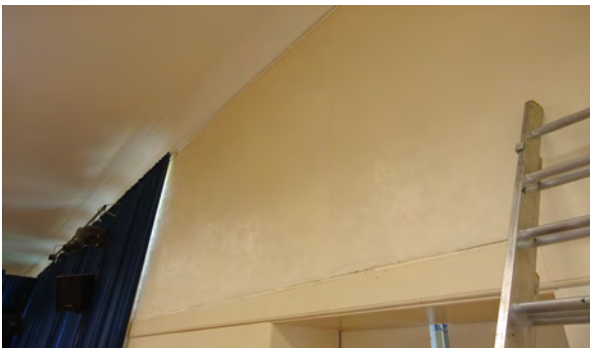
### **Item 51 Ref: 422644-33**

The textured coating to east wall at high level in the Hall (Rm 0/32) contains asbestos.

Any change in its appearance should be recorded and passed to Property Services.

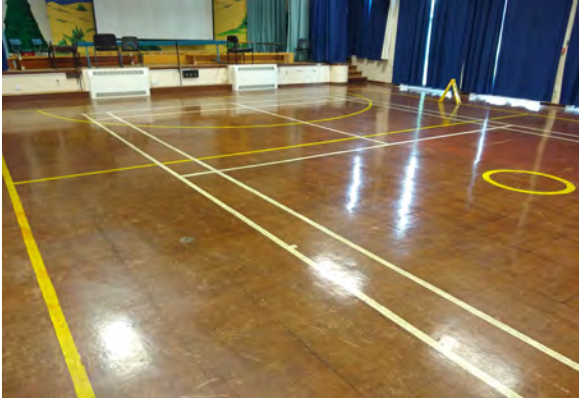
### **Item 52 Ref: 422644-34**

The floor covering in the Hall (Rm 0/32) does not contain asbestos.

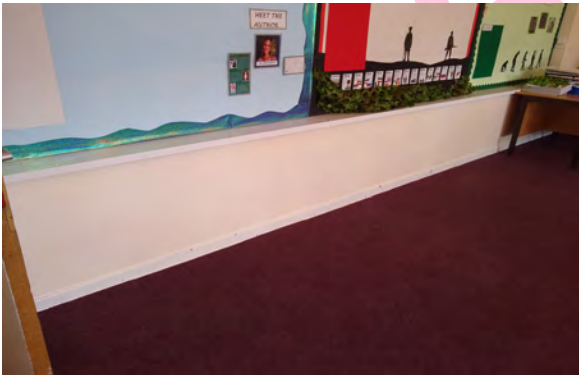
### **Item 53 Ref: 422644-36**

The decorative finish to low level walls in the Classroom 1 (Rm 0/36) does not contain asbestos.

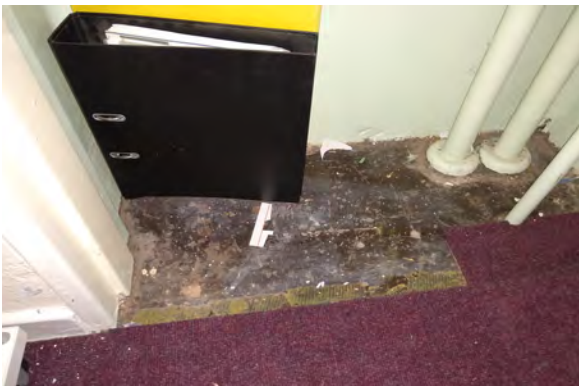
### **Item 54 Ref: 422644-37**

The subfloor & skirting in the Classroom 1 (Rm 0/36) does not contain asbestos.

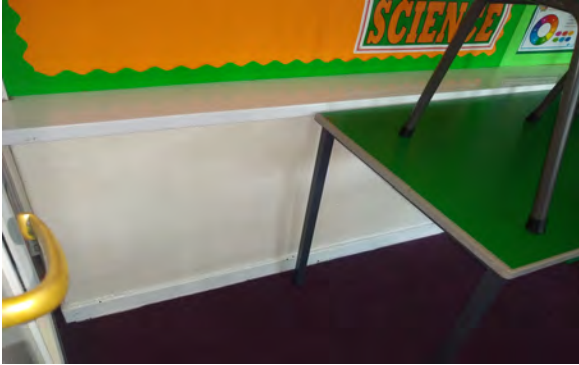
### **Item 55 Ref: As 422644-36**

The decorative finish to low level walls in the Classroom 2 (Rm 0/39) does not contain asbestos.

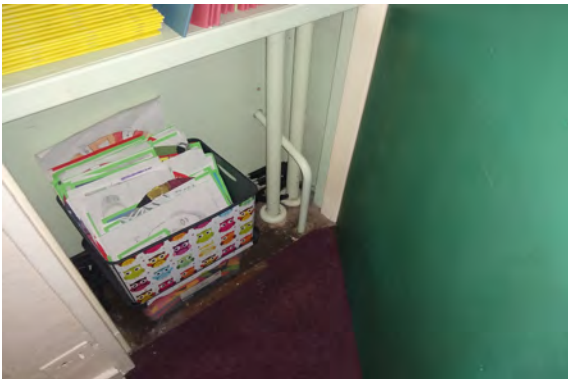
### **Item 56 Ref: As 422644-37**

The subfloor & skirting in the Classroom 2 (Rm 0/39) does not contain asbestos.

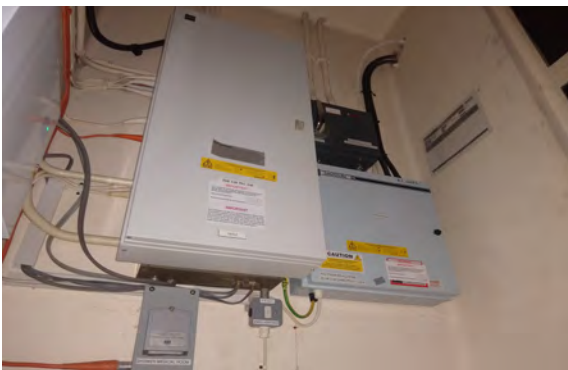
### **Item 57 Ref: Presumed**

The MEM electrics in the Store (Rm 0/41) are presumed to contain asbestos.

Any change in its appearance should be recorded and passed to Property Services.

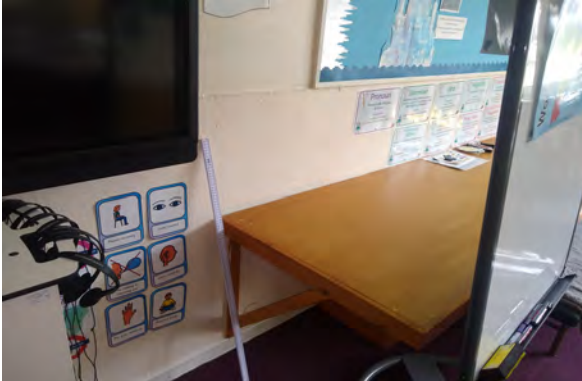
### **Item 58 Ref: As 422644-36**

The decorative finish to low level walls in the Classroom 3 (Rm 0/42) does not contain asbestos.

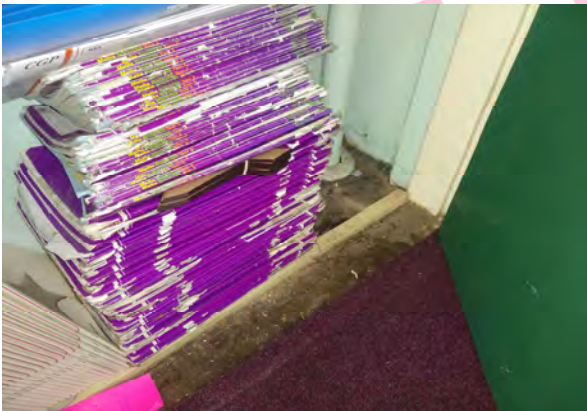
### **Item 59 Ref: As 422644-37**

The subfloor & skirting in the Classroom 3 (Rm 0/42) does not contain asbestos.

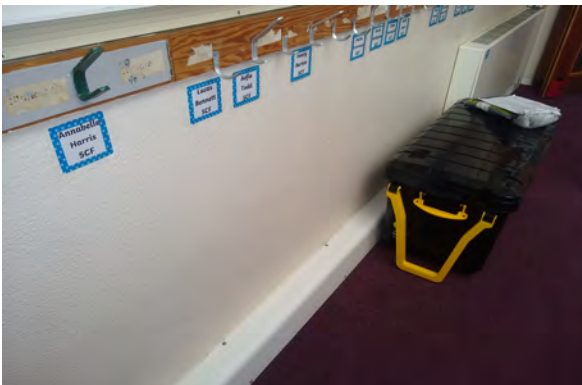
### **Item 60 Ref: As 422644-36**

The decorative finish to low level walls in the Stairwell (Rm 0/45) does not contain asbestos.

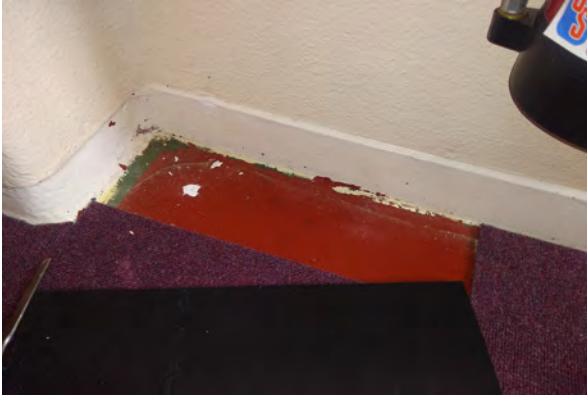
### **Item 61 Ref: 422644-38**

The red floor screed & skirting in the Stairwell (Rm 0/45) does not contain asbestos.

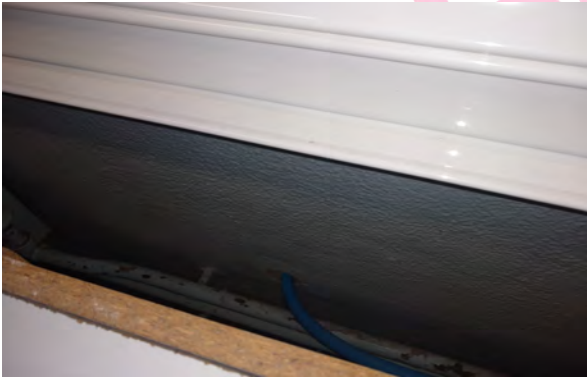
### **Item 62 Ref: As 422644-36**

The decorative finish to low level walls in the IT room (Rm 0/50) does not contain asbestos.

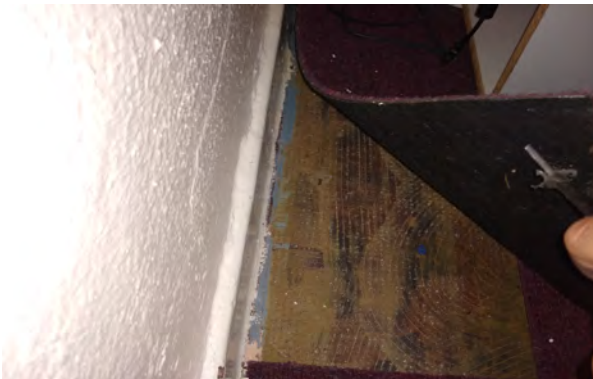
### **Item 63 Ref: As 422644-37**

The subfloor & skirting in the IT room (Rm 0/50) does not contain asbestos.

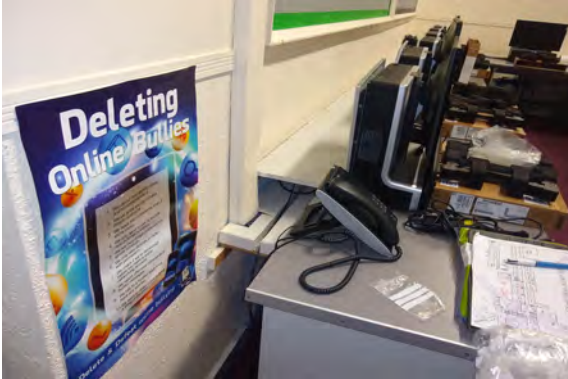
### **Item 64 Ref: 422644-39**

The decorative finish to low level wall in the IT room (Rm 0/50) does not contain asbestos.

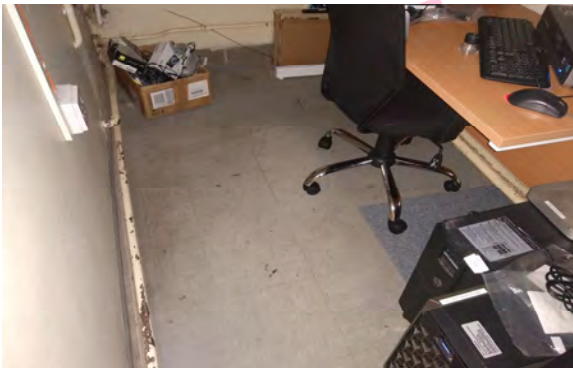
### **Item 65 Ref: 422644-40**

The floor covering in the Store (Rm 0/51) does not contain asbestos.

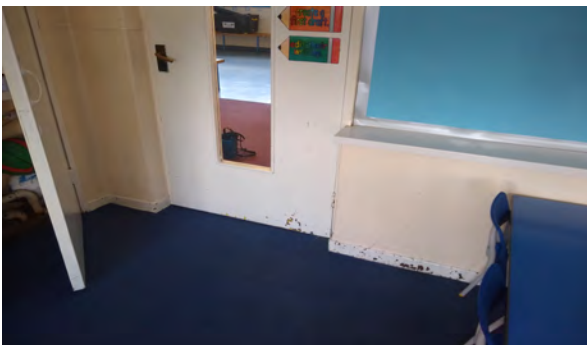
### **Item 66 Ref: As 422644-36**

The decorative finish to low level walls in Classroom 4 (Rm 0/52) does not contain asbestos.

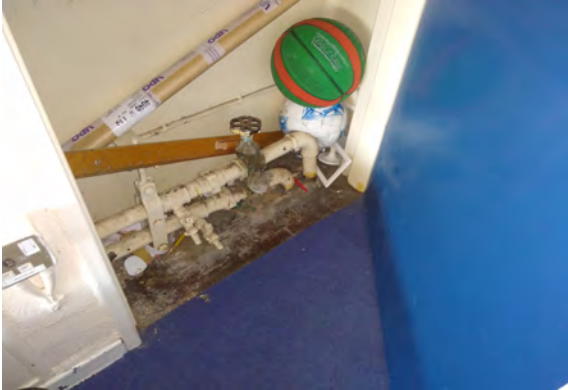
### **Item 67 Ref: As 422644-37**

The subfloor & skirting in Classroom 4 (Rm 0/52) does not contain asbestos.

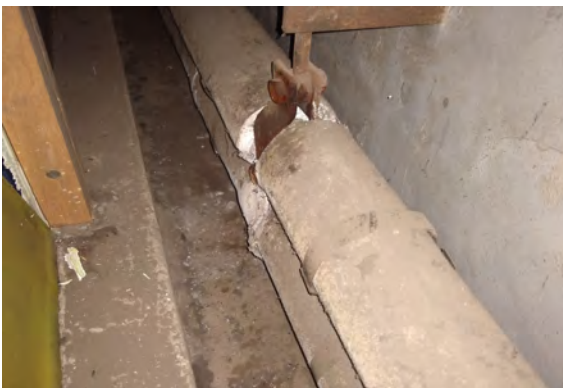
### **Item 69 Ref: 422644-42**

The debris to floor in Classroom 4 – void within pipework boxing between redundant heaters (Rm 0/52) contains asbestos.

Any change in its appearance should be recorded and passed to Property Services.

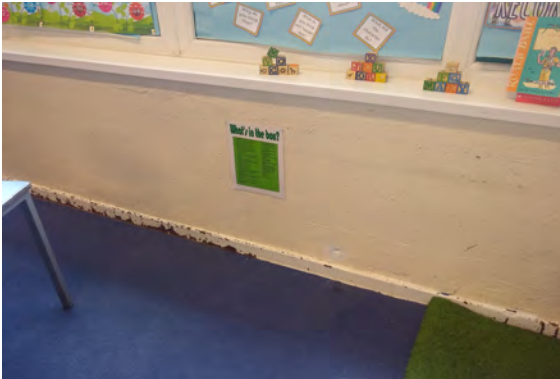
### **Item 70 Ref: 422644-43**

The decorative finish to low level walls in Classroom 5 (Rm 0/54) does not contain asbestos.

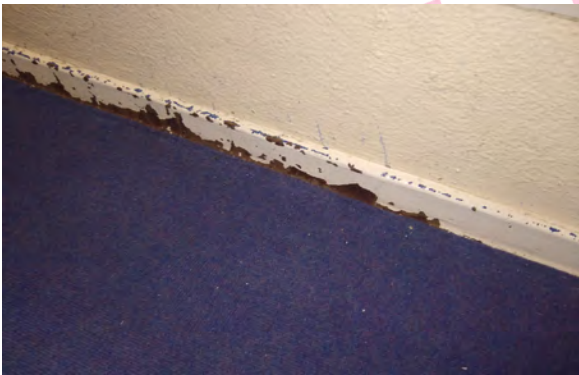
### **Item 71 Ref: 422644-44**

The subfloor and skirting in Classroom 5 (Rm 0/54) do not contain asbestos.

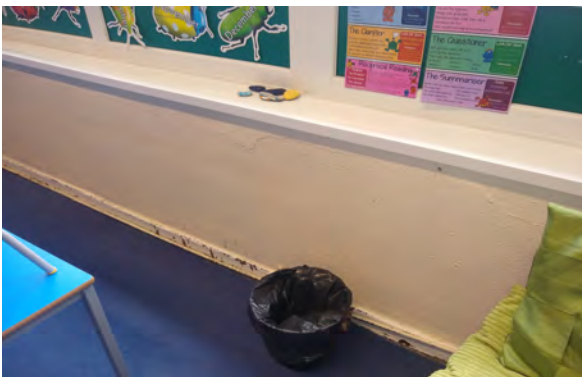
### **Item 72 Ref: As 422644-43**

The decorative finish to low level walls in Classroom 6 (Rm 0/57) does not contain asbestos.

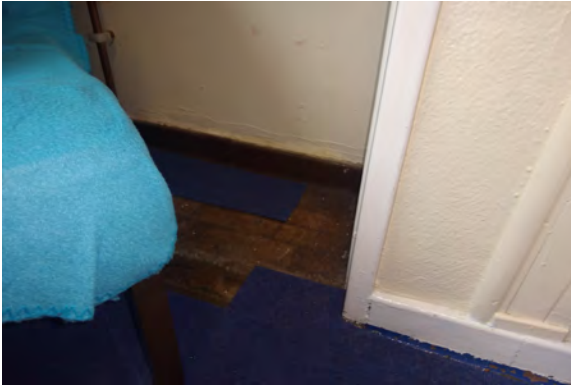
### **Item 73 Ref: As 422644-44**

The subfloor and skirting in Classroom 6 (Rm 0/57) do not contain asbestos.

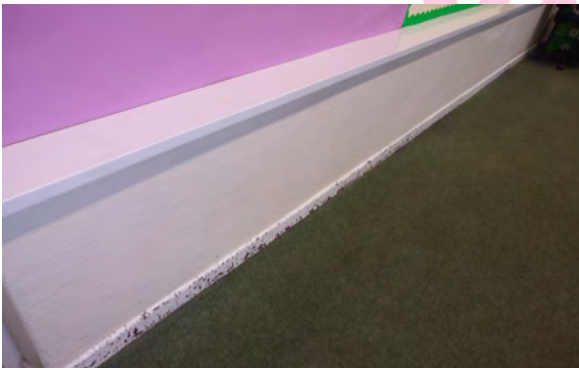
### **Item 74 Ref: As 422644-43**

The decorative finish to low level walls in Classroom 7 (Rm 0/60) does not contain asbestos.

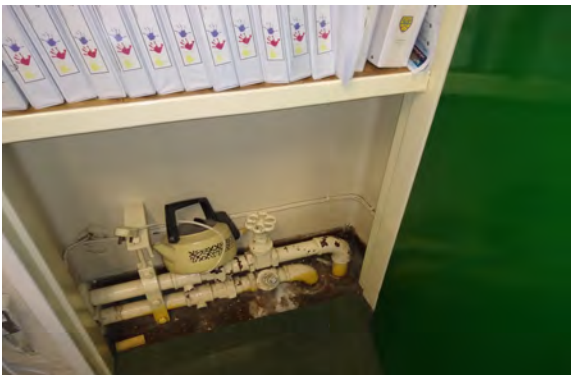
### **Item 75 Ref: As 422644-44**

The subfloor and skirting in Classroom 7 (Rm 0/60) do not contain asbestos.

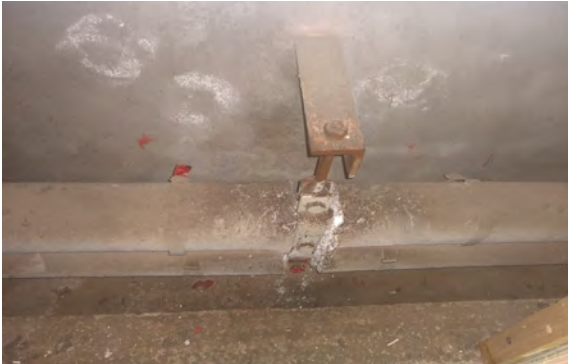
### **Item 76 Ref: 422644-45**

The pipe lagging in Classroom 7 – void within pipework boxing between redundant heaters (Rm 0/60) contains asbestos.

Any change in its appearance should be recorded and passed to Property Services.

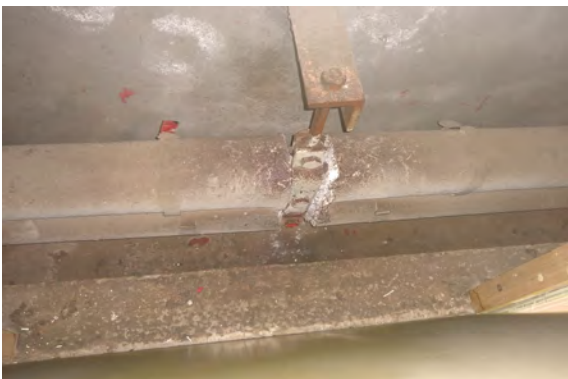
### **Item 77 Ref: 422644-46**

The debris to floor in Classroom 7 – void within pipework boxing between redundant heaters (Rm 0/60) contains asbestos.

Any change in its appearance should be recorded and passed to Property Services.

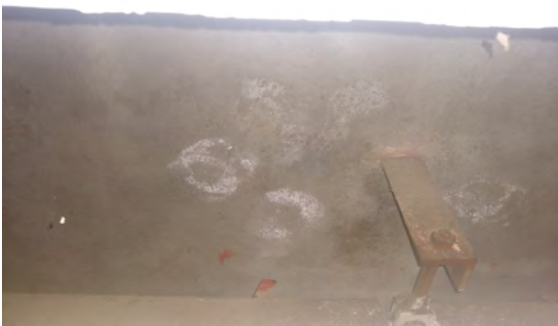
### **Item 78 Ref: 422644-47**

The debris to walls in Classroom 7 – void within pipework boxing between redundant heaters (Rm 0/60) contains asbestos.

Any change in its appearance should be recorded and passed to Property Services.

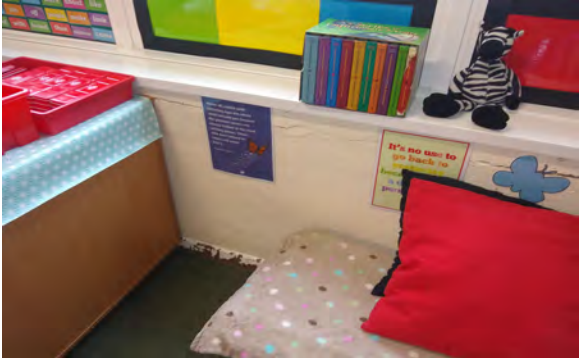
### **Item 79 Ref: As 422644-43**

The decorative finish to low level walls in Classroom 8 (Rm 0/61) does not contain asbestos.

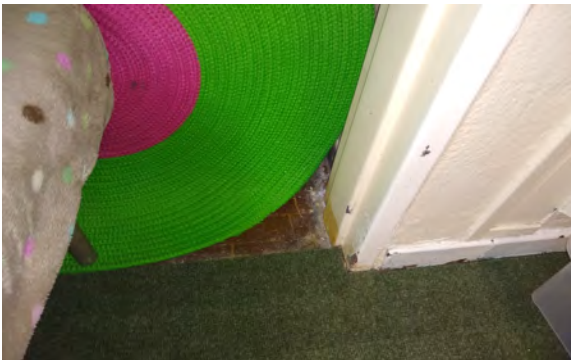
### **Item 80 Ref: As 422644-44**

The subfloor and skirting in Classroom 8 (Rm 0/61) do not contain asbestos.

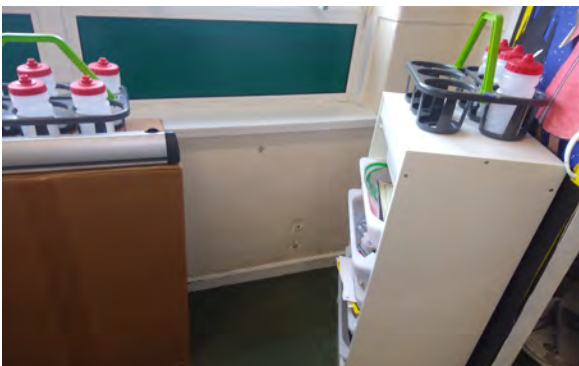
### **Item 81 Ref: As 422644-43**

The decorative finish to low level walls in Classroom 9 (Rm 0/64) does not contain asbestos.

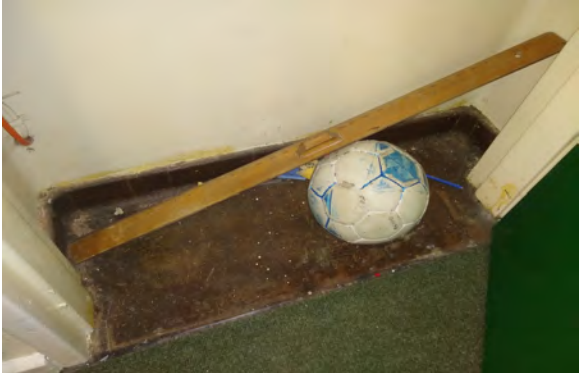
### **Item 82 Ref: As 422644-44**

The subfloor and skirting in Classroom 9 (Rm 0/64) do not contain asbestos.

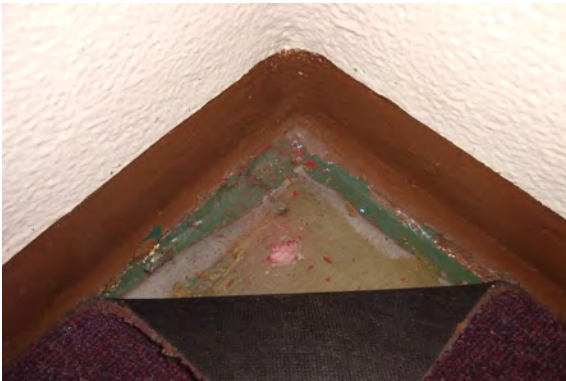
### **Item 83 Ref: 422644-48**

The floor screed in the Corridor (Rm 0/69) does not contain asbestos.

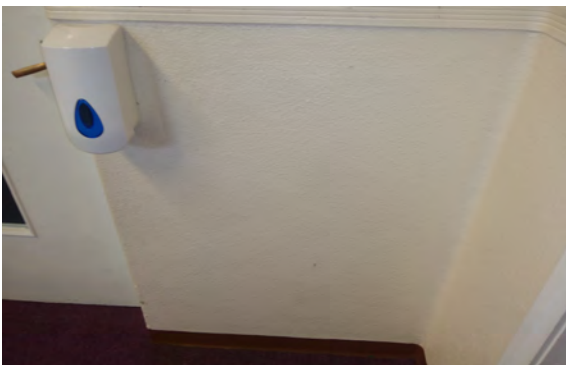
### **Item 84 Ref: As 422644-43**

The decorative finish to low level walls in the Corridor (Rm 0/69) does not contain asbestos.

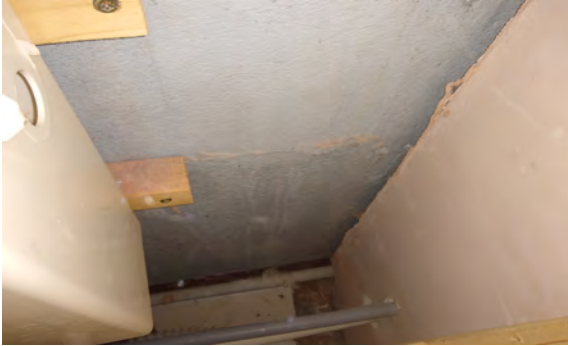
### **Item 85 Ref: As 422644-43**

The decorative finish to low level walls within toilet cistern boxing in the Girls/ Boys WC (Rm 0/72) does not contain asbestos.

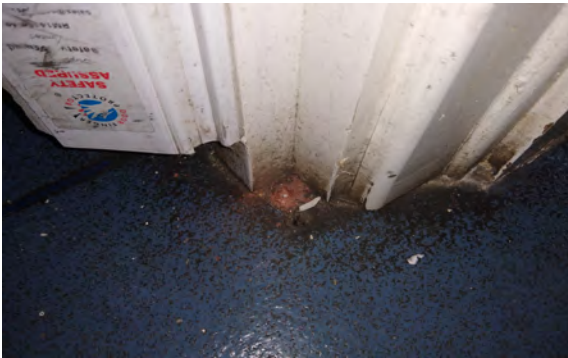
### **Item 86 Ref: As 422644-48**

The floor screed in the Girls/ Boys WC (Rm 0/72) does not contain asbestos.

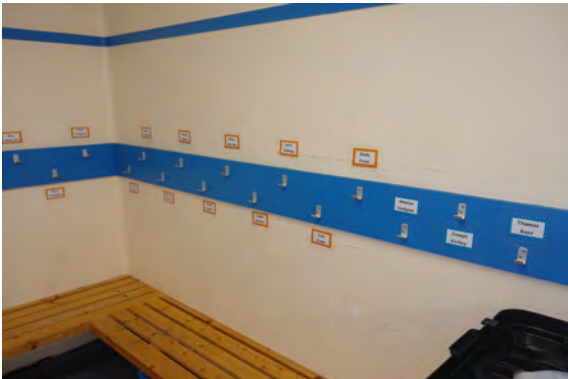
### **Item 87 Ref: 422644-49**

The decorative finish to low level walls in Cloaks area (Rm 0/74) does not contain asbestos.

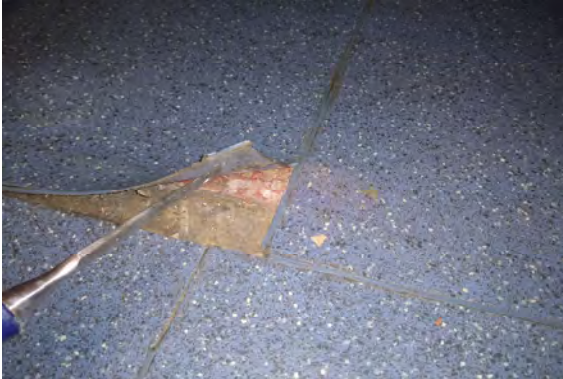
### **Item 88 Ref: As 422644-48**

The floor screed in the Cloaks area (Rm 0/74) does not contain asbestos.

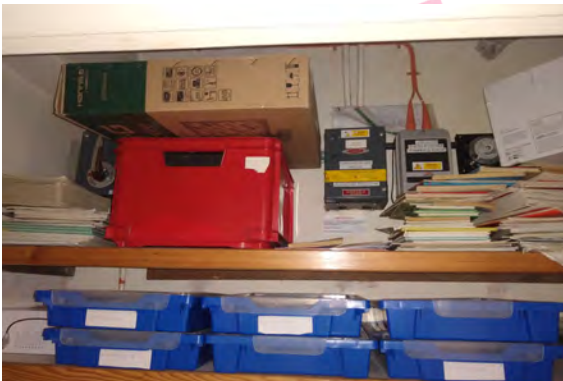
### **Item 89 Ref: Presumed**

The electrics in the Store (Rm 0/76) is presumed to contain asbestos.

Any change in its appearance should be recorded and passed to Property Services.

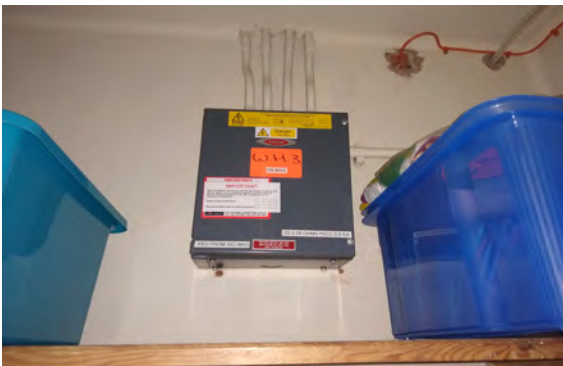
### **Item 90 Ref: Presumed**

The electrics in the Store (Rm 0/77) is presumed to contain asbestos.

Any change in its appearance should be recorded and passed to Property Services.

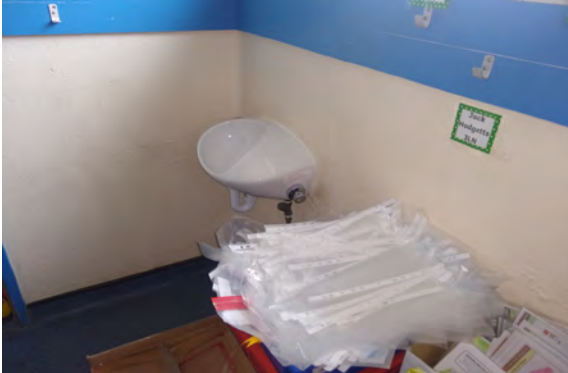
### **Item 91 Ref: As 422644-49**

The decorative finish to low level walls in the Cloaks area (Rm 0/79) does not contain asbestos.

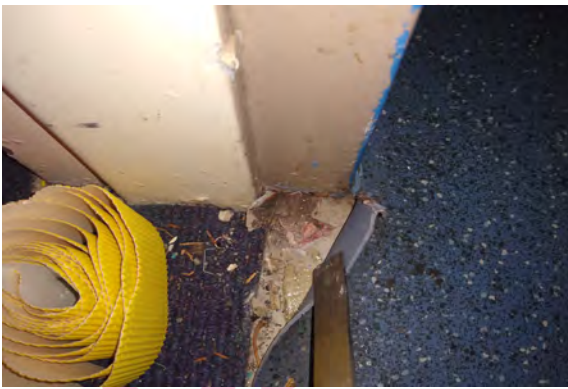
### **Item 92 Ref: As 422644-48**

The floor screed in the Cloaks area (Rm 0/79) does not contain asbestos.

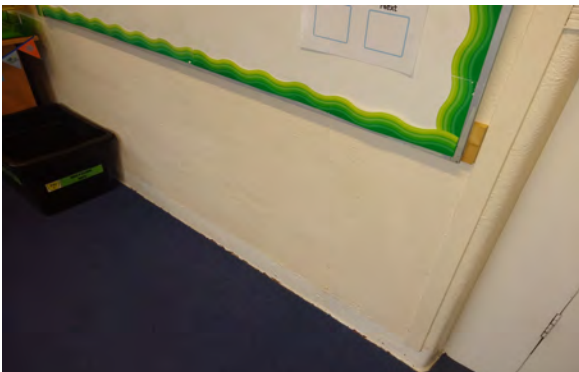
### **Item 93 Ref: As 422644-49**

The decorative finish to low level walls in the Year 3 Classroom (Rm 0/80) does not contain asbestos.

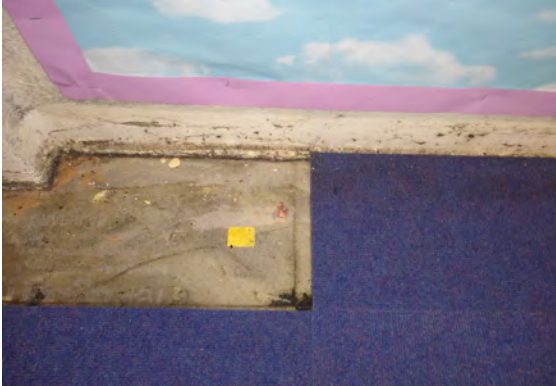
### **Item 94 Ref: As 422644-48**

The floor screed in the Year 3 Classroom (Rm 0/80) does not contain asbestos.

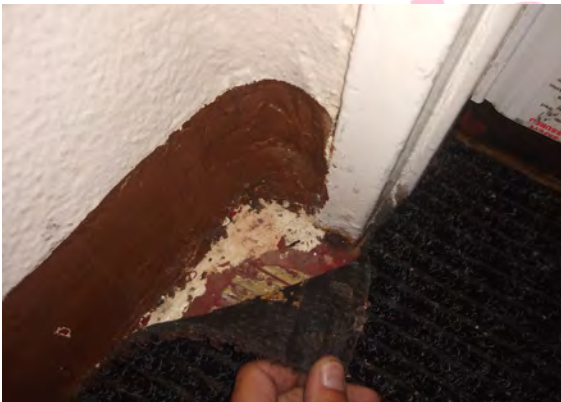
### **Item 95 Ref: As 422644-48**

The floor screed in the Corridor (Rm 0/81) does not contain asbestos.

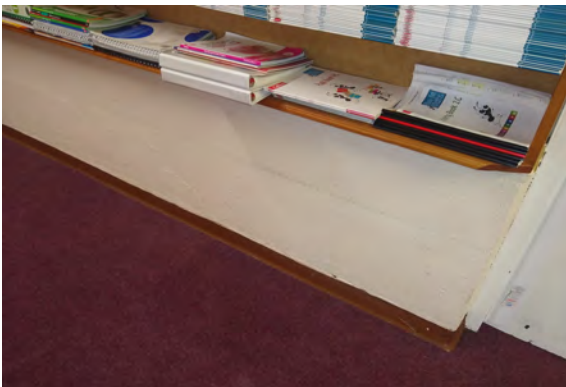
### **Item 96 Ref: As 422644-43**

The decorative finish to low level walls in the Corridor (Rm 0/81) does not contain asbestos.

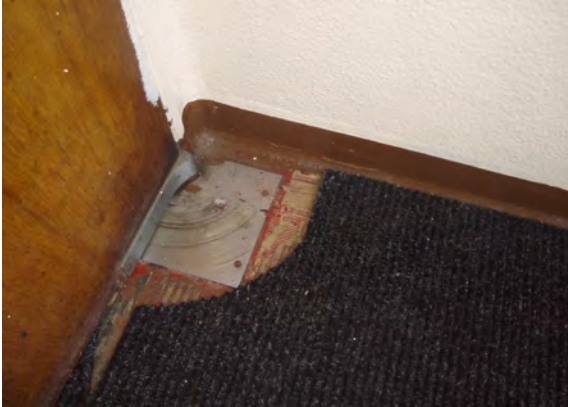
### **Item 97 Ref: As 422644-48**

The floor screed in the Lobby (Rm 0/82) does not contain asbestos.

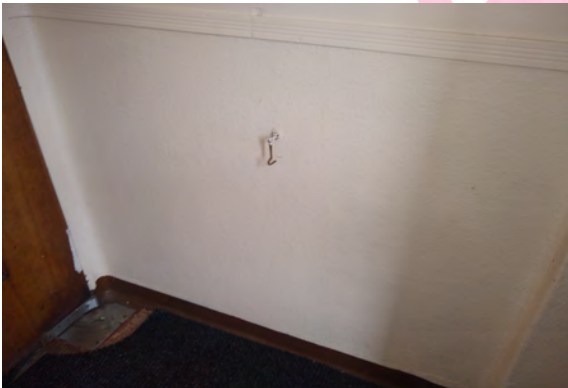
### **Item 98 Ref: As 422644-43**

The decorative finish to low level walls in the Lobby (Rm 0/82) does not contain asbestos.

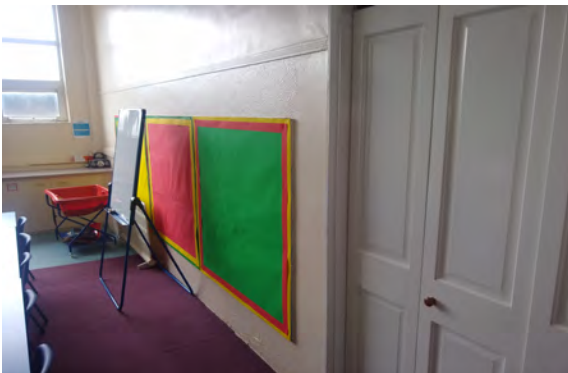
### **Item 99 Ref: As 422644-49**

The decorative finish to low level walls in the Intervention Room 3 (Rm 0/83) does not contain asbestos.

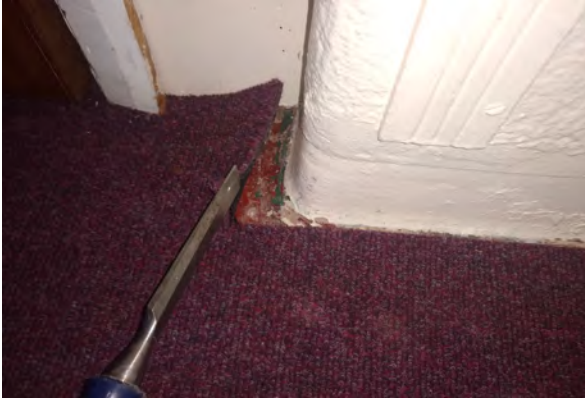
### **Item 100 Ref: As 422644-48**

The floor screed in the Intervention Room 3 (Rm 0/83) does not contain asbestos.

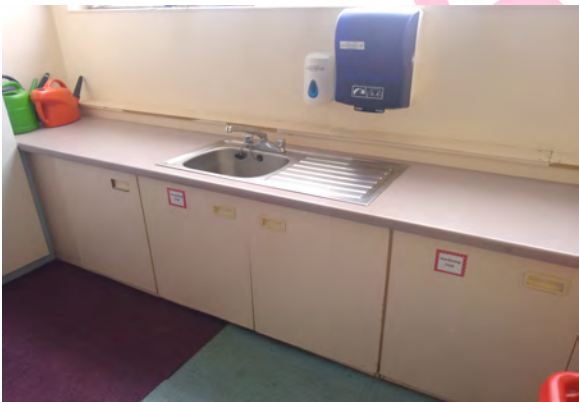
### **Item 101 Ref: 422644-50**

The sink pad in the Intervention Room 3 (Rm 0/83) does not contain asbestos.

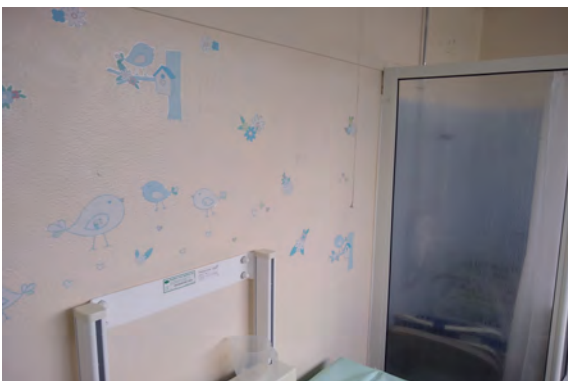
### **Item 102 Ref: As 422644-49**

The decorative finish to low level walls in the Accessible WC/ Shower (Rm 0/85) does not contain asbestos.
