ASBESTOS SURVEY REPORT FOR HILL VIEW JUNIOR SCHOOL ACADEMY,  
QUEEN ALEXANDRA ROAD, SUNDERLAND, TYNE AND WEAR, SR2 9HE.

**Hill View Junior School Academy, Queen Alexandra Road, Sunderland, SR2 9HE**

**Date: 24 April 2025**

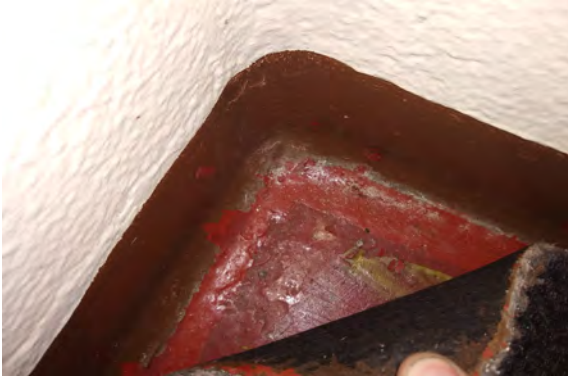
### **Item 103 Ref: As 422644-48**

The floor screed in the Lobby (Rm 0/86) does not contain asbestos.

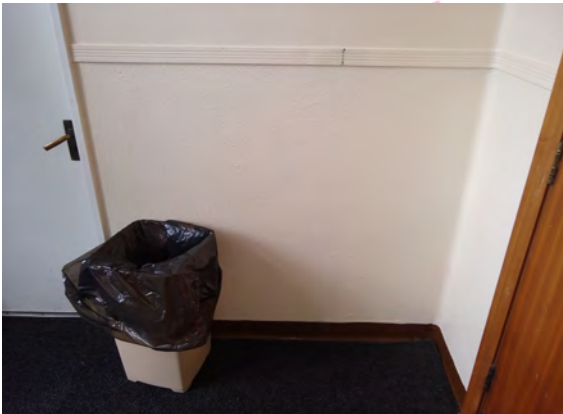
### **Item 104 Ref: As 422644-49**

The decorative finish to low level walls in the Lobby (Rm 0/86) does not contain asbestos.

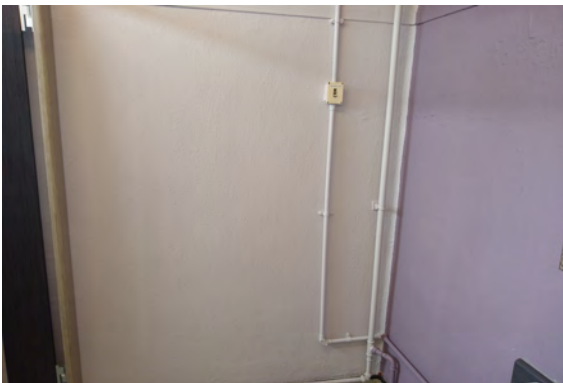
### **Item 105 Ref: 422644-51**

The decorative finish to low level walls in the Female Staff WC (Rm 0/87) does not contain asbestos.

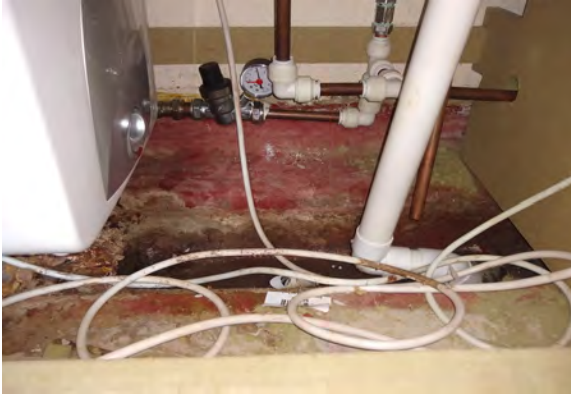
### **Item 106 Ref: 422644-52**

The floor screed in the Female Staff WC (Rm 0/87) does not contain asbestos.

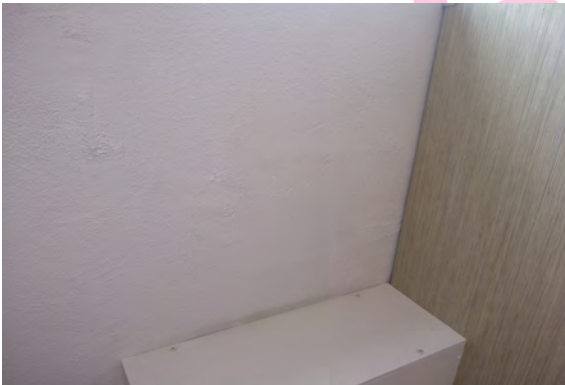
### **Item 107 Ref: 422644-53**

- (Item 107) Ref: 422644-53 – Patch repairs to decorative finish to low level walls (Female Staff WC 0/087) - No Risk
- (Item 108) Ref: As 422644-51 – Decorative finish to low level walls (Year 6 Classroom 0/089) – No Risk

The patch repairs to decorative finish to low level walls in the Female Staff WC (Rm 0/87) does not contain asbestos.

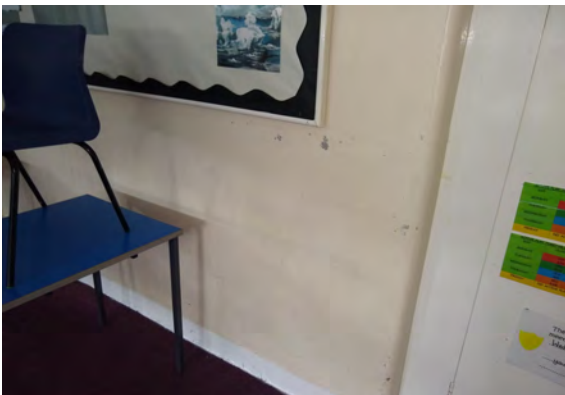
### **Item 108 Ref: As 422644-51**

The decorative finish to low level walls in the Year 6 Classroom (Rm 0/89) does not contain asbestos.

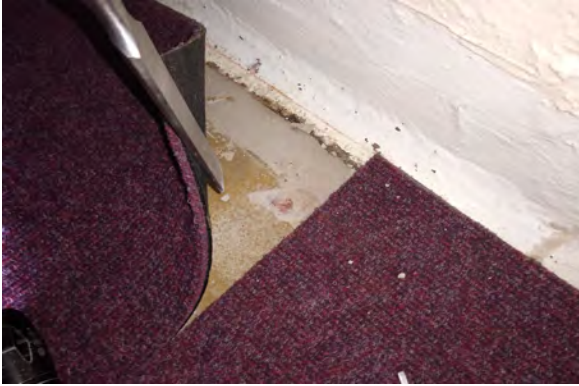
### **Item 109 Ref: As 422644-52**

The floor screed in the Year 6 Classroom (Rm 0/89) does not contain asbestos.

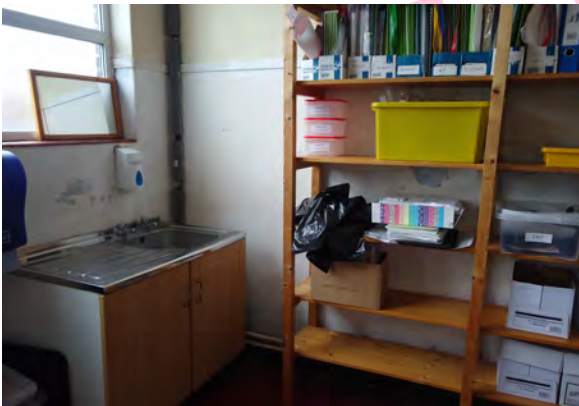
### **Item 110 Ref: As 422644-51**

The decorative finish to low level walls in the Store (Rm 0/90) does not contain asbestos.

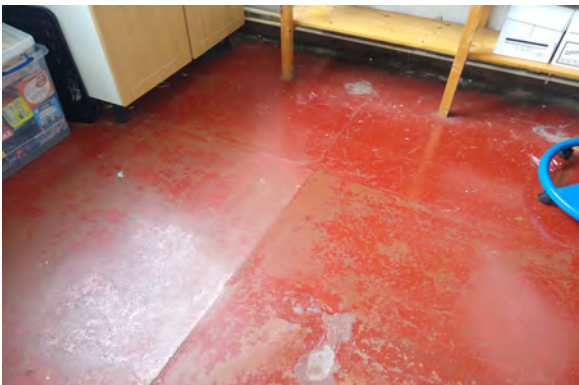
### **Item 111 Ref: As 422644-52**

The floor screed in the Store (Rm 0/90) does not contain asbestos.

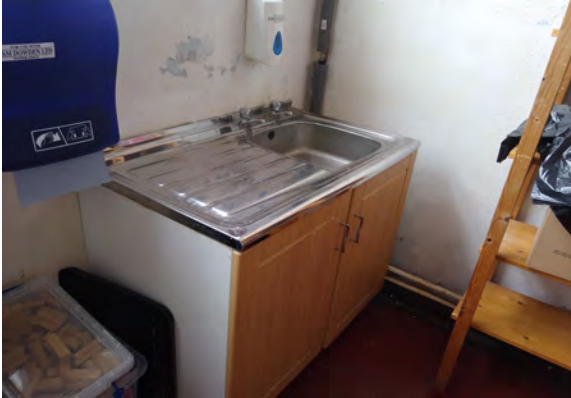
### **Item 112 Ref: 422644-54**

The sink pad in the Store (Rm 0/90) does not contain asbestos.

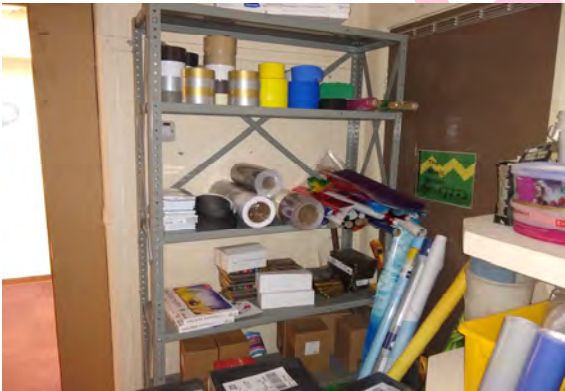
### **Item 113 Ref: As 422644-51**

The decorative finish to low level walls in the Store (Rm 0/91) does not contain asbestos.

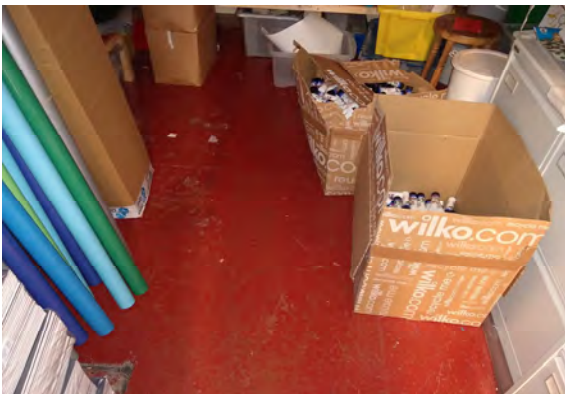
### **Item 114 Ref: As 422644-52**

The floor screed in the Store (Rm 0/91) does not contain asbestos.

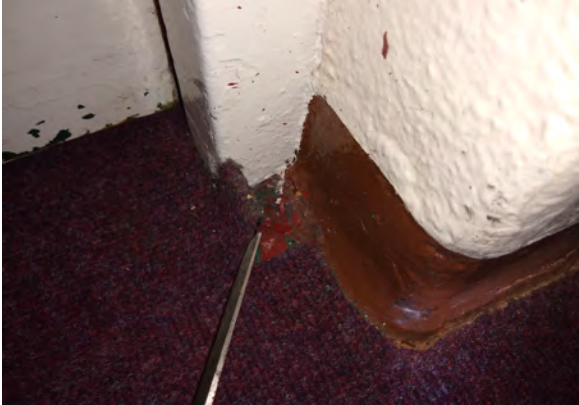
### **Item 115 Ref: As 422644-52**

The floor screed in the Corridor (Rm 0/92) does not contain asbestos.

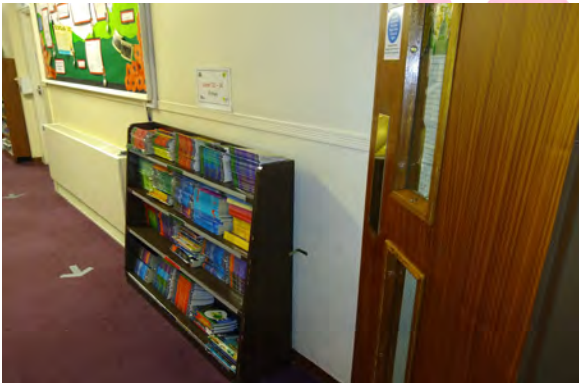
### **Item 116 Ref: As 422644-51**

The decorative finish to low level walls in the Corridor (Rm 0/92) does not contain asbestos.

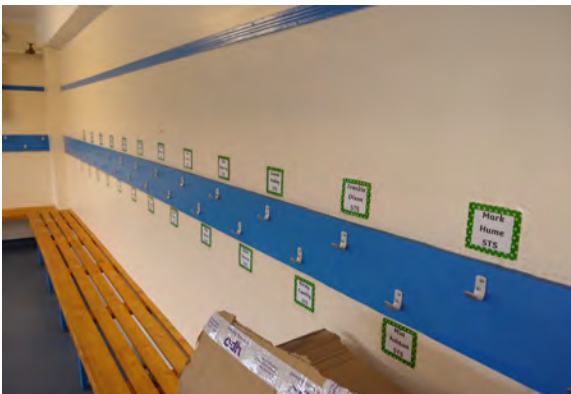
### **Item 117 Ref: As 422644-51**

The decorative finish to low level walls in the Cloaks area (Rm 0/93) does not contain asbestos.

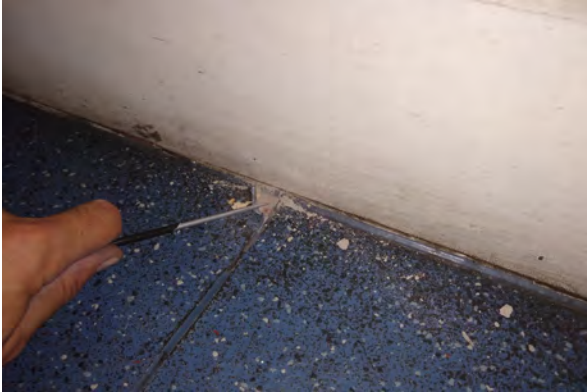
### **Item 118 Ref: As 422644-52**

The floor screed in the Cloaks area (Rm 0/93) does not contain asbestos.

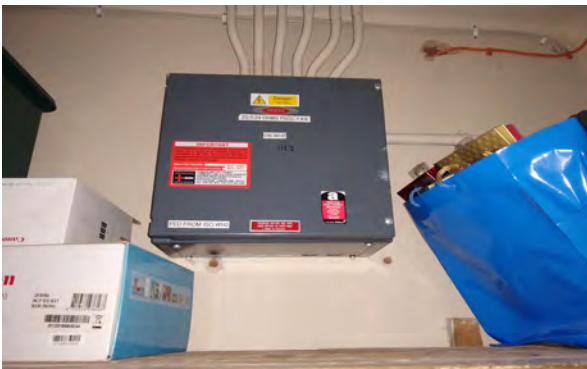
### **Item 120 Ref: Presumed**

The electrics in the Store (Rm 0/96) are presumed to contain asbestos.

Any change in its appearance should be recorded and passed to Property Services.

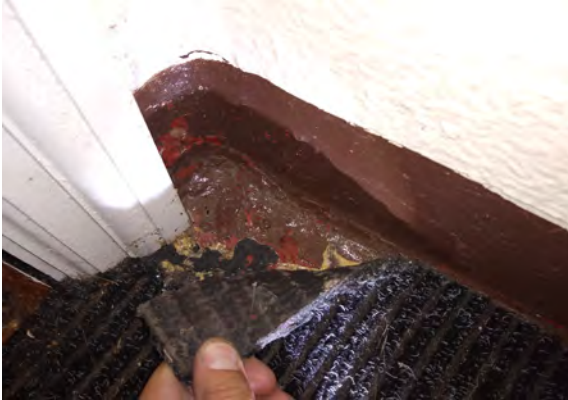
### **Item 121 Ref: As 422644-52**

The floor screed in the Lobby (Rm 0/97) does not contain asbestos.

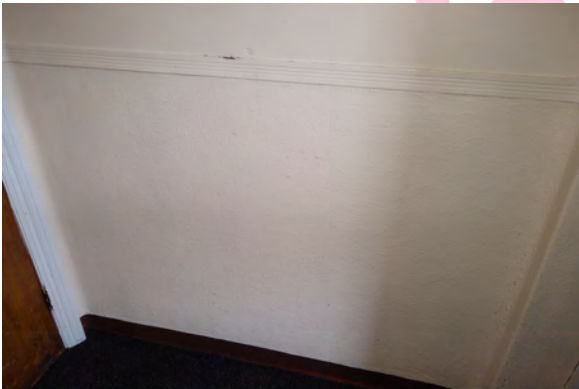
### **Item 122 Ref: As 422644-51**

The decorative finish to low level walls in the Lobby (Rm 0/97) does not contain asbestos.

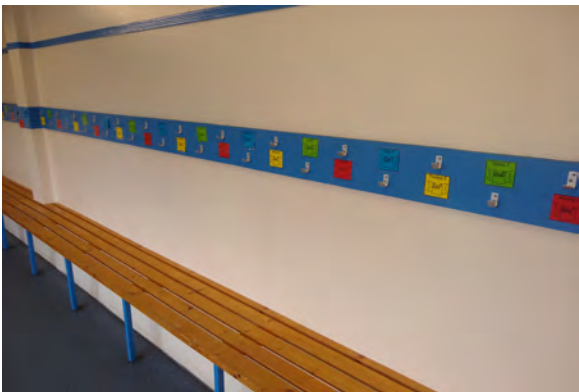
### **Item 123 Ref: As 422644-51**

The decorative finish to low level walls in the Cloaks area (Rm 0/99) does not contain asbestos.

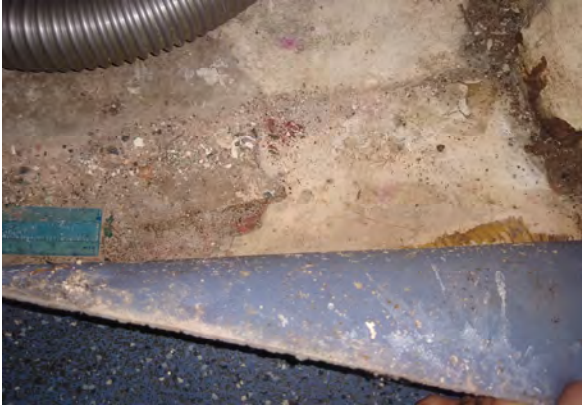
### **Item 124 Ref: As 422644-52**

The floor screed in the Cloaks area (Rm 0/99) does not contain asbestos.

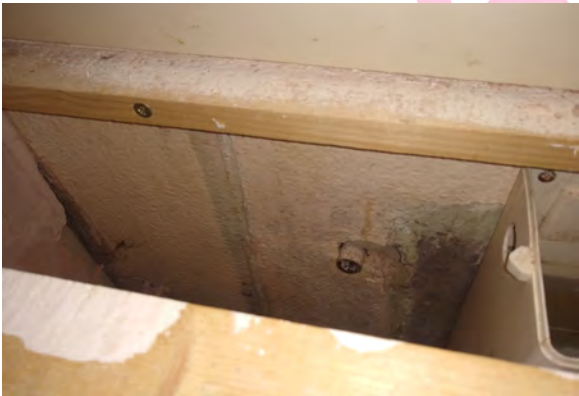
### **Item 125 Ref: As 422644-51**

The decorative finish to low level walls within toilet cistern boxing in the Girls/ Boys WC (Rm 0/101) does not contain asbestos.

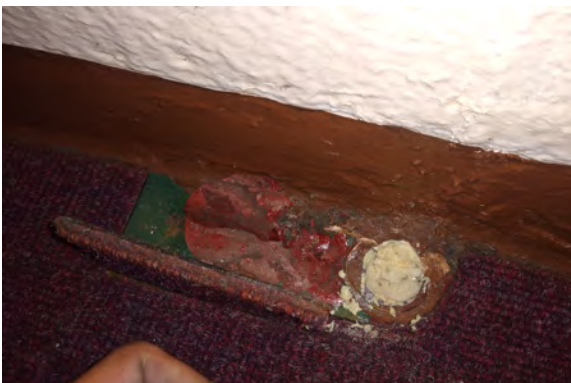
### **Item 126 Ref: As 422644-52**

The floor screed in the Corridor (Rm 0/104) does not contain asbestos.

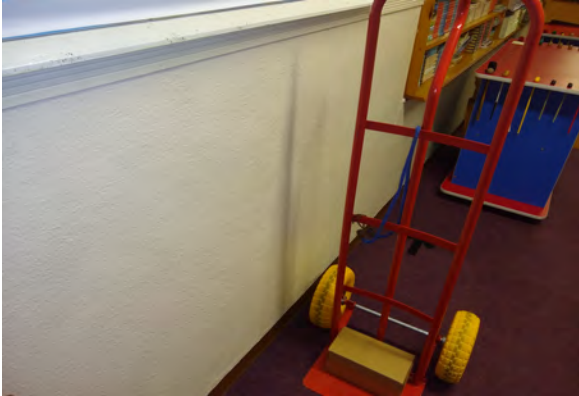
### **Item 127 Ref: As 422644-51**

The decorative finish to low level walls in the Corridor (Rm 0/104) does not contain asbestos.

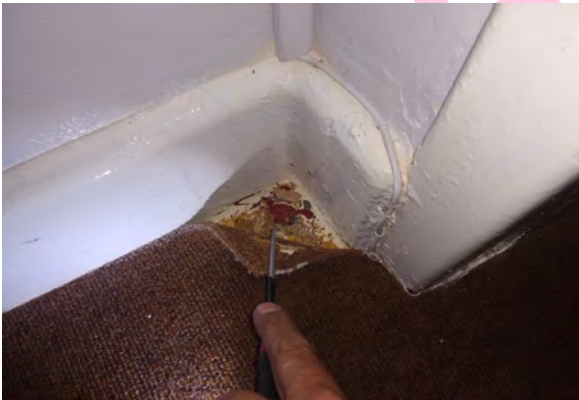
### **Item 128 Ref: As 422644-52**

The floor screed to area below stairs in the Head Teachers room (Rm 0/105) does not contain asbestos.

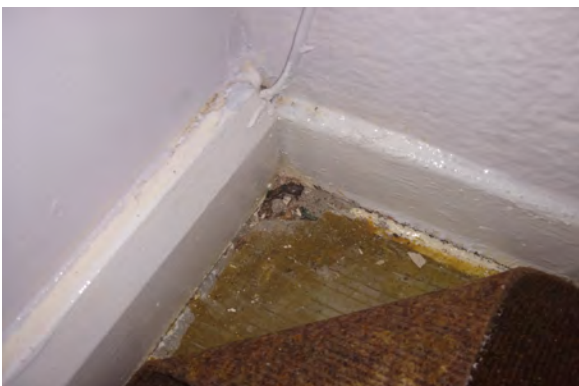
### **Item 129 Ref: 422644-55**

The subfloor in the Head Teachers room (Rm 0/105) does not contain asbestos.

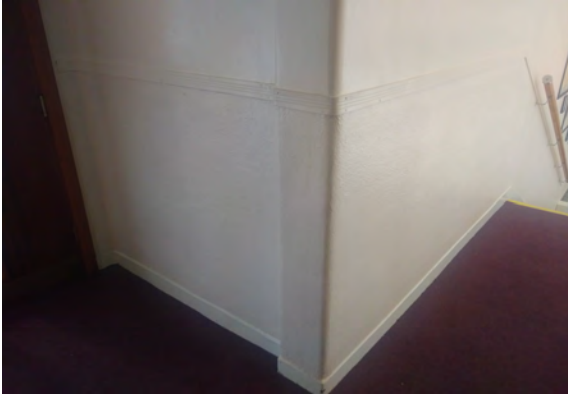
### **Item 130 Ref: 422644-56**

The decorative finish to low level walls in the Landing area (Rm 1/001) does not contain asbestos.

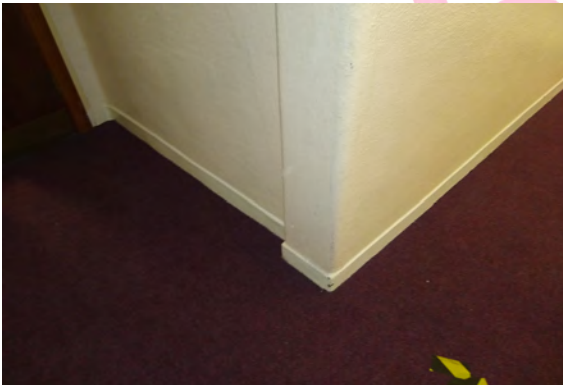
### **Item 131 Ref: As 422644-63**

The red skirting in the Landing area (Rm 1/001) does not contain asbestos.

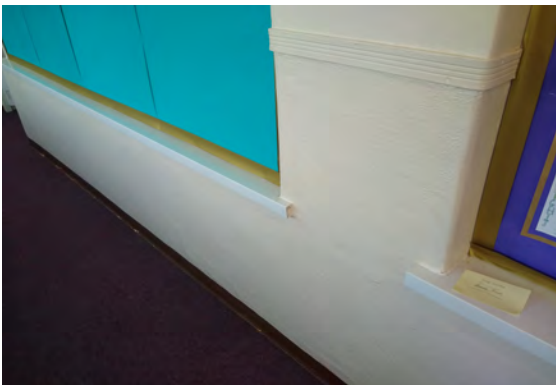
### **Item 132 Ref: As 422644-56**

The decorative finish to low level walls in the Corridor (Rm 1/004) does not contain asbestos.

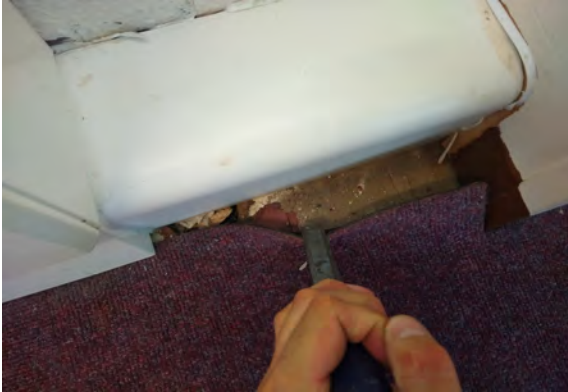
### **Item 133 Ref: 422644-57**

The red floor screed in the Corridor (Rm 1/004) does not contain asbestos.

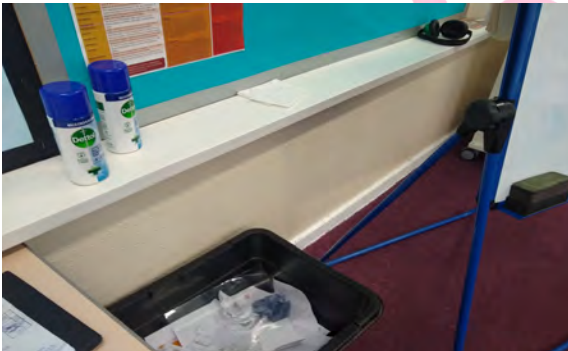
### **Item 134 Ref: As 422644-56**

The decorative finish to low level walls in Classroom 10 (Rm 1/005) does not contain asbestos.

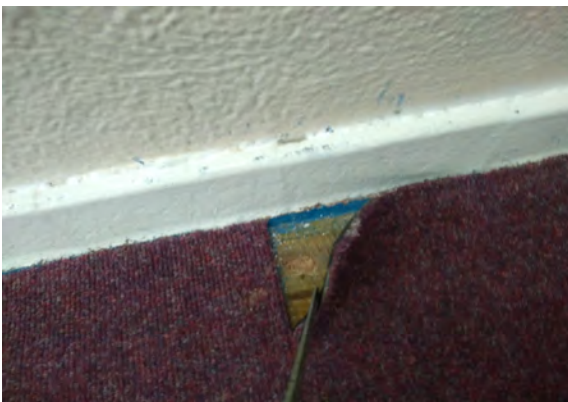
### **Item 135 Ref: 422644-58**

The subfloor and skirting in Classroom 10 (Rm 1/005) do not contain asbestos.

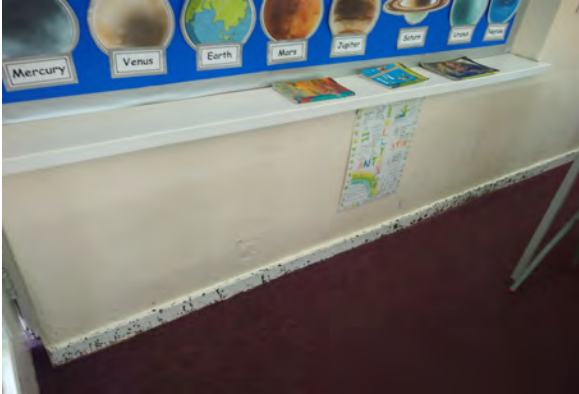
### **Item 136 Ref: As 422644-56**

The decorative finish to low level walls in Classroom 11 (Rm 1/008) does not contain asbestos.

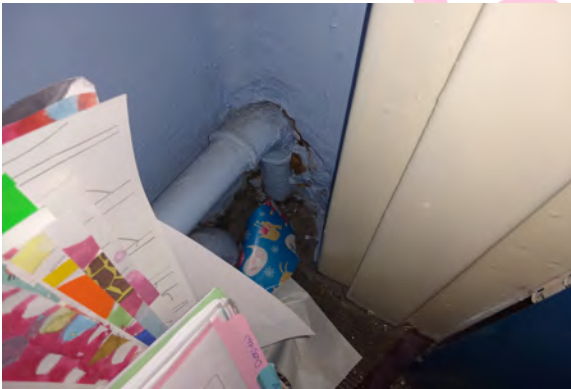
### **Item 137 Ref: As 422644-58**

The subfloor and skirting in Classroom 11 (Rm 1/008) do not contain asbestos.

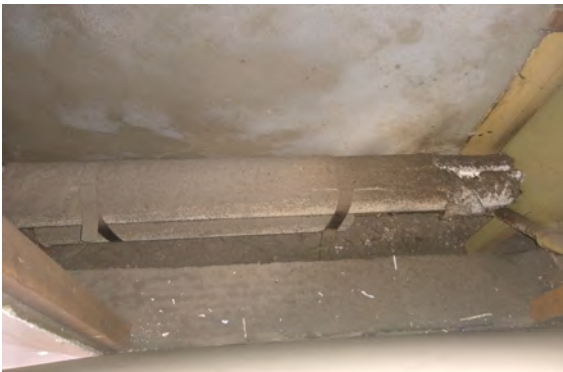
### **Item 138 Ref: 422644-59**

The pipe lagging in Classroom 11 – void within pipework boxing between redundant heaters (Rm 1/008) contains asbestos.

Any change in its appearance should be recorded and passed to Property Services.

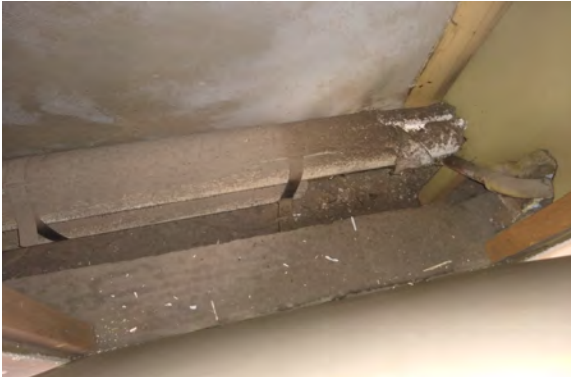
### **Item 139 Ref: 422644-60**

The debris to walls, pipe hangers & floor in Classroom 11 – void within pipework boxing between redundant heaters (Rm 1/008) contains asbestos.

Any change in its appearance should be recorded and passed to Property Services.

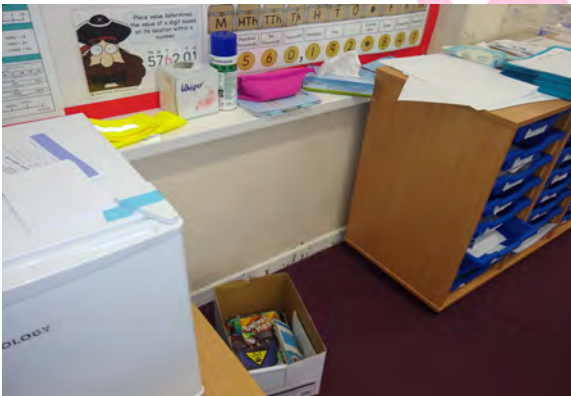
### **Item 140 Ref: As 422644-56**

The decorative finish to low level walls in Classroom 12 (Rm 1/009) does not contain asbestos.

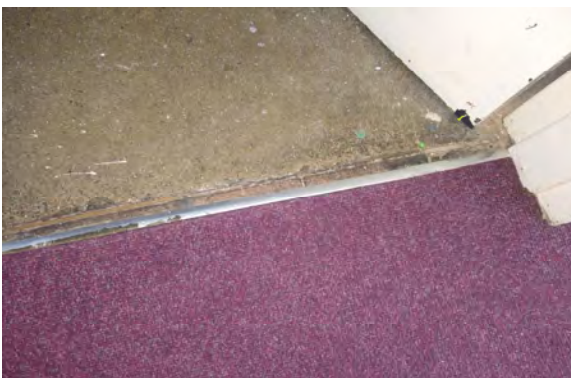
### **Item 141 Ref: As 422644-58**

The subfloor and skirting in Classroom 12 (Rm 1/009) do not contain asbestos.

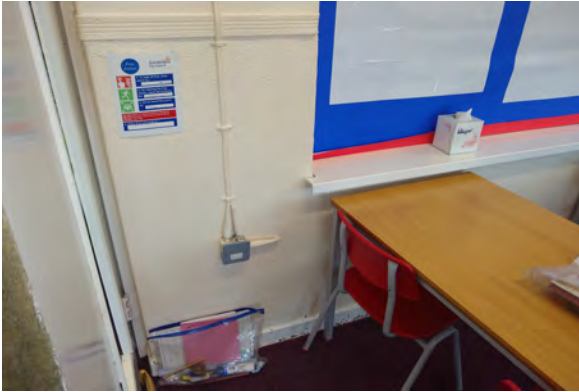
### **Item 142 Ref: As 422644-56**

The decorative finish to low level walls in Classroom 13 (Rm 1/012) does not contain asbestos.

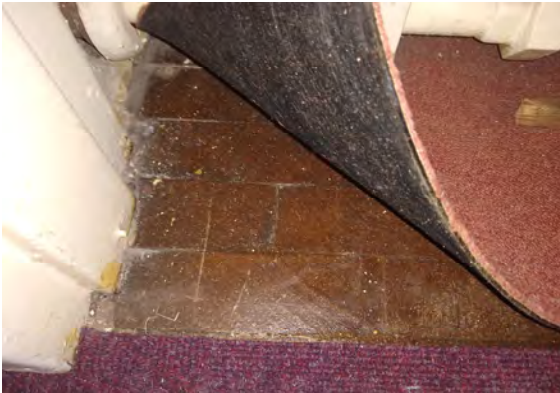
### **Item 143 Ref: As 422644-58**

The subfloor and skirting in Classroom 13 (Rm 1/012) do not contain asbestos.

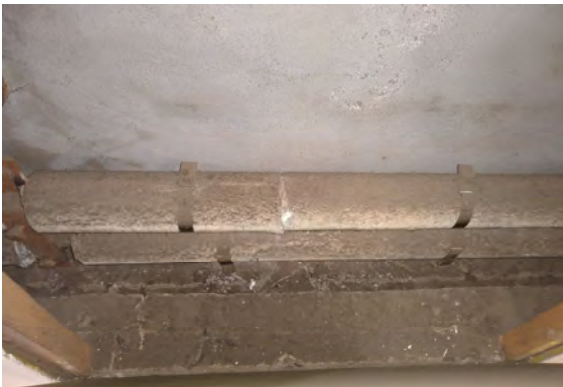
### **Item 144 Ref: 422644-61**

The pipe lagging in Classroom 13 – void within pipework boxing between redundant heaters (Rm 1/012) contains asbestos.

Any change in its appearance should be recorded and passed to Property Services.

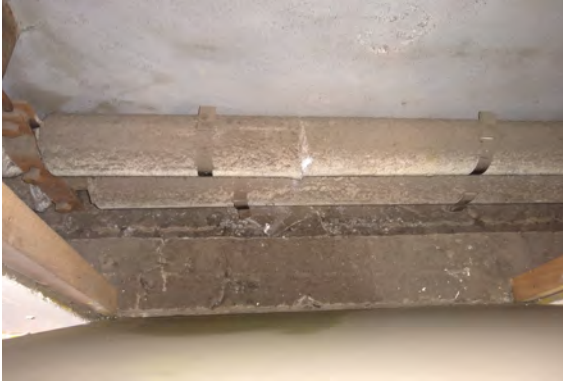
### **Item 145 Ref: 422644-62**

The debris to walls, pipe hangers & floor in Classroom 12 – void within pipework boxing between redundant heaters (Rm 1/012) contains asbestos.

Any change in its appearance should be recorded and passed to Property Services.

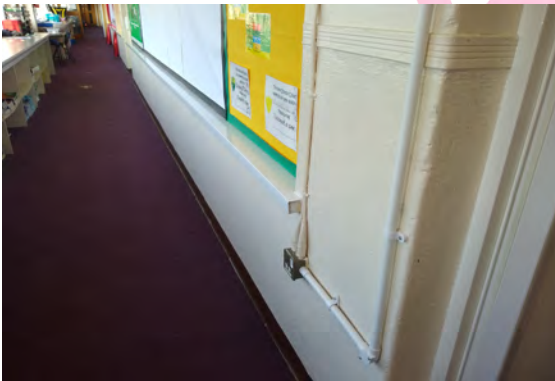
### **Item 146 Ref: As 422644-56**

The decorative finish to low level walls in Classroom 13 (Rm 1/013) does not contain asbestos.

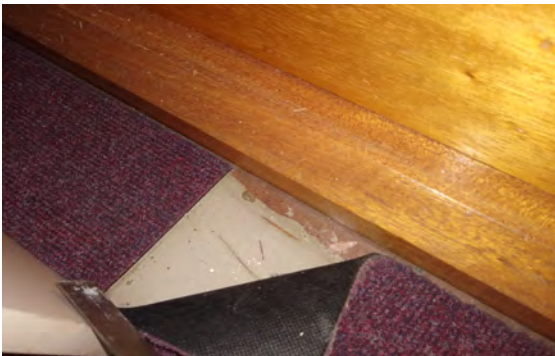
### **Item 147 Ref: As 422644-57**

The red floor screed in the Corridor (Rm 1/013) do not contain asbestos.

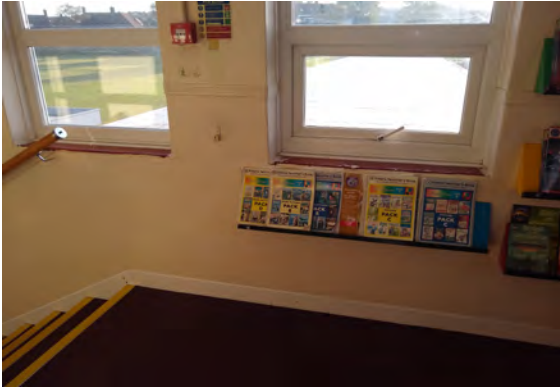
### **Item 148 Ref: As 422644-56**

The decorative finish to low level walls in the Stairwell (Rm 1/014) does not contain asbestos.

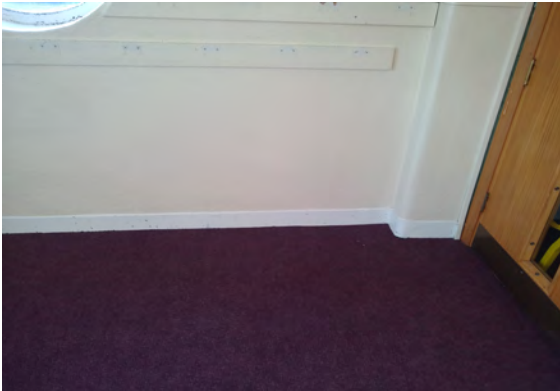
### **Item 149 Ref: 422644-63**

The red skirting in the Stairwell (Rm 1/014) does not contain asbestos.

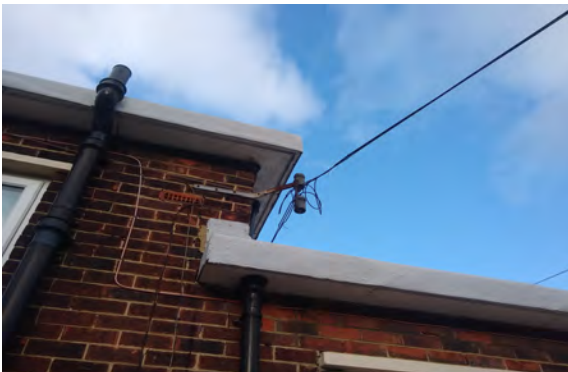
### **Item 155 Ref: 422644-69**

The telephone insulators (External) contains asbestos.

Any change in its appearance should be recorded and passed to Property Services.

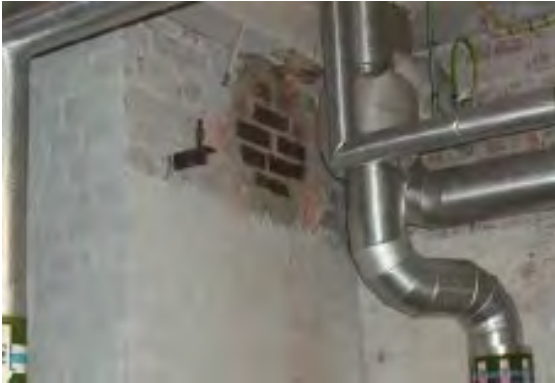
#### **Item 157 Ref: SC17525**

The insulation residue in the Plant Room (Basement) does not contain asbestos.

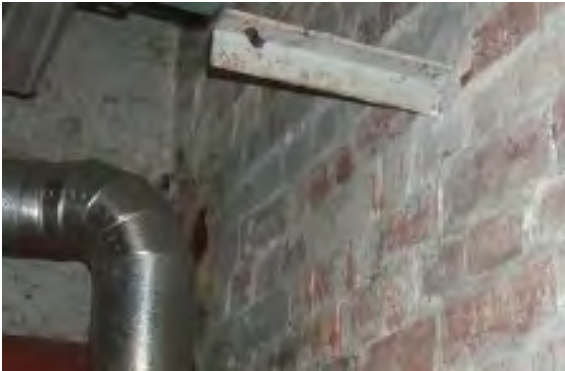
#### **Item 158 Ref: SC17526**

The insulation residue in the Plant Room (Basement) does not contain asbestos.

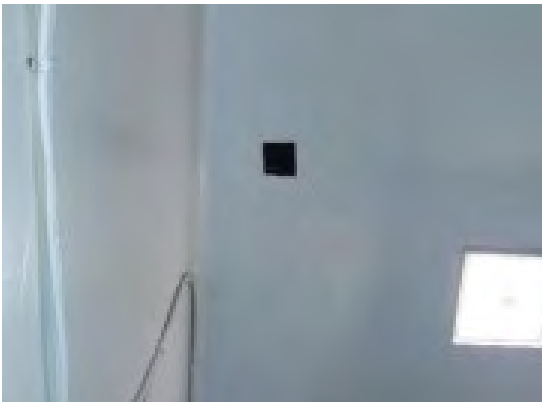
### **Item 162 Ref: VK001499**

The concrete and plaster finishes to ceilings (Ground Floor / 03 / Area 3) do not contain asbestos.

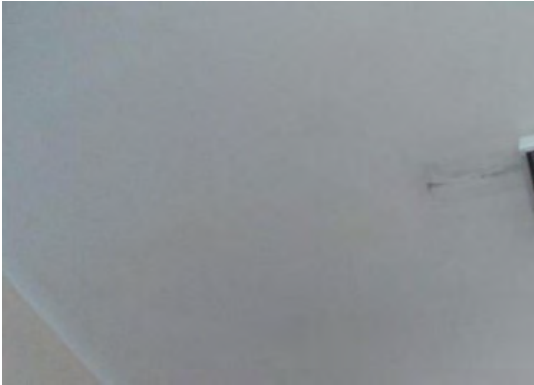
#### **Item 163 Ref: VK001500**

The concrete and plaster finishes to ceilings (Ground Floor / 04 / Area 4) do not contain asbestos.

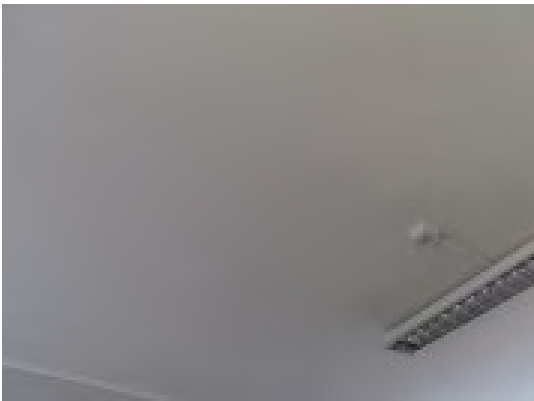
#### **Item 164 Ref: VK001501**

The concrete and plaster finishes to ceilings (Ground Floor / 05 / Area 5) do not contain asbestos.

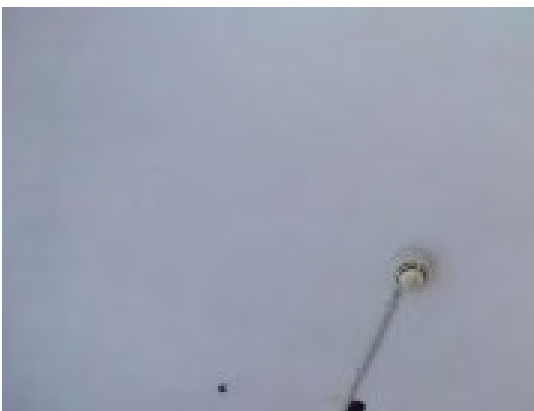
#### **Item 165 Ref: VK001502**

The concrete and plaster finishes to ceilings (Ground Floor / 06 / Area 6) do not contain asbestos.

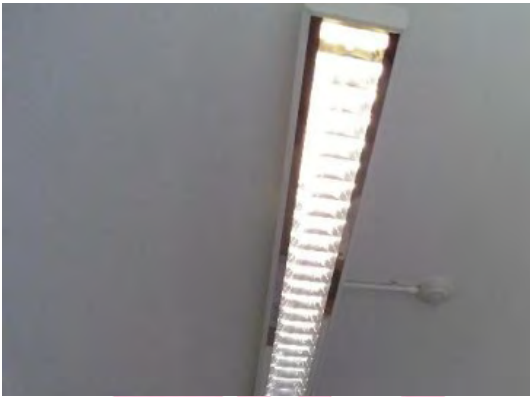
### **Item 167 Ref: VK001504**

The concrete and plaster finishes to ceilings (Ground Floor / 08 / Area 8) do not contain asbestos.

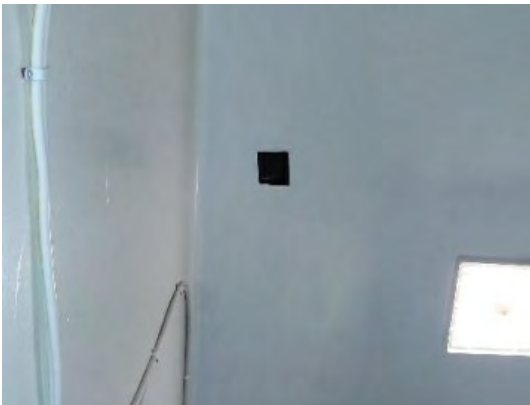
### **Item 168 Ref: VK001507**

The concrete and plaster finishes to ceilings (Ground Floor / 09 / Area 9) do not contain asbestos.

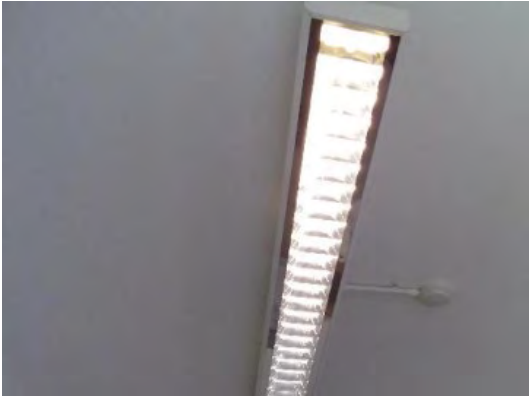
### **Item 169 Ref: VK001508**

The concrete and plaster finishes to ceilings (Ground Floor / 10 / Area 10) do not contain asbestos.

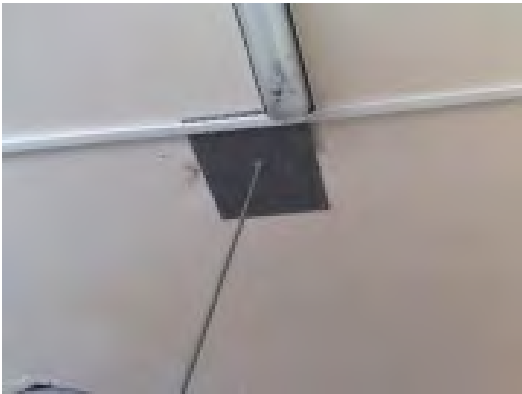
### **Item 170 Ref: VK001509**

The plaster finishes to ceilings (Ground Floor / 11 / Area 11) do not contain asbestos.

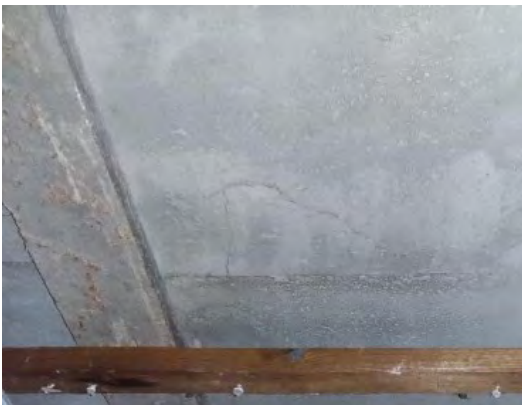
### **Item 171 Ref: VK001510**

The concrete and plaster finishes to ceilings (Ground Floor / 12 / Area 12) do not contain asbestos.

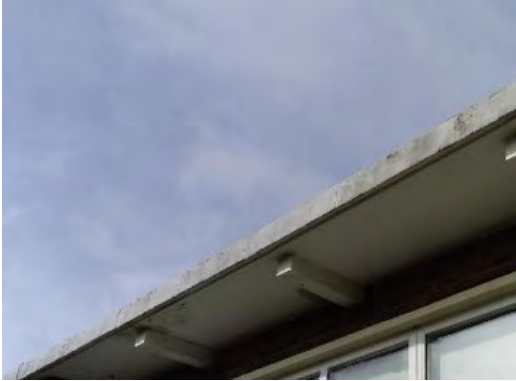
### **Item 172 Ref: VK001511**

The concrete, paint and bitumen felt to soffits and roof (Ground Floor / 13 / Area 13) do not contain asbestos.

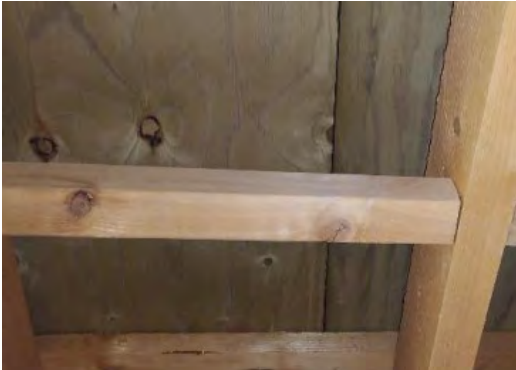
### **Item 173 Ref: VK001512**

The timber panels to roof (Ground Floor / 14 / Area 14) do not contain asbestos.

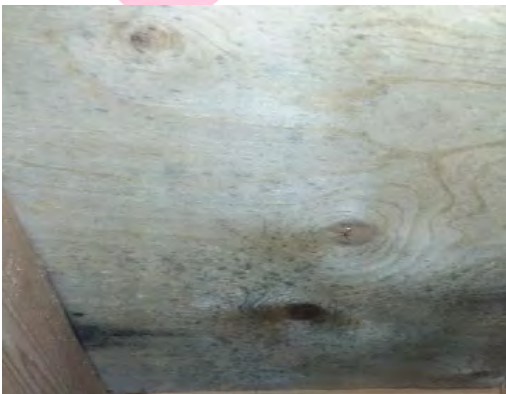
### **Item 174 Ref: VK001513**

The timber panels to roof (Ground Floor / 15 / Area 15) do not contain asbestos.
