ASBESTOS SURVEY REPORT FOR DERWENT HILL OUTDOOR EDUCATION AND TRAINING CENTRE, PORTINSCALE, KESWICK, CUMBRIA, CA12 5RD.

Derwent Hill Outdoor Education and Training Centre

Date: 07 April 2026

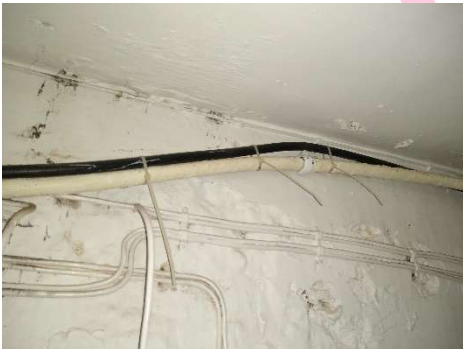
Item 2 Ref: 418920-14

The wrap to main cable in Store Room/-1/001 does not contain asbestos.

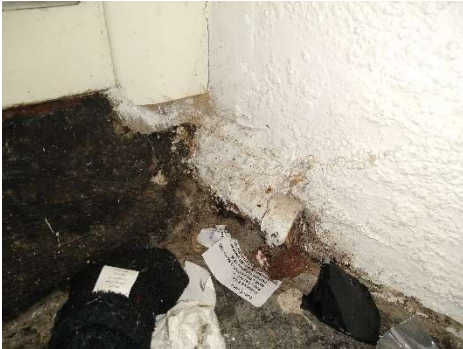
Item 4 Ref: As 418920-14

The wrap to cut off cable to fire exit in Store Room/-1/001 does not contain asbestos.

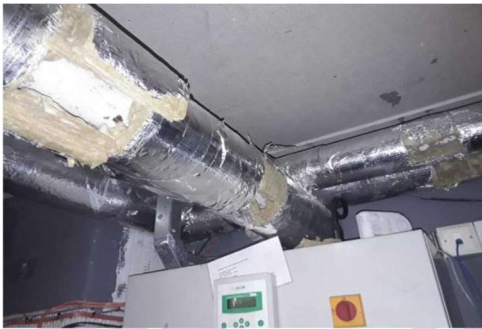
Item 61 Ref: 22-43184-1

The pipes - residual insulation beneath Mmmf to old pipework (thermal insulation) (Area 3/Plant Room) contain asbestos.

Any change in its appearance should be recorded and passed to Property Services.

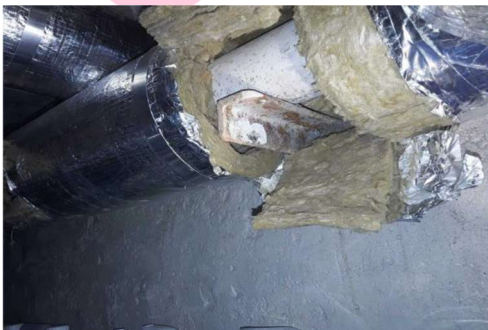
Item 62 Ref: 22-43184-4

The pipes – residual insulation to pipe bracket (thermal insulation) (Area 5/Cleaners Store) contain asbestos.

Any change in its appearance should be recorded and passed to Property Services.

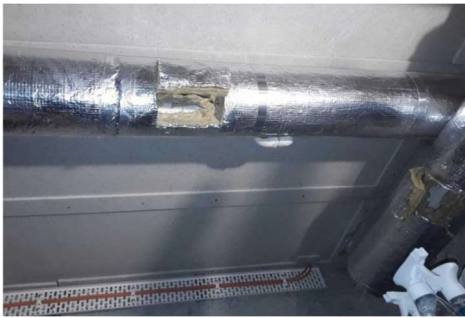
Item 63 Ref: 22-43184-5

The pipes - residual insulation beneath Mmmf lagging (thermal insulation) (Area 5/Cleaners Store) contain asbestos.

Any change in its appearance should be recorded and passed to Property Services.

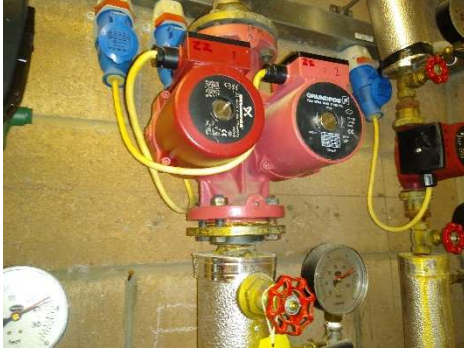
Item 32 Ref: 418920-28

The pipework flange gasket in Boiler Room 0/027 does not contain asbestos.

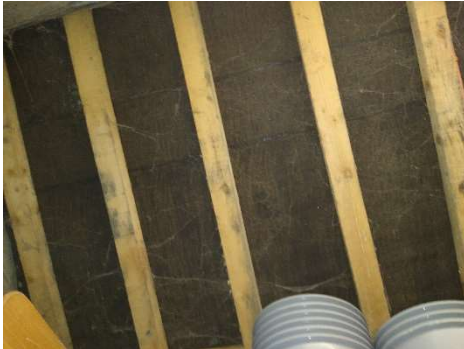
Item 36 Ref: As 418920-8

The sarking in Utility Room/0/004 does not contain asbestos.

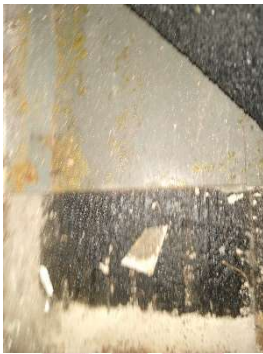
Item 40 Ref: 418920-2

The sub floor covering in Bedroom/0/001 contains asbestos.

Any change in its appearance should be recorded and passed to Property Services.

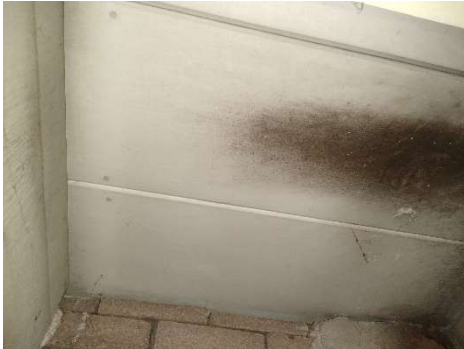
Item 42 Ref: As 418920-1

The ceiling in Kitchen cupboard/0/002 contains asbestos.

Any change in its appearance should be recorded and passed to Property Services.

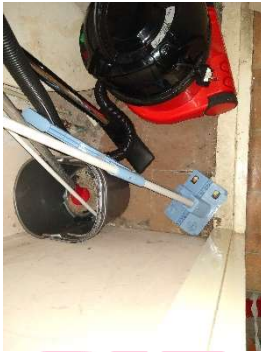
Item 43 Ref: 418920-3

The floor covering in Kitchen cupboard/0/002 contains asbestos.

Any change in its appearance should be recorded and passed to Property Services.

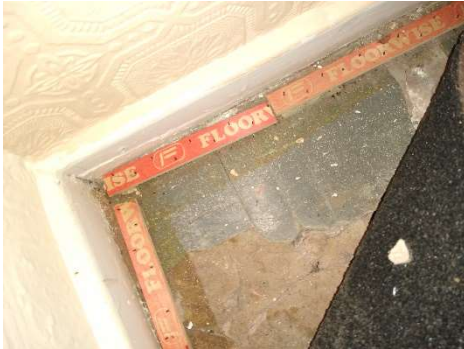
Item 45 Ref: As 418920-2

The sub floor covering in Living Room 0/003 contains asbestos.

Any change in its appearance should be recorded and passed to Property Services.

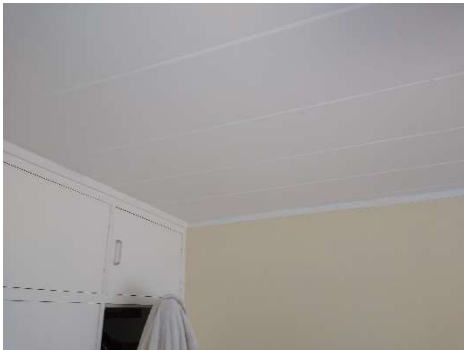
Item 48 Ref: As 418920-1

The ceiling in Bedroom 0/005 contains asbestos.

Any change in its appearance should be recorded and passed to Property Services.

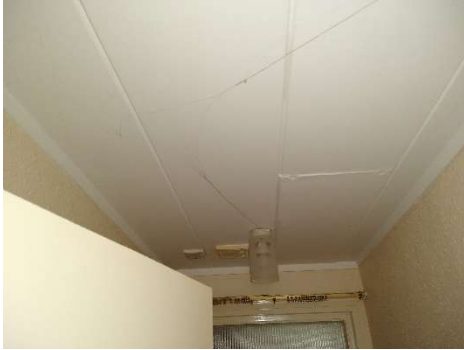
Item 54 Ref: As 418920-1

The ceiling in Toilet Room 0/008 contains asbestos.

Any change in its appearance should be recorded and passed to Property Services.
