ASBESTOS SURVEY REPORT FOR WASHINGTON MILLENIUM CENTRE LIBRARY/THE OVAL, WASHINGTON, NE37 2QD.

**Washington Millennium Centre, Washington, NE37 2QD**

**Date: 02 June 2026**

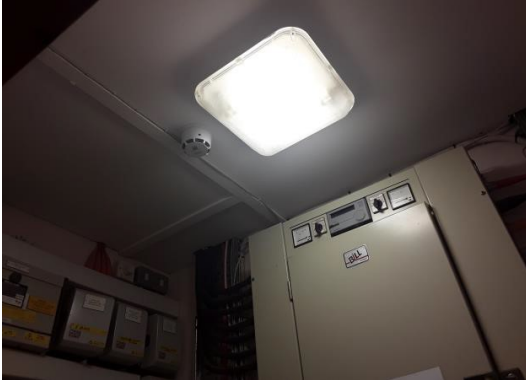
### **Item 37 Ref: 21-35078-1**

The ceiling (Area 17/CCTV Room) does not contain asbestos.

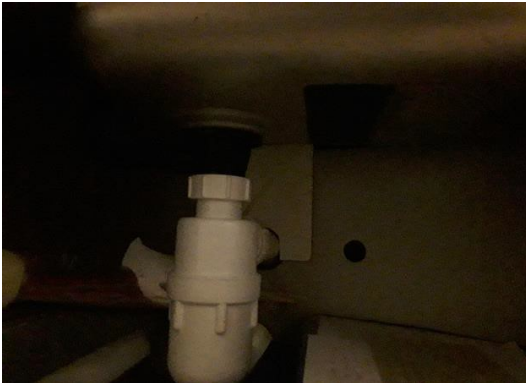
### **Item 38 Ref: 21-35078-3**

The sink pad (Area 29/Meeting Room Kitchen) does not contain asbestos.

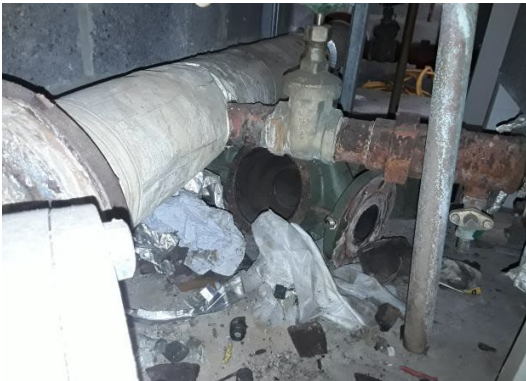
### **Item 39 Ref: 21-35078-10**

The redundant flange to floor behind boilers (Area 36/Boiler Room) contains asbestos.

Any change in appearance should be reported to Property Services.

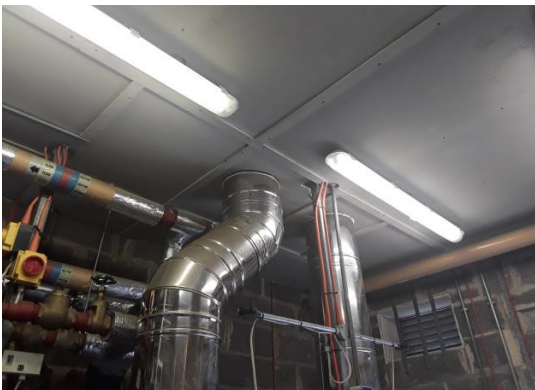
**Item 41 Ref: 21-35078-4**

The ceiling (Area 36/Boiler Room) does not contain asbestos.

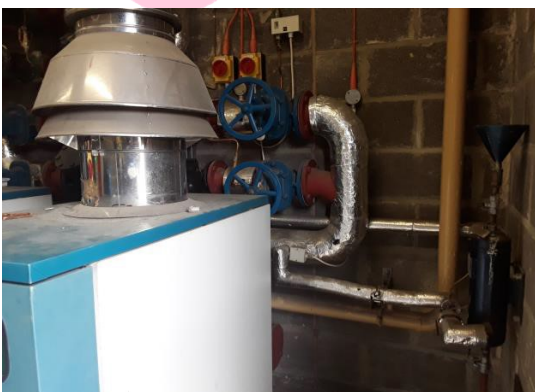
**Item 42 Ref: 21-35078-5**

The pipe flanges (Area 36/Boiler Room) contain asbestos.

Any change in appearance should be reported to Property Services.

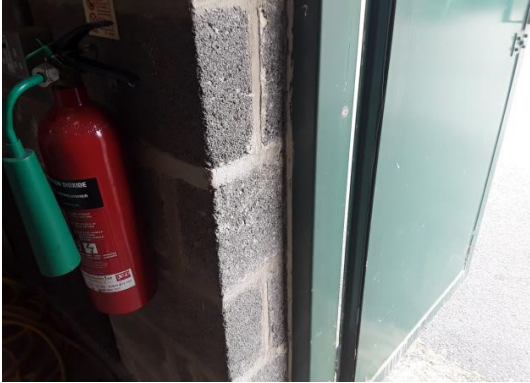
**Item 43 Ref: 21-35078-7**

The door frame sealant (Area 36/Boiler Room) does not contain asbestos.

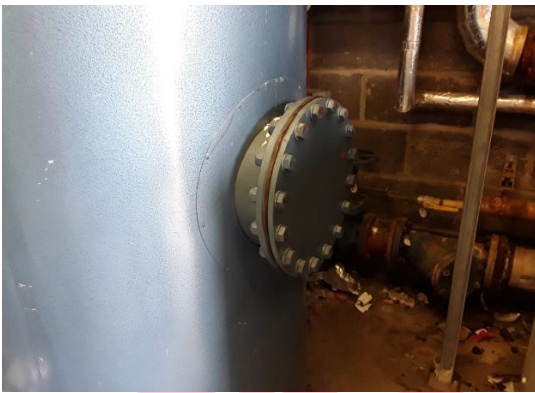
**Item 44 Ref: 21-35078-8**

The vessels tank gasket (Area 36/Boiler Room) does not contain asbestos.

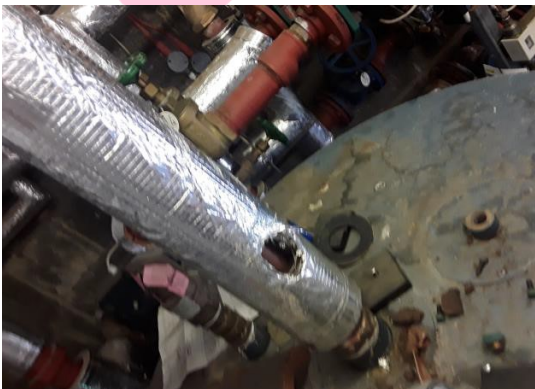
**Item 45 Ref: 21-35078-9**

The redundant gaskets on top of tank (Area 36/Boiler Room) do not contain asbestos.

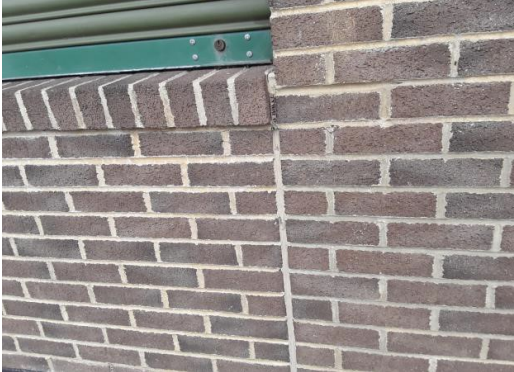
**Item 46 Ref: 21-35078-6**

The putty in expansion joints in walls (External) does not contain asbestos.

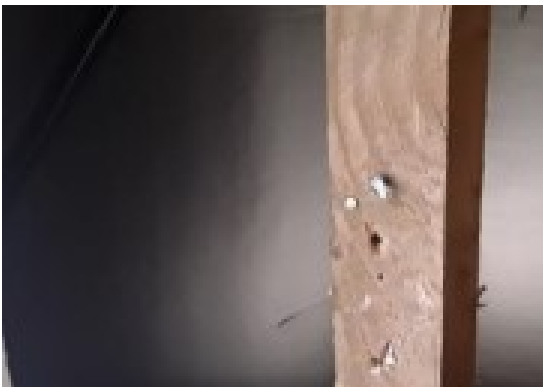
**Item 47 Ref: 21-37939-1**

The minor sporadic residue to existing nails in the ceiling (Area 2/Annexe room ceiling void) does contain asbestos.

Any change in appearance should be reported to Property Services.

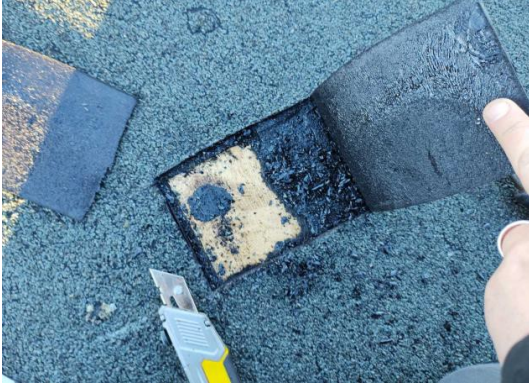
**Item 49 Ref: 22-41633-2**

The floor - felt roof (Bitumen)  
(Area: 1 Roof 1) does not  
contain asbestos.

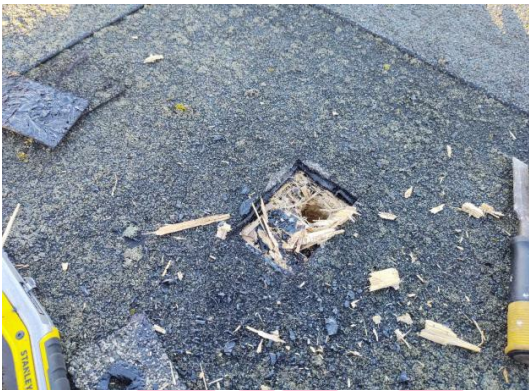
**Item 50 Ref: 22-41633-3**

The floor - felt roof (Bitumen)  
(Area: 1 Roof 1) does not  
contain asbestos.

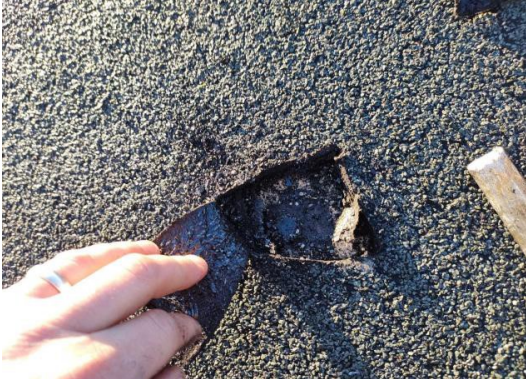
**Item 52 Ref: 22-41633-5**

The floor - felt roof (Bitumen)  
(Area: 1 Roof 1) does not  
contain asbestos.

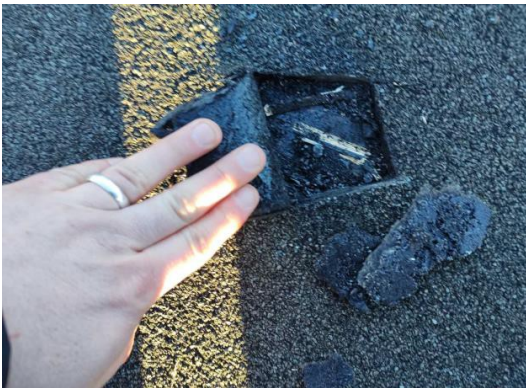
**Item 53 Ref: 22-41633-6**

The floor - felt roof (Bitumen)  
(Area: 1 Roof 1) does not  
contain asbestos.

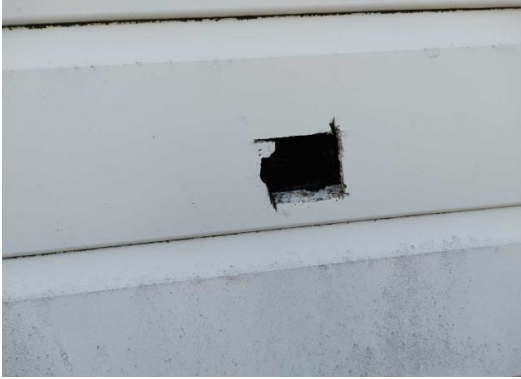
### **Item 55 Ref: 22-41633-9**

The infill panels - felt lining behind plastic cladding (Bitumen) (Area: 1 Roof 1) do not contain asbestos.

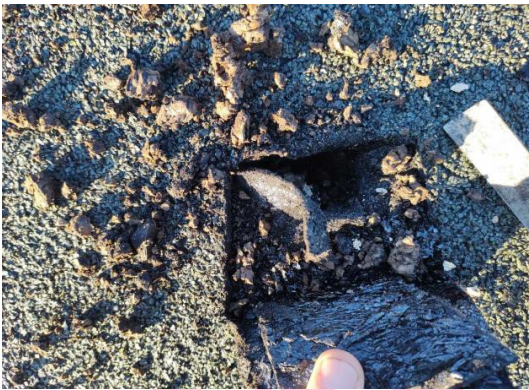
### **Item 56 Ref: 22-41633-8**

The floor - felt roof (Bitumen) (Area: 2 Roof 2) does not contain asbestos.

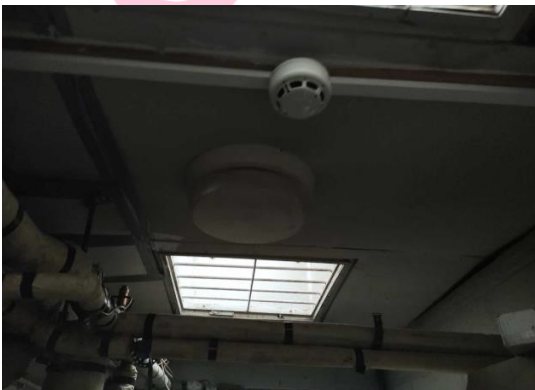
### **Item 57 Ref: 22-41633-11**

The ceiling - paper lined fibreboard ceiling tiles (Textile) (Area: 6 Caretakers Cupboard) contains asbestos.

Any change in appearance should be reported to Property Services.

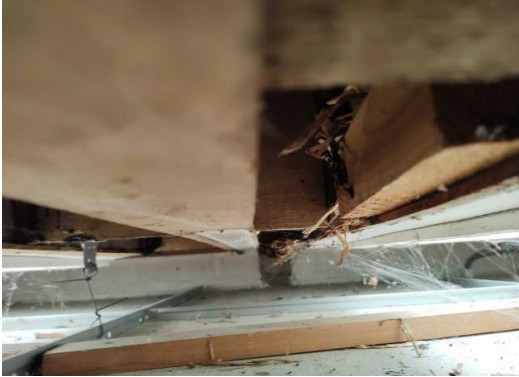
**Item 58 Ref: 22-41633-10**

The stramit & bitumen (debris) (Area: 7 Female WC-Ceiling Void) does not contain asbestos.

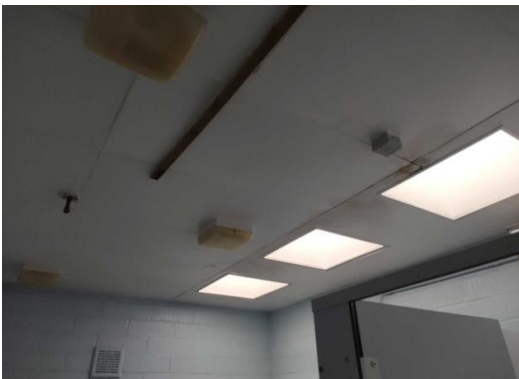
**Item 59 Ref: 22-41633-11**

The ceiling (Textile) (Area: 8 Male WC) contains asbestos.

Any change in appearance should be reported to Property Services.

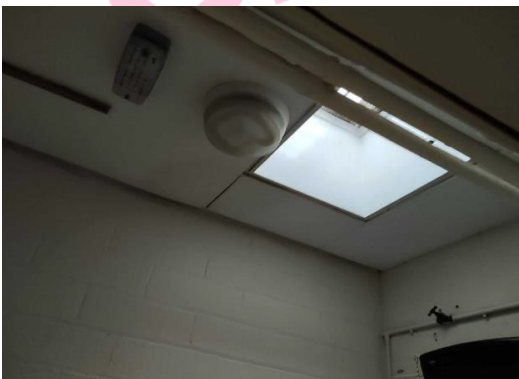
**Item 60 Ref: 22-41633-11**

The ceiling (Textile) (Area: 9 Disabled WC) contains asbestos.

Any change in appearance should be reported to Property Services.

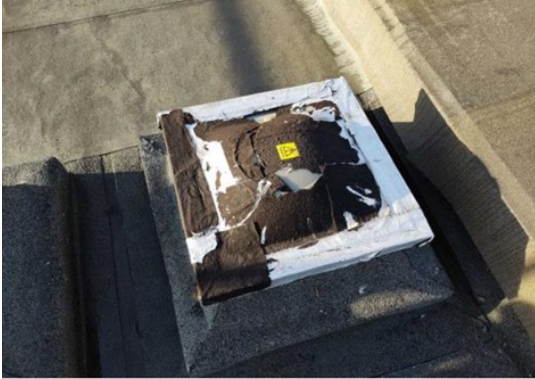
**Item 61 Ref: 22-52159-1**

The bitumen lining to one skylight (external/Roof 1) does not contain asbestos.

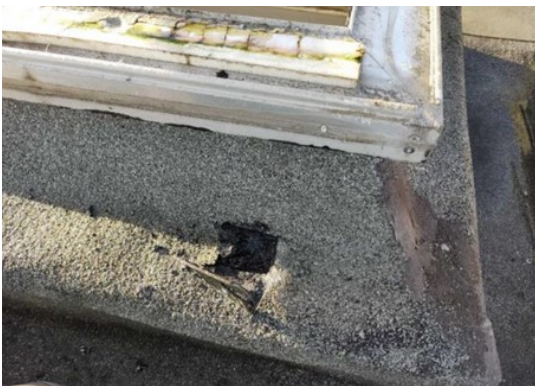
**Item 62 Ref: 22-52159-2**

The bitumen felt roof lining (external/Roof 1) does not contain asbestos.

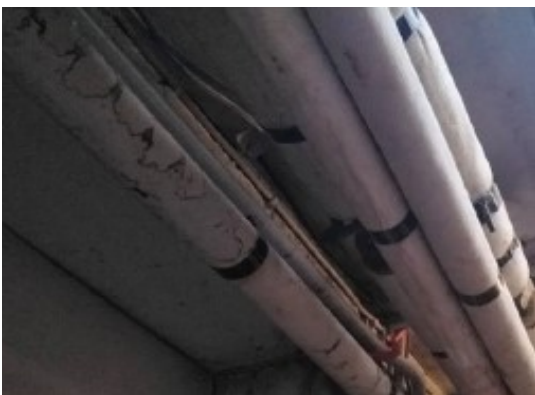
**Item 63 Ref: DC003402**

The pipework insulation in the store cupboards (Room 014/A) does not contain asbestos.

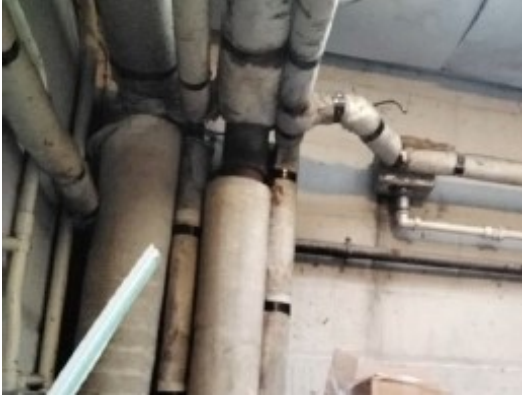
**Item 64 Ref: DC003403**

The pipework insulation in the store cupboards (Room 014/A) does not contain asbestos.

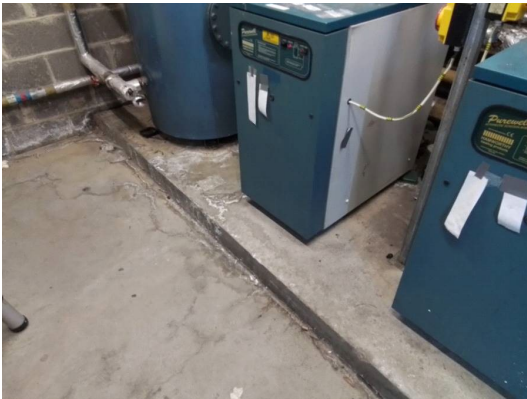
**Item 65 Ref: PZ000776**

The debris to floor (Boiler Room E/001) does not contain asbestos.

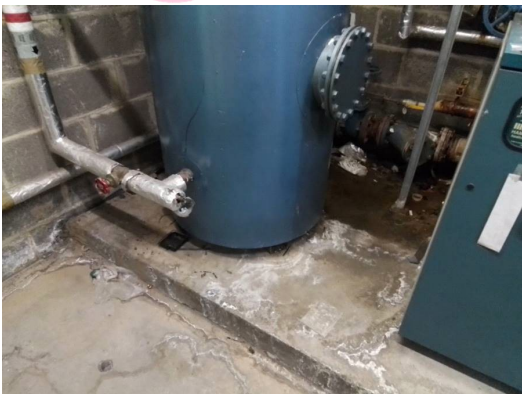
**Item 66 Ref: PZ000778**

The debris (Boiler Room E/001) does not contain asbestos.

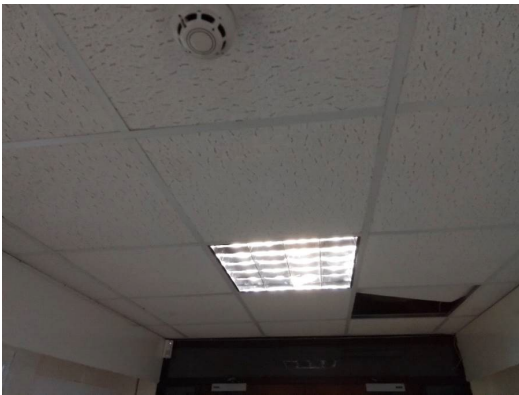
### Item 68 Ref: PZ000781

The debris adhesive to woodwool block (Entrance Hall/Foyer/Lobby G/001) (Older Building – The Oval) does not contain asbestos.

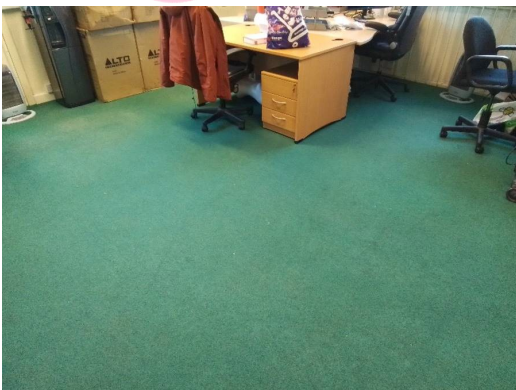
### Item 69 Ref: PZ000782

The floor adhesive (Office G/002) (Older Building -The Oval) contains asbestos.

Any change in appearance should be reported to Property Services.

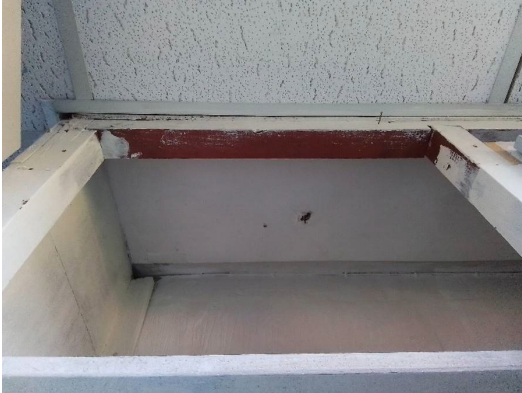
### **Item 73 Ref: PZ000783**

The ceiling within cupboard (Kitchen G/005) (Older Building – The Oval) contains asbestos.

Any change in appearance should be reported to Property Services.

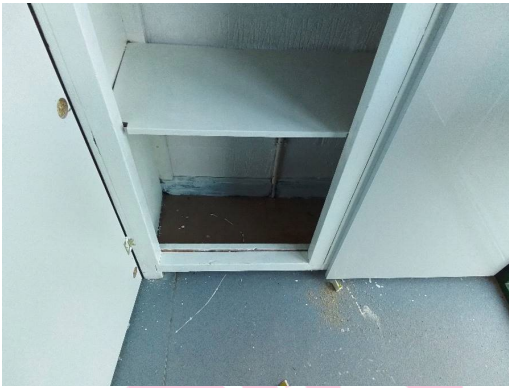
### **Item 74 Ref: PZ000784**

The floor tile with adhesive (Beige) (Kitchen G/005) (Older Building – The Oval) does not contain asbestos.

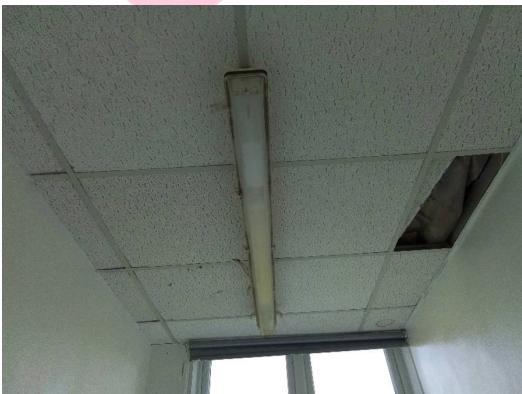
### **Item 75 Ref: As PZ000781**

The debris adhesive to woodwool block (Toilets G/006) (Older Building – The Oval) does not contain asbestos.

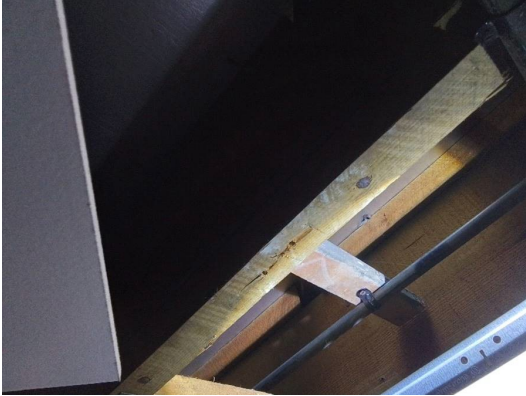
### Item 79 Ref: As PZ000787

The debris to beams nail holes and lying on tiles (Room Large G/012) (Older Building – The Oval) contains asbestos.

Any change in appearance should be reported to Property Services.

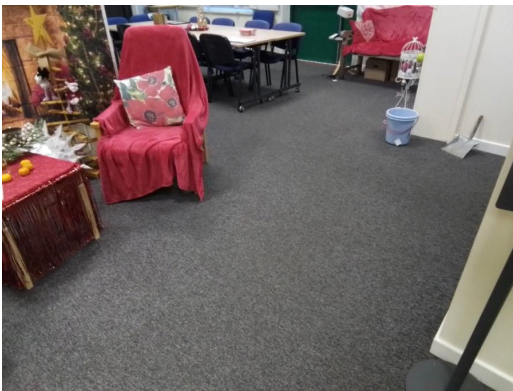
### Item 80 Ref: As PZ000782

The floor adhesive (Room Large G/012) (Older Building – The Oval) contains asbestos.

Any change in appearance should be reported to Property Services.

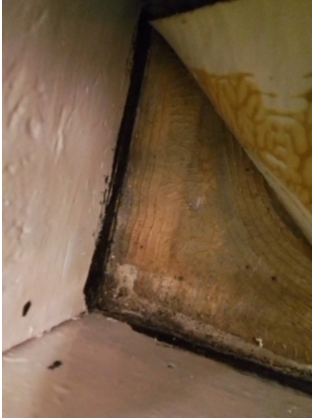
### **Item 82 Ref: As PZ000782**

The floor adhesive (Entrance Hall/Foyer/Lobby G/014) (Older Building – The Oval) contains asbestos.

Any change in appearance should be reported to Property Services.

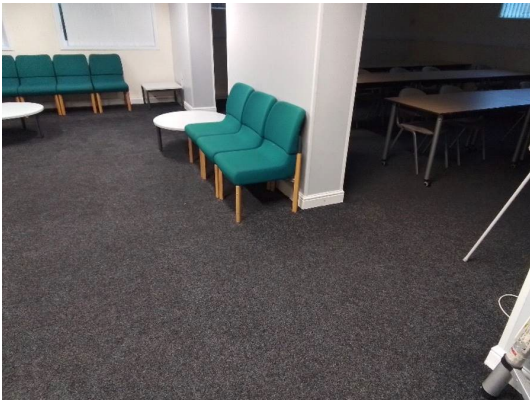
### Item 86 Ref: As PZ000782

The floor adhesive (Room Large G/017) (Older Building – The Oval) contains asbestos.

Any change in appearance should be reported to Property Services.

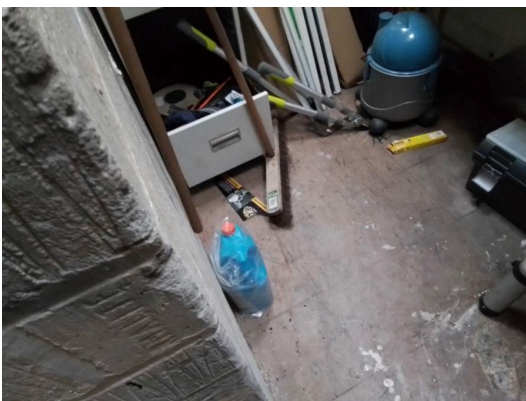
### Item 87 Ref: As PZ000784

The floor tile with adhesive (Beige) (Cupboard Electrical G/018) (Older Building – The Oval) does not contain asbestos.

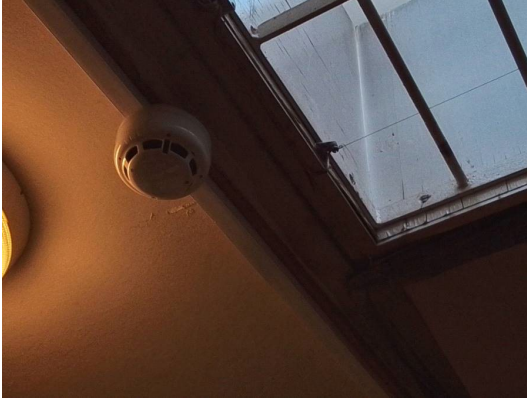
**Item 88 Ref: PZ000788**

The ceiling (Cupboard Electrical G/018) (Older Building – The Oval) contains asbestos.

Any change in appearance should be reported to Property Services.

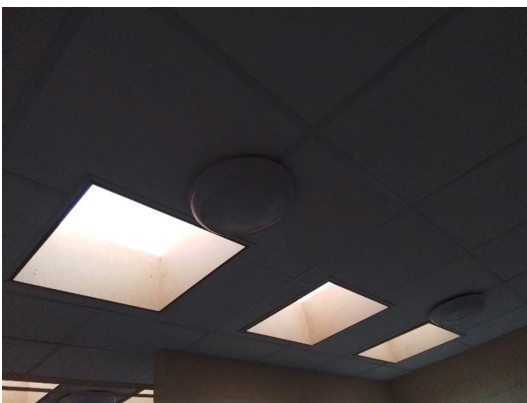
**Item 90 Ref: As PZ000788**

The debris (Female Toilets G/019) (Older Building – The Oval) contains asbestos.

Any change in appearance should be reported to Property Services.

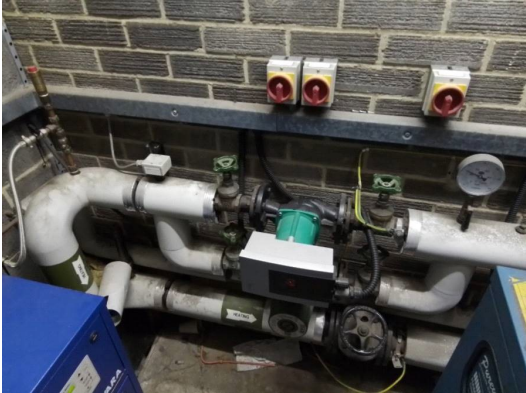
**Item 91 Ref: PZ000789**

The Pipework gaskets (Boiler Room E/001) (Older Building – The Oval) do not contain asbestos.

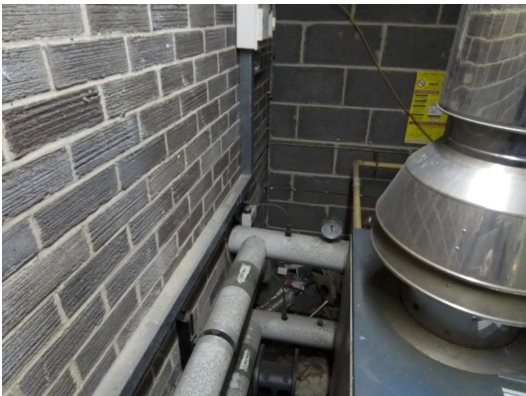
**Item 92 Ref: PZ000790**

The Debris (Boiler Room E/001) (Older Building – The Oval) does not contain asbestos.

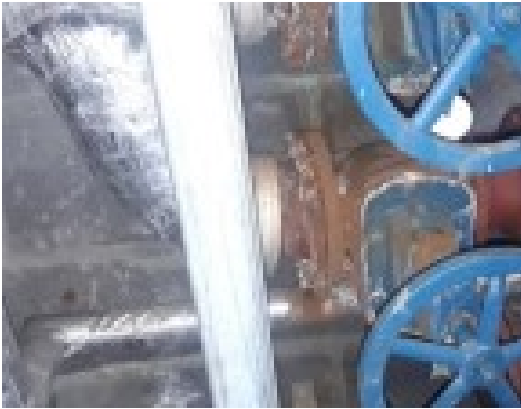
**Item 103 Ref: NZ001266**

The pipework gasket to pipework V6 left side (Boiler Room G/001 – The Oval) does contain asbestos.

Any change in appearance should be reported to Property Services.

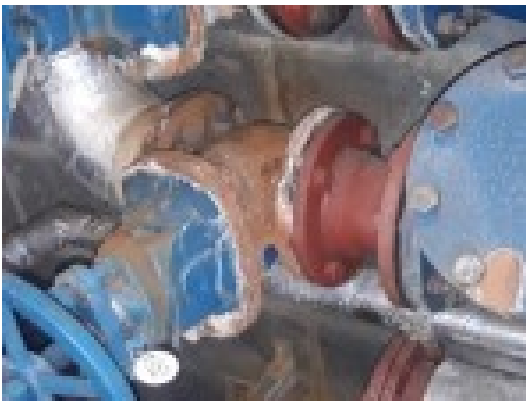
**Item 104 Ref: NZ001267**

The pipework gasket to pipework V6 right side (Boiler Room G/001 – The Oval) does contain asbestos.

Any change in appearance should be reported to Property Services

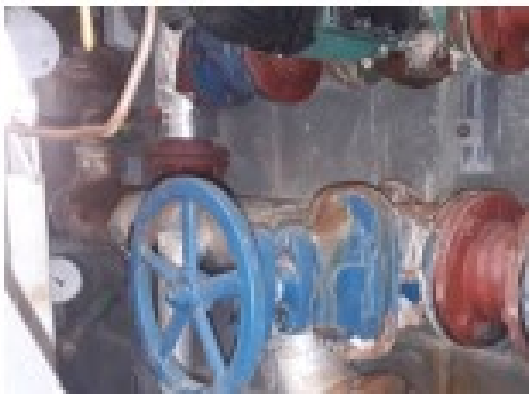
**Item 105 Ref: NZ001268**

The pipework gasket to pipework V8 left side (Boiler Room G/001 – The Oval) does contain asbestos.

Any change in appearance should be reported to Property Services

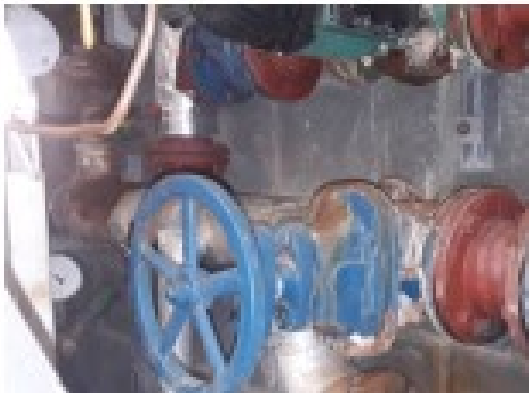
**Item 106 Ref: NZ001269**

The pipework gasket to pipework V8 right side (Boiler Room G/001 – The Oval) does contain asbestos.

Any change in appearance should be reported to Property Services

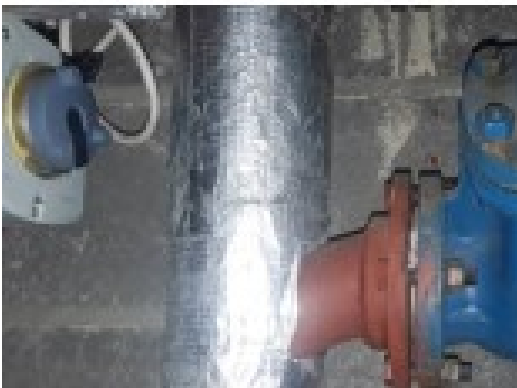
**Item 107 Ref: NZ001270**

The pipework gasket to pipework V12 left side (Boiler Room G/001 – The Oval) does contain asbestos.

Any change in appearance should be reported to Property Services

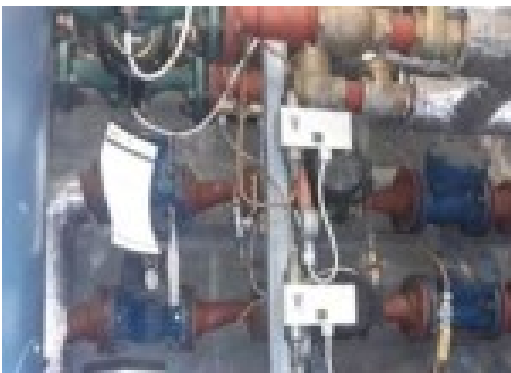
**Item 108 Ref: NZ001271**

The pipework gasket to pipework V12 right side (Boiler Room G/001 – The Oval) does contain asbestos.

Any change in appearance should be reported to Property Services

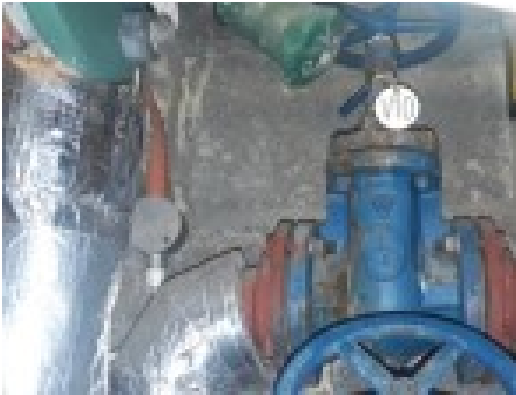
**Item 109 Ref: NZ001272**

The pipework gasket to pipework V10 left side (Boiler Room G/001 – The Oval) does contain asbestos.

Any change in appearance should be reported to Property Services

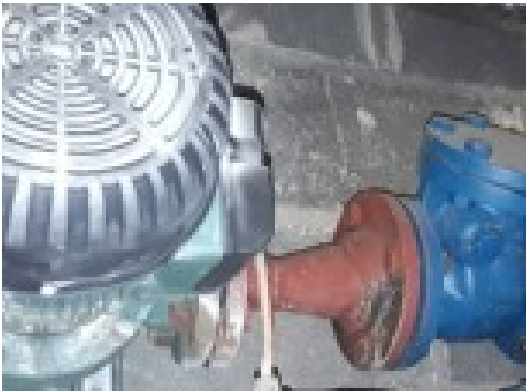
**Item 110 Ref: NZ001273**

The pipework gasket to pipework V10 right side (Boiler Room G/001 – The Oval) does contain asbestos.

Any change in appearance should be reported to Property Services

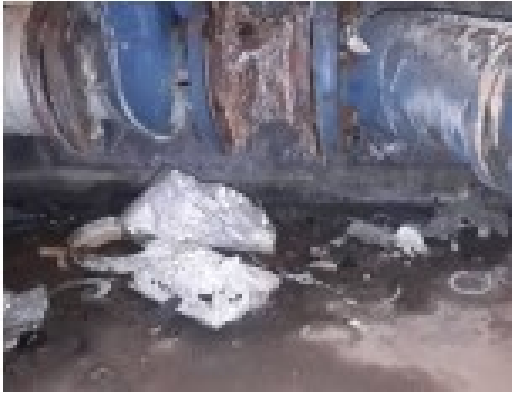
### **Item 112 Ref: NZ001275**

- (Item 111) Ref: NZ001274 – Pipework Gasket to pipework right of V21 rusting black pipework (Boiler Room G/001 The Oval Building) – Removed May 2024
- (Item 112) Ref: NZ001275 – Debris/Residue to floor discarded gaskets within water and insulation (Boiler Room G/001 The Oval Building) – Low Risk

The debris/residue to floor discarded gaskets within water and insulation (Boiler Room G/001 – The Oval) does contain asbestos.

Any change in appearance should be reported to Property Services

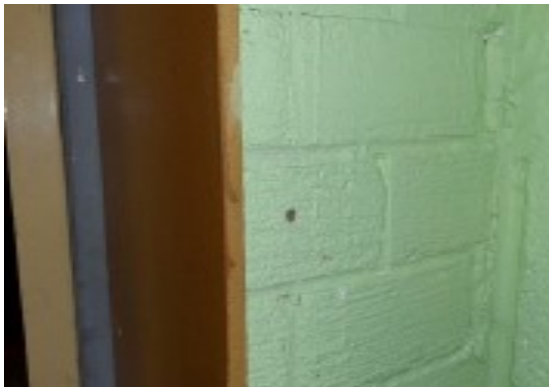
**Item 119 Ref: As RT000804**

The mastic residue to wall beside roller shutter door in Store 1 (G/02) does not contain asbestos.

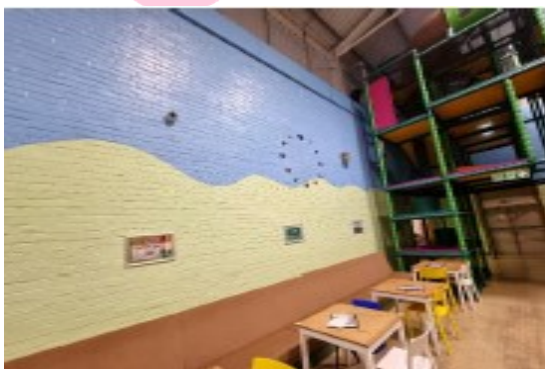
**Item 120 Ref: RT000805**

The paint to walls in soft play (G/03) does not contain asbestos.
