### **ASBESTOS SURVEY REPORT FOR WASHINGTON MILLENIUM CENTRE LIBRARY/THE OVAL, WASHINGTON, NE37 2QD.**

## **Asbestos Register for Washington Millennium Centre, Washington, NE37 2QD**

**Date: 23 July 2025**

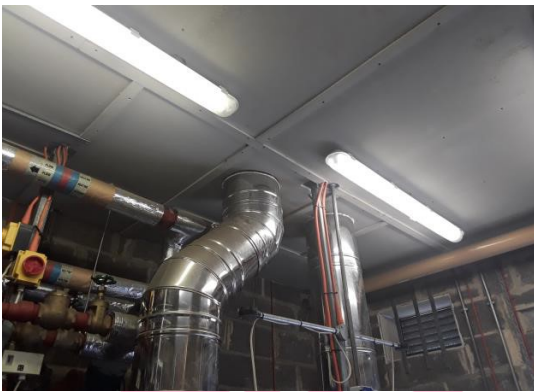
### **Item 41 Ref: 21-35078-4**

The ceiling (Area 36/Boiler Room) does not contain asbestos.

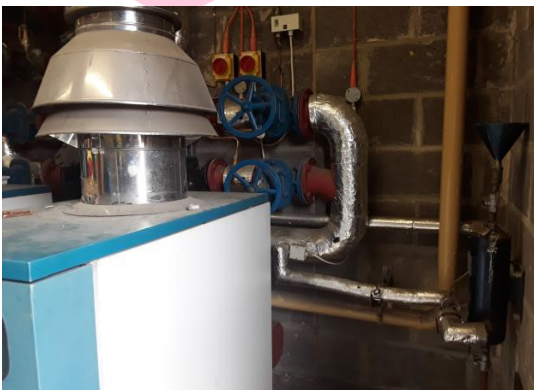
### **Item 42 Ref: 21-35078-5**

The pipe flanges (Area 36/Boiler Room) contain asbestos.

Any change in appearance should be reported to Property Services.

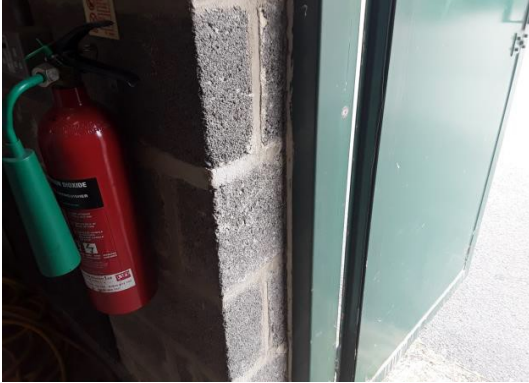
#### **Item 43 Ref: 21-35078-7**

The door frame sealant (Area 36/Boiler Room) does not contain asbestos.

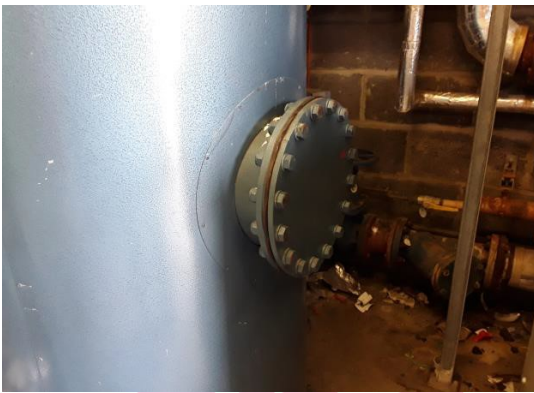
#### **Item 44 Ref: 21-35078-8**

The vessels tank gasket (Area 36/Boiler Room) does not contain asbestos.

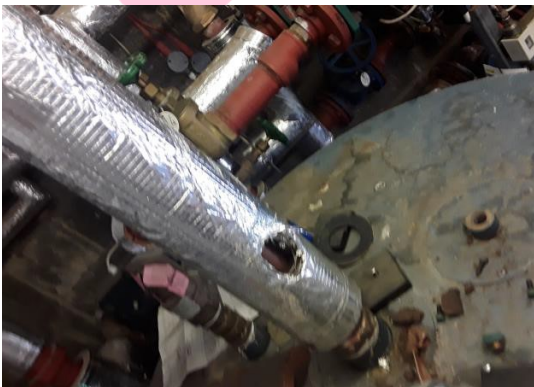
#### **Item 45 Ref: 21-35078-9**

The redundant gaskets on top of tank (Area 36/Boiler Room) do not contain asbestos.

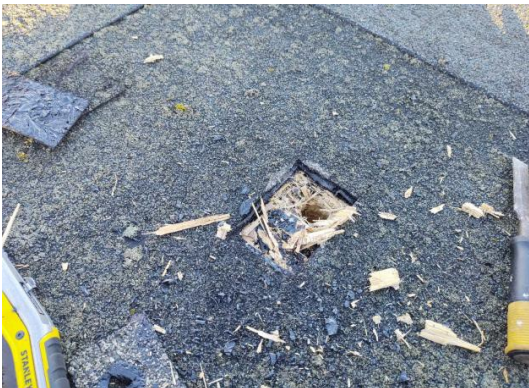
### **Item 50 Ref: 22-41633-3**

The floor - felt roof (Bitumen)  
(Area: 1 Roof 1) does not  
contain asbestos.

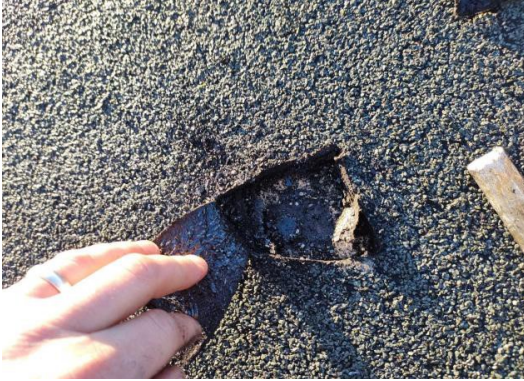
### **Item 52 Ref: 22-41633-5**

The floor - felt roof (Bitumen)  
(Area: 1 Roof 1) does not  
contain asbestos.

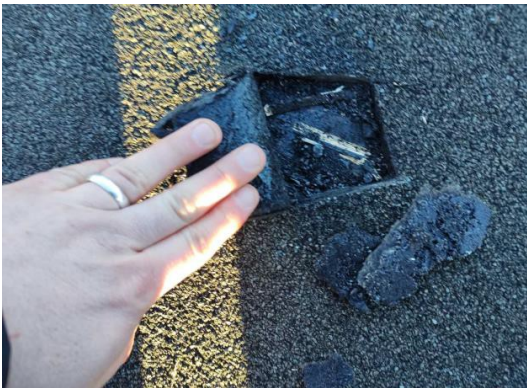
### **Item 53 Ref: 22-41633-6**

The floor - felt roof (Bitumen)  
(Area: 1 Roof 1) does not  
contain asbestos.

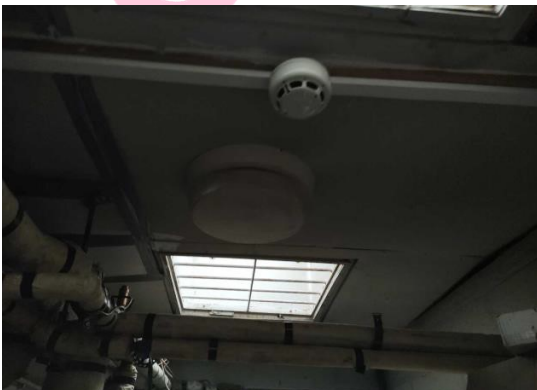
### **Item 57 Ref: 22-41633-11**

The ceiling - paper lined fibreboard ceiling tiles (Textile) (Area: 6 Caretakers Cupboard) contains asbestos.

Any change in appearance should be reported to Property Services.

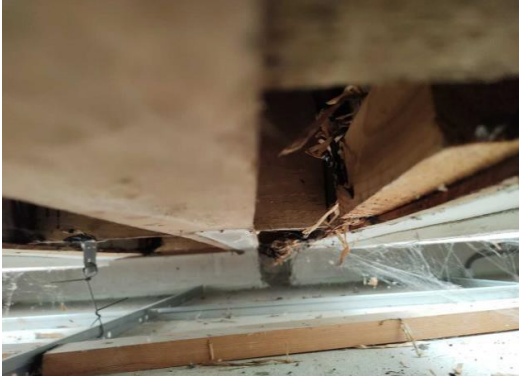
### **Item 58 Ref: 22-41633-10**

The stramit & bitumen (debris) (Area: 7 Female WC-Ceiling Void) does not contain asbestos.

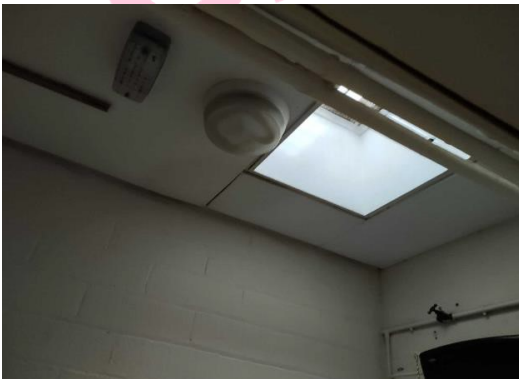
### **Item 60 Ref: 22-41633-11**

The ceiling (Textile) (Area: 9 Disabled WC) contains asbestos.

Any change in appearance should be reported to Property Services.

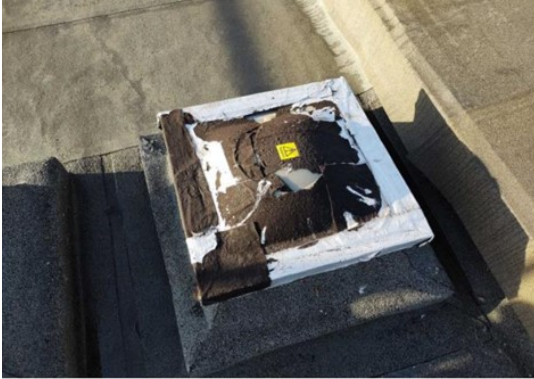
### **Item 61 Ref: 22-52159-1**

The bitumen lining to one skylight (external/Roof 1) does not contain asbestos.

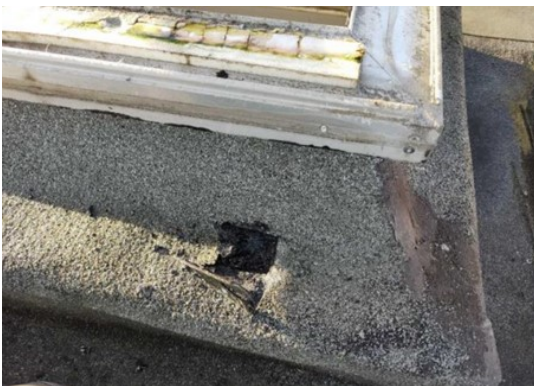
### **Item 62 Ref: 22-52159-2**

The bitumen felt roof lining (external/Roof 1) does not contain asbestos.

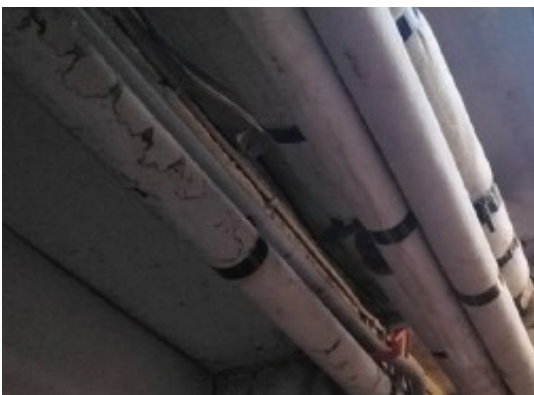
### **Item 63 Ref: DC003402**

The pipework insulation in the store cupboards (Room 014/A) does not contain asbestos.

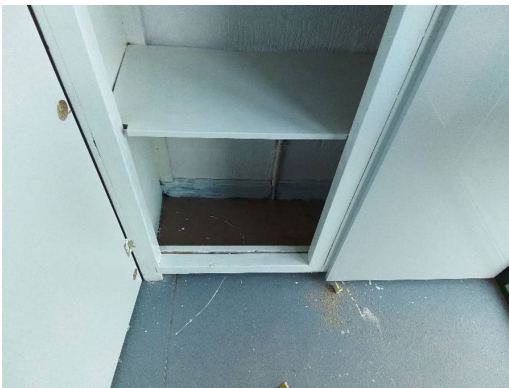
### **Item 74 Ref: PZ000784**

The floor tile with adhesive (Beige) (Kitchen G/005) (Older Building – The Oval) does not contain asbestos.

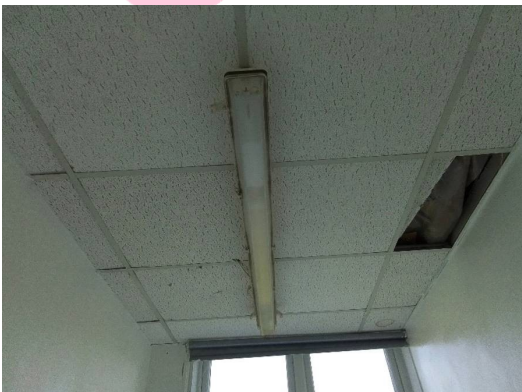
### **Item 75 Ref: As PZ000781**

The debris adhesive to woodwool block (Toilets G/006) (Older Building – The Oval) does not contain asbestos.

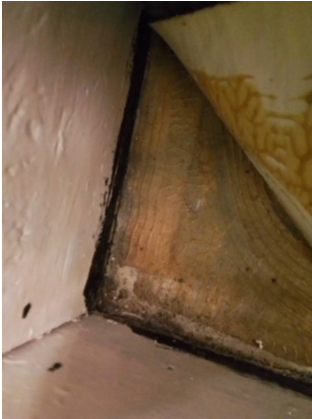
### **Item 82 Ref: As PZ000782**

The floor adhesive (Entrance Hall/Foyer/Lobby G/014) (Older Building – The Oval) contains asbestos.

Any change in appearance should be reported to Property Services.

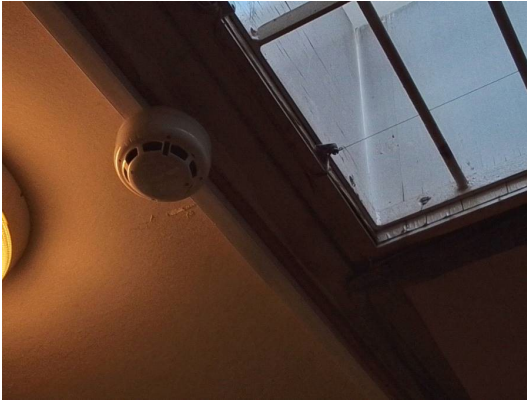
### **Item 88 Ref: PZ000788**

The ceiling (Cupboard Electrical G/018) (Older Building – The Oval) contains asbestos.

Any change in appearance should be reported to Property Services.

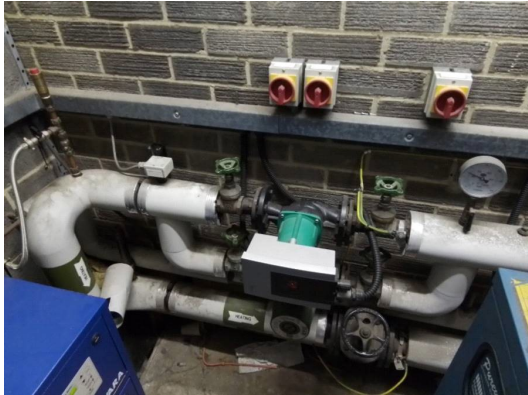
### **Item 91 Ref: PZ000789**

The Pipework gaskets (Boiler Room E/001) (Older Building – The Oval) do not contain asbestos.

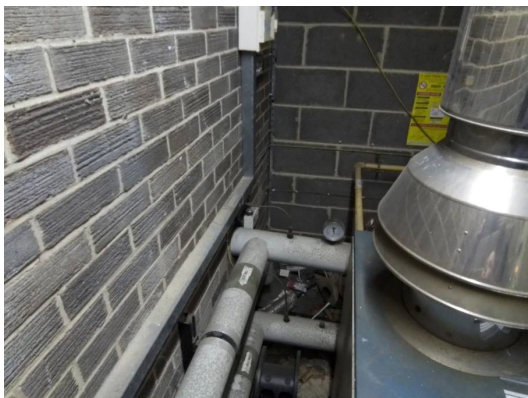
### **Item 92 Ref: PZ000790**

The Debris (Boiler Room E/001) (Older Building – The Oval) does not contain asbestos.

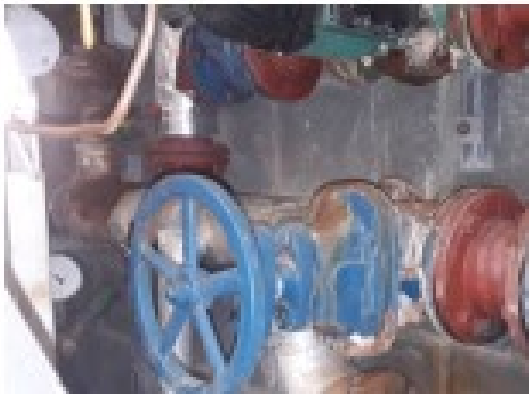
### **Item 106 Ref: NZ001269**

The pipework gasket to pipework V8 right side (Boiler Room G/001 – The Oval) does contain asbestos.

Any change in appearance should be reported to Property Services

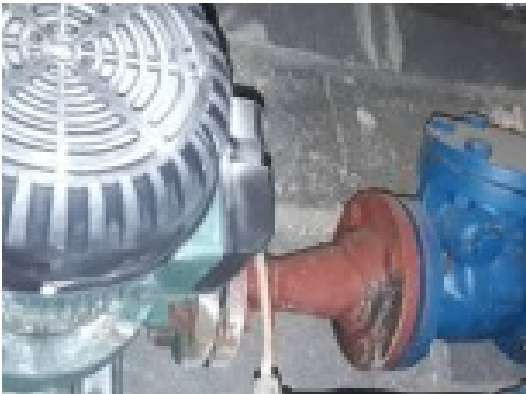
### **Item 110 Ref: NZ001273**

The pipework gasket to pipework V10 right side (Boiler Room G/001 – The Oval) does contain asbestos.

Any change in appearance should be reported to Property Services
