ASBESTOS SURVEY REPORT FOR WASHINGTON MILLENIUM CENTRE LIBRARY/THE OVAL, WASHINGTON, NE37 2QD.

Asbestos Register for

Washington Millennium Centre, Washington, NE37 2QD

Date: 19 June 2025

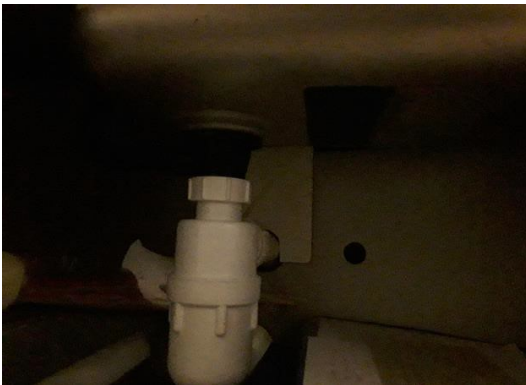
Item 38 Ref: 21-35078-3

The sink pad (Area 29/Meeting Room Kitchen) does not contain asbestos.

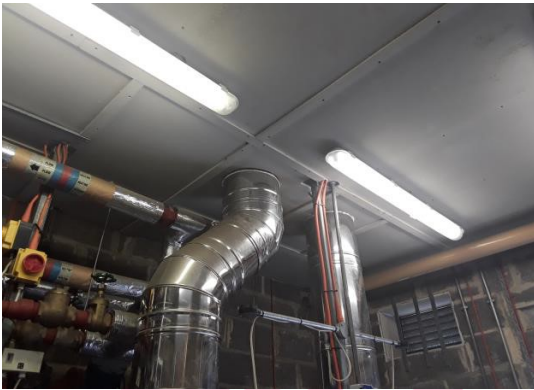
Item 41 Ref: 21-35078-4

The ceiling (Area 36/Boiler Room) does not contain asbestos.

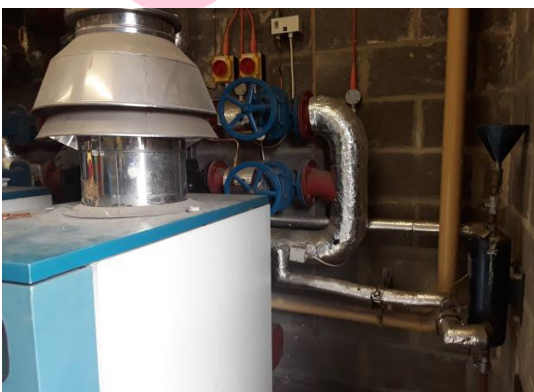
Item 42 Ref: 21-35078-5

The pipe flanges (Area 36/Boiler Room) contain asbestos.

Any change in appearance should be reported to Property Services.

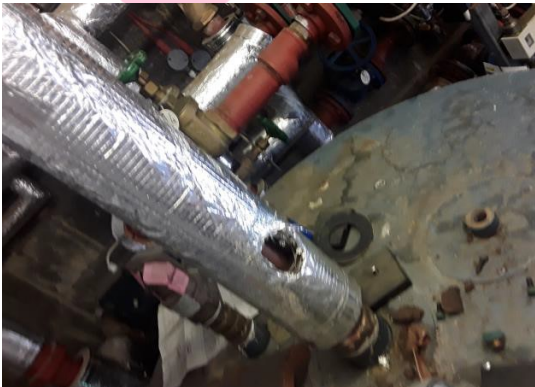
Item 45 Ref: 21-35078-9

The redundant gaskets on top of tank (Area 36/Boiler Room) do not contain asbestos.

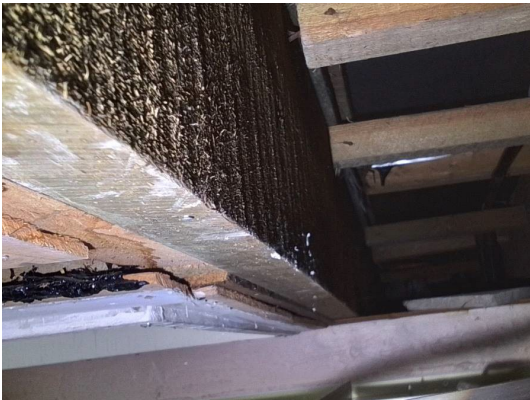
Item 77 Ref: As PZ000785

The debris within nail holes (Toilets G/011) (Older Building – The Oval) contains asbestos.

Any change in appearance should be reported to Property Services.

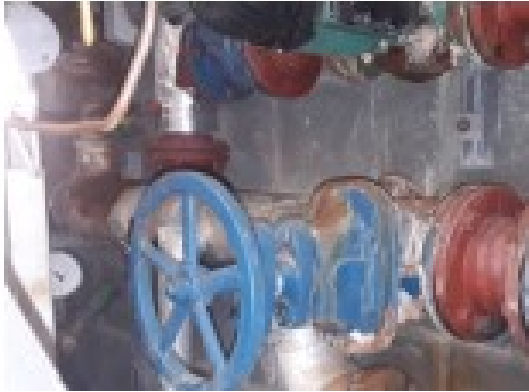
Item 106 Ref: NZ001269

The pipework gasket to pipework V8 right side (Boiler Room G/001 – The Oval) does contain asbestos.

Any change in appearance should be reported to Property Services

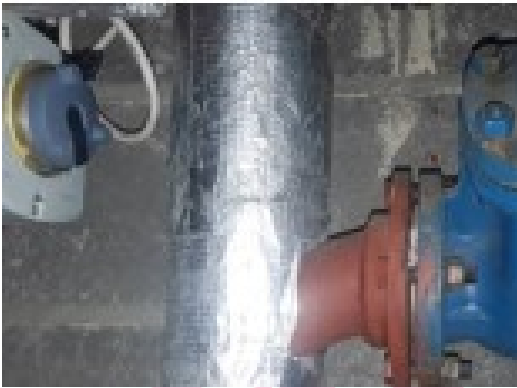
Item 107 Ref: NZ001270

The pipework gasket to pipework V12 left side (Boiler Room G/001 – The Oval) does contain asbestos.

Any change in appearance should be reported to Property Services
