ASBESTOS SURVEY REPORT FOR SOUTH HYLTON HOUSE, SOUTH HYLTON BANK, SR4 0JL.

**South Hylton House, South Hylton Bank, SR4 0JL**

**Date: 24 March 2026**

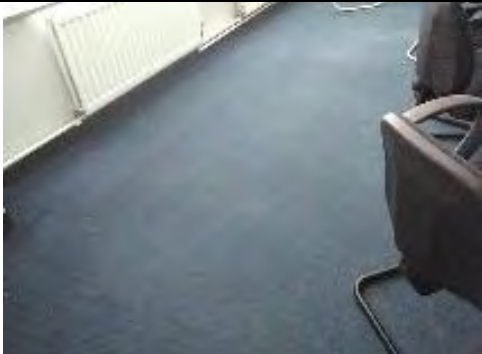
67.	As KX000907	Floor adhesive residue under floor covering	Block 1, Ground Floor, Office (Room G/023)	Contains asbestos - Any change in its appearance should be recorded and passed to Property Services.

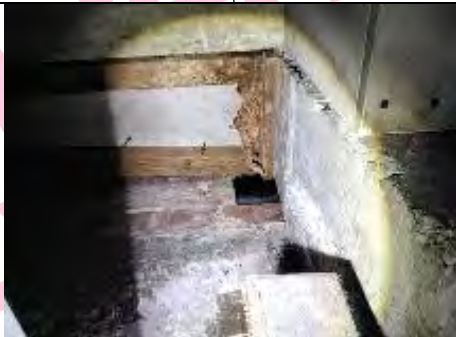
68.	As KX000906	Ceiling void debris to stench pipe penetration	Block 1, Ground Floor, Office (Room G/023)	Contains asbestos - Any change in its appearance should be recorded and passed to Property Services.

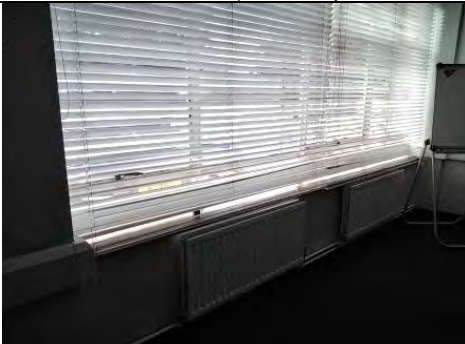
69.	As KX000898	Window Putty seal	Block 1, Ground Floor, Office (Room G/023)	Does not contain asbestos.

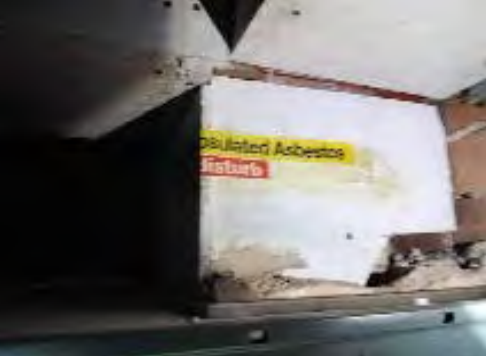
70.	As KX000897	Ceiling void column cladding	Block 1, Ground Floor, Office (Room G/023)	Contains asbestos - Any change in its appearance should be recorded and passed to Property Services.

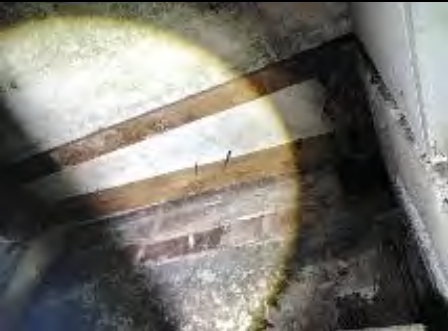
71.	KX000908	Ceiling void ceiling above possible shuttering to outer left hand corner adjacent window	Block 1, Ground Floor, Office (Room G/023)	Contains asbestos - Any change in its appearance should be recorded and passed to Property Services.

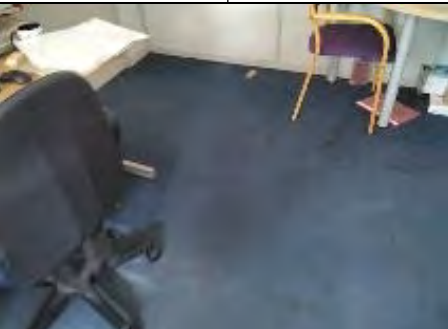
72.	As KX000907	Floor adhesive residue under floor covering	Block 1, Ground Floor, Office (Room G/024)	Contains asbestos - Any change in its appearance should be recorded and passed to Property Services.

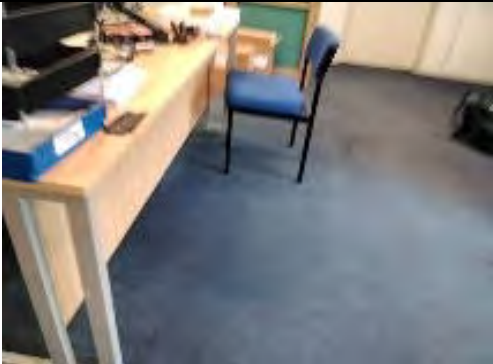
76.	As KX000907	Floor adhesive residue under floor covering	Block 1, Ground Floor, Large Office (Room G/025)	Contains asbestos - Any change in its appearance should be recorded and passed to Property Services.

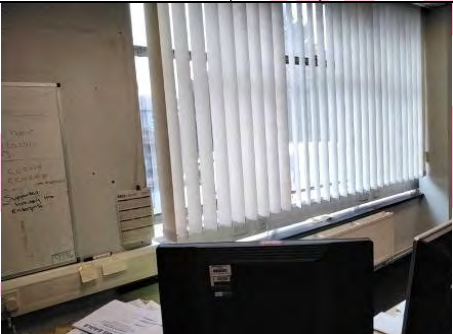
77.	As KX000898	Window Putty seal	Block 1, Ground Floor, Large Office (Room G/025)	Does not contain asbestos.

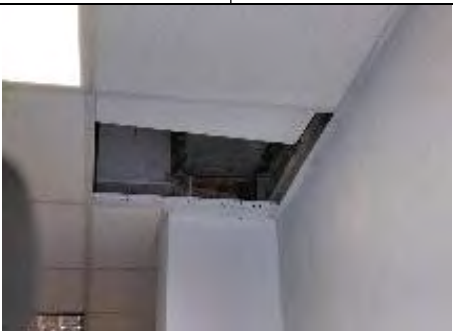
78.	As KX000897	Ceiling void column cladding remnants	Block 1, Ground Floor, Large Office (Room G/025)	Contains asbestos - Any change in its appearance should be recorded and passed to Property Services.

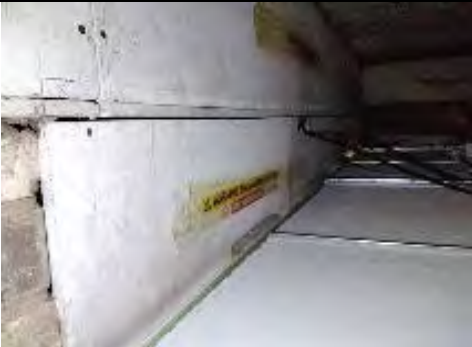
79.	As KX000893	Ceiling Void Window Header Panel	Block 1, Ground Floor, Large Office (Room G/025)	Contains asbestos - Any change in its appearance should be recorded and passed to Property Services.

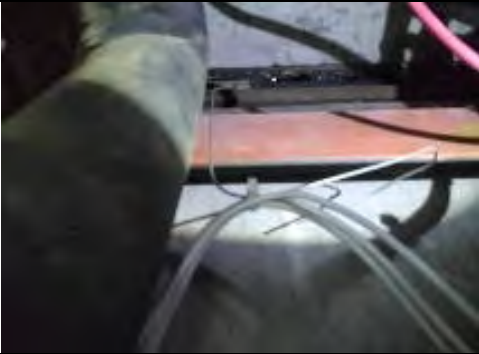
85.	As KX000906	Ceiling void debris to timber frame	Block 1, Ground Floor, Corridor (Room G/028)	Contains asbestos - Any change in its appearance should be recorded and passed to Property Services.

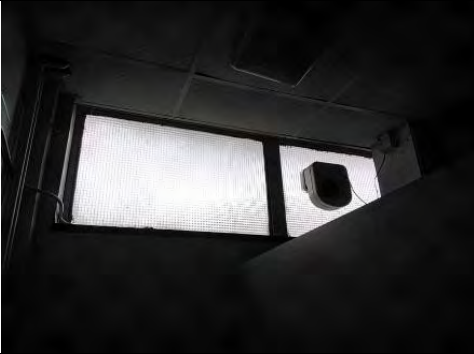
88.	As KX000912	Ceiling void beam cladding	Block 1, Ground Floor, Toilets Female (Room G/030)	Does not contain asbestos.
No photographic Evidence				
89.	As KX000903	Window putty/seal	Block 1, Ground Floor, Toilets Female (Room G/030)	Does not contain asbestos.

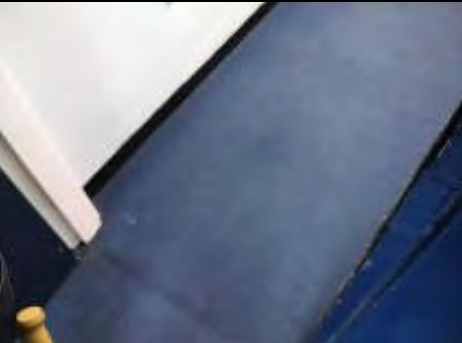
91.	As KX000907	Floor adhesive residue under floor covering	Block 1, Ground Floor, Corridor (Room G/031)	Contains asbestos - Any change in its appearance should be recorded and passed to Property Services.

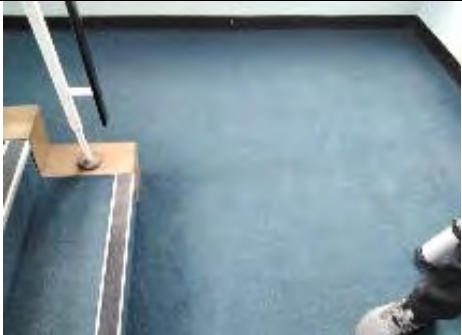
93.	As KX000907	Floor adhesive residue under floor covering	Block 1, Ground Floor, Stairwell/Staircase (Room G/032)	Contains asbestos - Any change in its appearance should be recorded and passed to Property Services.

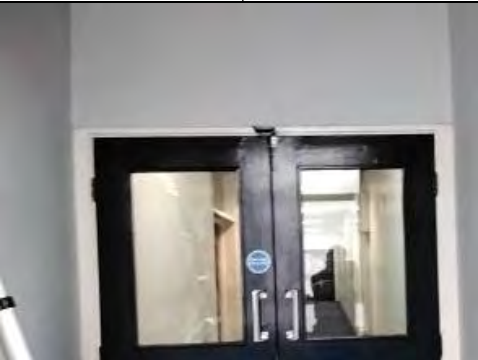
94.	As KX000914	Door window beading	Block 1, Ground Floor, Stairwell/Staircase (Room G/032)	Does not contain asbestos.

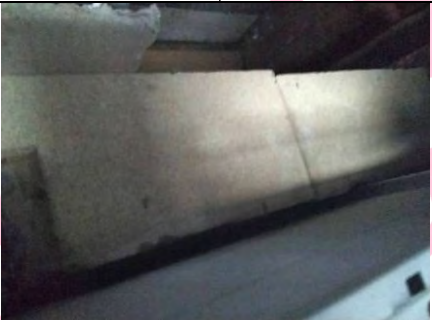
95.	As KX000912	Ceiling void beam cladding	Block 1, Ground Floor, Stairwell/Staircase (Room G/032)	Does not contain asbestos.

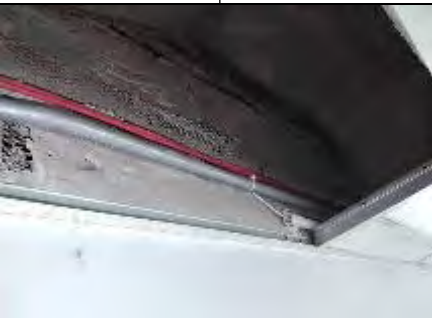
96.	As KX000906	Wall lining visible in ceiling void	Block 1, Ground Floor, Stairwell/Staircase (Room G/032)	Contains asbestos - Any change in its appearance should be recorded and passed to Property Services.

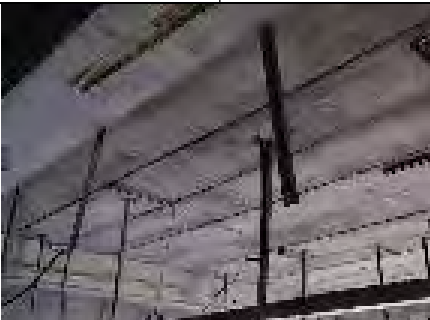
97.	As KX000894	Ceiling void beam cladding	Block 1, Ground Floor, Store Room Ceiling void inspected only (Room G/033)	Contains asbestos - Any change in its appearance should be recorded and passed to Property Services.

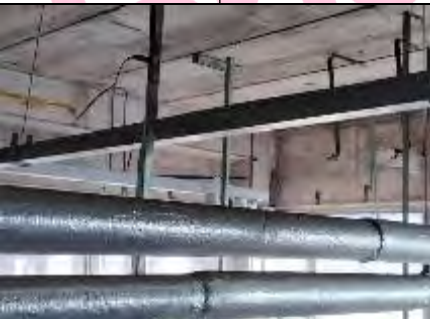
98.	As KX000897	Ceiling void column cladding	Block 1, Ground Floor, Store Room Ceiling void inspected only (Room G/033)	Contains asbestos - Any change in its appearance should be recorded and passed to Property Services.

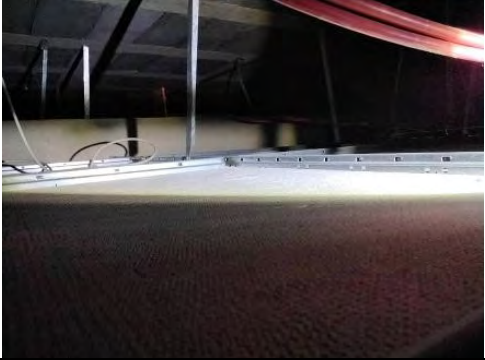
100.	As KX000912	Ceiling void beam cladding	Block 1, Ground Floor, Store Room (Room G/034)	Does not contain asbestos.

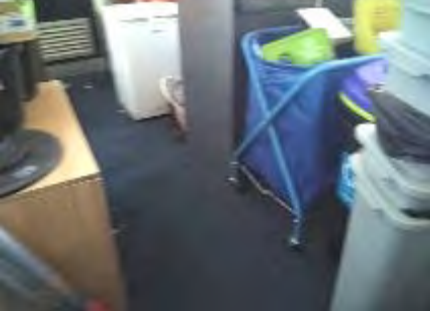
101.	As KX000907	Floor adhesive residue under floor covering	Block 1, Ground Floor, Store Room (Room G/034)	Contains asbestos - Any change in its appearance should be recorded and passed to Property Services.

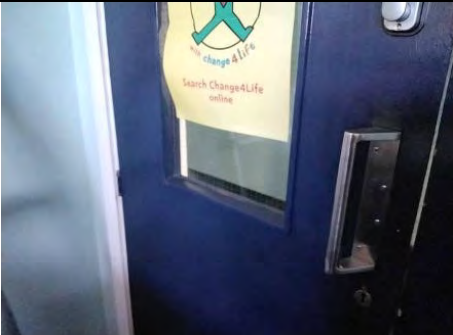
102.	As KX000914	Door window beading	Block 1, Ground Floor, Store Room (Room G/034)	Does not contain asbestos.

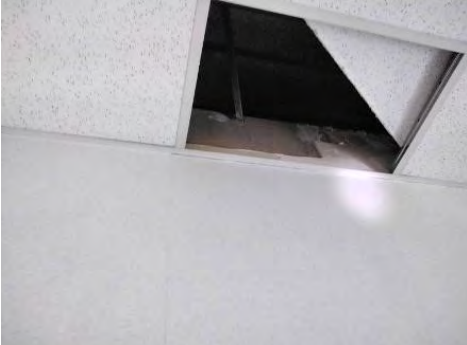
103.	As KX000912	Ceiling void beam cladding	Block 1, Ground Floor, Large Office (Room G/035)	Does not contain asbestos.

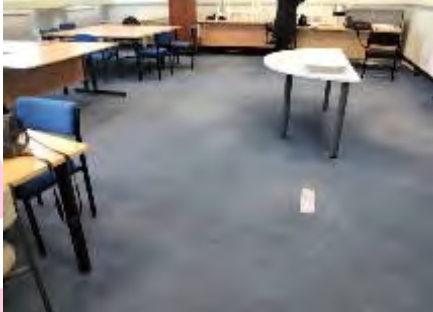
104.	As KX000907	Floor adhesive residue under floor covering	Block 1, Ground Floor, Large Office (Room G/035)	Contains asbestos - Any change in its appearance should be recorded and passed to Property Services.

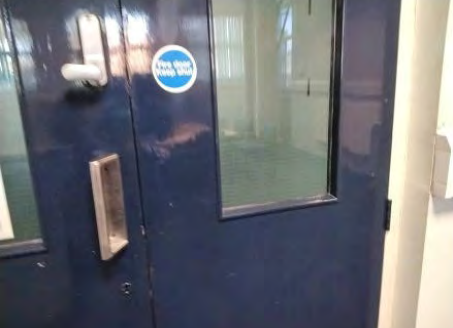
105.	As KX000914	Door window beading	Block 1, Ground Floor, Large Office (Room G/035)	Does not contain asbestos.

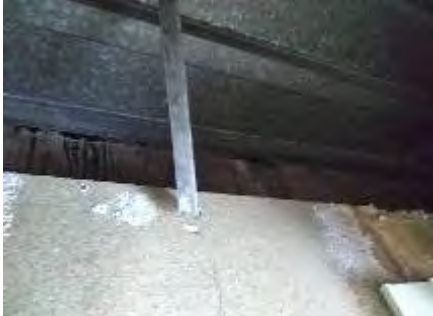
106.	As KX000906	Ceiling void debris to stench pipe penetration	Block 1, Ground Floor, Large Office (Room G/035)	Contains asbestos - Any change in its appearance should be recorded and passed to Property Services.

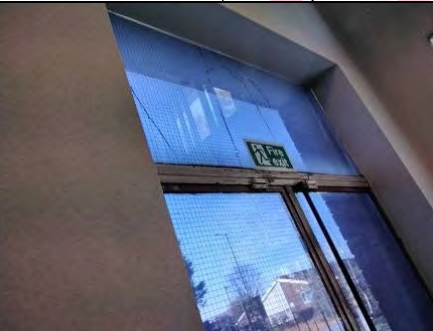
107.	KX000898	Window Putty/seal	Block 1, Ground Floor, Large Office (Room G/035)	Does not contain asbestos.

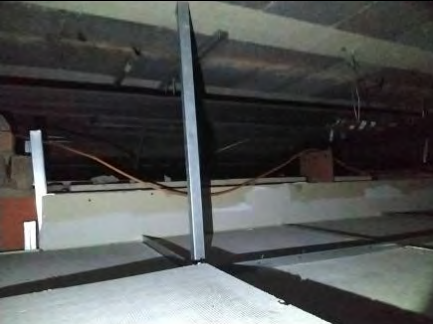
108.	As KX000912	Ceiling void beam cladding	Block 1, Ground Floor, Kitchen (Room G/036)	Does not contain asbestos.

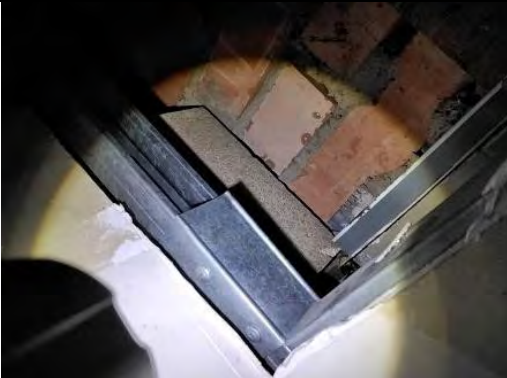
112.	KX000916	Wall putty to column	Block 1, Ground Floor, Kitchen (Room G/036)	Does not contain asbestos.

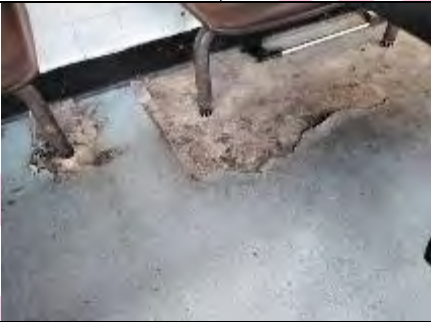
113.	KX000917	Floor adhesive residue under lino	Block 1, Ground Floor, Staff Room (Room G/037)	Contains asbestos - Any change in its appearance should be recorded and passed to Property Services.

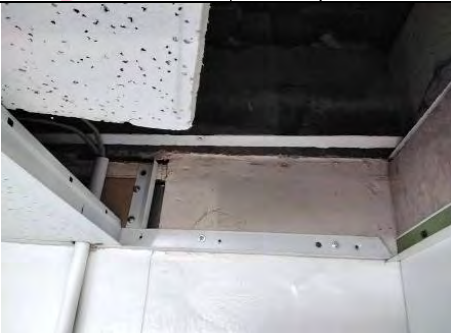
114.	KX000918	Ceiling void debris to upper ceiling grid	Block 1, Ground Floor, Staff Room (Room G/037)	Does not contain asbestos.

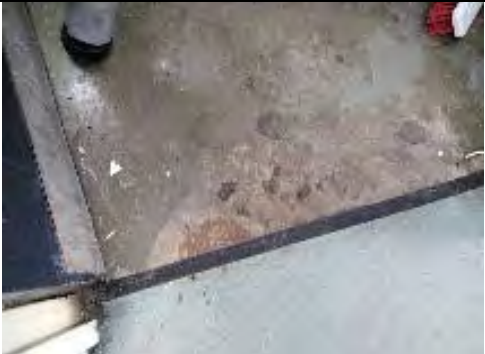
118.	As KX000917	Floor adhesive residue under lino	Block 1, Ground Floor, Tank Room (Room G/038)	Contains asbestos - Any change in its appearance should be recorded and passed to Property Services.

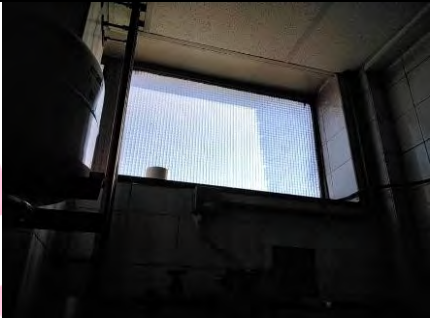
119.	As KX000903	Window putty/seal	Block 1, Ground Floor, Tank Room (Room G/038)	Does not contain asbestos.

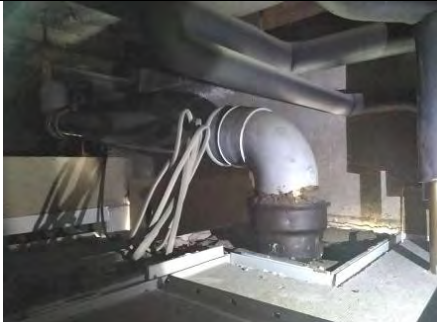
120.	KX000919	Pipe joints caulking/packing to metal/plastic	Block 1, Ground Floor, Tank Room (Room G/038)	Does not contain asbestos.

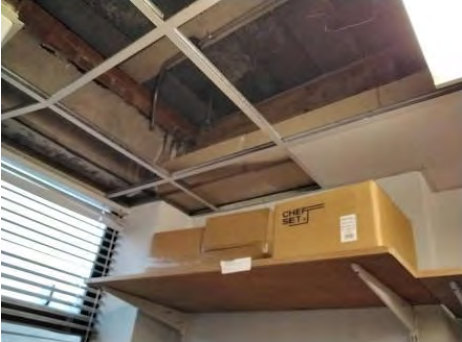
121.	As KX000912	Ceiling void beam cladding	Block 1, Ground Floor, Store Room (Room G/039)	Does not contain asbestos.

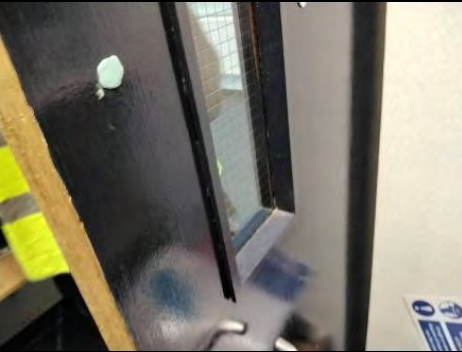
122.	As KX000914	Door window beading	Block 1, Ground Floor, Store Room (Room G/039)	Does not contain asbestos.

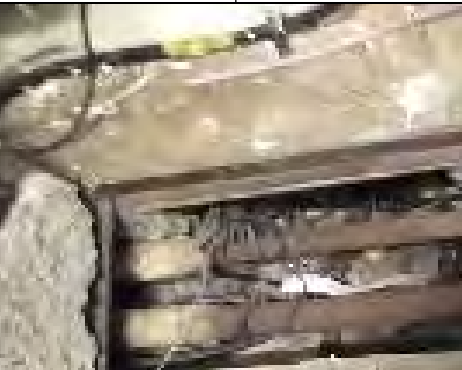
123.	KX000936	Floor void duct debris	Block 1, Ground Floor, Hub/Network Room (Room G/040)	Contains asbestos - Any change in its appearance should be recorded and passed to Property Services.

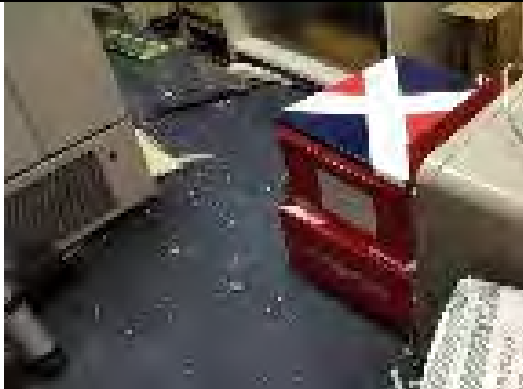
124.	As KX000936	Floor tile (under floor covering)	Block 1, Ground Floor, Hub/Network Room (Room G/040)	Contains asbestos - Any change in its appearance should be recorded and passed to Property Services.

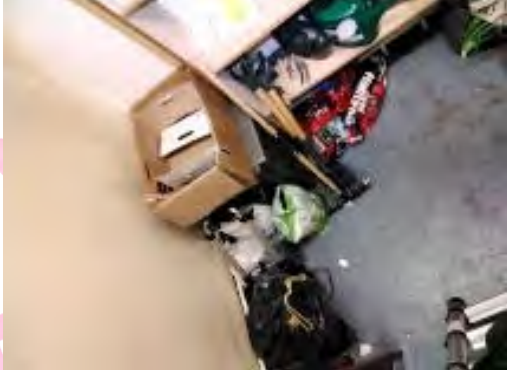
129.	KX000904	Boxing vertical adhesive residue under floor covering	Block 1, Ground Floor, Storage Area (Room G/042)	Does not contain asbestos.

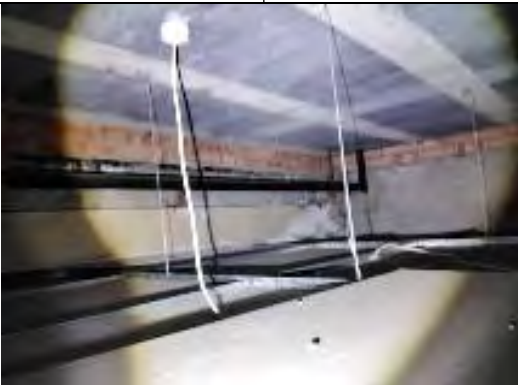
131.	KX000928	Ceiling void beam cladding	Block 1, First Floor, Landing within Stairwell (Room 1/001)	Contains asbestos - Any change in its appearance should be recorded and passed to Property Services.

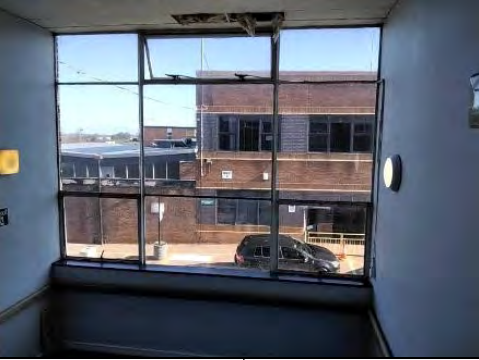
134.	As KX000892	Floor screed to stairs	Block 1, First Floor, Landing within Stairwell (Room 1/001)	Contains asbestos - Any change in its appearance should be recorded and passed to Property Services.

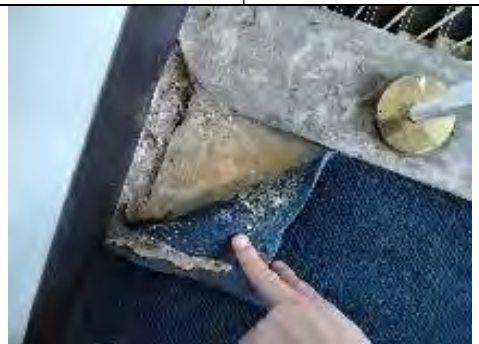
135.	KX000930	Floor screed under carpet	Block 1, First Floor, Landing within Stairwell (Room 1/001)	Contains asbestos - Any change in its appearance should be recorded and passed to Property Services.

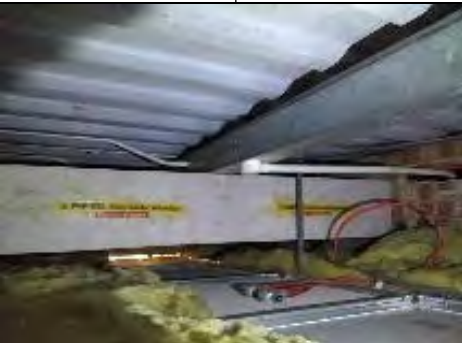
136.	As KX000928	Ceiling void beam cladding x4	Block 1, First Floor, Corridor (Room 1/002)	Contains asbestos - Any change in its appearance should be recorded and passed to Property Services.

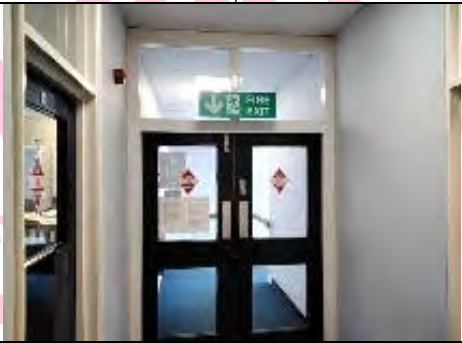
137.	As KX000929	Door window beading including to header	Block 1, First Floor, Corridor (Room 1/002)	Contains asbestos - Any change in its appearance should be recorded and passed to Property Services.

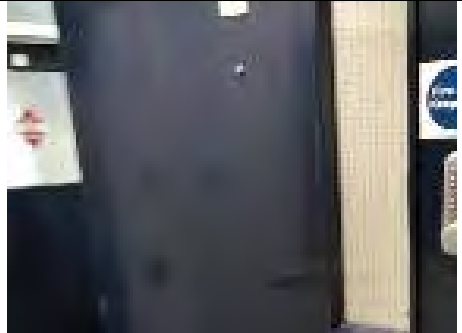
138.	As KX000929	Door window beading including to header	Block 1, First Floor, Office (Room 1/003)	Contains asbestos - Any change in its appearance should be recorded and passed to Property Services.

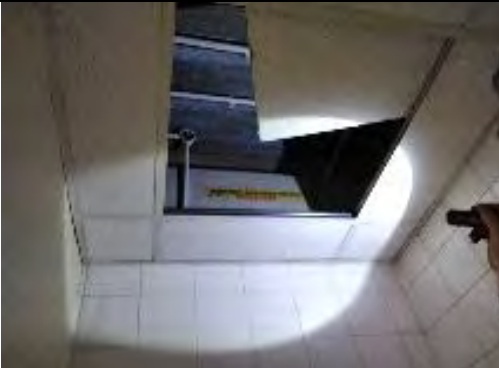
142.	As KX000928	Ceiling void beam cladding	Block 1, First Floor, Kitchen (Room 1/004)	Contains asbestos - Any change in its appearance should be recorded and passed to Property Services.

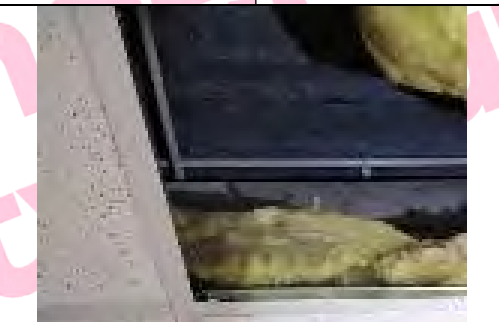
143.	As KX000928	Ceiling void beam cladding	Block 1, First Floor, Hallway/passageway to female toilets (Room 1/005)	Contains asbestos - Any change in its appearance should be recorded and passed to Property Services.

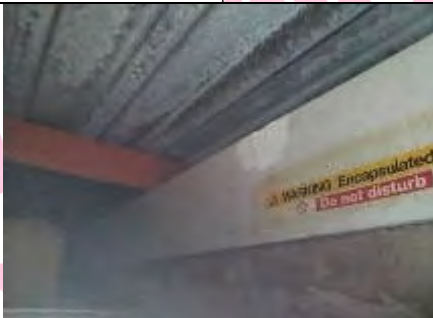
149.	As KX000928	Ceiling void beam cladding x 2	Block 1, First Floor, Store Room (Room 1/007)	Contains asbestos - Any change in its appearance should be recorded and passed to Property Services.

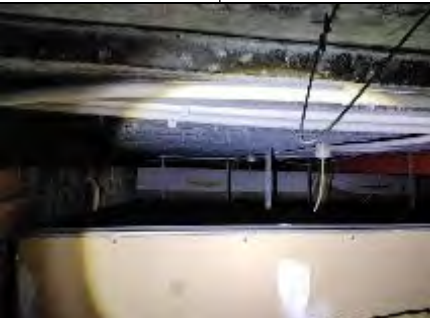
151.	As KX000928	Ceiling void beam cladding	Block 1, First Floor, Office ceiling void from adjacent room (Room 1/008)	Contains asbestos - Any change in its appearance should be recorded and passed to Property Services.

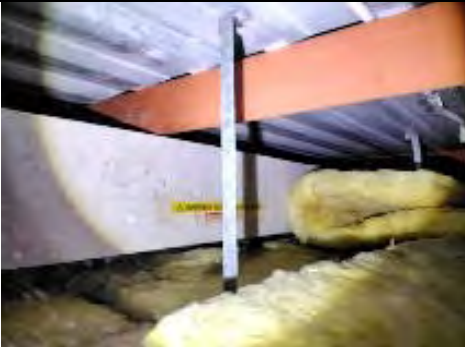
157.	As KX000928	Ceiling void beam cladding	Block 1, First Floor, Office (Room 1/010)	Contains asbestos - Any change in its appearance should be recorded and passed to Property Services.

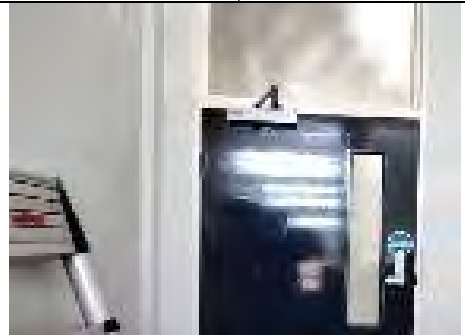
159.	As KX000929	Door window beading including to header	Block 1, First Floor, Office (Room 1/010)	Contains asbestos - Any change in its appearance should be recorded and passed to Property Services.

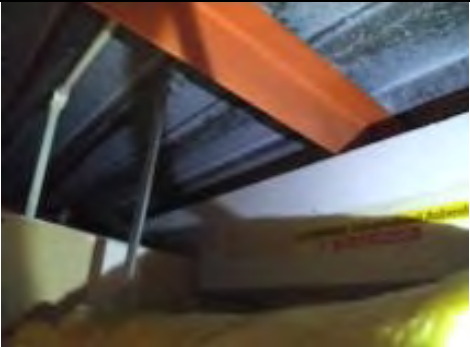
160.	As KX000928	Ceiling void beam cladding	Block 1, First Floor, Store Room (Room 1/011)	Contains asbestos - Any change in its appearance should be recorded and passed to Property Services.

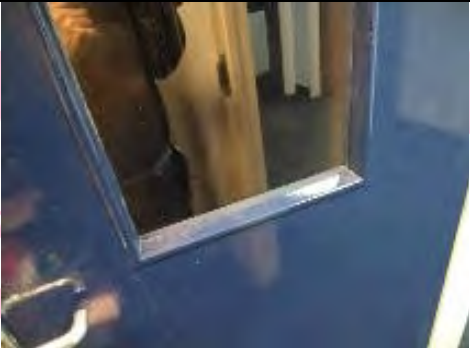
161.	As KX000929	Door window beading including to header	Block 1, First Floor, Store Room (Room 1/011)	Contains asbestos - Any change in its appearance should be recorded and passed to Property Services.

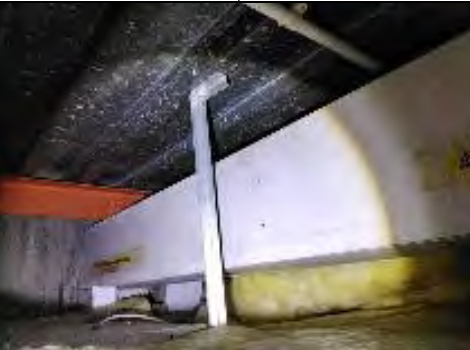
162.	As KX000928	Ceiling void beam cladding	Block 1, First Floor, Office (Room 1/012)	Contains asbestos - Any change in its appearance should be recorded and passed to Property Services.

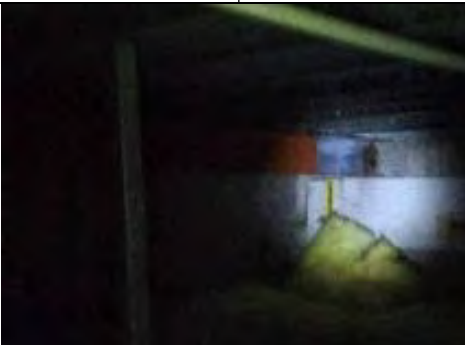
169.	As KX000928	Ceiling void column cladding	Block 1, First Floor, Office Small (Room 1/014)	Contains asbestos - Any change in its appearance should be recorded and passed to Property Services.

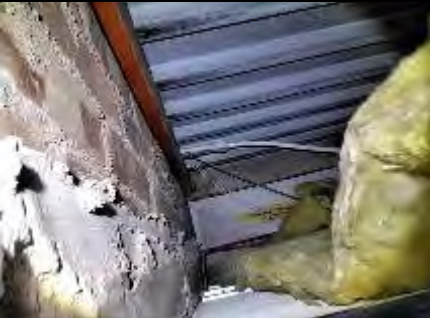
172.	As KX000928	Ceiling void beam cladding	Block 1, First Floor, Hallway/passageway (Room 1/016)	Contains asbestos - Any change in its appearance should be recorded and passed to Property Services.

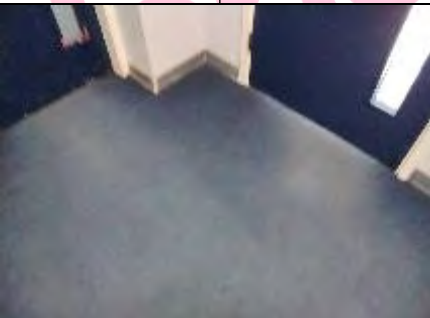
173.	KX000934	Floor screed including skirting	Block 1, First Floor, Hallway/passageway (Room 1/016)	Contains asbestos - Any change in its appearance should be recorded and passed to Property Services.

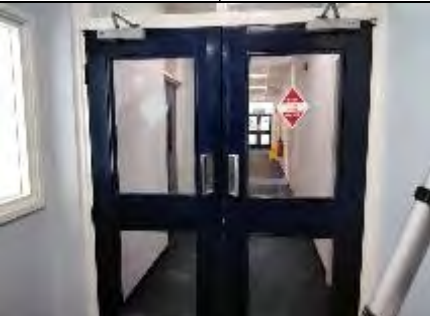
174.	As KX000929	Door window beading including to header panels	Block 1, First Floor, Hallway/passageway (Room 1/016)	Contains asbestos - Any change in its appearance should be recorded and passed to Property Services.

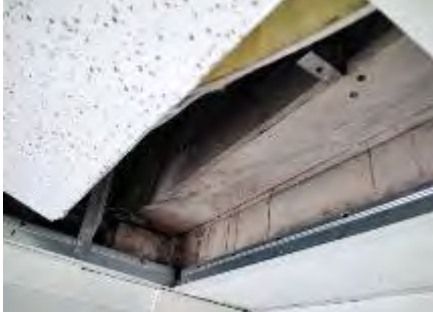
175.	As KX000928	Ceiling void beam cladding	Block 1, First Floor, Office (Room 1/017)	Contains asbestos - Any change in its appearance should be recorded and passed to Property Services.

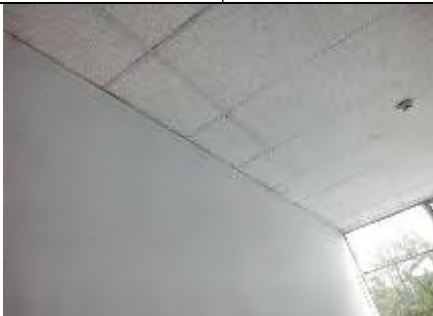
177.	As KX000928	Ceiling void beam cladding	Block 1, First Floor, Landing and Stairwell (Room 1/018)	Contains asbestos - Any change in its appearance should be recorded and passed to Property Services.

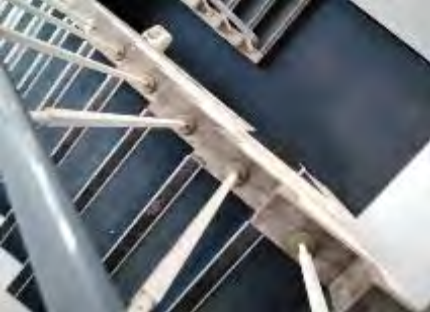
180.	As KX000892	Floor screed to stairs	Block 1, First Floor, Landing and Stairwell (Room 1/018)	Contains asbestos - Any change in its appearance should be recorded and passed to Property Services.

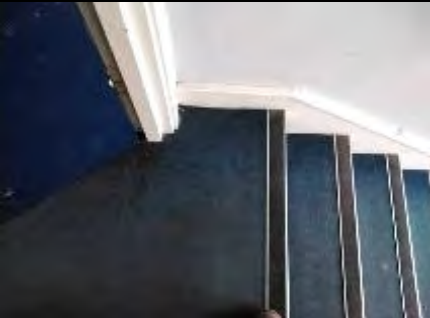
181.	As KX000930	Floor screed under carpet	Block 1, First Floor, Landing and Stairwell (Room 1/018)	Contains asbestos - Any change in its appearance should be recorded and passed to Property Services.

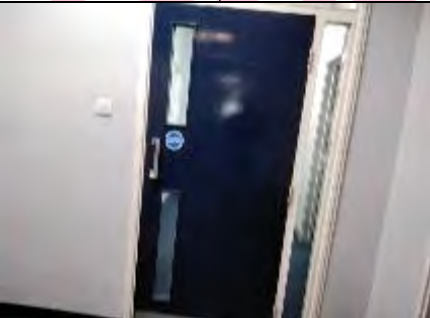
182.	As KX000929	Door window beading including to header panels	Block 1, First Floor, Corridor (Room 1/019)	Contains asbestos - Any change in its appearance should be recorded and passed to Property Services.

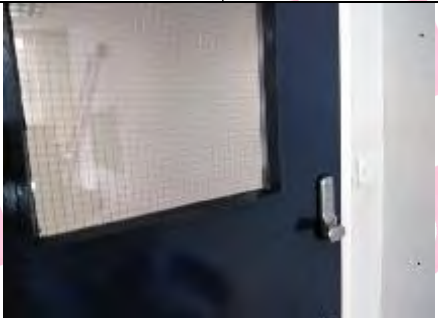
185.	As KX000929	Door window beading	Block 1, First Floor, Office (Room 1/022)	Contains asbestos - Any change in its appearance should be recorded and passed to Property Services.

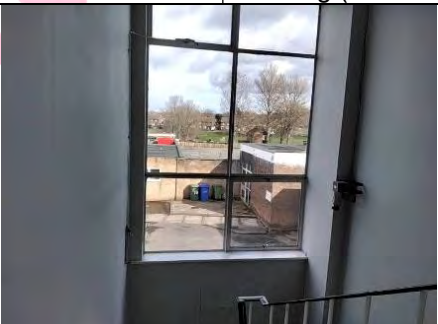
186.	As KX000903	Window putty/seal	Block 1, First Floor, Landing (Room 1/23)	Does not contain asbestos.

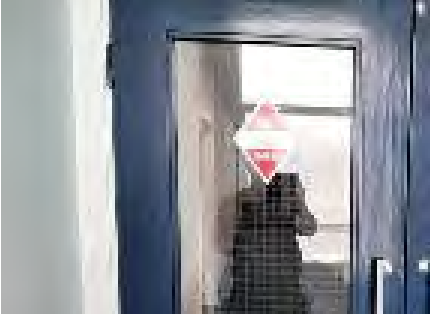
187.	As KX000929	Door window beading	Block 1, First Floor, Landing (Room 1/023)	Contains asbestos - Any change in its appearance should be recorded and passed to Property Services.

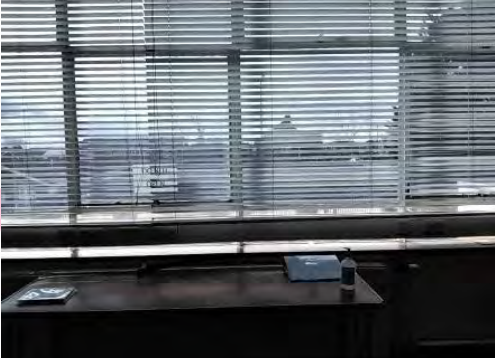
188.	As KX000903	Window putty/seal	Block 1, First Floor, Office (Room 1/24)	Does not contain asbestos.

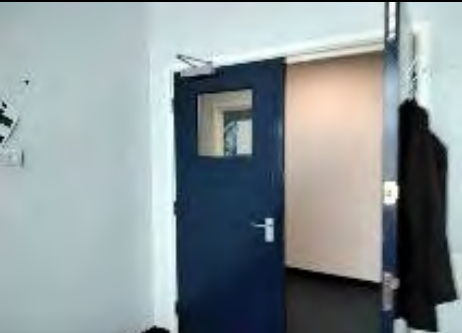
189.	As KX000929	Door window beading	Block 1, First Floor, Office (Room 1/024)	Contains asbestos - Any change in its appearance should be recorded and passed to Property Services.

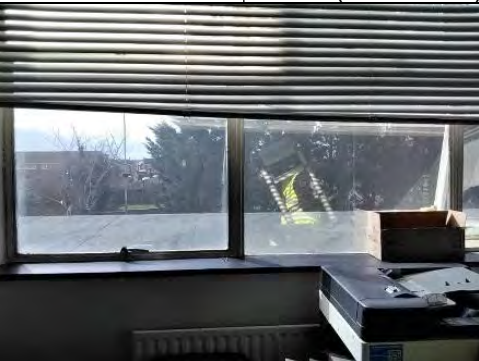
190.	As KX000903	Window putty/seal	Block 1, First Floor, Office (Room 1/25)	Does not contain asbestos.

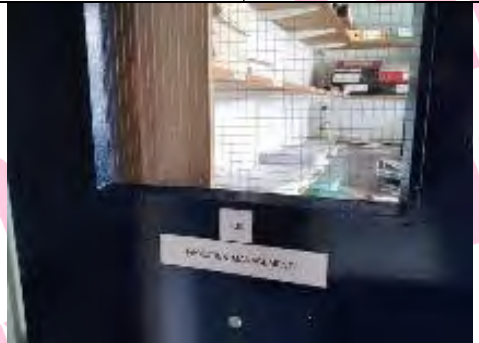
191.	As KX000929	Door window beading	Block 1, First Floor, Office (Room 1/025)	Contains asbestos - Any change in its appearance should be recorded and passed to Property Services.

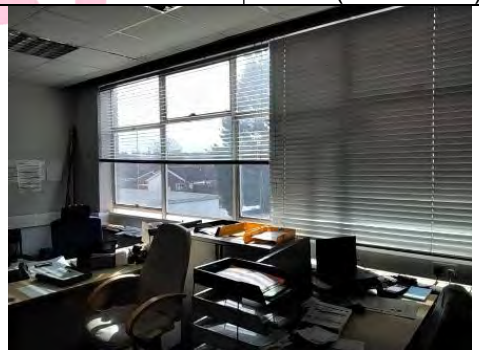
192.	As KX000903	Window putty/seal	Block 1, First Floor, Office (Room 1/26)	Does not contain asbestos.

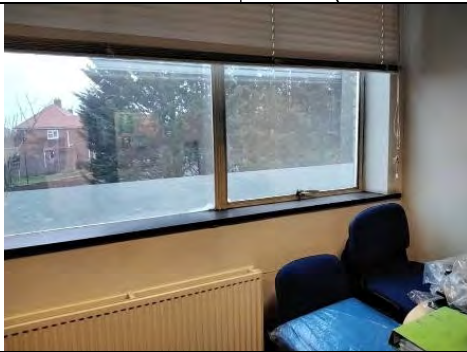
193.	As KX000903	Window putty/seal	Block 1, First Floor, Office (Room 1/27)	Does not contain asbestos.

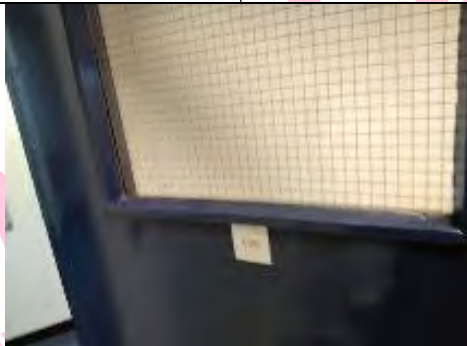
194.	As KX000929	Door window beading	Block 1, First Floor, Office (Room 1/027)	Contains asbestos - Any change in its appearance should be recorded and passed to Property Services.

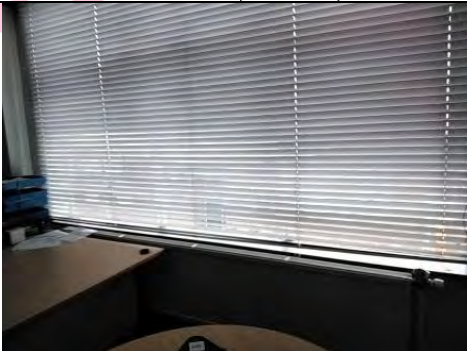
195.	As KX000903	Window putty/seal	Block 1, First Floor, Office (Room 1/28)	Does not contain asbestos.

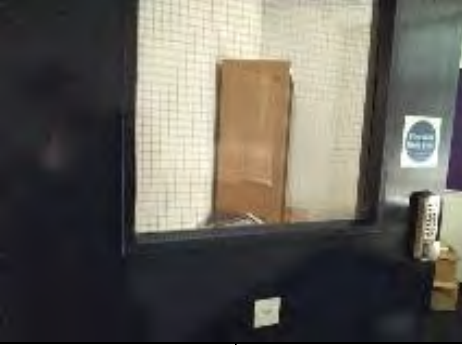
196.	As KX000929	Door window beading	Block 1, First Floor, Office (Room 1/028)	Contains asbestos - Any change in its appearance should be recorded and passed to Property Services.

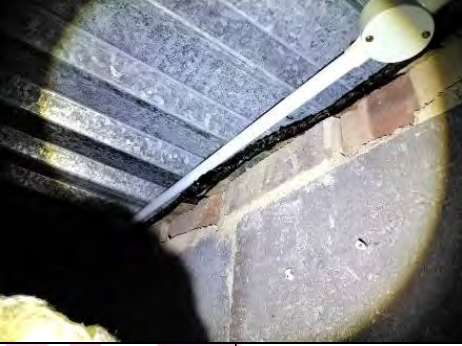
197.	KX000935	Ceiling void Packer to timber	Block 1, First Floor, Office (Room 1/28)	Does not contain asbestos.

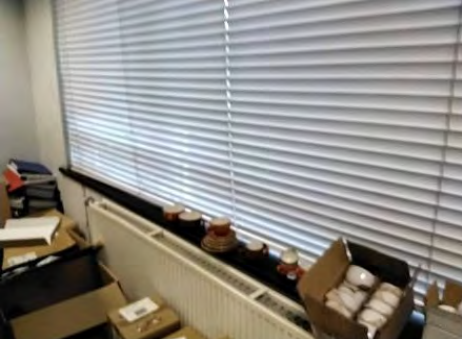
198.	As KX000903	Window putty/seal	Block 1, First Floor, Office (Room 1/29)	Does not contain asbestos.

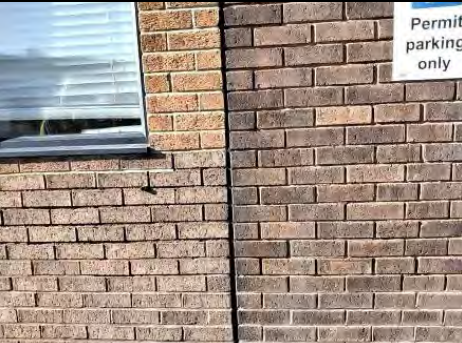
209.	KX000922	Wall seal to expansion joint	Block 1, External (Room E/001)	Does not contain asbestos.

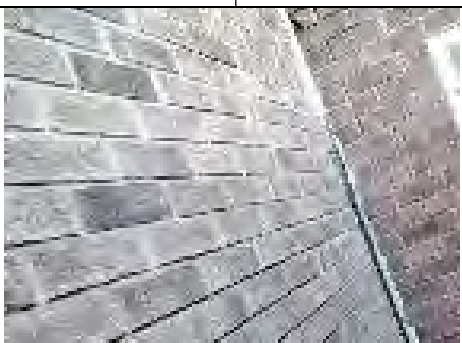
210.	KX000923	Wall seal to expansion joint	Block 1, External (Room E/001)	Contains asbestos - Any change in its appearance should be recorded and passed to Property Services.

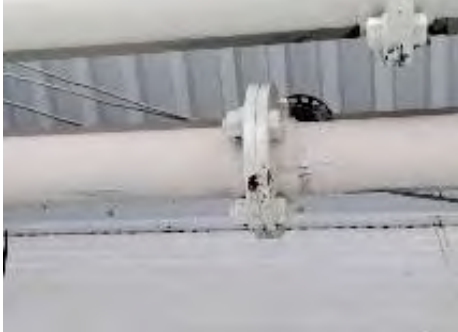
220.	Presumed	Ceiling void pipework	Block 2, Ground Floor, Office Service Support (Room G/015)	Presumed to contain asbestos - Any change in its appearance should be recorded and passed to Property Services.

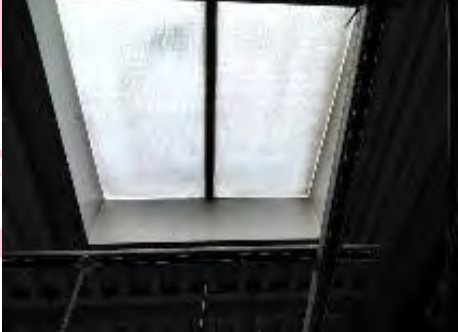
221.	Presumed	Roof Skylight gasket	Block 2, Ground Floor, Office Service Support (Room G/015)	Presumed to contain asbestos - Any change in its appearance should be recorded and passed to Property Services.

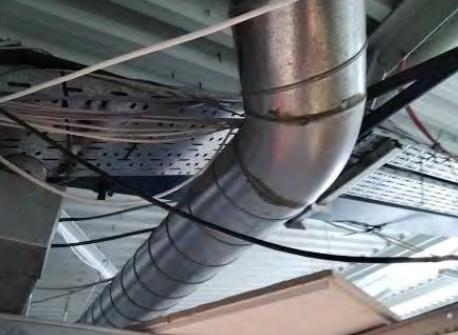
222.	KX000943	Ceiling void ductwork jointing	Block 2, Ground Floor, Office Service Support (Room G/015)	Does not contain asbestos.

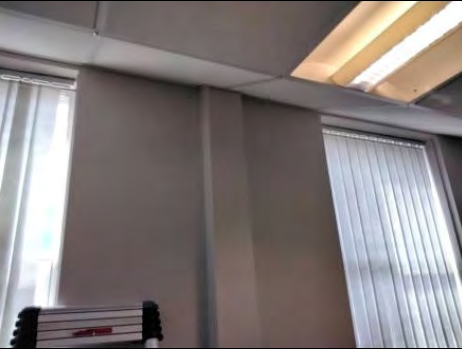
223.	KX000944	Wall coating	Block 2, Ground Floor, Office Service Support (Room G/015)	Does not contain asbestos.

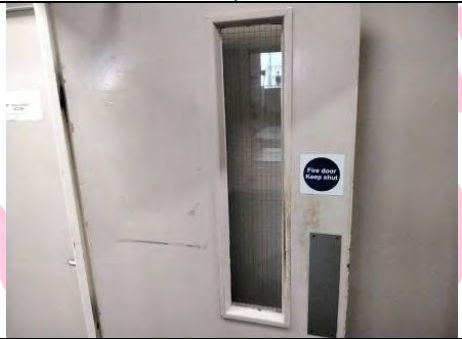
224.	KX000945	Door window beading	Block 2, Ground Floor, Office Service Support (Room G/015)	Does not contain asbestos.

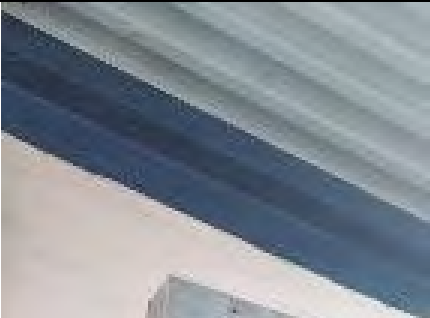
232.	KX000948	Firebreak above beams to roof cladding	Block 2, Ground Floor, Workshop Store (Room G/021)	Contains asbestos - Any change in its appearance should be recorded and passed to Property Services.

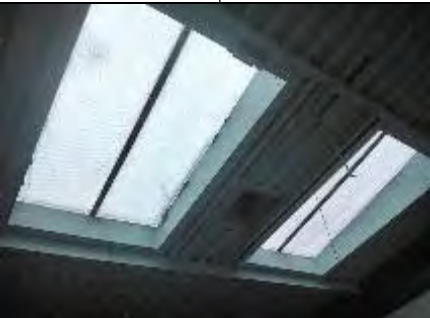
235.	Presumed	Roof skylight gasket	Block 2, Ground Floor, Office (Room G/022)	Presumed to contain asbestos - Any change in its appearance should be recorded and passed to Property Services.

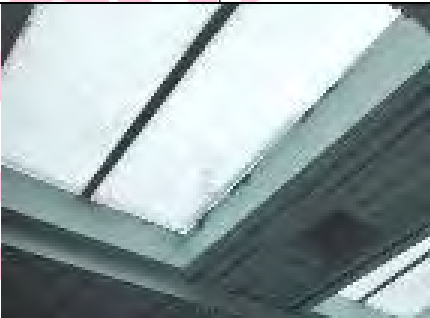
236.	Presumed	Roof vent lining upstands between skylights	Block 2, Ground Floor, Office (Room G/022)	Presumed to contain asbestos - Any change in its appearance should be recorded and passed to Property Services.

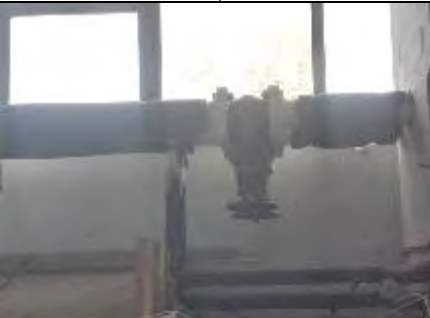
237.	As KX000951	Pipework gaskets	Block 2, Ground Floor, Office (Room G/022)	Contains asbestos - Any change in its appearance should be recorded and passed to Property Services.

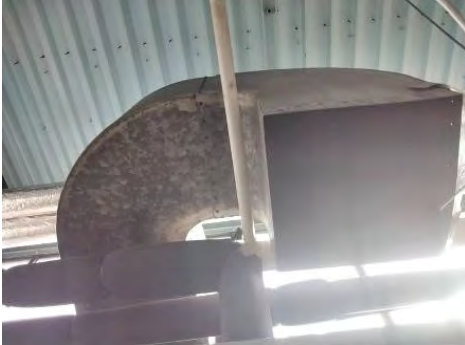
238.	KX000949	Ceiling void ductwork jointing	Block 2, Ground Floor, Office (Room G/022)	Does not contain asbestos.

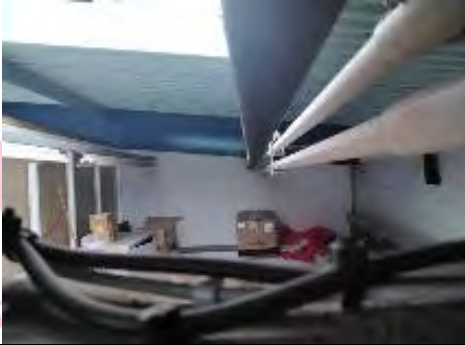
239.	As KX000948	Firebreak above beams to roof cladding	Block 2, Ground Floor, Store Room (Room G/023)	Contains asbestos - Any change in its appearance should be recorded and passed to Property Services.

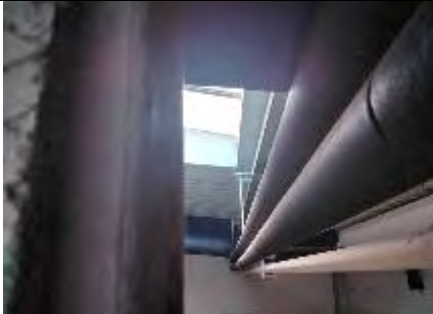
240.	Presumed	Roof skylight gasket	Block 2, Ground Floor, Store Room (Room G/023)	Presumed to contain asbestos - Any change in its appearance should be recorded and passed to Property Services.

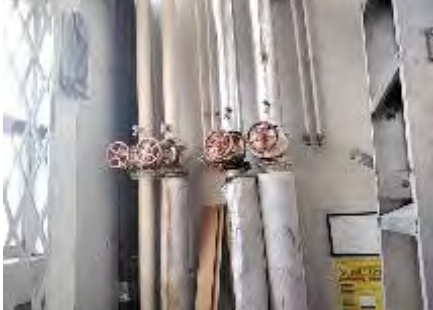
244.	KX000951	Pipework Gaskets	Block 2, Ground Floor, Switch Room (Room G/025)	Contains asbestos - Any change in its appearance should be recorded and passed to Property Services.

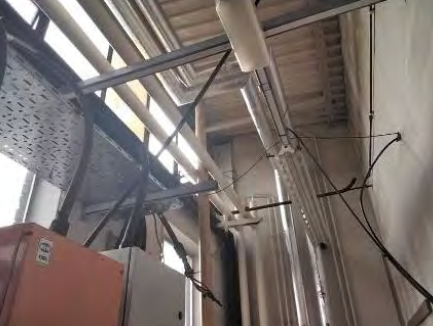
245.	As KX000942	Putty to column	Block 2, Ground Floor, Switch Room (Room G/025)	Does not contain asbestos.

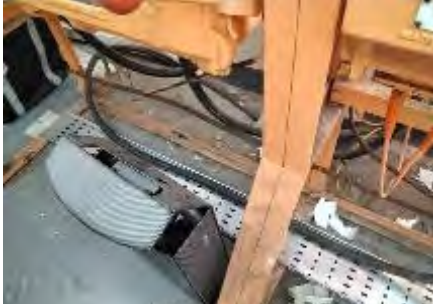
246.	KX000952	Debris poured bitumen set to floor	Block 2, Ground Floor, Switch Room (Room G/025)	Contains asbestos - Any change in its appearance should be recorded and passed to Property Services.

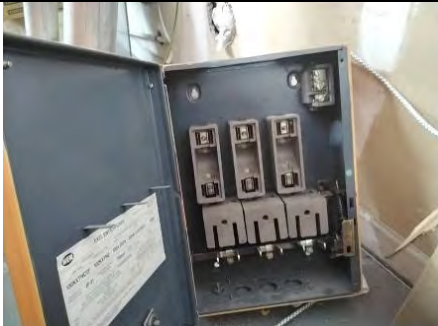
247.	KX000953	Electrical services fuses/flashguards putty behind removed fuses redundant orange fuse box	Block 2, Ground Floor, Switch Room (Room G/025)	Does not contain asbestos.

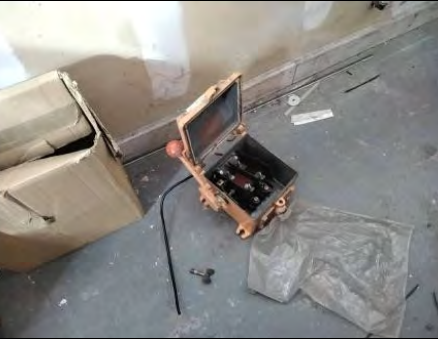
248.	KX000954	Electrical services door seal/gaskets redundant orange switch box	Block 2, Ground Floor, Switch Room (Room G/025)	Does not contain asbestos.

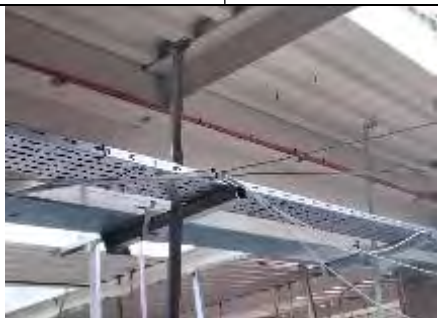
249.	As KX000948	Ceiling void fire breaks x 2 beams	Block 2, Ground Floor, Office Large (Room G/026)	Contains asbestos - Any change in its appearance should be recorded and passed to Property Services.

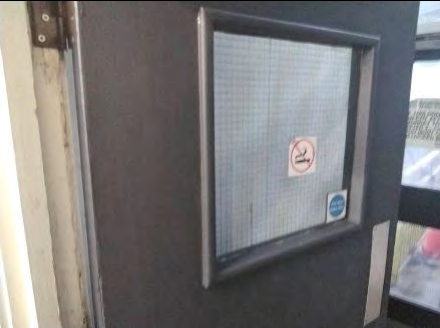
253.	As KX000945	Door window beading including door header panel	Block 2, Ground Floor, Locker Room (Room G/030)	Does not contain asbestos.

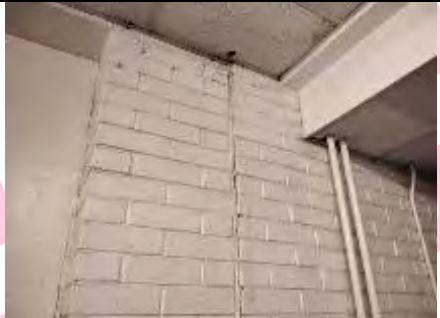
254.	As KX000947	Wall expansion joint	Block 2, Ground Floor, Locker Room (Room G/030)	Contains asbestos - Any change in its appearance should be recorded and passed to Property Services.

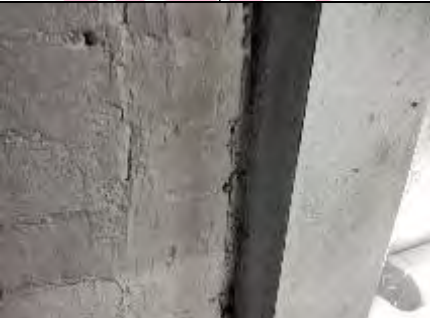
266.	KX000963	Wall packing to structural columns	Block 2, Ground Floor, Garage (Room G/037)	Contains asbestos - Any change in its appearance should be recorded and passed to Property Services.

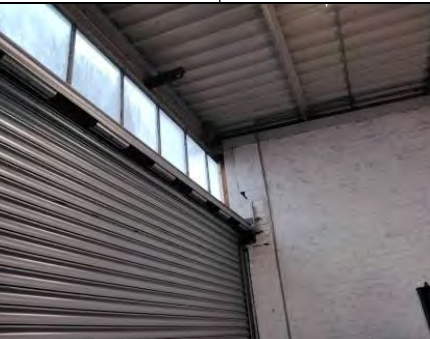
267.	As KX000964	Column cladding rear of panel on other side of wall	Block 2, Ground Floor, Garage (Room G/037)	Does not contain asbestos.

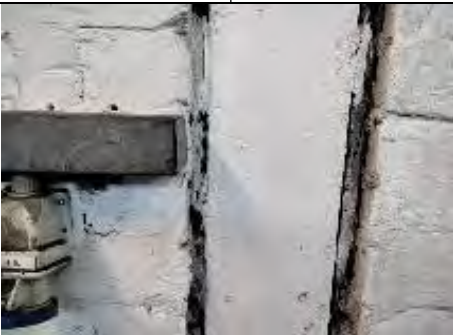
268.	As KX000963	Wall packing to structural columns	Block 2, Ground Floor, Garage (Room G/038)	Contains asbestos - Any change in its appearance should be recorded and passed to Property Services.

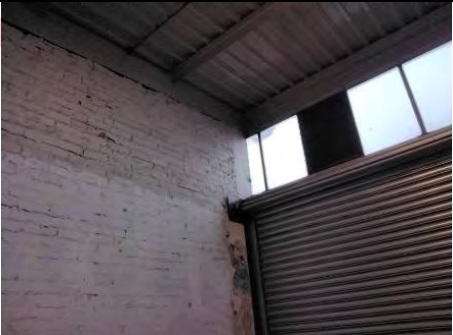
270.	As KX000964	Column cladding	Block 2, Ground Floor, Garage (Room G/038)	Does not contain asbestos.

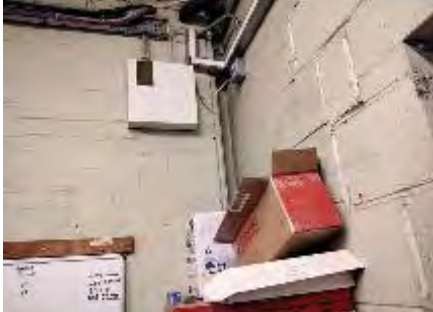
283.	As KX000963	Wall packing to structural column	Block 3, Ground Floor, Office (Room G/006)	Contains asbestos - Any change in its appearance should be recorded and passed to Property Services.

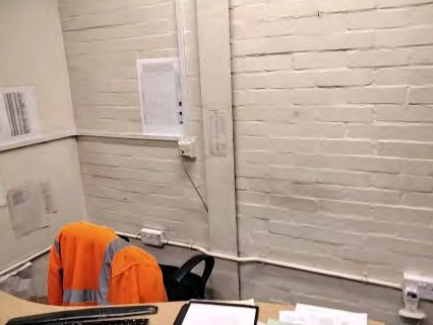
284.	KX000970	Wall packing to column	Block 3, Ground Floor, Office (Room G/008)	Does not contain asbestos.

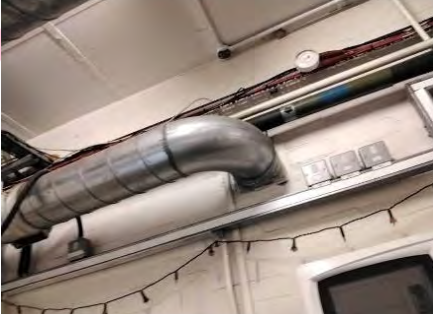
285.	KX000971	Ductwork beige and grey seals to joints	Block 3, Ground Floor, Kitchen (Room G/010)	Does not contain asbestos.

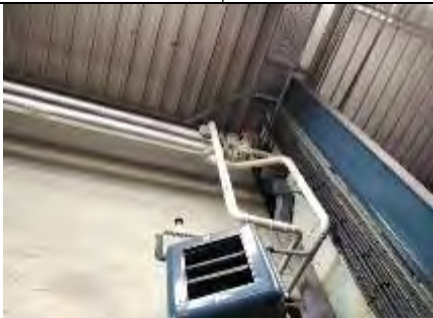
286.	Presumed	Pipework gaskets	Block 3, Ground Floor, Garage (Room G/013)	Presumed to contain asbestos - Any change in its appearance should be recorded and passed to Property Services.

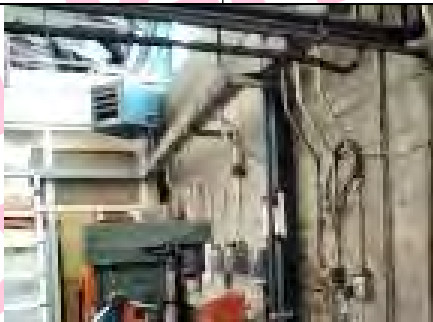
287.	KX000972	Wall seal to column	Block 3, Ground Floor, Garage (Room G/013)	Contains asbestos - Any change in its appearance should be recorded and passed to Property Services.

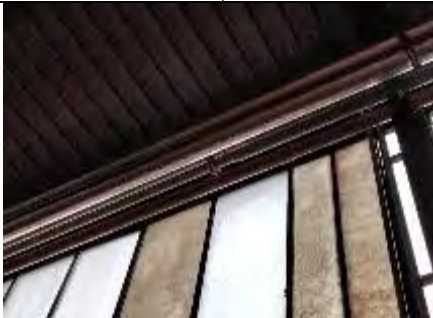
288.	Presumed	Pipework gaskets	Block 3, Ground Floor, Garage (Room G/014)	Presumed to contain asbestos - Any change in its appearance should be recorded and passed to Property Services.

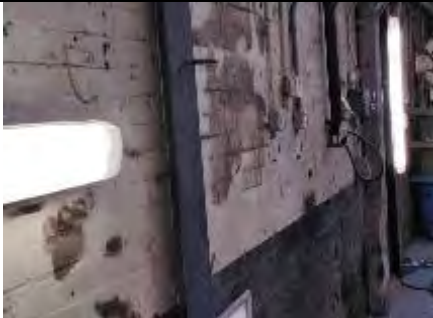
292.	As KX000972	Wall seal to column	Block 3, Ground Floor, Garage (Room G/015)	Contains asbestos - Any change in its appearance should be recorded and passed to Property Services.

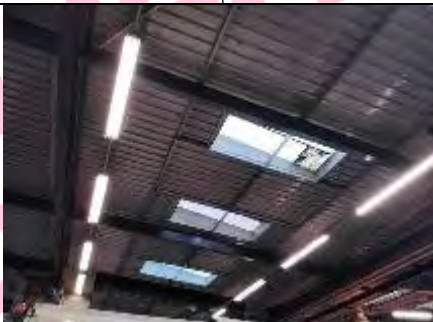
293.	Presumed	Roof skylight gasket	Block 3, Ground Floor, Garage (Room G/015)	Presumed to contain asbestos - Any change in its appearance should be recorded and passed to Property Services.

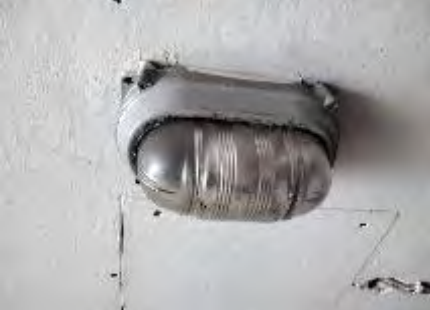
301.	KX000988	Electrical services putty	Garages, Ground Floor, Garage (Room G/002)	Contains asbestos - Any change in its appearance should be recorded and passed to Property Services.

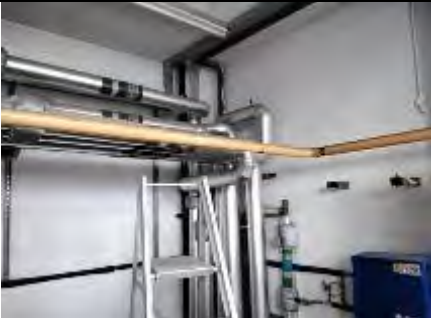
307.	KX000980	Debris/Residue right hand wall behind pipes leading to duct	Boiler House, Ground Floor, Boiler Room (G/001)	Contains asbestos - Any change in its appearance should be recorded and passed to Property Services.
