ASBESTOS SURVEY REPORT FOR SOUTH HYLTON HOUSE, SOUTH HYLTON BANK, SR4 0JL.

**South Hylton House, South Hylton Bank, SR4 0JL**

**Date: 24 March 2026**

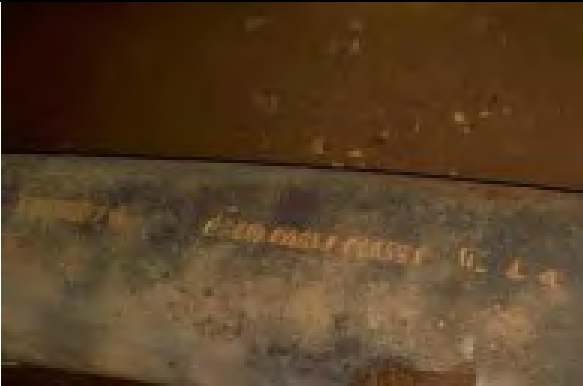
328	24-71128-3	Rope	Area 001 (Internal pipe run)	Does not contain asbestos

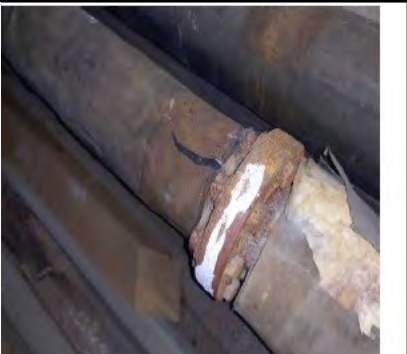
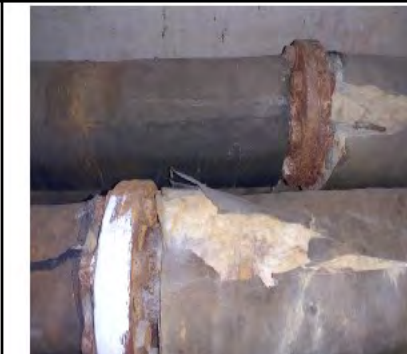
343	KG000962	Gasket Large Pipework	Block 2 Electrical intake room floor duct Z/01	Very Low Risk

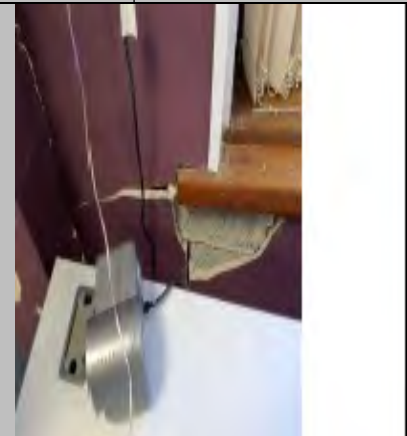
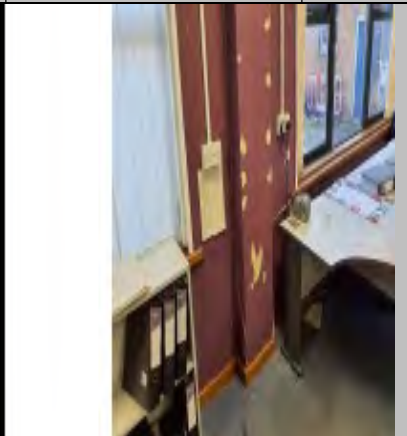
344	RO001440	Plastered masonry - walls	Block 2 Office G/01	No Risk

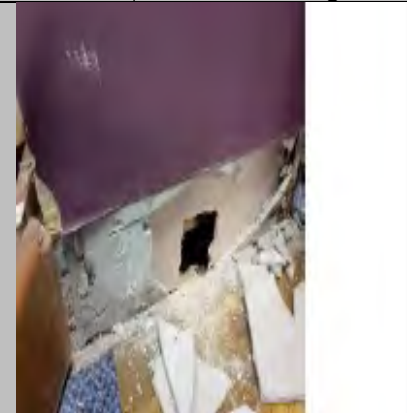
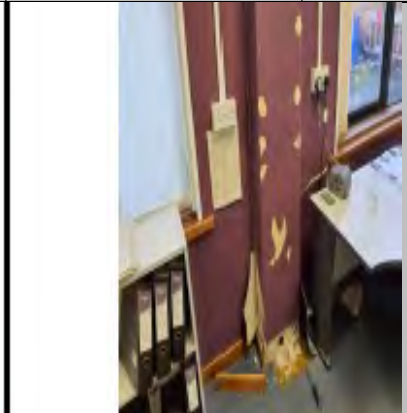
345	RO001441	Plasterboard steel column cladding	Block 2 Office G/01	No Risk
