ASBESTOS SURVEY REPORT FOR JACK CRAWFORD HOUSE,
COMMERCIAL ROAD, SUNDERLAND, SR2 8QR.

Jack Crawford House, Commercial Road, SR2 8QR

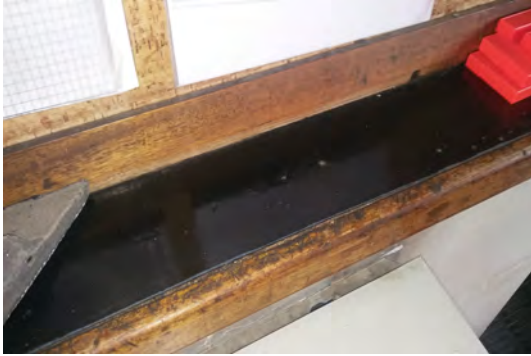
Item 1 Ref: 406299-78

- (Item 1) Ref: 406299-78 – Window Sill Covering (001/Gatehouse) – No Risk
- (Item 2) Ref: 406299-79 – Remnant floor adhesive beneath linoleum (001/Gatehouse) – Very Low Risk
- (Item 3) Ref: As 406299-78 – Window Sill Covering (002/Gatehouse WC) – No Risk
- (Item 4) Ref: As 406299-79 – Remnant floor adhesive beneath linoleum (002/Gatehouse WC) – Very Low Risk
- (Item 5) Ref: 406299-80 – Window Sill (External/Gatehouse) – No Risk
- (Item 6) Ref: 406299-81 – Damp proof course (External/Gatehouse) – Very Low Risk
- (Item 7) Ref: 406299-82 – Sealant to door frame (External/Gatehouse) – No Risk
- (Item 8) Ref: 406299-83 – Mastic seal to vent (External/Gatehouse) – No Risk
- (Item 9) Ref: 406299-84 – Sealant to window frame (External/Gatehouse) – No Risk
- (Item 10) Ref: 406299-85 – Flat roof felt (External/Gatehouse) – No Risk

The window sill covering in the gatehouse (Rm 0/01) does not contain asbestos.

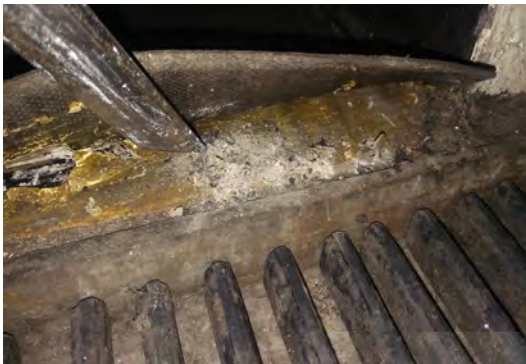
Item 2 Ref: 406299-79

The remnant floor adhesive beneath the linoleum in the gatehouse (Rm 0/01) contains asbestos.

Any change in its appearance should be recorded and passed to Property Services.

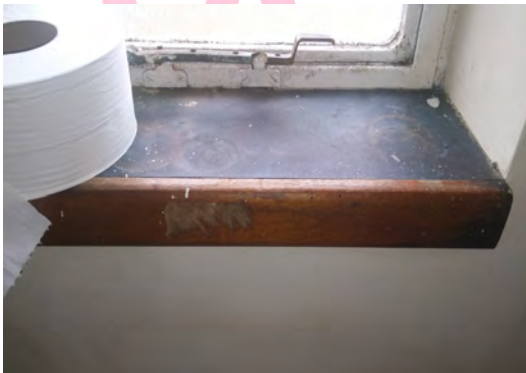
Item 3 Ref: As 406299-78

The window sill covering in the gatehouse wc (Rm 0/02) does not contain asbestos.

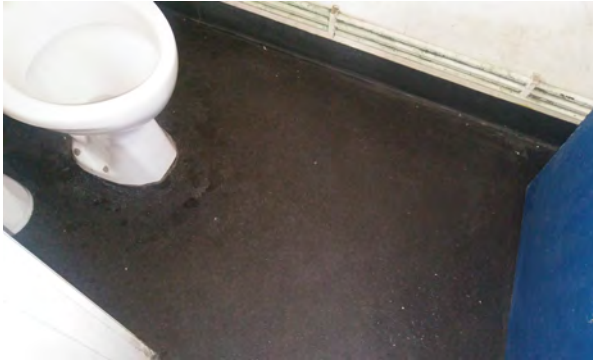
Item 4 Ref: As 406299-79

The remnant floor adhesive beneath the linoleum in the gatehouse wc (Rm 0/02) contains asbestos.

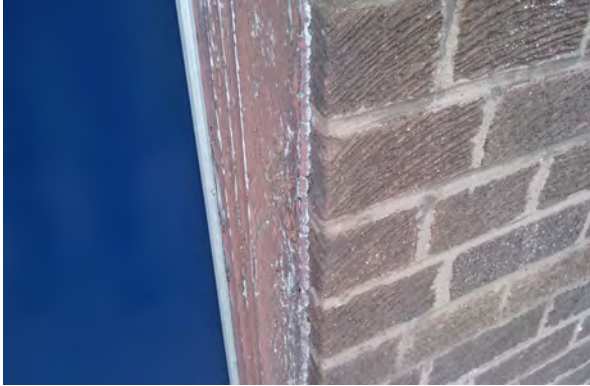
Item 7 Ref: 406299-82

The sealant to door frame to the gatehouse (External) does not contain asbestos.

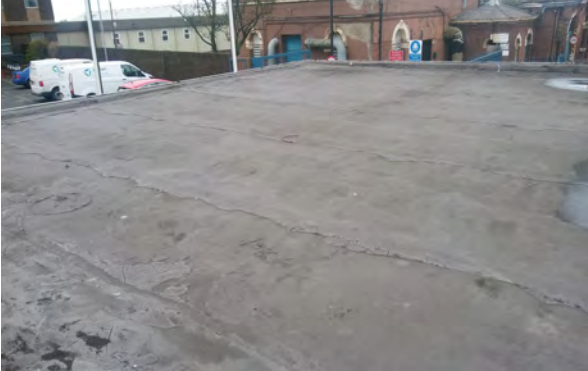
Item 10 Ref: 406299-85

The flat roof felt to the gatehouse (External) does not contain asbestos.

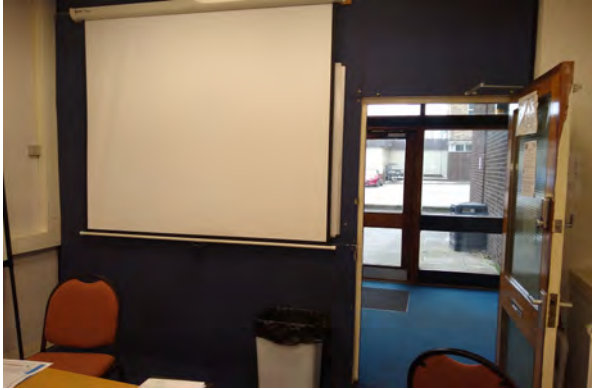
Item 11 Ref: 406299-23

- (Item 11) Ref: 406299-23 – Window beading to glazed partition wall behind fibreboard panels (060a/computer training room T1/Jacques restaurant) – Very Low Risk

The window beading to glazed partition wall (behind fibreboard panels) in the Jaques Restaurant – computer training room T1 (Rm 0/60a) contains asbestos.

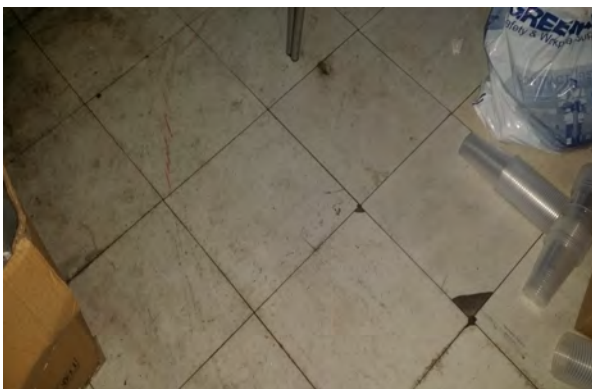
Item 13 Ref: 406299-38

The floor covering in Jaques Restaurant – Store (Rm 0/60) does not contain asbestos.

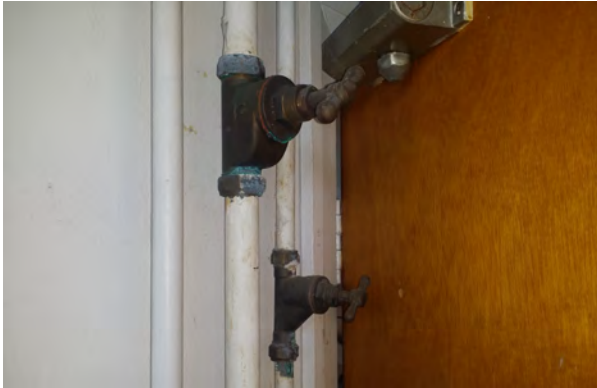
Item 14 Ref: 406299-39

The gasket to pipework in Jacques Restaurant – Store (Rm 0/60) does not contain asbestos.

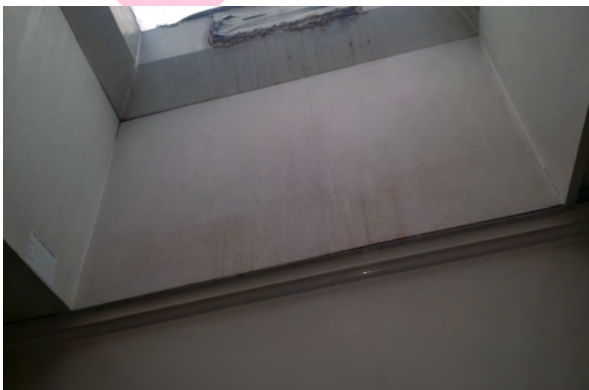
Item 16 Ref: 406299-40

- (Item 16) Ref: 406299-40 – Skylight surround (061/Office Jacques restaurant) – Low Risk
- (Item 17) Ref: As 406299-38 – Floor covering (061/Office Jacques restaurant) – No Risk

The skylight surround in the Jacques Restaurant – office (Rm 0/61) contains asbestos.

**** There is decay to this skylight. This area should not be accessed until a clean-up & air tests can be done ****

Item 15	Gasket to pipework (060/Store void above Jacques restaurant)	Very Low Risk	12 monthly	Do not inspect
Item 16	Skylight surround (061/Office Jacques restaurant)	Low Risk	6 monthly	21/10/2026 – decay but area sealed

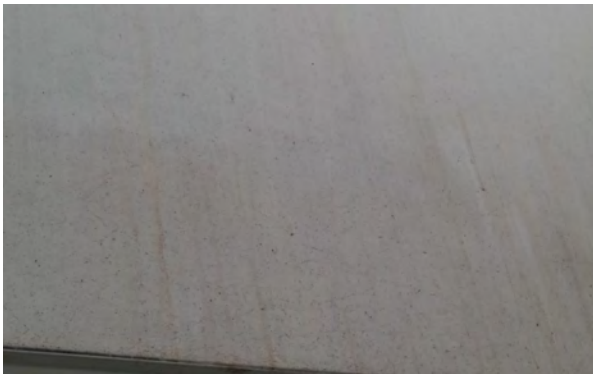
Item 18 Ref: As406299-40

The skylight surround in the Jaques Restaurant – office – void above (Rm 0/61) contains asbestos.

Any change in its appearance should be recorded and passed to Property Services.

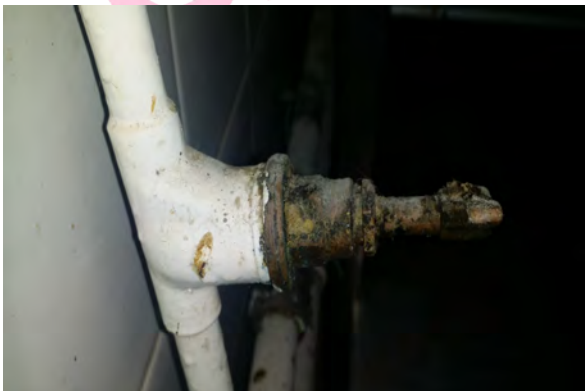
Item 19 Ref: As406299-39

The gasket to pipework in Jaques Restaurant – Store (Rm 0/62) does not contain asbestos.

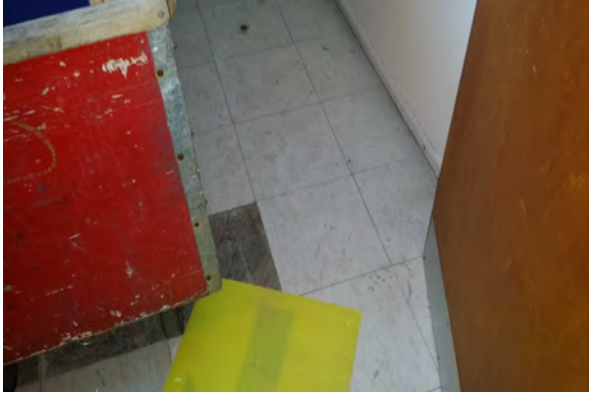
Item 20 Ref: As406299-38

The floor covering in Jaques Restaurant – store (Rm 0/63) does not contain asbestos.

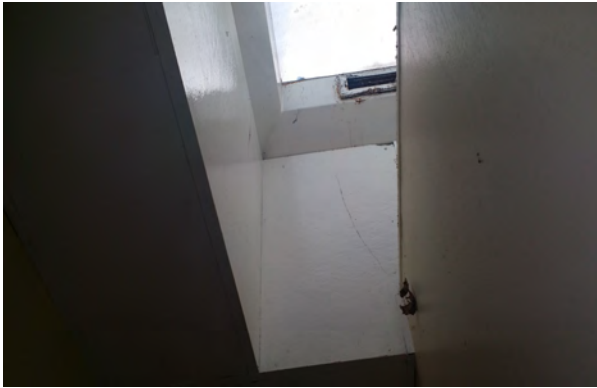
Item 23 Ref: As406299-40

The skylight surround in the Jacques Restaurant – toilet (Rm 0/65) contains asbestos.

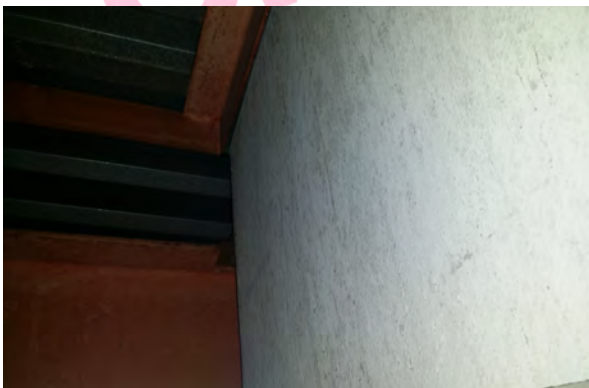
Item 25 Ref: As406299-40

The skylight surround in the Jacques Restaurant – toilet – void above (Rm 0/65) contains asbestos.

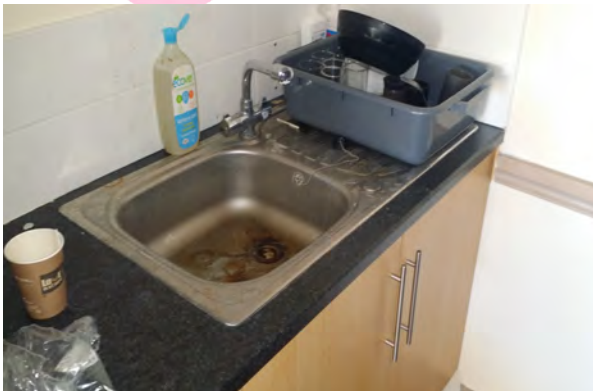
Item 28 Ref: 406299-30

The sink pad in Jaques Restaurant – kitchen (Rm 0/71) does not contain asbestos.

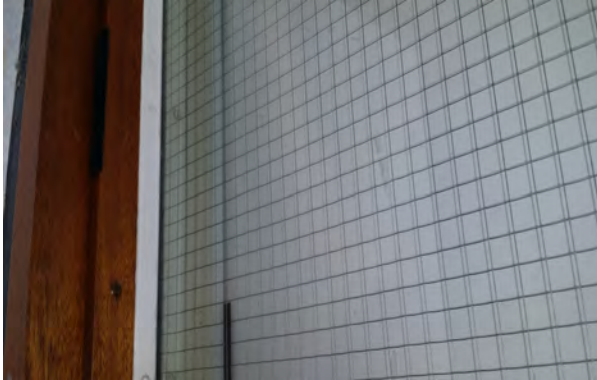
Item 29 Ref: As406299-23

The beading above double doors to lobby behind the sign in the Jaques Restaurant – store – void above (Rm 0/71) contains asbestos.

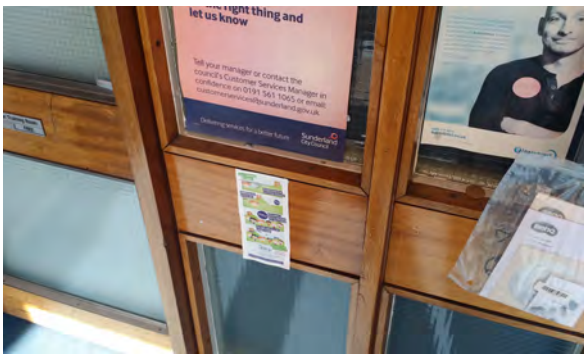
Item 31 Ref: As406299-23

The beading to computer room windows in the Jaques Restaurant – lobby (Rm 0/71b) contains asbestos.

Any change in its appearance should be recorded and passed to Property Services.

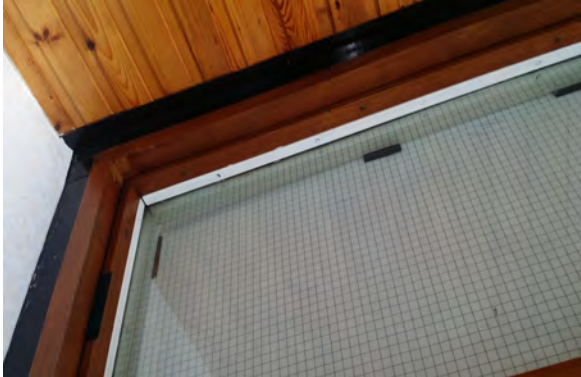
Item 32 Ref: As406299-23

The beading above double doors to stores in the Jaques Restaurant – lobby (Rm 0/71b) contains asbestos.

Any change in its appearance should be recorded and passed to Property Services.

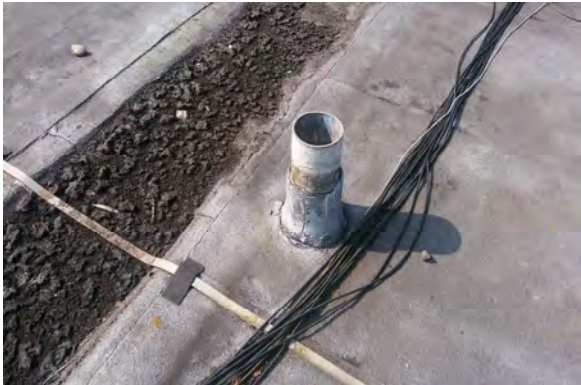
Item 33 Ref: 406299-64

The flue to Jaques Restaurant (External) contains asbestos.

Any change in its appearance should be recorded and passed to Property Services.

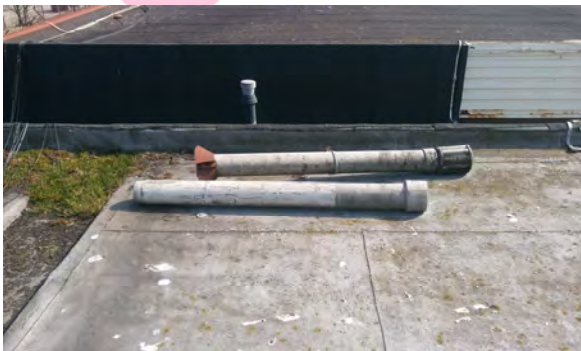
Item 34 Ref: 406299-65

The redundant flues to the flat roof of Jaques Restaurant (External) contains asbestos.

Any change in its appearance should be recorded and passed to Property Services.

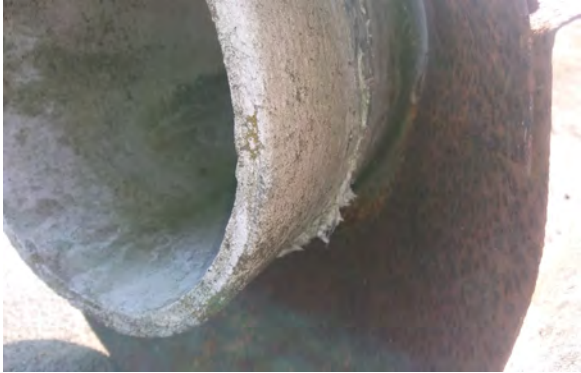
Item 35 Ref: 406299-66

The rope seal to redundant flue to Jaques Restaurant (External) contains asbestos.

Any change in its appearance should be recorded and passed to Property Services.

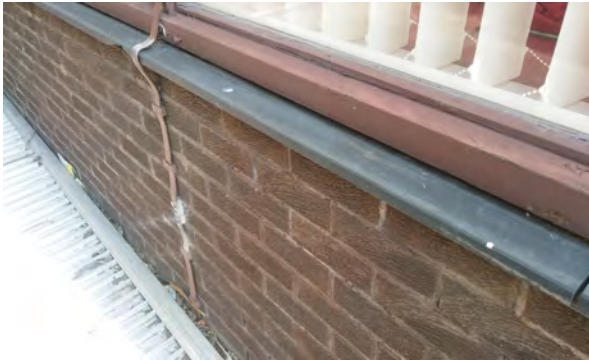
Item 36 Ref: 406299-67

The window sill to Jaques Restaurant (External) does not contain asbestos.

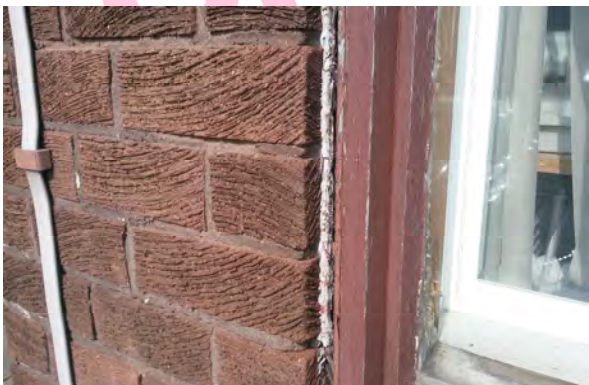
Item 37 Ref: 406299-68

The sealant to window frames to Jaques Restaurant (External) contains asbestos.

Any change in its appearance should be recorded and passed to Property Services.

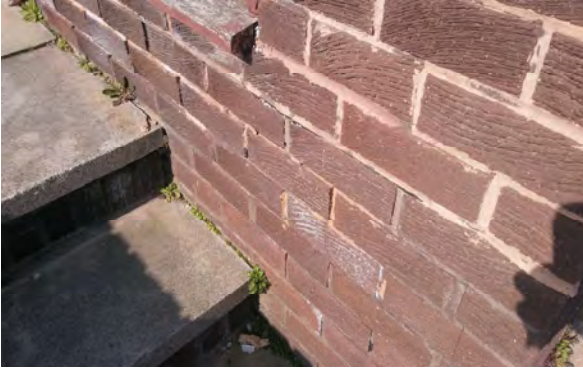
Item 38 Ref: 406299-69

The damp proof course to
Jaques Restaurant
(External) contains asbestos.

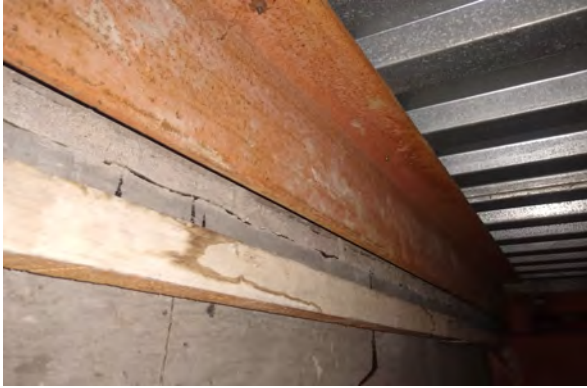
Item 39 Ref: As 406299-1

The membrane to top of concrete beam in the lobby – void above (Rm 0/01) does not contain asbestos.

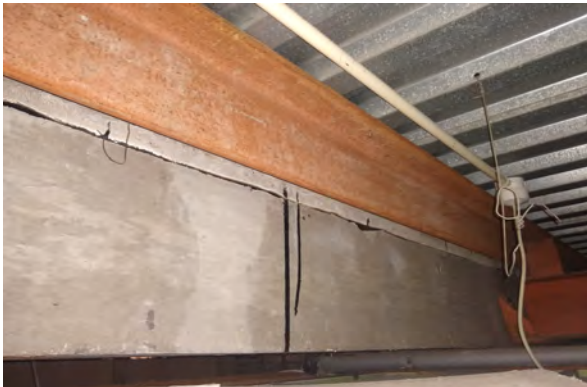
Item 40 Ref: 406299-1

The membrane to top of concrete beam in the main entrance lobby – void above (Rm 0/01a) does not contain asbestos.

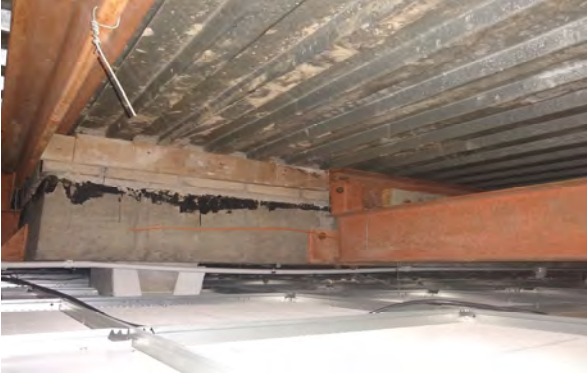
Item 42 Ref: As 406299-1

The membrane to top of concrete beam in the office – void above (Rm 0/02) does not contain asbestos.

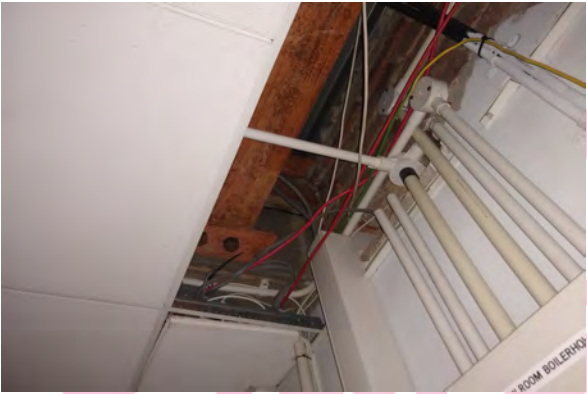
Item 43 Ref: As 406299-1

The membrane to top of concrete beam in the store – void above (Rm 0/02a) does not contain asbestos.

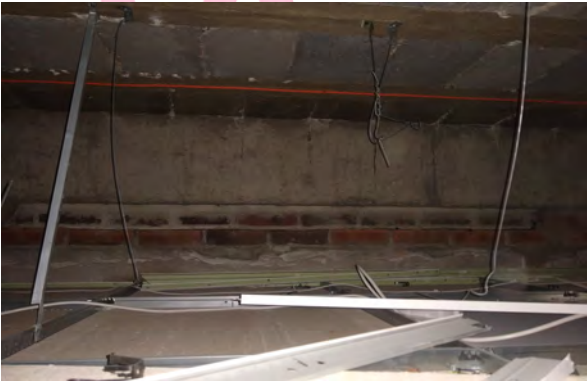
Item 44 Ref: As 406299-6

The membrane to brick wall in the meeting room – void above (Rm 0/04) does not contain asbestos.

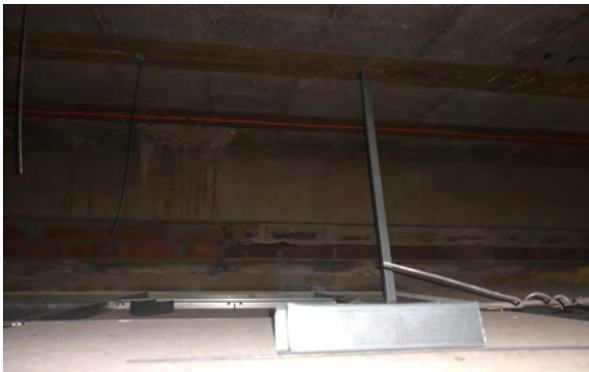
Item 46 Ref: As 406299-6

The membrane to brick wall in the office – void above (Rm 0/06) does not contain asbestos.

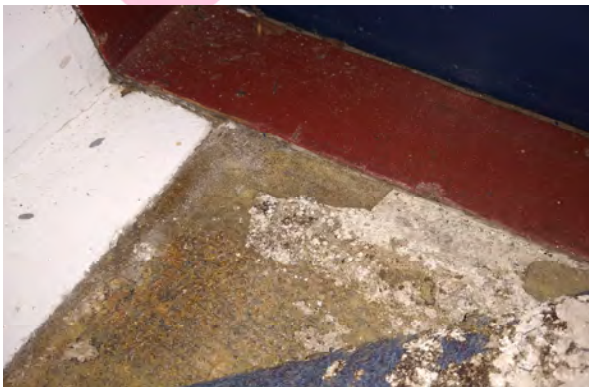
Item 47 Ref: 406299-9

The remnant adhesive to floor in the stairwell (Rm 0/09) contains asbestos.

Any change in its appearance should be recorded and passed to Property Services.

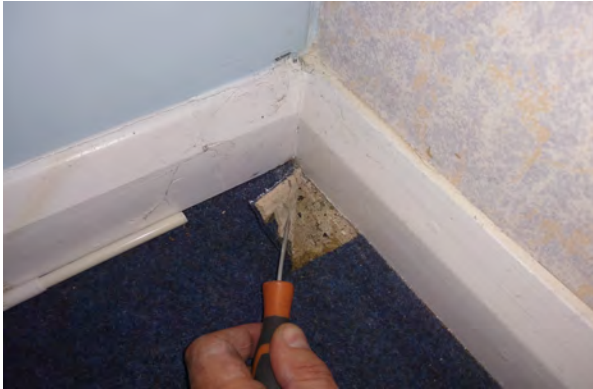
Item 48 Ref: As 406299-9

The remnant adhesive to floor beneath carpet & screed in the open office (Rm 0/10) contains asbestos.

Any change in its appearance should be recorded and passed to Property Services.

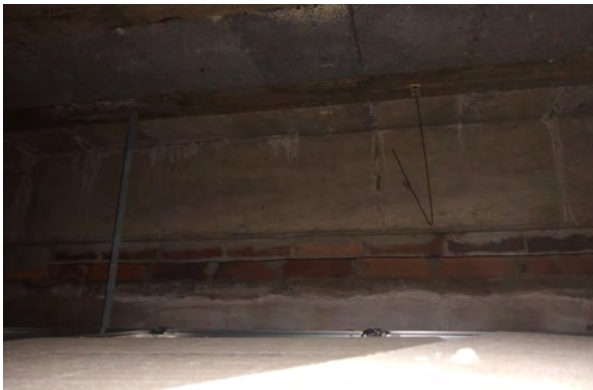
Item 49 Ref: As 406299-6

The membrane to brick wall in the open office – void above (Rm 0/10) does not contain asbestos.

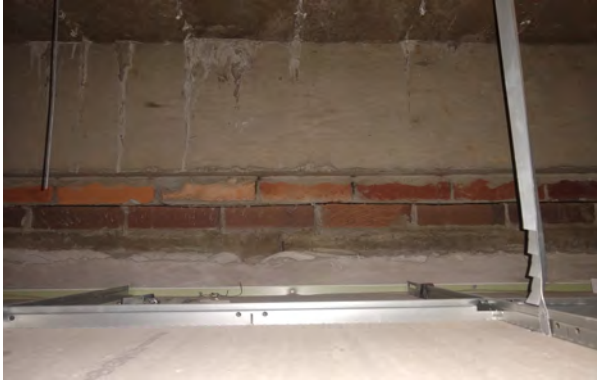
Item 54 Ref: As 406299-6

The membrane to brick wall in the evidence store – void above (Rm 0/11) does not contain asbestos.

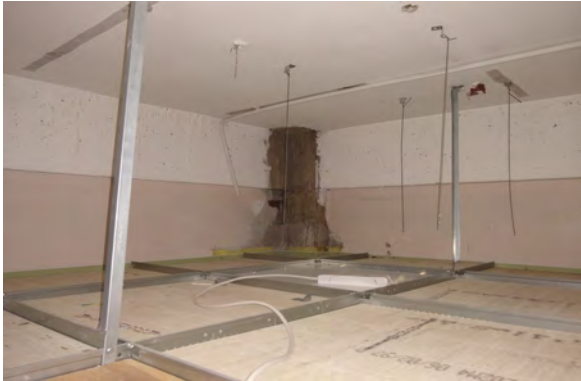
Item 55 Ref: As 406299-6

The protruding membrane to wall in the office – void above (Rm 0/13) does not contain asbestos.

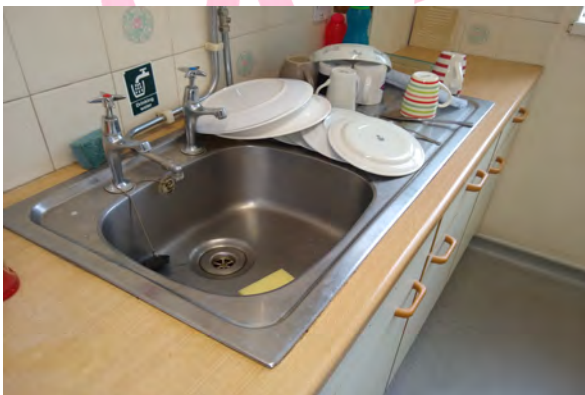
Item 56 Ref: 406299-10

The sink pad in the kitchen (Rm 0/14) does not contain asbestos.

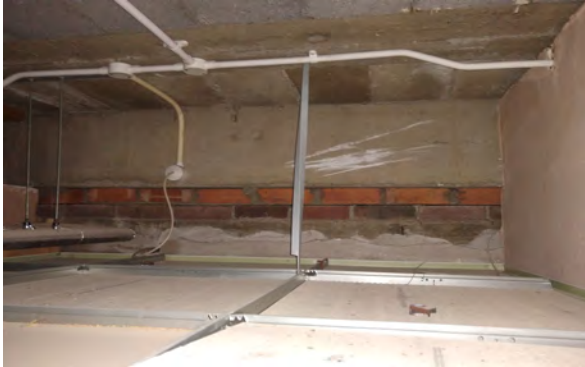
Item 57 Ref: As 406299-6

The membrane to brick wall in the kitchen – void above (Rm 0/14) does not contain asbestos.

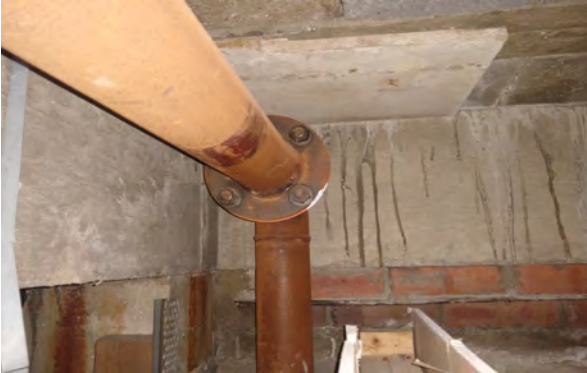
Item 60 Ref: 406299-22

The pipework flange gasket in the office – void above (Rm 0/15) contains asbestos.

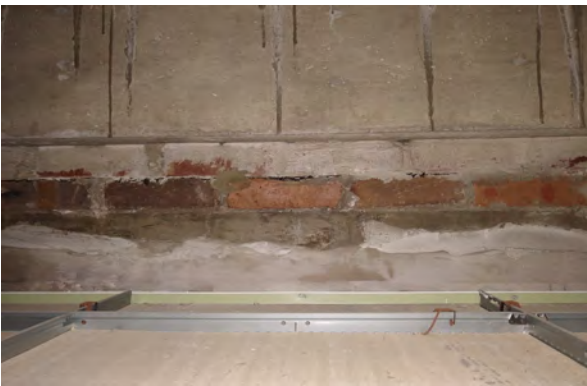
Item 61 Ref: As 406299-6

The membrane to brick wall in the office – void above (Rm 0/16) does not contain asbestos.

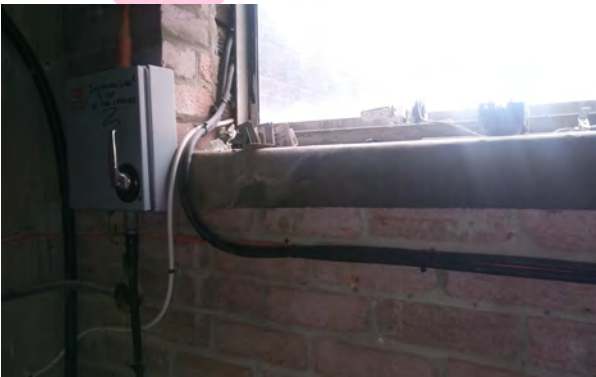
Item 62 Ref: As406299-75

The damp proof membrane to window sill in the switchroom (Rm 0/17) contains asbestos.

Item 62	Damp proof membrane to window sill (017/Switch room)	Very Low Risk	12 monthly	21/4/2027
<i>Item 63</i>	<i>Loose lying fuse end caps (017/Switch room)</i>	<i>Very Low Risk</i>	<i>12 monthly</i>	<i>Removed May 2020</i>

Any change in its appearance should be recorded and passed to Property Services.

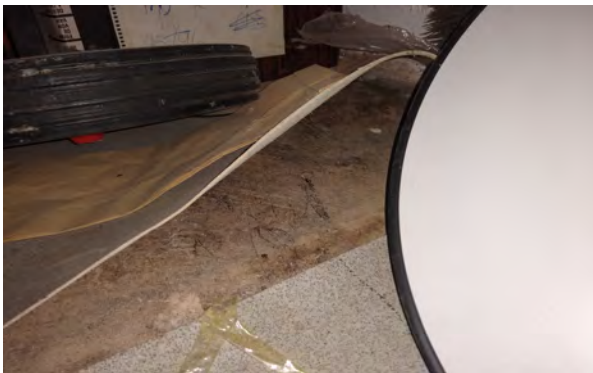
Item 68 Ref: As 406299-9

The remnant adhesive to floor beneath the linoleum in the service riser (Rm 0/19) contains asbestos.

Any change in its appearance should be recorded and passed to Property Services.

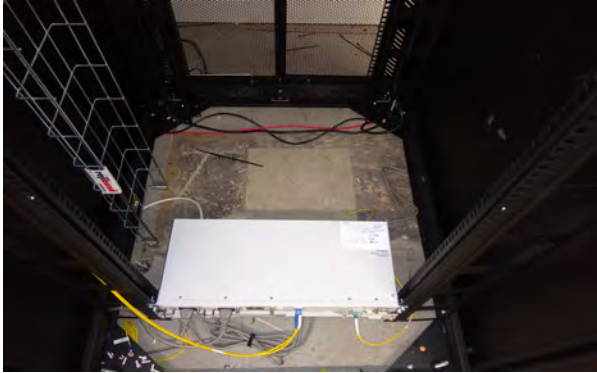
Item 69 Ref: 406299-7

The remnant floor covering below server in the server room (Rm 0/27) contains asbestos.

Any change in its appearance should be recorded and passed to Property Services.

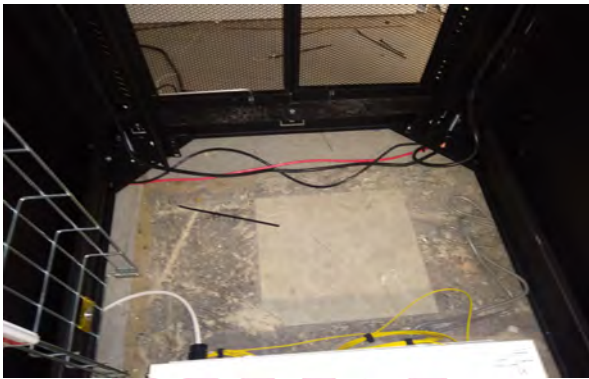
Item 70 Ref: 406299-8

The remnant adhesive to floor beneath linoleum in the server room (Rm 0/27) contains asbestos.

Any change in its appearance should be recorded and passed to Property Services.

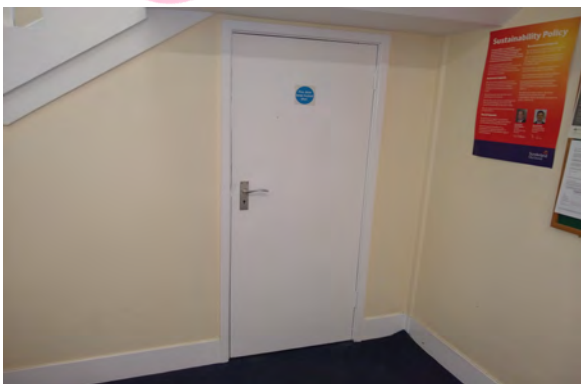
Item 71 Ref: 406299-3

The panel to door in the stairwell (Rm 0/28) contains asbestos.

Any change in its appearance should be recorded and passed to Property Services.

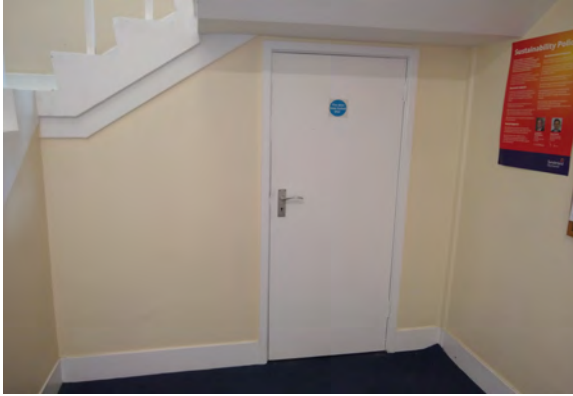
Item 72 Ref: 406299-4

The wall below stairs in the stairwell (Rm 0/28) contains asbestos.

Any change in its appearance should be recorded and passed to Property Services.

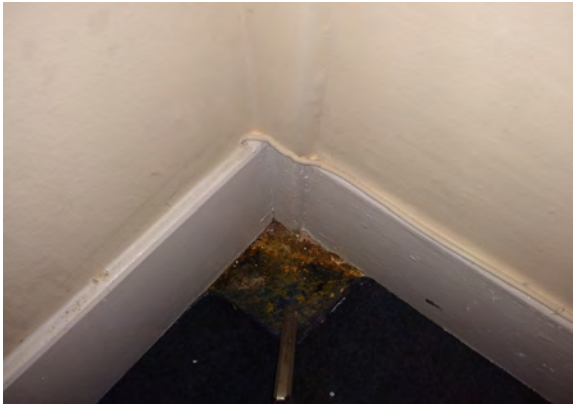
Item 73 Ref: 406299-5

The remnant adhesive to floor in the stairwell (Rm 0/28) does not contain asbestos.

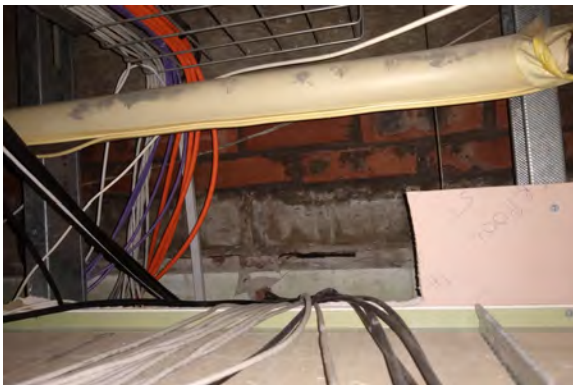
Item 74 Ref: As 406299-1

The membrane below concrete beam in the corridor – void above (Rm 0/33) does not contain asbestos.

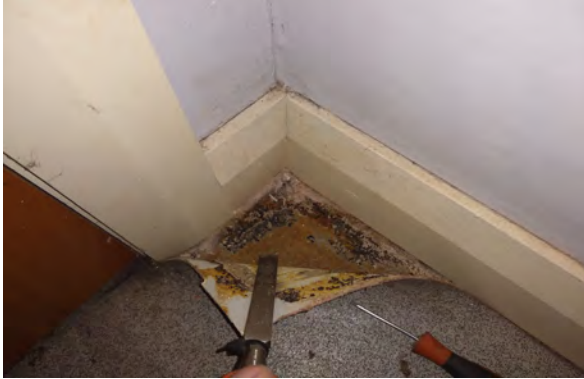
Item 75 Ref: As 406299-5

The remnant adhesive to floor in the interview room (Rm 0/35) does not contain asbestos.

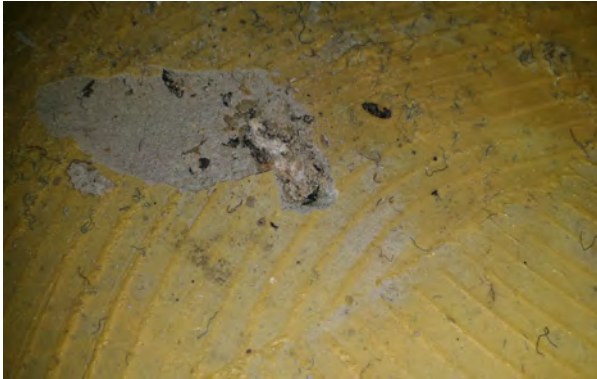
Item 78 Ref: As406299-14

The remnant adhesive backing to floor in the office (Rm 1/104 & 105) contains asbestos.

Any change in its appearance should be recorded and passed to Property Services.

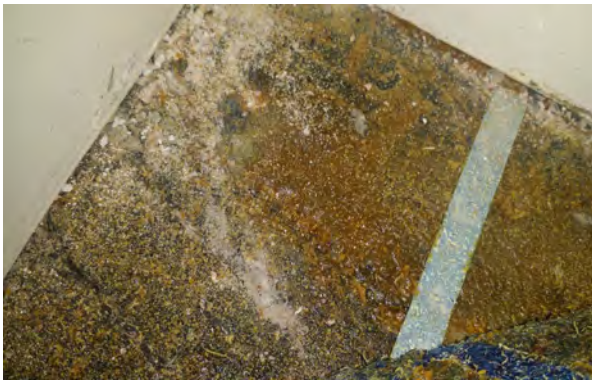
Item 79 Ref: As406299-14

The remnant adhesive backing to floor in the office (Rm 1/106 & 107) contains asbestos.

Any change in its appearance should be recorded and passed to Property Services.

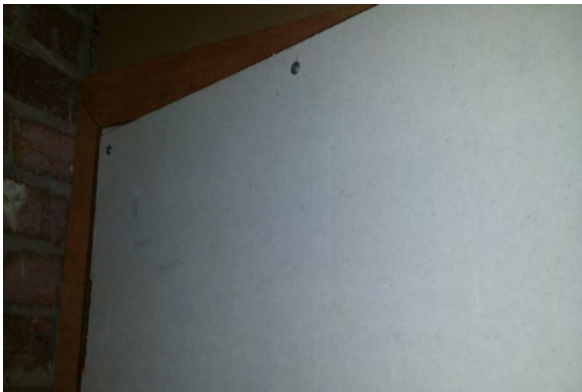
Item 82 Ref: 406299-11

The panel to back of the door in the riser cupboard (Rm 1/112) does not contain asbestos.

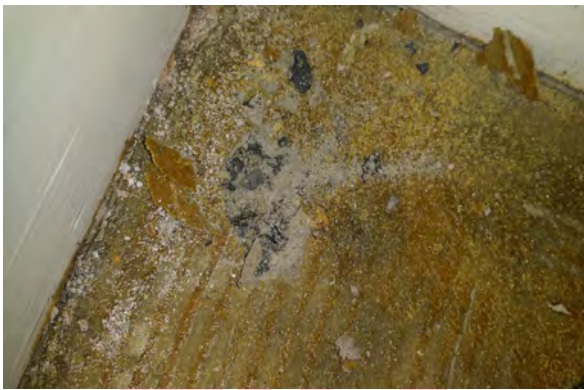
Item 85 Ref: As406299-14

The remnant adhesive backing to floor in the corridor (Rm 1/115) contains asbestos.

Any change in its appearance should be recorded and passed to Property Services.

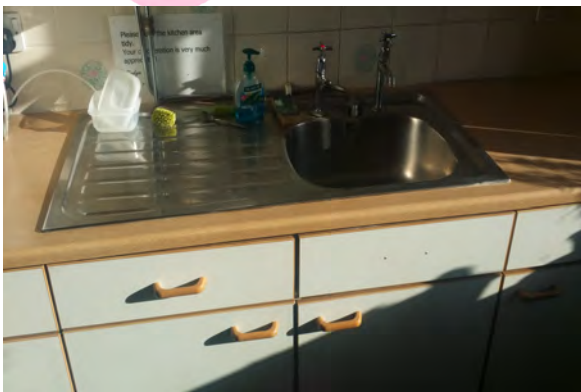
Item 86 Ref: 406299-20

The sink pad in the canteen (Rm 1/118) does not contain asbestos.

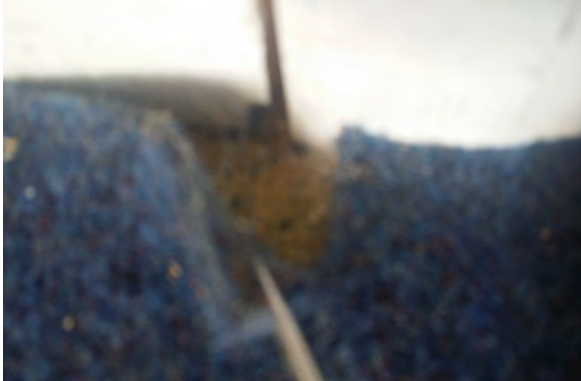
Item 87 Ref: 406299-19

The adhesive backing to floor in the office (Rm 1/127c) contains asbestos.

Any change in its appearance should be recorded and passed to Property Services.

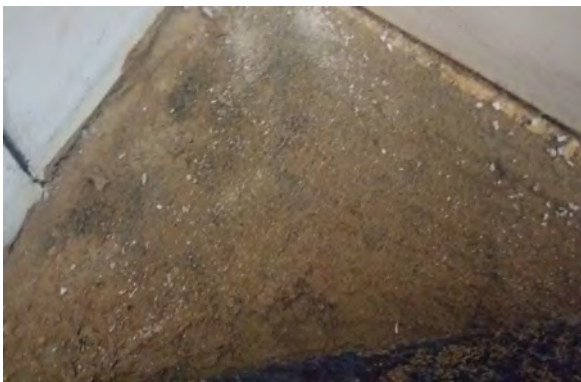
Item 88 Ref: As406299-19

The adhesive backing to floor in the office (Rm 1/128) contains asbestos.

Any change in its appearance should be recorded and passed to Property Services.

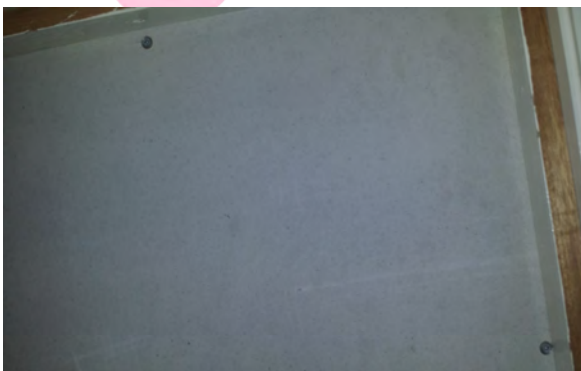
Item 89 Ref: 406299-31

The panel to back of the door in the riser cupboard (Rm 2/01) does not contain asbestos.

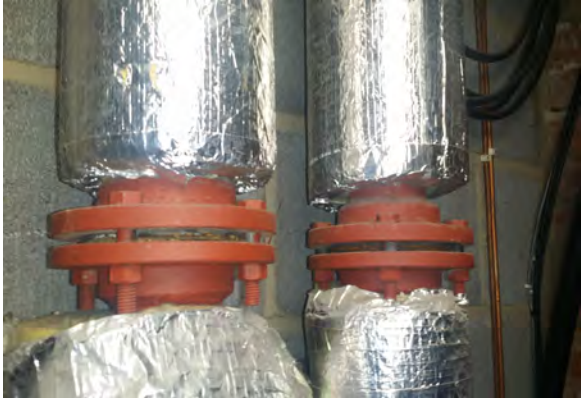
Item 90 Ref: 406299-32

The gasket to pipework in the riser cupboard (Rm 2/01) contains asbestos.

Any change in its appearance should be recorded and passed to Property Services.

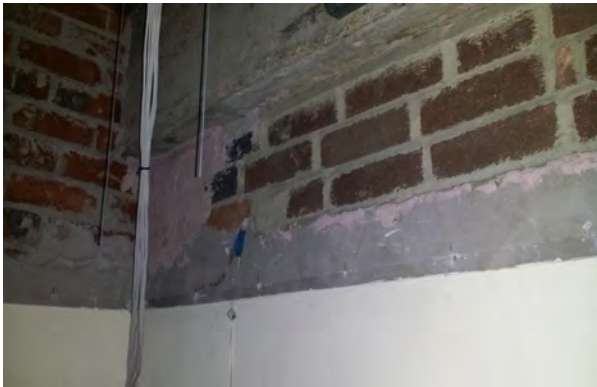
Item 91 Ref: As406299-37

The insulation to walls in the highways asset team office – void above (Rm 2/04) does not contain asbestos.

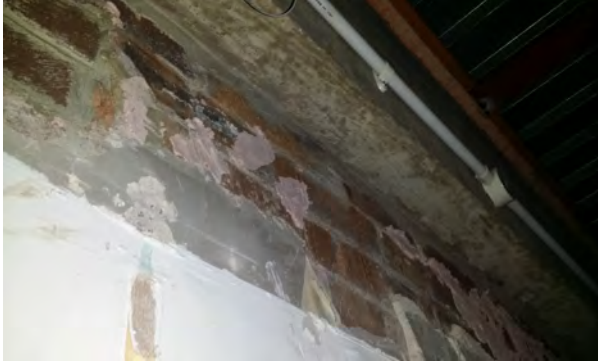
Item 93 Ref: 406299-37

The insulation to walls in the network ops office – void above (Rm 2/09) does not contain asbestos.

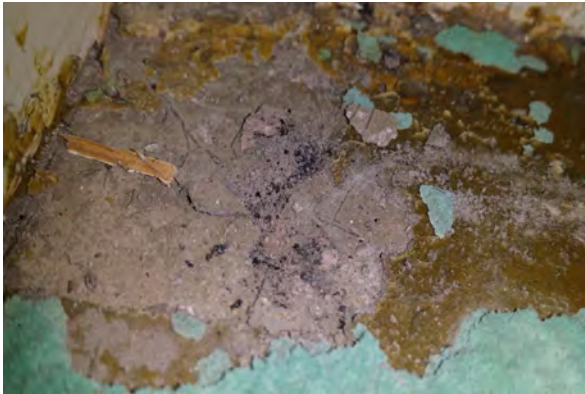
Item 94 Ref: As406299-15

The remnant adhesive backing to floor in the meeting room (Rm 2/11) contains asbestos.

Any change in its appearance should be recorded and passed to Property Services.

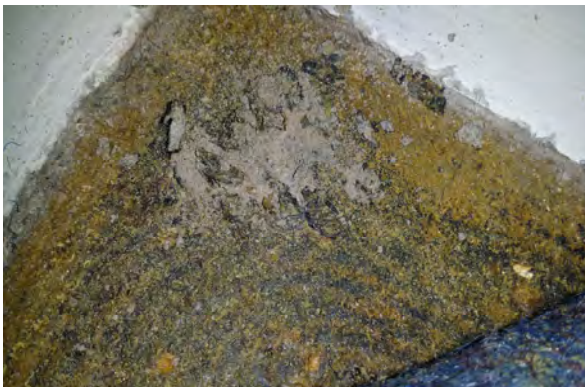
Item 95 Ref: 406299-15

The remnant adhesive backing to floor in the stairwell (Rm 2/210) contains asbestos.

Any change in its appearance should be recorded and passed to Property Services.

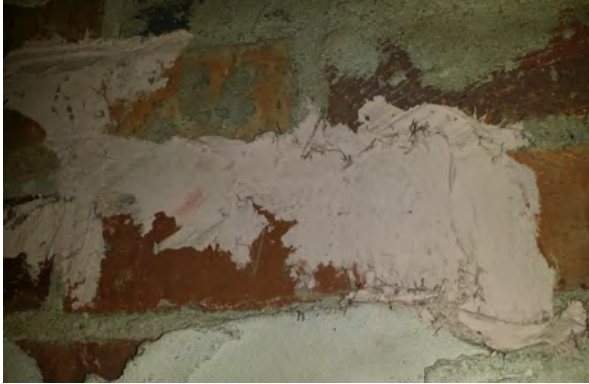
Item 96 Ref: 406299-16

The insulation to walls in the stairwell – void above (Rm 2/210) does not contain asbestos.

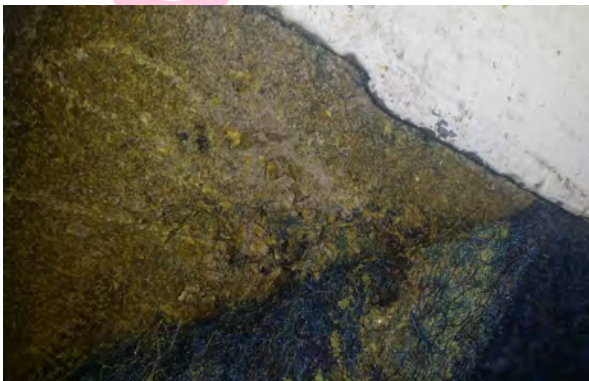
Item 98 Ref: As406299-15

The remnant adhesive backing to floor in the stairwell (Rm 2/227) contains asbestos.

Any change in its appearance should be recorded and passed to Property Services.

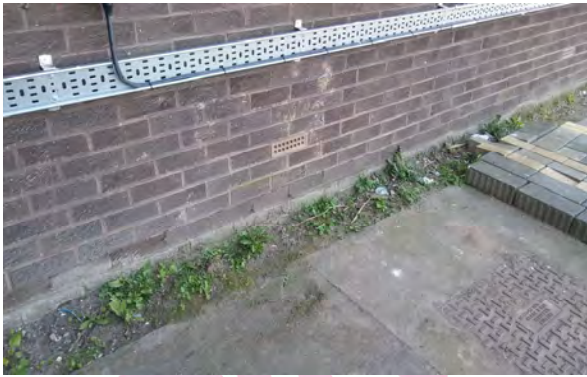
Item 100 Ref: 406299-71

The damp proof course to the main building (External) contains asbestos.

Any change in its appearance should be recorded and passed to Property Services.

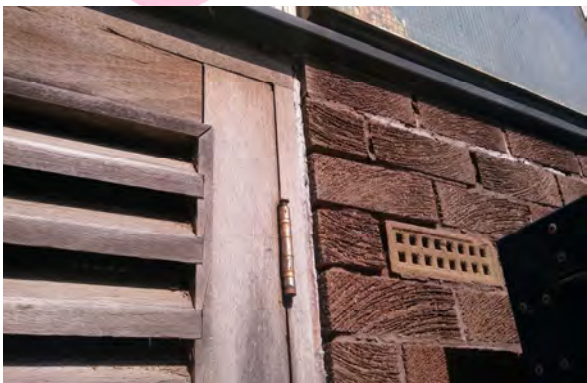
Item 101 Ref: 406299-72

The sealant to boiler house door to the main building (External) does not contain asbestos.

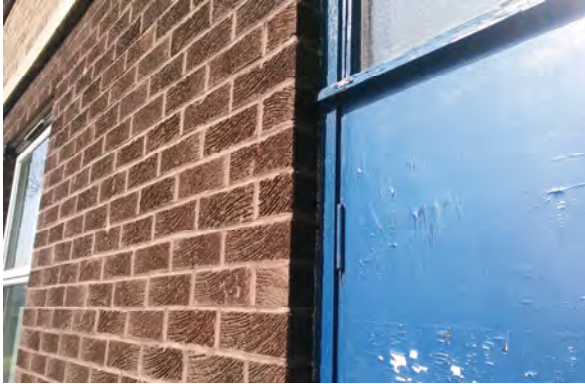
Item 102 Ref: 406299-73

The sealant to door frame to the main building - adj 009 (External) does not contain asbestos.

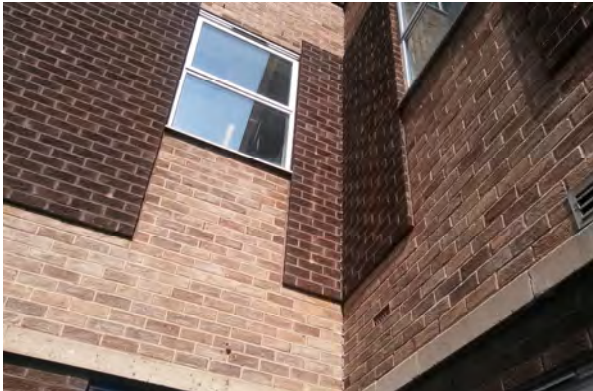
Item 103 Ref: 406299-74

The expansion joint to the main building adj 009 (External) contains asbestos.

Any change in its appearance should be recorded and passed to Property Services.

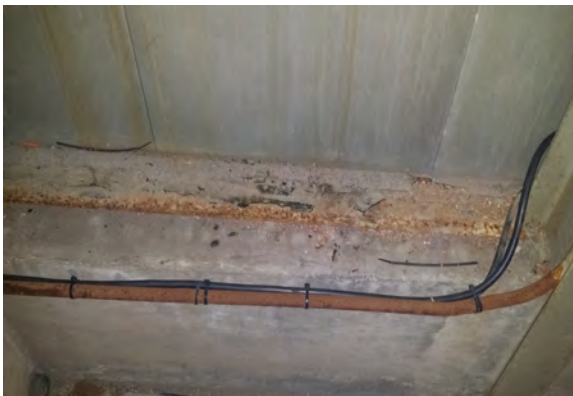
Item 106 Ref: 406299-35

The covering above concrete ledge in the tank room (Rm 3/001) does not contain asbestos.

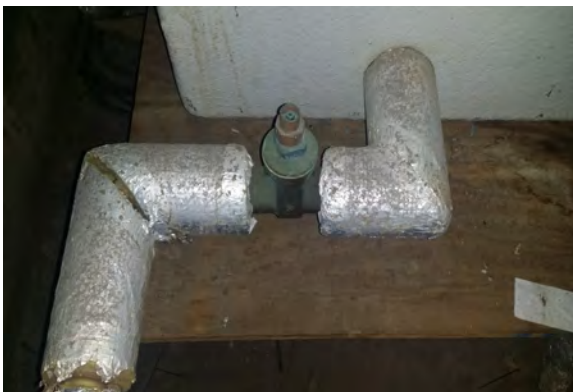
Item 107 Ref: 406299-36

The gasket to pipework in the tank room (Rm 3/001) contains asbestos.

Any change in its appearance should be recorded and passed to Property Services

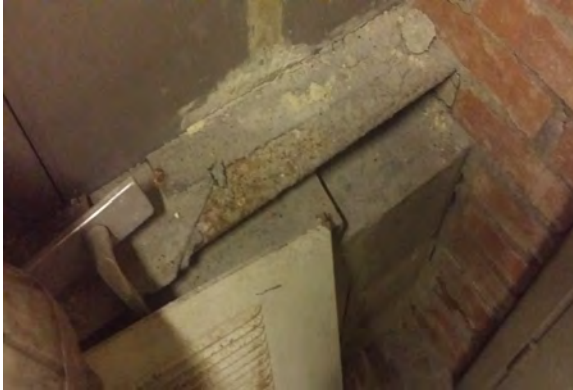
Item 108 Ref: 406299-18

The felt to metal wall frame in the lift motor room access lobby above mens toilet riser (Rm 3/002) does not contain asbestos.

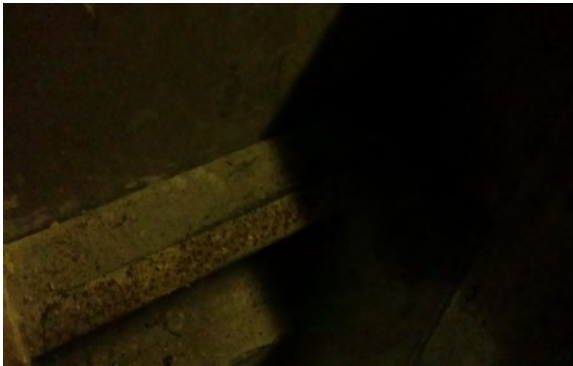
Item 109 Ref: As 406299-18

The felt to metal wall frame in the lift motor room (Rm 3/003) does not contain asbestos.

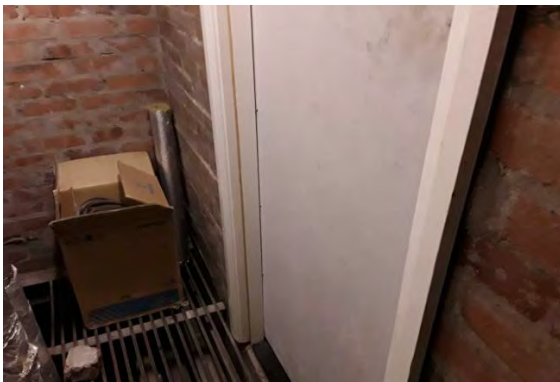
Item 156 Ref: 22-43097-1

The insulating board to rear of entrance (Area 1/Plant Room) does not contain asbestos.

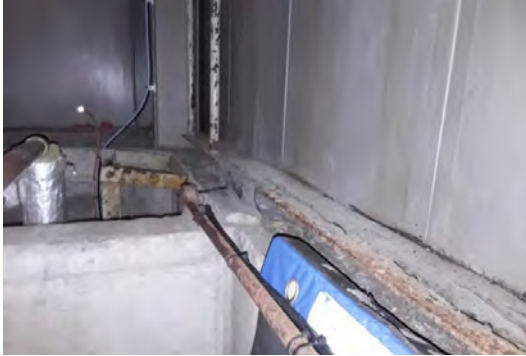
Item 157 Ref: 22-43097-2

The flashing to walls (Area 1/Plant Room) does not contain asbestos.

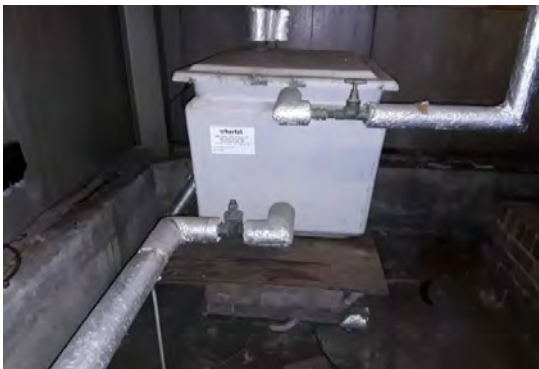
Item 158 Ref: 22-43097-3

The stop taps gaskets (Area 1/Plant Room) contain asbestos.

Removed October 2022

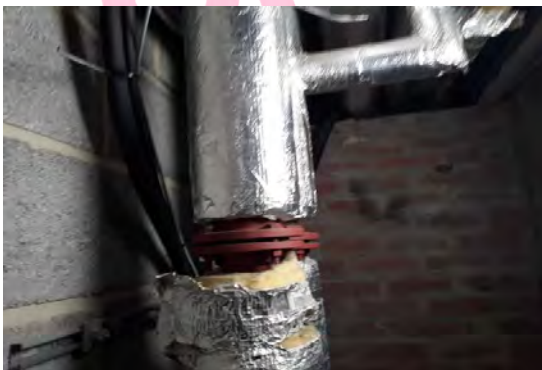
Item 159 Ref: 22-43097-6

The pipe flange gaskets (Area 1/Plant Room) contain asbestos.

Removed October 2022

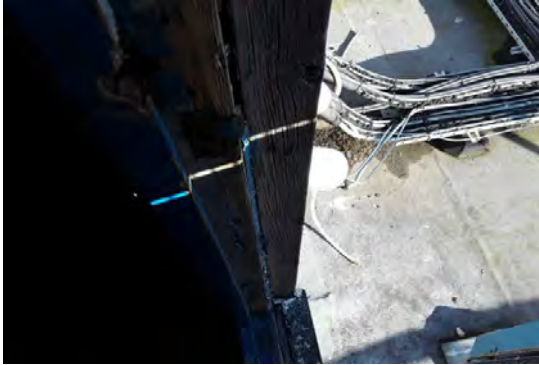
Item 160 Ref: 22-43097-4

The door frame sealant (Area 2/External Area around flue) contains asbestos.

Any change in its appearance should be recorded and passed to Property Services

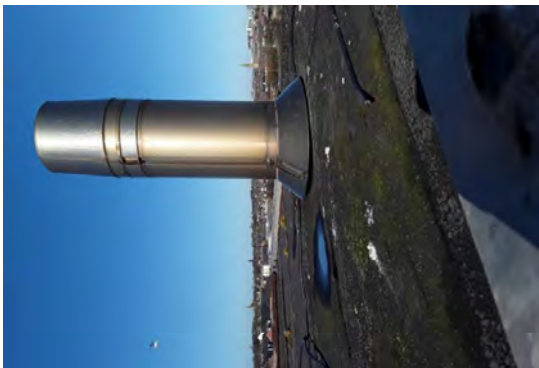
Item 161 Ref: 22-43097-5

The felt around external flue (Area 2/External area) does not contain asbestos.

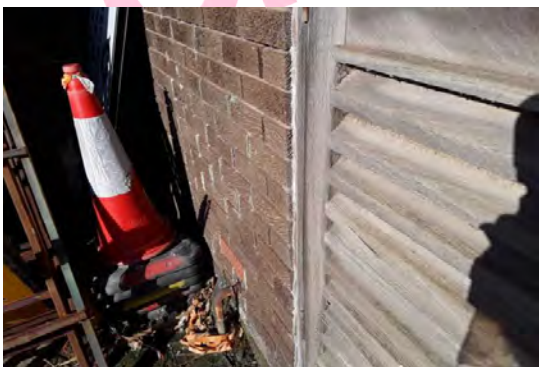
Item 162 Ref: 22-43097-10

The door frame sealant (Area 3 /Main Boiler Room) does not contain asbestos.

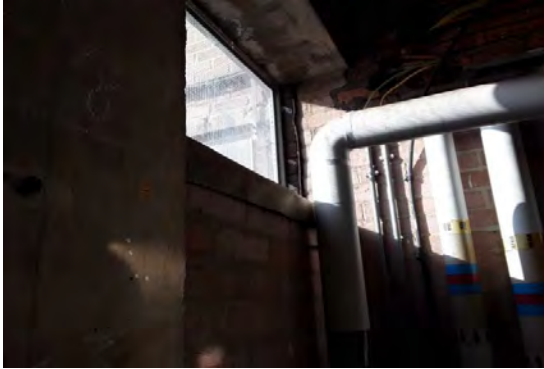
Item 163 Ref: 22-43097-7

The flashing beneath windows (Area 3 /Main Boiler Room) contains asbestos.

Any change in its appearance should be recorded and passed to Property Services

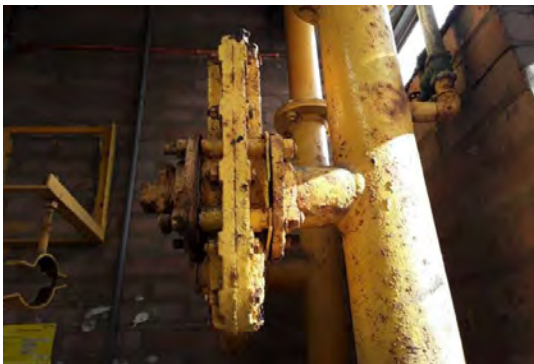
Item 164 Ref: 22-43097-9

The flanges to gas pipes (Area 3/Main Boiler Room) do not contain asbestos.

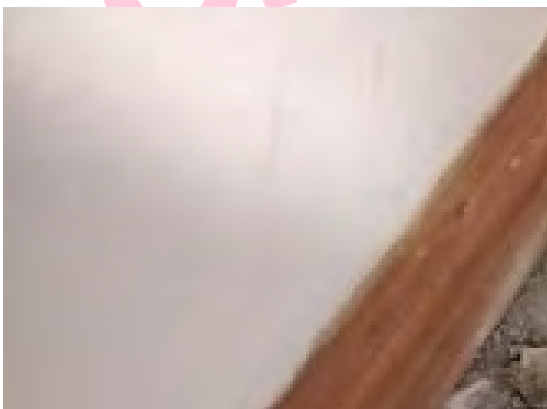
Item 165 Ref: VA004895

The bitumen adhesive to floor below screed in the Ground Floor Lift Corridor contains asbestos.

Any change in its appearance should be recorded and passed to Property Services

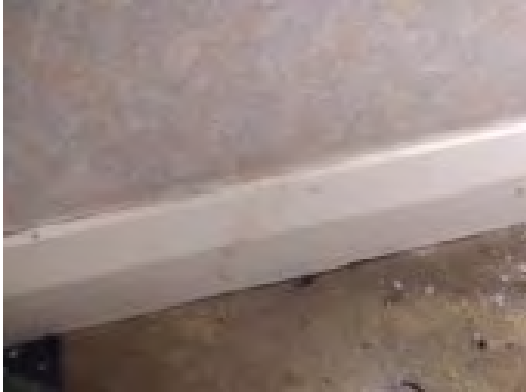
Item 166 Ref: VA004896

The bitumen adhesive to floor below screed in the First Floor Lift Corridor contains asbestos.

Any change in its appearance should be recorded and passed to Property Services

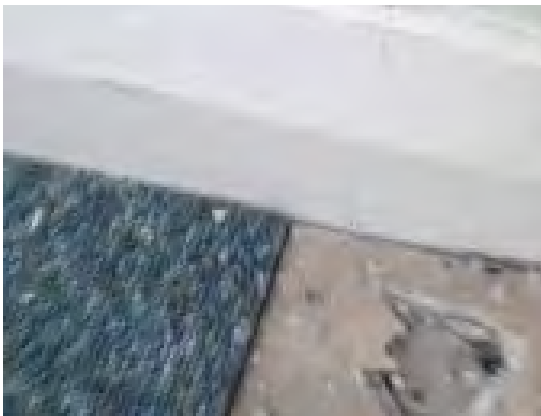
Item 167 Ref: VA004897

The bitumen adhesive to floor below screed in the Second Floor Lift Corridor contains asbestos.

Any change in its appearance should be recorded and passed to Property Services

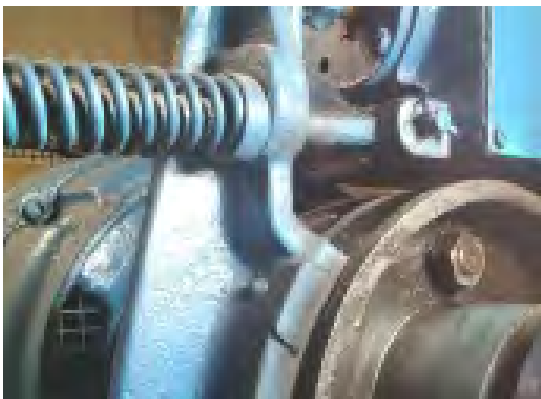
Item 168 Ref: VA004899

The brake pads to lift motor in the Second Floor Lift Motor Room contains asbestos.

Removed May 2024.

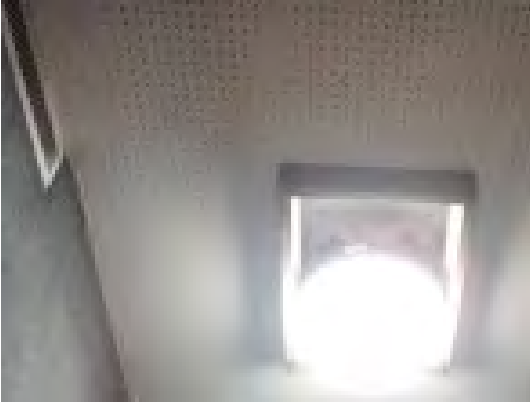
Item 169 Ref: DC003894

The ceiling in the lift cabin (G/001) does not contain asbestos.
