ASBESTOS SURVEY REPORT FOR JACK CRAWFORD HOUSE,
COMMERCIAL ROAD, SUNDERLAND, SR2 8QR.

Jack Crawford House, Commercial Road, SR2 8QR

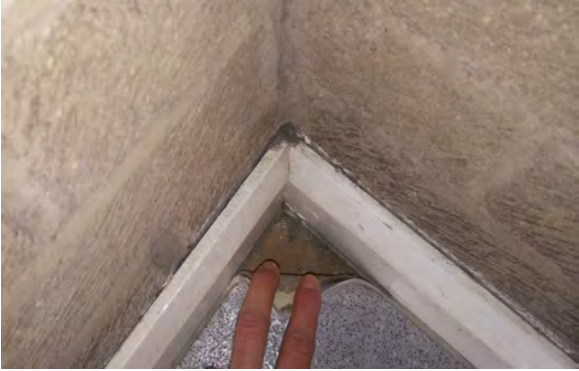
Item 110 Ref: As 406299-41

The subfloor in the Depot - entrance lobby (Rm 0/140) does not contain asbestos.

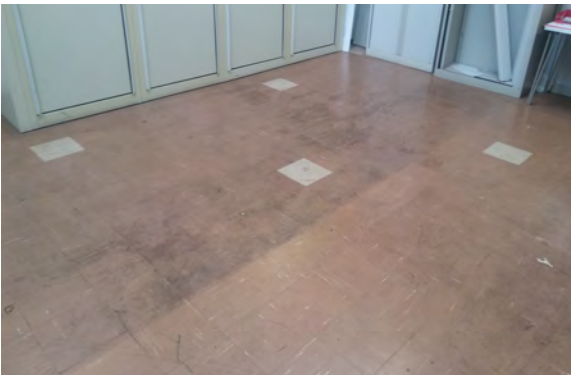
Item 111 Ref: 406299-41

The floor covering in the Depot - circulation (Rm 0/141) does not contain asbestos.

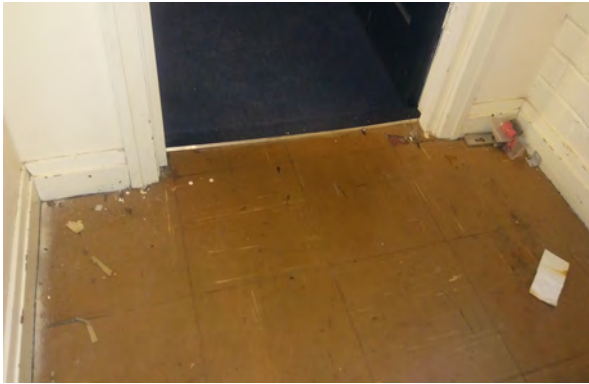
Item 113 Ref: As 406299-41

The floor covering in the Depot – store (Rm 0/143) does not contain asbestos.

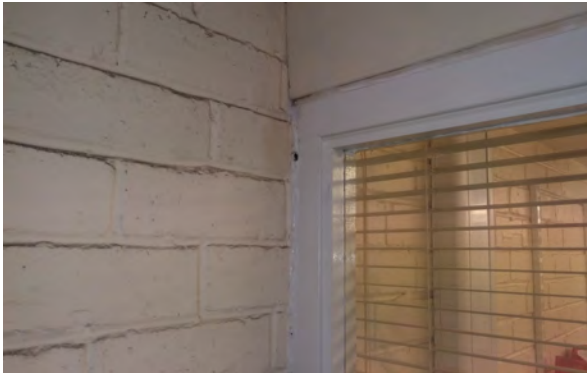
Item 116 Ref: 406299-44

The sealant to partition wall adj 049 in the Depot store (Rm 0/148) contains asbestos.

Any change in its appearance should be recorded and passed to Property Services.

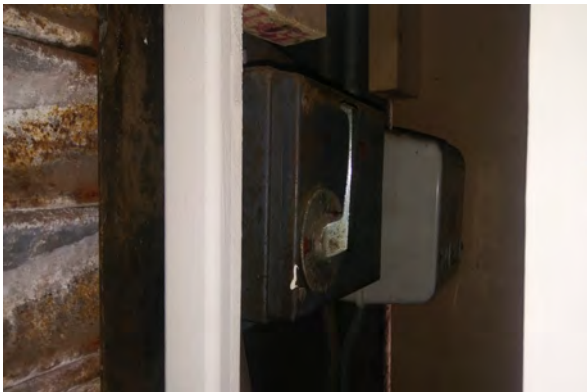
Item 117 Ref: Presumed

The MEM switch gear adj roller shutter in the Depot store (Rm 0/151) contains asbestos.

Any change in its appearance should be recorded and passed to Property Services.

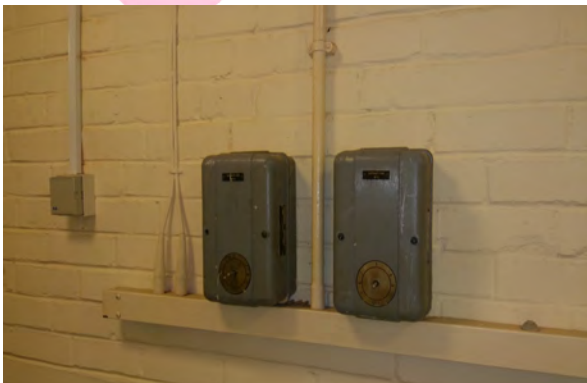
Item 118 Ref: Presumed

The extractor fan regulators in the Depot circulation (Rm 0/157) contains asbestos.

Any change in its appearance should be recorded and passed to Property Services.

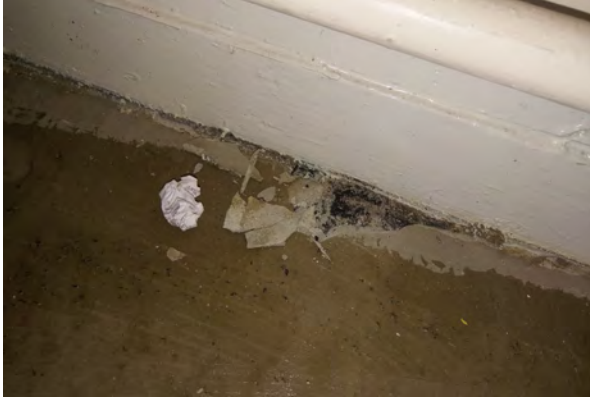
Item 119 Ref: 406299-55

The remnant adhesive to floor beneath screed in the Depot canteen (Rm 0/159) contains asbestos.

Any change in its appearance should be recorded and passed to Property Services.

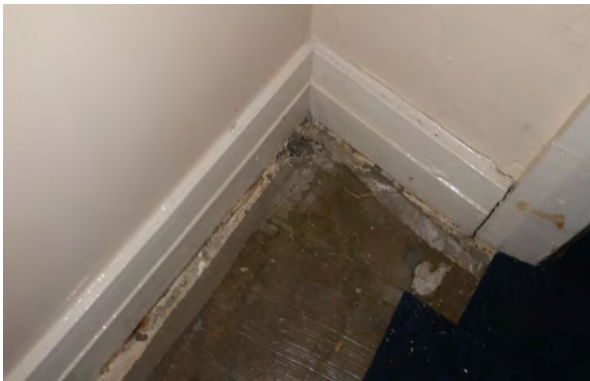
Item 120 Ref: 406299-56

The subfloor in the Depot office (Rm 0/160) contains asbestos.

Any change in its appearance should be recorded and passed to Property Services.

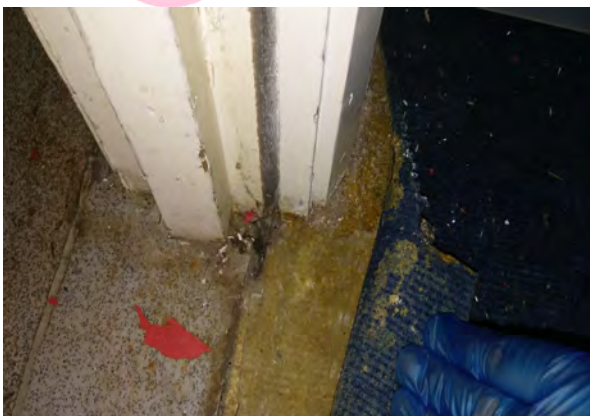
Item 121 Ref: As 406299-55

The remnant adhesive to floor beneath screed in the Depot store (Rm 0/162) contains asbestos.

Any change in its appearance should be recorded and passed to Property Services.

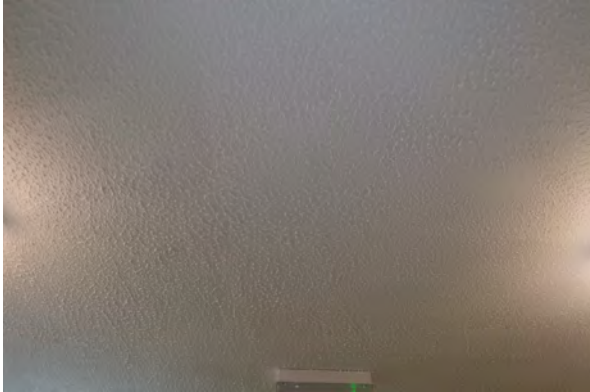
Item 122 Ref: 406299-54

The decorative finish to ceiling in the Depot female wc (Rm 0/164) contains asbestos.

Any change in its appearance should be recorded and passed to Property Services.

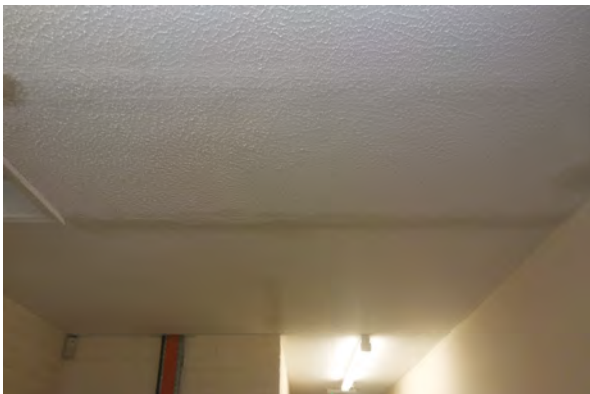
Item 123 Ref: 406299-52

The decorative finish to ceiling in the Depot circulation (Rm 0/170) contains asbestos.

Any change in its appearance should be recorded and passed to Property Services.

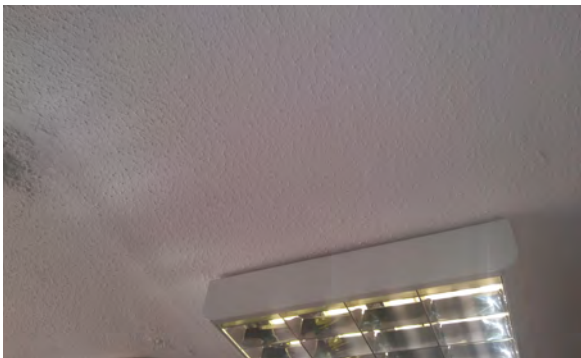
Item 124 Ref: As 406299-52

The decorative finish to ceiling in the Depot office (Rm 0/171) contains asbestos.

Any change in its appearance should be recorded and passed to Property Services.

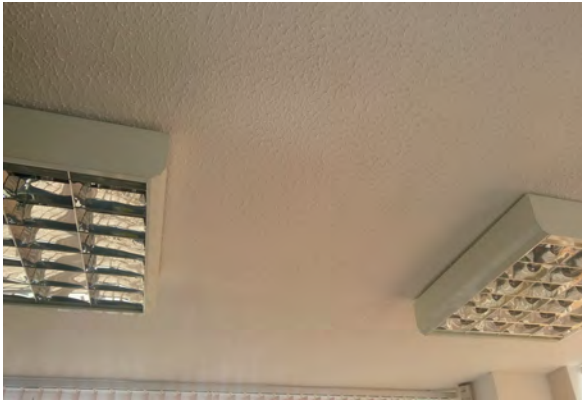
Item 125 Ref: As 406299-52

The decorative finish to ceiling in the Depot office (Rm 0/172) contains asbestos.

Any change in its appearance should be recorded and passed to Property Services.

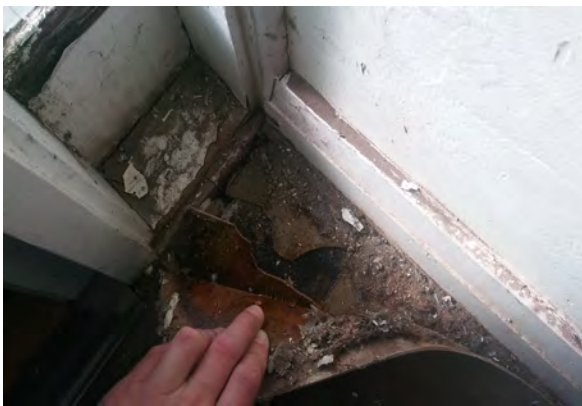
Item 126 Ref: As 406299-53

The subfloor in the Depot store (Rm 0/175) contains asbestos.

Any change in its appearance should be recorded and passed to Property Services.

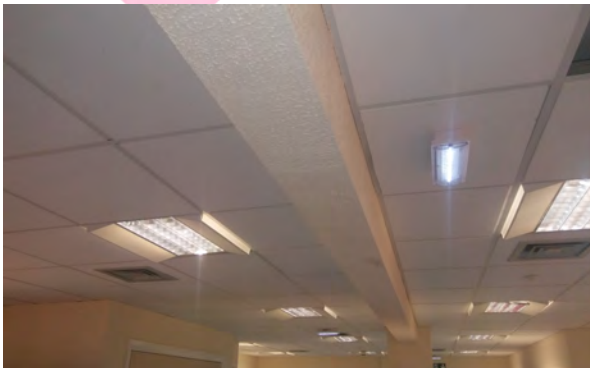
Item 127 Ref: 406299-46

The decorative finish to beam in the Depot staff room (Rm 0/182) contains asbestos.

Any change in its appearance should be recorded and passed to Property Services.

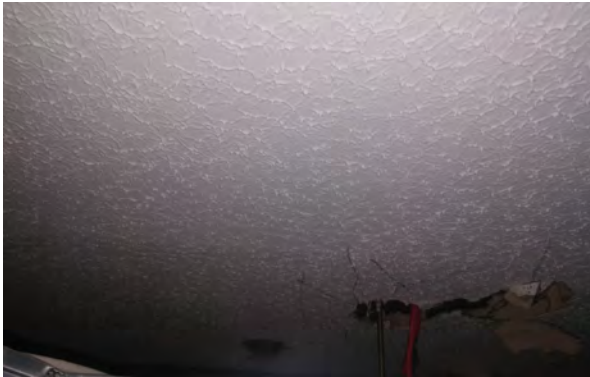
Item 128 Ref: 406299-45

The decorative finish to fixed ceiling and beam in the Depot staff room – void above suspended ceiling (Rm 0/182) contains asbestos.

Any change in its appearance should be recorded and passed to Property Services.

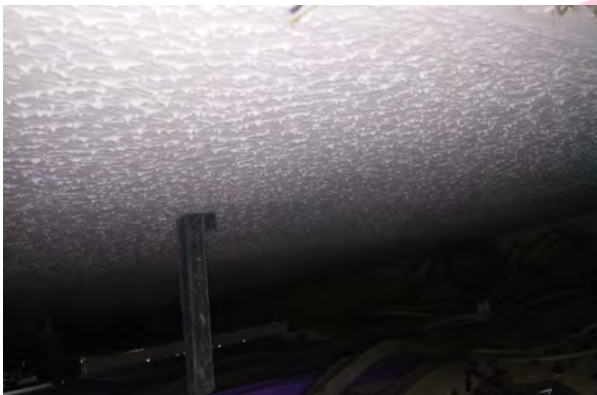
Item 129 Ref: As 406299-45

The decorative finish to ceiling in the Depot server room – void above suspended ceiling (Rm 0/183) contains asbestos.

Any change in its appearance should be recorded and passed to Property Services.

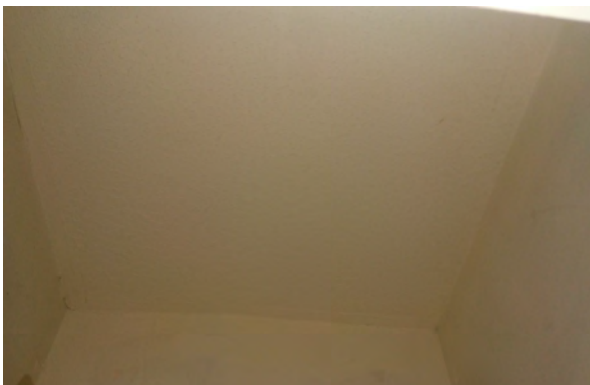
Item 130 Ref: As 406299-45

The decorative finish to ceiling in the Depot Store (Rm 0/183a) contains asbestos.

Any change in its appearance should be recorded and passed to Property Services.

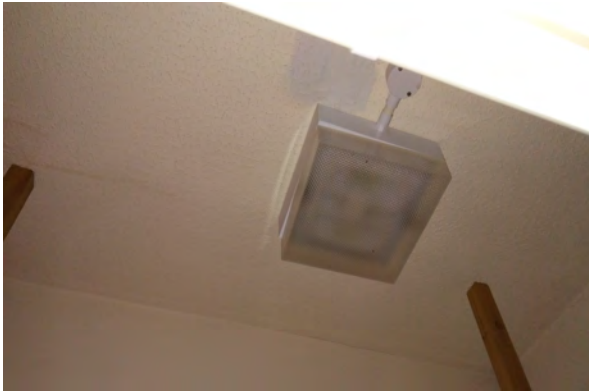
Item 131 Ref: As 406299-52

The decorative finish to ceiling in the Depot Store (Rm 0/184) contains asbestos.

Any change in its appearance should be recorded and passed to Property Services.

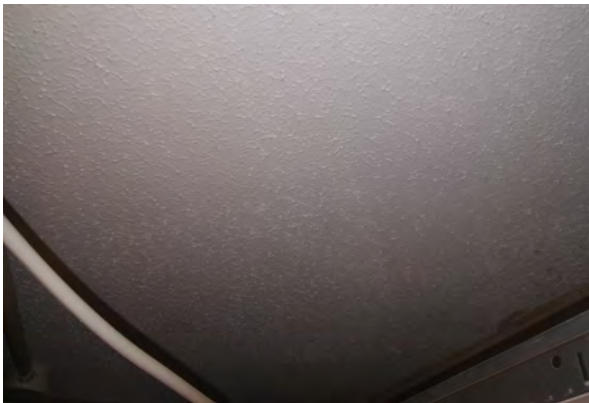
Item 132 Ref: As 406299-45

The decorative finish to ceiling in the Depot circulation – void above suspended ceiling (Rm 0/185) contains asbestos.

Any change in its appearance should be recorded and passed to Property Services.

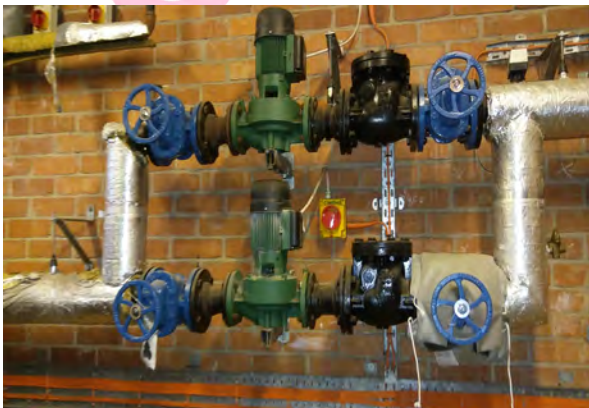
Item 133 Ref: 406299-62

- (Item 133) Ref: 406299—62 – Gasket to pipework (0/191/Boiler room) – Very Low Risk
- (Item 134) Ref: 406299-47 – Textured coating to loose lying timber frames (1/170/Circulation plant room above) – No Risk

The gasket to boiler house in the Depot boiler house (Rm 0/191) contains asbestos.

Any change in its appearance should be recorded and passed to Property Services.

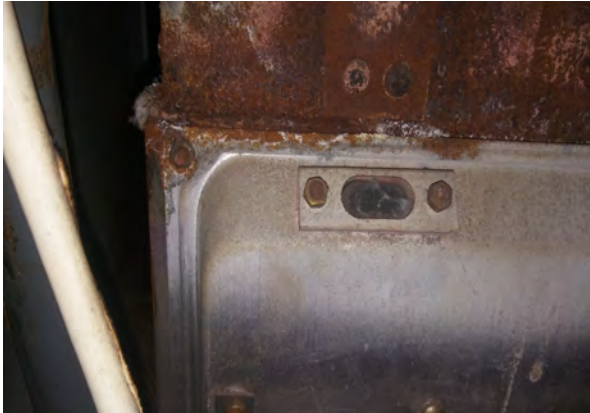
Item 135 Ref: 406299-48

The gasket to redundant boiler sight glass in the Depot circulation – plant room above (Rm 0/170) contains asbestos.

Any change in its appearance should be recorded and passed to Property Services.

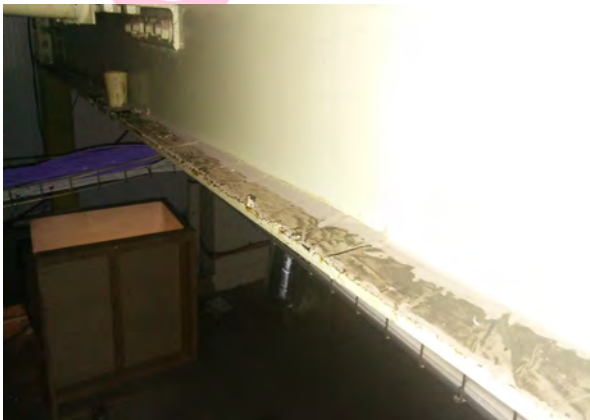
Item 136 Ref: 406299-49

The felt to beams in the Depot circulation – plant room above (Rm 1/170) does not contain asbestos.

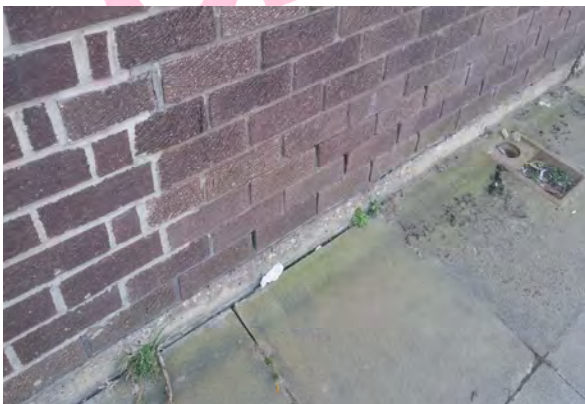
Item 139 Ref: 406299-57

The damp proof course to the Depot (External) contains asbestos.

Any change in its appearance should be recorded and passed to Property Services.

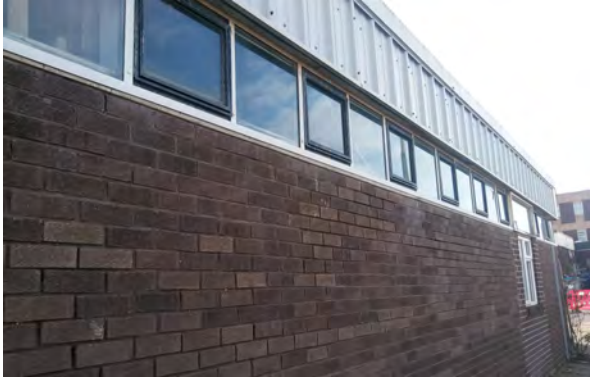
Item 140 Ref: 406299-58

The remnant mastic to brick wall and high level windows to north elevation to the Depot (External) does not contain asbestos.

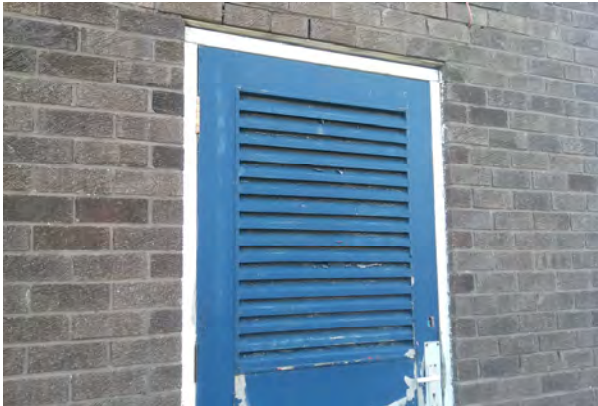
Item 141 Ref: 406299-59

The sealant to boiler room door frame to the Depot (External) does not contain asbestos.

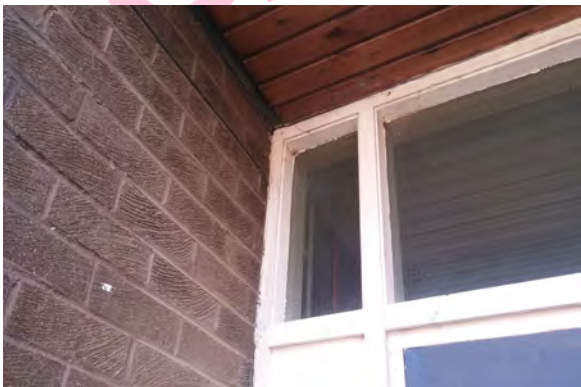
Item 142 Ref: 406299-60

The sealant to door frame 0/158 to the Depot (External) does not contain asbestos.

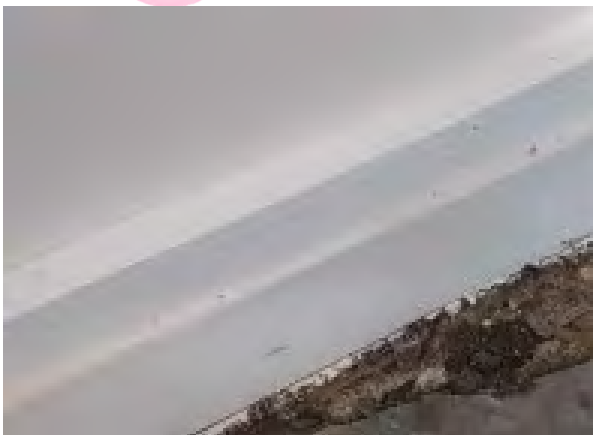
Item 145 Ref: 21-33672-2

The screed below top layer of screed in Refuse Supervisors Office does not contain asbestos.

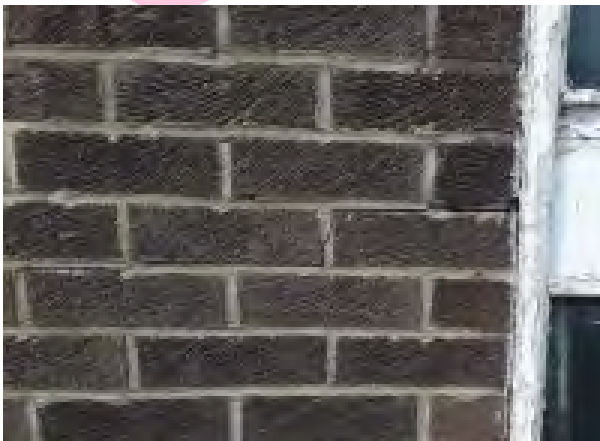
Item 148 Ref: 21-33925-2

The frame sealant to the brickwork around frame (Area 1/External access door to offices, toilet and canteen) does not contain asbestos.

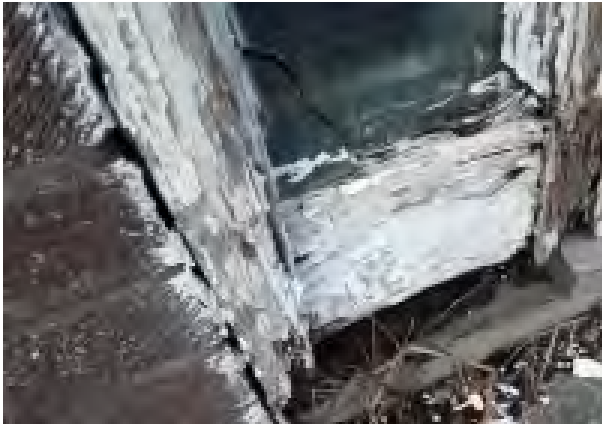
Item 149 Ref: 21-33925-3

The damp proof course (Area 1/External access door to offices, toilet and canteen) does contain asbestos.

Any change in its appearance should be recorded and passed to Property Services.

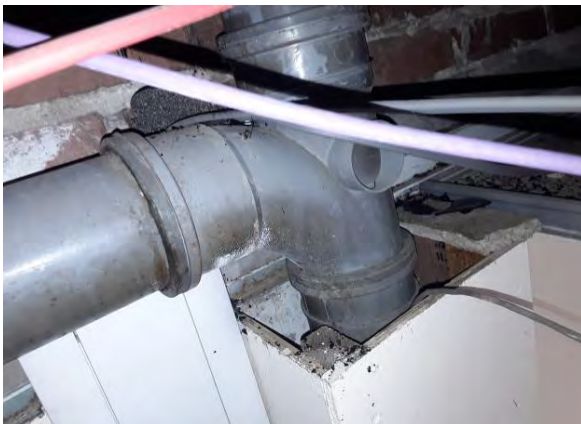
Item 152 Ref: 21-33618-1

The felt debris around downpipes penetration to Area 1 (Ceiling void above office, refuse team) does not contain asbestos.

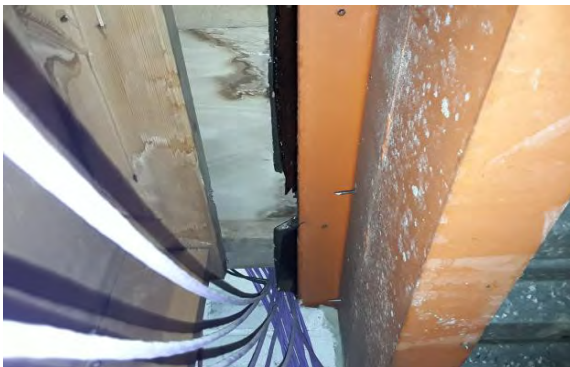
Item 153 Ref: 21-33618-2

The felt debris around downpipes penetration to Area 2 (Ceiling void above environmental services office) does not contain asbestos.

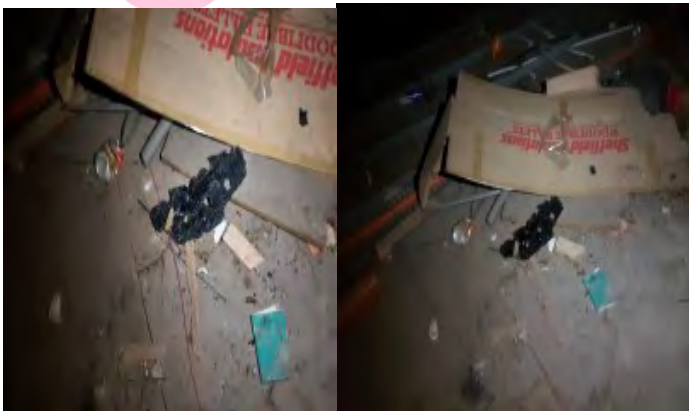
Item 174 Ref: RO001392

The bitumen debris on the ledge in the circulation 185 area does not contain asbestos.

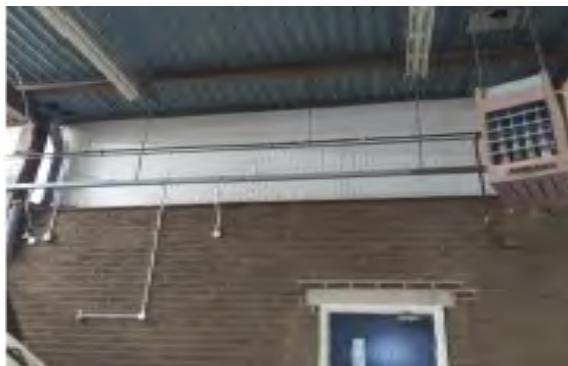
Item 176 Ref: HD001081

The galbestos ceiling in the Highways store (G/01) does not contain asbestos.

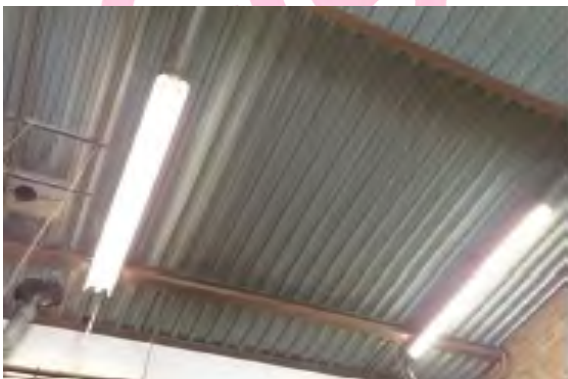
Item 177 Ref: As HD001081

The galbestos ceiling in the Highways store (G/02) does not contain asbestos.

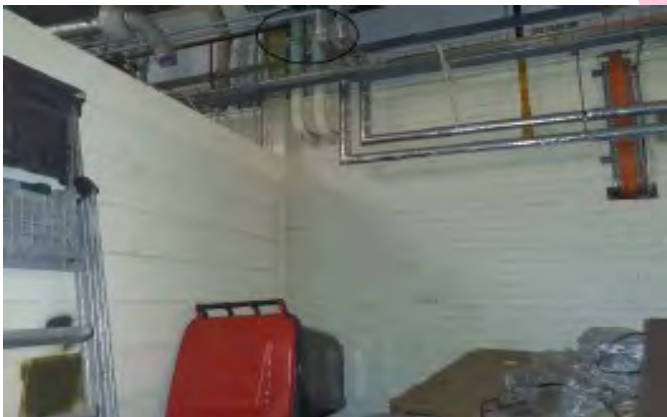
Item 179 Ref: As HD001081

The galbestos ceiling in the Highways store (G/04) does not contain asbestos.
