ASBESTOS SURVEY REPORT FOR SUNDERLAND EMPIRE THEATRE, 4-5 HIGH STREET WEST, SUNDERLAND, SR1 3EX

## *Control of Asbestos Regulations 2012*

**Sunderland Empire Theatre, 4-5 High Street West,  
Sunderland, SR1 3EX**

**Date: 19 January 2026**

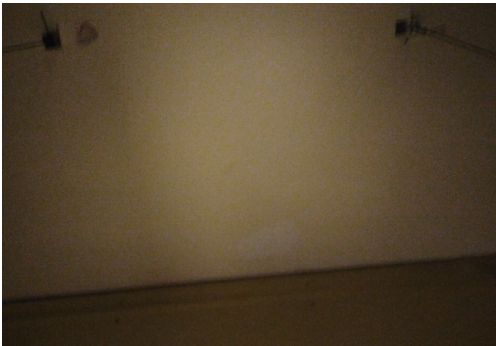
### **Item 1 Ref: 405964-48**

- (Item 1) Ref: 405964-48 – Ceiling - textured coating (0/003/office - void above) – No Risk
- (Item 2) Ref: 405964-49 – Ceiling - textured coating (0/013/storage area) – No Risk

The ceiling - textured coating (0/003/office - void above) does not contain asbestos.

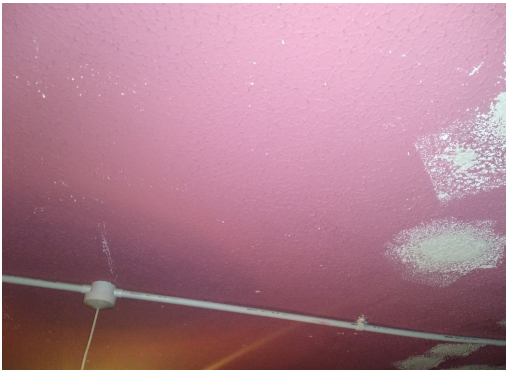
### **Item 2 Ref: 405964-49**

The ceiling - textured coating (0/013/storage area) does not contain asbestos.

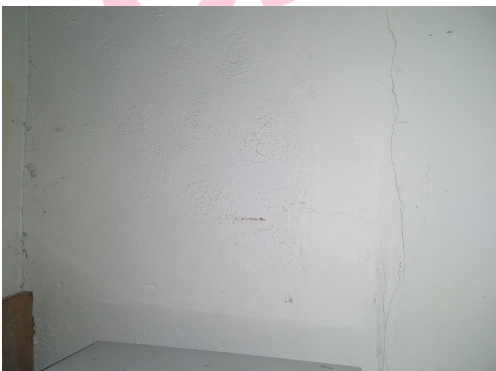
### **Item 3 Ref: 405964-54**

The wall – textured coating (0/013/storage area) does not contain asbestos.

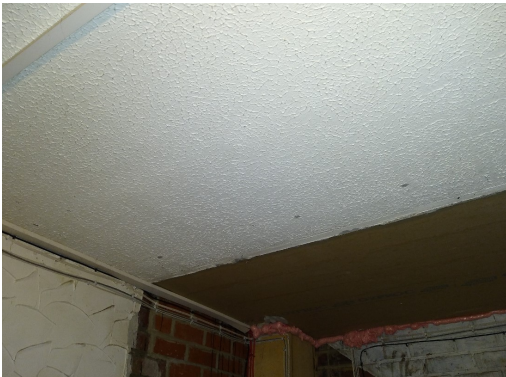
**Item 4 Ref: 405964-44**

The ceiling - textured coating (1/018/storage area) does not contain asbestos.

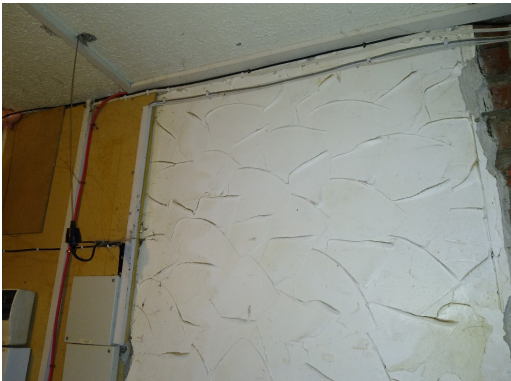
**Item 5 Ref: 405964-45**

The wall – textured coating (1/018/storage area) does not contain asbestos.

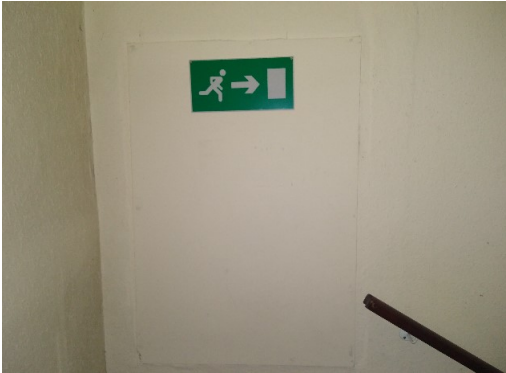
**Item 10 Ref: 405964-40**

The panel to wall – insulating board (2/002/landing & stairwell) does not contain asbestos.

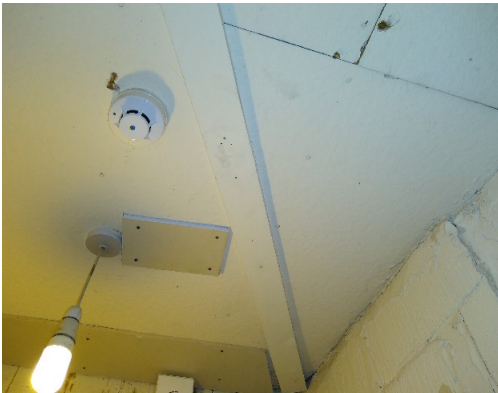
**Item 11 Ref: 405964-41**

The ceiling - fibreboard (2/007/landing & stairwell 3) does not contain asbestos.

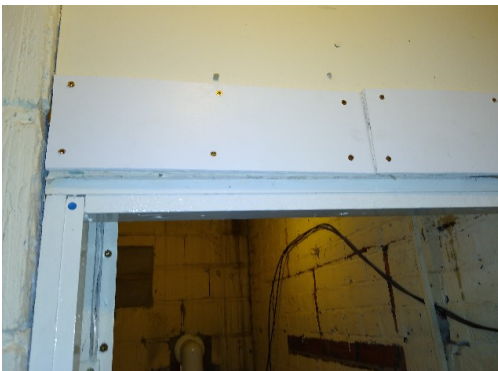
**Item 12 Ref: As 405964-40**

The panel above door – insulating board (2/007/landing & stairwell 3) does not contain asbestos.

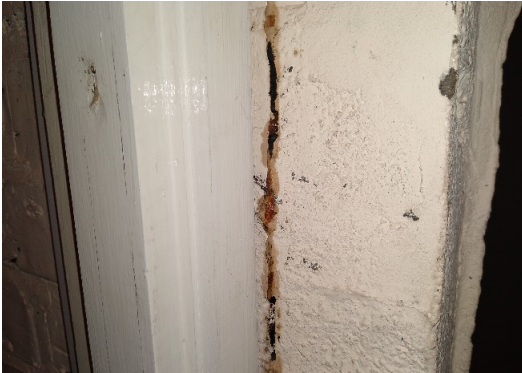
### **Item 13 Ref: 405964-42**

The wall beside door frame to boiler room – bituminous product (2/007/landing & stairwell 3) does not contain asbestos.

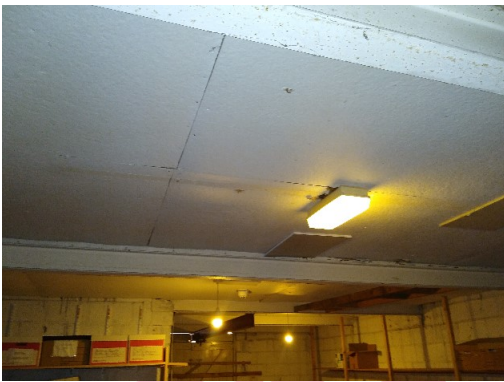
### **Item 14 Ref: As 405964-41**

The ceiling – fibreboard (2/009/archive room) does not contain asbestos.

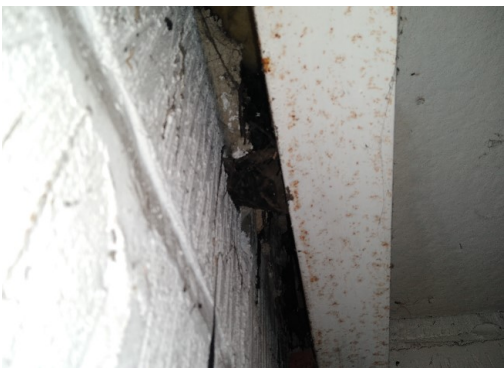
### **Item 15 Ref: 405964-43**

The flat roof debris – bituminous felt (2/009/archive room) does not contain asbestos.

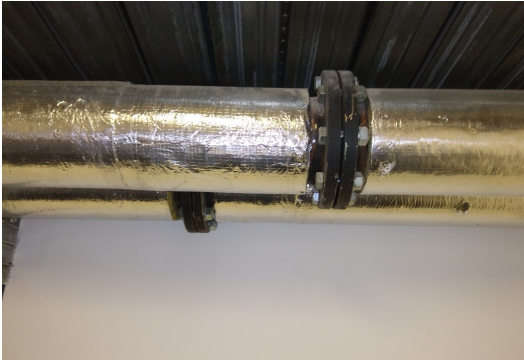
**Item 19 Ref: As 405964-35**

The pipework flange gaskets (0/005/bandroom) do not contain asbestos.

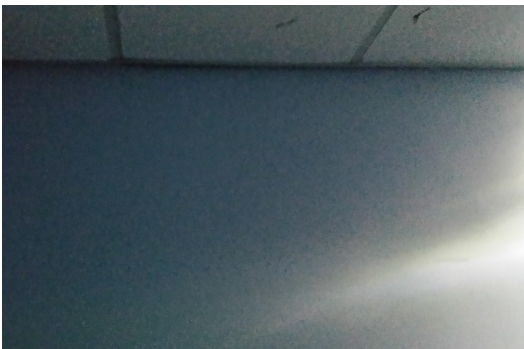
**Item 21 Ref: As 405964-24**

The cladding to column behind plaster (1/003A/stairwell) does not contain asbestos.

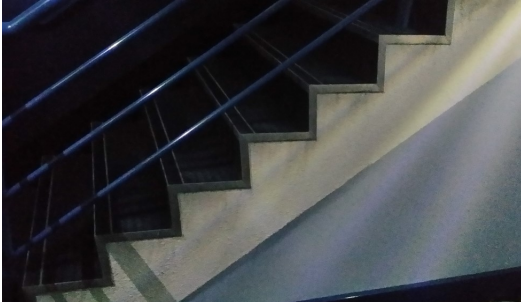
### **Item 22 Ref: 405964-25**

The decorative finish to side of stairs – textured coating (1/003A/stairwell) does not contain asbestos.

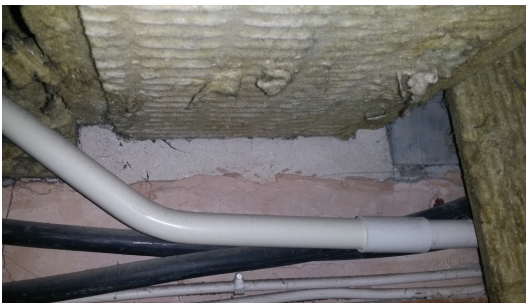
### **Item 23 Ref: As 405964-24**

The cladding to column (1/003A/stairwell void above) does not contain asbestos.

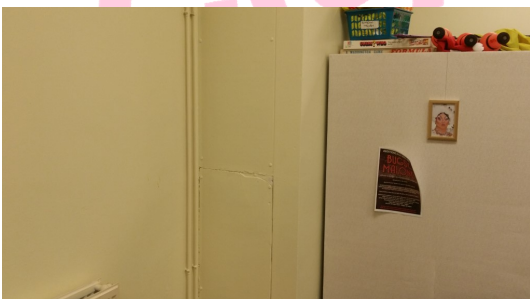
### **Item 24 Ref: 405964-20**

The panels to boxing (1/005/green room) do not contain asbestos.

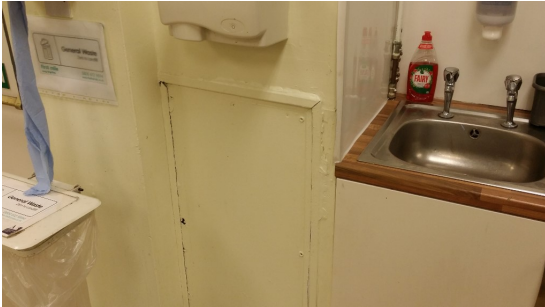
**Item 25 Ref: 405964-23**

The panels to boxing – insulating board (1/005/green room) do not contain asbestos.

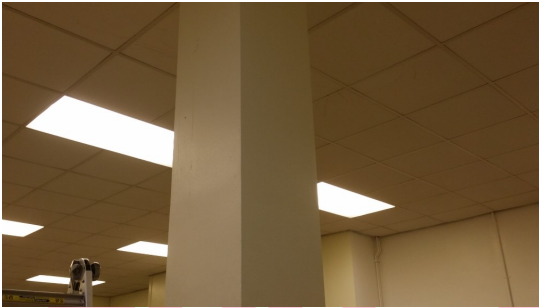
**Item 26 Ref: 405964-24**

The boxing to columns (1/005/green room) do not contain asbestos.

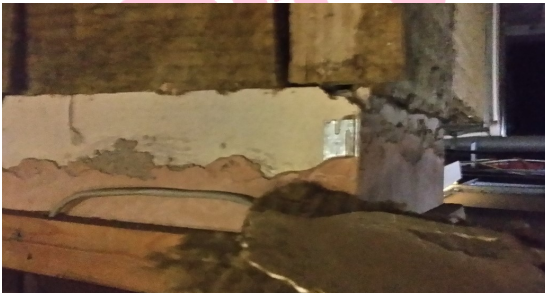
**Item 27 Ref: As 405964-24**

The boxing to columns (1/005/green room void above) do not contain asbestos.

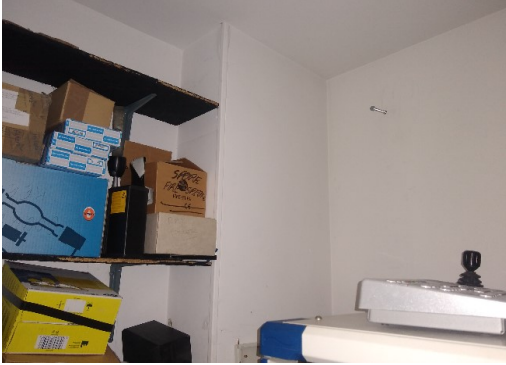
### **Item 28 Ref: 405964-37**

The column cladding (1/005A/rack room) does not contain asbestos.

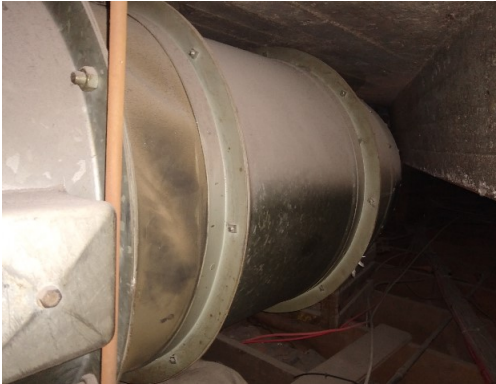
**Item 31 Ref: 405964-85**

- (Item 31) Ref: 405964-85 – Ductwork flange gaskets (1/020/stalls seating area-void above) – Very Low Risk
- (Item 32) Ref: As 405964-85 – Flange gaskets to loose lying ductwork sections (1/020/stalls seating area-void above) – Very Low Risk

The ductwork flange gaskets (1/020/stalls seating area-void above) contains asbestos.

Any change in appearance should be recorded and passed to Property Services.

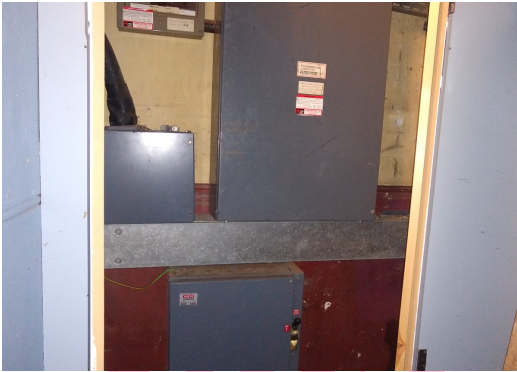
### **Item 35 Ref: PRESUMED**

The electrics (1/025/store) are presumed to contain asbestos.

Any change in appearance should be recorded and passed to Property Services.

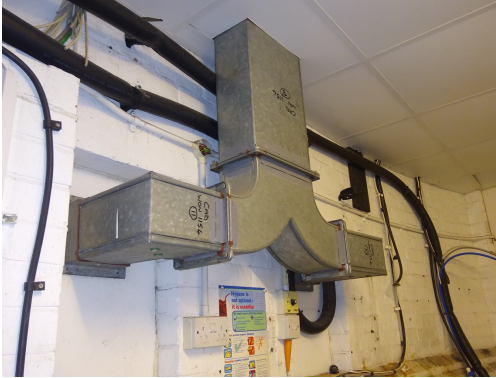
### **Item 37 Ref: PRESUMED**

The red sealant to ductwork joints (1/030/cellar) is presumed to contain asbestos.

Any change in appearance should be recorded and passed to Property Services.

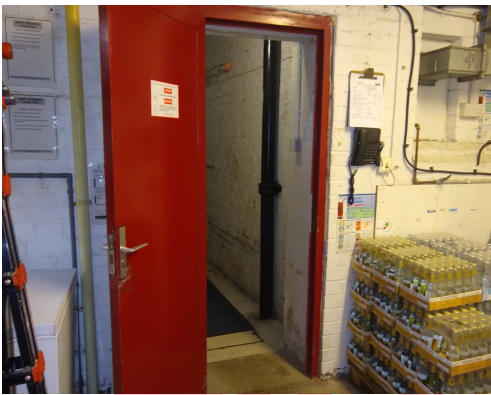
### **Item 38 Ref: As 405964-38**

The sealant to door frame (1/030/cellar) contains asbestos.

Any change in appearance should be recorded and passed to Property Services.

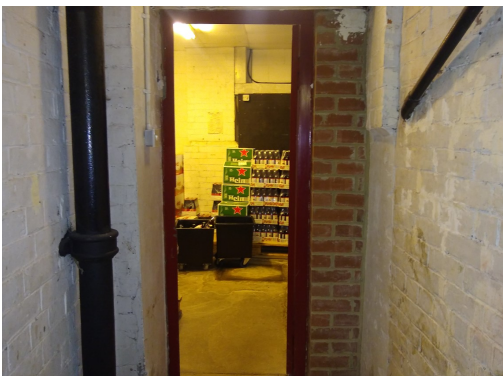
### **Item 39 Ref: 405964-38**

The sealant to door frames (1/030A/corridor) contain asbestos.

Any change in appearance should be recorded and passed to Property Services.

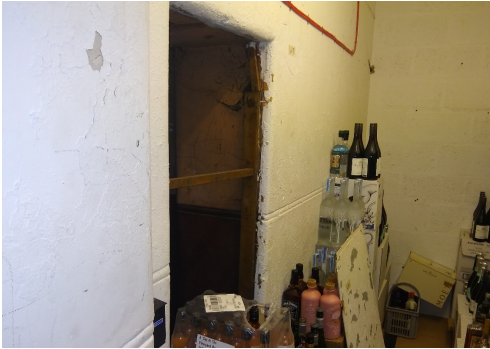
### **Item 40 Ref: 405964-51**

The decorative finish to walls – textured coating (1/030B/ champagne store) does not contain asbestos.

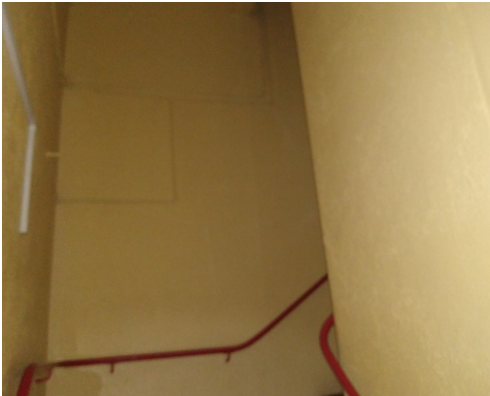
### **Item 41 Ref: 405964-34**

The decorative finish to walls within stairwell – textured coating (1/031/stairwell) does not contain asbestos.

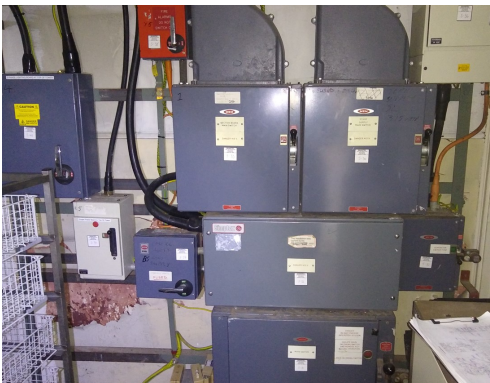
### **Item 42 Ref: PRESUMED**

The electrics (1/033/electrical intake) is presumed to contain asbestos.

Any change in appearance should be recorded and passed to Property Services.

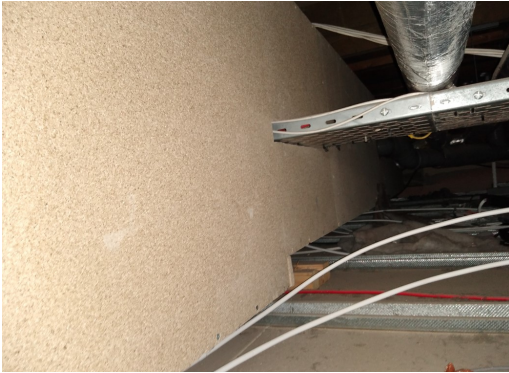
### **Item 43 Ref: As 405964-26**

The firebreak panels (1/043/lobby & corridor-void above) do not contain asbestos.

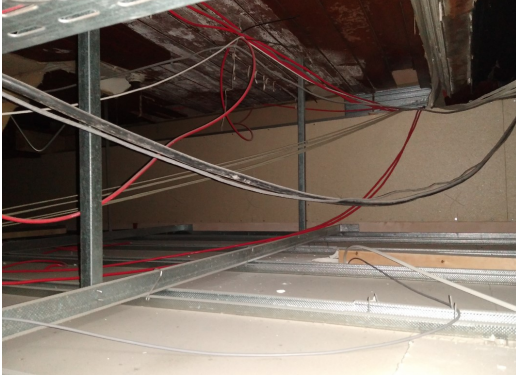
### **Item 46 Ref: 405964-26**

The firebreak panels (1/046/main entrance & bar-void above) do not contain asbestos.

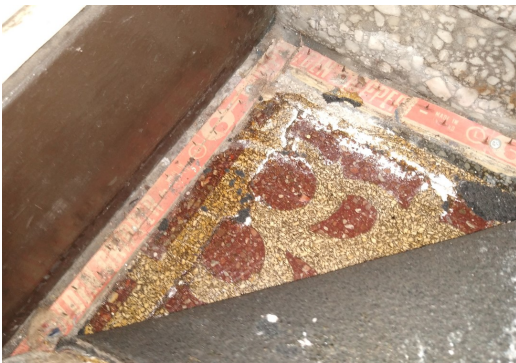
### **Item 48 Ref: As 405964-28**

The floor covering below carpet (1/047/stairwell lobby) does not contain asbestos.

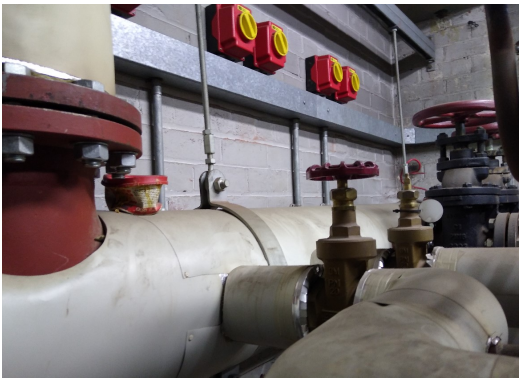
### **Item 53 Ref: 405964-88**

The debris to walls – raised deck area – insulation (1/054/boiler room) does not contain asbestos.

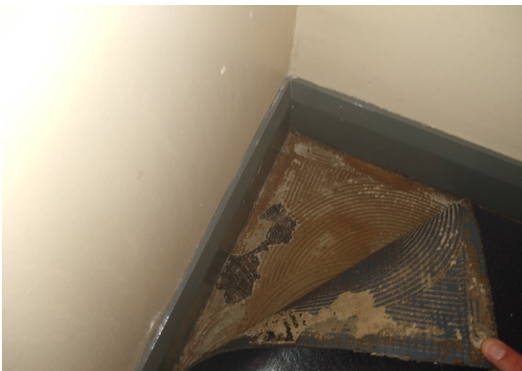
**Item 63 Ref: 405964-18**

The remnant bitumen adhesive below modern linoleum (3/006/disabled WC – Block A) contains asbestos.

Any change in appearance should be recorded and passed to Property Services.

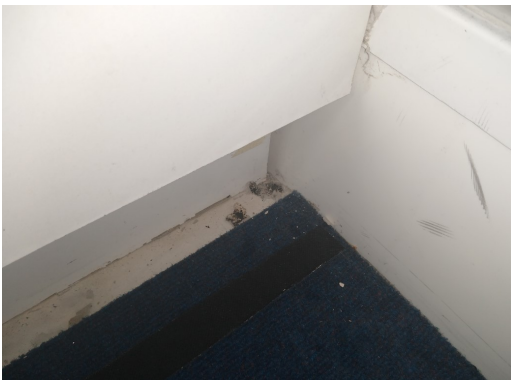
**Item 65 Ref: As 405964-17**

The remnant bitumen adhesive below carpet (3/009/dressing room 7 – Block A) contains asbestos.

Any change in appearance should be recorded and passed to Property Services.

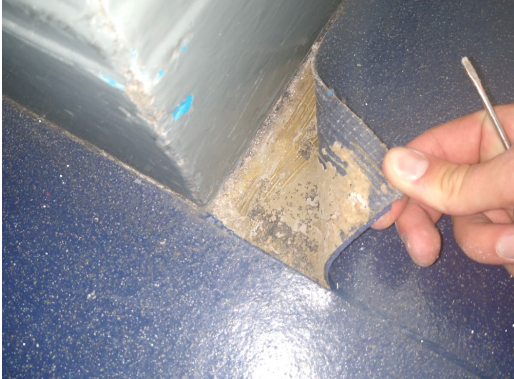
**Item 67 Ref: As 405964-17**

The remnant bitumen adhesive below modern linoleum (3/010A/corridor – Block A) contains asbestos.

Any change in appearance should be recorded and passed to Property Services.

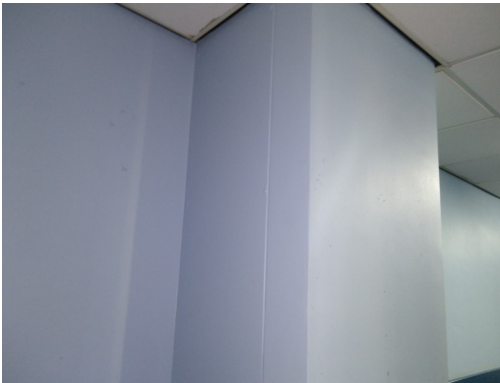
**Item 68 Ref: As 405964-21**

The panel to riser – insulating board (3/012/corridor – Block B) does not contain asbestos.

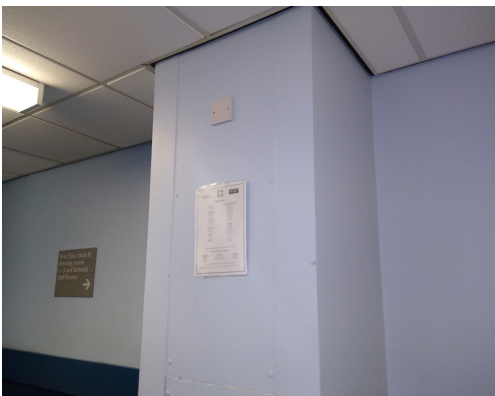
**Item 69 Ref: As 405964-21**

The panel to riser – insulating board (3/012A/corridor – Block B) does not contain asbestos.

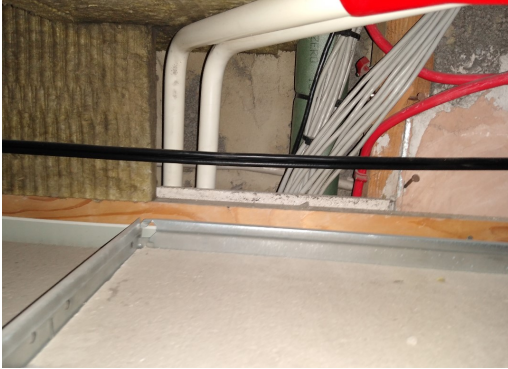
**Item 70 Ref: As 405964-21**

The boxing – insulating board (3/012A/corridor – Block B ceiling void) does not contain asbestos.

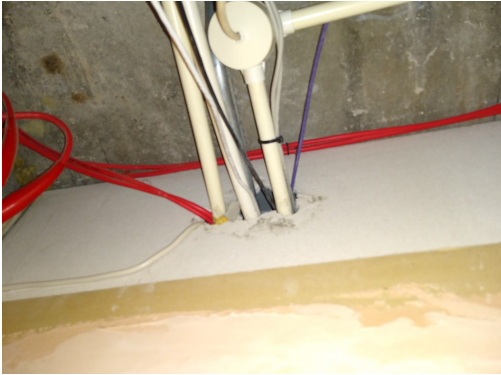
**Item 73 Ref: As 405964-21**

The bulkhead above corridor – insulating board (3/013/managers office – Block B ceiling void) does not contain asbestos.

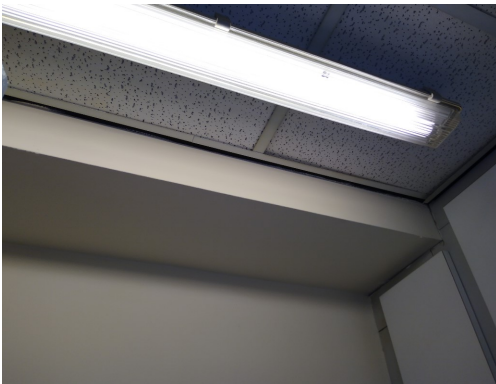
**Item 74 Ref: As 405964-21**

The boxing – insulating board (3/013A/managers shower room – Block B) does not contain asbestos.

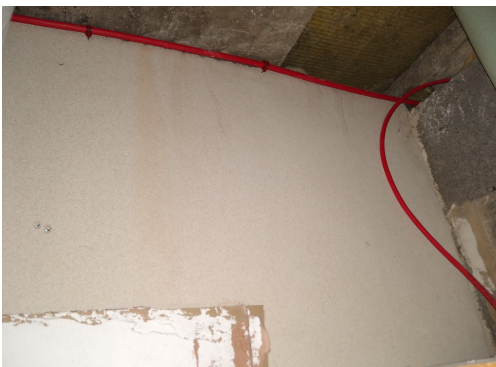
**Item 75 Ref: As 405964-21**

The boxing – insulating board (3/013A/managers shower room 2 – Block B ceiling void) does not contain asbestos.

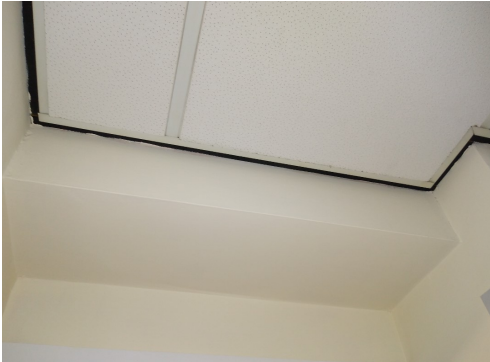
### **Item 76 Ref: As 405964-4**

The boxing in corridor (3/014/dressing room 1 - Block B) does not contain asbestos.

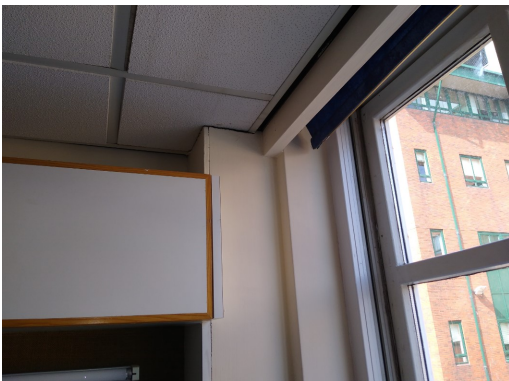
### **Item 77 Ref: As 405964-3**

The corner boxing to pipework – insulating board (3/014/dressing room 1 - Block B) does not contain asbestos.

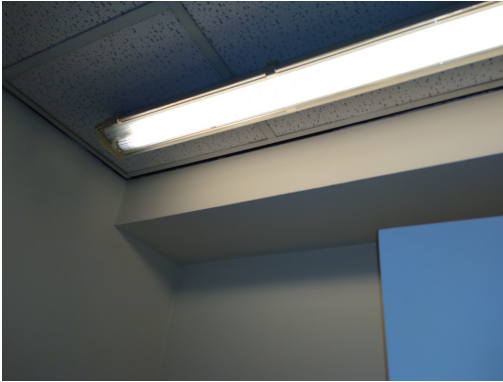
**Item 79 Ref: As 405964-21**

The boxing – insulating board (03/14A/shower room 1 – Block B) does not contain asbestos.

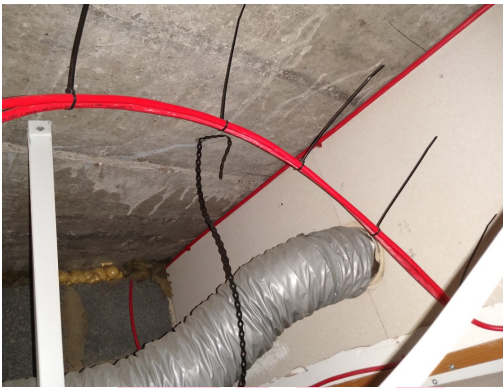
**Item 80 Ref: As 405964-21**

The boxing – insulating board (3/014A/shower room 1 – Block B ceiling void) does not contain asbestos.

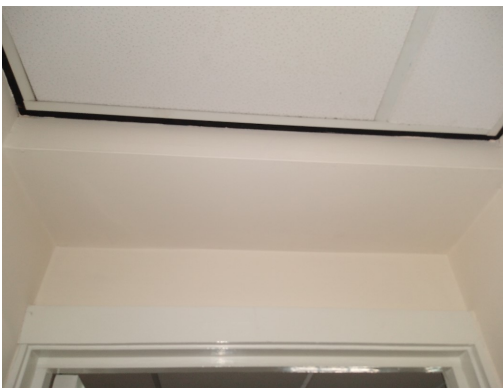
**Item 81 Ref: As 405964-4**

The boxing in corridor (3/015/dressing room 2 - Block B) does not contain asbestos.

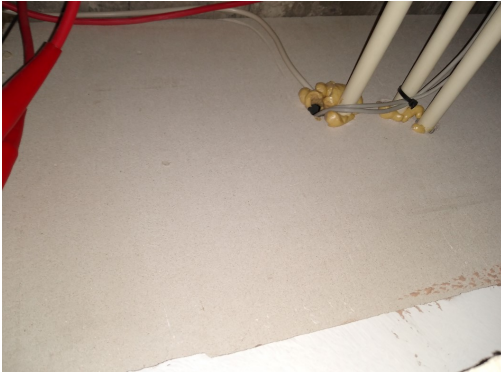
**Item 82 Ref: As 405964-21**

The bulkhead above corridor – insulating board (3/015/dressing room 2 – Block B ceiling void) does not contain asbestos.

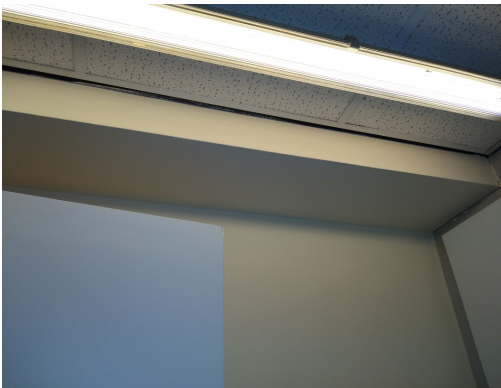
**Item 83 Ref: As 405964-21**

The boxing – insulating board (3/015A/shower room 2 – Block B) does not contain asbestos.

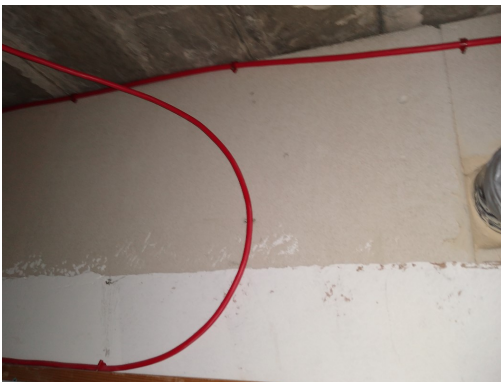
**Item 84 Ref: As 405964-21**

The boxing – insulating board (3/015A/shower room 2 – Block B ceiling void) does not contain asbestos.

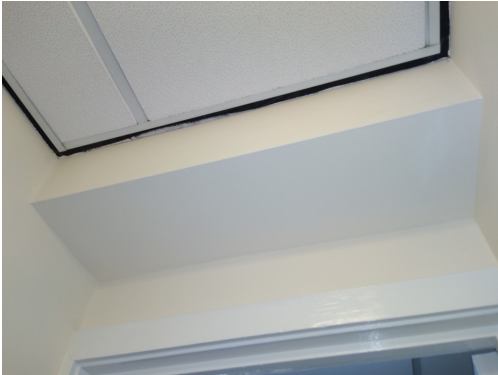
### **Item 85 Ref: As 405964-4**

The boxing in corridor (3/016/dressing room 3 - Block B) does not contain asbestos.

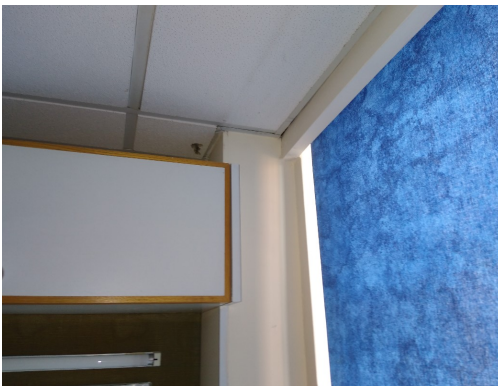
### **Item 86 Ref: As 405964-3**

The corner boxing to pipework – insulating board (3/016/dressing room 3 - Block B) does not contain asbestos.

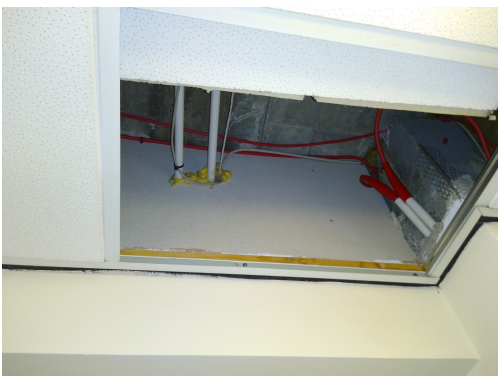
### **Item 87 Ref: As 405964-21**

The bulkhead above corridor – insulating board (3/016/dressing room 3 – Block B ceiling void) does not contain asbestos.

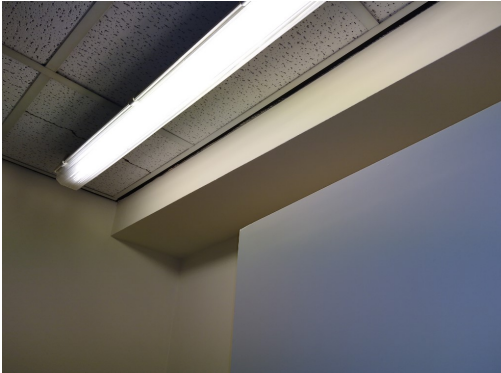
**Item 88 Ref: As 405964-21**

The boxing – insulating board (3/016A/shower room 3 – Block B) does not contain asbestos.

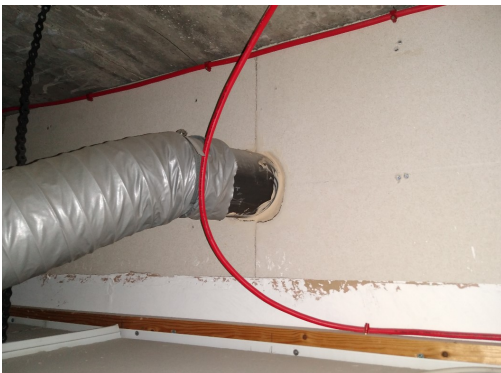
**Item 89 Ref: As 405964-21**

The boxing – insulating board (3/016A/shower room 3 – Block B ceiling void) does not contain asbestos.

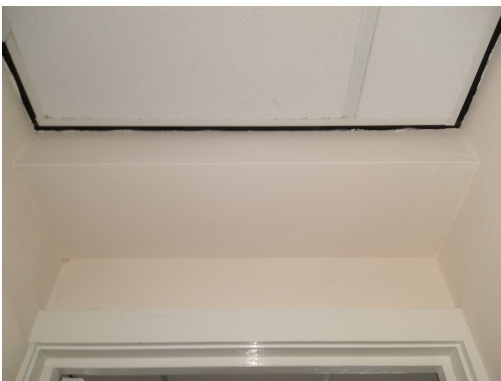
**Item 90 Ref: As 405964-4**

The boxing in corridor (3/017/dressing room 4 - Block B) does not contain asbestos.

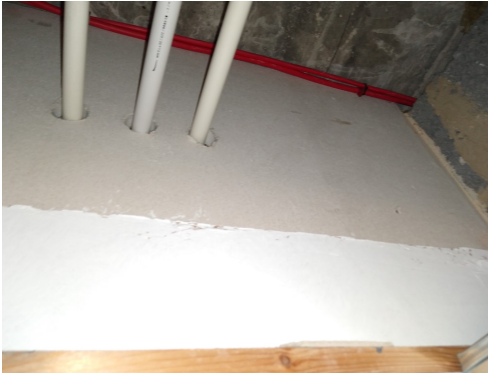
**Item 91 Ref: As 405964-21**

The bulkhead above corridor – insulating board (3/017/dressing room 4 – Block B ceiling void) does not contain asbestos.

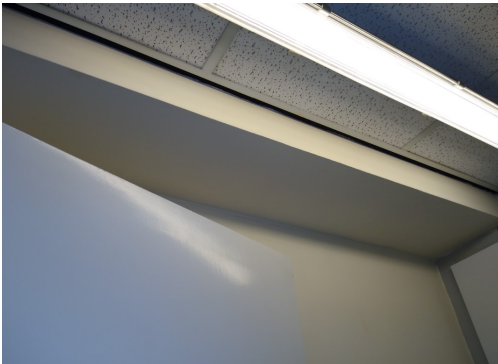
**Item 92 Ref: As 405964-21**

The boxing – insulating board (3/017A/shower room 4 – Block B) does not contain asbestos.

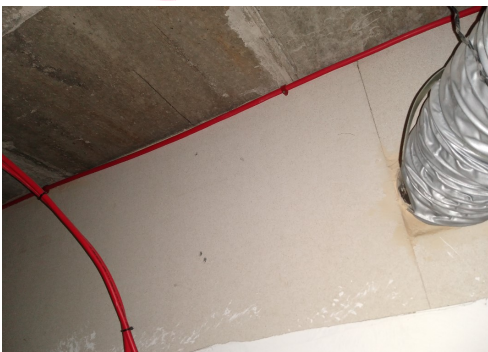
**Item 93 Ref: As 405964-21**

The boxing – insulating board (3/017A/shower room 4 – Block B ceiling void) does not contain asbestos.

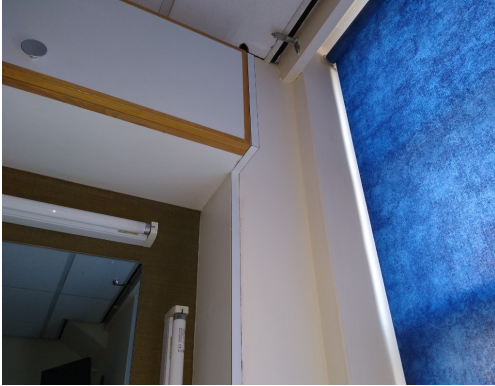
### **Item 94 Ref: As 405964-2**

The corner boxing to pipework – insulation board (3/018/dressing room 5 – Block B) does not contain asbestos.

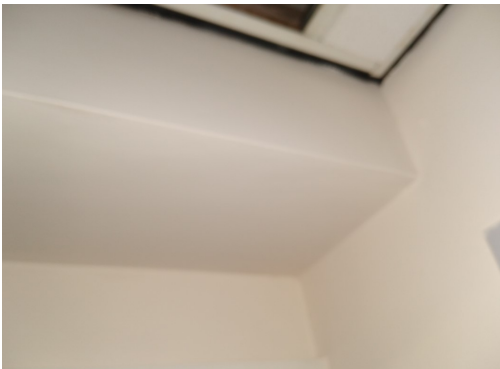
### **Item 95 Ref: As 405964-4**

The boxing in corridor (3/018/dressing room 5 – Block B) does not contain asbestos.

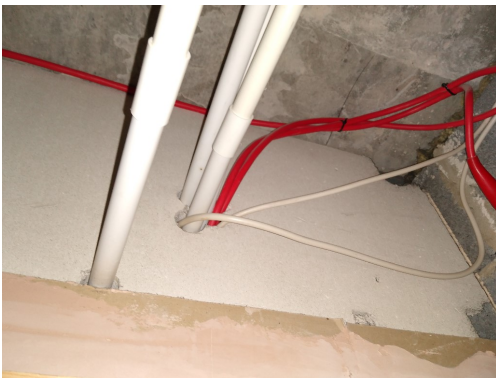
### **Item 96 Ref: As 405964-21**

The bulkhead above corridor – insulating board (3/018/dressing room 5 – Block B ceiling void) does not contain asbestos.

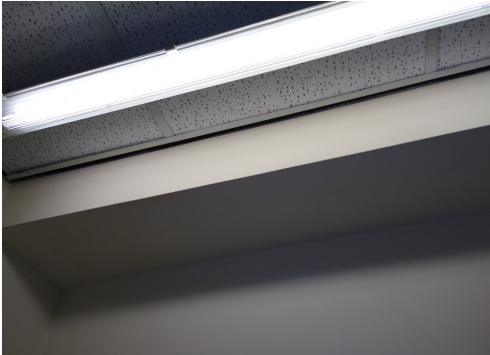
### **Item 97 Ref: As 405964-21**

The boxing – insulating board (3/018A/shower room 5 – Block B) does not contain asbestos.

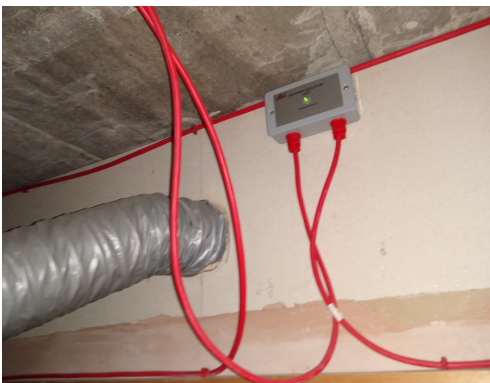
### **Item 98 Ref: As 405964-21**

The boxing – insulating board (3/018A/shower room 5 – Block B ceiling void) does not contain asbestos.

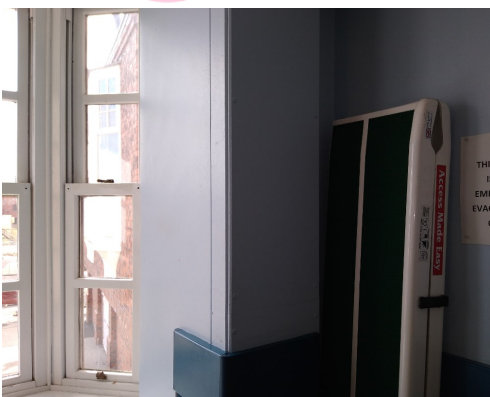
### **Item 99 Ref: As 405964-21**

The panel to riser – insulating board (3/019/stairwell – Block B) does not contain asbestos.

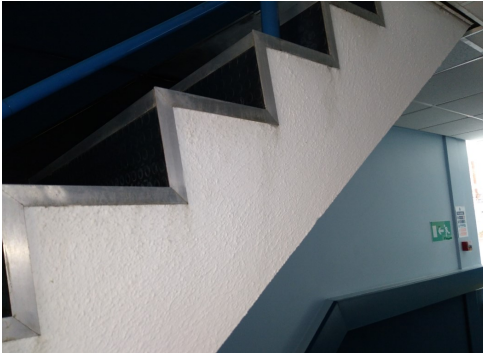
### **Item 100 Ref: As 405964-10**

The decorative finish to stairs & suspended ceiling upstand – textured coating (3/019/stairwell – Block B) does not contain asbestos.

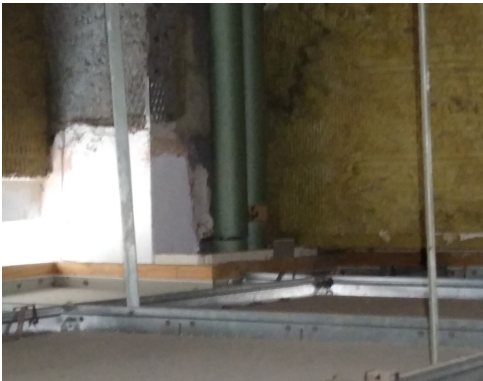
### **Item 101 Ref: As 405964-21**

The boxing – insulating board (3/019/stairwell – Block B ceiling void) does not contain asbestos.

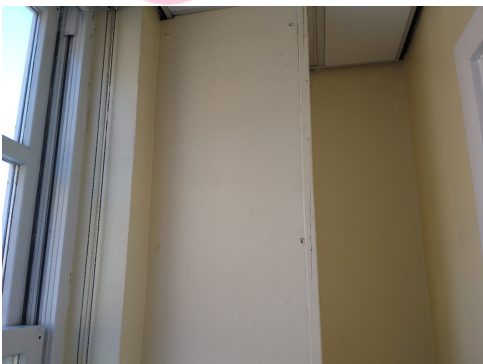
### **Item 102 Ref: As 405964-21**

The panel to riser – insulating board (3/021/male WC & lobby – Block B) does not contain asbestos.

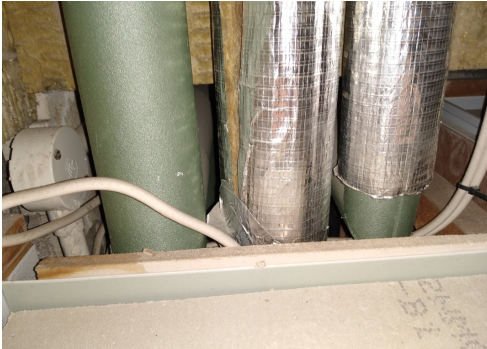
**Item 103 Ref: As 405964-21**

The boxing – insulating board (3/021/male WC & lobby – Block B ceiling void) does not contain asbestos.

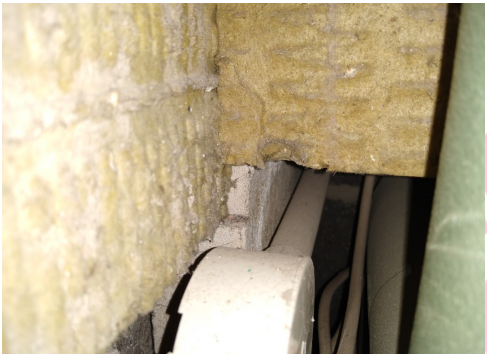
**Item 104 Ref: 405964-22**

The wall panel within riser – insulating board (3/021/male WC & lobby – Block B ceiling void) does not contain asbestos.

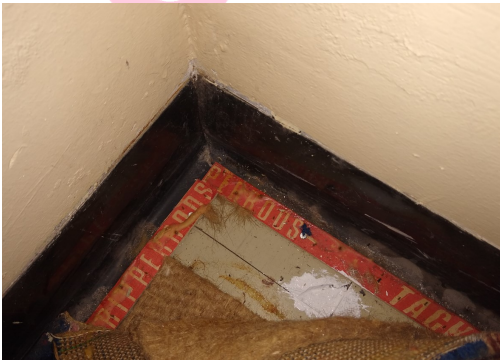
**Item 105 Ref: 405964-53**

The subfloor – floor tile with bitumen adhesive (3/022/corridor) does not contain asbestos.

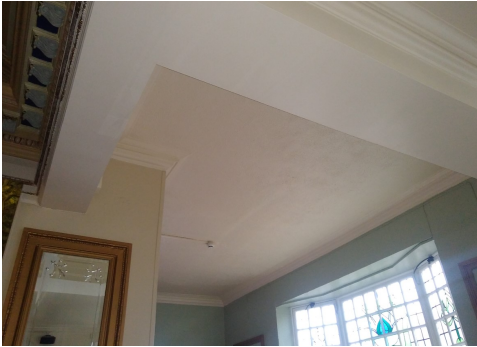
**Item 106 Ref: 405964-55**

The textured coating to concrete ceiling (3/024/dress circle bar/bistro) does not contain asbestos.

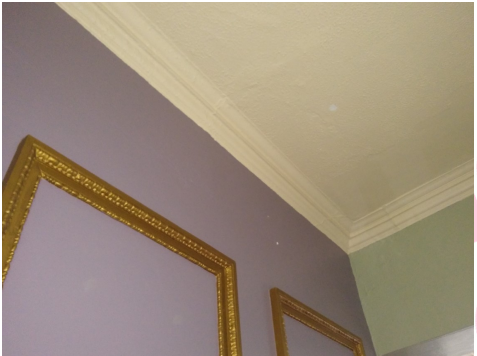
**Item 107 Ref: 405964-56**

The textured coating to walls at high level (3/024/dress circle bar/bistro) does not contain asbestos.

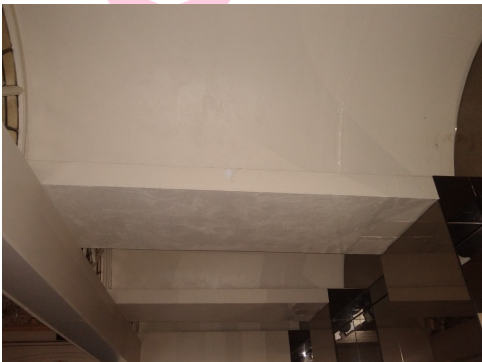
**Item 108 Ref: 405964-57**

The textured coating to wood vaulted ceiling above bar (3/024/dress circle bar/bistro) does not contain asbestos.

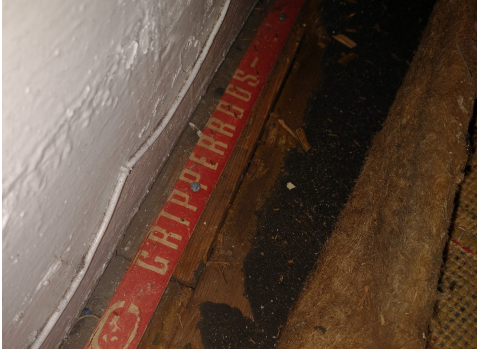
### **Item 109 Ref: 405964-61**

The subfloor – bituminous adhesive to back of parquet flooring (3/027/security office) does not contain asbestos.

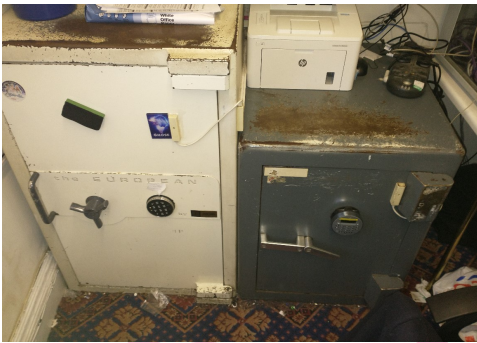
### **Item 110 Ref: PRESUMED**

The lining to safe (3/027/security office) is presumed to contain asbestos.

Any change in appearance should be recorded and passed to Property Services.

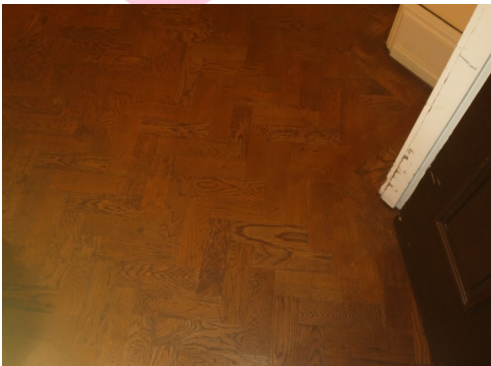
### **Item 111 Ref: As 405964-61**

The subfloor – bituminous adhesive to back of parquet flooring (3/028/lift lobby) does not contain asbestos.

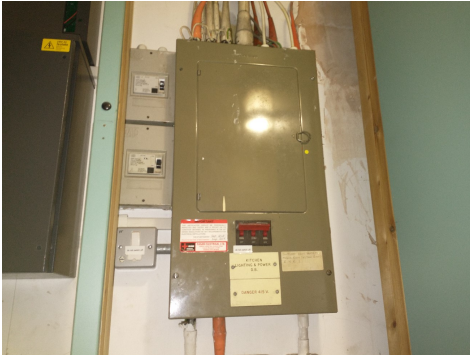
### Item 112 Ref: PRESUMED

The 415kv DB board – bacolite (3/029/female toilets) is presumed to contain asbestos.

Item 111	No asbestos	Is present		
<b>Item 112</b>	<b>415kv DB board (3/029 Female toilets)</b>	<b>Very Low Risk</b>	<b>12 monthly</b>	<b>14/01/2027</b>
Item 113	Loose lying flue sections (3/029 Female toilets-void above)	Very Low Risk	12 monthly	Removed April 2022

Any change in appearance should be recorded and passed to Property Services.

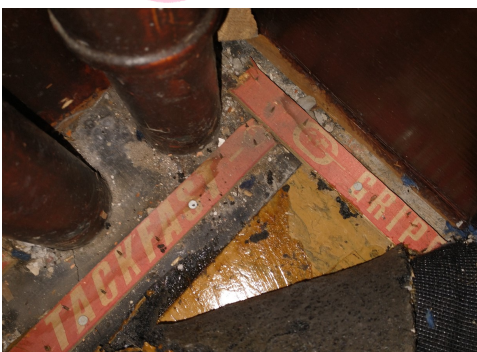
### Item 114 Ref: 405964-62

- (Item 113) *Ref: 405964-67 – Loose lying flue sections adjacent hatch (3/029/female toilets – void above) – Removed April 2022*
- (Item 114) Ref: 405964-62 – Subfloor – linoleum (3/031/corridor) – No Risk

The subfloor – linoleum (3/031/corridor) does not contain asbestos.

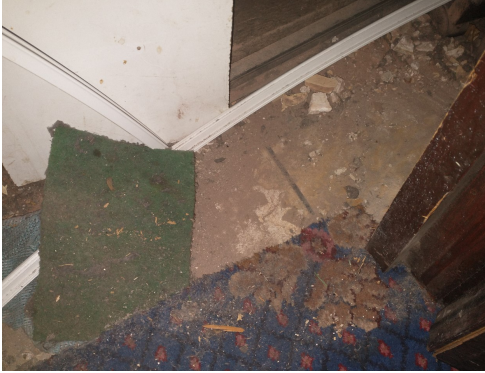
### Item 115 Ref: As 405964-62

The subfloor – linoleum (3/031A/corridor riser) does not contain asbestos.

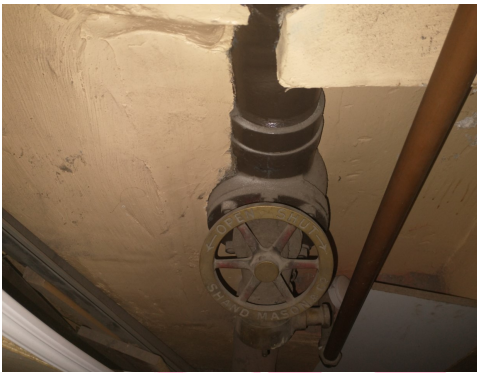
### Item 116 Ref: 405964-70

The gasket to pipework (3/031A/corridor riser) does not contain asbestos.

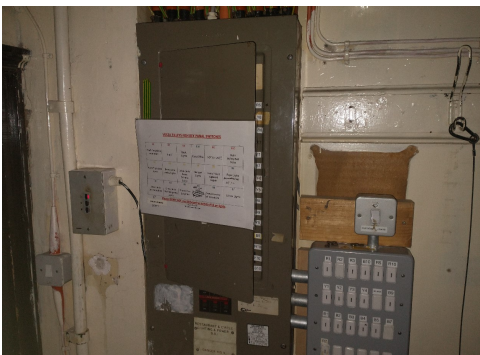
### Item 117 Ref: PRESUMED

The 415kv DB electrics box – bacolite (3/32/electrics cupboard) is presumed to contain asbestos.

Any change in appearance should be recorded and passed to Property Services.

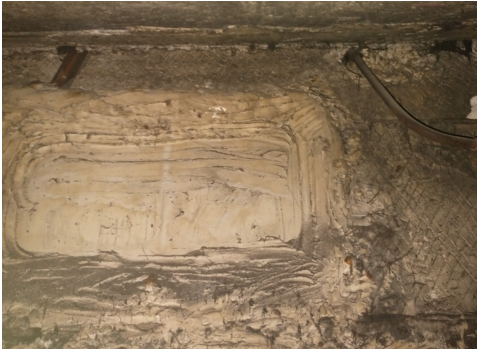
### **Item 118 Ref: 405964-66**

The coating to wall – plaster (3/032/electrics cupboard – void) does not contain asbestos.

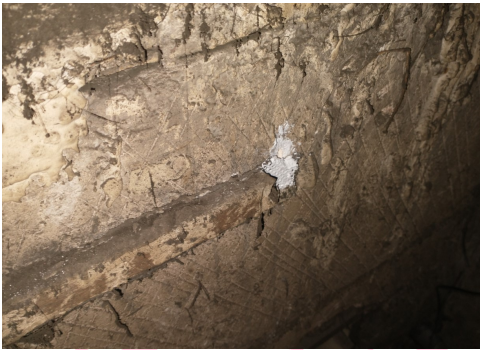
### **Item 119 Ref: 405964-65**

The packing behind joists – millboard (3/032/electrics cupboard – void) contains asbestos.

Any change in appearance should be recorded and passed to Property Services.

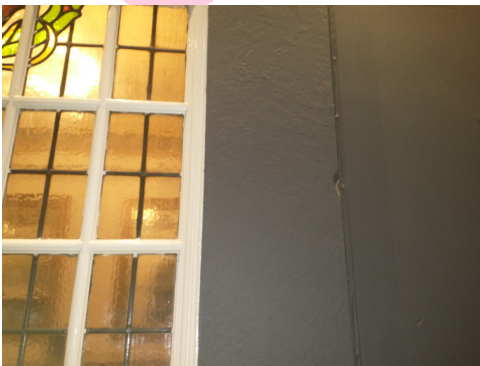
### **Item 120 Ref: 405964-69**

The textured coating to walls (3/032A/stairwell landing) does not contain asbestos.

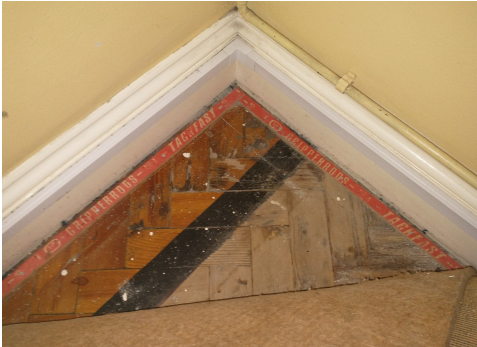
### **Item 121 Ref: As 405964-61**

The subfloor – bituminous adhesive to back of parquet flooring (3/033/lobby) does not contain asbestos.

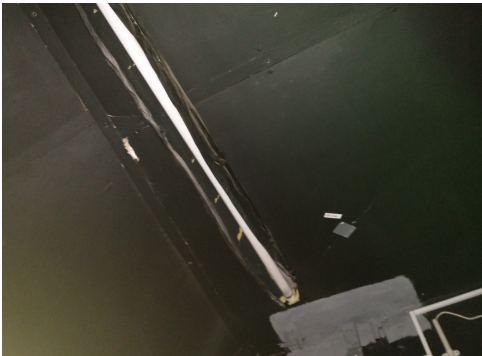
### **Item 122 Ref: 405964-68**

The ceiling (3/036/sound room) contains asbestos.

Any change in appearance should be recorded and passed to Property Services.

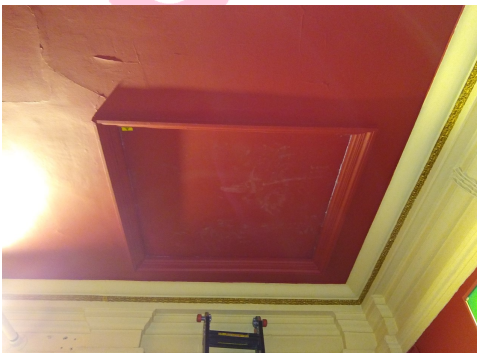
### **Item 123 Ref: 405964-63**

The hatches (3/040/dress circle) do not contain asbestos.

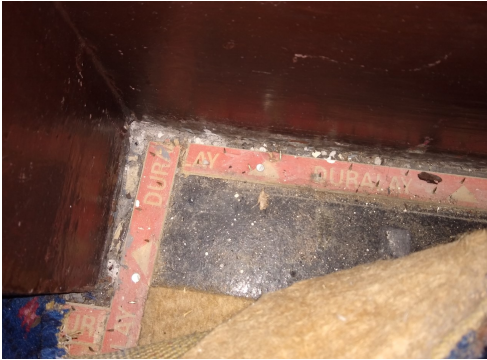
### **Item 124 Ref: 405964-64**

The subfloor – linoleum (3/040/dress circle) does not contain asbestos.

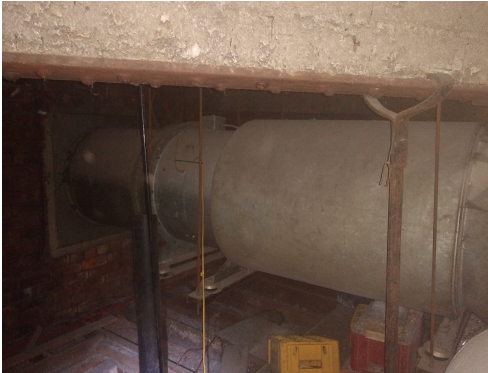
### **Item 127 Ref: As 405964-59**

The ductwork flange gaskets northeast (3/040/dress circle – void above) contains asbestos.

Any change in appearance should be recorded and passed to Property Services.

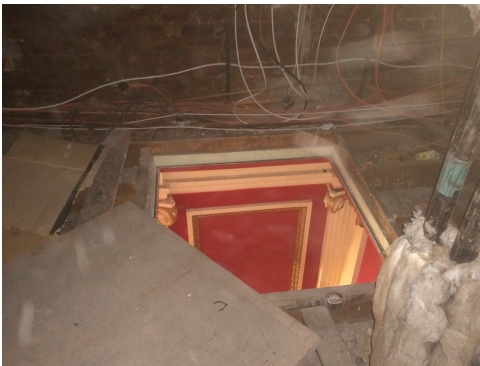
### **Item 128 Ref: 405964-60**

The debris surrounding large hatch (3/040/dress circle – void above) does not contain asbestos.

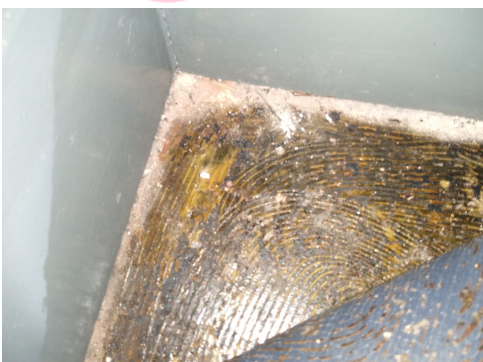
### **Item 129 Ref: As 405964-15**

The remnant bitumen adhesive below modern linoleum (4/002/corridor – Block A) contains asbestos.

Any change in appearance should be recorded and passed to Property Services.

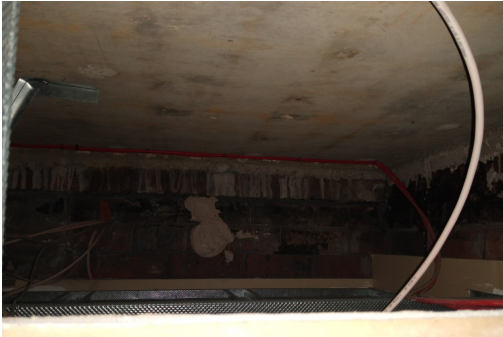
### **Item 130 Ref: As 405964-14**

The bitumen to walls above WC lobby area (4/002/corridor – Block A – void above) does not contain asbestos.

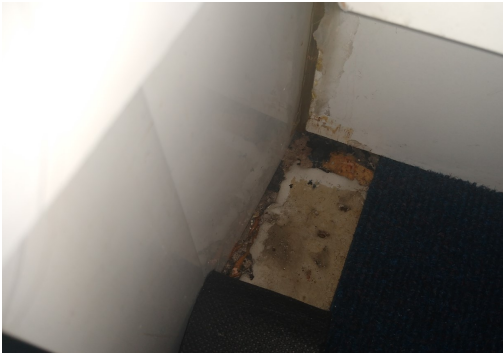
### **Item 131 Ref: As 405964-16**

The remnant bitumen adhesive below carpet (4/003/dressing room 9 – Block A) contains asbestos.

Any change in appearance should be recorded and passed to Property Services.

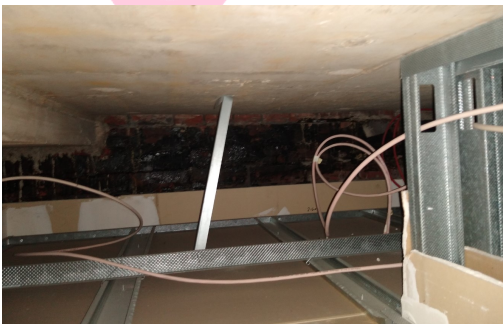
### **Item 132 Ref: As 405964-14**

The bitumen to walls (4/004/male WC – Block A – void above) does not contain asbestos.

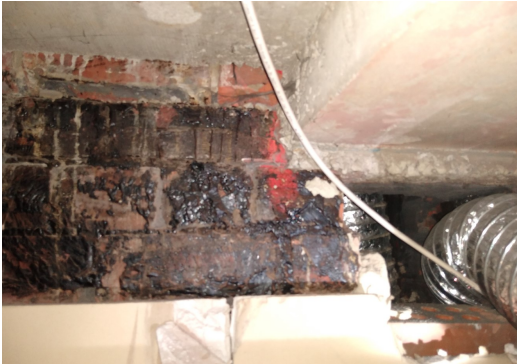
### **Item 133 Ref: 405964-14**

The bitumen to walls (4/005/female WC – Block A – void above) does not contain asbestos.

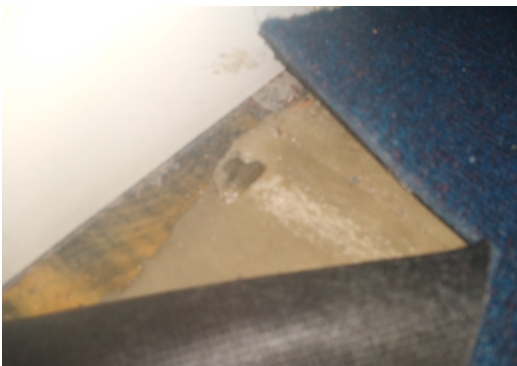
### **Item 134 Ref: As 405964-15**

The remnant bitumen adhesive below carpet (4/006/dressing room 10 – Block A) contains asbestos.

Any change in appearance should be recorded and passed to Property Services.

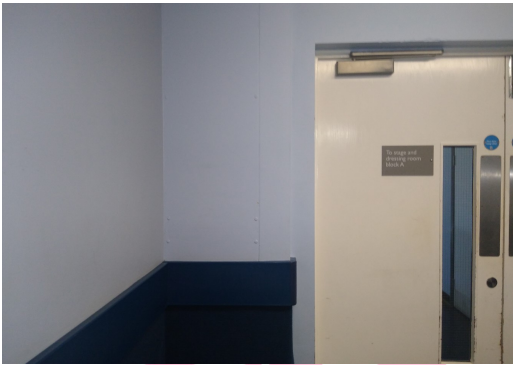
### **Item 137 Ref: As 405964-13**

The panel to boxing (4/011/corridor – Block B) does not contain asbestos.

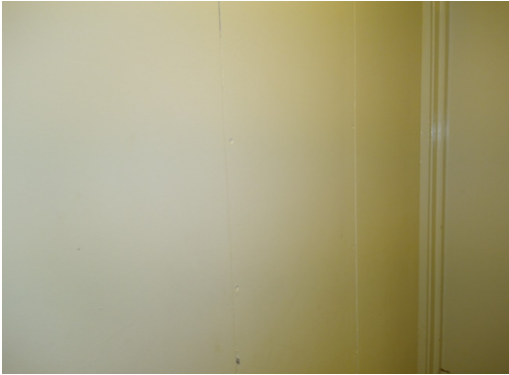
**Item 139 Ref: 405964-13**

The panel to boxing  
(4/012/dressing room 10 –  
Block B) does not contain  
asbestos.

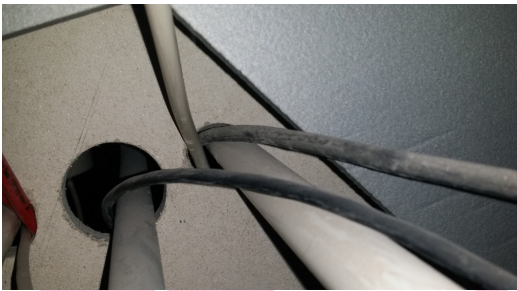
**Item 140 Ref: As 405964-12**

The firebreak above door  
(4/012/dressing room 10 –  
Block B – void above) does  
not contain asbestos.

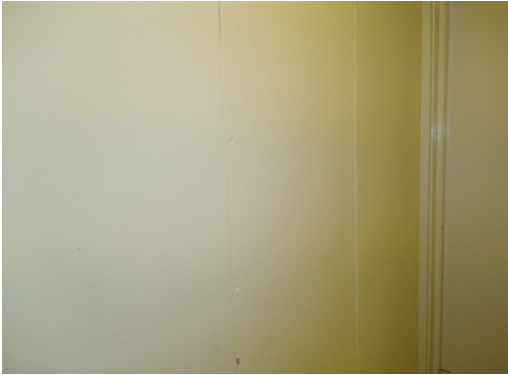
**Item 142 Ref: As 405964-12**

The panel to boxing (4/012/dressing room 10 – Block B) does not contain asbestos.

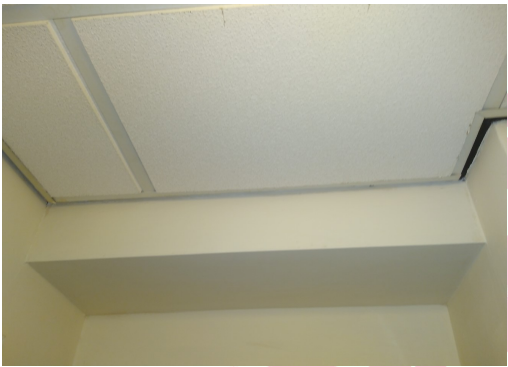
**Item 143 Ref: As 405964-12**

The boxing to beams below plasterboard (4/013/dressing room 9 – Block B) does not contain asbestos.

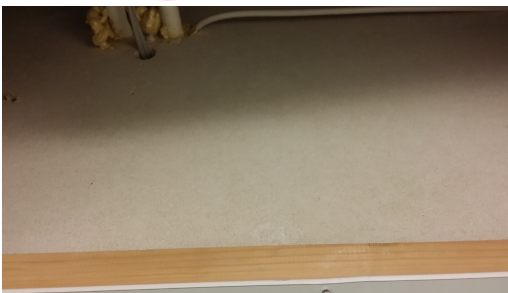
**Item 144 Ref: 405964-12**

The firebreak above door (4/013/dressing room 9 – Block B – void above) does not contain asbestos.

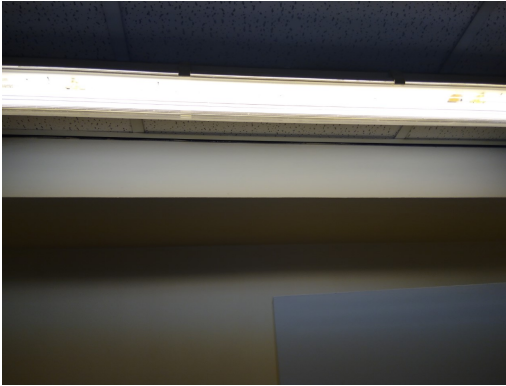
### **Item 145 Ref: As 405964-12**

The boxing to beam below plasterboard (4/013A/shower room – Block B) does not contain asbestos.
