ASBESTOS SURVEY REPORT FOR SUNDERLAND EMPIRE THEATRE, 4-5 HIGH STREET WEST, SUNDERLAND, SR1 3EX

## *Control of Asbestos Regulations 2012*

**Sunderland Empire Theatre, 4-5 High Street West,  
Sunderland, SR1 3EX**

**Date: 19 January 2026**

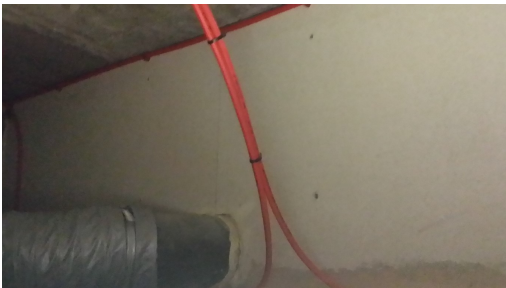
### **Item 146 Ref: As 405964-12**

The firebreak (4/013A/shower room – void above) does not contain asbestos.

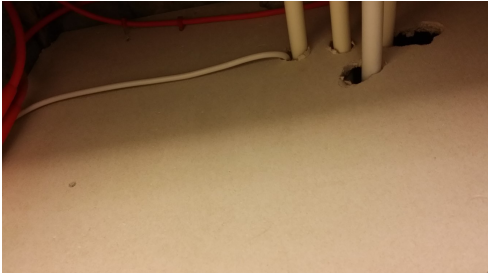
### **Item 148 Ref: As 405964-11**

The firebreak above door (4/014/dressing room 8 – Block B – void above) does not contain asbestos.

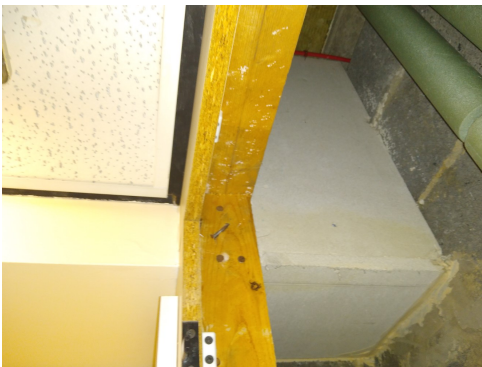
### **Item 149 Ref: As 405964-11**

The boxing to beam below plasterboard (4/014A/shower room – Block B) does not contain asbestos.

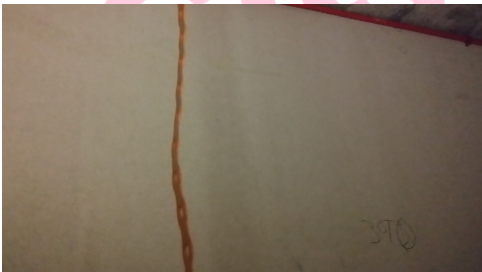
### **Item 150 Ref: As 405964-11**

The firebreak above door (4/014A/shower room – Block B – void above) does not contain asbestos.

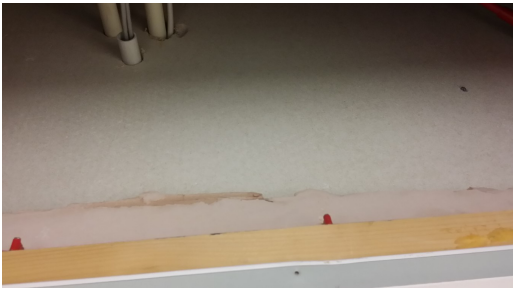
**Item 152 Ref: As 405964-11**

The firebreak above door (4/015/dressing room 7 – Block B – void above) does not contain asbestos.

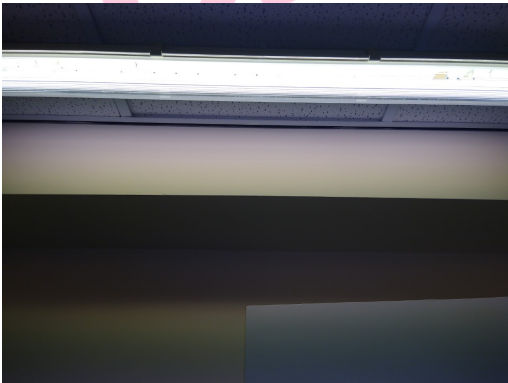
**Item 153 Ref: As 405964-11**

The boxing to beam below plasterboard (4/015A/shower room – Block B) does not contain asbestos.

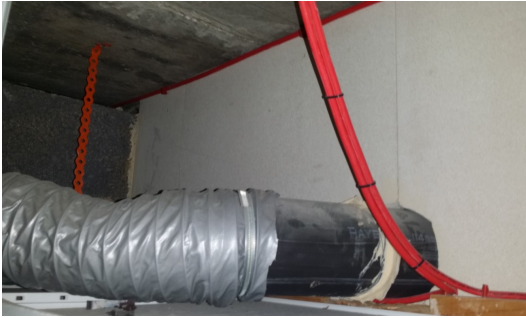
**Item 154 Ref: As 405964-11**

The firebreak (4/015A/shower room – Block B – void above) does not contain asbestos.

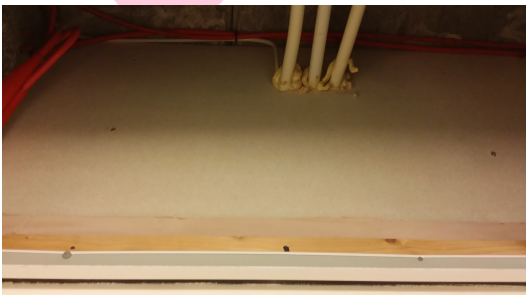
**Item 156 Ref: As 405964-11**

The firebreak (4/016/dressing room 6 – Block B – void above) does not contain asbestos.

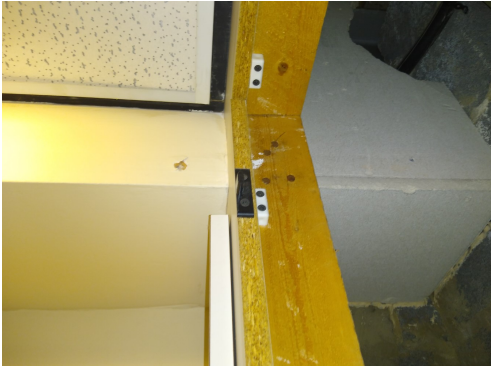
**Item 157 Ref: As 405964-11**

The boxing to beam below plasterboard (4/016A/shower room – Block B) does not contain asbestos.

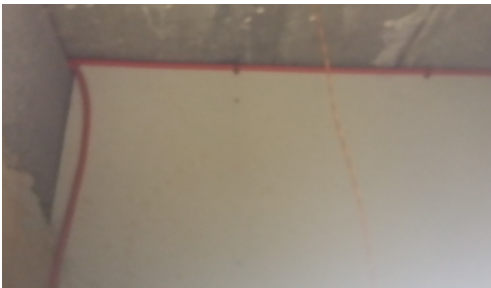
**Item 158 Ref: As 405964-11**

The firebreak (4/016A/shower room – Block B – void above) does not contain asbestos.

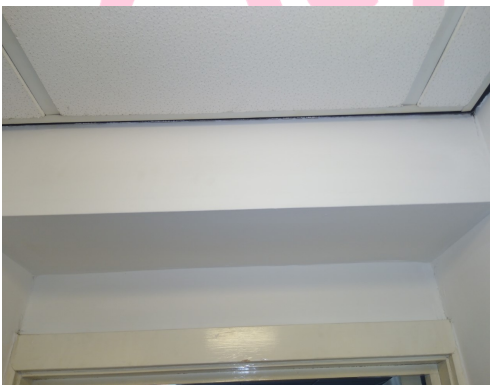
**Item 159 Ref: As 405964-11**

The boxing to beam below plasterboard (4/017/venue technical manager – Block B) does not contain asbestos.

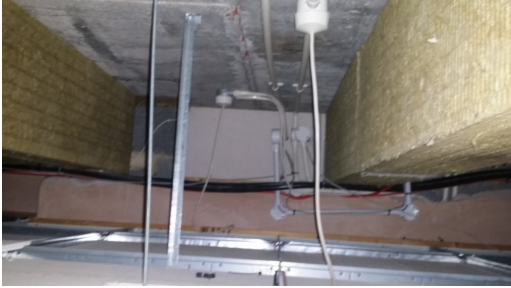
### **Item 160 Ref: As 405964-11**

The firebreak above door (4/017/venue technical manager – Block B – void above) does not contain asbestos.

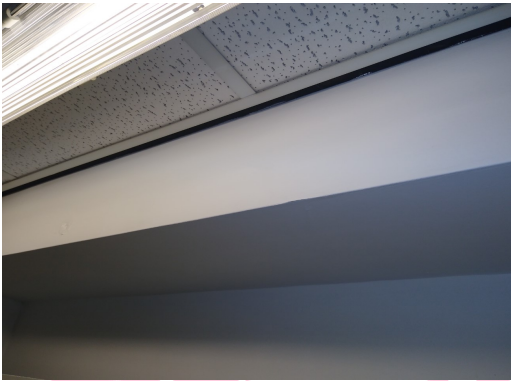
### **Item 161 Ref: As 405964-11**

The boxing to beam below plasterboard (4/017A/shower room – Block B) does not contain asbestos.

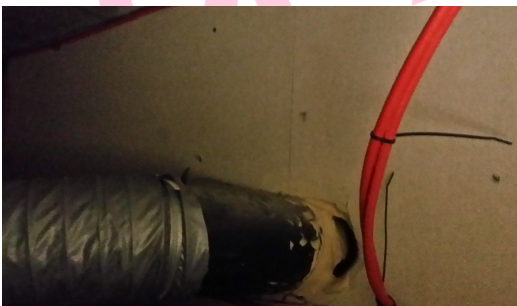
### **Item 162 Ref: As 405964-11**

The firebreak (4/017A/shower room – Block B – void above) does not contain asbestos.

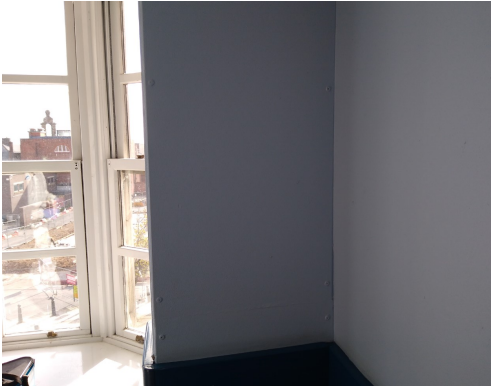
### **Item 163 Ref: 405964-9**

The boxing to pipework (4/018/stairwell – Block B) does not contain asbestos.

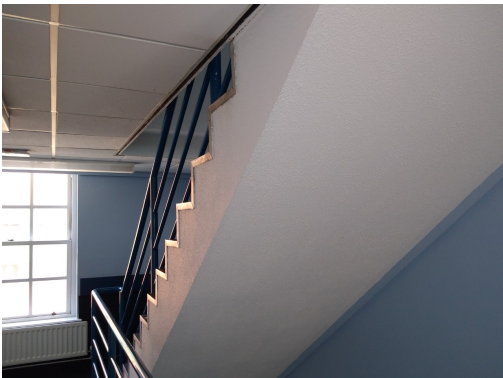
### **Item 164 Ref: 405964-10**

The decorative finish to stairs & suspended ceiling up stand (4/018/stairwell – Block B) does not contain asbestos.

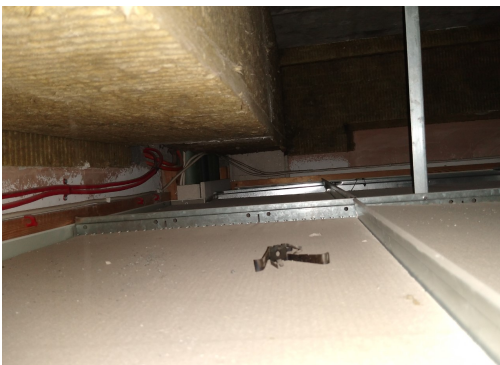
### **Item 165 Ref: As 405964-9**

The top of boxing (4/018/stairwell – Block B – void above) does not contain asbestos.

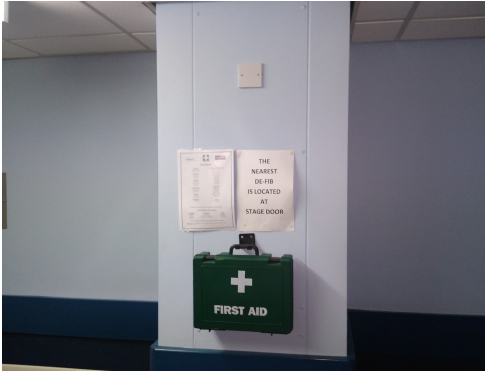
**Item 166 Ref: As 405964-13**

The panel to boxing (4/018A/corridor – Block B) does not contain asbestos.

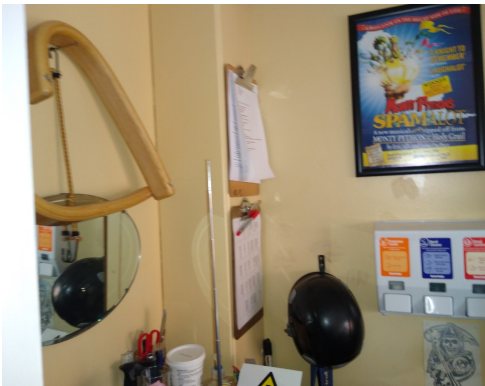
**Item 167 Ref: As 405964-9**

The panels to boxing (4/020/office – Block B) does not contain asbestos.

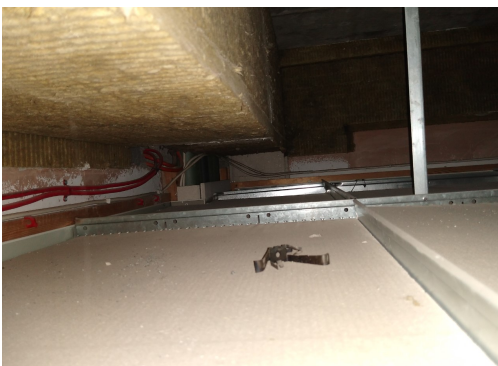
**Item 168 Ref: 405964-83**

The subfloor – linoleum (4/023/upper circle) does not contain asbestos.

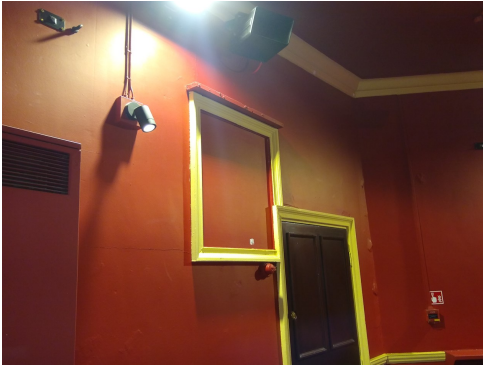
### **Item 169 Ref: 405964-84**

The panel to wall (4/023/upper circle) does not contain asbestos.

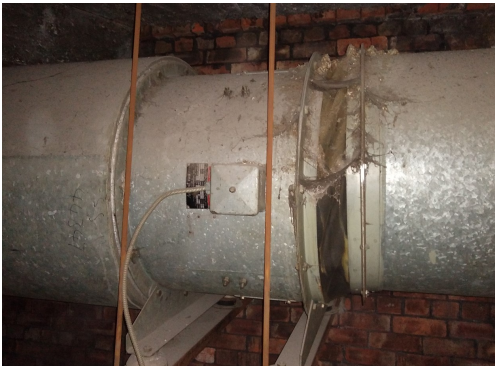
### **Item 170 Ref: 405964-79**

- (Item 170) Ref: 405964-79 – Ductwork flange gaskets northeast (4/023/upper circle – void above) – Low Risk
- (Item 171) Ref: As 405964-79 – Flange gaskets to loose lying ductwork southwest (4/023/upper circle – void above) – Low Risk

The ductwork flange gaskets northeast (4/023/upper circle – void above) contain asbestos.

Any change in appearance should be recorded and passed to Property Services.

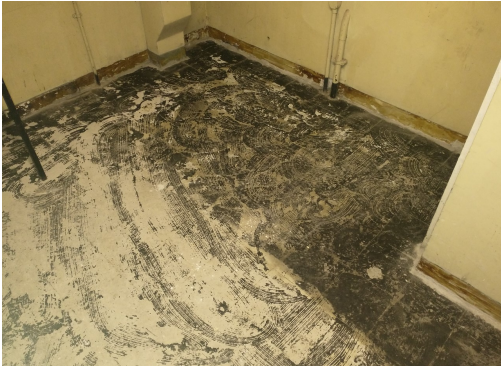
### **Item 172 Ref: 405964-74**

The remnant adhesive to floor (4/024/old projectors room) contains asbestos.

Removed April 2022.

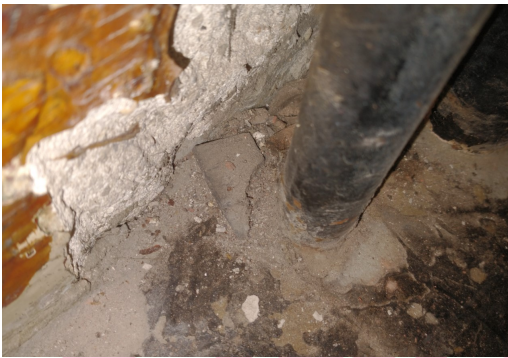
### **Item 173 Ref: 405964-75**

The remnant floor tiles debris to floor (4/024/old projectors room) contains asbestos.

Any change in appearance should be recorded and passed to Property Services.

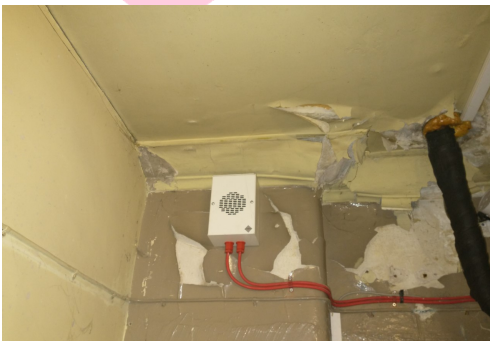
### **Item 174 Ref: 405964-76**

The coving plaster (4/024/old projectors room) does not contain asbestos.

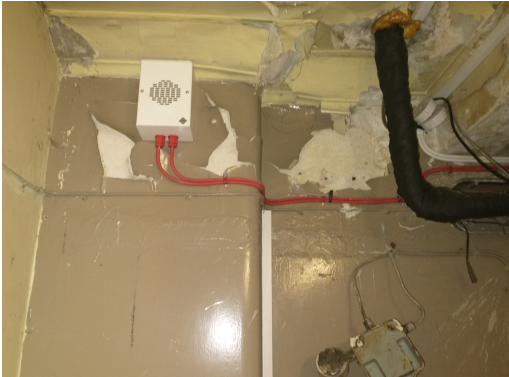
**Item 175 Ref: 405964-77**

The anti condensation paint to wall (4/024/old projectors room) does not contain asbestos.

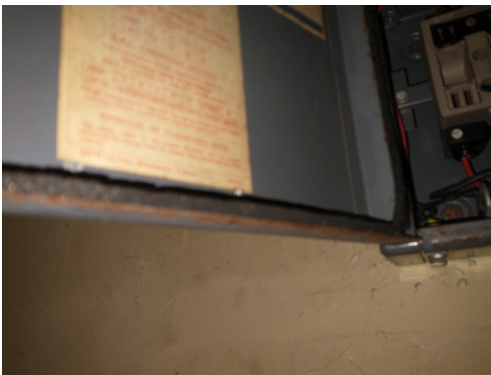
**Item 177 Ref: 405964-80**

The seal within MEM bioscope DB (4/024/old projectors room) does not contain asbestos.

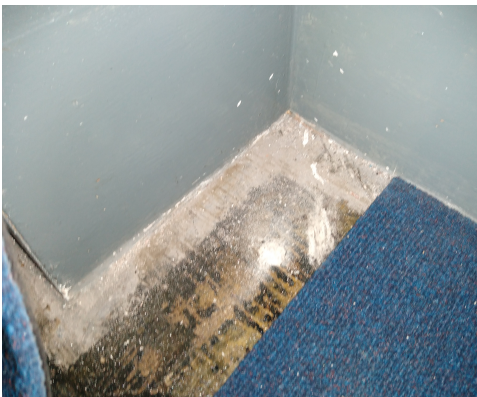
### **Item 183 Ref: 405964-15**

The remnant bitumen adhesive below carpet (4/025/stairwell & landing – Block A) contains asbestos.

Any change in appearance should be recorded and passed to Property Services.

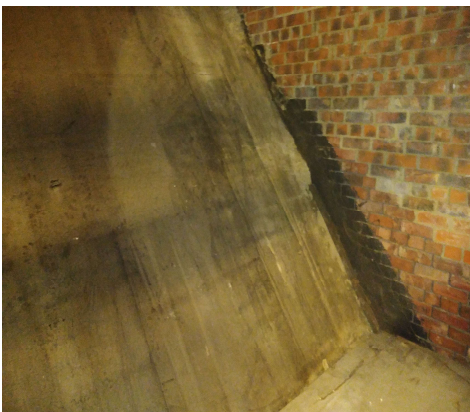
### **Item 195 Ref: 405964-6**

The redundant roof covering to old roof (6/03/loft void) does not contain asbestos.

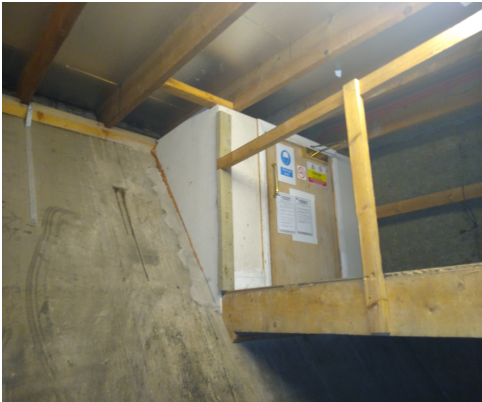
**Item 197 Ref: 405964-7**

The walls to entrance into void above seating area (6/04/loft void) does not contain asbestos.

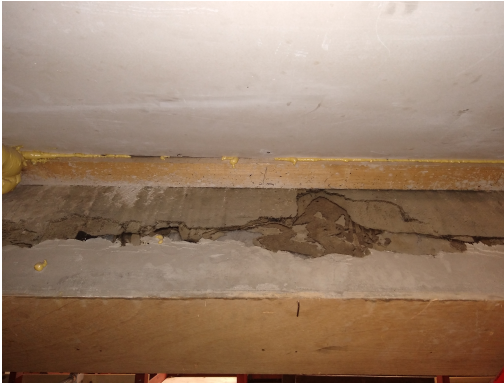
### **Item 199 Ref: As 405964-6**

The protruding roof felt adjacent entrance (6/07/void over auditorium) does not contain asbestos.

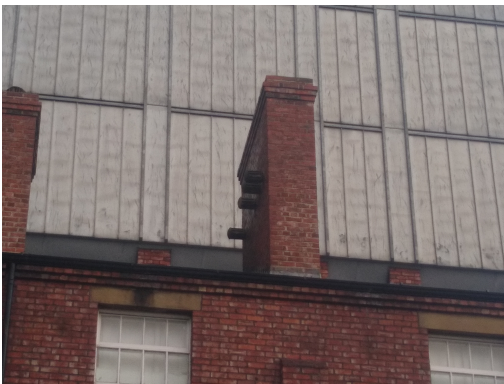
### **Item 201 Ref: PRESUMED**

The flue cowls to chimney south east (External) is presumed to contain asbestos.

Any change in appearance should be recorded and passed to Property Services.
