ASBESTOS SURVEY REPORT FOR SUNDERLAND EMPIRE THEATRE, 4-5 HIGH STREET WEST, SUNDERLAND, SR1 3EX

Control of Asbestos Regulations 2012

Asbestos Register for

**Sunderland Empire Theatre, 4-5 High Street West,
Sunderland, SR1 3EX**

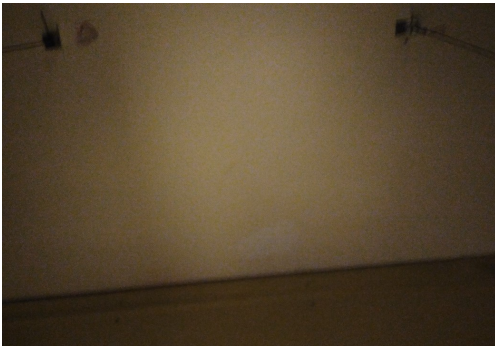
Item 1 Ref: 405964-48

The ceiling - textured coating (0/003/office - void above) does not contain asbestos.

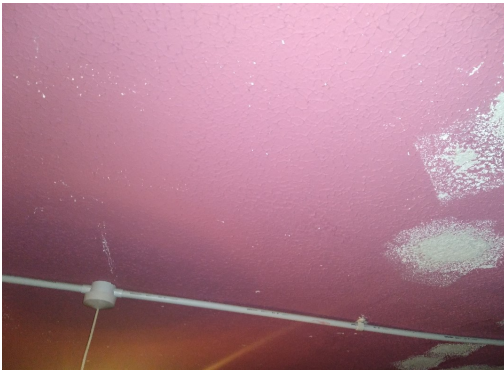
Item 2 Ref: 405964-49

The ceiling - textured coating (0/013/storage area) does not contain asbestos.

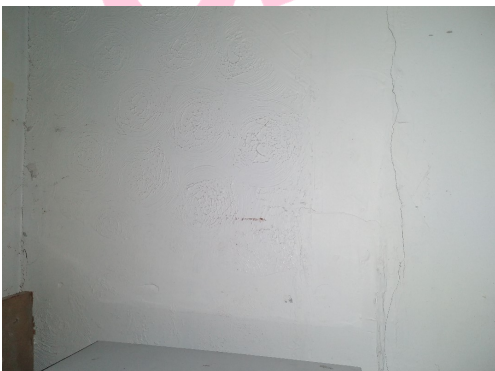
Item 3 Ref: 405964-54

The wall – textured coating (0/013/storage area) does not contain asbestos.

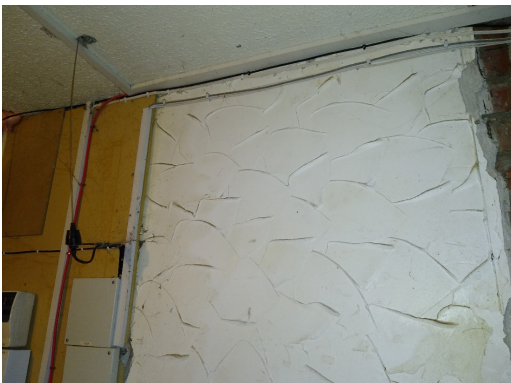
Item 5 Ref: 405964-45

The wall – textured coating (1/018/storage area) does not contain asbestos.

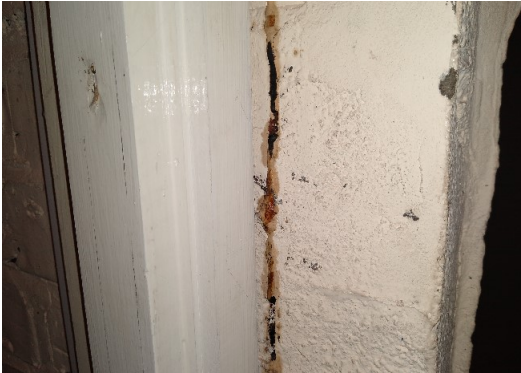
Item 13 Ref: 405964-42

The wall beside door frame to boiler room – bituminous product (2/007/landing & stairwell 3) does not contain asbestos.

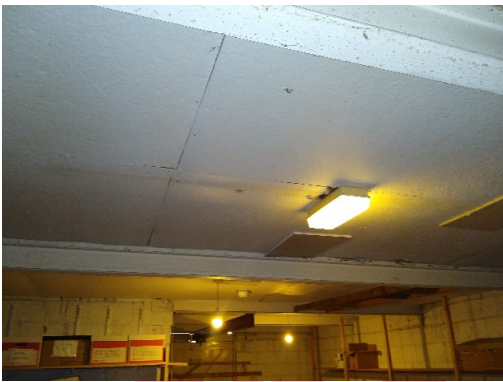
Item 14 Ref: As 405964-41

The ceiling – fibreboard (2/009/archive room) does not contain asbestos.

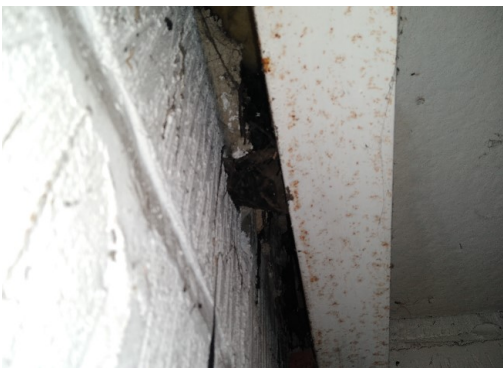
Item 15 Ref: 405964-43

The flat roof debris – bituminous felt (2/009/archive room) does not contain asbestos.

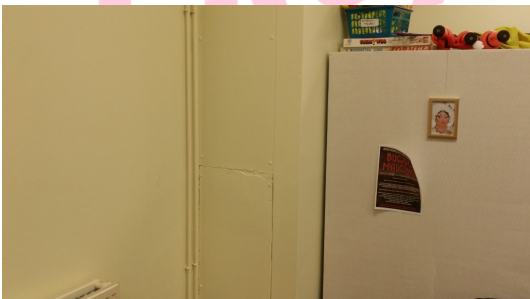
Item 24 Ref: 405964-20

The panels to boxing (1/005/green room) do not contain asbestos.

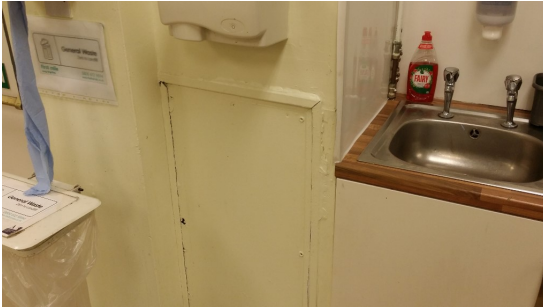
Item 25 Ref: 405964-23

The panels to boxing – insulating board (1/005/green room) do not contain asbestos.

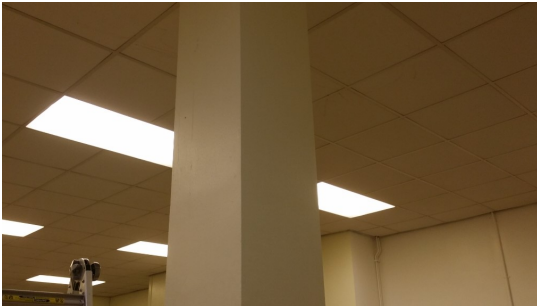
Item 26 Ref: 405964-24

The boxing to columns (1/005/green room) do not contain asbestos.

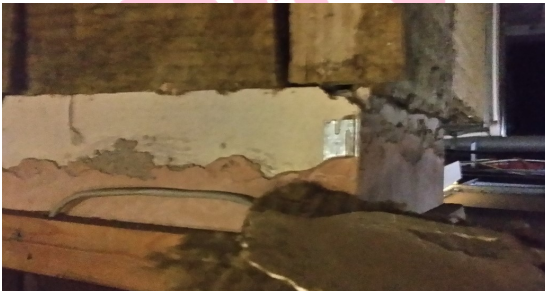
Item 27 Ref: As 405964-24

The boxing to columns (1/005/green room void above) do not contain asbestos.

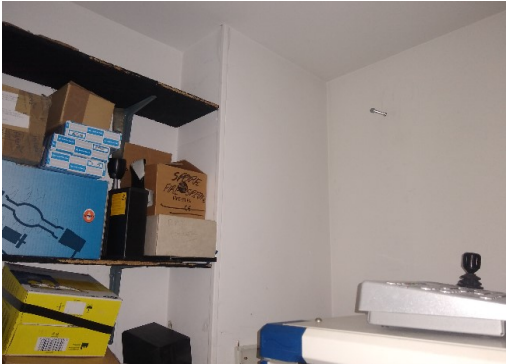
Item 28 Ref: 405964-37

The column cladding (1/005A/rack room) does not contain asbestos.

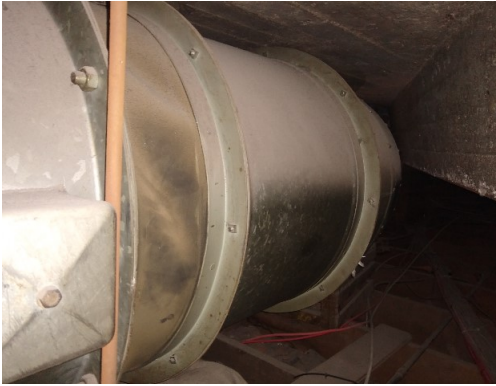
Item 31 Ref: 405964-85

- (Item 31) Ref: 405964-85 – Ductwork flange gaskets (1/020/stalls seating area-void above) – Very Low Risk
- (Item 32) Ref: As 405964-85 – Flange gaskets to loose lying ductwork sections (1/020/stalls seating area-void above) – Very Low Risk

The ductwork flange gaskets (1/020/stalls seating area-void above) contains asbestos.

Any change in appearance should be recorded and passed to Property Services.

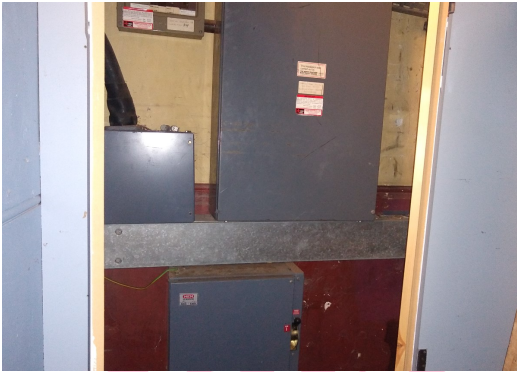
Item 35 Ref: PRESUMED

The electrics (1/025/store) are presumed to contain asbestos.

Any change in appearance should be recorded and passed to Property Services.

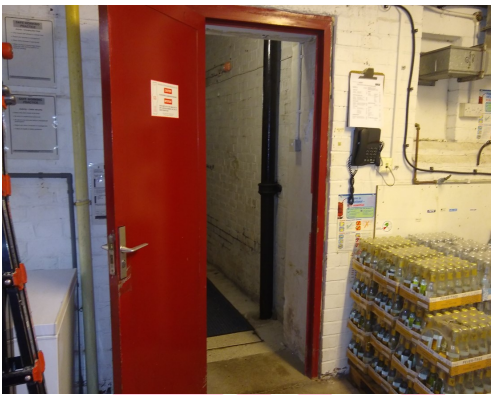
Item 38 Ref: As 405964-38

The sealant to door frame (1/030/cellar) contains asbestos.

Any change in appearance should be recorded and passed to Property Services.

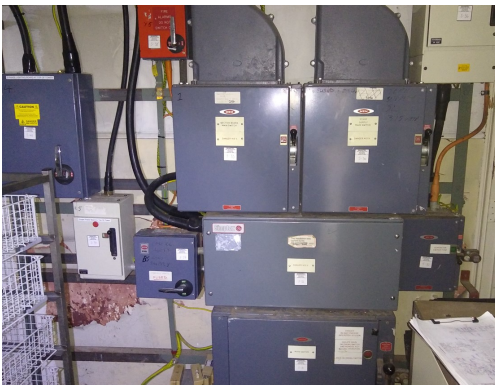
Item 42 Ref: PRESUMED

The electrics (1/033/electrical intake) is presumed to contain asbestos.

Any change in appearance should be recorded and passed to Property Services.

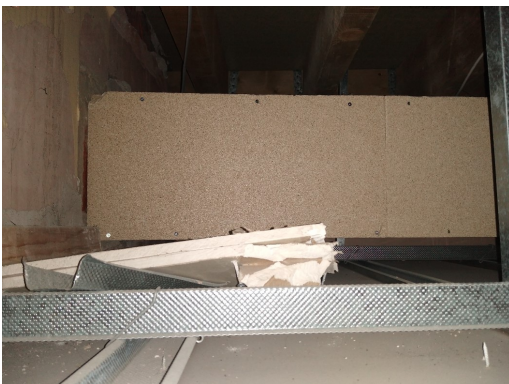
Item 45 Ref: 405964-30

The firebreak panels to beams (1/045/lobby & stairwell to contact centre-void above) do not contain asbestos.

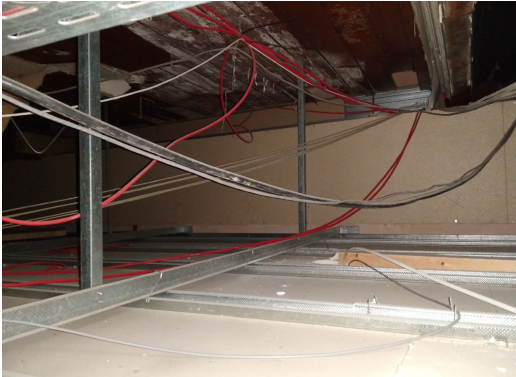
Item 46 Ref: 405964-26

The firebreak panels (1/046/main entrance & bar-void above) do not contain asbestos.

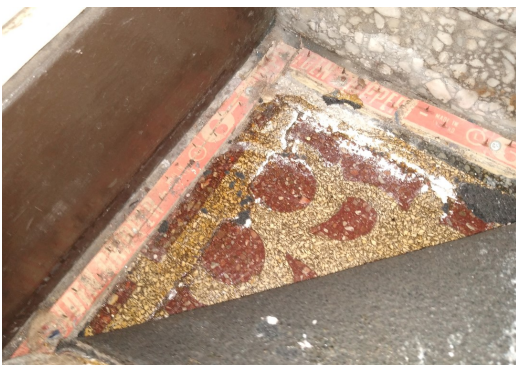
Item 48 Ref: As 405964-28

The floor covering below carpet (1/047/stairwell lobby) does not contain asbestos.

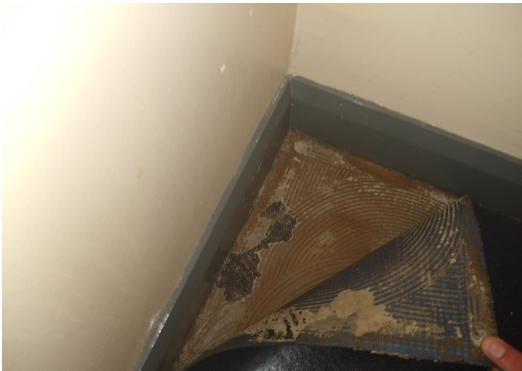
Item 63 Ref: 405964-18

The remnant bitumen adhesive below modern linoleum (3/006/disabled WC – Block A) contains asbestos.

Any change in appearance should be recorded and passed to Property Services.

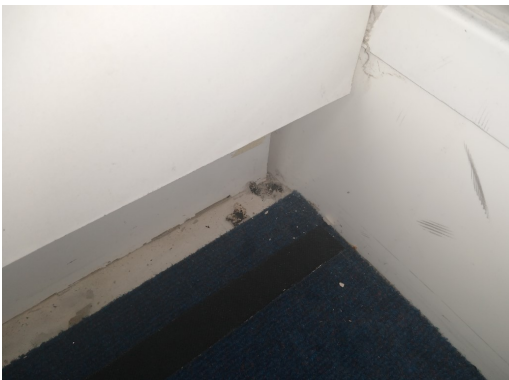
Item 65 Ref: As 405964-17

The remnant bitumen adhesive below carpet (3/009/dressing room 7 – Block A) contains asbestos.

Any change in appearance should be recorded and passed to Property Services.

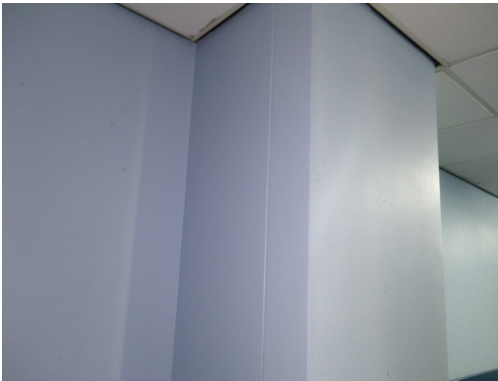
Item 68 Ref: As 405964-21

The panel to riser – insulating board (3/012/corridor – Block B) does not contain asbestos.

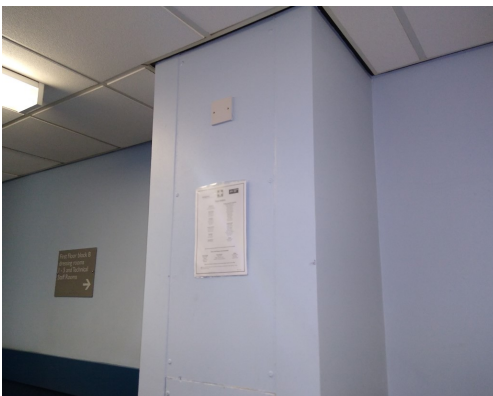
Item 69 Ref: As 405964-21

The panel to riser – insulating board (3/012A/corridor – Block B) does not contain asbestos.

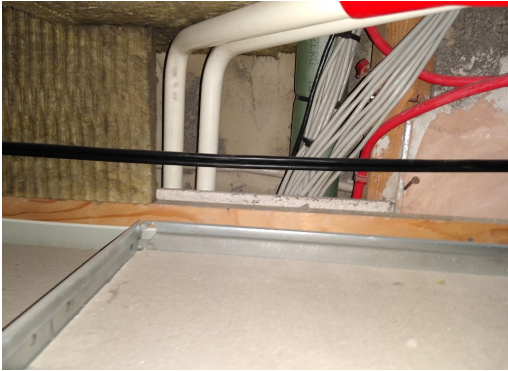
Item 70 Ref: As 405964-21

The boxing – insulating board (3/012A/corridor – Block B ceiling void) does not contain asbestos.

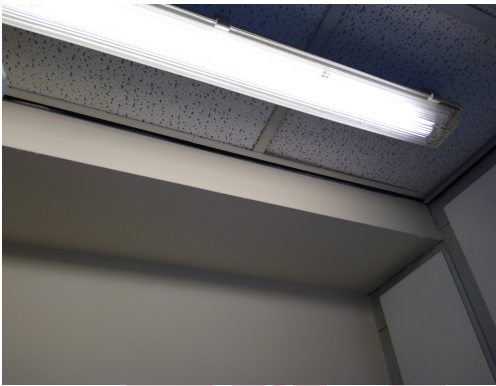
Item 74 Ref: As 405964-21

The boxing – insulating board (3/013A/managers shower room – Block B) does not contain asbestos.

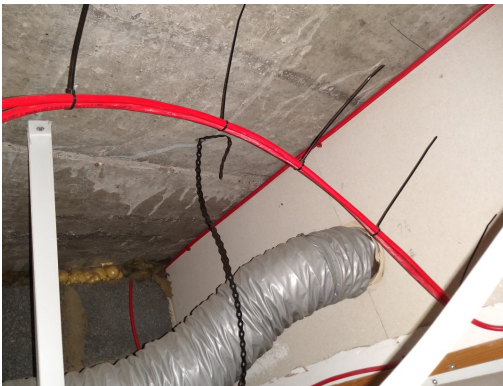
Item 80 Ref: As 405964-21

The boxing – insulating board (3/014A/shower room 1 – Block B ceiling void) does not contain asbestos.

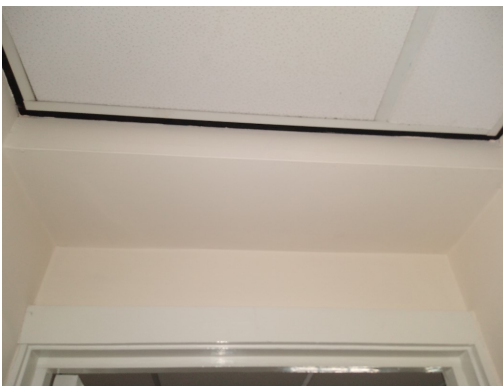
Item 81 Ref: As 405964-4

The boxing in corridor (3/015/dressing room 2 - Block B) does not contain asbestos.

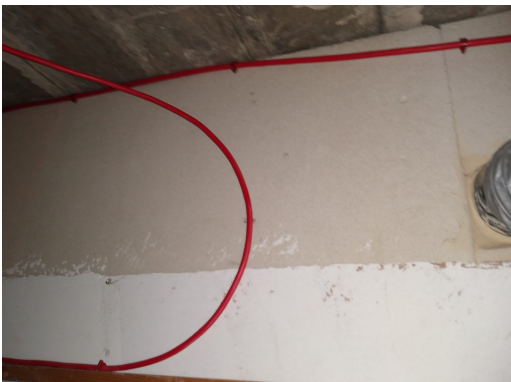
Item 84 Ref: As 405964-21

The boxing – insulating board (3/015A/shower room 2 – Block B ceiling void) does not contain asbestos.

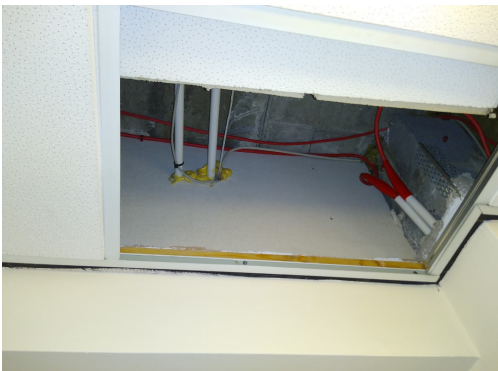
Item 87 Ref: As 405964-21

The bulkhead above corridor – insulating board (3/016/dressing room 3 – Block B ceiling void) does not contain asbestos.

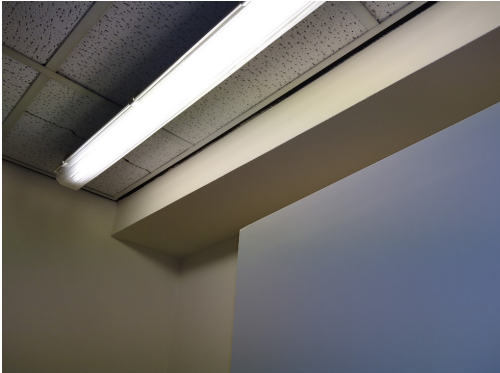
Item 88 Ref: As 405964-21

The boxing – insulating board (3/016A/shower room 3 – Block B) does not contain asbestos.

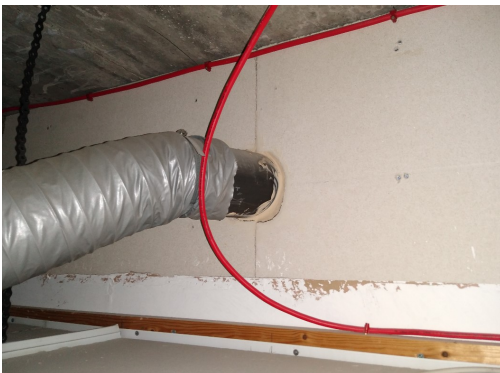
Item 89 Ref: As 405964-21

The boxing – insulating board (3/016A/shower room 3 – Block B ceiling void) does not contain asbestos.

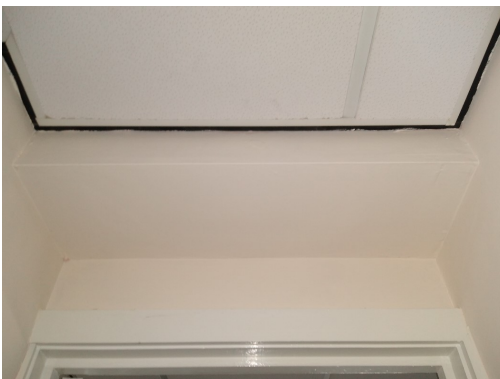
Item 90 Ref: As 405964-4

The boxing in corridor (3/017/dressing room 4 - Block B) does not contain asbestos.

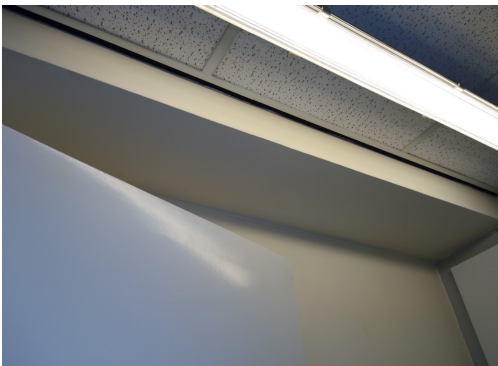
Item 92 Ref: As 405964-21

The boxing – insulating board (3/017A/shower room 4 – Block B) does not contain asbestos.

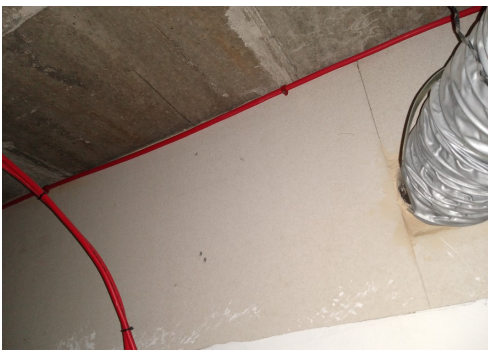
Item 93 Ref: As 405964-21

The boxing – insulating board (3/017A/shower room 4 – Block B ceiling void) does not contain asbestos.

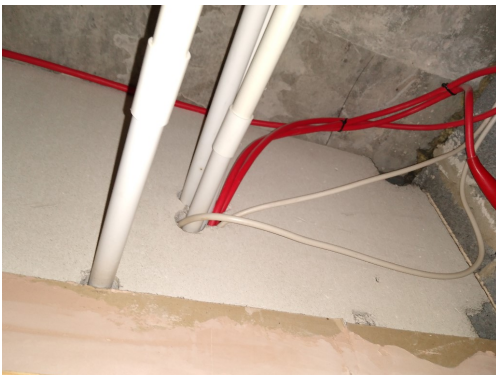
Item 96 Ref: As 405964-21

The bulkhead above corridor – insulating board (3/018/dressing room 5 – Block B ceiling void) does not contain asbestos.

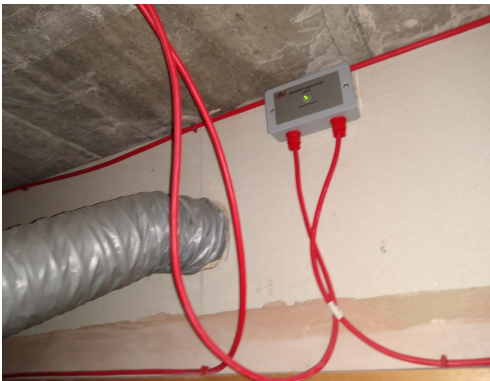
Item 98 Ref: As 405964-21

The boxing – insulating board (3/018A/shower room 5 – Block B ceiling void) does not contain asbestos.

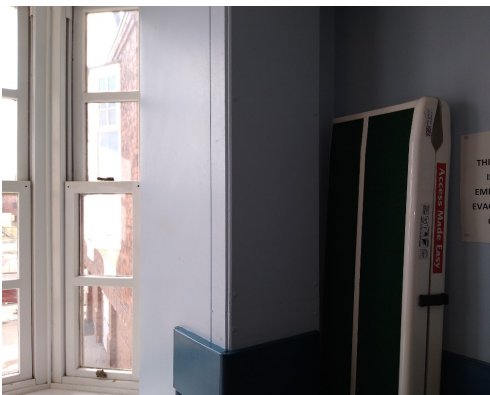
Item 99 Ref: As 405964-21

The panel to riser – insulating board (3/019/stairwell – Block B) does not contain asbestos.

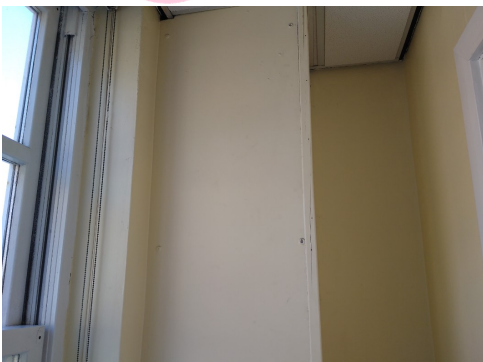
Item 102 Ref: As 405964-21

The panel to riser – insulating board (3/021/male WC & lobby – Block B) does not contain asbestos.

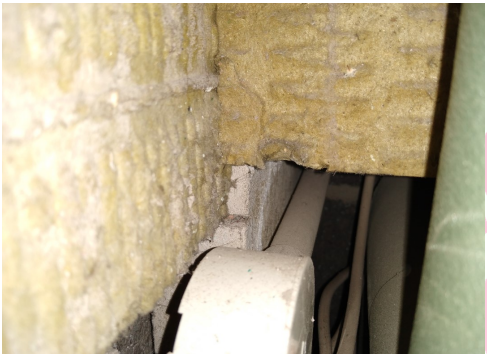
Item 104 Ref: 405964-22

The wall panel within riser – insulating board (3/021/male WC & lobby – Block B ceiling void) does not contain asbestos.

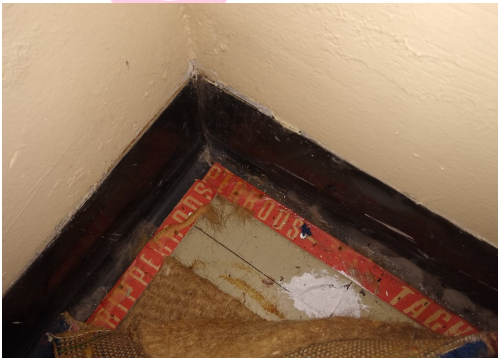
Item 105 Ref: 405964-53

The subfloor – floor tile with bitumen adhesive (3/022/corridor) does not contain asbestos.

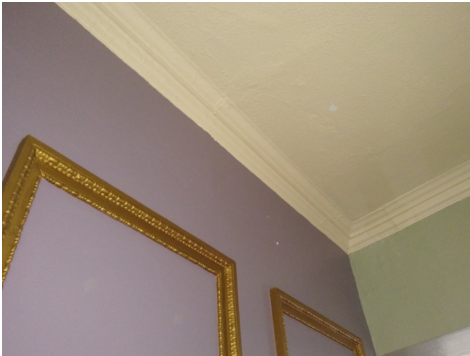
Item 107 Ref: 405964-56

The textured coating to walls at high level (3/024/dress circle bar/bistro) does not contain asbestos.

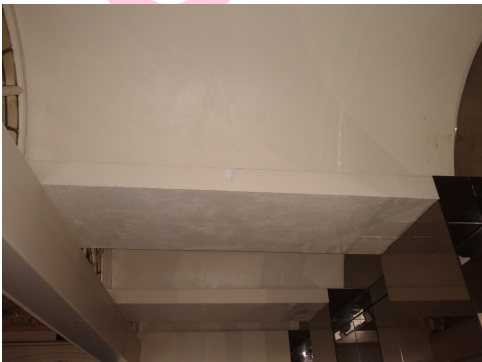
Item 108 Ref: 405964-57

The textured coating to wood vaulted ceiling above bar (3/024/dress circle bar/bistro) does not contain asbestos.

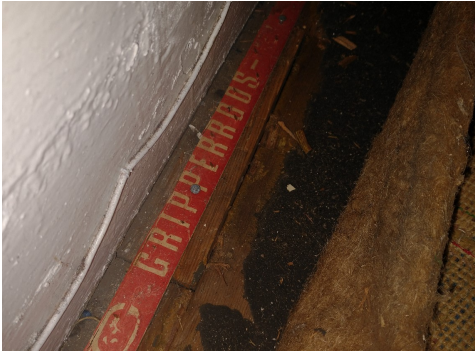
Item 109 Ref: 405964-61

The subfloor – bituminous adhesive to back of parquet flooring (3/027/security office) does not contain asbestos.

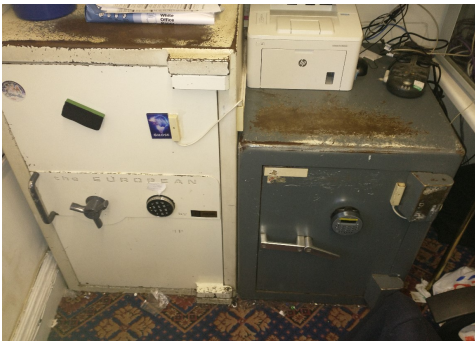
Item 110 Ref: PRESUMED

The lining to safe (3/027/security office) is presumed to contain asbestos.

Any change in appearance should be recorded and passed to Property Services.

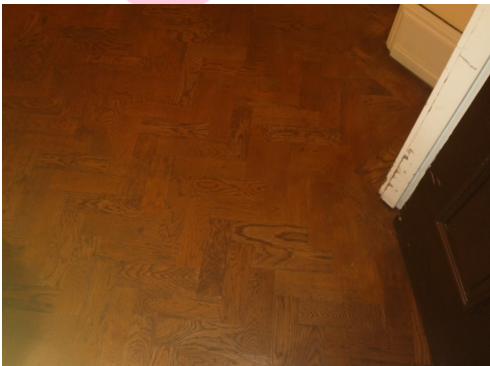
Item 111 Ref: As 405964-61

The subfloor – bituminous adhesive to back of parquet flooring (3/028/lift lobby) does not contain asbestos.

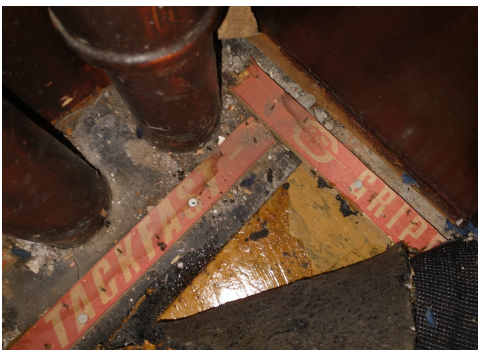
Item 114 Ref: 405964-62

The subfloor – linoleum (3/031/corridor) does not contain asbestos.

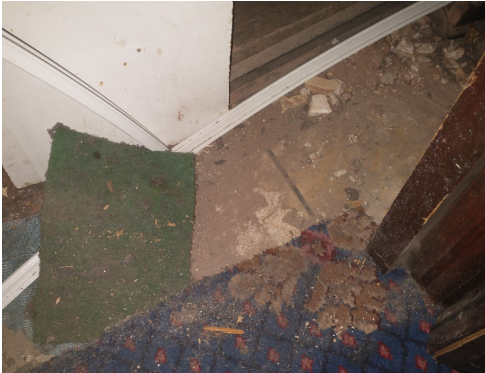
Item 115 Ref: As 405964-62

The subfloor – linoleum (3/031A/corridor riser) does not contain asbestos.

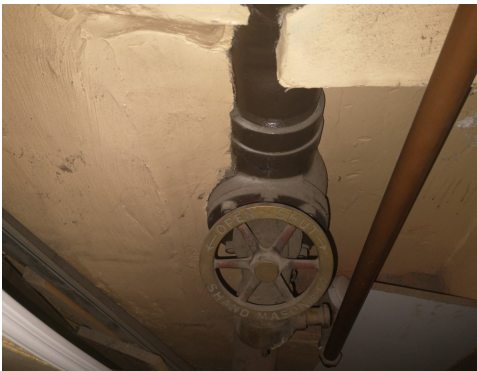
Item 116 Ref: 405964-70

The gasket to pipework (3/031A/corridor riser) does not contain asbestos.

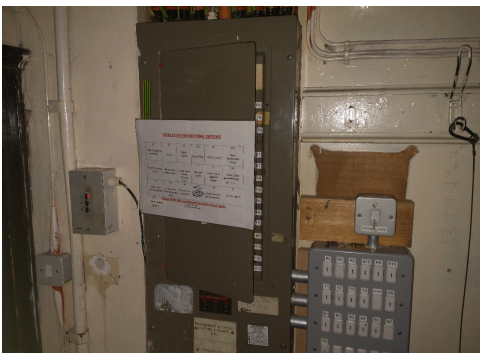
Item 117 Ref: PRESUMED

The 415kv DB electrics box – bacolite (3/32/electrics cupboard) is presumed to contain asbestos.

Any change in appearance should be recorded and passed to Property Services.

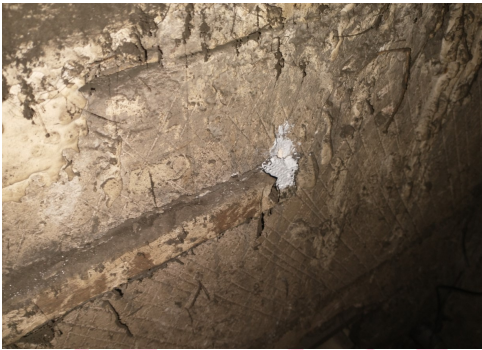
Item 119 Ref: 405964-65

The packing behind joists – millboard (3/032/electrics cupboard – void) contains asbestos.

Any change in appearance should be recorded and passed to Property Services.

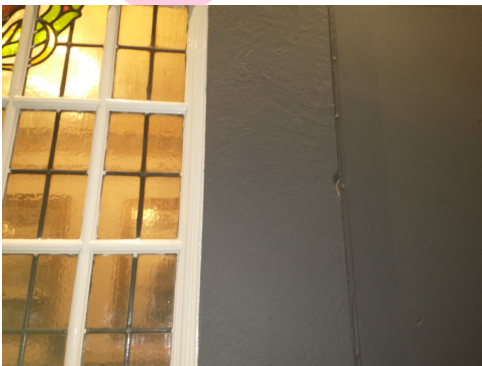
Item 120 Ref: 405964-69

The textured coating to walls (3/032A/stairwell landing) does not contain asbestos.

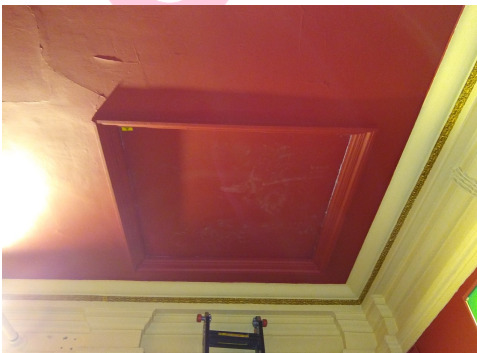
Item 123 Ref: 405964-63

The hatches (3/040/dress circle) do not contain asbestos.

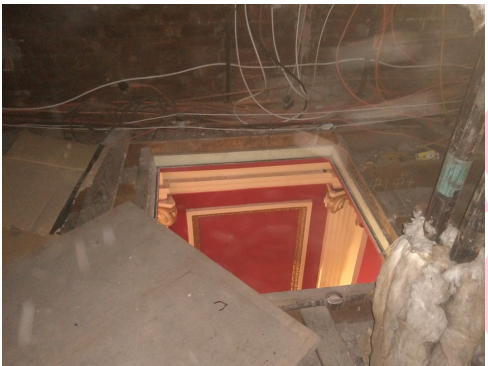
Item 128 Ref: 405964-60

The debris surrounding large hatch (3/040/dress circle – void above) does not contain asbestos.

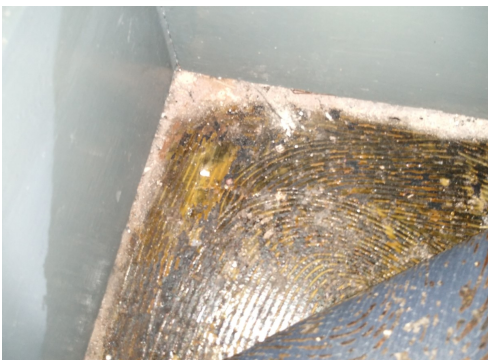
Item 129 Ref: As 405964-15

The remnant bitumen adhesive below modern linoleum (4/002/corridor – Block A) contains asbestos.

Any change in appearance should be recorded and passed to Property Services.

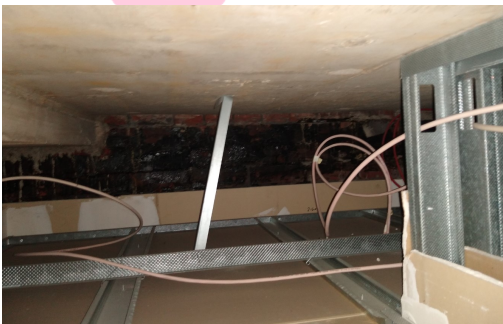
Item 132 Ref: As 405964-14

The bitumen to walls (4/004/male WC – Block A – void above) does not contain asbestos.

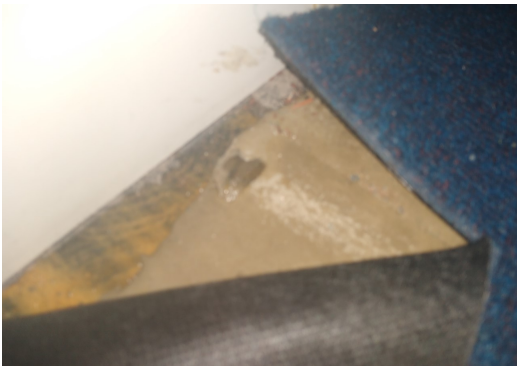
Item 134 Ref: As 405964-15

The remnant bitumen
adhesive below carpet
(4/006/dressing room 10 –
Block A) contains asbestos.

Any change in appearance
should be recorded and
passed to Property Services.

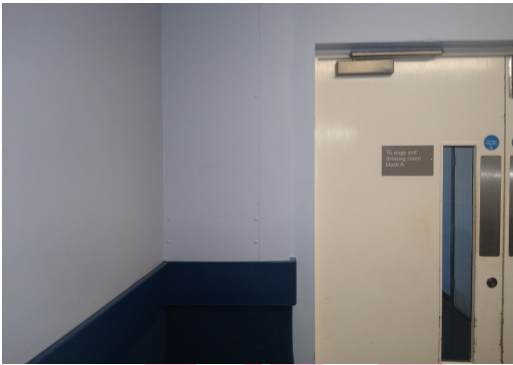
Item 137 Ref: As 405964-13

The panel to boxing (4/011/corridor – Block B) does not contain asbestos.

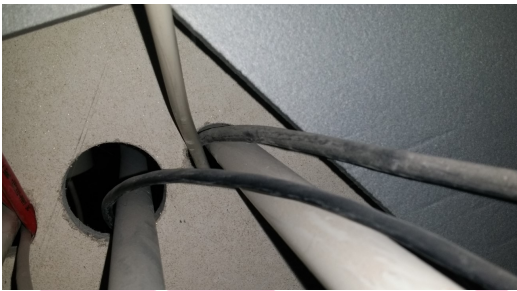
Item 140 Ref: As 405964-12

The firebreak above door
(4/012/dressing room 10 –
Block B – void above) does
not contain asbestos.

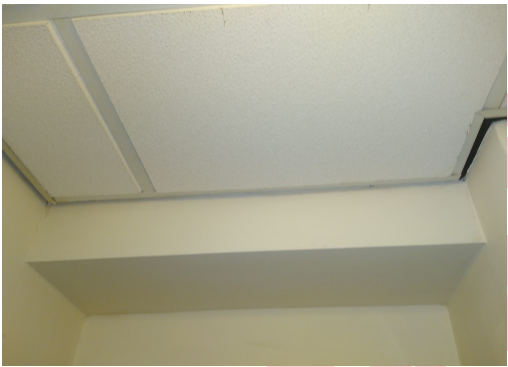
Item 143 Ref: As 405964-12

The boxing to beams below
plasterboard (4/013/dressing
room 9 – Block B) does not
contain asbestos.

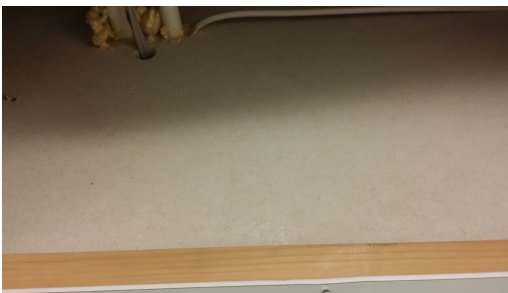
Item 144 Ref: 405964-12

The firebreak above door
(4/013/dressing room 9 –
Block B – void above) does
not contain asbestos.

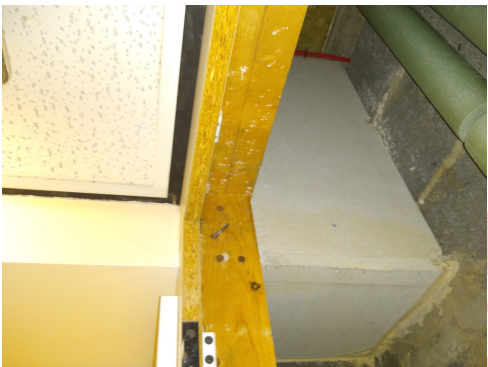
Item 149 Ref: As 405964-11

The boxing to beam below plasterboard (4/014A/shower room – Block B) does not contain asbestos.

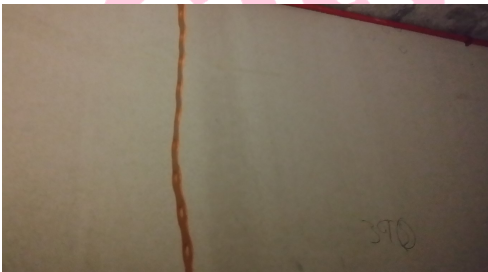
Item 150 Ref: As 405964-11

The firebreak above door (4/014A/shower room – Block B – void above) does not contain asbestos.

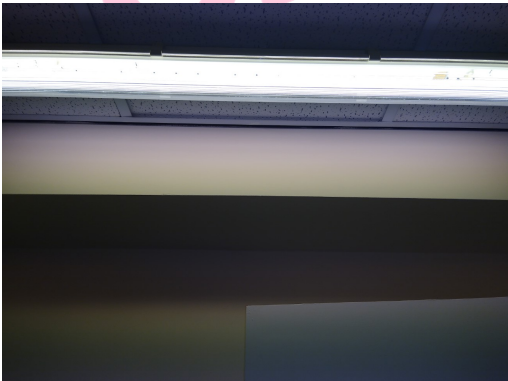
Item 153 Ref: As 405964-11

The boxing to beam below plasterboard (4/015A/shower room – Block B) does not contain asbestos.

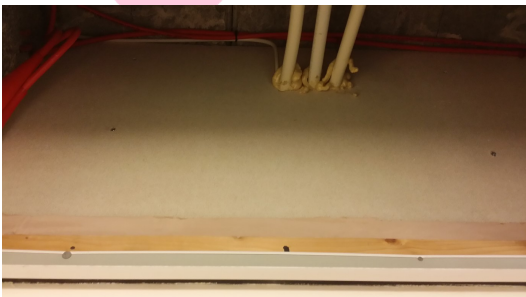
Item 156 Ref: As 405964-11

The firebreak (4/016/dressing room 6 – Block B – void above) does not contain asbestos.

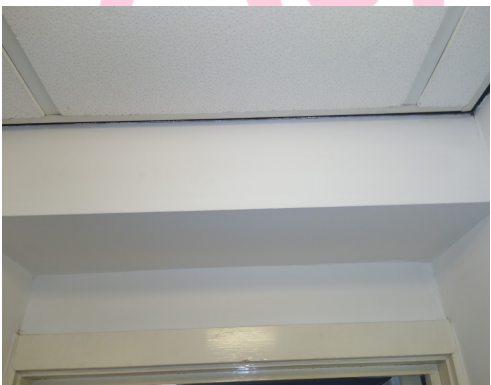
Item 159 Ref: As 405964-11

The boxing to beam below plasterboard (4/017/venue technical manager – Block B) does not contain asbestos.

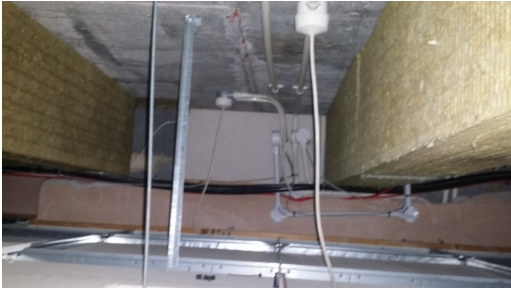
Item 160 Ref: As 405964-11

The firebreak above door (4/017/venue technical manager – Block B – void above) does not contain asbestos.

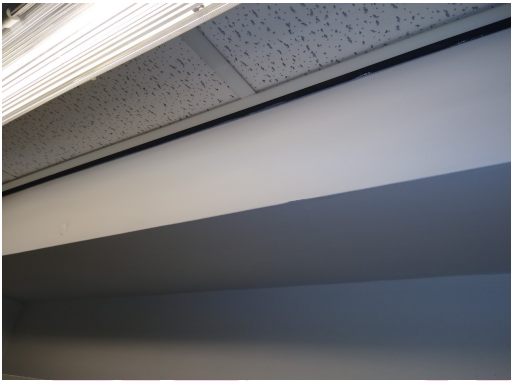
Item 161 Ref: As 405964-11

The boxing to beam below plasterboard (4/017A/shower room – Block B) does not contain asbestos.

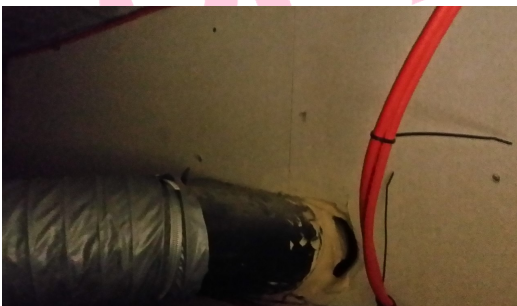
Item 162 Ref: As 405964-11

The firebreak (4/017A/shower room – Block B – void above) does not contain asbestos.

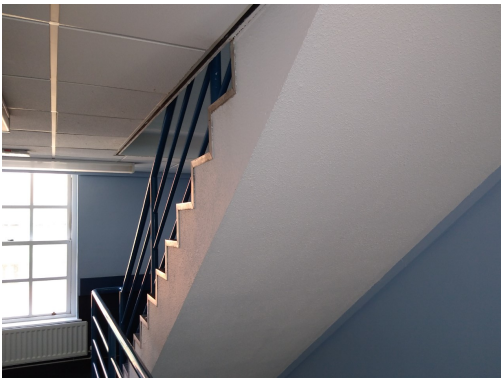
Item 164 Ref: 405964-10

The decorative finish to stairs
& suspended ceiling up stand
(4/018/stairwell – Block B)
does not contain asbestos.

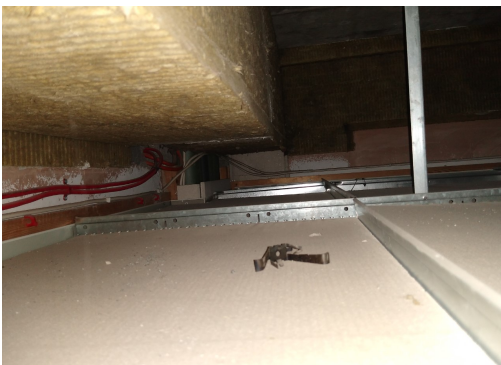
Item 165 Ref: As 405964-9

The top of boxing
(4/018/stairwell – Block B –
void above) does not contain
asbestos.

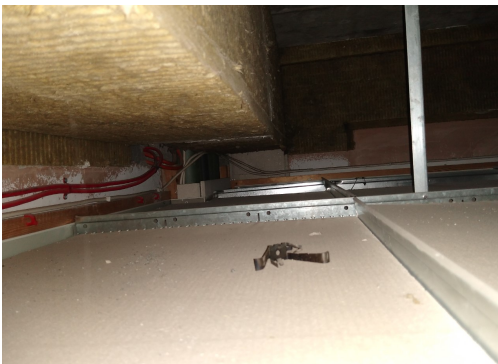
Item 168 Ref: 405964-83

The subfloor – linoleum
(4/023/upper circle) does not
contain asbestos.

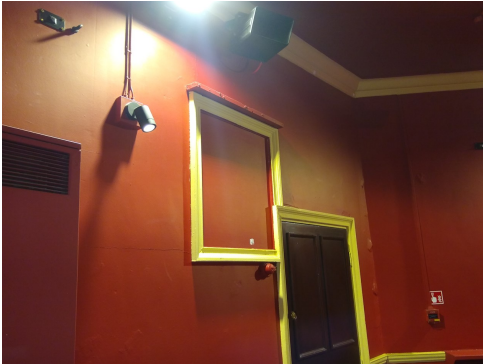
Item 169 Ref: 405964-84

The panel to wall (4/023/upper circle) does not contain asbestos.

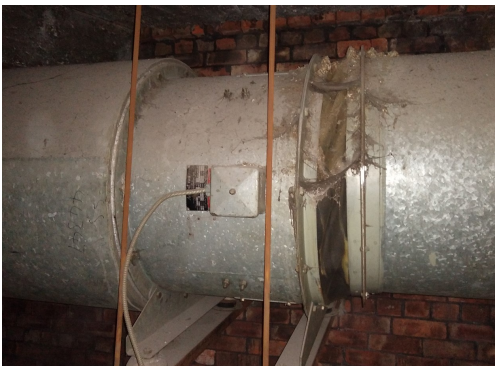
Item 170 Ref: 405964-79

- (Item 170) Ref: 405964-79 – Ductwork flange gaskets northeast (4/023/upper circle – void above) – Low Risk
- (Item 171) Ref: As 405964-79 – Flange gaskets to loose lying ductwork southwest (4/023/upper circle – void above) – Low Risk

The ductwork flange gaskets northeast (4/023/upper circle – void above) contain asbestos.

Any change in appearance should be recorded and passed to Property Services.

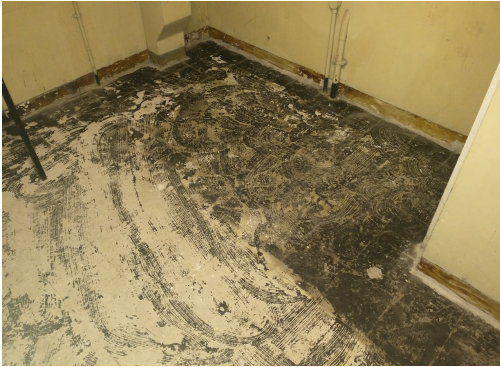
Item 172 Ref: 405964-74

The remnant adhesive to floor (4/024/old projectors room) contains asbestos.

Removed April 2022.

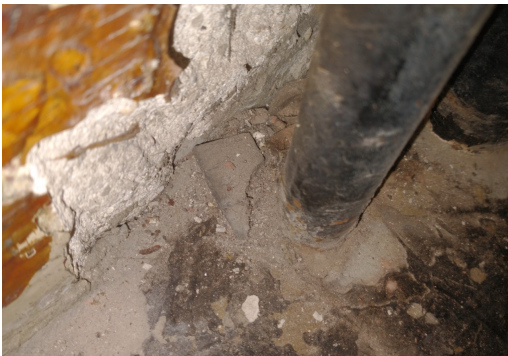
Item 173 Ref: 405964-75

The remnant floor tiles debris to floor (4/024/old projectors room) contains asbestos.

Any change in appearance should be recorded and passed to Property Services.

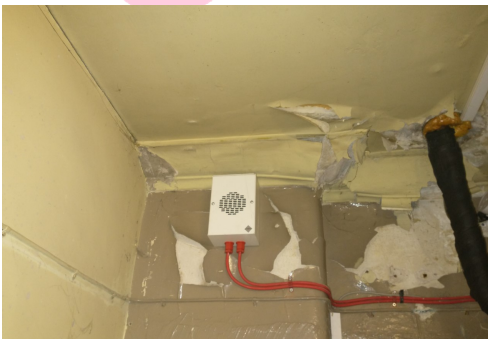
Item 174 Ref: 405964-76

The coving plaster (4/024/old projectors room) does not contain asbestos.

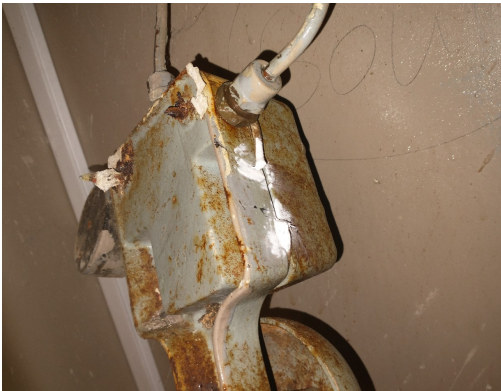
Item 176 Ref: 405964-78

The rope seal to redundant fire bell (4/024/old projectors room) does not contain asbestos.

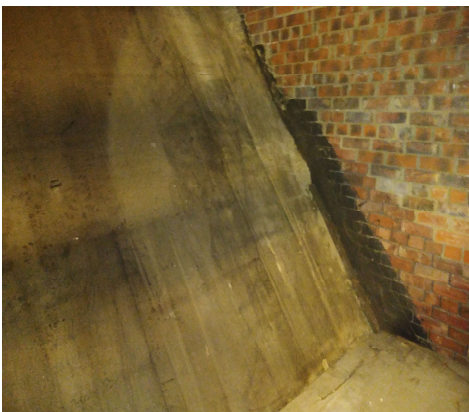
Item 195 Ref: 405964-6

The redundant roof covering to old roof (6/03/loft void) does not contain asbestos.

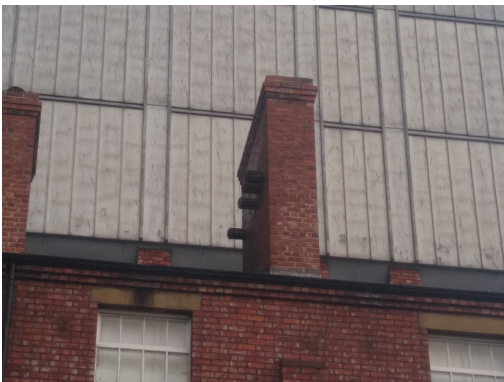
Item 201 Ref: PRESUMED

The flue cowls to chimney south east (External) is presumed to contain asbestos.

Any change in appearance should be recorded and passed to Property Services.
