ASBESTOS SURVEY REPORT FOR LEECHMERE TRAINING CENTRE (INCLUDING TELECARE HOUSE), SUNDERLAND

Asbestos Register for LEECHMERE CENTRE, SUNDERLAND

Premises Manager / Samo: - Tenant Date: 16 January 2025

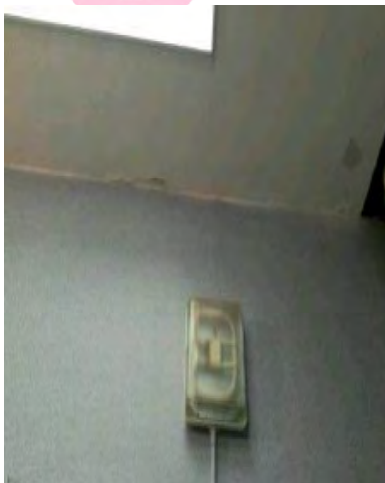
Item 6 - Ref: CB000915

CB000915 – Textured coating (Stores Male WC) (Item 6) - Low Risk

The textured coating to the ceiling in the Stores male wc contains asbestos.

Any change in its appearance should be recorded and passed to Property Services.

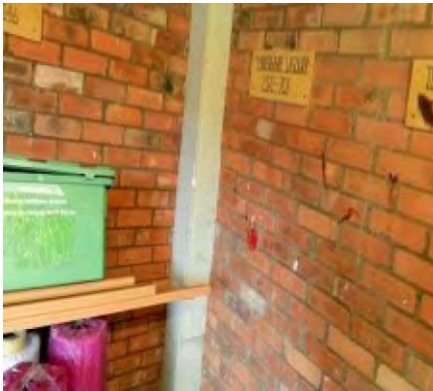
Item 7 - Ref: DJC04/1429

CB000913 – Insulating board boxing (Stores External Cupbd) (Item 7) –Low Risk

The insulating board boxing to the stores external cupboard contains asbestos.

Any change in its appearance should be recorded and passed to Property Services.

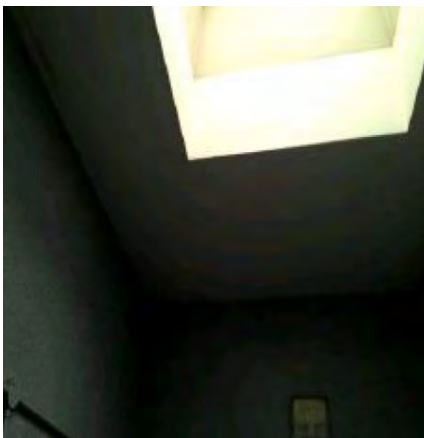
Item 8 - Ref: CB000915

As CB000915 – Textured coating (Stores Female WC) (Item 8) – Removed Nov 2016

The textured coating to the ceiling in the Stores Female WC contains asbestos.

**This was removed
November 2016.**

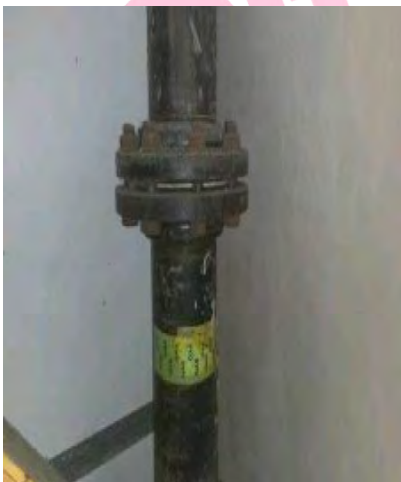
Item 9 - Ref: CB000918

CB000918 – Gasket (Gas Store) (Item 9) – Very Low Risk

The gasket to the gas store contains asbestos.

Any change in its appearance should be recorded and passed to Property Services.

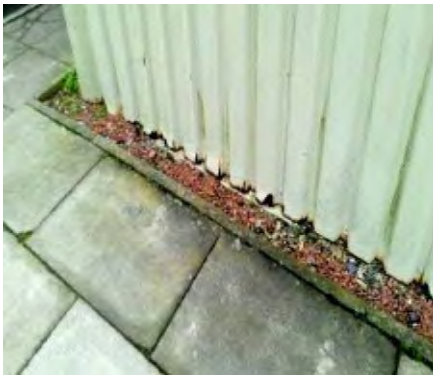
Item 10 - Ref: 170761-1

170761-1 - Corrugated wall cladding (External) (Item 10) – Very Low Risk

The corrugated wall cladding to the external is presumed to contain asbestos.

Any change in its appearance should be recorded and passed to Property Services.

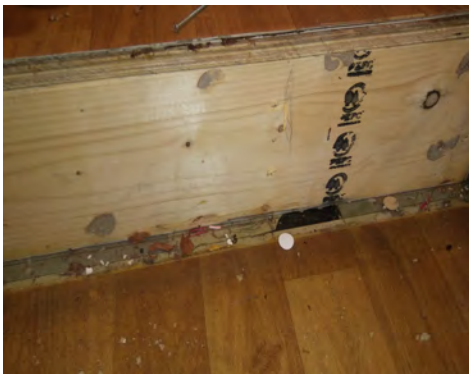
Item 25 - Ref: 315020-1

315020-1 – Floor covering (Seminar Room) (Item 25) – Very low Risk

The floor covering below the wood skirting and stage in the Seminar Room contains asbestos.

Any change in its appearance should be recorded and passed to Property Services.

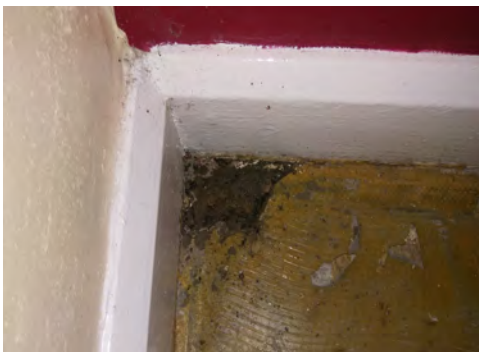
Item 26 - Ref: 315202-2

315202-2 – Remnant bitumen adhesive (Seminar Room) (Item 26) – Very Low Risk

The remnant bitumen adhesive below modern linoleum and modern screed in the Seminar Room contains asbestos.

Any change in its appearance should be recorded and passed to Property Services.

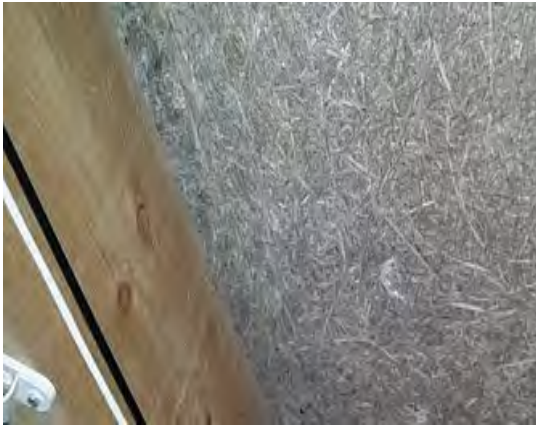
Item 27 - Ref: 70826-1

70826-1 – Underside of Roof (ILC entrance-void above 0/001) (Item 27) – No risk

The underside of roof in ILC entrance ceiling void (Rm 0/001) does not contain asbestos.

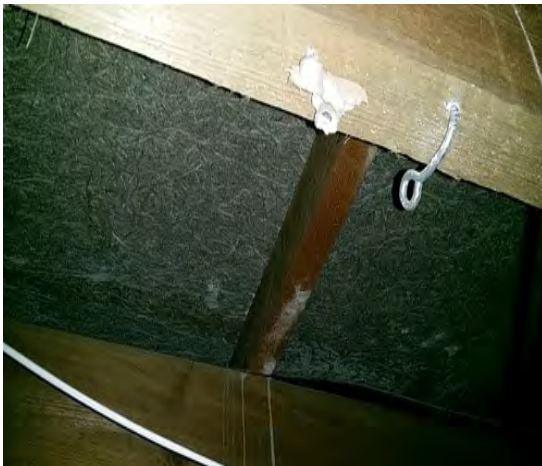
Item 28 - Ref: As 70826-3

As 70826-3 – Debris to nail in beams (ILC entrance-void above 0/001) (Item 28) – Low Risk

The debris to nails in wood beams in ILC entrance ceiling void (Rm 0/001) contains asbestos.

Any change in its appearance should be recorded and passed to Property Services.

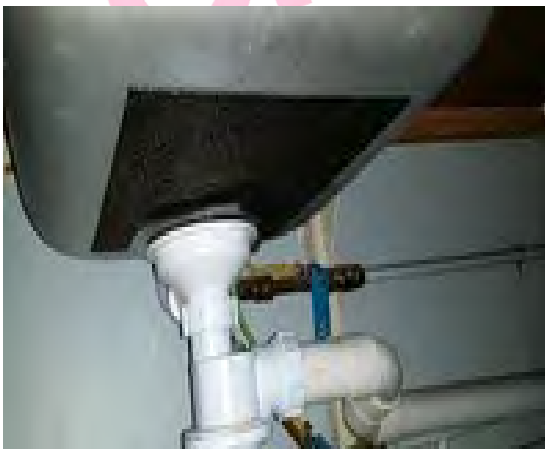
Item 29 - Ref: Presumed

Presumed – Sink Pad (Kitchen 0/010) (Item 29) – Very low Risk

The sink pad in kitchen (Rm 0/010) is presumed to contain asbestos.

Any change in its appearance should be recorded and passed to Property Services.

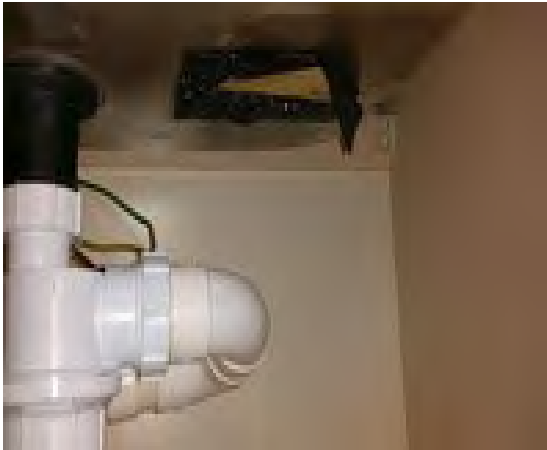
Item 30 - Ref: Presumed

Presumed – Sink Pad (Kitchen 0/035) (Item 30) – Very low Risk

The sink pad in kitchen (Rm 0/035) is presumed to contain asbestos.

Any change in its appearance should be recorded and passed to Property Services.

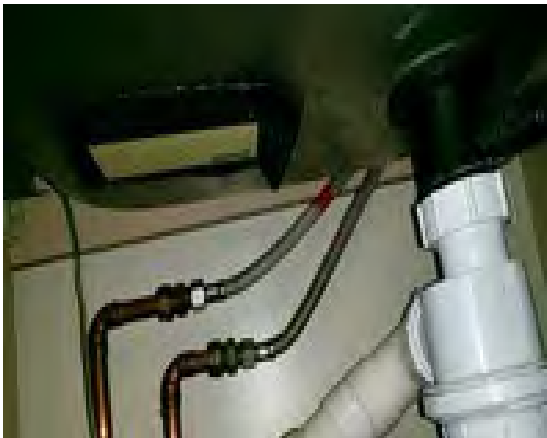
Item 31 - Ref: Presumed

Presumed – Sink Pad (Kitchen 0/049) (Item 31) – Very low Risk

The sink pad in kitchen (Rm 0/049) is presumed to contain asbestos.

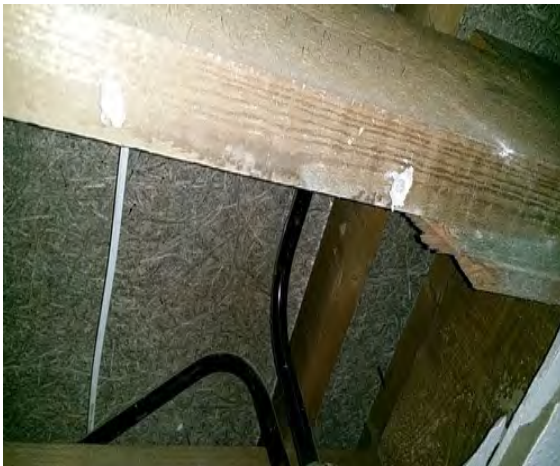
Item 34 - Ref: 70826-3

70826-3 – Debris to nail in beams (ILC reception office-void above 0/066) (Item 34) – Removed November 2019

The debris to nails in wood beams in ILC reception office ceiling void (Rm 0/066) contains asbestos.

Removed November 2019

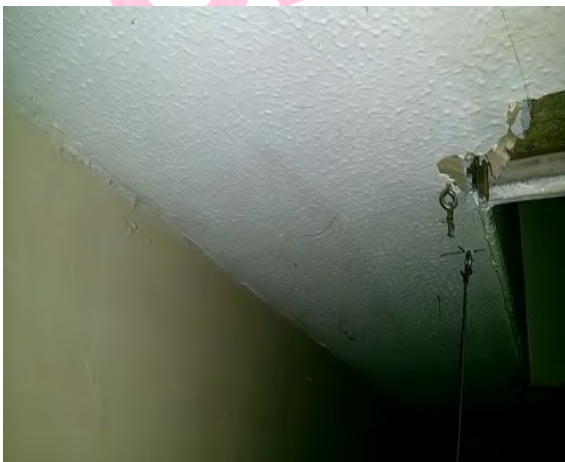
Item 35 - Ref: 70826-2

70826-2 – Textured Coating to ceiling (ILC reception office-void above 0/066) (Item 35) – Removed – confirmed on reinspection survey J142852 Dec 2025

The textured coating to former plasterboard ceiling in ILC reception office ceiling void (Rm 0/066) contains asbestos.

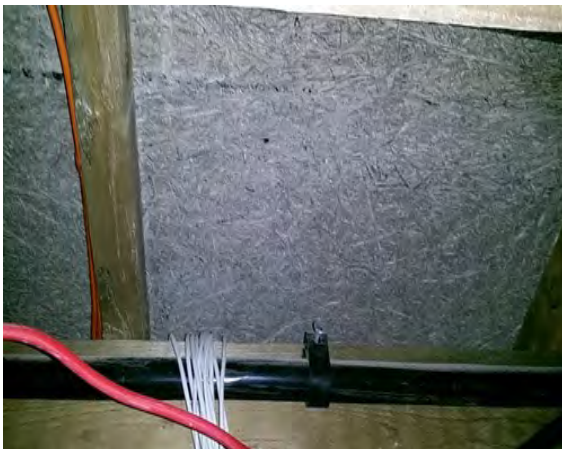
Item 37 - Ref: As 70826-1

As 70826-1 – Underside of Roof (Sub main electrics intake room-void above 0/067) (Item 37) – No Risk

The underside of roof in Sub main electric intake room ceiling void (Rm 0/067) does not contain asbestos.

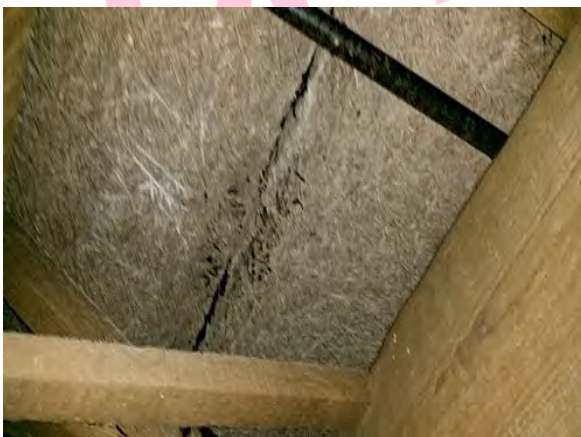
Item 41 - Ref: As 70826-1

As 70826-1 – Underside of Roof (Female Toilets & Lobby-void above 0/070) (Item 41) – No Risk

The underside of roof in Female Toilets & Lobby ceiling void (Rm 0/070) does not contain asbestos.

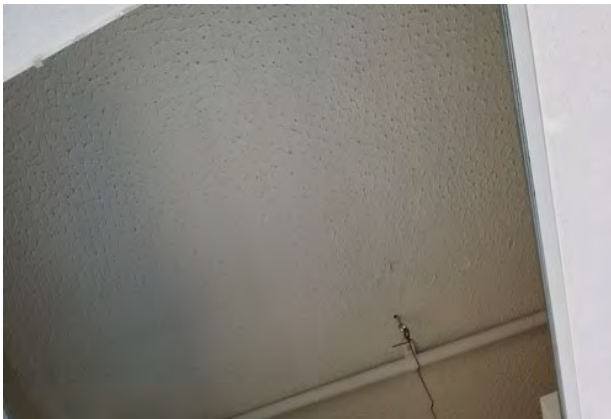
Item 67 - Ref: As 70826-5

The textured coating to plasterboard ceiling in Operations Managers Office ceiling void (Rm 0/085) contains asbestos.

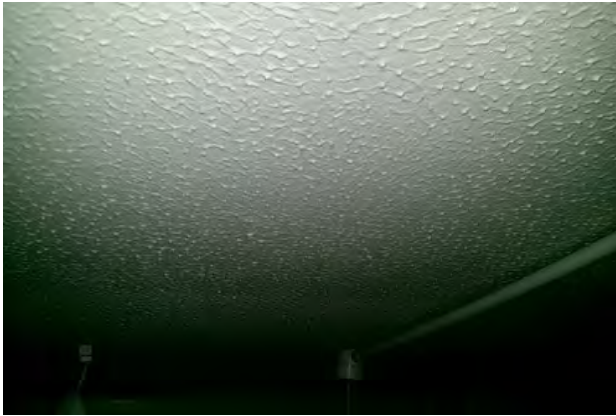
Item 69 - Ref: As 70826-5

The textured coating to ceiling in Operations Managers Office ceiling void (Rm 0/087) contains asbestos.

Any change in its appearance should be recorded and passed to Property Services.

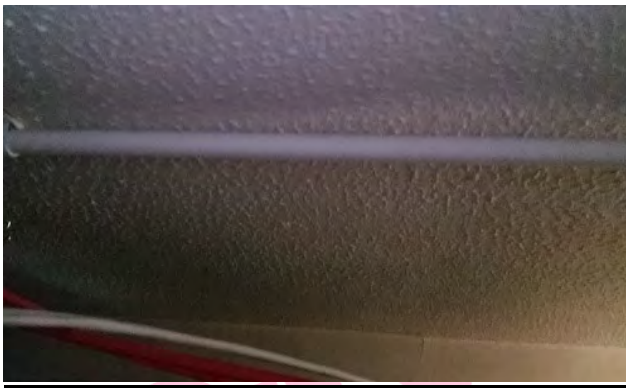
Item 70 - Ref: As 70826-5

The textured coating to ceiling in Operations Managers Office ceiling void (Rm 0/088) contains asbestos.

Any change in its appearance should be recorded and passed to Property Services.

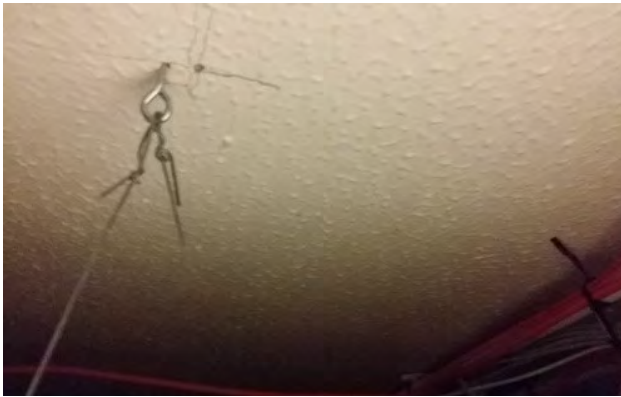
Item 71 - Ref: As 70826-5

The textured coating to ceiling in Fire Exit void above (Rm 0/089) contains asbestos.

Any change in its appearance should be recorded and passed to Property Services.

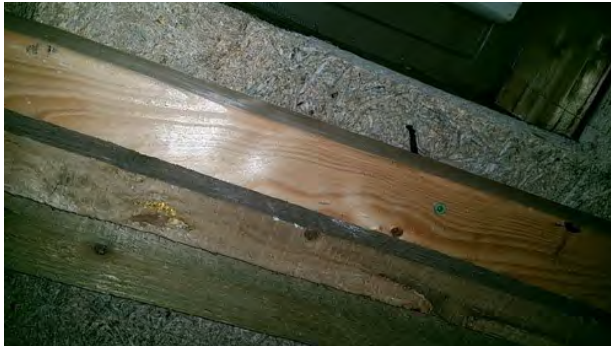
Item 72 - Ref: As 70826-6

The Underside of Roof in Office-void above (Rm 0/090) does not contain asbestos.

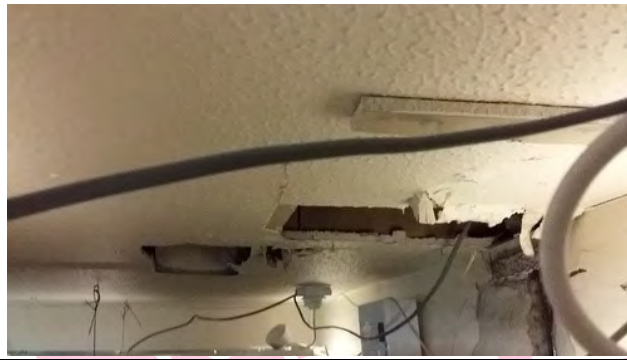
Item 73 - Ref: 70826-8

The textured coating to ceiling in Office-void above (Rm 0/090) contains asbestos.

Any change in its appearance should be recorded and passed to Property Services.

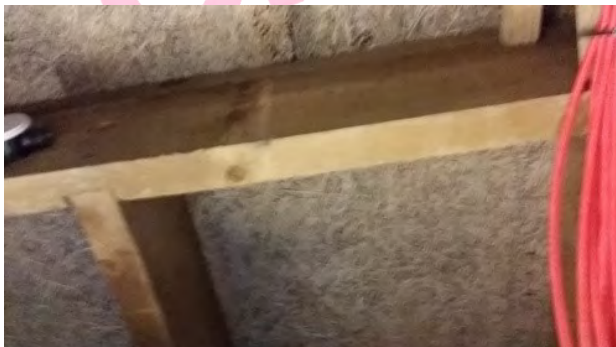
Item 74 - Ref: As 70826-6

The Underside of Roof in Office-void above (Rm 0/091) does not contain asbestos.

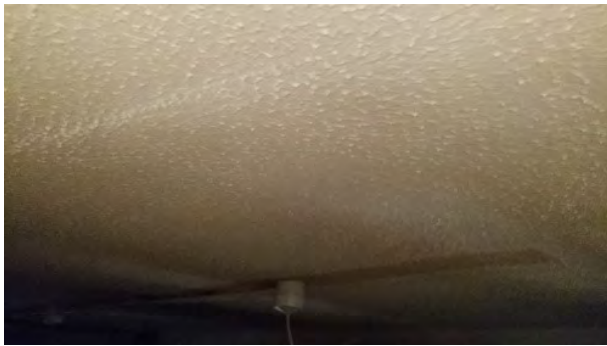
Item 75 - Ref: 70826-9

The textured coating to ceiling in Chief operating Officer-void above (Rm 0/092) contains asbestos.

Any change in its appearance should be recorded and passed to Property Services.

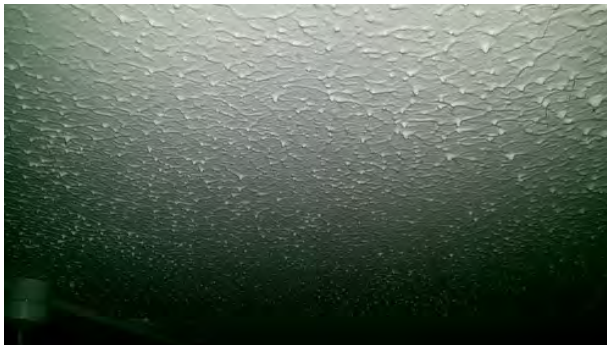
Item 76 - Ref: As 70826-9

The textured coating to ceiling in Office-void above (Rm 0/093) contains asbestos.

Any change in its appearance should be recorded and passed to Property Services.

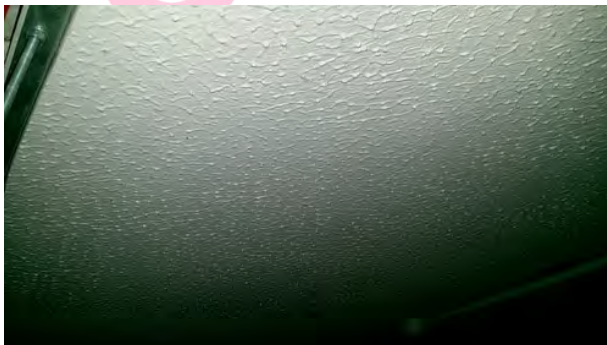
Item 77 - Ref: As 70826-9

The textured coating to ceiling in Human resource office-void above (Rm 0/094) contains asbestos.

Any change in its appearance should be recorded and passed to Property Services.

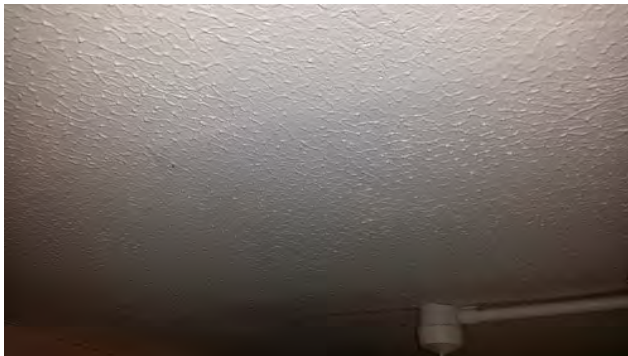
Item 78 - Ref: As 70826-9

The textured coating to ceiling in Operational Managers office-void above (Rm 0/095) contains asbestos.

Any change in its appearance should be recorded and passed to Property Services.

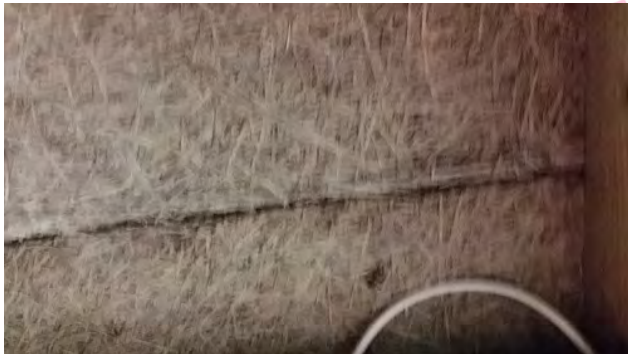
Item 79 - Ref: As 70826-1

The Underside of Roof Leechmere Reception Office-void above (Rm 0/096) does not contain asbestos.

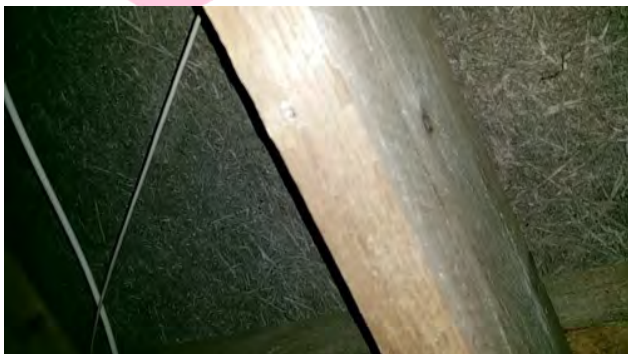
Item 80 - Ref: 70826-10

The debris to nail holes in beams in Leechmere Reception Office-void above (Rm 0/096) contains asbestos.

Removed as per reinspection survey Sept 2019

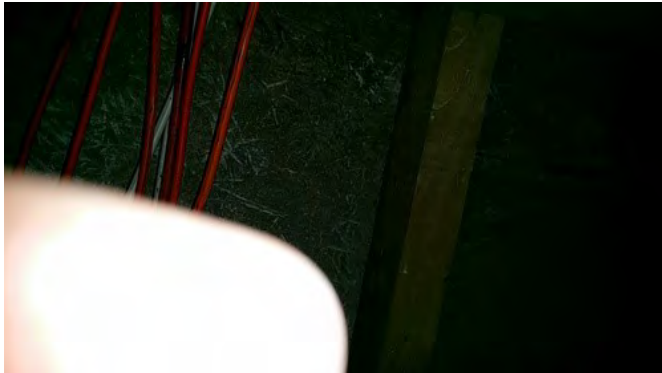
Item 81 - Ref: As 70826-1

The underside of roof in Leechmere Reception Area-void above (Rm 0/097) does not contain asbestos.

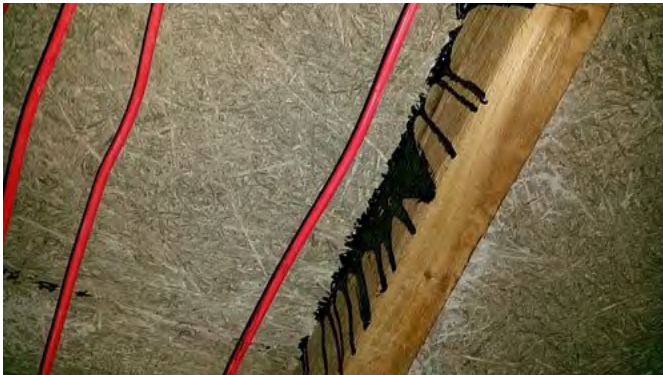
Item 82 - Ref: As 70826-6

The underside of roof in Corridor-void above (Rm 0/098) does not contain asbestos.

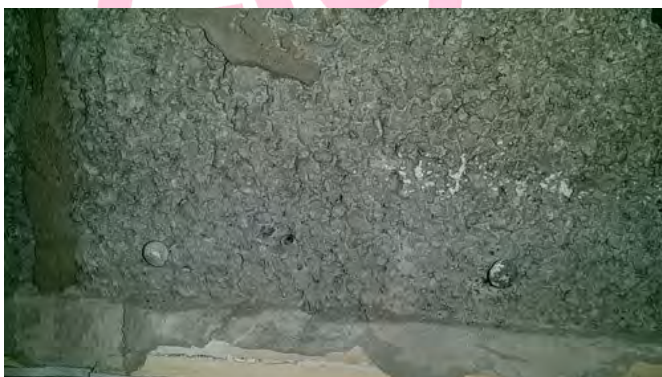
Item 83 - Ref: 70826-11

The debris to nails in wall at former ceiling in Corridor-void above (Rm 0/098) contains asbestos.

Removed as per reinspection survey Sept 2019

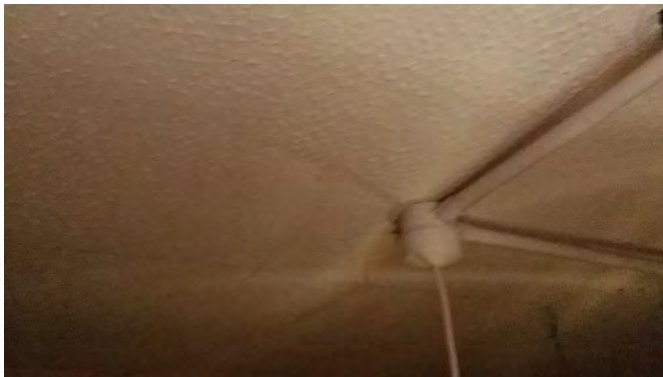
Item 84 - Ref: As 70826-9

The textured coating to ceiling in Female Toilets-void above (Rm 0/099) contains asbestos.

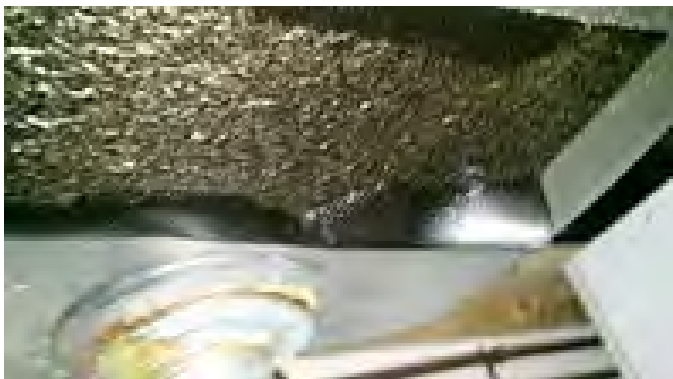
Item 86 - Ref: Presumed

The sink pads in Kitchen (Rm 0/101) are presumed to contain asbestos.

Any change in its appearance should be recorded and passed to Property Services.

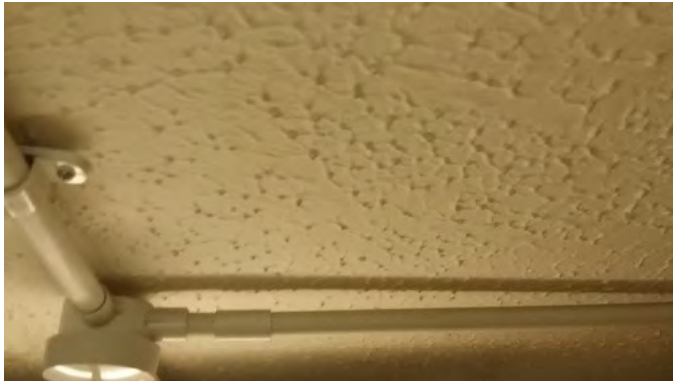
Item 87 - Ref: As 70826-9

The textured coating to ceiling in Kitchen-void above (Rm 0/101) contains asbestos.

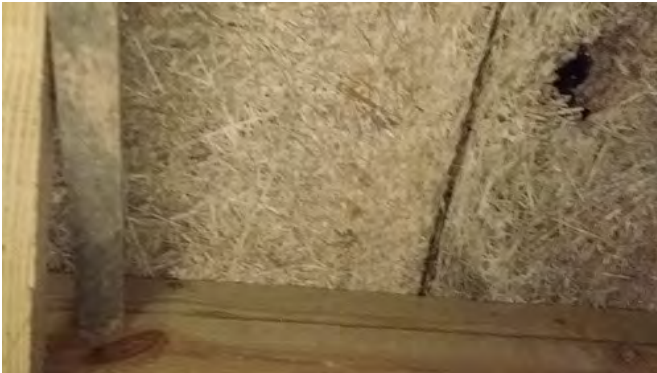
Item 90 - Ref: 70826-12

The underside of roof in Disabled Toilet-void above (Rm 0/104) does not contain asbestos.

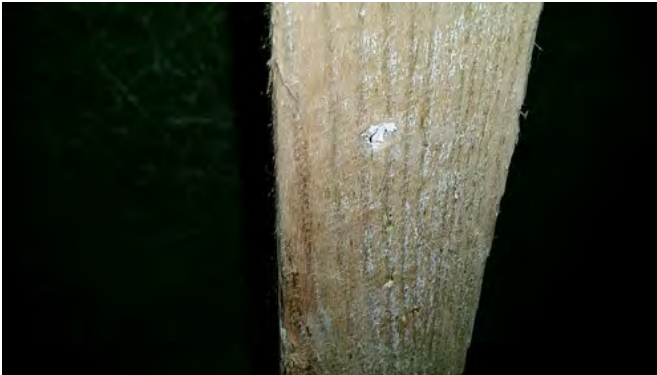
Item 91 - Ref: 70826-13

The debris to beams in Disabled Toilet-void above (Rm 0/104) does not contain asbestos.

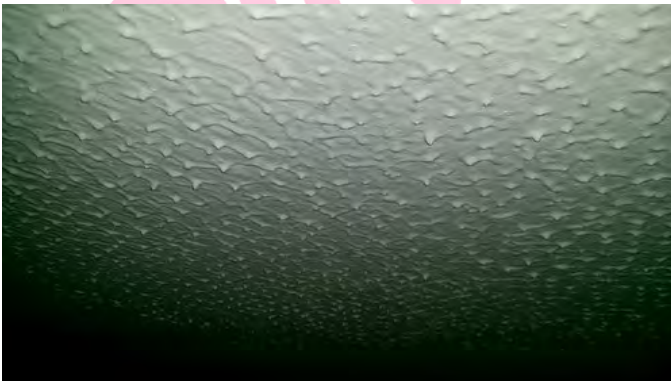
Item 92 - Ref: 70826-14

The textured coating to ceiling in Training Rm-void above (Rm 0/105) contains asbestos.

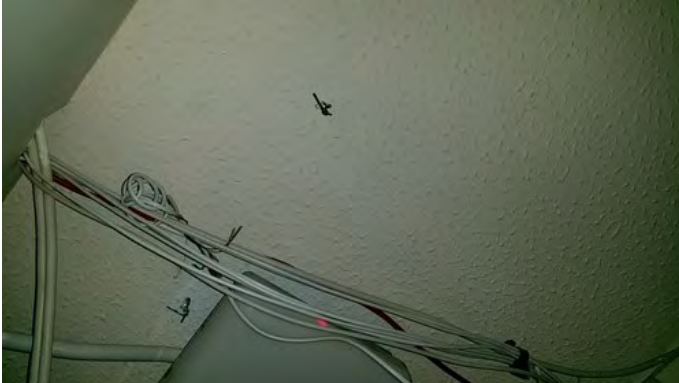
Item 96 - Ref: As 70826-14

The textured coating to ceiling in Electrics Cupboard -void above (Rm 0/107a) contains asbestos.

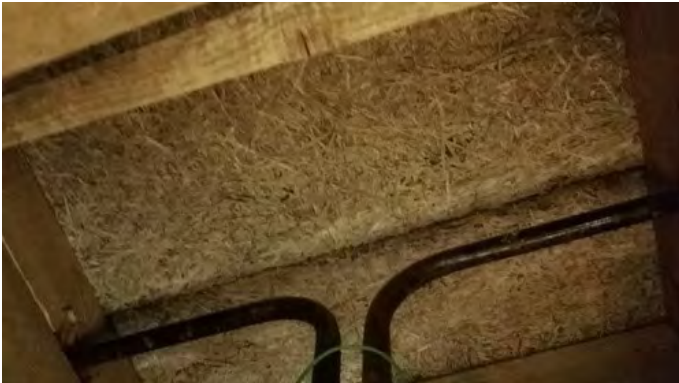
Item 97 - Ref: As 70826-12

The underside of roof in Male Toilet -void above (Rm 0/108) does not contain asbestos.

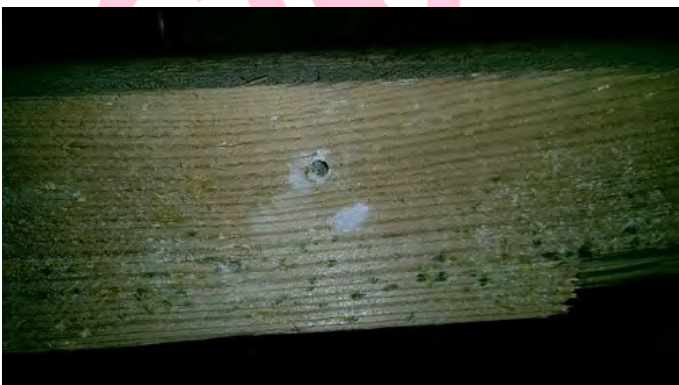
Item 98 - Ref: As 70826-13

The Debris to beams in Male toilet -void above (Rm 0/108) does not contain asbestos.

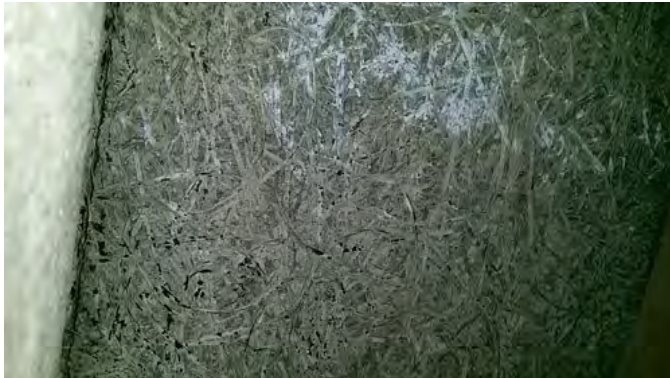
Item 99 - Ref: As 70826-12

The underside of roof in Female Toilet -void above (Rm 0/109) does not contain asbestos.

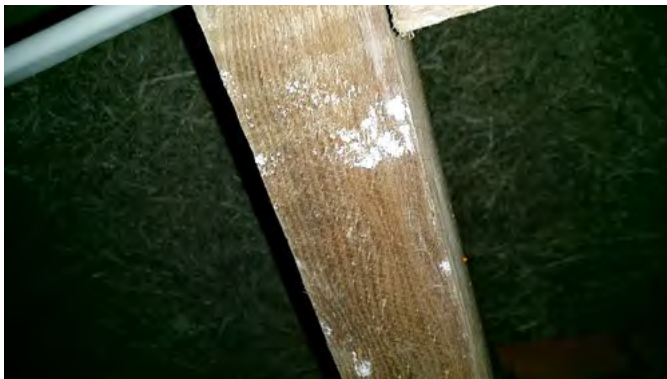
Item 100 - Ref: As 70826-13

The debris to beams in Female Toilet -void above (Rm 0/109) does not contain asbestos.

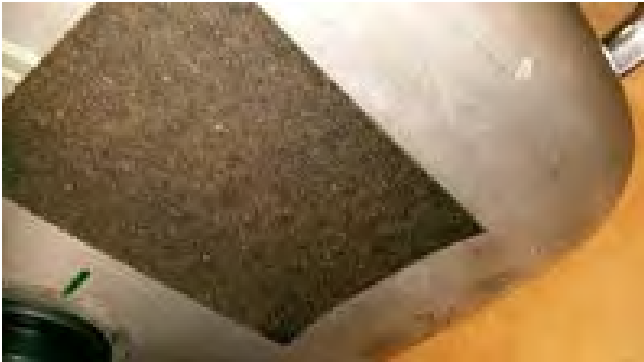
Item 102 - Ref: Presumed

The sink pads in Bar Area (Rm 0/111) are presumed to contain asbestos.

Any change in its appearance should be recorded and passed to Property Services.

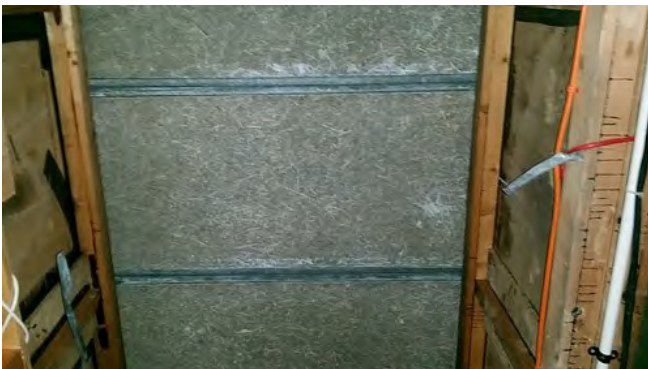
Item 103 - Ref: As 70826-12

The underside of roof in Bar Area -void above (Rm 0/111) does not contain asbestos.

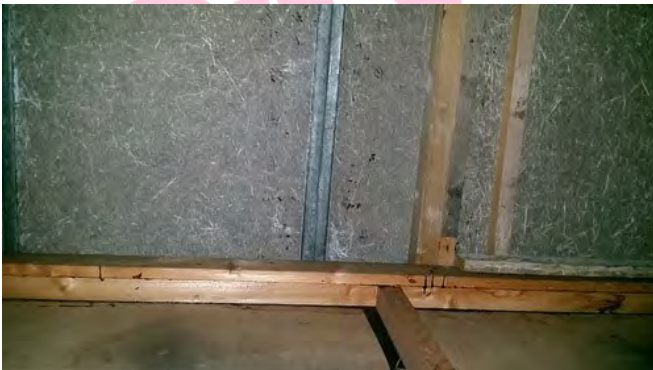
Item 104 - Ref: As 70826-12

The underside of roof in Store -void above (Rm 0/112) does not contain asbestos.

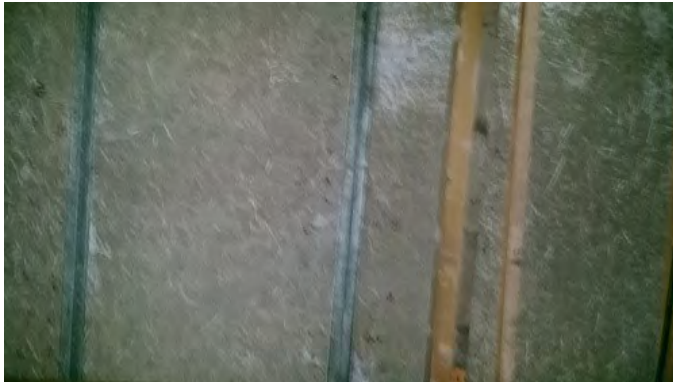
Item 105 - Ref: As 70826-12

The underside of roof in Barrel Store -void above (Rm 0/113) does not contain asbestos.

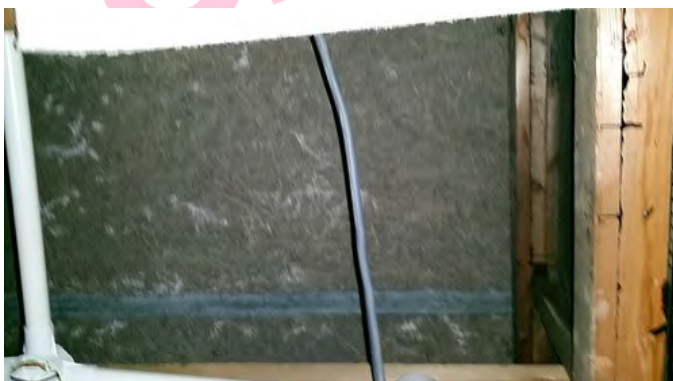
Item 107 - Ref: As 70826-12

The underside of roof in Kitchen -void above (Rm 0/114) does not contain asbestos.

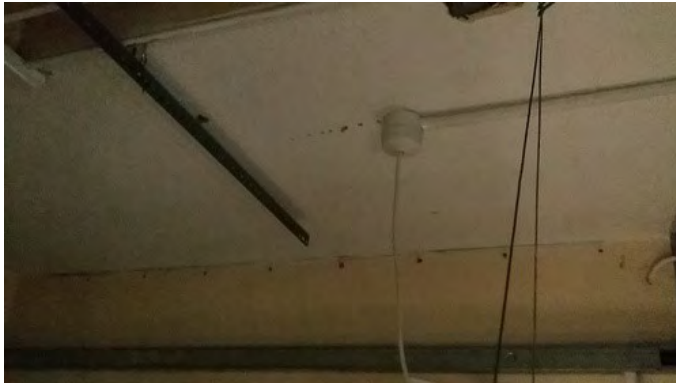
Item 108 - Ref: As 70826-14

The textured coating to ceiling in Kitchen -void above (Rm 0/114) contains asbestos.

Any change in its appearance should be recorded and passed to Property Services.

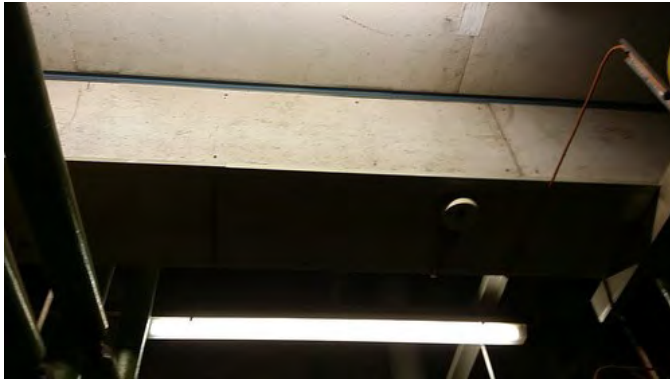
Item 111 - Ref: 70826-22

The boxing to beam in Boiler Room (Rm 0/116) contains asbestos.

Removed Oct '20

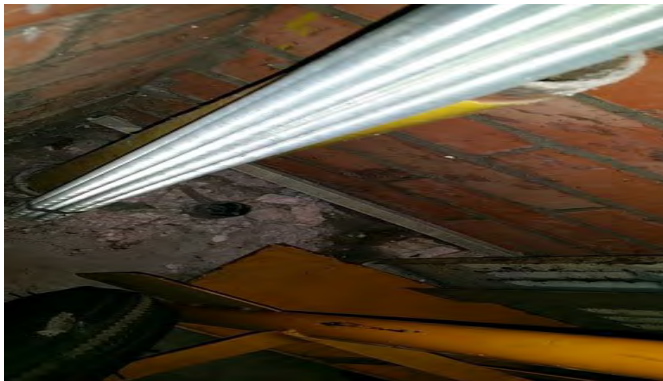
Item 112 - Ref: 70826-25

The debris to floor in Boiler Room (Rm 0/116) does not contain asbestos.

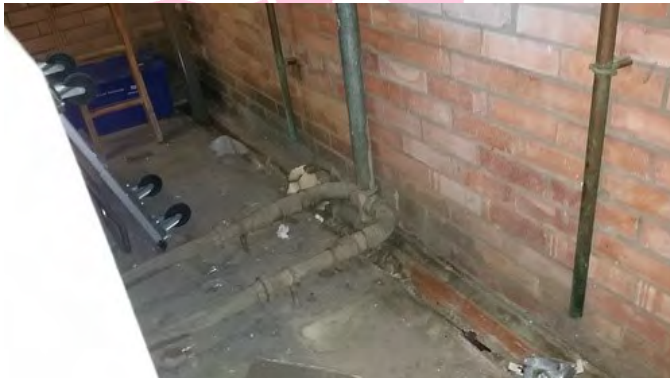
Item 113 - Ref: 70826-26

The general debris to floor in Boiler Room (Rm 0/116) contains asbestos.

**Removed as per
reinspection survey Sept
2019**

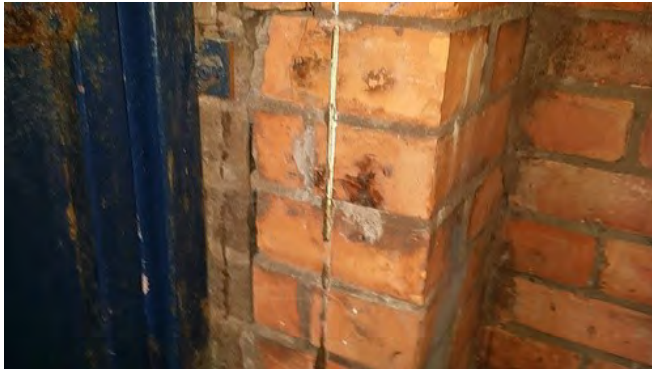
Item 114 - Ref: 70826-27

The remnant mastic to door frame in Boiler Room (Rm 0/116) contains asbestos.

Removed Oct '20

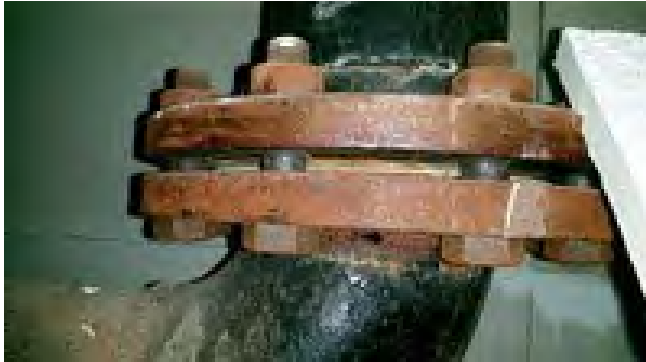
Item 115 - Ref: Presumed

The flange gaskets in Caretakers Office (Rm 0/117) are presumed to contain asbestos.

Any change in its appearance should be recorded and passed to Property Services.

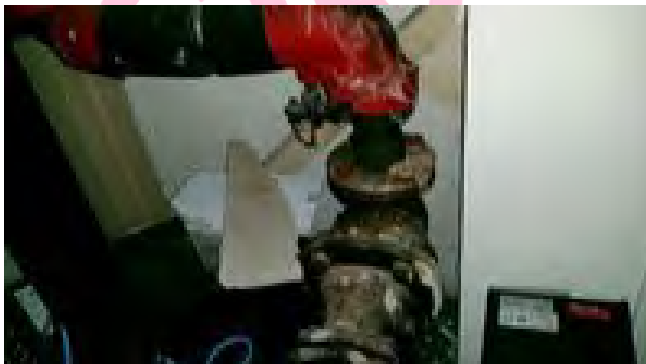
Item 116 - Ref: Presumed

The flange gaskets in Server Room (Rm 0/118) are presumed to contain asbestos.

Any change in its appearance should be recorded and passed to Property Services.

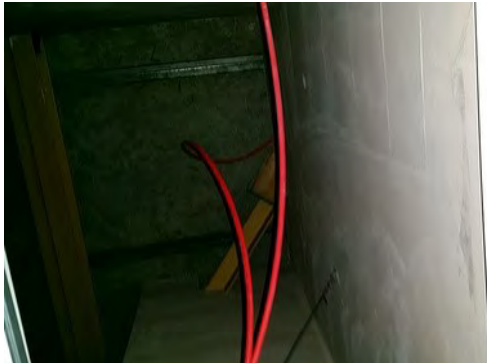
Item 117 - Ref: As 70826-12

The underside of roof in Server Room -void above (Rm 0/118) does not contain asbestos.

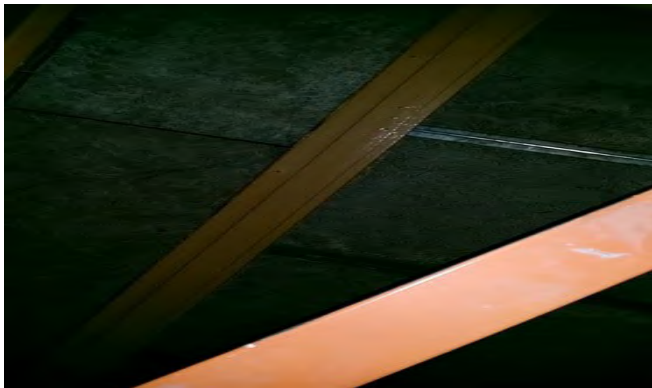
Item 118 - Ref: As 70826-12

The underside of roof in Corridor -void above (Rm 0/119) does not contain asbestos.

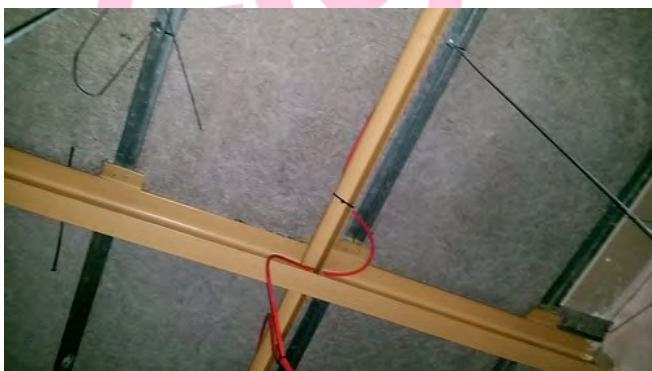
Item 119 - Ref: As 70826-12

The underside of roof in Office -void above (Rm 0/120) does not contain asbestos.

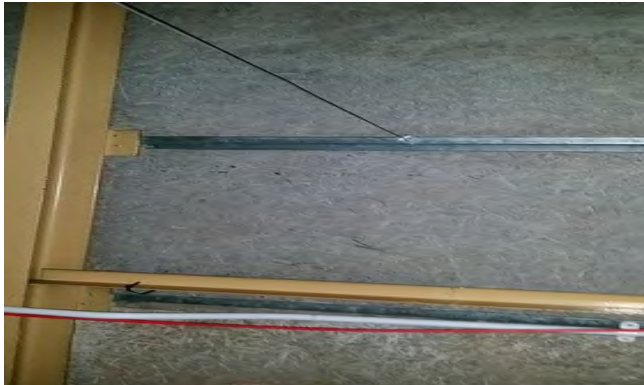
Item 120 - Ref: As 70826-12

The underside of roof in General Office -void above (Rm 0/121) does not contain asbestos.

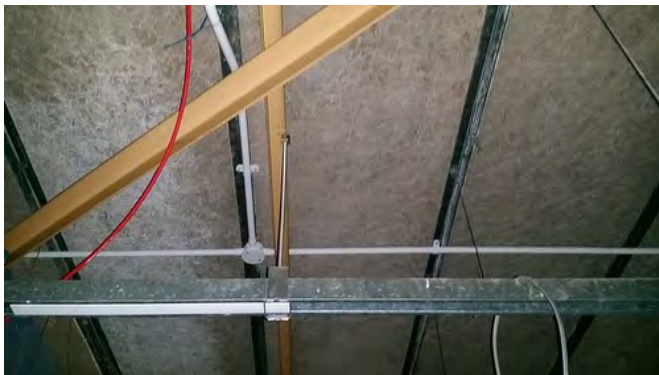
Item 121 - Ref: As 70826-12

The underside of roof in Managers Office -void above (Rm 0/122) does not contain asbestos.

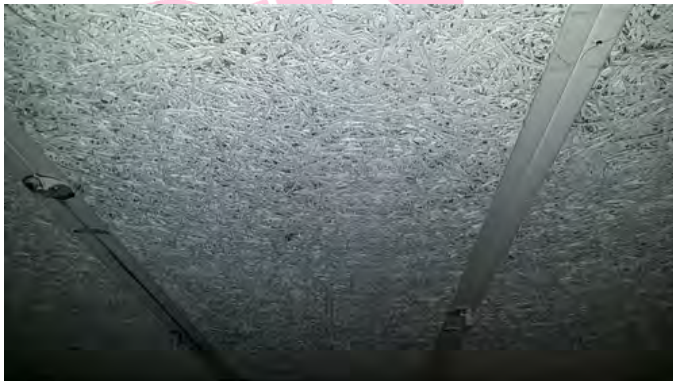
Item 122 - Ref: 70826-28

The underside of roof in Refurb Warehouse -void above (Rm 0/123) does not contain asbestos.

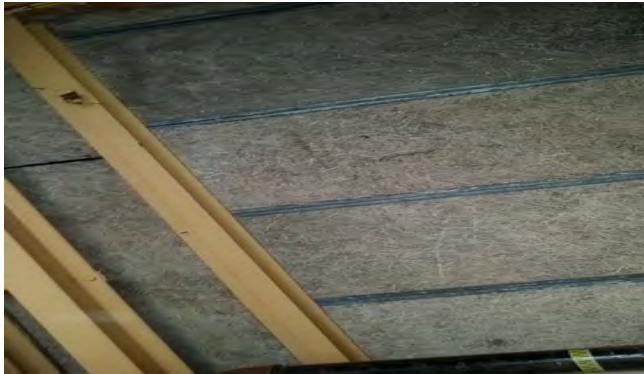
Item 123 - Ref: As 70826-28

The underside of roof in Gas Store -void above (Rm 0/124) does not contain asbestos.

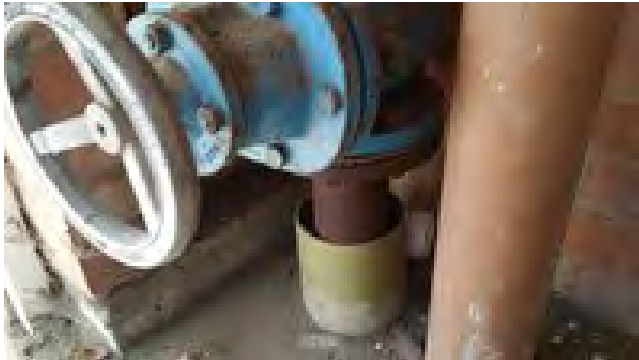
Item 124 - Ref: Presumed

The flange gaskets in Gas Store (Rm 0/124) are presumed to contain asbestos.

Any change in its appearance should be recorded and passed to Property Services.

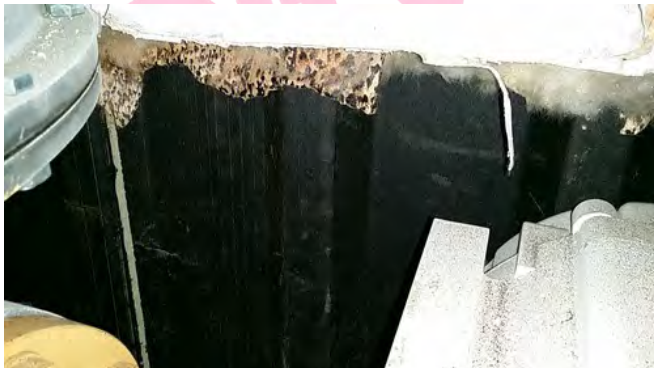
Item 125 - Ref: 70826-29

The coating to external wall in Gas Store (Rm 0/124) contains asbestos.

Any change in its appearance should be recorded and passed to Property Services.

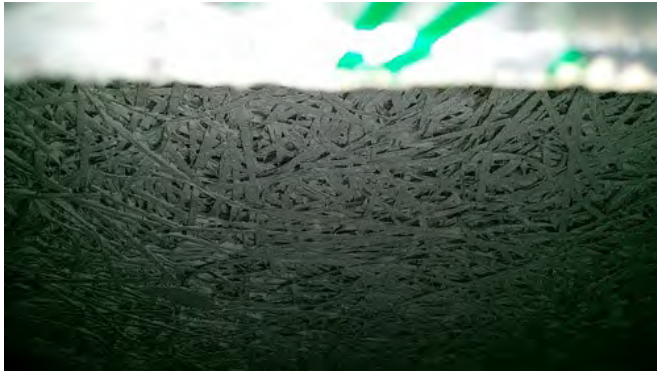
Item 126 - Ref: As 70826-28

The underside of roof in Spares Workshop -void above (Rm 0/127) does not contain asbestos.

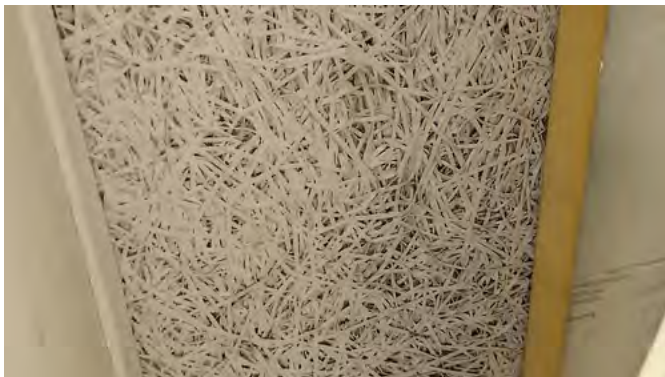
Item 127 - Ref: As 70826-28

The underside of roof in Machine Wash Area -void above (Rm 0/128) does not contain asbestos.

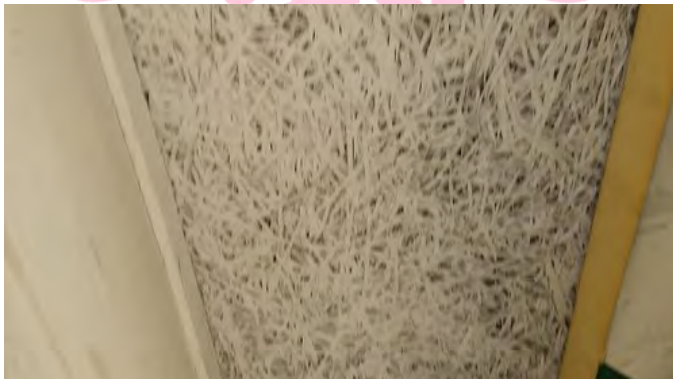
Item 128 - Ref: As 70826-28

The underside of roof in Office -void above (Rm 0/129) does not contain asbestos.

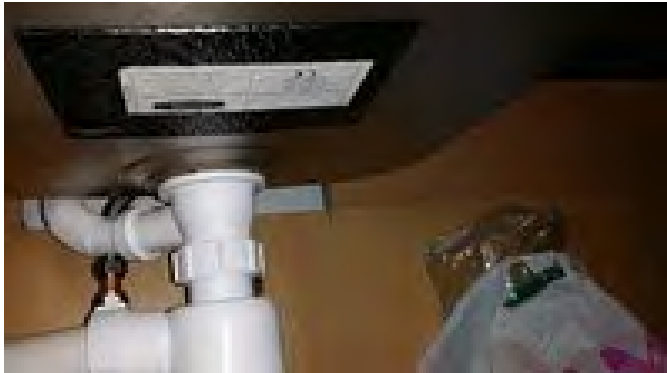
Item 129 - Ref: Presumed

The sink pads in Hand Wash Area (Rm 0/130) are presumed to contain asbestos.

Any change in its appearance should be recorded and passed to Property Services.

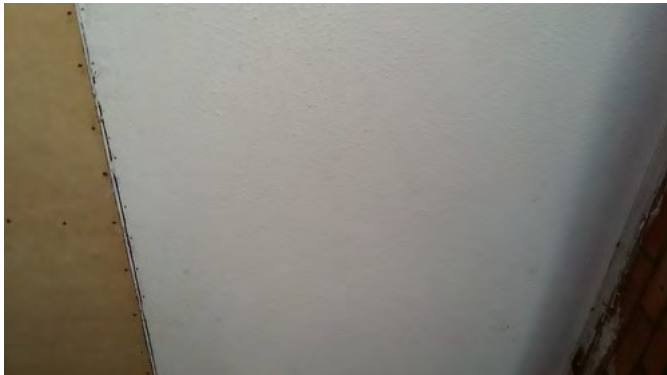
Item 130 - Ref: As 70826-31

The coating to plasterboard ceiling in Gas Cylinder Store (Rm 0/133) contains asbestos.

Any change in its appearance should be recorded and passed to Property Services.

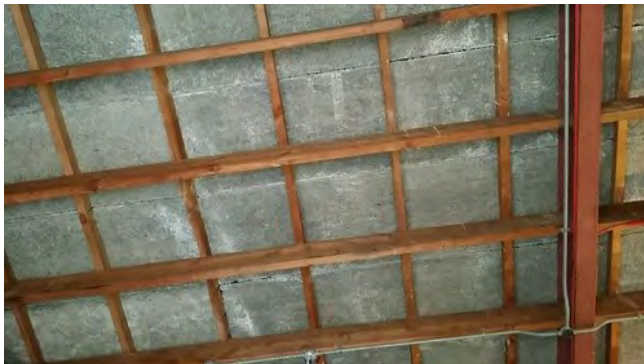
Item 132 - Ref: As 70826-28

The underside of roof in Former compressor room (Rm 0/134) does not contain asbestos.

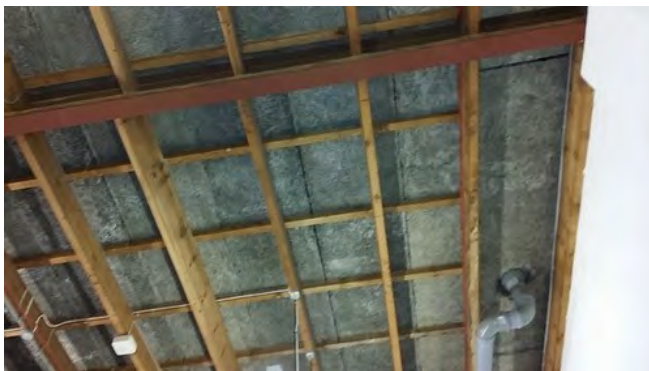
Item 133 - Ref: As 70826-28

As 70826-28 – Underside of Roof (Equipment Store 0/135) (Item 133) – No Risk
As 70826-28 – Underside of Roof (Document Store 0/136) (Item 134) – No Risk
70826-34 – Underside of roof above stramit (Boiler Room 0/137) (Item 135) – No Risk
70826-35 – Underside of roof (Boiler Room 0/137) (Item 136) -No Risk
70826-37 – General debris to floor (Boiler Room 0/137) (Item 137) – No Risk
70826-36 – Loose lying gasket to floor (Boiler Room 0/137) (Item 138) – No Risk
Presumed – Flange Gaskets (Boiler Room 0/137) (Item 139) – Removed Oct 2020
70826-15 – Underside of roof (Tank Room 1/001) (Item 140) – No Risk
70826-16 – Debris to beams (Tank Room 1/001) (Item 141) – No Risk
70826-17 – Boiler Flue (Tank Room 1/001) (Item 142) – Removed Oct 2020
*70826-18 – Seal to loose lying light fitting (Tank Room 1/001) (Item 143) –Removed
November 2019*
*70826-19 – General debris to floor (Tank Room 1/001) (Item 144) –Removed

The underside of roof in Equipment Store (Rm 0/135) does not contain asbestos.

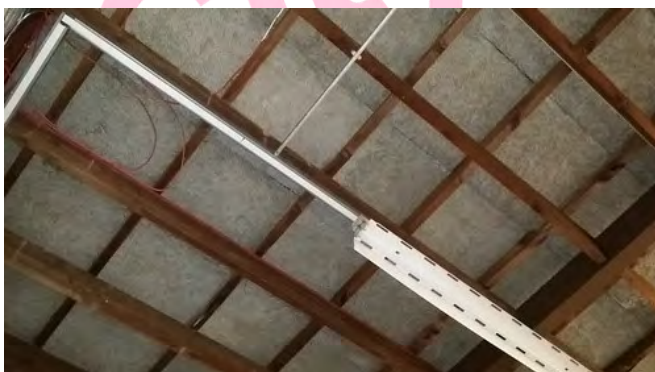
Item 134 - Ref: As 70826-28

The underside of roof in Document Store (Rm 0/136) does not contain asbestos.

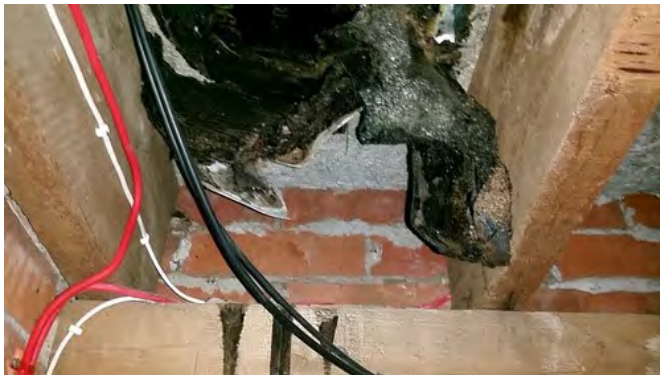
Item 135 - Ref: 70826-34

The underside of roof above stramit in Boiler Room (Rm 0/137) does not contain asbestos.

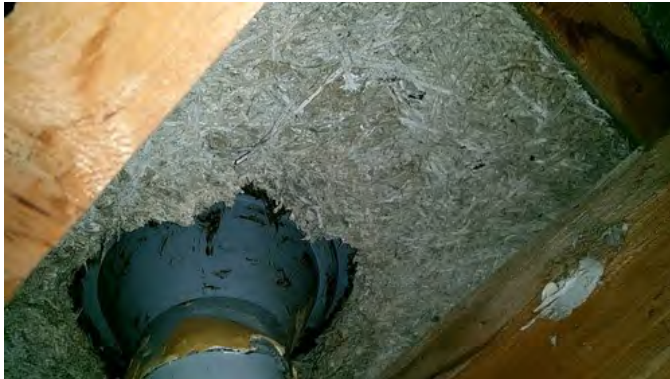
Item 136 - Ref: 70826-35

The underside of roof in Boiler Room (Rm 0/137) does not contain asbestos.

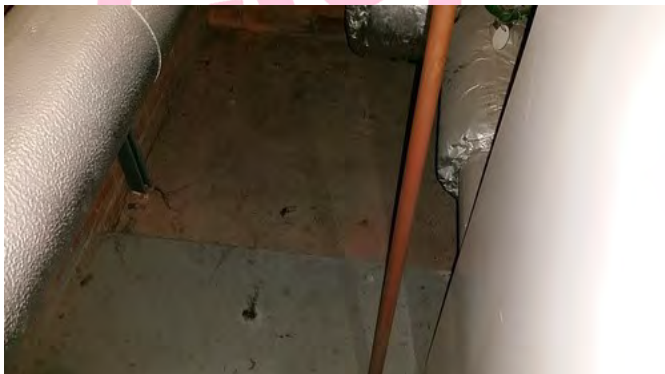
Item 137 - Ref: 70826-37

The general debris to floor in Boiler Room (Rm 0/137) does not contain asbestos.

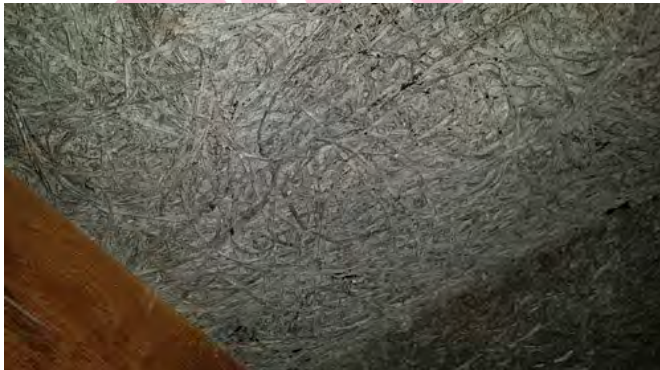
Item 140 - Ref: 70826-15

The underside of roof in Tank Room (Rm 1/001) does not contain asbestos.

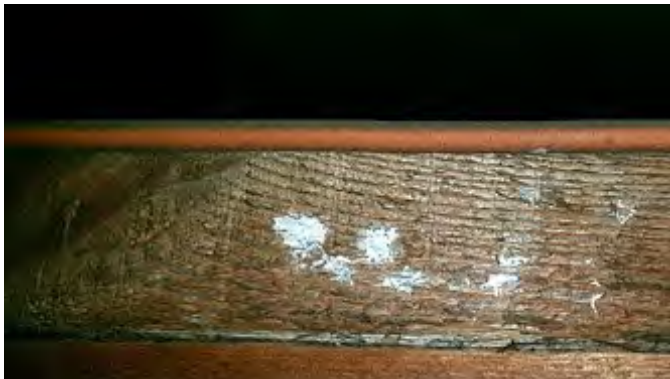
Item 141 - Ref: 70826-16

The debris to beams in Tank Room (Rm 1/001) does not contain asbestos.

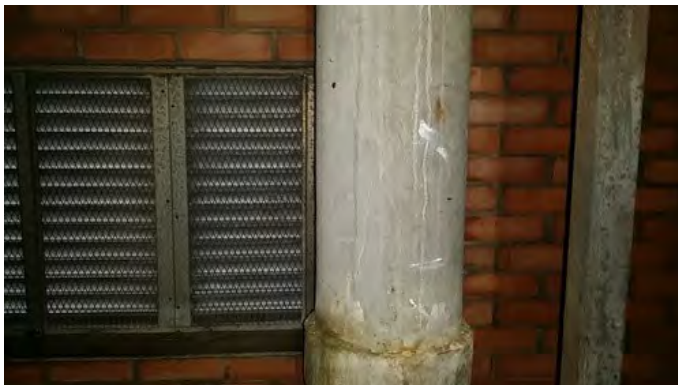
Item 142 - Ref: 70826-17

The boiler flue in Tank Room (Rm 1/001) contains asbestos.

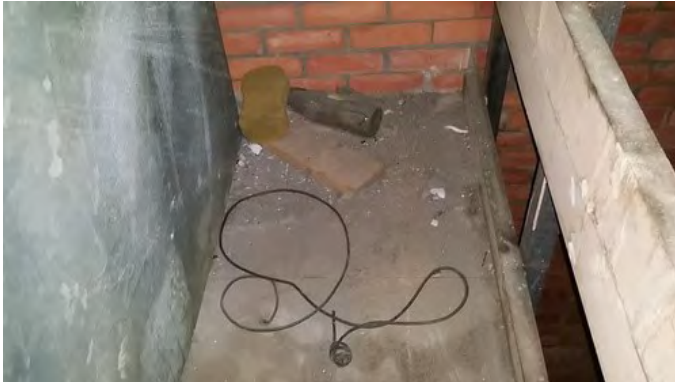
Item 144 - Ref: 70826-19

The general debris to floor in Tank Room (Rm 1/001) contains asbestos.

Item 143	Seal to loose lying light fitting (Tank Room 1/001)	Very Low		Removed November 2019
Item 144	General debris to floor (Tank Room 1/001)	Low Risk		Removed November 2019

Removed November 2019

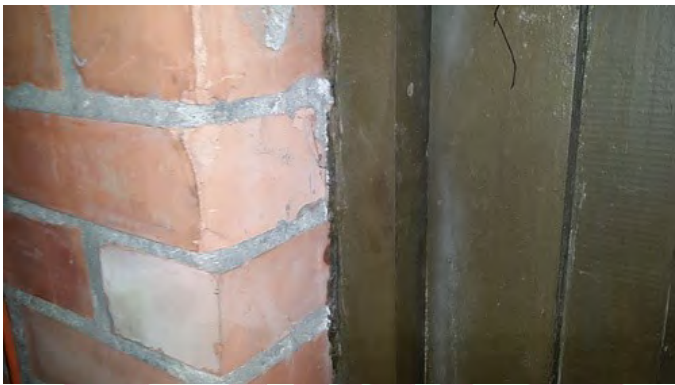
Item 145 - Ref: 70826-20

The mastic to door frame in Tank Room (Rm 1/001) contains asbestos.

Any change in its appearance should be recorded and passed to Property Services.
